CHARACTERIZATION AND HAZARD ZONATION OF THE MEADOW CREEK LANDSLIDE AFFECTING STATE ROUTE 9, PART OF THE COAL HILL LANDSLIDE COMPLEX, WESTERN KANE COUNTY, UTAH

by Francis X. Ashland, Greg N. McDonald, Lucas M. Shaw, and James A. Bay

SPECIAL STUDY 131
UTAH GEOLOGICAL SURVEY
a division of
UTAH DEPARTMENT OF NATURAL RESOURCES
2009

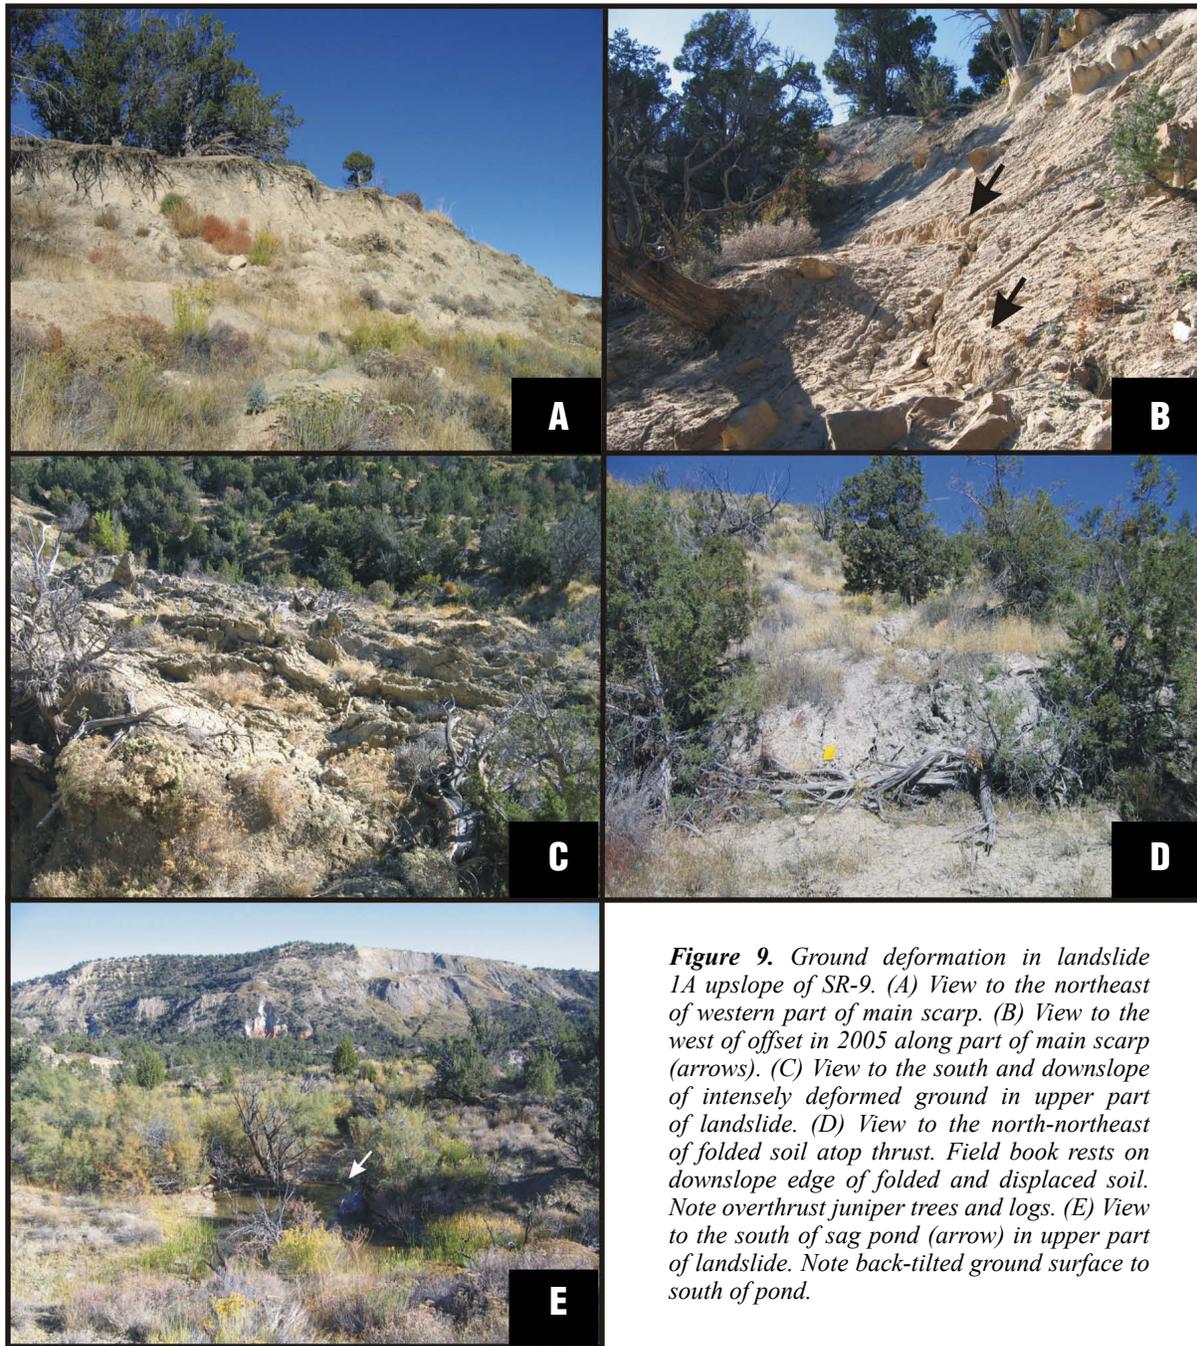
Figure 9. Ground deformation in landslide 1A upslope of SR-9. (A) View to the northeast of western part of main scarp. (B) View to the west of offset in 2005 along part of main scarp (arrows). (C) View to the south and downslope of intensely deformed ground in upper part of landslide. (D) View to the north-northeast of folded soil atop thrust. Field book rests on downslope edge of folded and displaced soil. Note overthrust juniper trees and logs. (E) View to the south of sag pond (arrow) in upper part of landslide. Note back-tilted ground surface to south of pond.

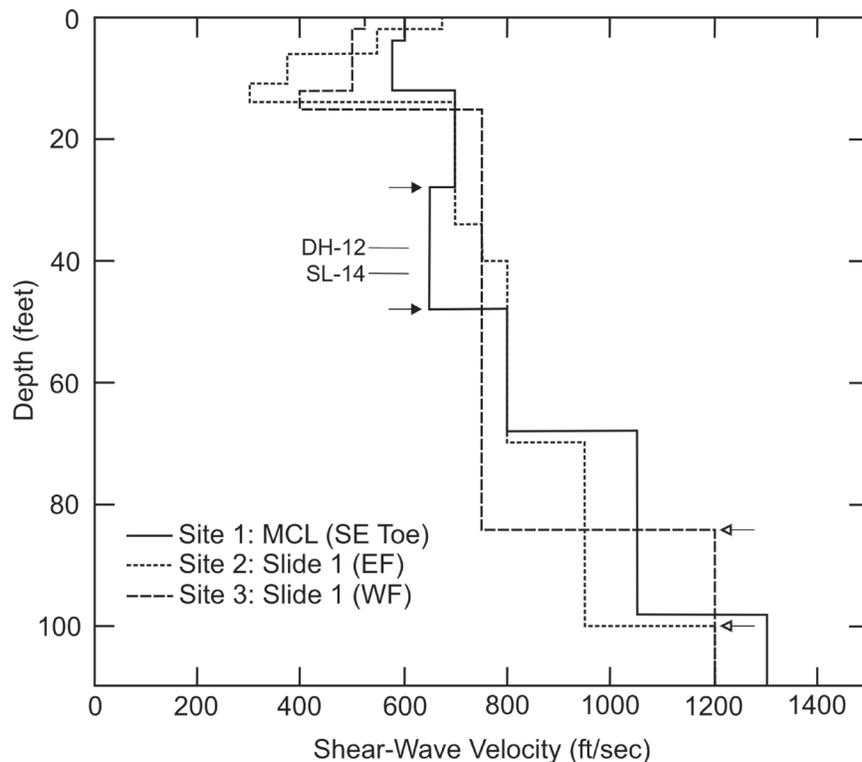
The three measured shear-wave-velocity profiles are compared on figure 14. A significant inversion exists at site 1, near the toe of the Meadow Creek landslide, at a depth of between 28 and 48 feet (9–14 m). This velocity inversion is not as large as the more shallow ones at sites 2 and 3, but is consistent with a surface-of-rupture zone. Data from a nearby geotechnical borehole and seismic refraction line (Stouffer, 1964), located about 300 to 400 feet (90–120 m) to the east-southeast of site 1, support this interpretation, and indicate landslide depths of 38 and 42 feet (12 and 13 m), respectively. These depths are bracketed by the upper and lower boundaries defining the velocity inversion at site 1.

The near-surface soils in the top 15 feet (5 m) are stiffer at site 1 than at sites 2 and 3. Both sites 2 and 3 have a significant velocity inversion in the upper 15 feet with a very low-velocity layer at the base of the inversion. However, both sites 2 and 3 are along abandoned SR-15, and a highway embankment exists on the downslope side of the test areas. The shallow velocity inversion may be related to fill density or condition in the embankment fill and reflect a decreasing level of compaction of the fill with depth. No other velocity inversions were de-

Figure 14. Comparison of shear-wave-velocity profiles determined from SASW testing. Site 1 is on the southeastern toe of the Meadow Creek landslide (MCL) near a previous geotechnical borehole (DH-12) and seismic refraction line (SL-14) (see Stouffer, 1964). A shear-wave-velocity inversion between the depths of 28 and 48 feet (8.5–15 m) (solid arrows) brackets the depth of the landslide deposit determined from the borehole and seismic line (38 and 42 feet [12–13 m], respectively). Sites 2 and 3 are on the east (EF) and west (WF) flanks of landslide 1 along abandoned SR-15. Sharp velocity contrasts at depths of 84 and 100 feet (26–30 m) (open arrows) may indicate the depth of the landslide. See figure 13 for site locations.

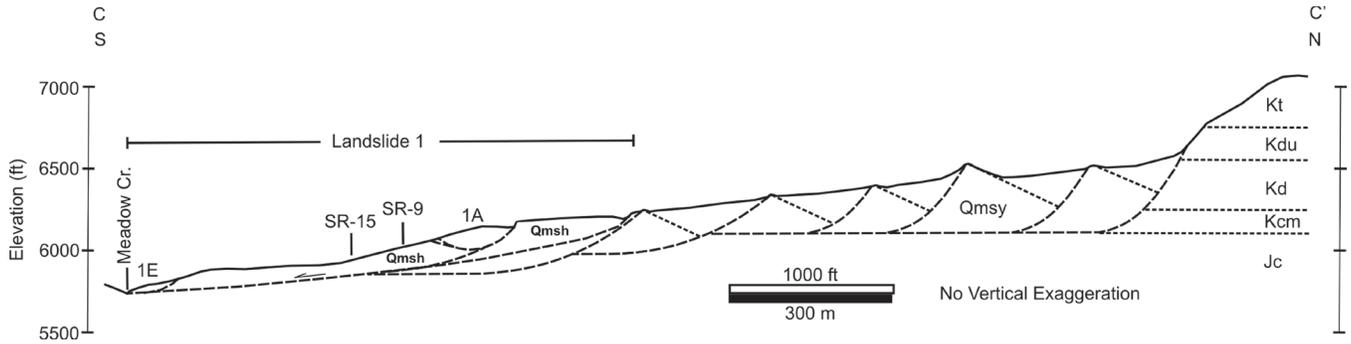
Cross section C-C' (figure 15) shows a conceptual model of the Meadow Creek landslide. The cross section assumes that the basal surface of rupture in the upper part of the landslide is relatively flat sloping, roughly parallel to bedding, and in the Cedar Mountain Formation. The dip (about 25 degrees) of back-tilted blocks of Dakota Formation that form the prominent ridges in the upper part of the landslide are based on field measurements. The subsurface geometries of landslides 1 and 1A are constrained by field mapping of the toe and main-scarp locations and, for landslide 1, the depth determined by SASW testing along SR-15. The basal surface of rupture of landslide 1 is likely in the Carmel Formation although landslide debris at the surface appears to be mostly derived from overlying formations.

Figure 15. Conceptual geologic cross section of the Meadow Creek landslide. See figure 4 for section line location. Geologic units: Qmsh – historical landslide 1 (including landslides 1A and 1E), Qmsy –Meadow Creek landslide, Kt – Tropic Shale, Kdu – upper member of Dakota Formation, Kd – main body of the Dakota Formation, Kcm – Cedar Mountain Formation, Jc – Carmel Formation. Bedrock unit thicknesses estimated from Hylland (2000).

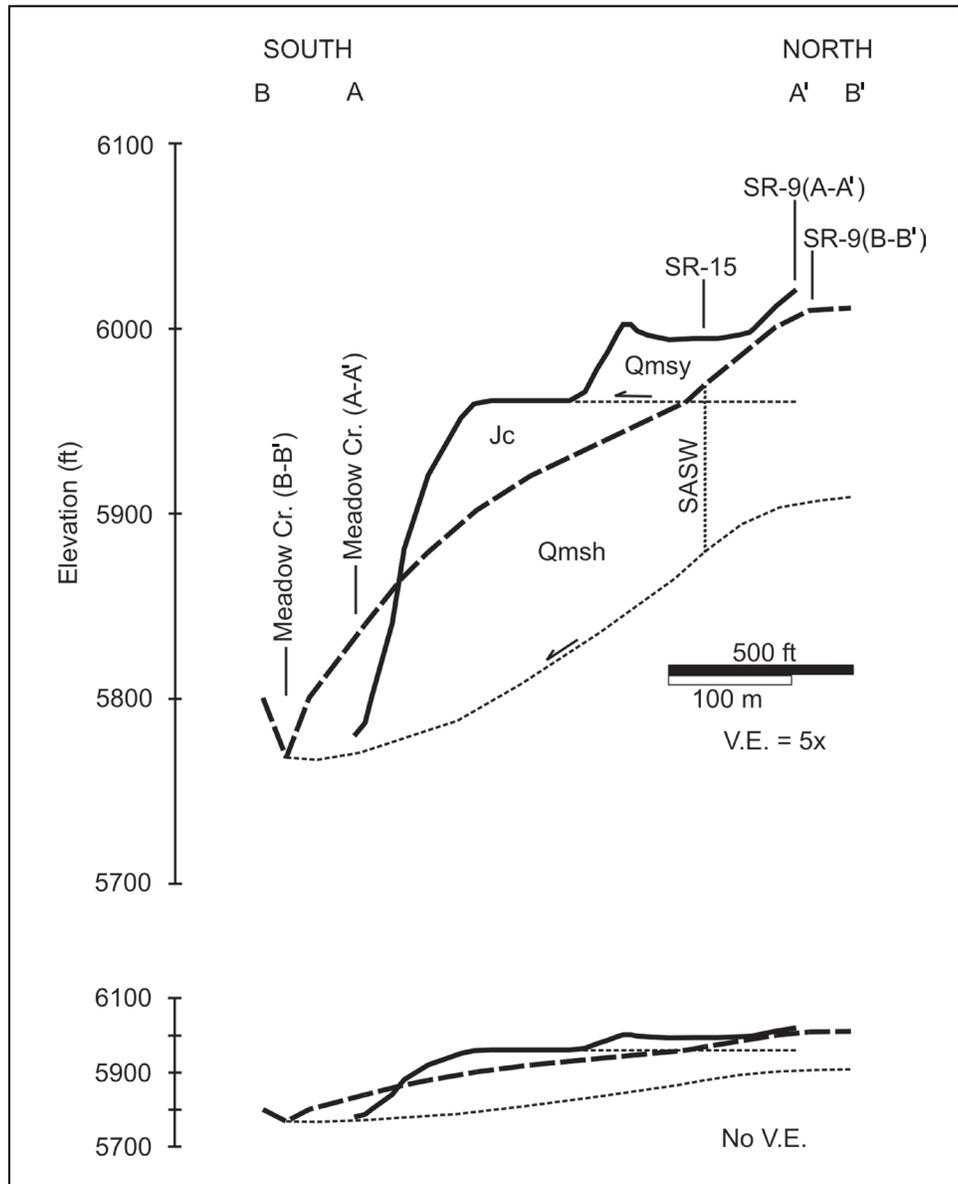
Cross section B-B' through the lower east side of landslide 1 shows an estimated geometry using a possible depth from the SASW testing along abandoned SR-15. Cross section B-B' suggests a deeper basal surface-of-rupture zone in landslide 1 than in the adjacent part of the Meadow Creek landslide directly to the east. Thus, a subhorizontal erosional surface in the Carmel Formation must be at least 60 feet (18 m) lower than at cross section A-A', if it exists at all beneath landslide 1.

Figure 16. Geologic cross sections showing possible geometries and minimum depths of southernmost Meadow Creek landslide (A-A') and southern part of landslide 1 (B-B'). Solid black and long dashed lines are topographic profiles for cross sections A-A' and B-B', respectively. Short dashed lines are estimated surfaces of rupture. Vertical line shows estimated depth of landslide deposits from SASW testing. Lower cross sections are same as upper without vertical exaggeration (V.E.). See plate 1 for cross-section line locations. Geologic units: Qmsh – landslide 1, Qmsy – Meadow Creek landslide, Jc – Carmel Formation.

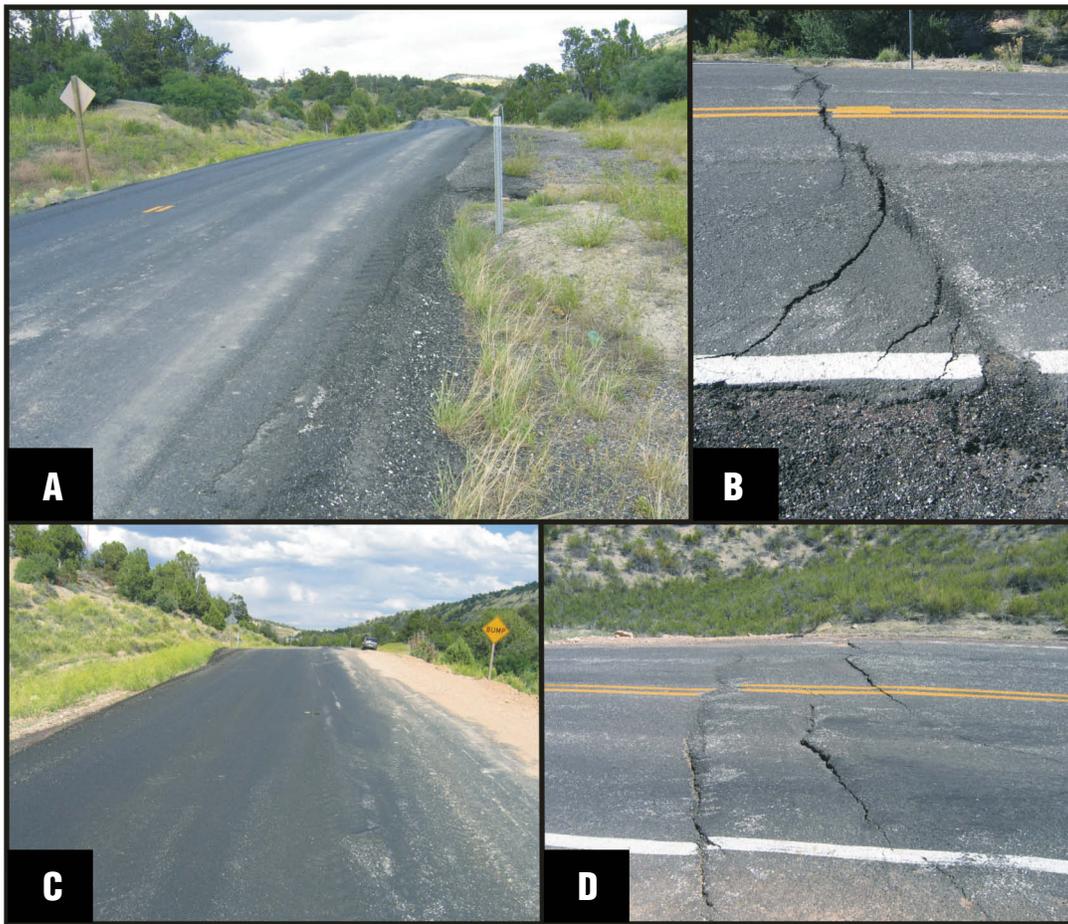
Figure 20. Additional road damage to SR-9 by May 2007. (A) View to the east where SR-9 crosses the west-flank shear zone. Note highway surface was recently repaved. Photograph taken on June 13, 2006. (B) View to the south of damage along west-flank shear zone on May 8, 2007. Measured horizontal offset of yellow striping was about 3 inches (8 cm). (C) View to the east where SR-9 crosses the east-flank shear zone. Note highway surface was recently repaved. Photograph taken on June 13, 2006. (D) View to the north of damage along east-flank shear zone on May 8, 2007. Measured horizontal offset of white stripe (lower left) was about 1.7 inches (4.2 cm).
