GROUND SURFACE SUBSIDENCE
IN
CEDAR CITY, UTAH

by
Bruce N. Kaliser, Chief
Urban and Engineering Geology Section
Utah Geological and Mineral Survey

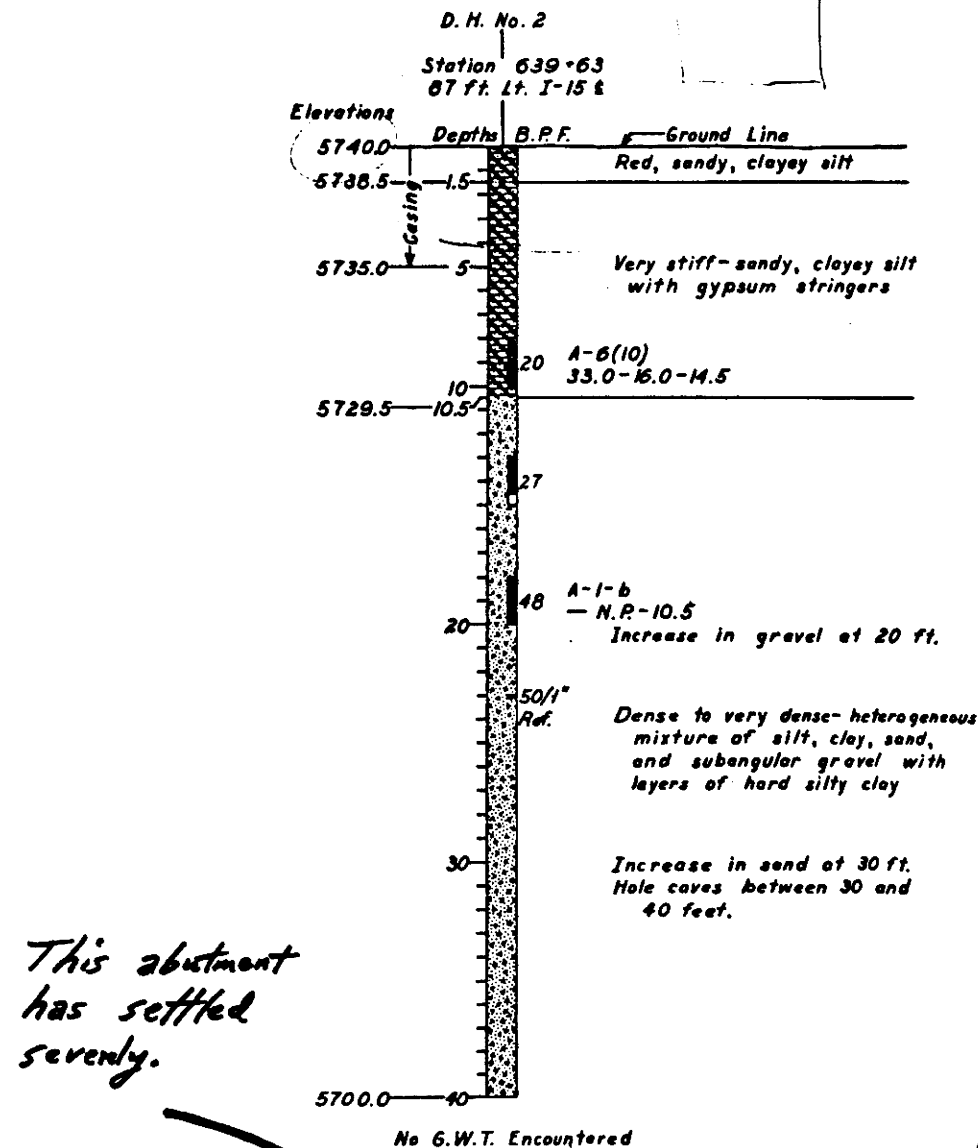
Fig. 2 - Hamilton Fort Bridge data

Interstate Highway I-15 has also experienced problems including repeated patches on a section south of the south Cedar City interchange; the bridge, even farther south, over the interstate to Hamilton Fort (figure 2); and the stretch north of the north Cedar City interchange. The west abutment of the bridge settled 18 inches during the first year it was constructed and has subsequently settled farther, about 12 inches.

Orig. → 1975 : settled .67 ft.
1975 → 1999 : settled .36 ft.
settled 1.03 ft. to date

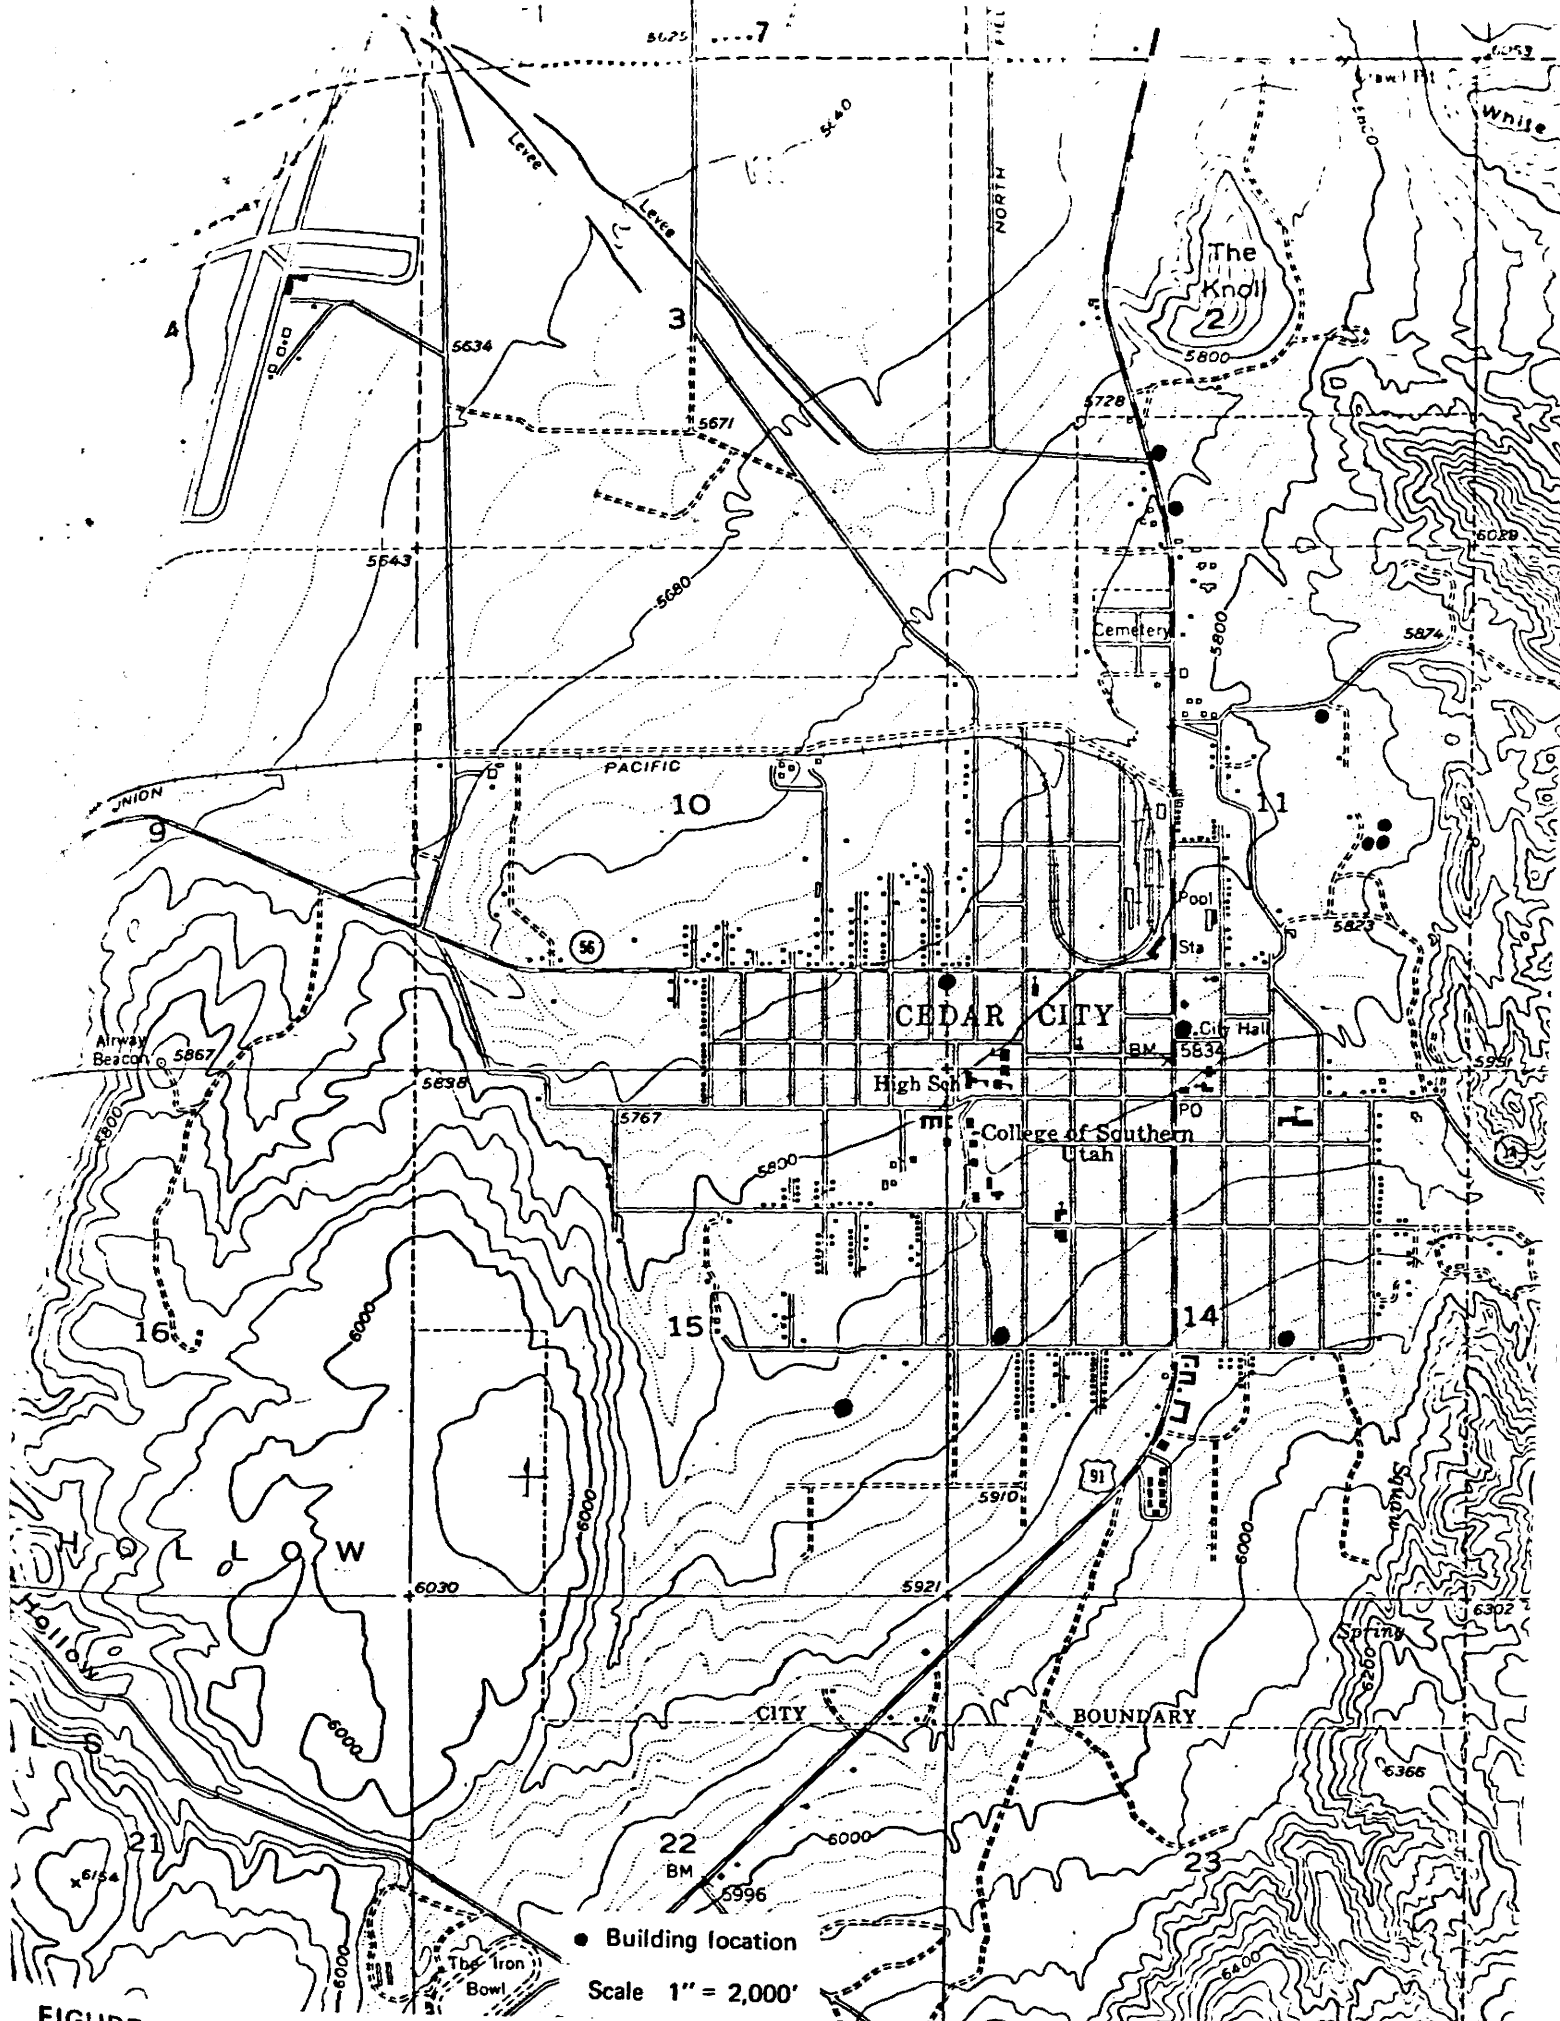
FIGURE 3. LOCATION OF BUILDINGS JACKED UP, FROM SINGLE CONTRACTOR'S RECORDS.

Figure 3 shows the locations of a number of structures in town that have been so seriously affected by ground movement as to require jacking.

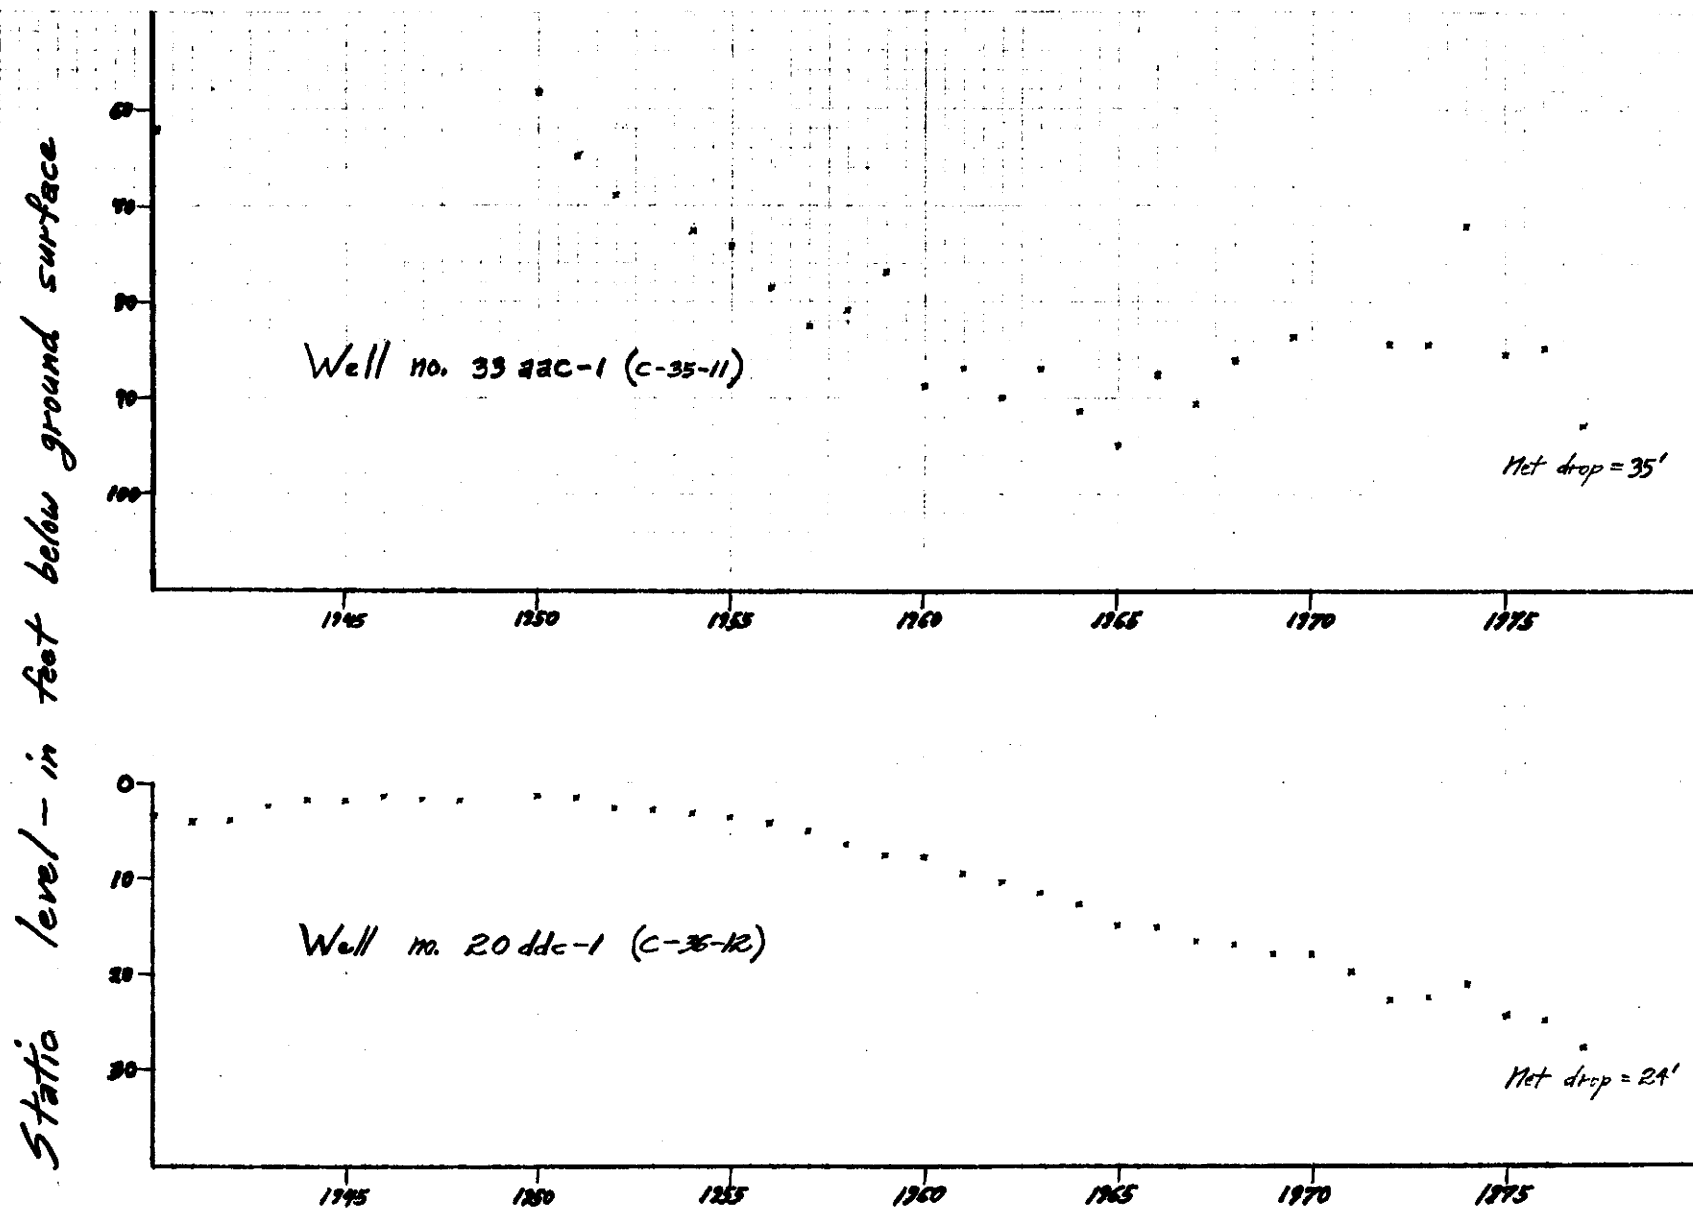
Fig. 4 - Decline of ground water levels, Cedar City area

Still another possible fault mechanism is that the fault zone, occurring as it does along the margin of the wedge of valley sediments, may be acting as a hinge for dropping the valley floor to the west. The valley floor could be settling due to tectonic processes of earth deformation that remain active or due to ground surface subsidence resulting from the withdrawals of groundwater at depth in the valley fill sediments (Figure 4).

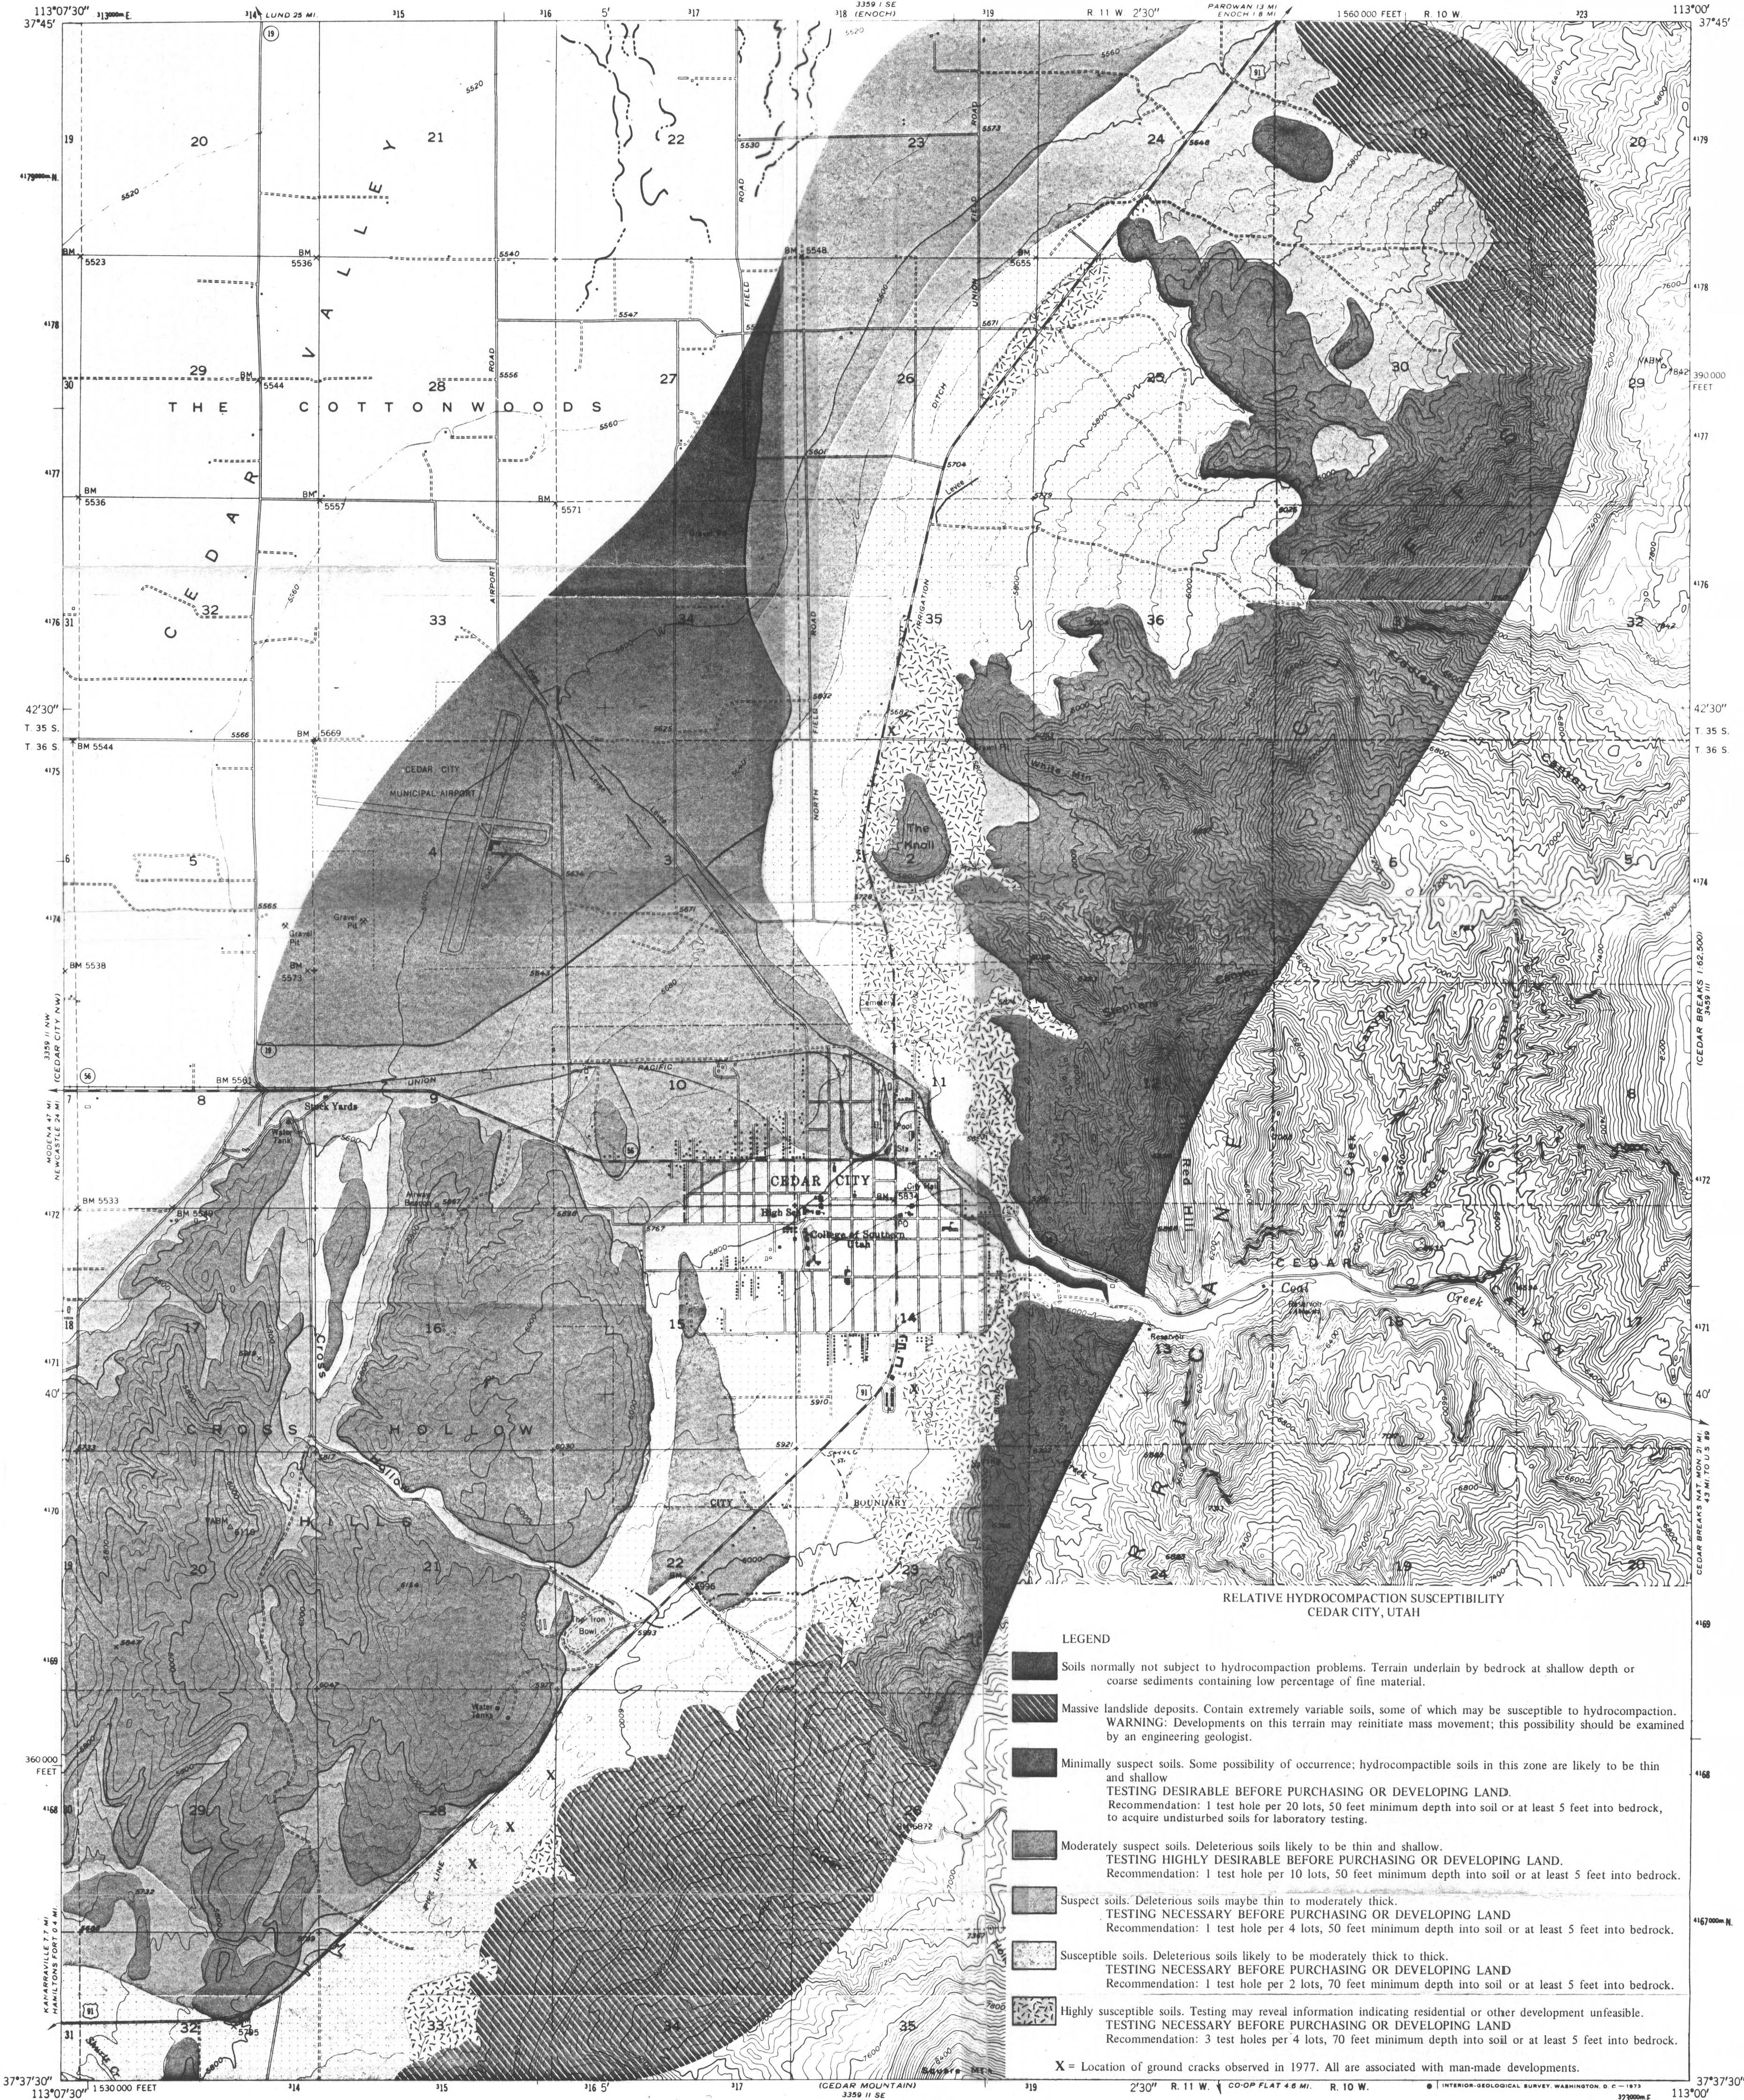
Relative degree of susceptibility to hydrocompaction is depicted on this map (see legend). Geomorphologic analysis, with aerial photographs at a scale of 1:20,000 as the primary tool, was principally employed in the preparation of this map. Only limited field checking has been done; no drilling, sampling or testing undertaken other than that shown in RI No. 124.

Purpose of this map is to inform all interested government agencies, private enterprises, and individuals planning to construct new buildings or to purchase existing buildings of a potential natural hazard from unstable ground, termed "hydrocompaction". This geologic phenomenon may be aggravated by activities of man.
