UTAH GEOLOGICAL AND MINERAL SURVEY

REPORT OF INVESTIGATION

NO. 208

TECHNICAL REPORTS FOR 1985
SITE INVESTIGATION SECTION

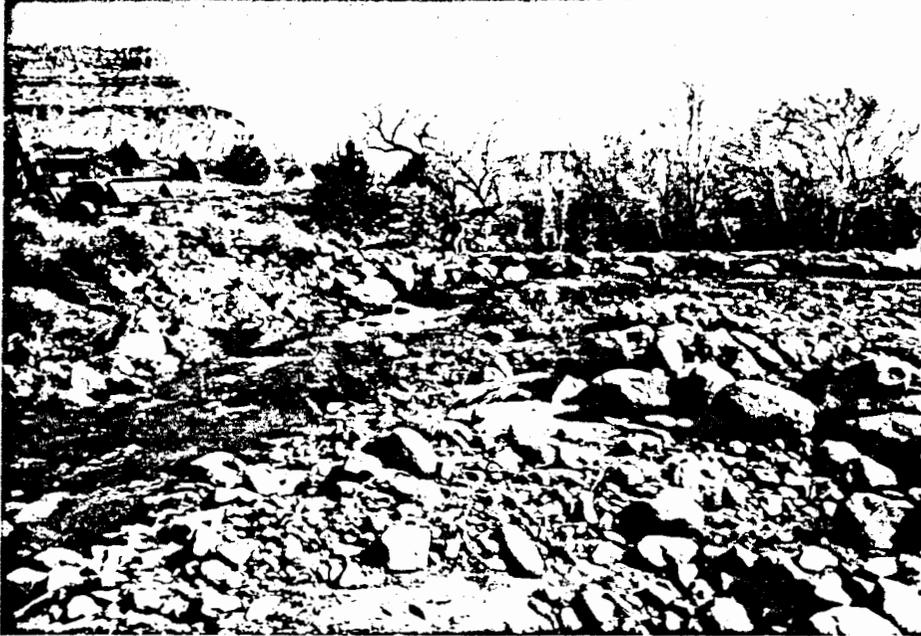
Photograph of the diversion dam on North Creek,
Washington County, Utah.
