TECHNICAL REPORTS FOR 1994 - 1995

APPLIED GEOLOGY PROGRAM

REPORT OF INVESTIGATION 228 February 1996
UTAH GEOLOGICAL SURVEY
a division of
Utah Department of Natural Resources

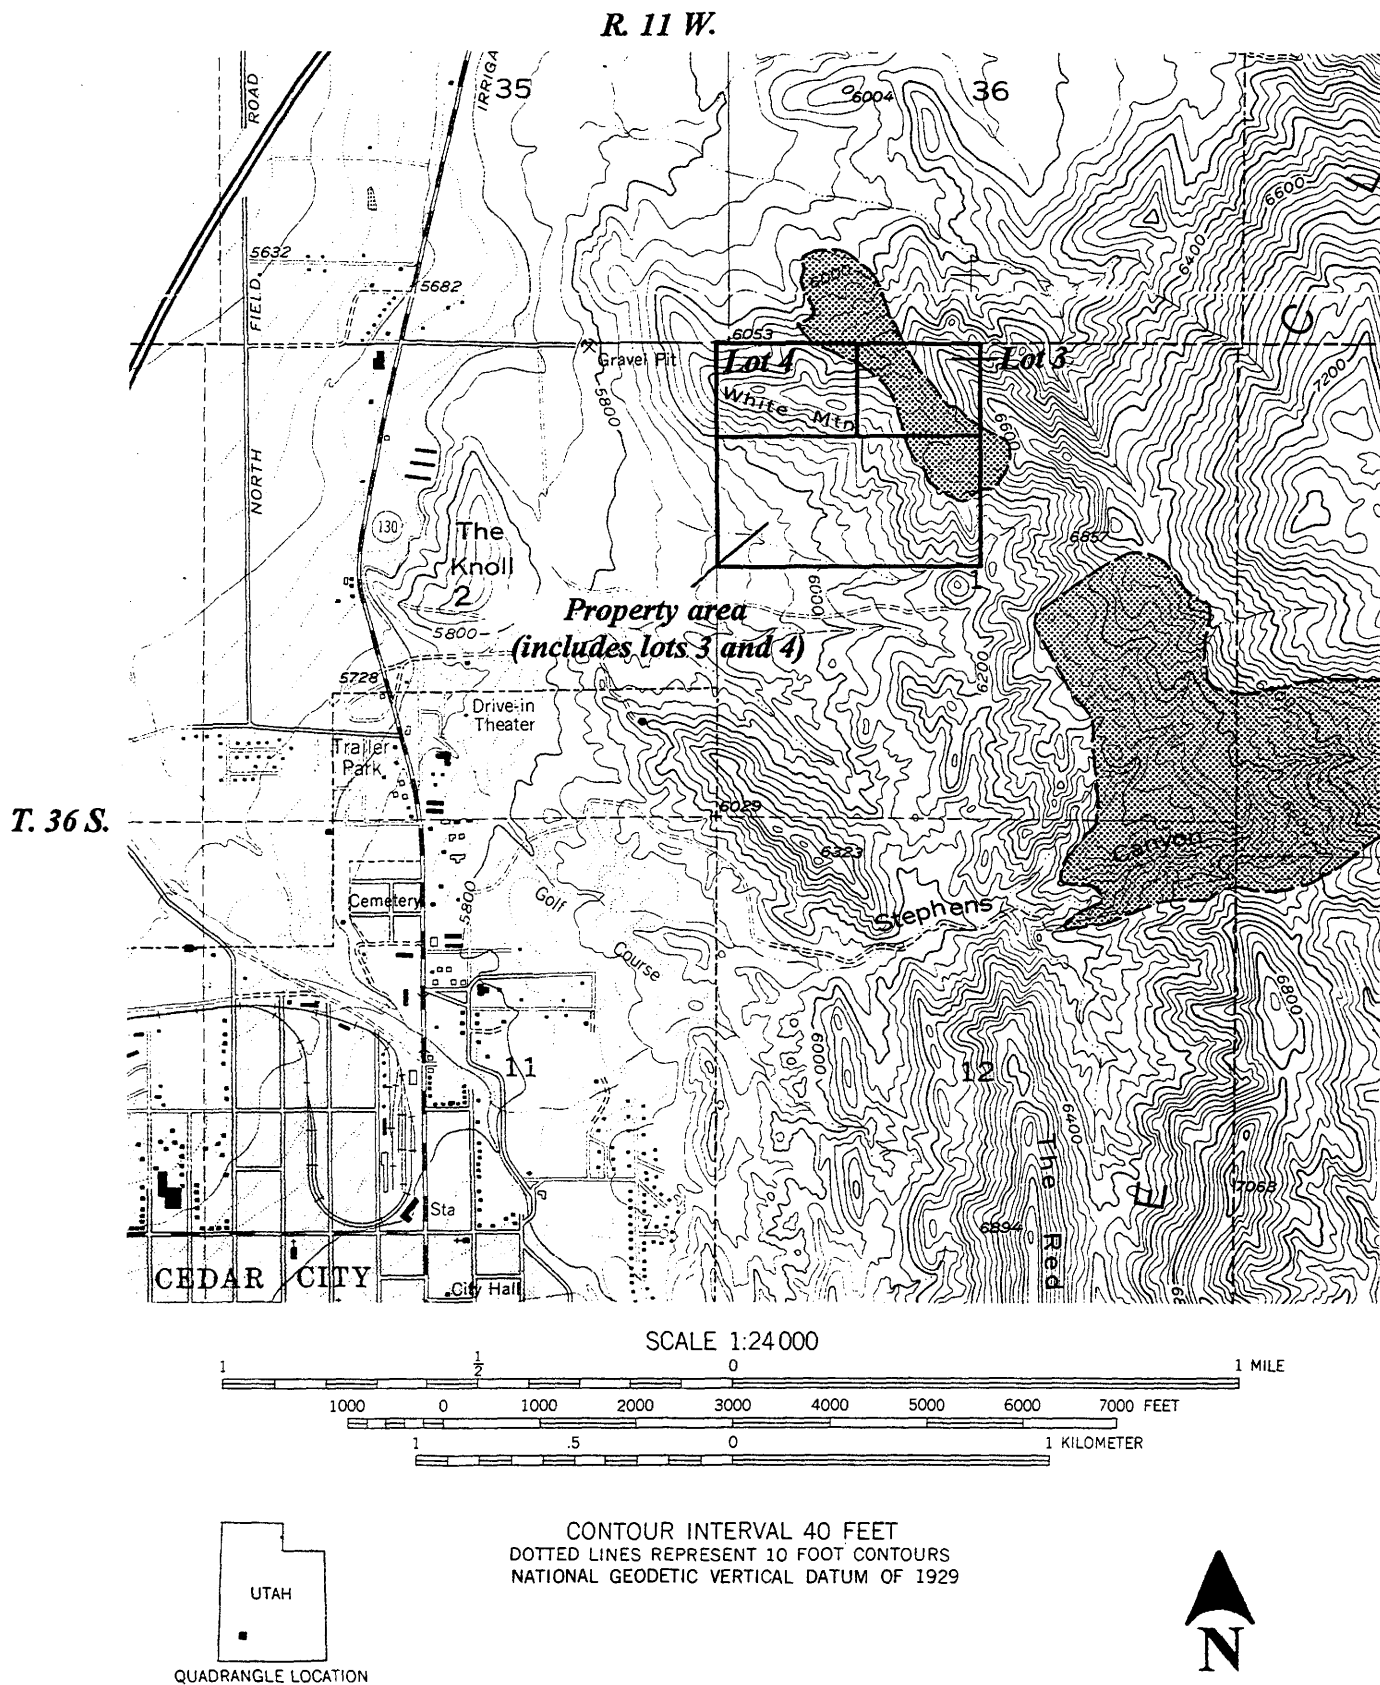
Attachment 1. Location of property and nearby landslide deposits (shaded) mapped by Averitt and Threet (1973).

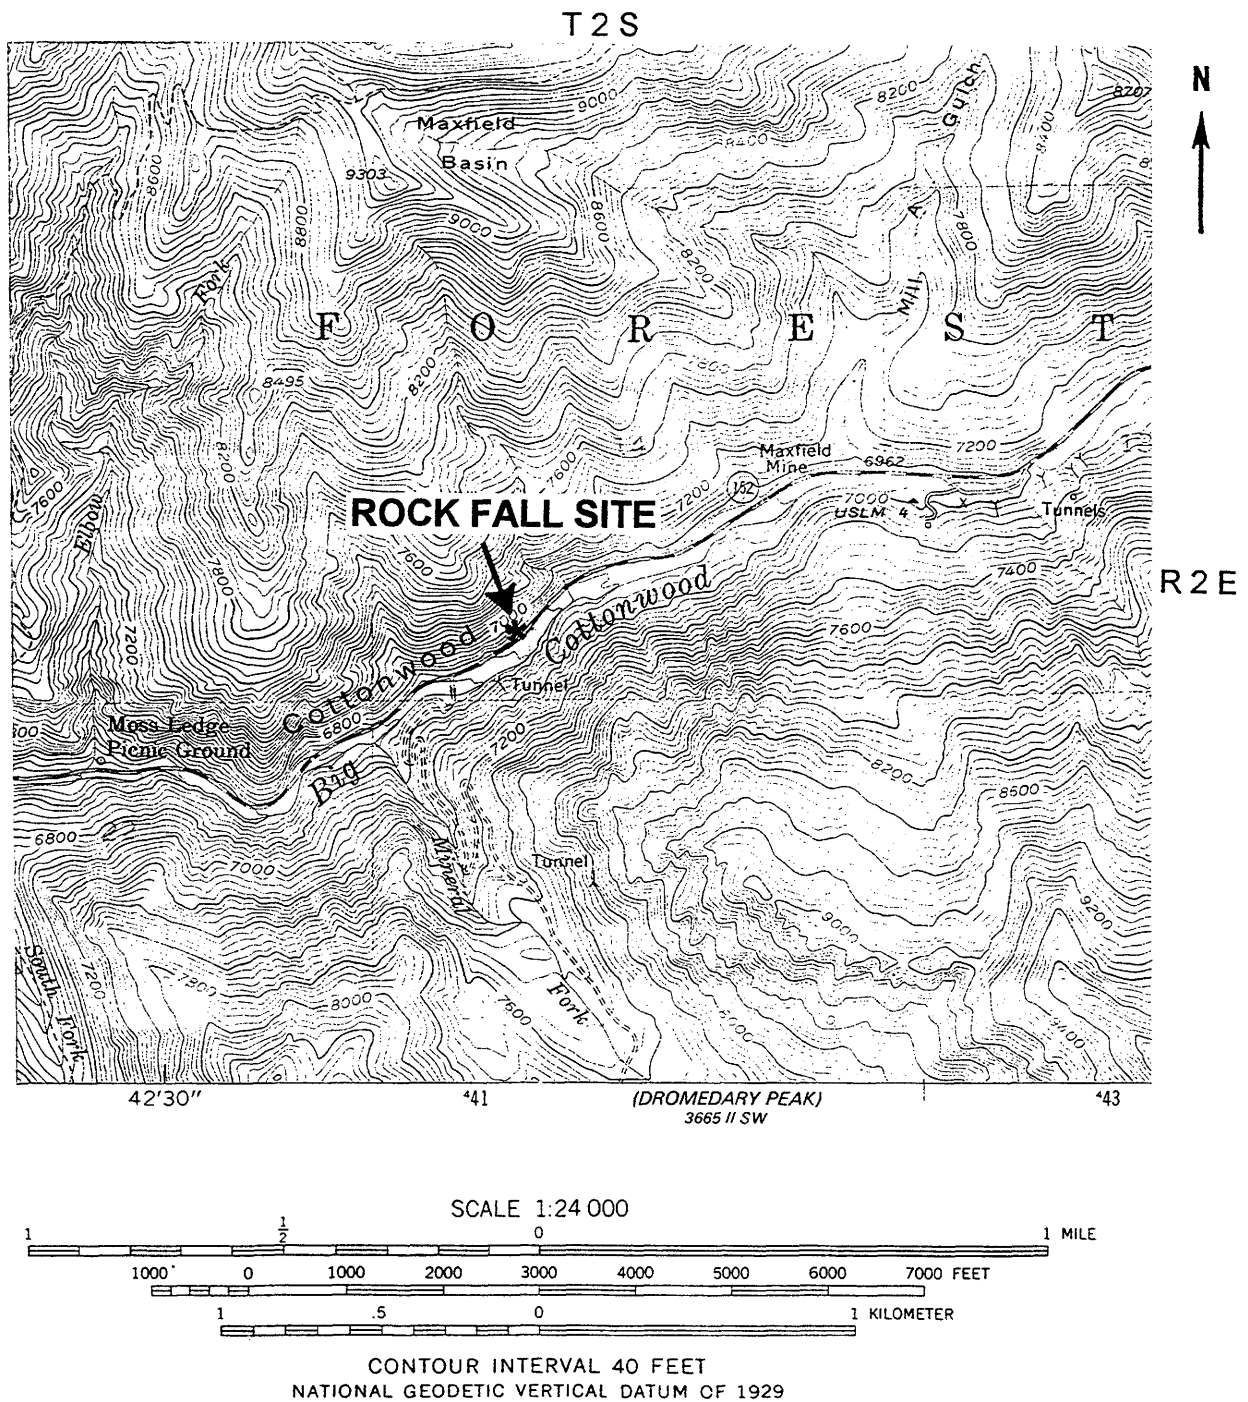
Attachment 1. Location of rock fall that occurred January 13, 1995 in Big Cottonwood Canyon, Salt Lake County, Utah.

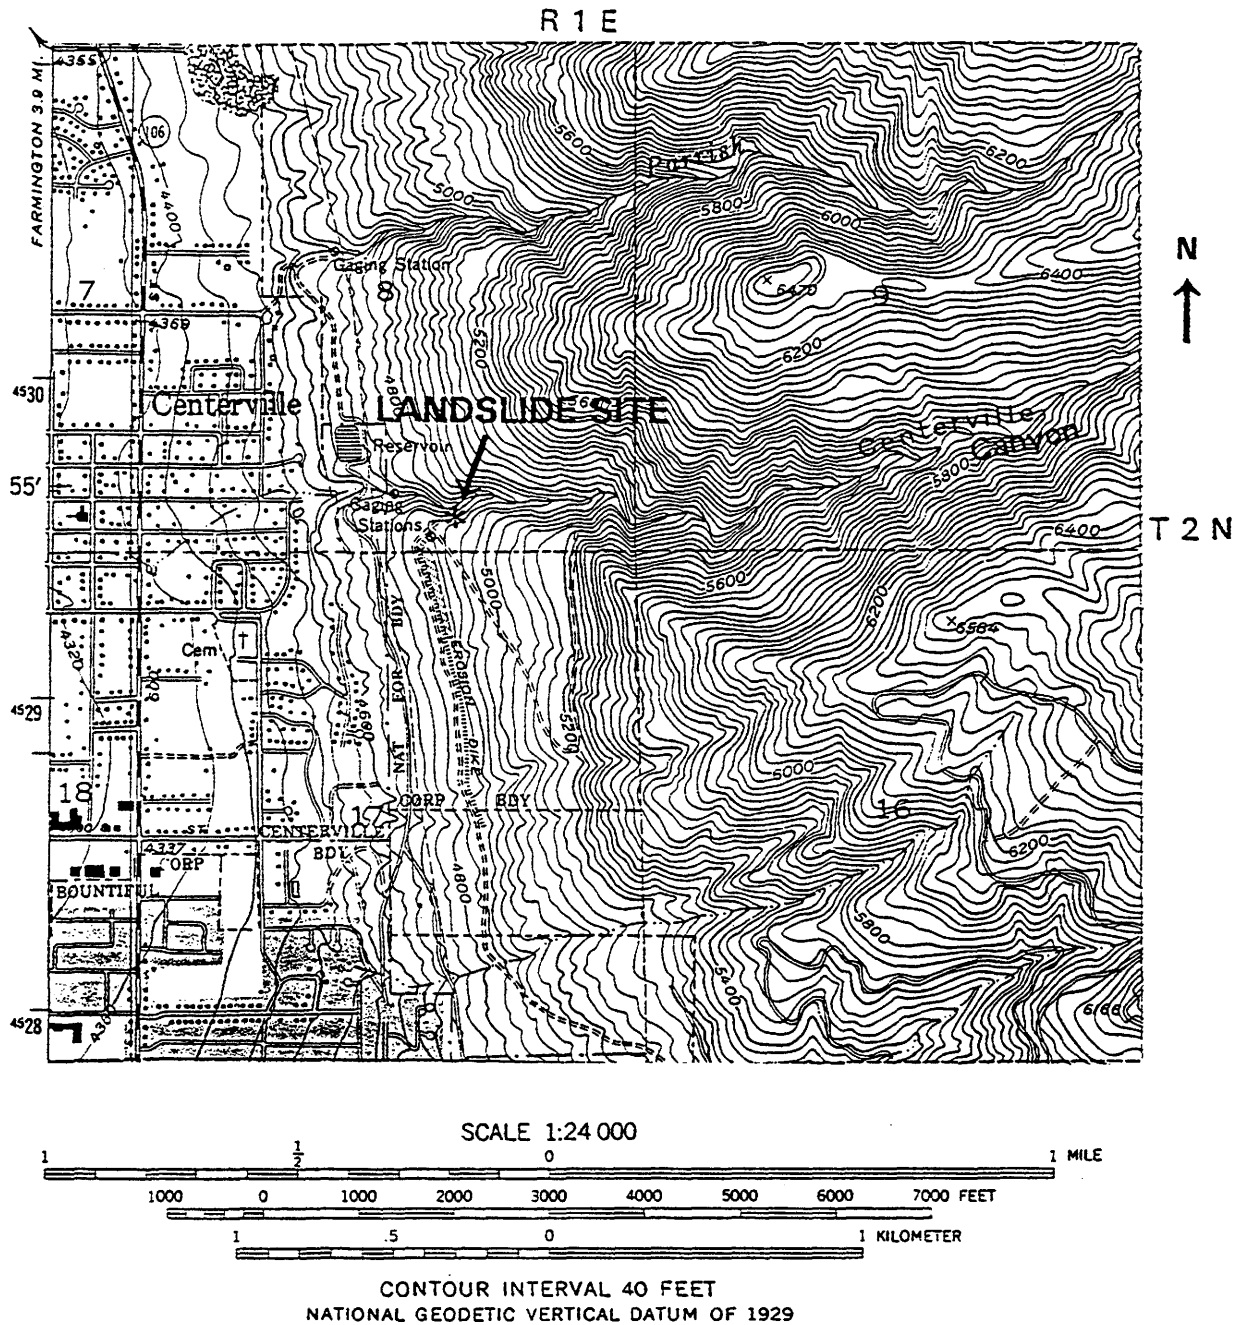
Attachment 1. Location of landslides near Centerville, Utah.

Centerville City should monitor conditions at the site periodically, especially during periods of heavy precipitation and/or rapid snowmelt. The abandoned water pipeline should also be checked to ensure that water does not flow through it at any time, since water introduced near the top of the slides may promote further landsliding. If water is observed discharging from the broken pipeline, it should be plugged or removed. The UGS should be notified immediately of any major changes in landslide activity at the site.

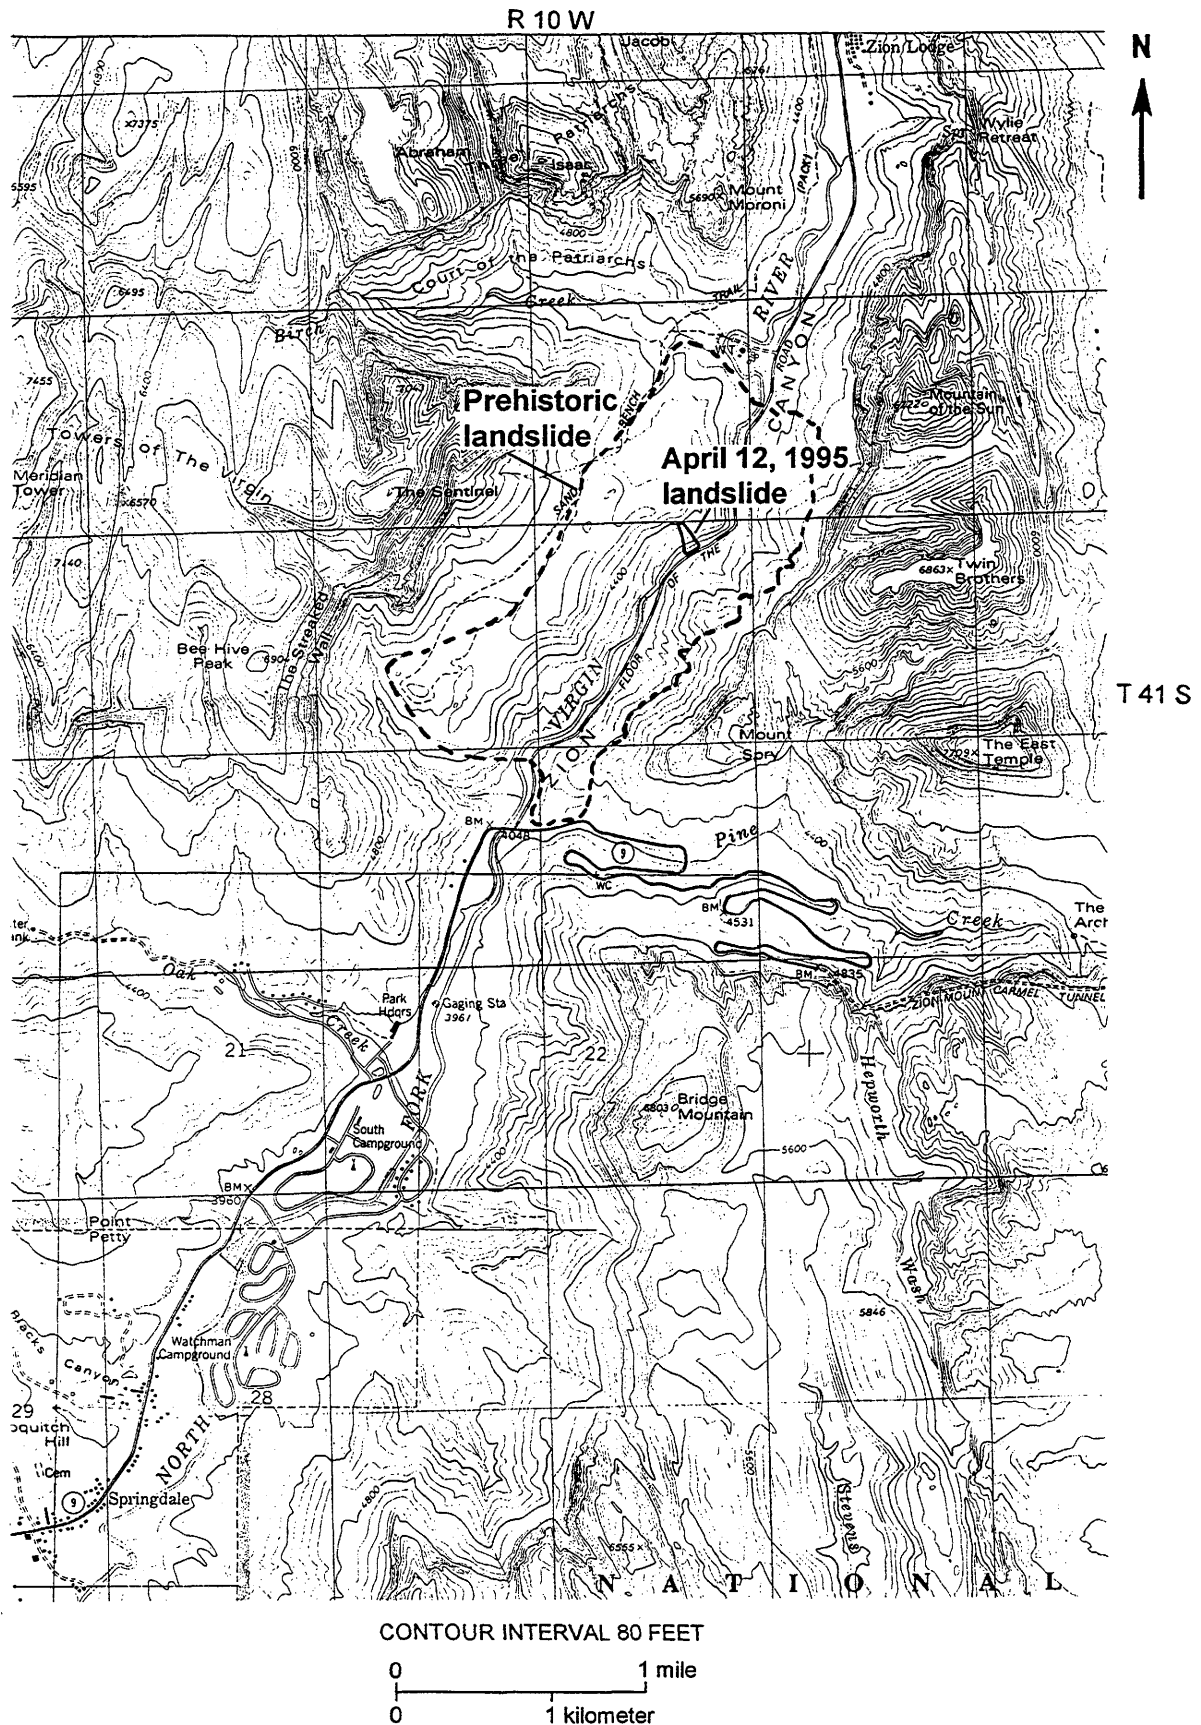
Attachment 1. The landslide of April 12, 1995 and a generalized outline of the prehistoric landslide (modified from Hamilton, 1978) in Zion Canyon.
