# RECONNAISSANCE OF THE SHURTZ LAKE LANDSLIDE, UTAH COUNTY, UTAH

by  
*F.X. Ashland*  
*Utah Geological Survey*

REPORT OF INVESTIGATION 234 July 1997  
UTAH GEOLOGICAL SURVEY  
*a division of*  
UTAH DEPARTMENT OF NATURAL RESOURCES

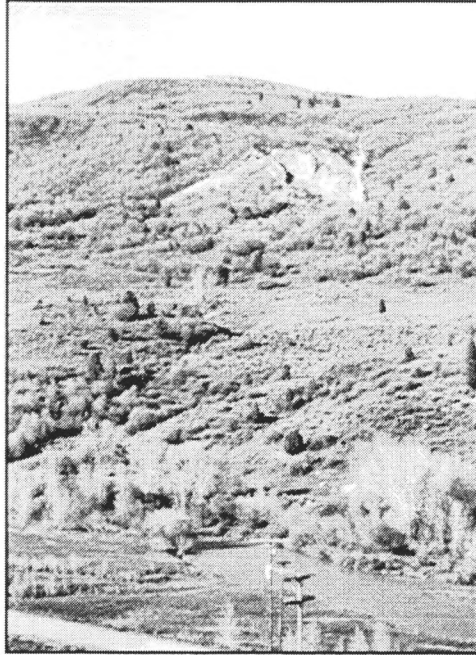
**Figure 2.** The Shurtz Lake landslide on May 9, 1997. View is to the south from Utah Highway 6. Spanish Fork River is visible in bottom of photograph.

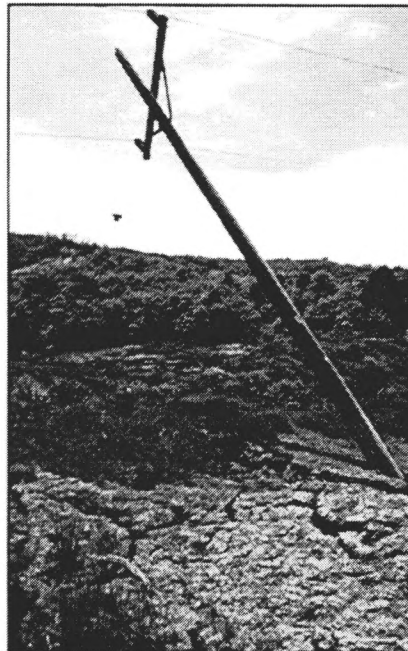
**Figure 3.** Transmission pole tilted by landslide movement. Pole is one of two in upslope set of Utah Power & Light (UP&L) transmission poles on landslide. Downslope movement caused one of three powerlines to be severed from pole. Powerlines were subsequently abandoned by UP&L.

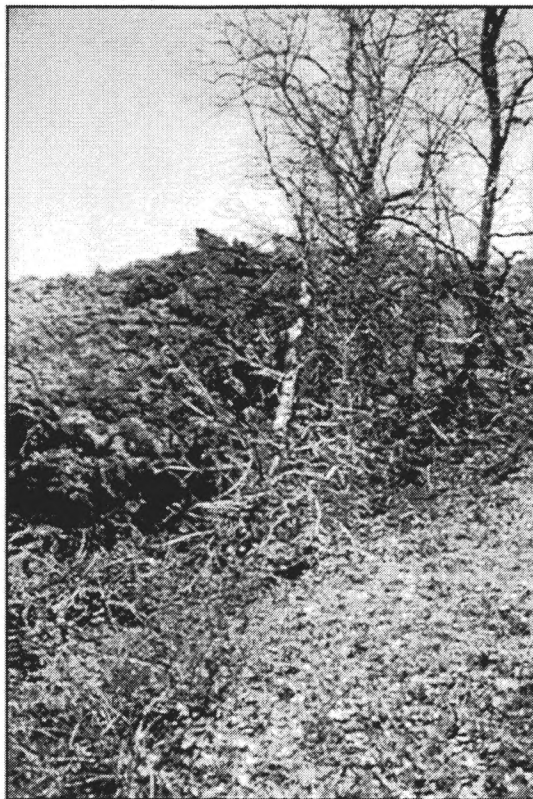
**Figure 4.** Lateral levee along northwestern edge of left-flank earth flow. Levee is about 10 to 15 feet high.

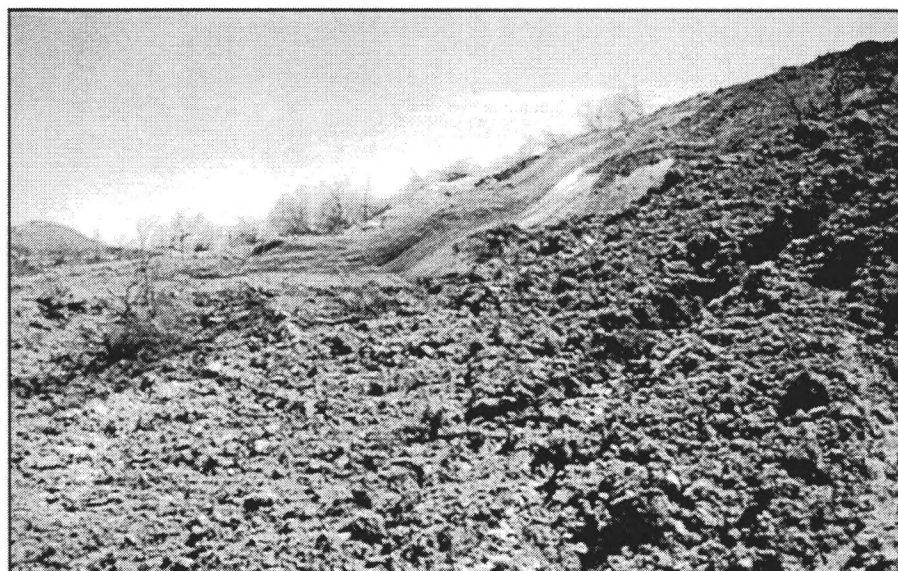
**Figure 5.** Left-side earth flows. View is to the east from on top of left-flank lateral levee. Inside of opposite earth-flow levee shows ground-parallel slickenlines indicating direction of flow.

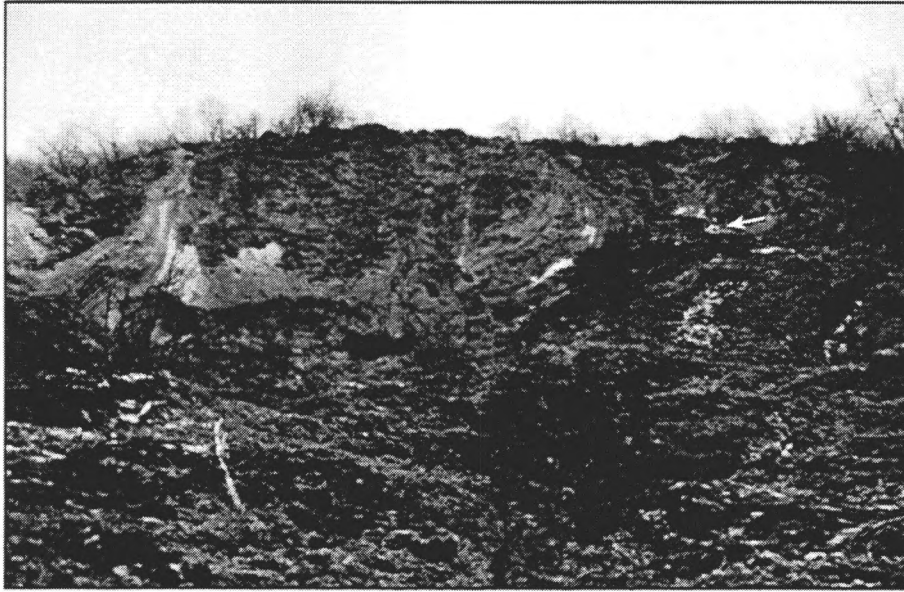
**Figure 6.** Main scarp of left-flank earth flow. Scarp height exceeds 50 feet. Note geologist (arrow) for scale.

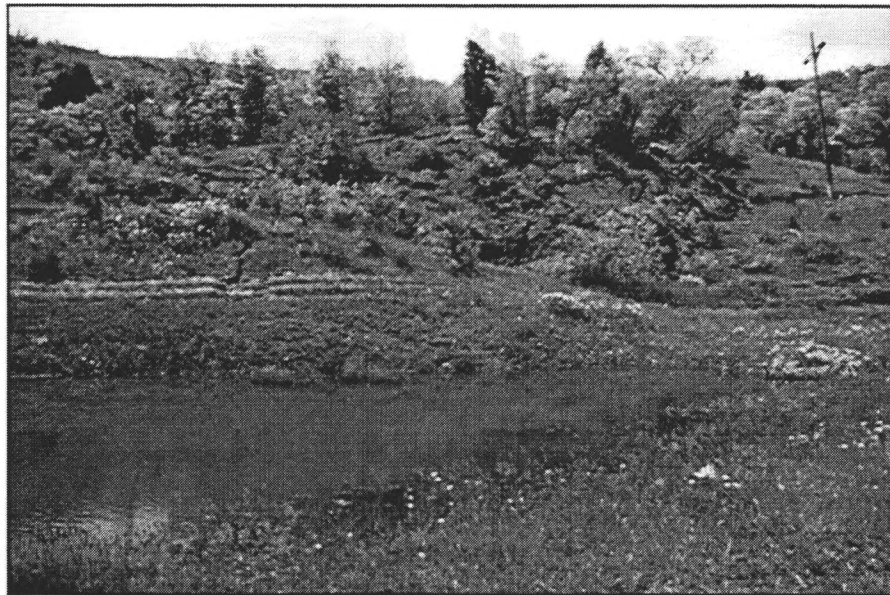
**Figure 7.** Deformed soil and vegetation downslope of left-side earth flows. Earth-flow deposits are directly upslope of trees near top of photograph. Note intense ground cracking and steep downslope tilt of leading edge of deformed materials. Note also tilt of power-line access road (center left) and transmission pole (upper right).

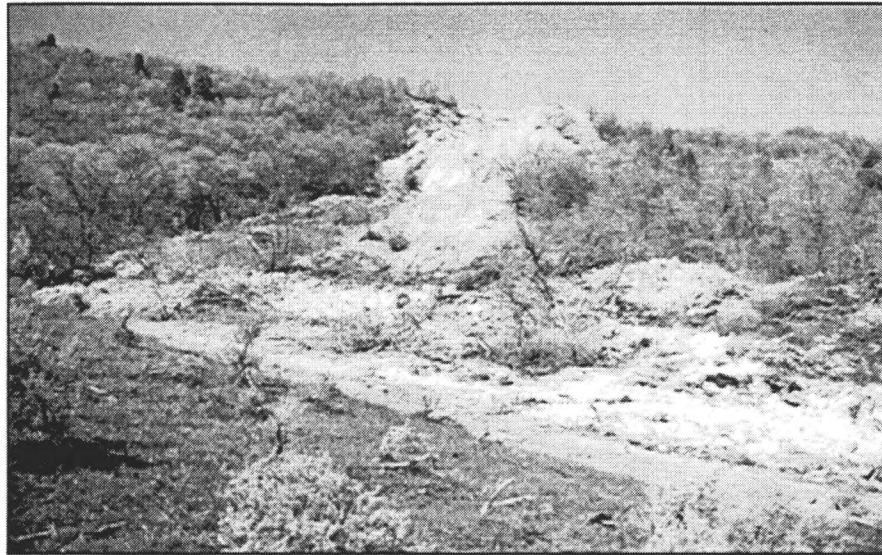
A third earth flow exists along the right flank of the landslide (figure 8). Its head is about the same elevation as that of the left-side earth flows but the right-flank earth flow appears to be slightly longer. Lateral levees similar to those bounding the left-flank earth flow exist on both sides of the upper part of the right-flank earth flow. Near the top of the earth flow, the partially exposed slip surface is curvilinear and irregular. The earth-flow deposits bifurcate, with the main body of the earth flow bending to the north with its tip in a cattle pond which was completely drained by May 9. Loose pond-bottom vegetation was displaced around the tip of the earth flow in the pond,

**Figure 8.** Right-flank earth flow. View is to south-southwest from near the toe of the deposits.

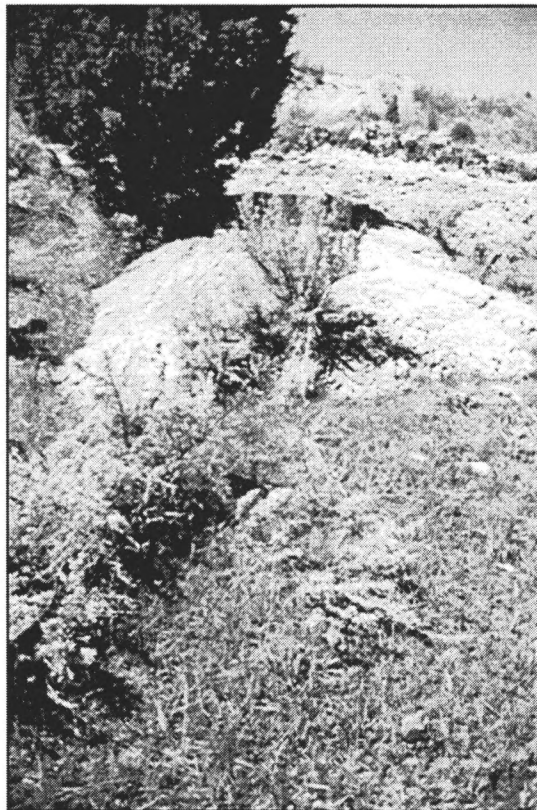
**Figure 9.** Small finger extending northeast from main body of right-flank earth flow. View is to south-southwest. Water continued to drain from base of earth flow on May 30, 1997.

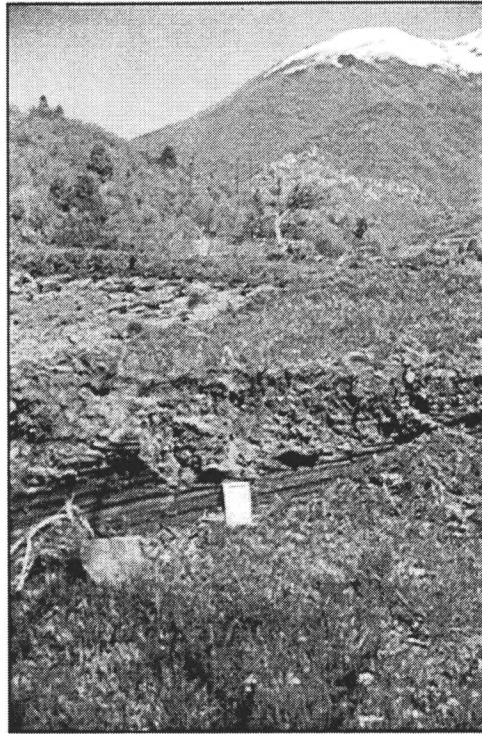
**Figure 10.** Ground deformation directly downslope of right-flank earth flow. View is to northwest. Ground has heaved upward about 24 inches. Note nearly horizontal slickenlines behind field book indicating earliest movement of heaved block was downslope parallel to ground surface. Dry cattle pond behind scarp was drained as ground tilted and cracked. Field book is 7-1/2 inches high.

At least one pre-existing pond was drained and another is in jeopardy of being drained by the landsliding (figures 10 and 11). A cattle pond on the right flank of the slide was drained because of ground tilting and cracking. A second small pond is located directly downslope of the power-line access road and southeast of the northwesternmost set of transmission poles. Deformed soils directly upslope of the pond appeared to be gradually encroaching on it. In addition, longitudinal ground cracks downslope of the pond could eventually propagate upslope and drain the pond.

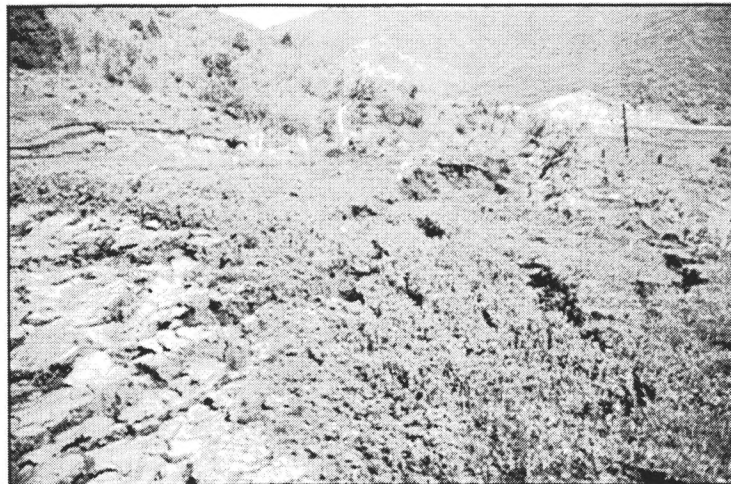
**Figure 11.** Ground deformation directly downslope of drained cattle pond. View is to northwest. Ground to right of cattle pond was displaced by upslope earth-flow deposits and coherent slide blocks (see figure 10). Intense ground cracking likely contributed to rapid draining of cattle pond.

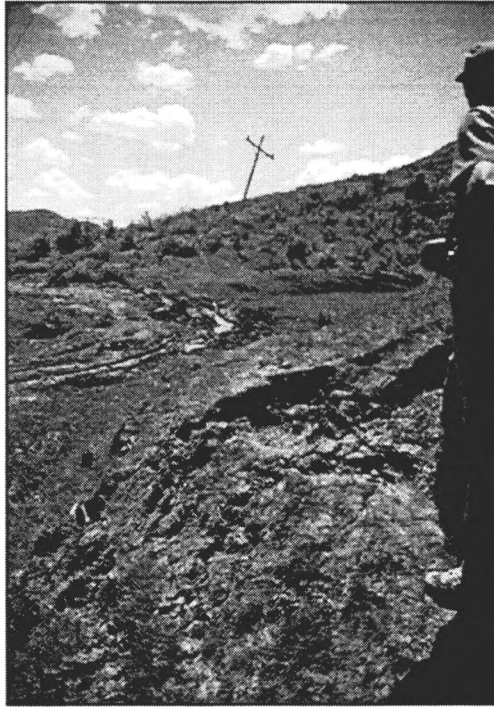
**Figure 12.** Ground tilting and cracking downslope of left-side earth flows. View is to southeast. Power-line access road (below geologist's foot) was tilted to nearly vertical between May 6 and 9, 1997. Transmission pole shown in figure 3 is visible in distance.

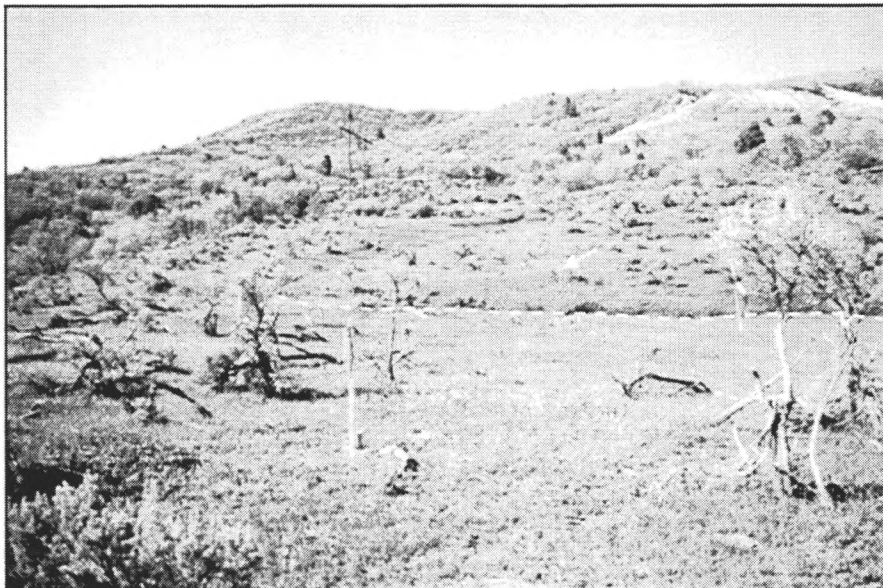
Downslope of the deformed soils, contractional features consist of a series of mostly downslope-directed thrusts (figure 13) involving topsoil and shallow soils. Through May 19, several stacked thrust sheets existed between the downslope edge of the deformed deposits below the earth flows and the toe of the landslide. The downslope set of UP&L transmission poles are founded in soils that were thrust downslope. Downslope displacement of the northwesternmost of these poles is directly related to the thrusting, and was estimated on May 9 to be about 38 feet. In addition, vertical uplift in the vicinity of the poles ranged from 6 to 8 feet (Scott Burton, UP&L, verbal communication, May 9, 1997). Heights of individual thrust-sheet fronts ranged from several inches to several feet. Topsoil at the leading edge of the thrust sheets is commonly folded. Fold axes trend generally parallel to the leading edge of the thrust sheets and perpendicular to the direction of thrusting. A few upslope- and side-directed thrusts exist between and slightly downslope of the deformed deposits below the earth flows.

**Figure 13.** Thrusting at toe of landslide on May 7, 1997. Stake in foreground is on original ground surface downslope of slide. Stake in distance (arrow) is near tip of slide on lowest thrust sheet. Dashed line indicates lowest thrust. View is to the south.

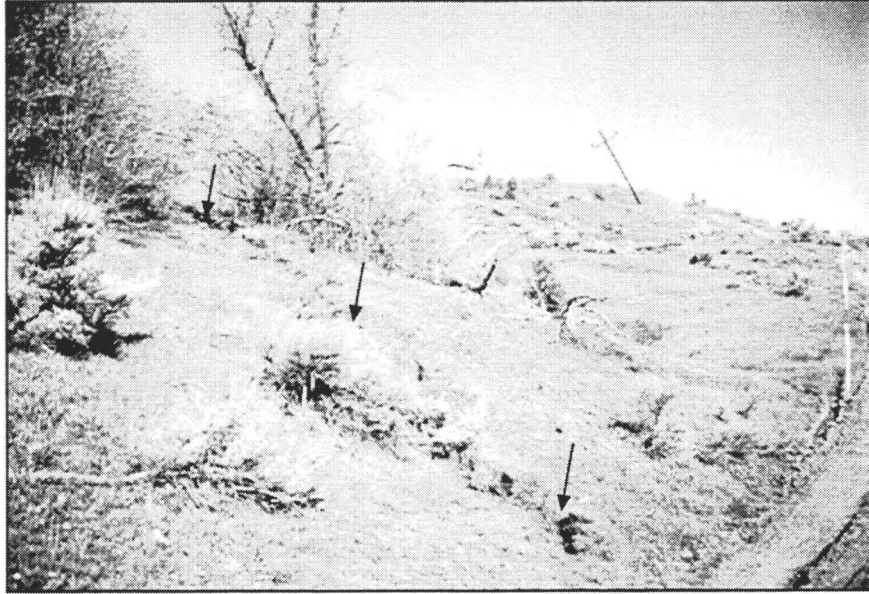
**Figure 14.** Right-lateral scarp (arrows) upslope of power-line access road. The ground surface on north side of scarp is heaved upward several inches. Note tilt of transmission pole. View is to the west-northwest.

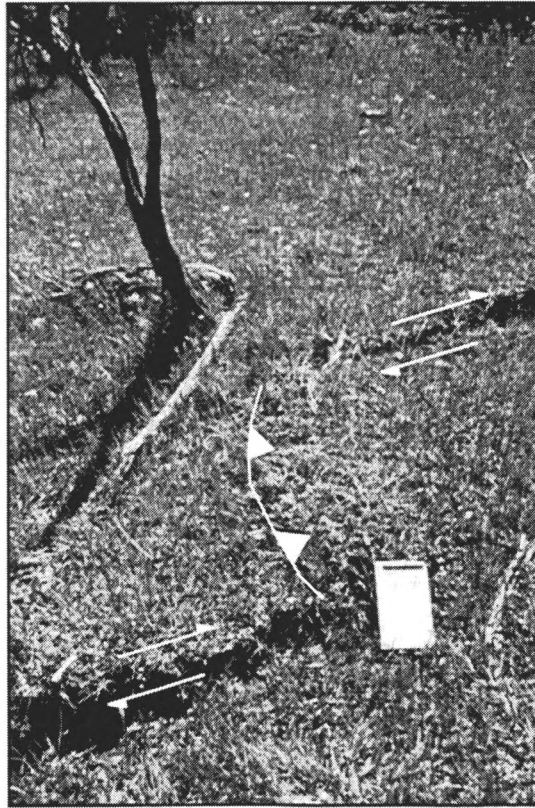
additional longitudinal right-lateral shear cracks or shears. Along a left-stepping set of right-lateral shears thrusting occurs in the zone between the shear crack tips (figure 15).

**Figure 15.** Thrusting between left-stepping en echelon right-lateral shear cracks. Topsoil to right of thrust has moved toward left over original ground surface.

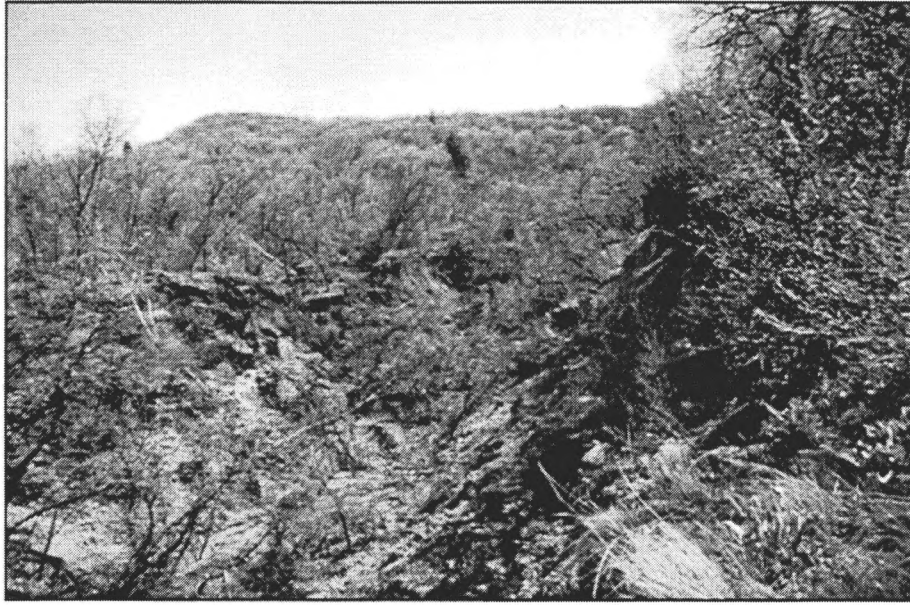
Upslope of the crown of the earth flows is a large area of slumping and extensional deformation that extends for about 1,500 feet upslope to the south. Along the left-flank drainage, slumping into the deeply incised gully (figure 16) continues for about 1,500 feet above the head of the left-flank earth flow. Dropped slump blocks are visible on both sides of the gully. The landslide is about 600 to 700 feet wide directly above the earth flows but narrows toward the head. This area consists of relatively coherent soil blocks separated by ground cracks or scarps (figure 17), suggesting lateral spreading as the dominant style of ground deformation. Visual estimates of an offset tree line on the right flank of the upper part of the slide suggest a combination of downslope movement and extension on the order of 30 to 50 feet. The main scarp (figure 18) of the landslide ranges between about 10 and 40 feet high and is about 200 to 300 feet across. The head of the landslide is in a relatively gently sloping area where the average slope is less than 20 percent and local slopes are considerably flatter. The crown of the landslide, last observed on May 19, is about 200 feet upslope and south of where the left-flank drainage enters the slide area from the southwest. At the point of intersection of the drainage and the landslide, the drainage is generally incised less than 5 feet. Water was flowing in the drainage and into the left side of the landslide throughout the month of May (figure 19).

**Figure 16.** Slumping along the left-flank gully upslope of the crown of the left-flank earth flow. View is to the south.

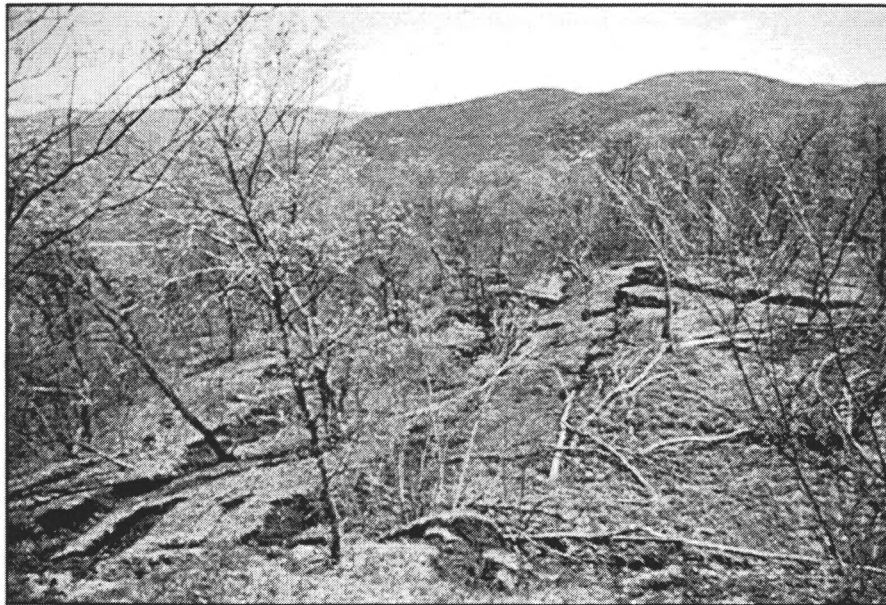
**Figure 17.** Ground cracks and scarps in the upper part of the landslide indicating lateral spreading. View is to the east.

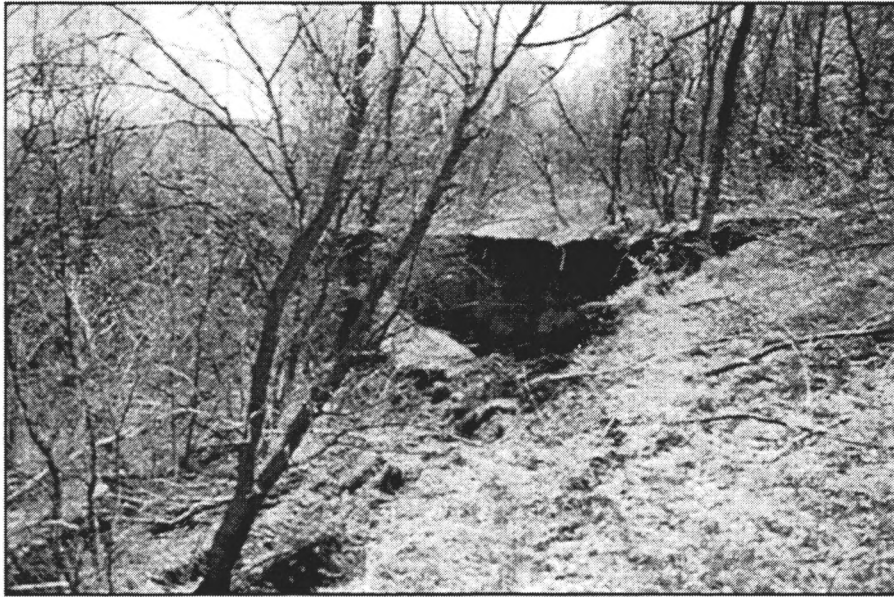
**Figure 18.** Main scarp of landslide. Scarp height ranges from approximately 10 to 40 feet. View is to the southeast.

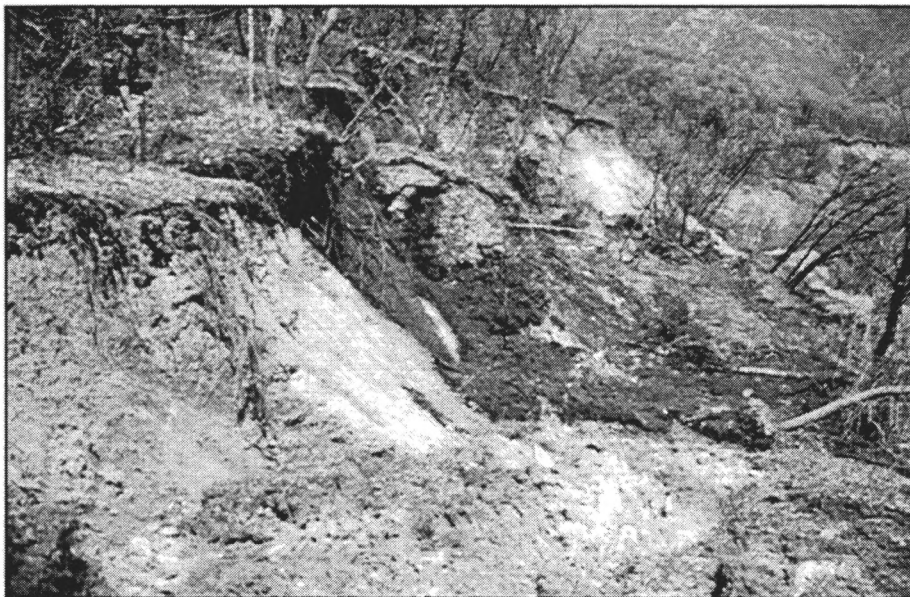
**Figure 19.** Intersection of left-flank drainage with left-flank of landslide. Geologist (upper left corner) stands next to drainage. Water flowed into slide mass throughout the month of May. View is to the north.

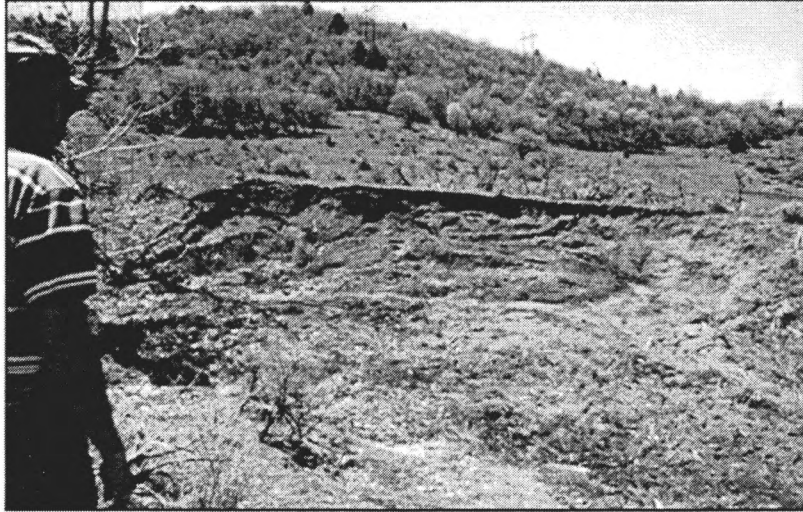
**Figure 20.** Local slump below the Shurtz Lake landslide in the left bank of the left-flank drainage. Slumping into gully may have been caused by rapid downcutting in early May. View is to the west.

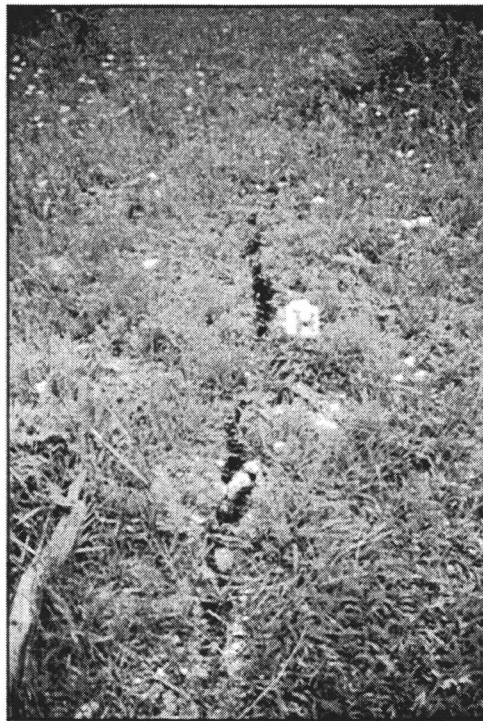
I observed ground cracks (figure 21) and minor scarps over 200 feet downslope and northeast of the May 7 toe of the landslide. Cracks and scarps along the slopes of the central drainage could be followed for several hundred feet downslope and across the foot of the youngest of the

**Figure 21.** Ground crack observed on May 30 over 200 feet downslope of May 7 toe of landslide. Deformation suggests distribution of landslide activity is enlarging and progressing downslope. Cracks likely formed following heavy precipitation over the Memorial Day weekend. Field book is about 7-1/2 inches long.

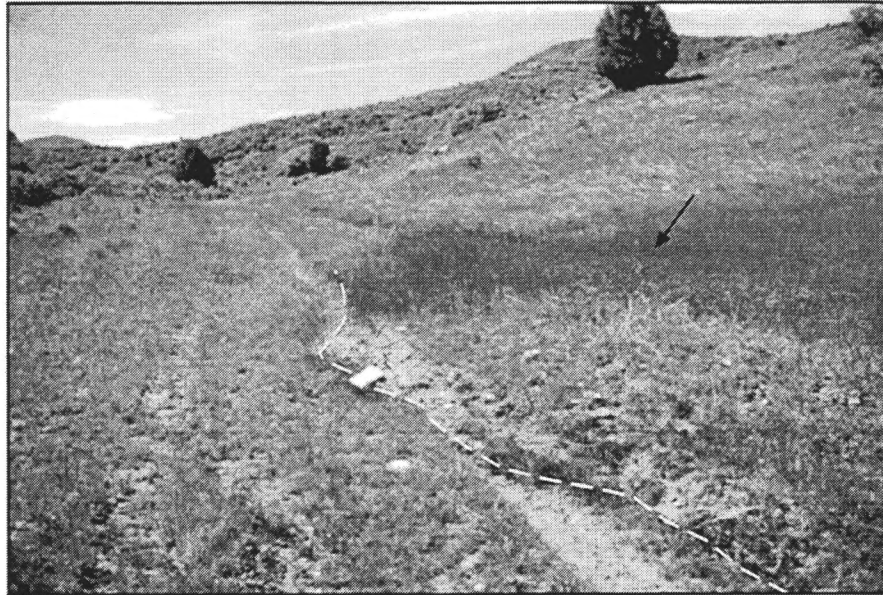
Shallow thrusts (figure 22) of topsoil and shallow soil exist in several locations at the toe of the oldest prehistorical landslide deposits that abut the D&RGW railroad grade. Topsoil was generally thrust several inches to several feet downslope over the original ground surface. In one location, an old four-wheel-drive road was deformed by a thrust so that the upslope rut was moved to within a foot of the downslope rut. Seeps exist in the vicinity of most of the thrusts. Ground cracks and scarps were visible upslope of the thrusts (figure 23). These features suggested thrusting at the railroad grade level may have been caused by local slumping at the toe of the older prehistorical landslide deposits, perhaps unrelated to the May 6 landslide. However, an association of this slumping with ground cracks farther upslope suggests a cause-and-effect relationship. For instance, slumping at the toe could be caused by oversteepening of the lower part of the slope as a result of gradual deep-seated movement and increased pore pressure following the May 6 landslide and the Memorial Day weekend precipitation.

**Figure 22.** Thrusting in older landslide deposits abutting abandoned D&RGW railroad grade. Topsoil and underlying soil (on right) has been thrust over upslope rut. Field book is near tip of thrust sheet. Note wet soil and darker vegetation (arrow) directly upslope of thrust indicating seepage. View is to the south.

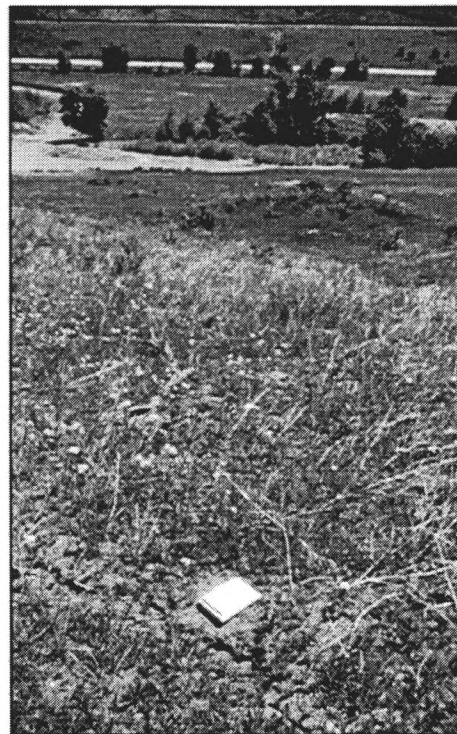
**Figure 23.** Scarp upslope of thrusts near abandoned D&RGW railroad grade. Note proximity of landslide deformation to Spanish Fork River (near top of photograph) on May 30, 1997. Field book is about 7-1/2 inches long. View is to the northeast.
