GEOLOGIC HAZARDS OF THE ZION NATIONAL PARK GEOLOGIC-HAZARD STUDY AREA, WASHINGTON AND KANE COUNTIES, UTAH

by William R. Lund, Tyler R. Knudsen, and David L. Sharrow

SPECIAL STUDY 133
UTAH GEOLOGICAL SURVEY
a division of
UTAH DEPARTMENT OF NATURAL RESOURCES
2010

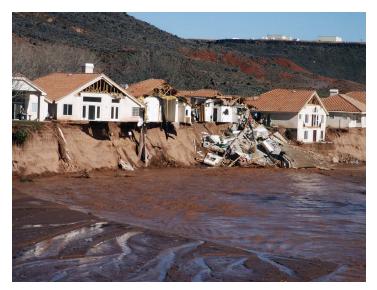
Figure 2.1. Damage to homes caused by flooding on the Santa Clara River near St. George, Utah, in January 2005.

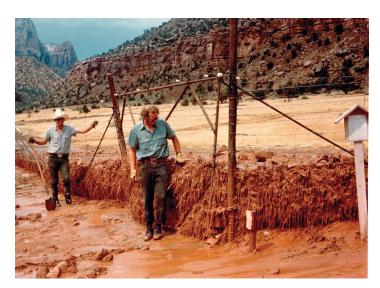
Figure 2.3. Sediment deposited by a small debris flow that discharged from an ephemeral drainage north of the Watchman housing area in 1979 (photo courtesy of NPS).

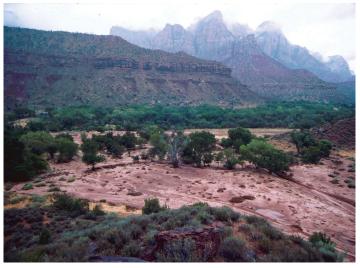
Figure 2.4. The 1998 Sammy's Canyon debris flow inundated the current site of the Zion National Park shuttle bus maintenance facility, visitor center, and part of the Watchman campground (photo courtesy of NPS).

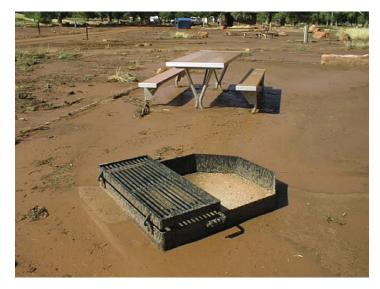
Figure 2.5. Sediment deposited by sheetflooding in the Watchman campground at the distal end of the 1998 Sammy's Canyon debris flow (photo courtesy of NPS).

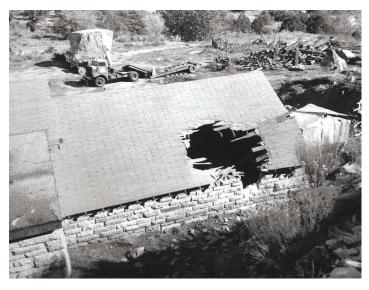
Figure 3.1. Damage to the roof of the Zion National Park maintenance facility in Oak Canyon caused by a rock-fall boulder in 1946 (photo courtesy of the National Park Service).

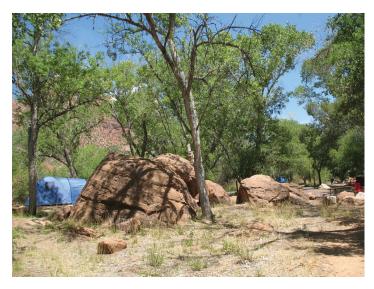
During our field reconnaissance, we observed several large boulders and boulder clusters in lower Zion Canyon well beyond the limits of normal rock-fall accumulation bordering canyon

Figure 3.4. Cluster of large rock-fall boulders in the Watchman campground far beyond the area of normal rock-fall accumulation at the base of canyon walls in lower Zion Canyon.

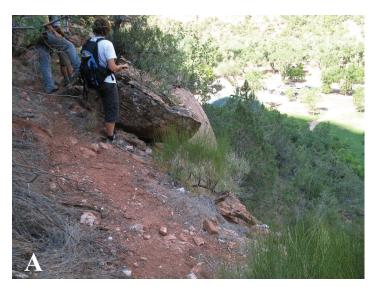
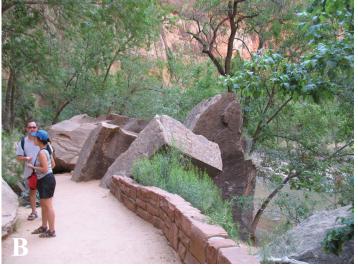
Figure 3.6. Permanent park facilities in rock-fall hazard zones. A. Precariously balanced boulder on a steep slope directly above Zion Lodge. B. Large rock-fall boulders along the heavily traveled River Walk Trail.

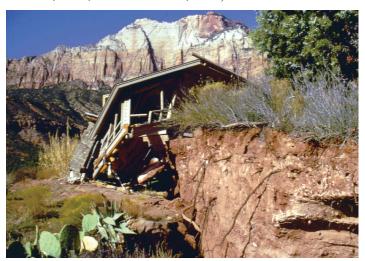
Figure 4.1. Home destroyed by the 1992 Springdale landslide in Springdale, Utah.

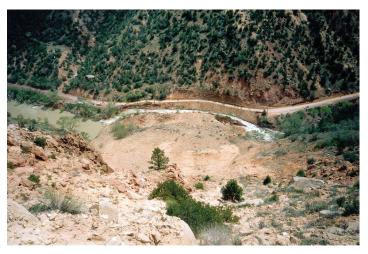
In April 1995, part of the Sentinel landslide reactivated and blocked the North Fork of the Virgin River for about an hour. The river subsequently breached the landslide dam and inundated Zion Canyon Scenic Drive. The ensuing erosion destroyed about 600 feet of roadway and underground utility lines. A temporary, one-lane road was constructed in the rubble slope to the east of the highway to evacuate people from the upper canyon (figure 4.5). Similar landslides occurred at or near this location in 1924 and again in 1941 (Grater, 1945; Solomon, 1996a). Ground water appears to be a contributing factor to the landslide reactivation. An outcrop of the Springdale Sandstone Member of the Kayenta Formation at the south end of the landslide produces several seeps and small springs. During excavation to place a rock buttress at the toe of the landslide in 2000, springs were observed discharging near river level from both the upstream and downstream margins of the slide mass. Both the winters of 1941 and 1995 were exceptionally wet, with January through April precipitation being 182 percent and 235 percent of the 70-year average, respectively.

Figure 4.5. Temporary road graded around the Sentinel landslide, April 1995 (photo credit G.F. Wieczorek, U.S. Geological Survey).

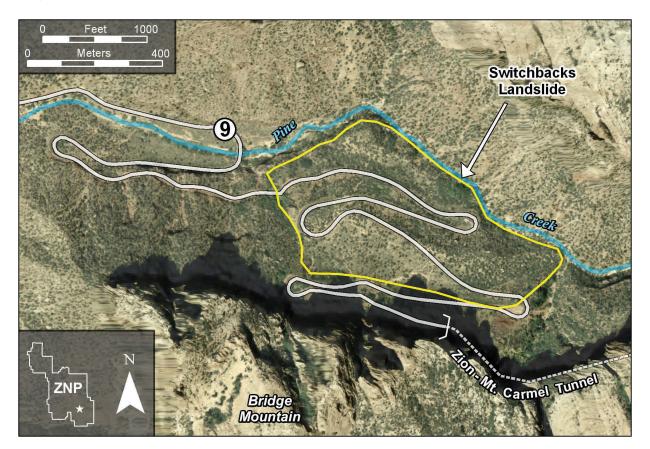
As part of the Yeh and Associates (2008) study, several boreholes were drilled in settlement areas along the roadway, subsurface materials were sampled and tested, and inclinometers and piezometers installed to monitor future landslide movement and changes in ground-water levels. Laboratory testing indicated that fill materials in the roadway are less than 95% of maximum dry density (ASTM D 698, T 99 method A; 2002) and susceptible to compaction upon wetting. A preliminary global slope-stability analysis showed that slope stability is highly dependent on ground-water conditions. The factor of

Figure 4.6. Zion-Mount Carmel Highway Switchbacks landslide (image source 2006 National Agricultural Imagery Program).

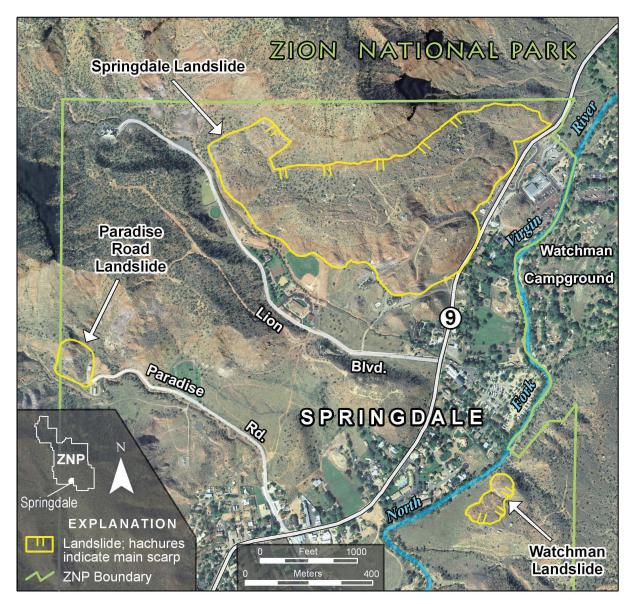
The landslide lies a few hundred feet southwest of the Zion National Park boundary and formed in unconsolidated deposits that have accumulated at the base of the steep east wall of Zion Canyon. The area of the landslide is approximately 3.1 acres, and the landslide toe abuts flat-lying alluvial terrace deposits

Figure 4.7. Springdale, Paradise Road, and Watchman landslides in Springdale, Utah (image source 2006 National Agricultural Imagery Program).

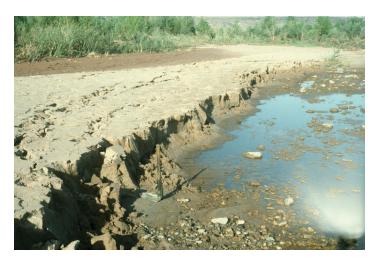
Figure 5.8. Lateral-spread cracking from liquefaction along the Virgin River resulting from the September 2, 1992, M 5.8 St. George earthquake. Folding shovel for scale (photo credit W.E. Mulvey).

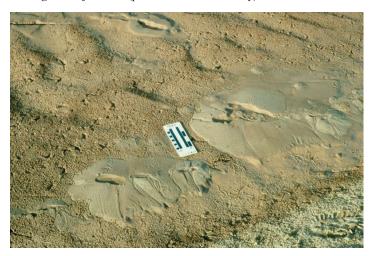
Figure 5.9. Sand blows from liquefaction along the Virgin River resulting from the September 2, 1992, M 5.8 St. George earthquake. Scale card shows centimeters (left) and inches (right) (photo credit W.E. Mulvey).

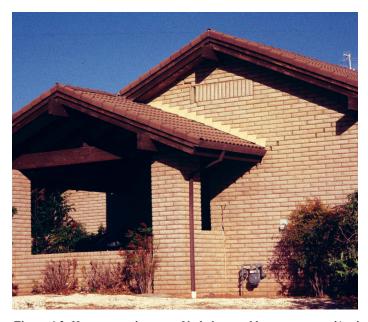
Figure 6.2. Home in southwestern Utah damaged by expansive soil/rock.

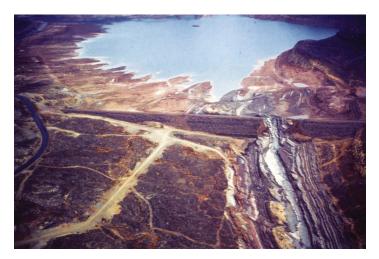
Figure 6.5. Quail Creek dike failure, January 1, 1989, in southwestern Utah was due in part to gypsum dissolution in the underlying Shnabkaib Member of the Moenkopi Formation (photo credit Ben Everitt).

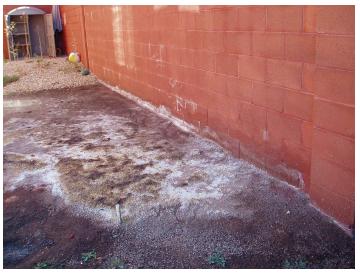
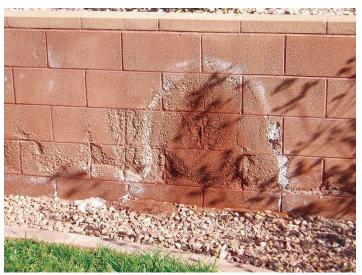
Figure 6.6. Corrosion of masonry block walls in southwestern Utah due to the reaction of the non-Type V cement used in the masonry blocks with high-sulfate soils (photo credit David Black, Rosenberg Associates).

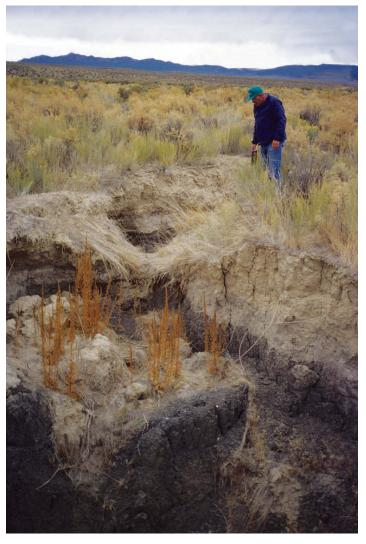
Figure 6.8. Collapsed pipe in fine-grained floodplain alluvium in southwestern Utah.
