Landslide Investigation of Timber Lakes Estates, Wasatch County, Utah: Landslide Inventory and Preliminary Geotechnical-Engineering Slope Stability Analysis

MISCELLANEOUS PUBLICATION 05-9 November 2005
UTAH GEOLOGICAL SURVEY
a division of
UTAH DEPARTMENT OF NATURAL RESOURCES

**Landslide Investigation of Timber Lakes Estates, Wasatch County,
Utah: Landslide Inventory and Preliminary Geotechnical-Engineering
Slope Stability Analysis**

Revised March 31, 2005

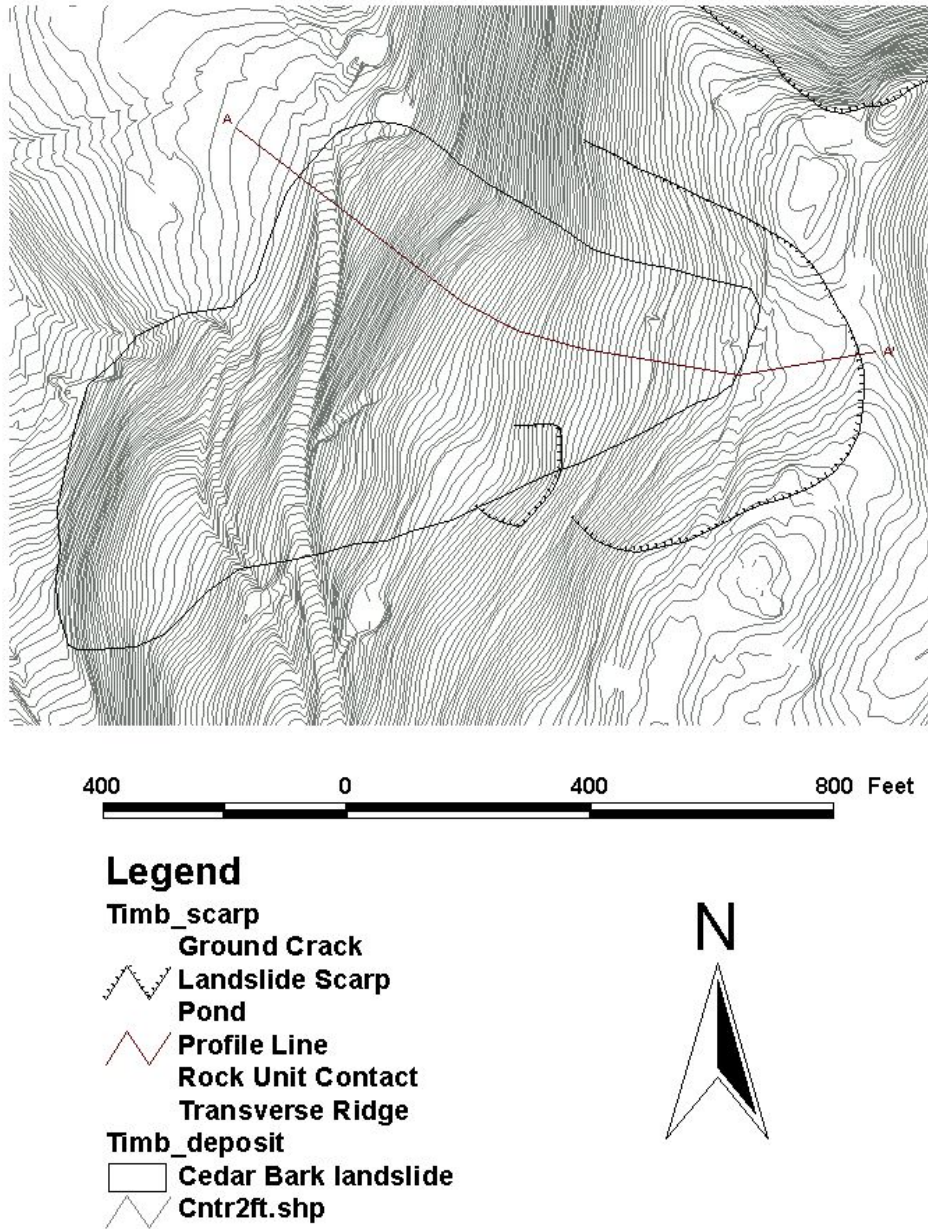
Figure 2. Map of Cedar Bark landslide.

The Cedar Bark slide, located in northern Timber Lakes (Fig. 1, Fig. 2), initiated as a rotational earth slide in glacial till and changed into an earth flow down slope. The landslide has a west aspect and an area of 12 acres. The distance between the main scarp and the most distal tip is approximately 1,340 ft (Fig. 2). The width of the landslide deposit ranges from approximately 1,000 ft at the foot of the slide to about 150 ft near the head (Fig. 2).

The Cedar Bark slide displays a very subdued horseshoe-shaped main scarp east of the slide deposit (Fig. 2). The landslide also contains a subtle, bowl-shaped minor scarp on the left flank of the slide deposit (Fig. 2). About midway through the slide, an abrupt change in slope occurs (Fig. 2). This ridge, trending perpendicular to the direction of movement, is interpreted to be directly above the toe of the initial rupture surface. Down slope from this point, the slide apparently behaved as an earth flow. The profile A-A' (Fig. 2) used for modeling of the Cedar Bark slide is shown in Figure 3. The average slope along A-A', from the head of the landslide deposit to the toe is 15 degrees (Table 3).

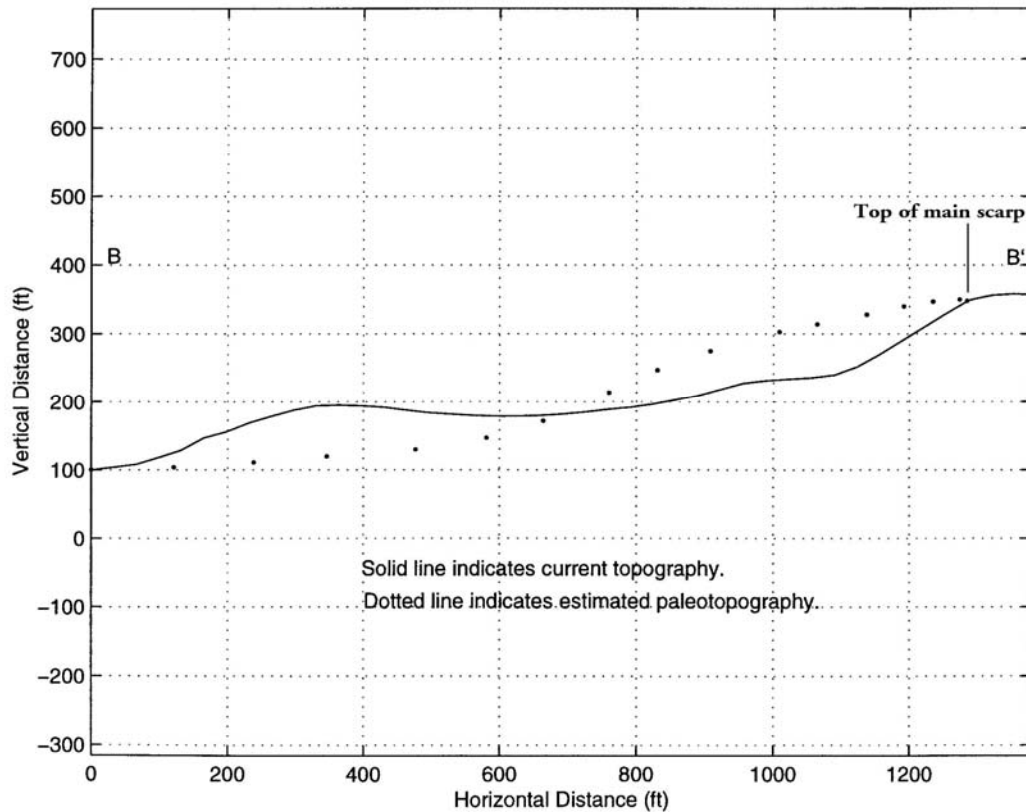
Figure 5. Beaver Bench landslide profile B-B'.

of the Beaver Bench slide is shown in Figure 5. The average slope along B-B', from the head of the landslide deposit to the toe is 8 degrees (Table 3).

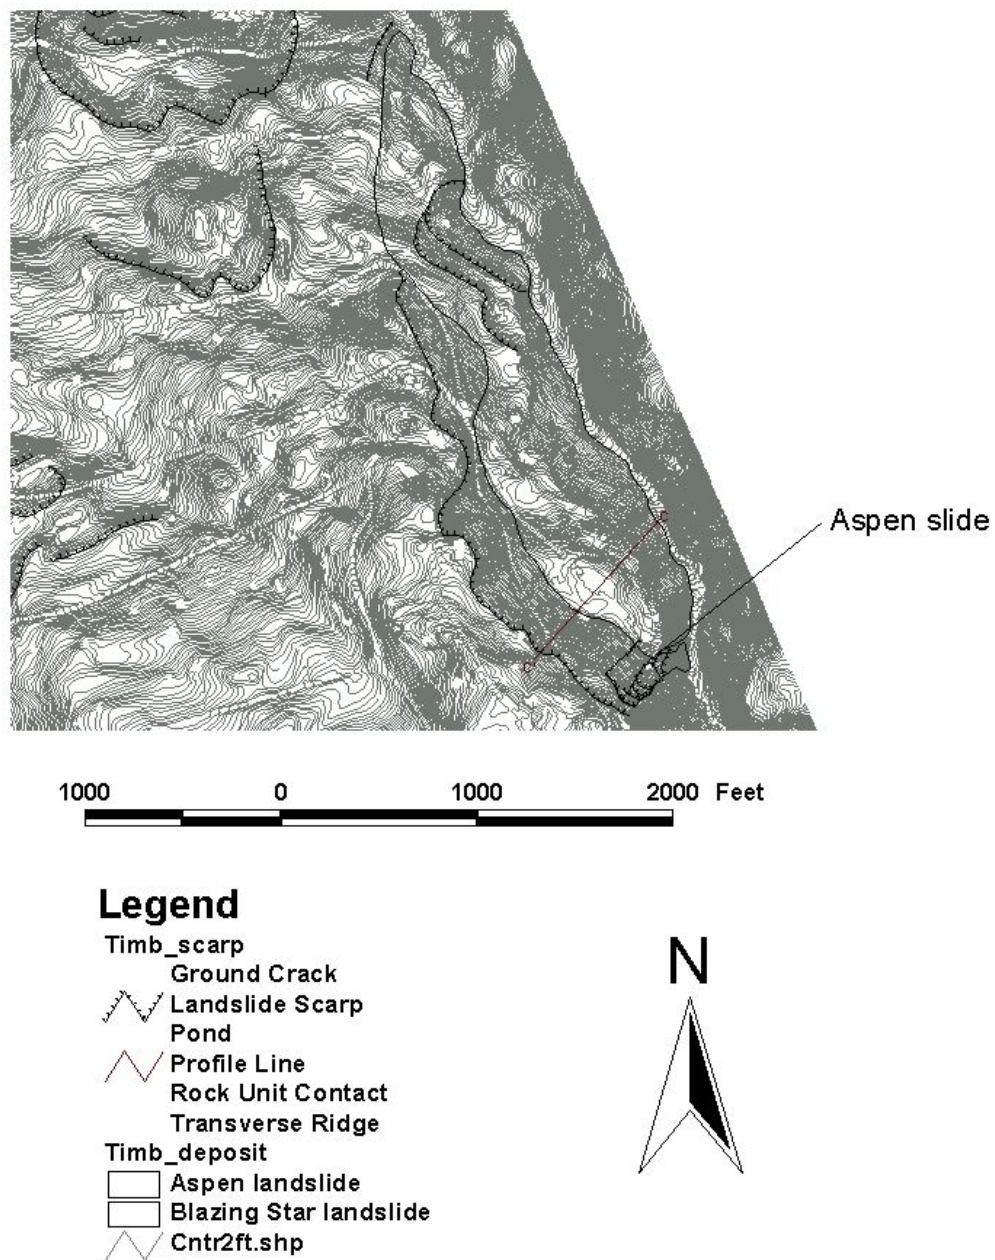
Figure 6. Map of Blazing Star landslide.

The Blazing Star slide has a prominent, primarily linear main scarp immediately west of the landslide deposit for roughly the southern two-thirds of the landslide (Fig. 6). A prominent main scarp is absent for most of the northern one-third of the landslide (Fig. 6). About where the continuous main scarp dies out, a series of minor scarps radiate out to the southeast (Fig. 6). These features suggest scissor-type motion of the slide mass about a point located where displacement along the main scarp dies out. On the slopes directly above Lake Creek, where the creek is actively eroding the toe of the slide, there are numerous, steep, discontinuous escarpments that may be minor landslide scarps or debris slide scarps. The Aspen slide, which was initiated by a developer cutting a steep slope above Lake Creek, is adjacent to the southeastern boundary of the Blazing Star slide (Fig. 6). The profile C-C' (Fig. 6) used for modeling of the Blazing Star slide is shown in Figure 7. The average slope along C-C', from the head of the landslide deposit to the toe is 13 degrees (Table 3).

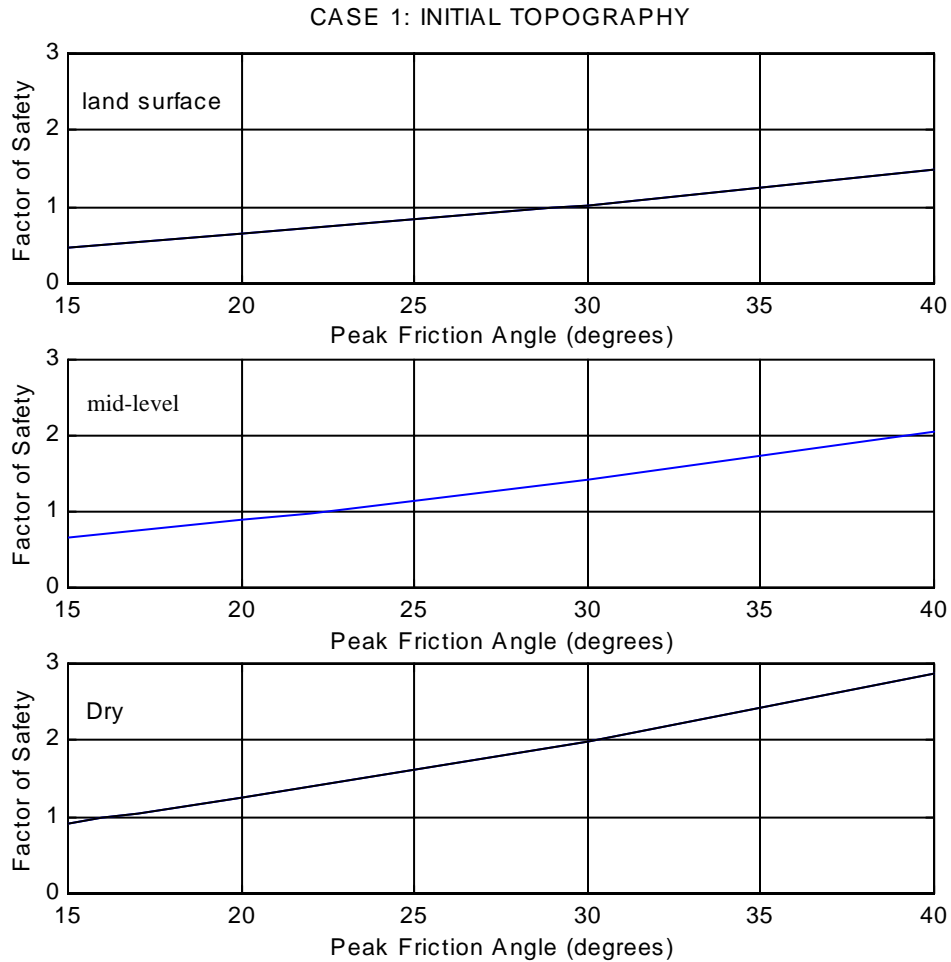
Peak Friction Angles (Case 1): We estimated peak friction angles of 16, 22 and 29 degrees under dry conditions, mid-level water table, and total saturation of the slide, respectively (Fig. 8, Table 4). Sample stability analyses are shown in Figure 9.

Figure 8: Factor of Safety as a function of Peak Friction Angle for the Cedar Bark landslide (Case 1 Analysis). The height of the ground water within the slide mass varies from zero (dry), to mid-level, to the land surface when the slide is fully saturated.

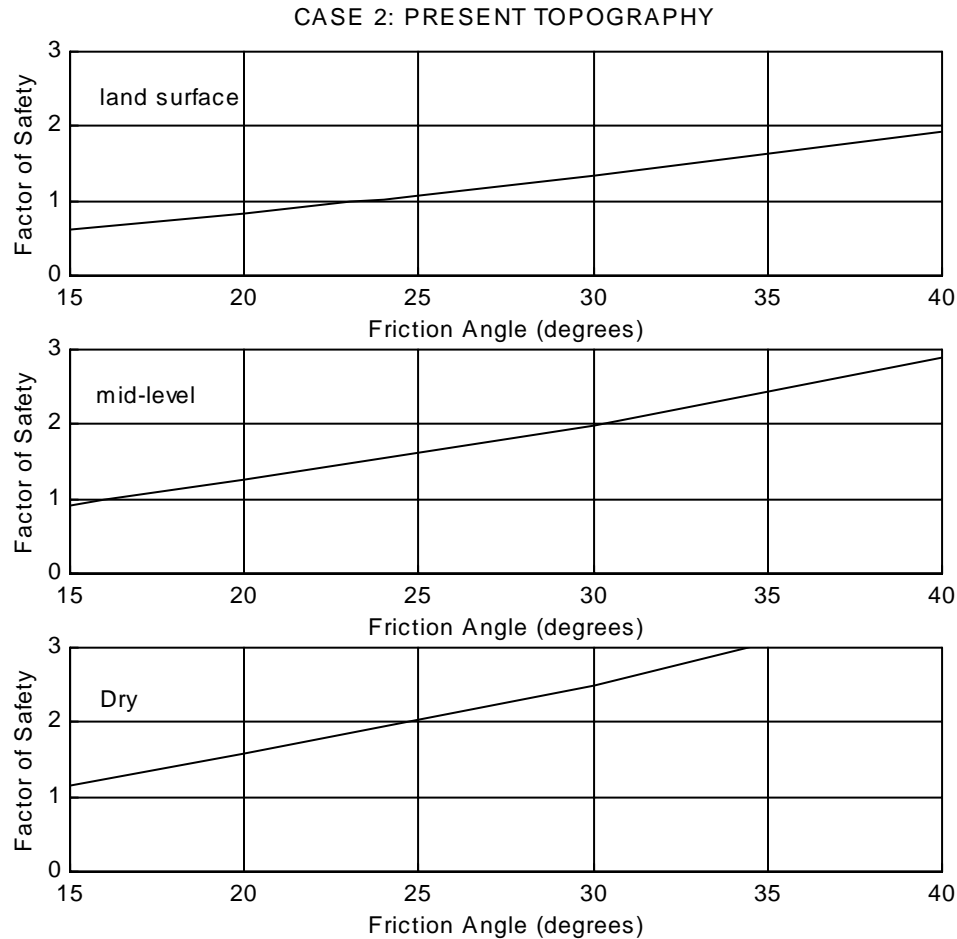
Residual Friction Angles (Case 2): The factor of safety was greater than 1.0 for residual friction angles as low as 15 degrees under dry conditions (Fig. 10, Table 4). The factor of safety was 1.0 at a lower bound residual friction angle of ~16 degrees and mid-level groundwater table. The lower bound residual friction angle was ~23 degrees under simulated conditions of groundwater saturation. Sample stability analyses are shown in Figure 11.

Figure 10: Factor of Safety as a function of Friction Angle for the Cedar Bark landslide (Case 2 Analysis). The height of the ground water within the slide mass varies from zero (dry), to mid-level, to the land surface when the slide is fully saturated.

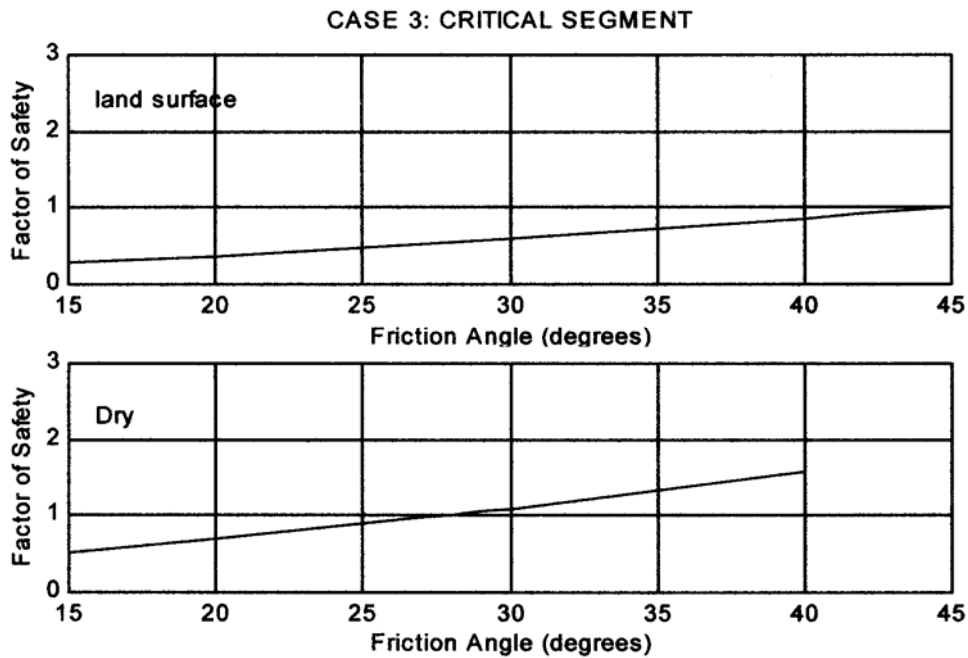
Critical Segment (Case 3): The steep slope at the toe of the Cedar Bark slide is the most critical segment found by modeling (Fig. 12, Table 4). Debris slides and shallow slumps are probable under saturated conditions and possible under less than saturated conditions, given the projection of the friction angle curve between saturated and dry conditions for $FS = 1$ (Fig. 12; Table 4). Because the most critical segment has not yet failed, the peak friction angle for the glacial till must be greater than the minimum critical friction angle. Thus, the peak friction angle for the glacial till is greater than 27 degrees (Fig. 12; Table 4), provided cohesion is negligible and the materials that compose the most critical area are representative of materials at greater depth within the Cedar Bark slide. Sample stability analyses are shown in Figure 13.

Figure 12: Factor of Safety as a function of Friction Angle for the Cedar Bark landslide (Case 3 Analysis). The height of the ground water within the slide mass varies from zero (dry) to the land surface when the slide is fully saturated.

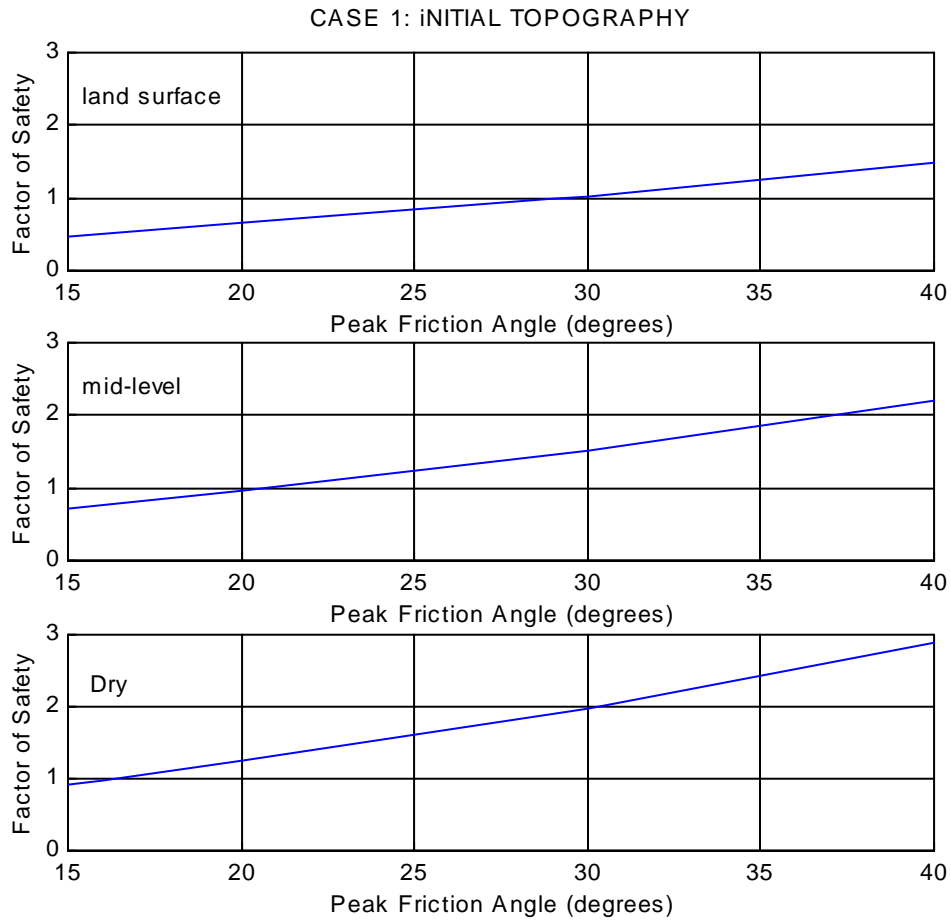
Peak Friction Angles (Case 1): We estimated peak friction angles of 16, 20 and 29 degrees under dry conditions, mid-level water table, and total saturation of the slide, respectively (Fig. 14, Table 5). Sample stability analyses are shown in Figure 15.

Figure 14: Factor of Safety as a function of Peak Friction Angle for the Beaver Bench landslide (Case 1 Analysis). The height of the ground water within the slide mass varies from zero (dry), to mid-level, to the land surface when the slide is fully saturated.

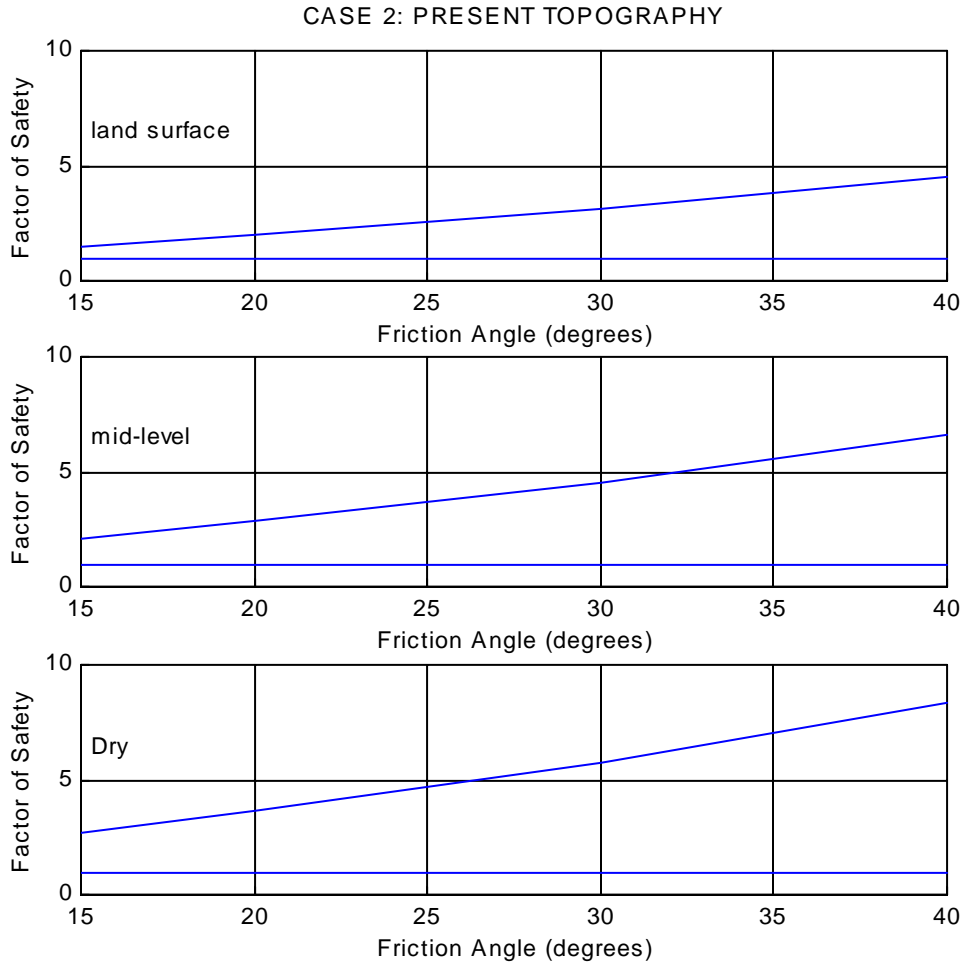
Residual Friction Angles (Case 2): The factor of safety is greater than 1.0 even for very low friction angles of 15 degrees and saturated groundwater conditions (Fig. 16, 17; Table 5). Extrapolating from Figure 16, the residual friction angle under fully saturated groundwater conditions is approximately 12 degrees. Sample stability analyses are shown in Figure 17.

Figure 16: Factor of Safety as a function of Friction Angle for the Beaver Bench landslide (Case 2 Analysis). The height of the ground water within the slide mass varies from zero (dry), to mid-level, to the land surface when the slide is fully saturated.

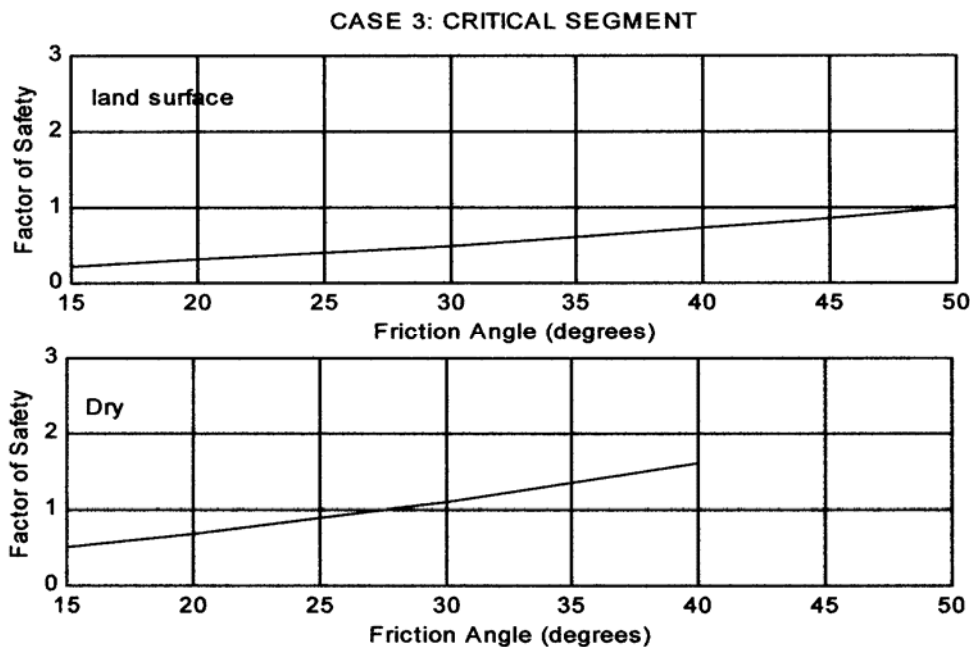
Critical Segment (Case 3): The steep slope formed by the main scarp is the most critical segment identified by stability modeling (Fig. 18, Table 5), although the steep toe of the slide is nearly as critical. Debris slides and shallow slumps are probable under saturated groundwater conditions and possible under less than saturated conditions, given the projection of the friction angle curve between saturated and dry conditions for $FS = 1$ (Fig. 18; Table 5). Because the most critical segment has not yet failed, the peak friction angle for the Keetley Volcanics must be greater than the minimum critical friction angle. Thus, the peak friction angle for the Keetley Volcanics is greater than 27 degrees (Fig. 18; Table 5), provided cohesion is negligible and the materials that compose the most critical area are representative of materials at greater depth within the Beaver Bench slide. Sample stability analyses are shown in Figure 19.

Figure 18: Factor of Safety as a function of Friction Angle for the Beaver Bench landslide (Case 3 Analysis). The height of the ground water within the slide mass varies from zero (dry) to the land surface when the slide is fully saturated.

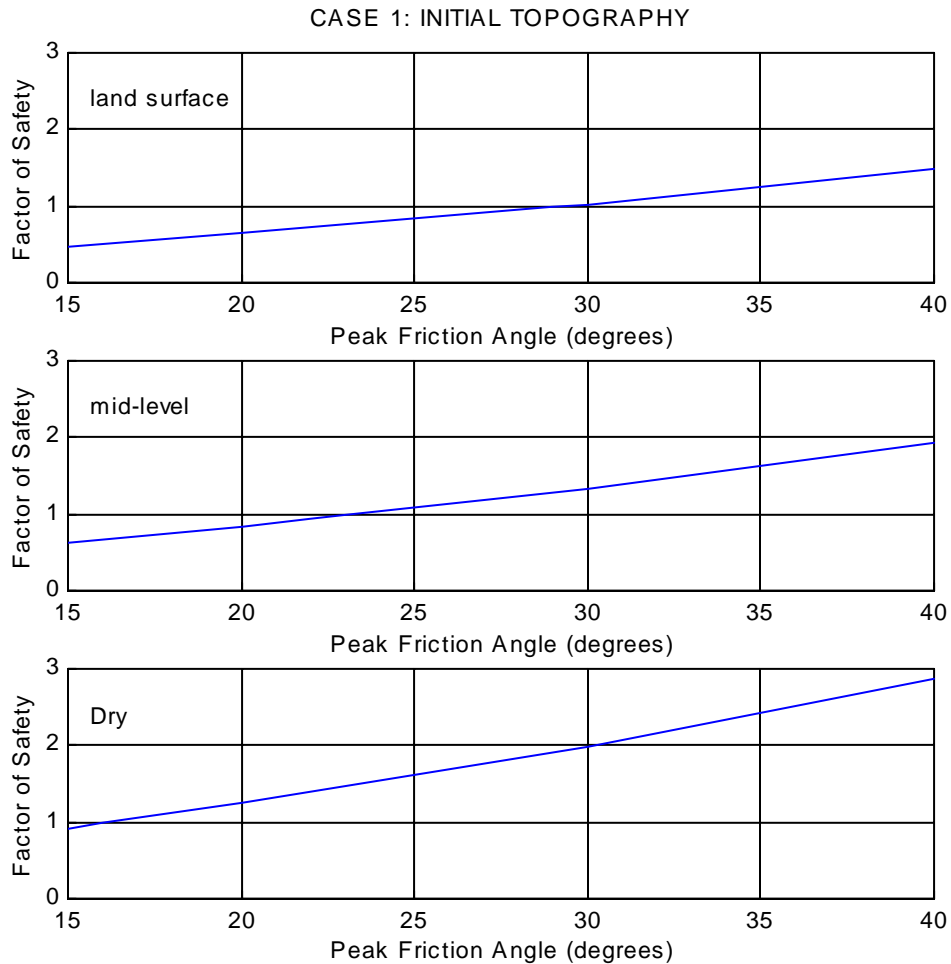
Peak Friction Angles (Case 1): We estimated peak friction angles of 16, 23 and 29 degrees under dry conditions, mid-level water table, and total saturation of the slide, respectively (Fig. 20, Table 6). Sample stability analyses are shown in Figure 21.

Figure 20: Factor of Safety as a function of Peak Friction Angle for the Blazing Star landslide (Case 1 Analysis). The height of the ground water within the slide mass varies from zero (dry), to mid-level, to the land surface when the slide is fully saturated.

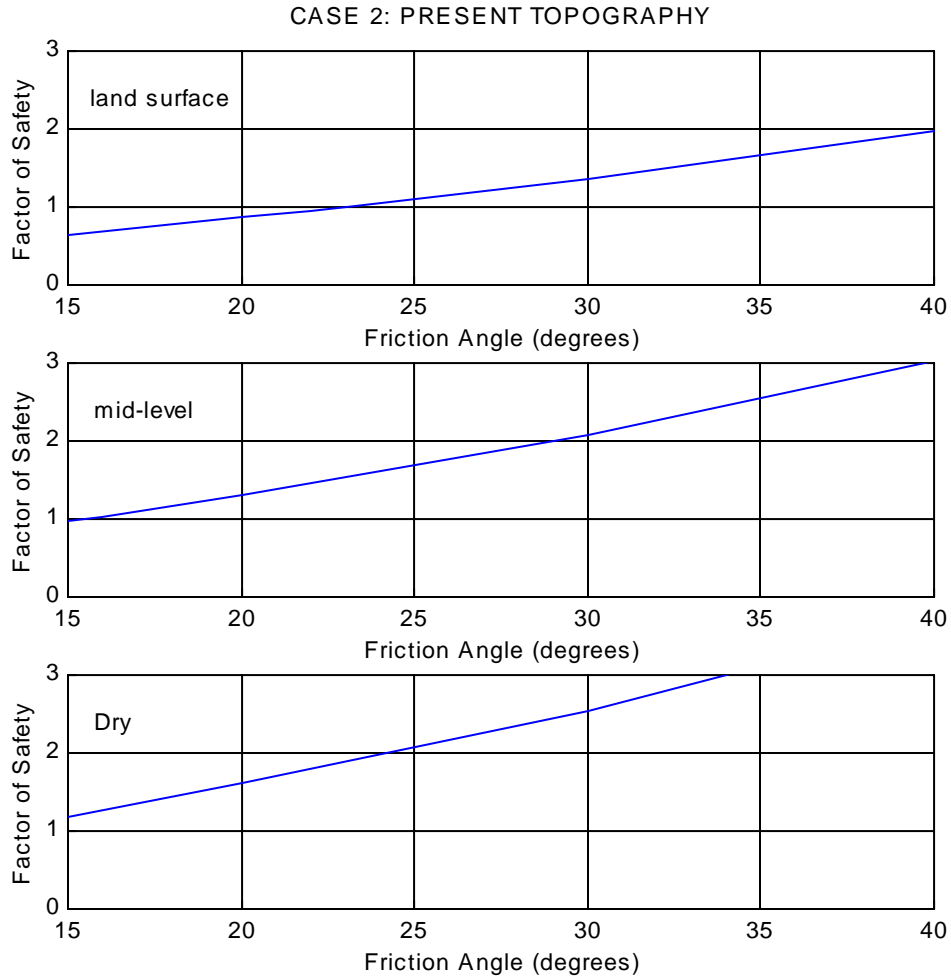
Residual Friction Angles (Case 2): The factor of safety is greater than 1.0 under dry conditions for friction angles as low as 15 degrees. Lower bound residual friction angles of 15 and 23 degrees were estimated under mid-level and saturated groundwater conditions (Fig. 22, Table 6). Sample stability analyses are shown in Figure 23.

Figure 22: Factor of Safety as a function of Friction Angle for the Blazing Star landslide (Case 2 Analysis). The height of the ground water within the slide mass varies from zero (dry), to mid-level, to the land surface when the slide is fully saturated.

These types of uncertainties lead the Utah Geological Survey (Hylland, 1996) to recommend the use of conservative parameters and a factor of safety of greater than or equal to 1.5 in preliminary analyses such as those reported here. At mid-level and saturated groundwater conditions, if friction angles are less than 23 and 32 degrees, respectively, the present configuration of the Cedar Bark slide has a factor of safety of less than 1.5 (Figs. 10, 11; Table 4). Likewise, at mid-level and saturated groundwater conditions, if friction angles are less than 22 and 31 degrees, respectively, the present configuration of the Blazing Star slide has a factor of safety of less than 1.5 (Figs. 22, 23; Table 6).

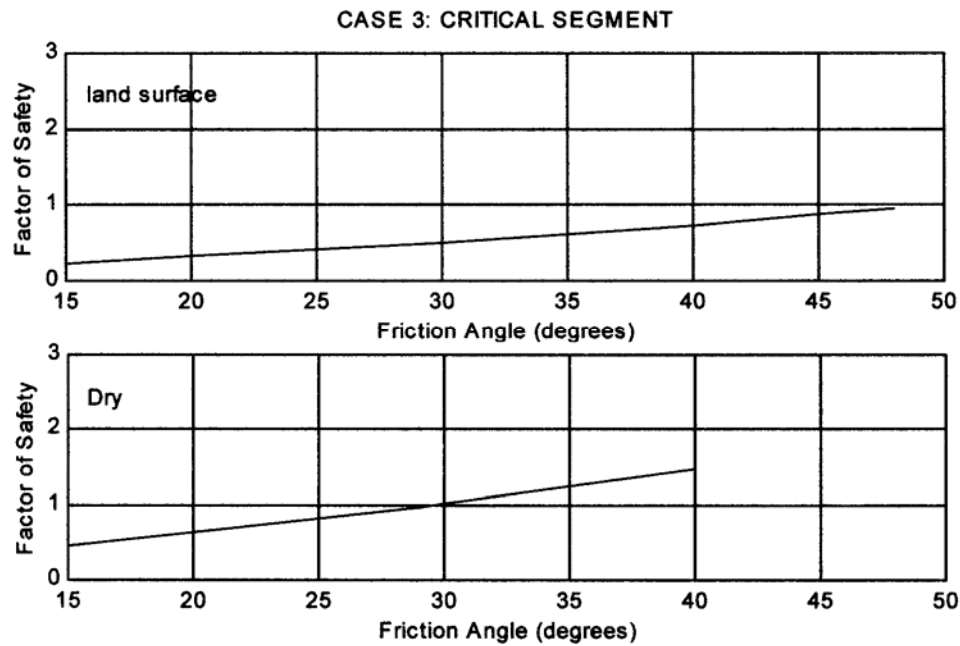
Critical Segment (Case 3): Debris slides and shallow slumps along the steep bank of Lake Creek are probable under saturated groundwater conditions and possible under less than saturated conditions, given the projection of the friction angle curve between saturated and dry conditions for $FS = 1$ (Fig. 24, Table 6). This result is substantiated by recent debris slides that were mapped in that area. One of these recent debris slides had a small spring at the base of the main debris slide scarp. The main scarp of the Blazing Star slide is nearly as steep as the toe, and, thus, is also prone to local instability. Sample stability analyses are shown in Figure 25.

Figure 24: Factor of Safety as a function of Friction Angle for the Blazing Star landslide (Case 3 Analysis). The height of the ground water within the slide mass varies from zero (dry) to the land surface when the slide is fully saturated.
