## Utah Geological Survey Technical Report

Project: Landslides of 2005 at a horse ranch near the East Lawn Memorial Hills Cemetery, Provo, Utah County, Utah		
By: F.X. Ashland, P.G.	Date: January 11, 2006	County: Utah
USGS Quadrangle: Orem (1047)	Section/Township/Range: Sec. 18, T. 6 S., R. 3 E.	
Requested by: Incident Investigation	Date report received at UGS:	Technical Report number: 06-01

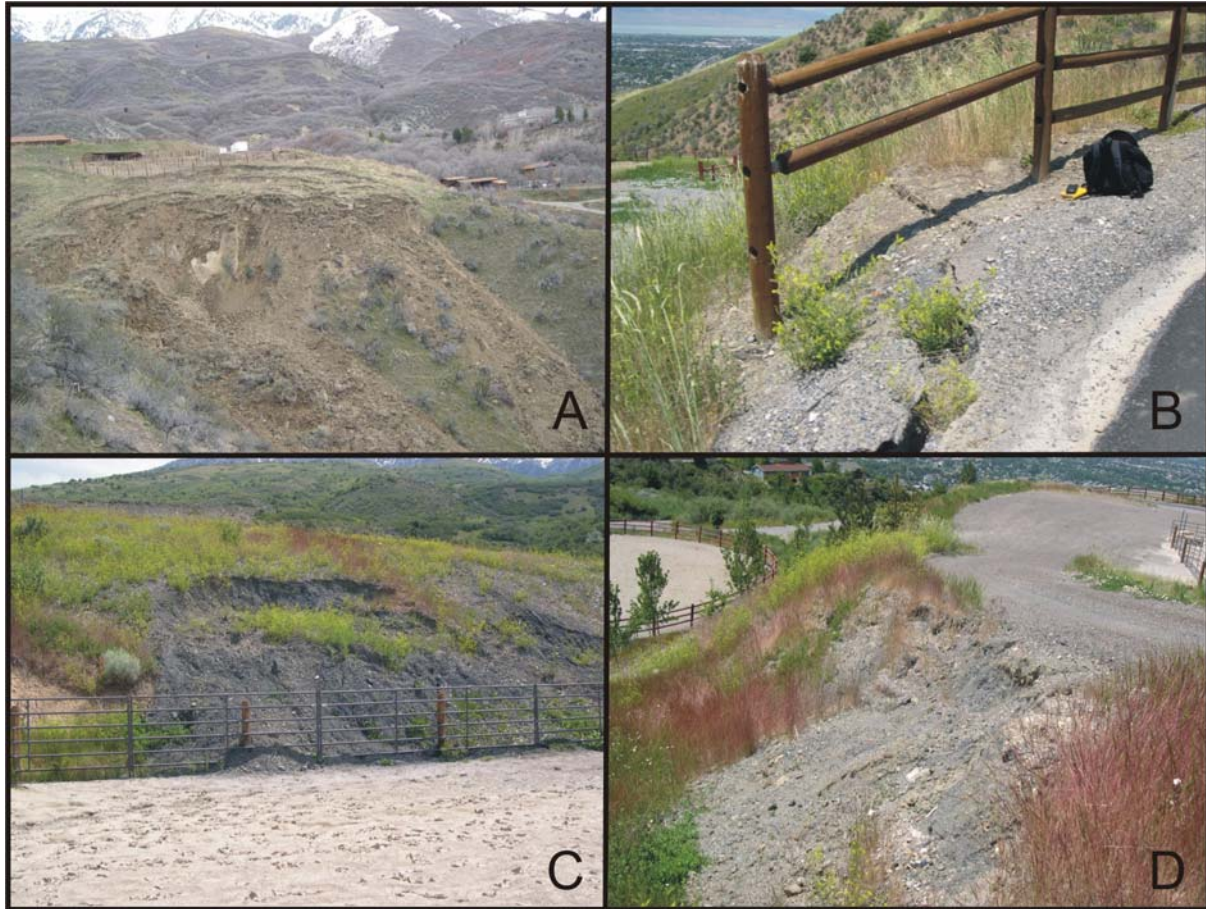
The northern part of the main landslide (figure 2A) consisted of an earth flow in the lower western part, and an earth slide in the upper eastern part that together form a complex earth slide-earth flow. Figure 5 shows that movement in the earth flow was to the southwest. Scarp orientation indicates movement in the upper earth slide was generally westward and locally west-northwest. The entire northern part of the main landslide was about 490 feet long. Local relief between the toe of the earth flow and main scarp of the earth slide was about 165 feet, indicating an average slope of the complex earth slide-earth flow of about 34 percent. The average slope of the lower earth flow was slightly steeper, about 41 percent. Several internal (minor) scarps cut the upper earth slide, including two with large offsets. The lower of these two scarps was about 70 feet upslope of the top of the earth flow, arcuate in plan view, and between 3.5 and 7 feet high on June 23. The second large-offset scarp (figure 6D) crossed the middle of the corral and reached a maximum height of about 6 feet near the southeastern edge of the corral. Observations between March and June suggest that the northern part of the landslide remained active during this period and enlarged upslope of the tack shed. On June 23, the main scarp east of the large-offset internal scarps reached a maximum height of only about a foot and crossed a cut slope above a tack shed northeast of the corral.

The closest small slide to the main landslide was in a steep southwest-facing slope below a paved access road to a large barn on the property, a short distance southeast of the tack shed. Offset on the main scarp caused minor damage to a wooden fence and to the edge of the pavement atop the slope (figure 2B). Based on its proximity to ground deformation features in the crown of the main landslide, the small slide may actually be within the limits of the main landslide, although it is mapped as a separate slide on figures 4 and 5.

The two other small slides were upslope of a large barn and riding arena (figure 4). One was on a southeast-facing slope east of the large barn (figure 2D). Offset on the main scarp severed a buried drain or water pipe. The other small slide (figure 2C) was in a cut slope directly northeast of a riding arena. The landslide was localized in a weathered block of Manning Canyon Shale or homogenous debris derived from the shale.

**Figure 2.** Landslides in 2005 on horse ranch east of East Lawn Memorial Hills Cemetery, Provo. (A) View to the east of north part of main landslide on March 17. (B) Minor offset on main scarp of small companion slide to main landslide southeast of tack shed that caused minor damage to fence. View is to the west. (C) View to the east of small landslide northeast of riding arena in highly weathered Manning Canyon Shale or debris derived from the shale. Movement direction is to the west-southwest. (D) View to the west-southwest of main scarp of small landslide east of barn. Movement direction is to the southeast. Photographs of small landslides (B, C, and D) taken on June 23.

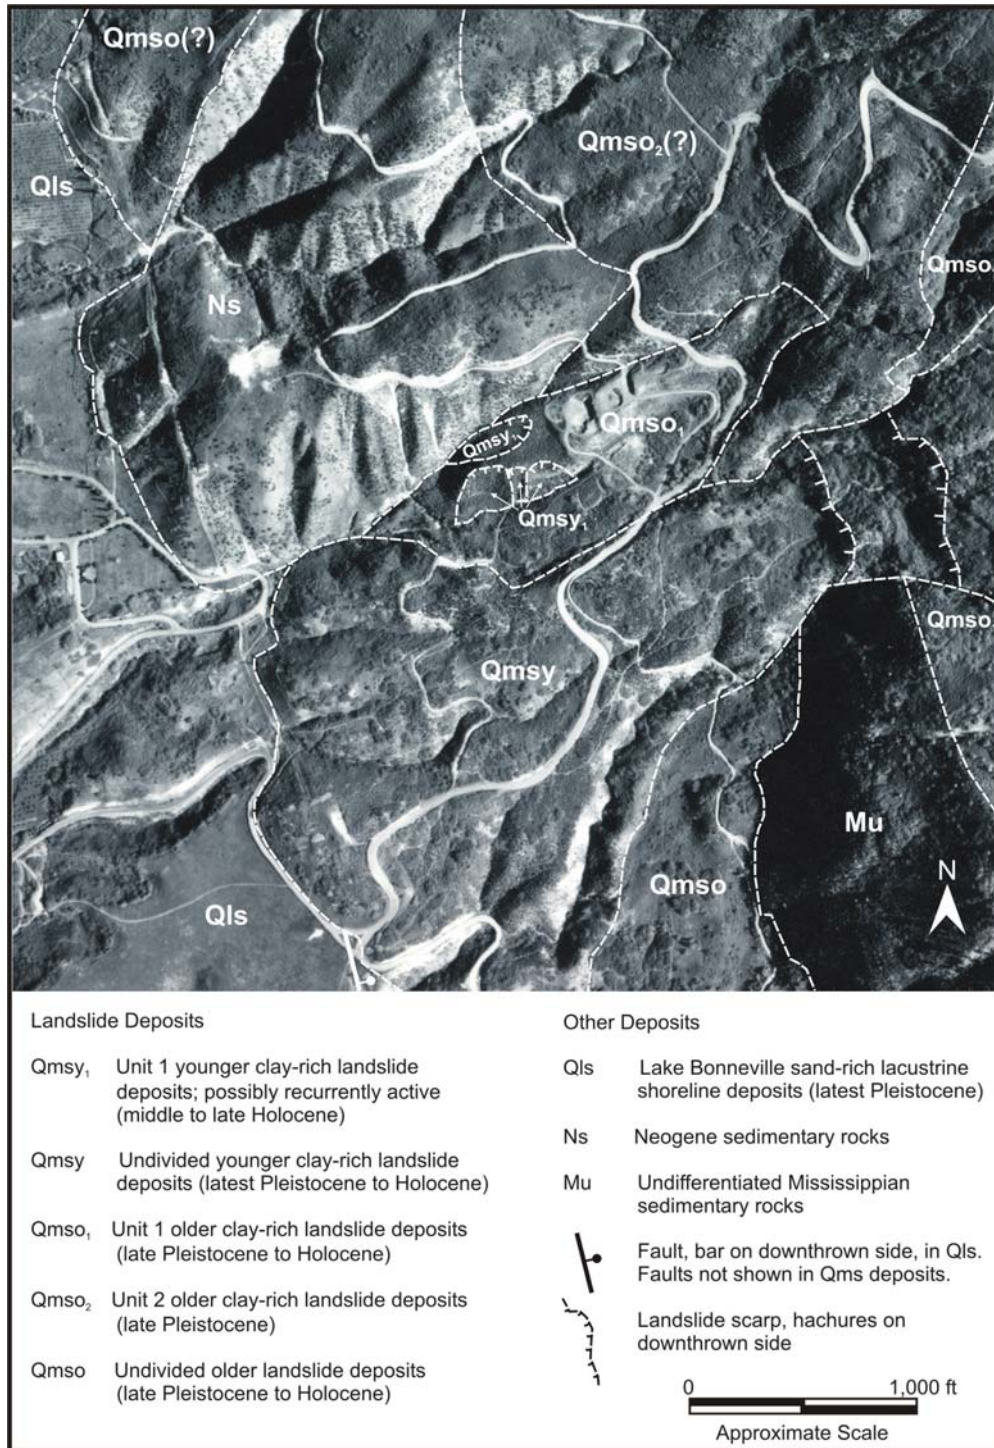
The horse ranch is underlain by prehistoric landslide deposits that comprise the northern part of the Sherwood Hills landslide complex (Machette, 1992; Ashland, 2003). Figure 3 shows the local geology and younger pre-existing landslides within the prehistoric older landslide deposits. The younger pre-existing landslides with well-defined boundaries indicate local partial reactivation of the prehistoric landslide deposits prior to the area's use as a horse ranch. Landslide deposits consist of clay-rich debris with angular cobble and boulder clasts supported in a clay-rich soil matrix. The debris is likely derived, in part, from residual and colluvial deposits formed on the Mississippian Manning Canyon Shale, a formation that underlies the eastern part of the Sherwood Hills landslide complex.

Grading and fill placement at the top of the younger pre-existing landslides (Qmsy<sub>1</sub> in figure 3) were also likely contributing causes of the landsliding. The additional load of the fill in the upper part of these landslides increased driving forces and likely left the pre-existing slides marginally stable prior to the rising ground-water levels in 2005 or the onset of movement in previous years.

**Figure 3.** Aerial photograph geologic map of the northern part of the Sherwood Hills landslide complex showing prehistoric landslides and landslide deposits prior to development. Unit 1 younger landslides (Qmsy<sub>1</sub>) and unit 1 older landslide deposits (Qmso<sub>1</sub>) underlie site of 2005 landslides on horse ranch property.

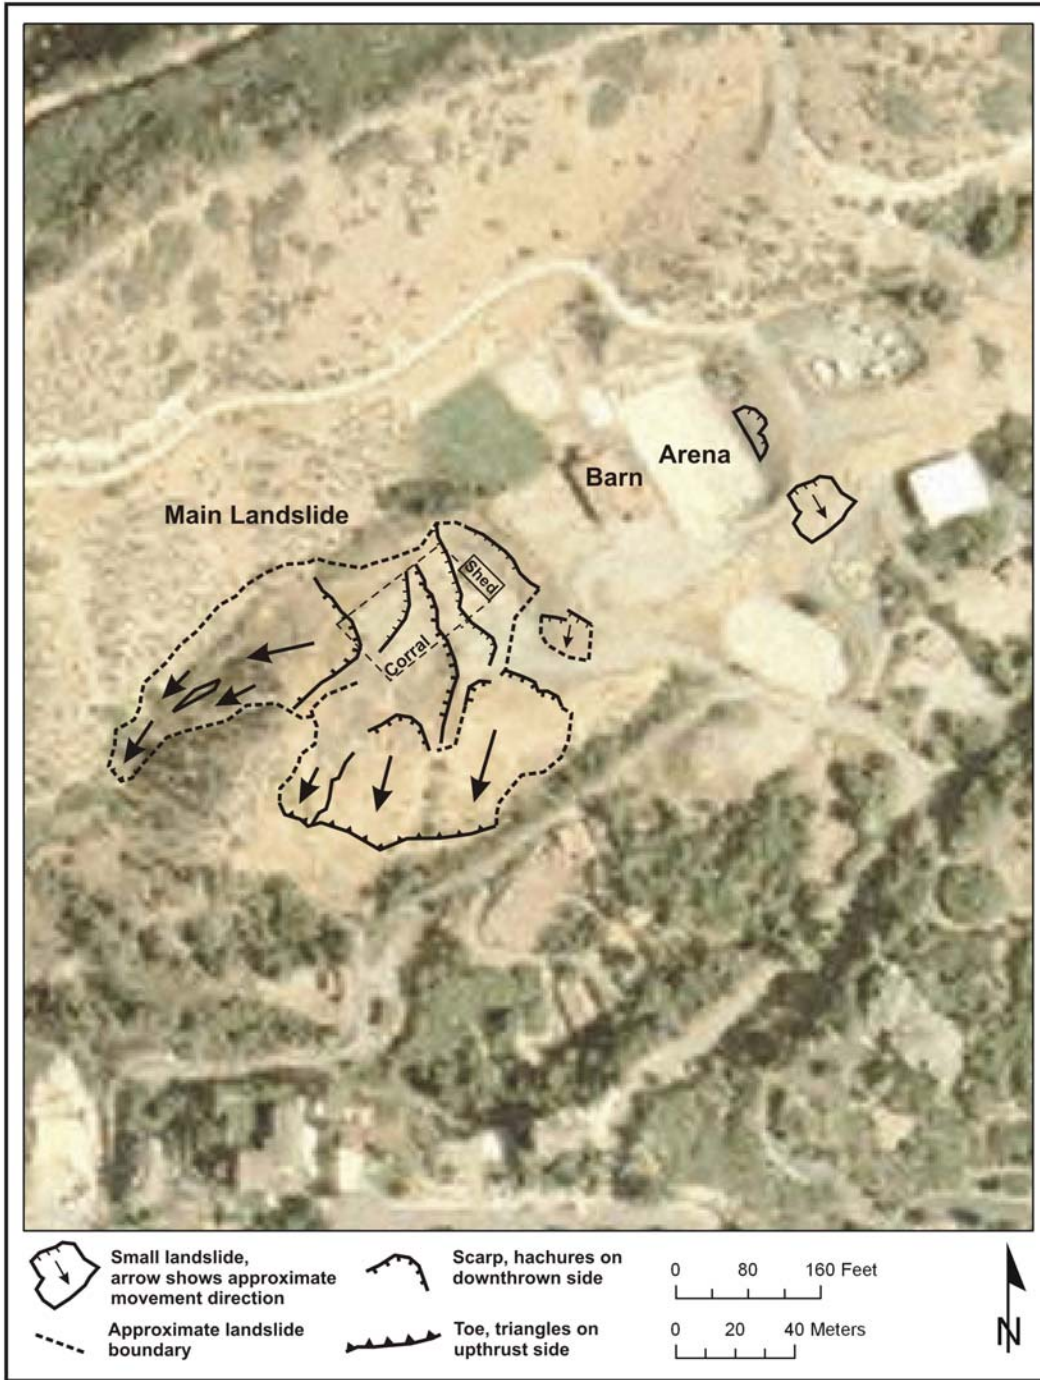
Four separate landslides were active in 2005 on the horse ranch (figure 4). The main landslide is a reactivation of younger pre-existing landslides in the underlying prehistoric landslide deposits. The other three landslides occurred in either cut or fill slopes. Fill materials were likely locally derived, making distinguishing fill from native landslide deposits difficult.

The main landslide is on the southwest-trending ridge occupied in part by the corral (figure 4). The landslide consists of two slides that overlap at the ridge crest, one on the northern slope of the ridge and one on the southern slope, that have divergent movement directions. Our mapping indicates that the northern part of the landslide moved first and that the southern part expanded upslope, capturing part of the northern part of the slide. Evidence for this includes a severed toe thrust on the western edge of the landslide that initially was in the northern part of the slide before it was cut off by the main scarp of the southern part of the slide. Figure 5 is a detailed map of the main landslide showing the major internal deformation features, movement directions, scarp heights, and deposit thicknesses. By June 23, the main landslide was about 2.4 acres in size.

**Figure 4.** Map showing 2005 landslides on horse ranch property. The main landslide consists of two parts that overlap near a southwest-trending ridge crest, a northern complex earth slide-earth flow that moved west-southwest and a southern earth slide that moved south-southwest. The other three small landslides occurred in either cut or fill slopes.

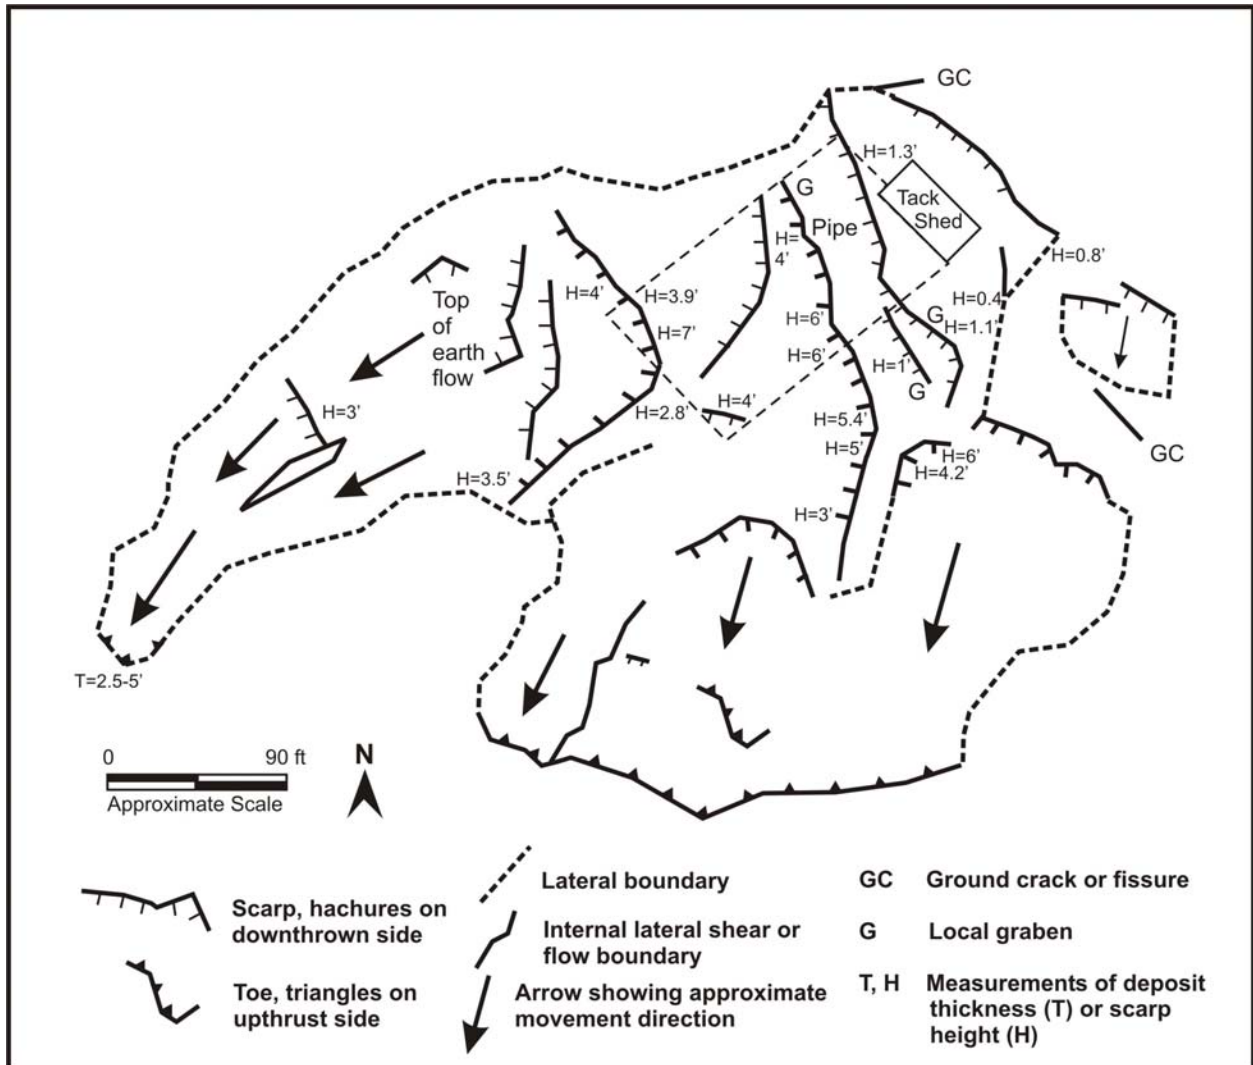
The southern part of the main landslide consisted of an earth slide about 340 feet wide and between 160 and 200 feet long. Figure 5 shows the movement direction of the southern part of the slide was generally to the south-southwest. In the east, the southern part of the slide abutted the northern earth slide, but in the west the southern part of the slide overlapped the northern part. The northern boundary of the southern part of the landslide extended into the southern corner of the corral and about 80 feet of the northern part of the slide was captured by the southern part. Local relief in the southern part of the landslide ranged between about 50 and 95 feet, with an average slope between about 32 and 46 percent. The main scarp of the southern part of the slide consisted of two separate arcuate scarp areas divided by a narrow south-trending ridge (figure 5). The scarps locally reached a maximum height of about 6 feet on June 23. Figure 6F shows damage to a wooden fence caused by ground deformation in the upper part of the southern part of the main landslide. A well-defined landslide toe exists along the bank of a drainage in the east and near the base of the slope in the west (figures 4 and 5).

**Figure 5.** Detailed map of main landslide. Height of scarps or deposit thicknesses in feet on June 23 also shown. Dashed rectangular area is approximate boundary of corral. Pipe indicates drainpipe exposed in scarp.

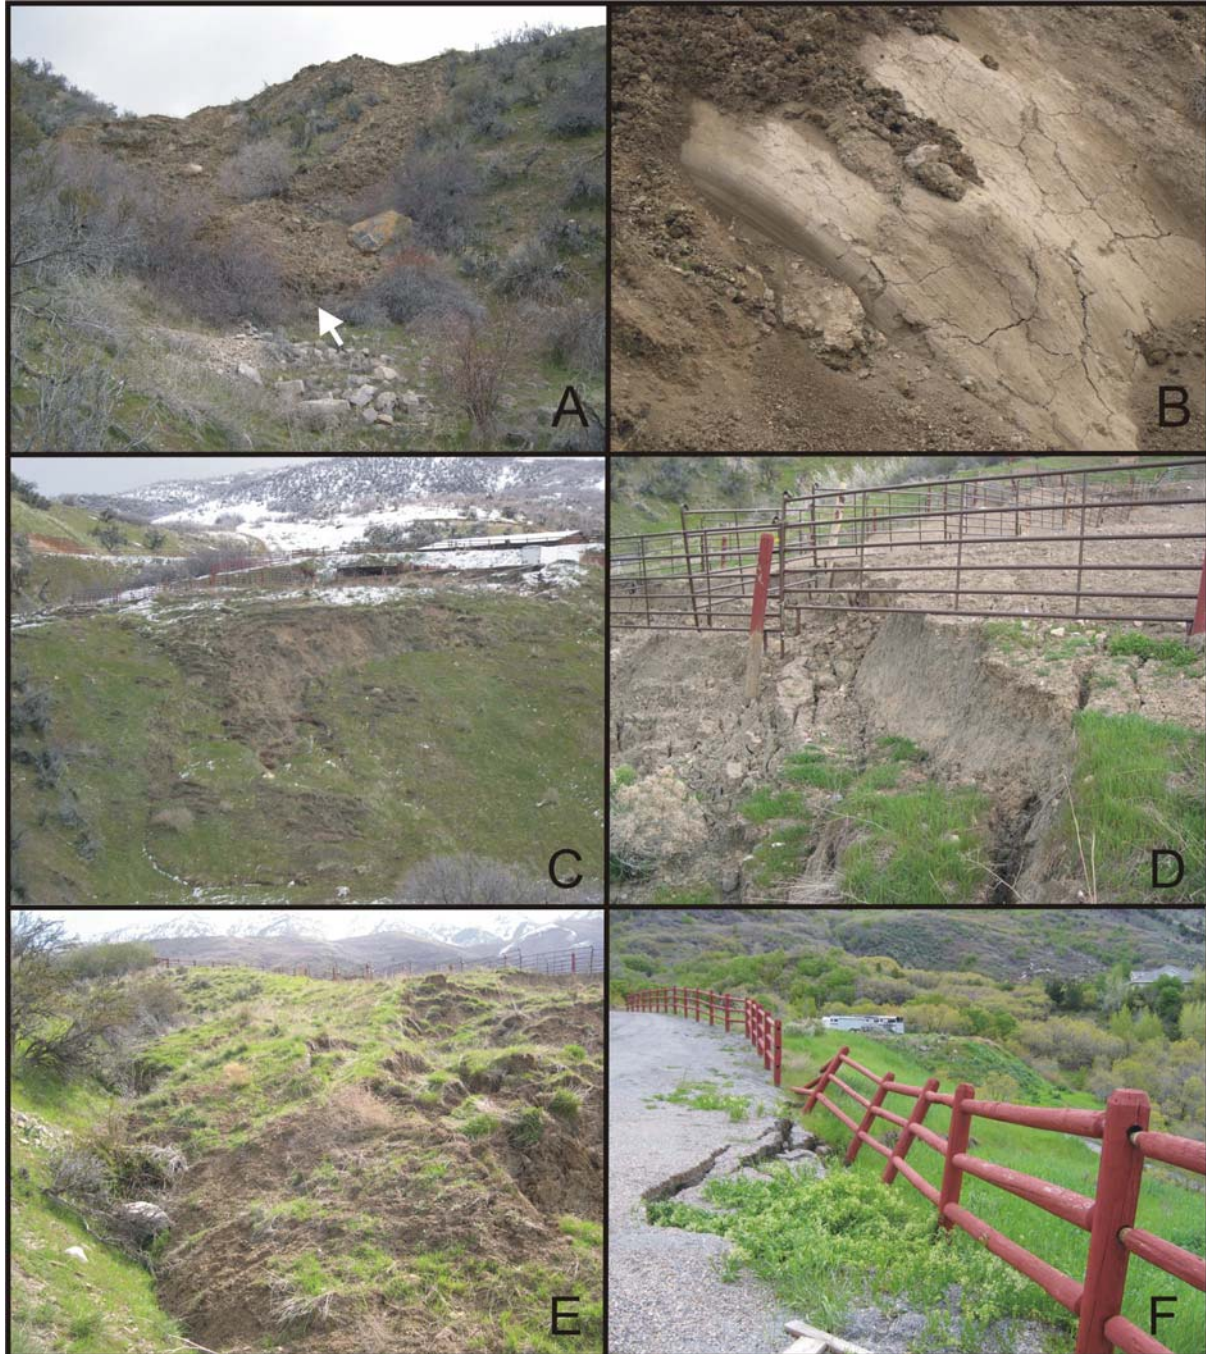
**Figure 6.** Ground deformation in the main landslide, March 17 to May 12, 2005. (A) View to the northeast of earth-flow toe (arrow) on March 17. (B) Slickensided clay in north part of landslide on March 17. (C) View to the north of south part of landslide on March 29. (D) View to the northwest of large internal scarp that crossed horse corral on April 18. (E) View to the northeast of north edge of landslide on April 18. (F) View to the east of damage to fence due to offset of main scarp of south part of landslide on May 12.
