## Utah Geological Survey

| Project:<br>March 12, 2005, fatal earth-fall landslide along Kanab Creek,<br>Kane County, Utah | | | |
| By:<br>William R. Lund, P.G. | Date:<br>03-06-05 | County:<br>Kane | |
| Requested by:<br>Fatality Investigation | | | Job number:<br>05-02 |

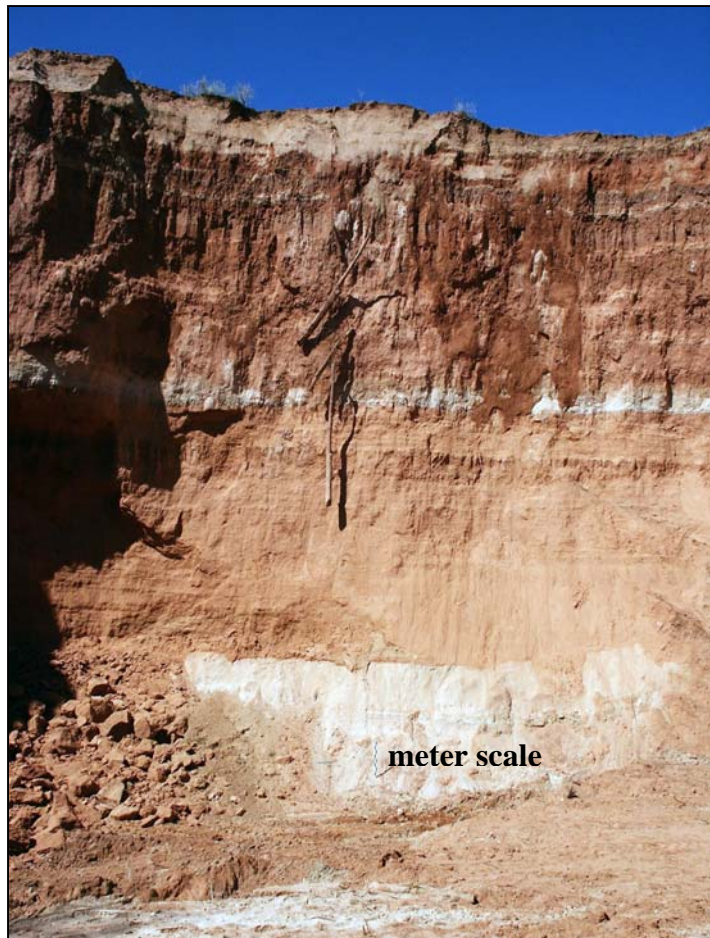
*Figure 1. This approximately 60-foot-high arroyo wall failed on March 12, 2005, creating an earth-fall landslide that buried one child and partially buried two others. Alternating layers of sand, silty sand, and silty clay comprise the majority of the stream cut.*

Geologic materials exposed in the arroyo wall where the landslide occurred consist chiefly of alternating layers of medium- to thick-bedded (6 inches to 2 feet) red sand, silty sand, and silty clay with discontinuous, thin interbeds of well-sorted white sand, gray clay, and gravel and cobbles (figure 1; appendix). These materials were deposited by Kanab Creek, and were derived chiefly from Mesozoic sedimentary rocks (sandstone, siltstone, and claystone) that crop out in the Kanab Creek drainage basin (Sargent and Philpott, 1987). A few feet of loose, wind-blown sand caps the cut.

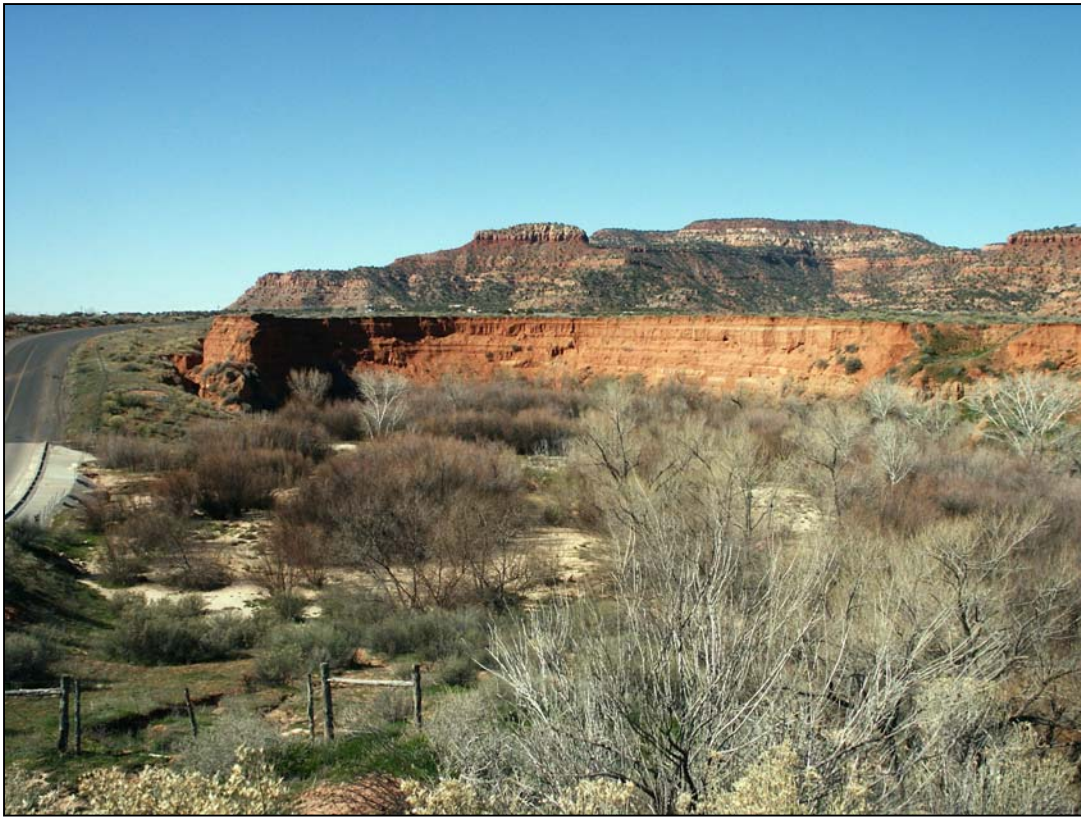
*Figure 3. View to the southwest of Kanab Creek, showing the steep-walled arroyo that formed due to floods in the 1880s.*

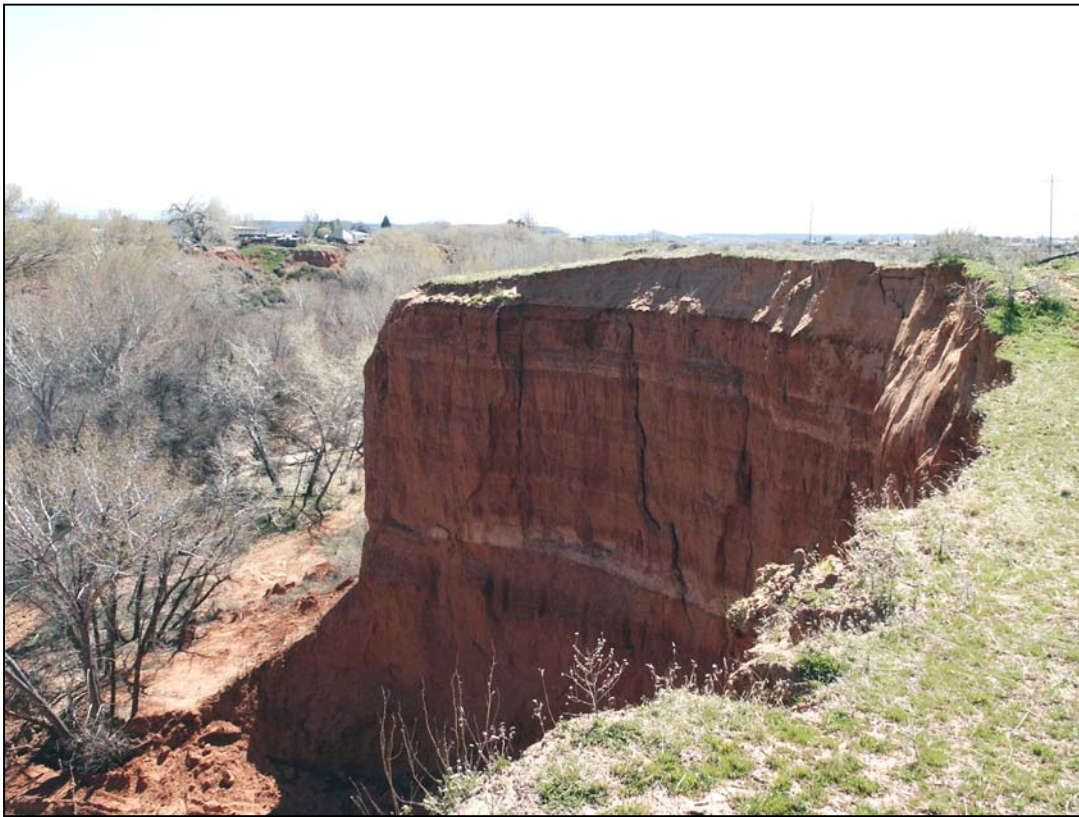
Examination of the arroyo wall where the landslide occurred revealed several deep, vertical cracks oriented parallel to the wall and spaced several feet apart (figure 4). One or more of these cracks served as the failure plane for the landslide as material in the wall detached along a crack(s) and fell into the arroyo. Similar cracks are present in the arroyo walls both up- and downstream from the landslide (figure 5). Evidence of cracks at the ground surface at the top of the arroyo was limited, except in one area immediately adjacent to the landslide where additional failure is imminent (figure 6). The unstable arroyo wall continued to spall material during the field reconnaissance, making close inspection of the cracks unsafe.

*Figure 4. Deep, vertical cracks parallel to the arroyo wall along which a section of the wall detached creating an earth-fall landslide.*

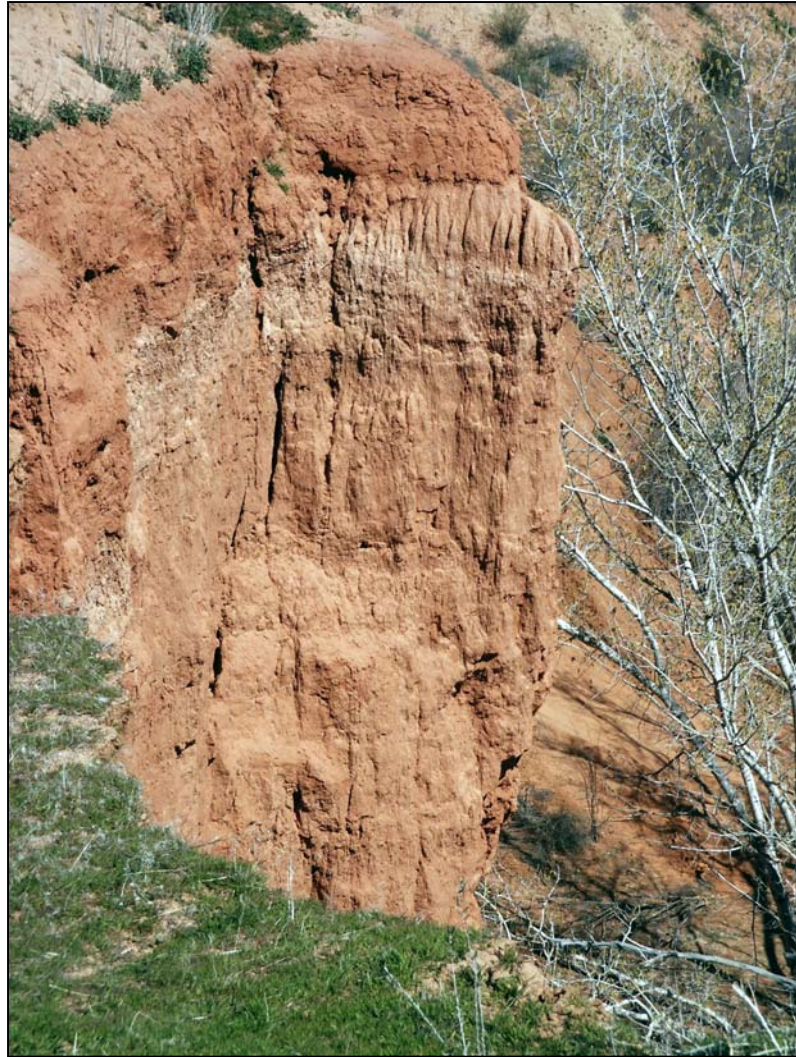
*Figure 5. Vertical cracks parallel to the arroyo wall in an area adjacent to the landslide that has not yet failed; such cracks are typical where arroyo walls are vertical.*

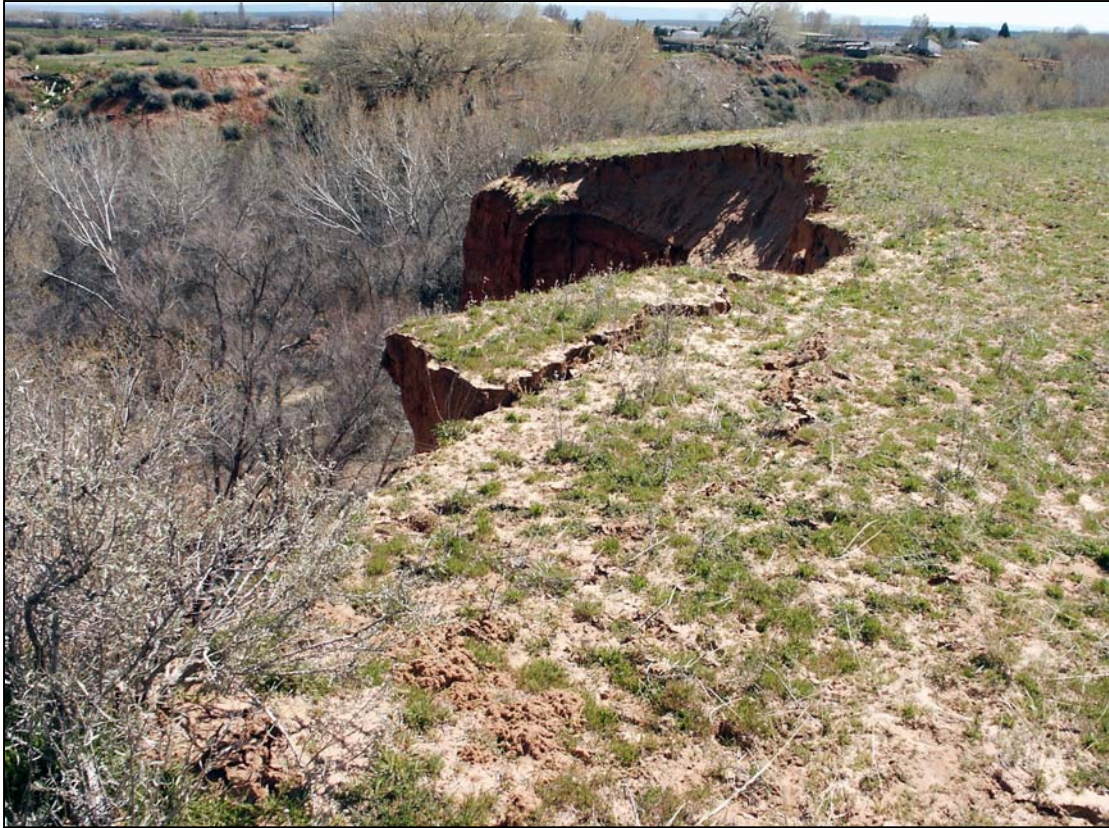
*Figure 6. Partially detached section of the arroyo wall where additional failure is imminent.*
