## Utah Geological Survey

Project: Preliminary hazard assessment of the Frontier Drive landslide, Mountain Green, Morgan County, Utah			Requesting Agency: Emergency Response
By: Francis X. Ashland	Date: 9-4-01	County: Morgan	Job No:  01-07
USGS Quadrangle: Snow Basin (1088)		Section/Township/Range. Section 23, T. 5 N., R. 1 E.

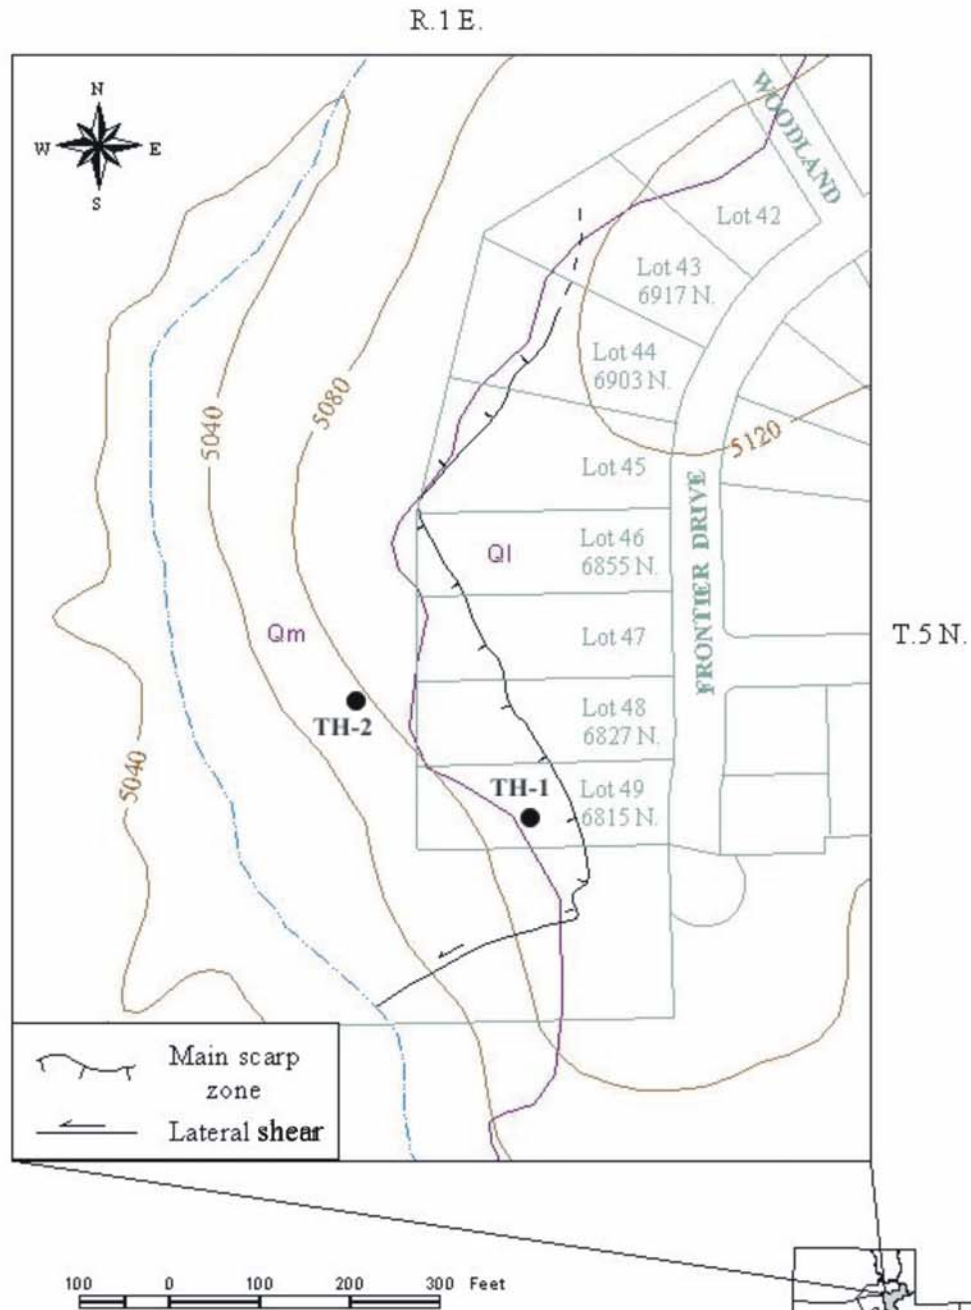
The Frontier Drive landslide is on a generally west-facing slope between an unnamed creek on the west and the approximate crest of the natural slope on the east (figure 1). The landslide is along the western edge of the Trapper's Pointe subdivision (Landmark Surveying and Engineering, Inc., [LSE], 2001) in Mountain Green, Morgan County, and is approximately between elevations 5,020 and 5,100 feet. The main scarp of the landslide (figure 2) generally coincides with the inferred position of the natural crest of the slope prior to hillside modifications during development of the site. Locally, an individual main scarp is difficult to recognize and instead a zone of scarps and transverse ground cracks or crown cracks exists (figure 2b). The main scarp steps to the west and transitions into a ground crack with no vertical offset at the north end of the landslide (figure 2c). The ground crack does not extend downslope to the creek. Thus, the exact position of the northern boundary of the landslide is uncertain. The toe of the landslide is along the east edge of the creek at the base of the slope in the southern part of the landslide. The toe locally consists of zones of overriding thrusts that form a stair-stepped geometry in the lower slope (figure 3). The location of the toe in the northern part of the landslide is less certain. I observed probable toe-like features in the lower third of the slope in the northern part of the landslide. The southern edge of the landslide is bound by a discrete left-lateral shear.

Figure 1. Location and sketch map of the Frontier Drive landslide in Mountain Green, Morgan County, Utah. The landslide is bounded on the east by a main scarp zone and on the west by an unnamed creek. The main scarp zone transitions to the north into a zone of ground cracking (dashed line). The main scarp zone roughly coincides with the contact between landslide deposits (Qm) and lacustrine deposits (Ql) of King and others (in preparation). A lateral shear bounds the landslide on the south. Earthtec (2001) boreholes TH-1 and TH-2 shown.

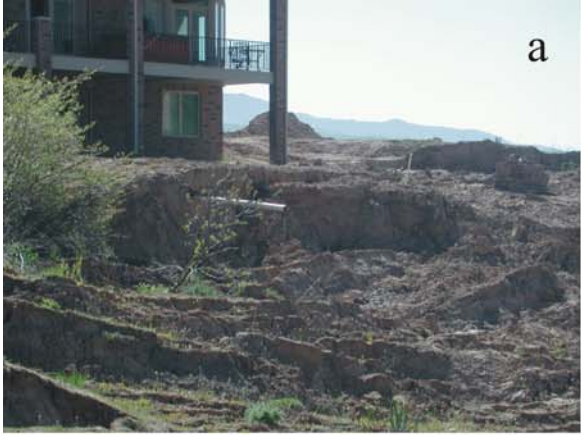
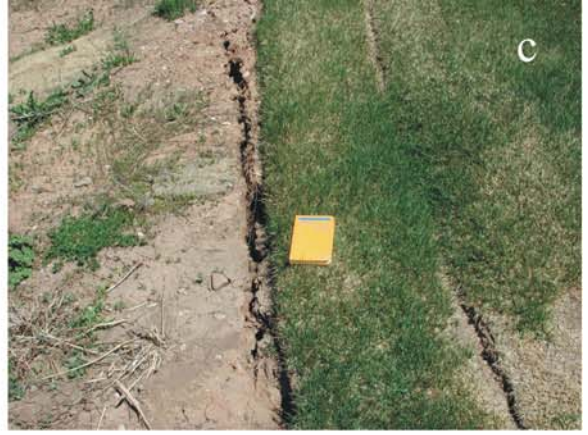
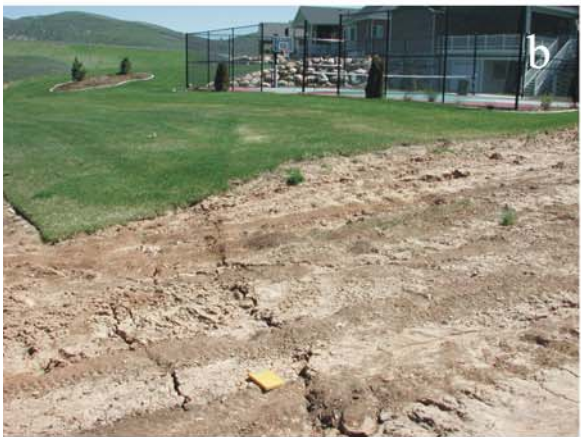
*Figure 2. Main scarp zone of the Frontier Drive landslide. (a) View to the southeast of main scarp at lot 49 (6815 N.). (b) View to north of main scarp zone near lots 44 and 45. (c) View to the north of main scarp-ground cracks along west edge of lot 43.*

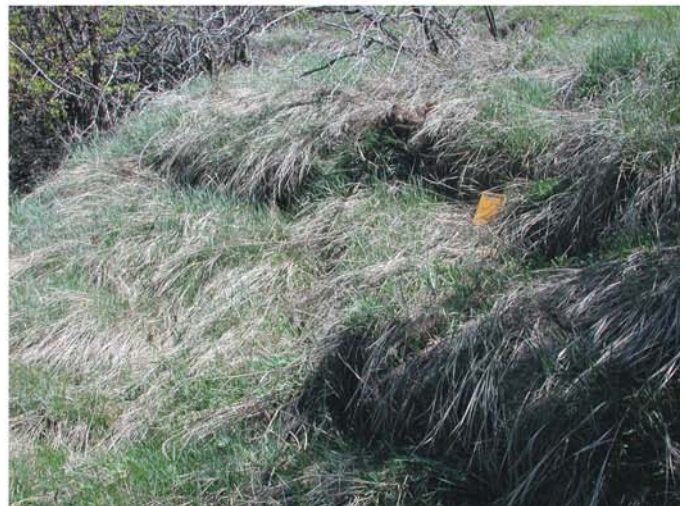
*Figure 3. Toe of the Frontier Drive landslide. Overriding thrusts form stair-stepped geometry in lower slope. View is to the northeast. Field book measures about 9 inches in height.*

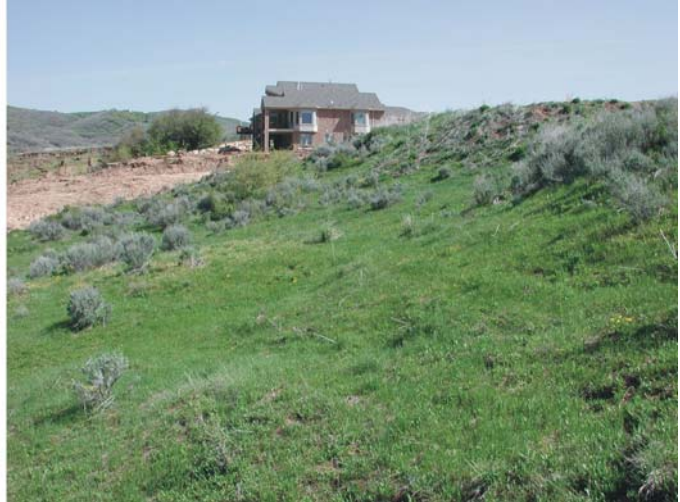
*Figure 4. Scarp of pre-existing landslide (vegetation-covered slope on right) south of the Frontier Drive landslide. View is to the north. House in background is on lot 49 (6815 N.).*

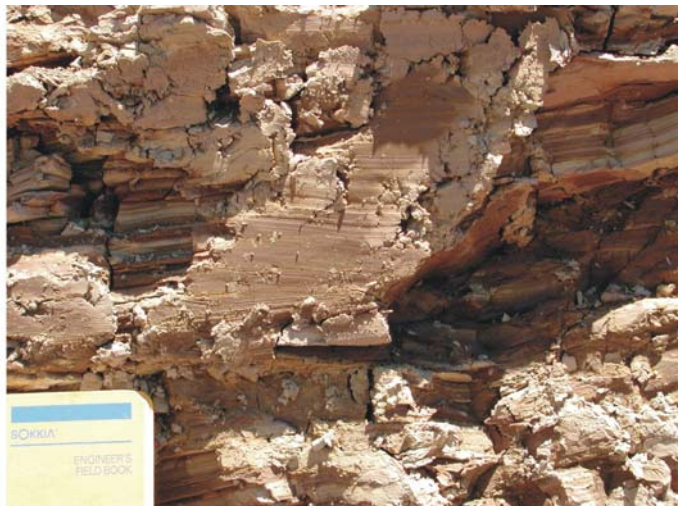
Frontier Drive consist of reddish brown, laminated clay (figure 5). Atterberg limits tests of the clay soils by Earthtec (2001) indicate the soils consist of low (CL) and high plasticity (CH) clay. The arcuate scarp-like features that appear on the September 17, 1980, aerial photograph are in the area mapped by King and others (in preparation) as lacustrine deposits. Whereas the features may be caused by landsliding, their exact origin is uncertain.

*Figure 5. Exposure of laminated lacustrine clay south of the Frontier Drive landslide. Field book shown for scale.*

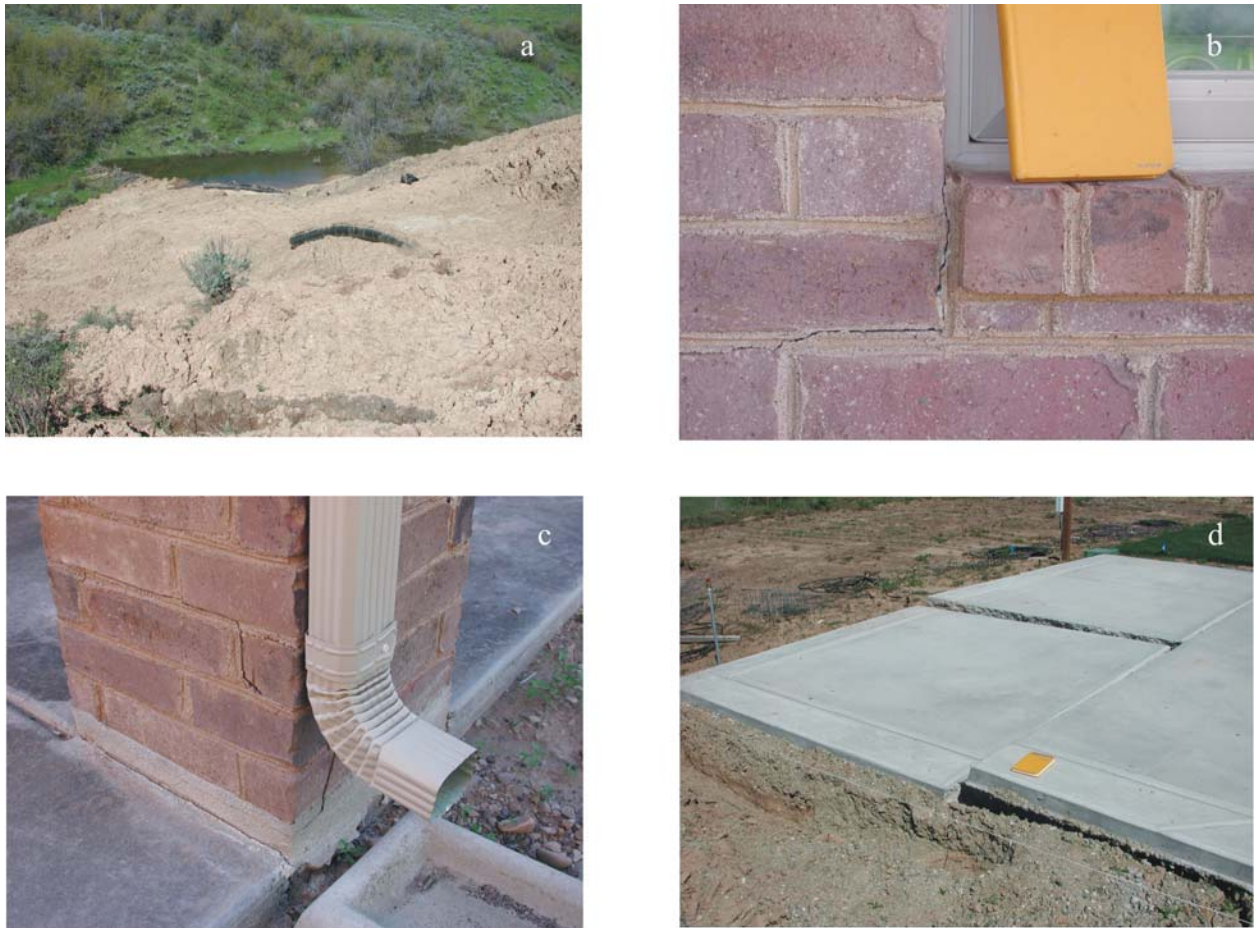
Landsliding has affected seven residential lots and common-area open space west of Frontier Drive. The most damage occurred to lots 48 (6825 N.) and 49 (6815 N.). Figures 6a through 6d show some of the damage. Table 3 summarizes the building and lot damage caused by the landslide.

*Figure 6. Damage caused by the Frontier Drive landslide. (a) Severed and segmented storm drain pipe downslope of lot 49. (b) Stair-stepping crack in wall of house on lot 49 ( 6815 N.). (c) Cracking of brick veneer of porch column of house on lot 49 caused by downslope movement (d) Damage to concrete patio or pad on lot 46 (6855 N.).*

<b>Lot Number, Address or Parcel Description</b>	<b>Description of Damage</b>
Storm drain pipe easement - open space parcel - common area (south of lot 49)	Storm drain pipe severed (figure 6a) and released water which caused accelerated landsliding, erosion, and perhaps earth flow. Ground surface along easement severely disrupted.
Lot 49 - 6814 N.	Main scarp zone underlies western part of house. Cracking of exterior brick walls on west and north (figure 6b) and porch column brick veneer (figure 6c), and of concrete patio. Tilting of patio and porch. Horizontal displacement of porch column. Severe disruption to ground surface in entire rear lot. Perimeter foundation drain pipe currently exposed in main scarp zone. Minor cracking inside house near structural beam.
Lot 48 - 6827 N.	Severe disruption to ground surface in western part of rear lot.
Lot 47 - Vacant	Main scarp zone crosses western part of lot.

Lot 46 - 6855 N.	Cracking, settlement, and tilting of concrete pad or patio (figure 6d). Main scarp zone crosses westernmost edge of lot.
Lot 45 - House under construction	Main scarp zone crosses near western boundary of lot. Crown cracks and incipient scarps cross recently placed fill.
Lot 44 - 6903 N.	Main scarp zone crosses western landscaped part of rear lot. Landscaping slightly disrupted. Slight offsets and cracks in lawn.
Lot 43 - 6917 N.	Transverse ground cracking along western edge of landscaped lot.
Western open space parcel - common area (lower slope)	Ground surface disrupted. Severity of disruption increases to south.

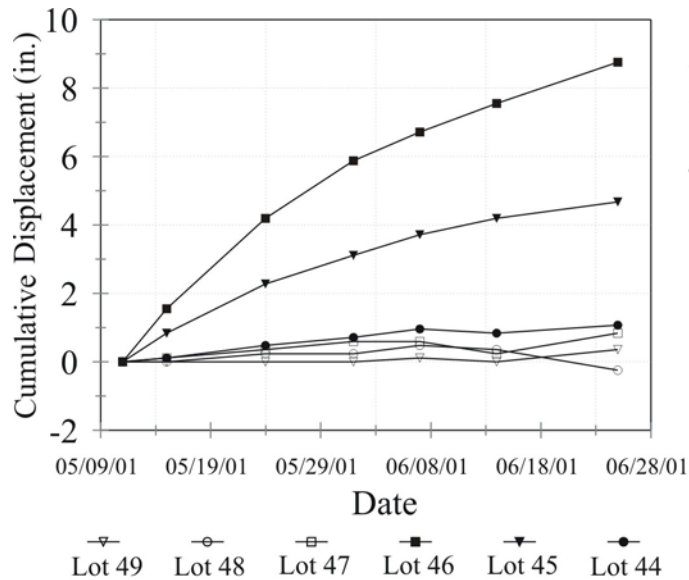
Landslide movement continued throughout the period of this investigation (May 11, 2001 through June 25, 2001). Figure 7 shows cumulative displacement (movement) for this period at six survey stations in the main scarp zone. The survey stations measure stretching (extension) across the main scarp zone. The data show movement at the four northernmost stations (on or near [west of] lots 44 through 47). Field observations suggest movement possibly occurred at the other two southern stations (on lots 48 and 49), but the measurements indicate that the movement, if any, was less than the accuracy of the measurement technique. The maximum average rate of movement declined from a slow rate in early May to a very slow rate in late June. The absence of any significant movement in the main scarp zone in the southern part of the landslide may be due to the ability of the numerous minor scarps downslope of the main scarp zone (figure 8) to accommodate movement.

Figure 7. Cumulative displacement plot showing the amount of stretching across the main scarp zone between May 11 and June 25, 2001. Up to 8.8 inches of stretching occurred at lot 46 (6855 N.). Whereas movement continued through the period of measurement, the rate of movement decreased. Apparent movement amounts of less than a half inch are likely the result of measurement error or stake disturbance, and not landslide movement.

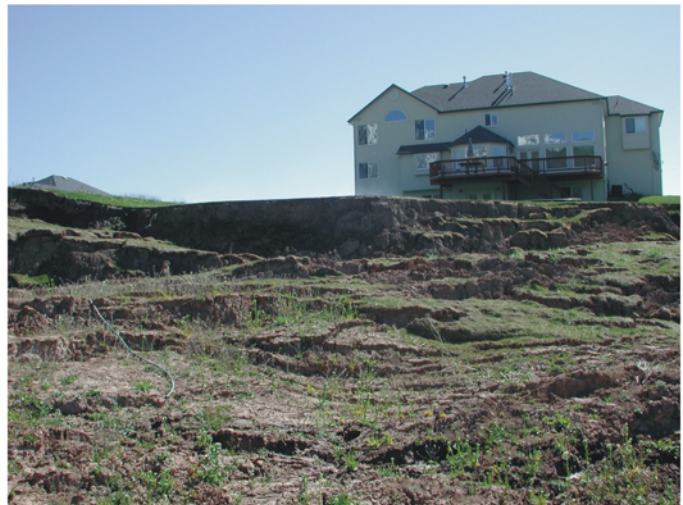
Figure 8. Minor scarps (in foreground below main scarp) in the upper part of the Frontier Drive landslide. View is to the east-northeast. House in background is on lot 48 (6827 N.).

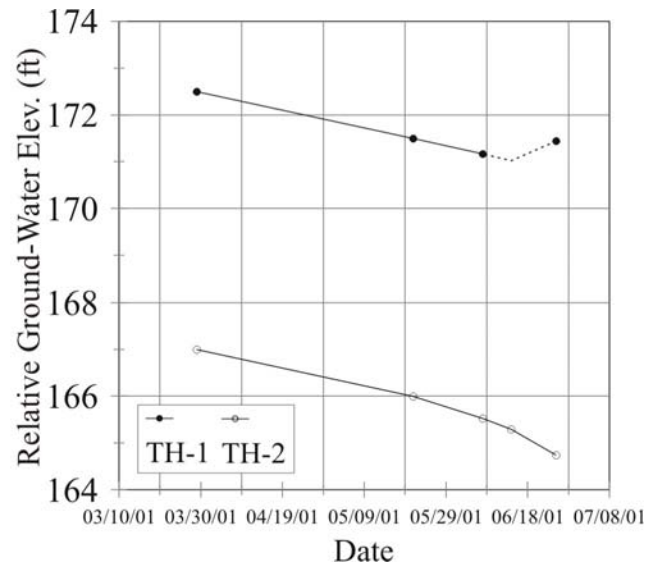
Ground water in the slope is relatively shallow and ground-water levels declined slightly since the initial measurement by Earthtec (2001) in late March. During the measurement period (March 29 through June 25, 2001), ground water was about 18 to 19.5 feet deep in Earthtec's well TH-1 located near the main scarp zone. Ground water was less than 5 feet deep in Earthtec's well TH-2 located downslope of the main scarp and about 20 feet lower in elevation than well TH-1. Ground-water levels declined by about 1.3 to 1.5 feet between March 29 and June 25, 2001. Figure 9 shows that the rate of ground-water-level decline was relatively constant. Earthtec (2001) observed numerous seeps in the hillside in March that gradually dried up sometime after late April. Based on this observation, I infer that ground water was near or at the surface in the lower slope in March.

The slight decline in ground-water levels in the lower slope was sufficient to dry up the seeps in this area. Comparison of figure 7 with figure 9 indicates that the rate of landslide movement decreased with declining ground-water levels.

*Figure 9. Plot showing fluctuation in ground-water levels in two wells in the Frontier Drive landslide. Ground-water levels declined about 1.3 to 1.5 feet from March 29 to June 25, 2001. Well TH-1 is located in the main scarp zone on lot 49. Well TH-2 is located downslope of lot 48. Dashed line shows inferred level where data are lacking.*
