Utah Geological Survey Technical Report

Project: Preliminary assessment of two landslides in 2005 between a sewer line and Gordon Creek, Mountain Green, Morgan County, Utah		
By: F.X. Ashland, P.G.	Date: March 13, 2006	County: Morgan
USGS Quadrangles: Snow Basin (1344)	Section/Township/Range: Secs. 22 and 27, T. 5 N., R. 1 E.	
Requested by: Incident Investigation	Date report received at UGS:	Technical Report number: 06-04

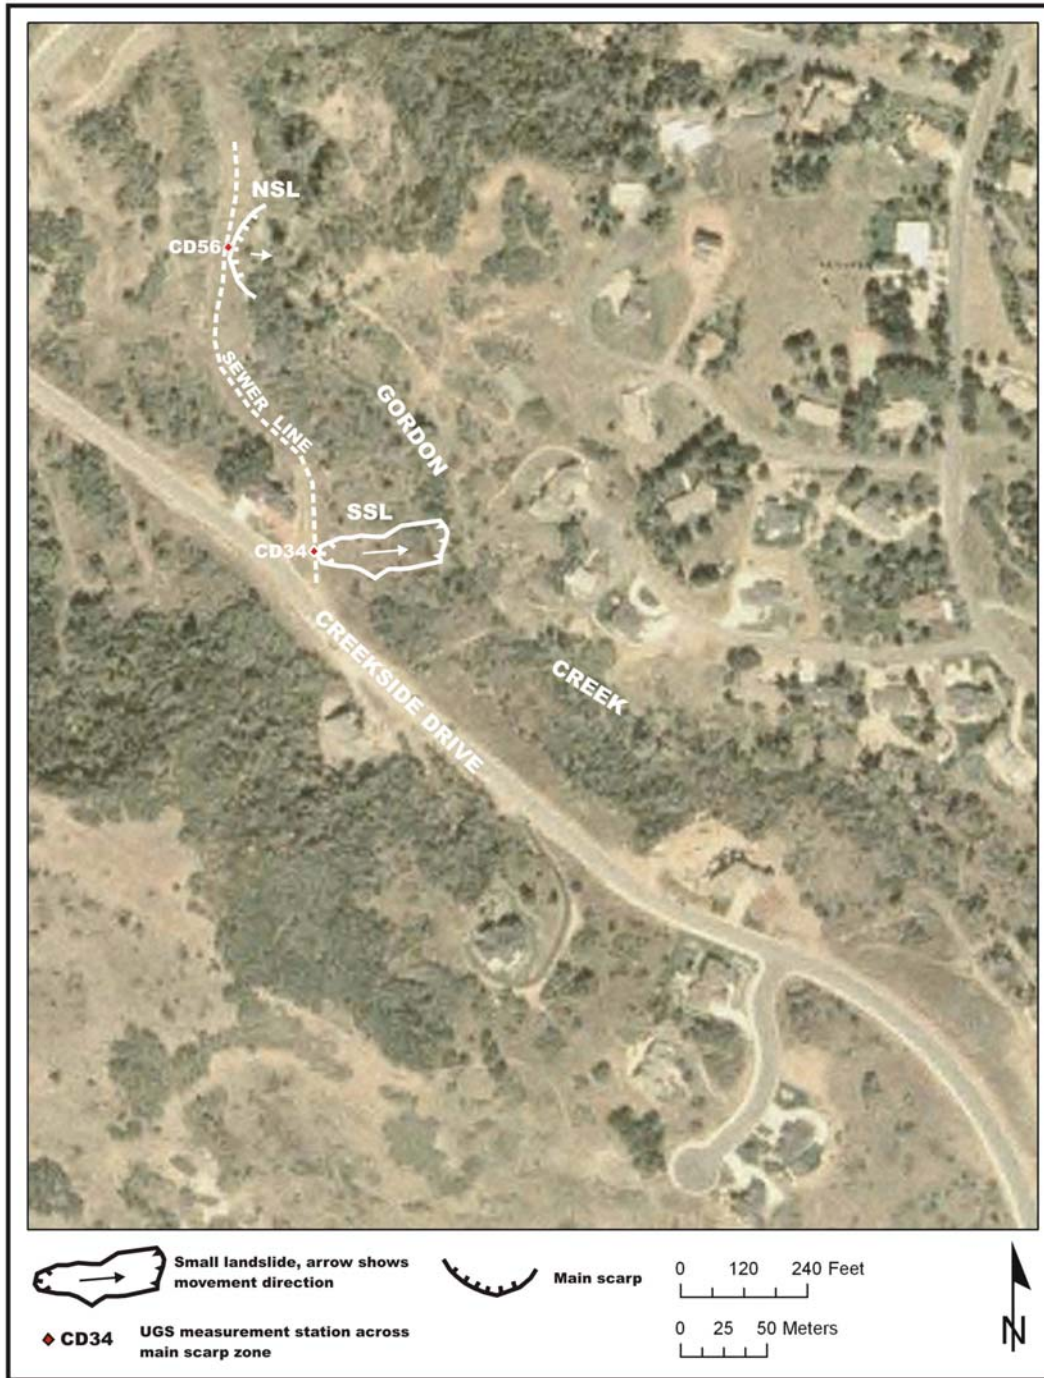
The two small landslides occur at separate locations on the northeast-facing slope between the buried sewer line and Gordon Creek, north of Creekside Drive in the Highlands West subdivision in Mountain Green (figure 2). In this report we refer to the landslides as the Southern and Northern Sewer-Line landslides. Table 1 summarizes the approximate dimensions and average slope of the two landslides.

Figure 2. Aerial photograph showing approximate locations of two small landslides between Gordon Creek and buried sewer line northeast of Creekside Drive in Mountain Green. Northern Sewer-Line (NSL) and Southern Sewer-Line (SSL) landslides shown. Locations and boundaries of landslides approximate.

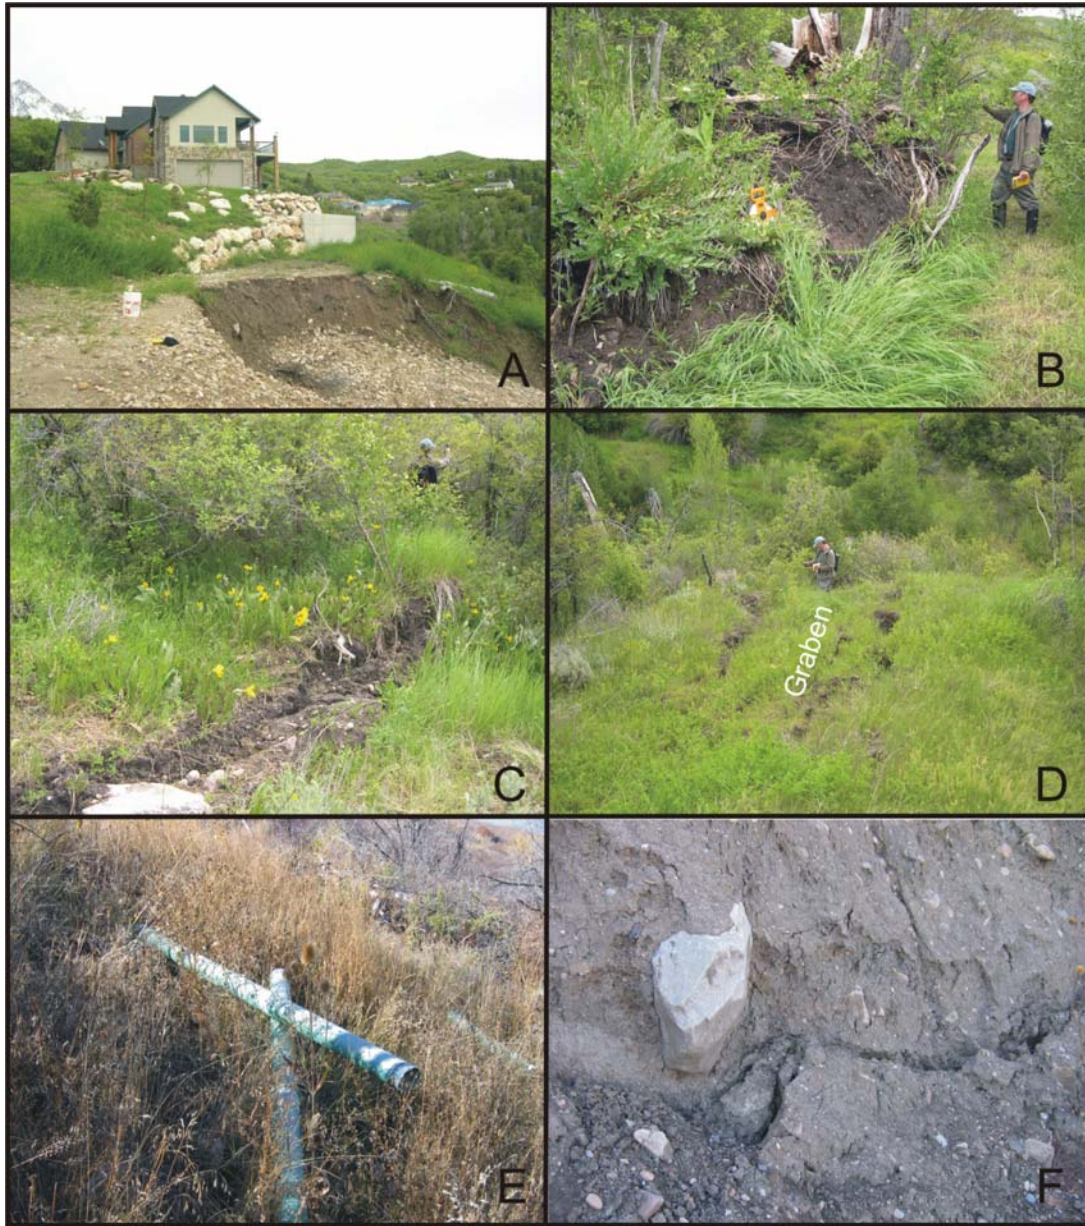
The Southern Sewer-Line landslide (figure 3) is on a relatively flat slope (about 25 percent) between the sewer line and Gordon Creek. The head of the landslide included embankment fill from the sewer-line corridor, but most of the landslide occurred on a natural slope that had been partly disturbed by emplacement of a drainpipe between the sewer line and the creek. Broken pieces of the drainpipe were exposed on the upper north flank of the landslide and had been thrust to the surface in the lower part of the slide. However, most of the lower part of the landslide is in undisturbed native soils. On June 8, the main scarp exceeded seven feet (2 m) in height (figure 3A), but continued offset throughout the remainder of 2005 increased the scarp height slightly. The main scarp cut across the eastern half of the sewer-line corridor. Landsliding displaced the downslope side of the sewer-line embankment, but the sewer line had not been exposed in the main scarp face as of November 1. A house at 6110 N. Creekside Drive is to the west-northwest of the head of the landslide, but not directly upslope.

The toe of the landslide overrode the active flood plain of Gordon Creek. The downslope tip of the slide was as close as 3.4 feet (1 m) from the southwest edge of the incised creek on October 12, 2005 (figure 3B). A wooden bridge across the creek, used for a trail crossing, is directly downslope of the landslide. Internal deformation features include an east-trending graben in the lower part of the landslide (figure 3D). A broken and displaced drainpipe in the lower part of the landslide (figure 3E) indicated about 3.9 feet (1.2 m) of shortening as shown by the downslope distance the upper pipe was displaced at the break.

Figure 3. Southern Sewer-Line landslide. (A) View to the northwest of main scarp of the Southern Sewer Line landslide. Landsliding destroyed the eastern part of the sewer corridor embankment, but had not exposed the sewer pipe as of January 13, 2006. House at 6110 N. Creekside Drive visible in background. (B) View to the northwest of toe of the landslide. Lower toe thrust/fold is approximately 5 feet high. West edge of Gordon Creek (not visible just to the right of the edge of the photograph) was only 3.4 feet from toe on October 12, 2005. (C) View downslope of right-flank shear cutting across natural slope. (D) View downslope of east-trending graben in lower part of slide. (E) Broken drainpipe in lower part of slide. Upslope pipe displaced about 3.9 feet downslope. (F) Recent offset of main scarp on November 1, 2005, due to continued movement of slide in latter part of 2005.

The UGS recommends that the sewer company regularly monitor the condition of the buried sewer line for potential leakage and develop a contingency plan if sewage is discharged from a break upslope of the creek. We also recommend that the sewer company hire a professional geotechnical engineering firm to assess potential landslide stabilization options. Ideally, stabilization efforts should be conducted in the dry summer months of June through August, in the absence of an emergency situation that requires more immediate action.

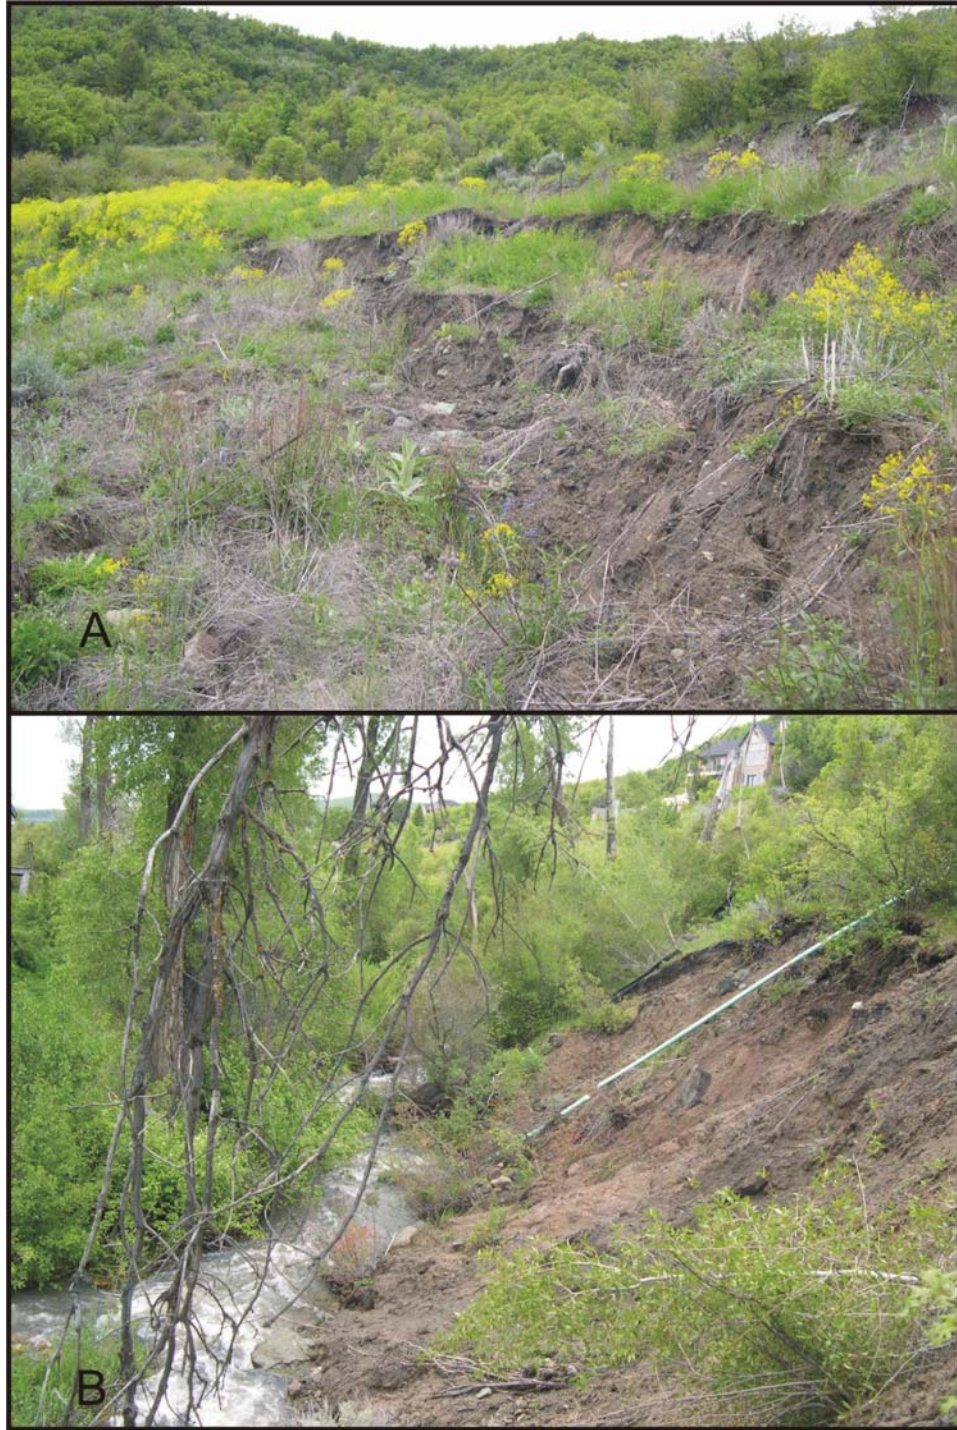
The Northern Sewer-Line landslide (figure 4) occurred in a location where Gordon Creek cuts into the base of a relatively steep slope below the sewer line. The landslide is crescent shaped, widening in a downslope (eastern) direction. On June 8, the main scarp zone of the landslide was within a few feet of the downslope edge of the sewer-line corridor. The main scarp zone (figure 4A) consisted of two parallel scarps separated by about 3 to 4 feet (1-1.2 m) with roughly equal amounts of offset. The maximum offset on the upper (main) scarp on June 8 was about 4 feet (1.2 m). The toe of the landslide was being directly eroded by Gordon Creek on June 8 (figure 4B). In the lower part of the landslide, shallow sliding into the creek had removed all surficial soils and vegetation. As in the Southern Sewer-Line landslide, a drainpipe was exposed in both the upper and lower parts of the slide. The pipe was broken in the lower part of the landslide.

Figure 4. Northern Sewer-Line landslide. (A) View to the south-southwest of main scarp zone of the landslide. Top of main scarp was only a few feet from the east edge of the sewer-line corridor. (B) View to the south of toe of the landslide along Gordon Creek. Note drainpipe exposed along south flank of landslide.

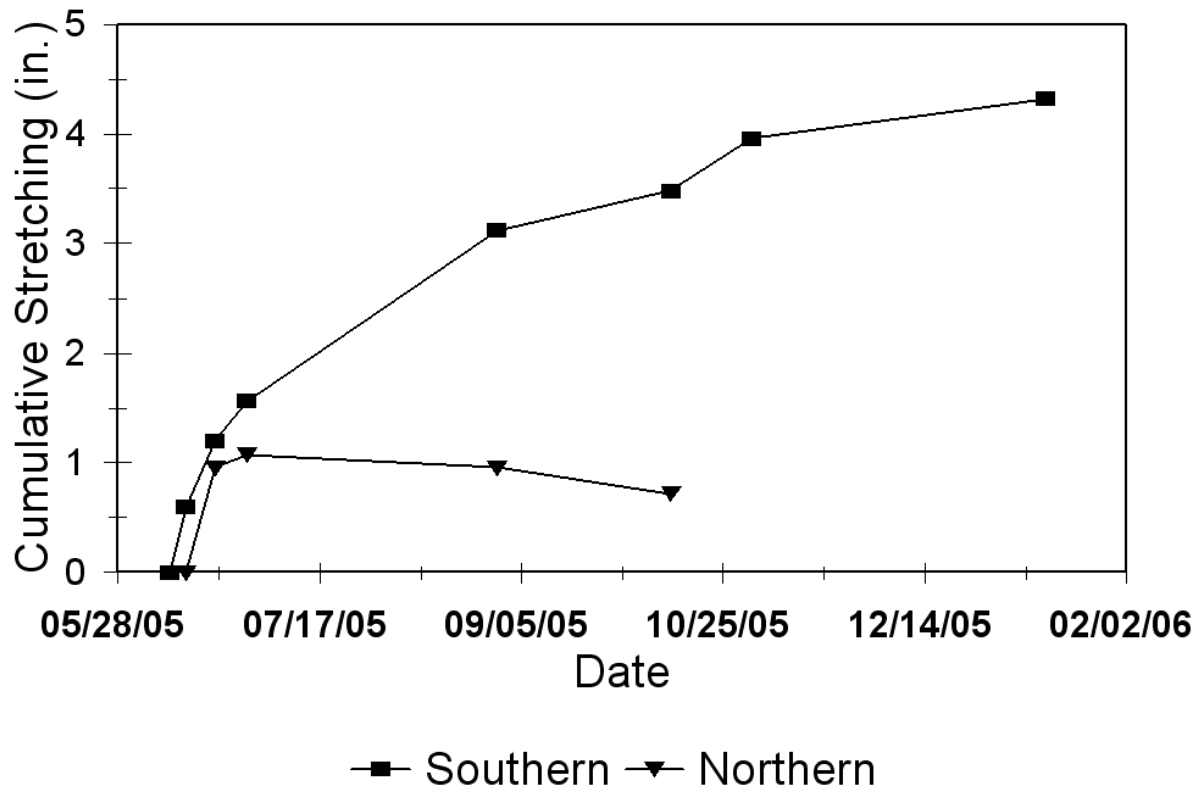
Most of the landslide movement in 2005 preceded our initial site visit on June 8. Local residents indicated that movement of the two slides initiated earlier in the year, roughly coincident with the end of the snowmelt in the area. In early June, the UGS installed survey stakes to measure landslide movement across the main scarp zone of each landslide (figure 5). At the Southern Sewer-Line landslide, movement continued throughout the latter part of the year (June 10, 2005, through January 13, 2006). The plot shows a gradual decrease in the rate of movement in the latter part of June and movement at a relatively steady rate subsequently. Total movement (stretching) during the measurement interval exceeded 4 inches (10 cm) and was accompanied by additional offset on the main scarp (figure 2F). At the Northern Sewer-Line landslide, the rate of movement slowed in the latter part of June in a similar manner as at the Southern Sewer-Line landslide, but movement suspended by the end of the month.

Figure 5. Landslide movement and ground deformation between June 10, 2005 and January 13, 2006. Plot shows continuous movement (stretching) at survey stake station across main scarp of the Southern Sewer-Line landslide (squares). The rate of movement slowed in late June, but movement continued at a relatively steady rate through January 13, 2006. At the Northern Sewer-Line landslide (triangles), movement continued through most of June, but likely suspended by the end of the month. Subsequent minor shortening across main scarp zone is likely due to collapse of extensional fissures separating soil blocks in zone.
