## Utah Geological Survey

Project: Investigation of the April 11, 2009, 1550 East Provo rock fall, Provo, Utah			
By: Richard E. Giraud, P.G., Ashley H. Elliott, and Jessica J. Castleton	Date: 07-2-09	County: Utah	
USGS Quadrangles: Orem (1088), Bridal Veil Falls (1087)	Section/Township/Range: Sections 32 and 33, R. 3 E., T. 6 S., SLBM		
Requested by: Lewis Billings, Mayor, Provo City		Job number: 09-02

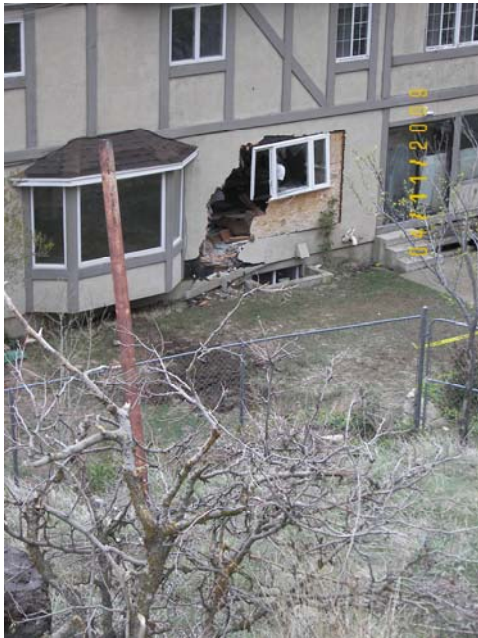
(A)

On April 11, 2009, rock-fall debris bounced and rolled downslope and damaged a vacant house and playhouse (figures 3 and 4). The rock that damaged the vacant house at 1496 North 1550 East traveled through the house and into the garage. Figure 3 shows house damage and figure captions describe the rock's travel path through the house. We estimate the rock's dimensions to be 4 x 5 x 4 feet (figure 3D) and weight to be about 6 tons. The dimensions of this rock are similar to other equidimensional to rectangular rock-fall boulders deposited on the alluvial fan to the south. The rock that damaged the playhouse at 1522 North 1550 East (figure 4) bounced into a chain link fence, pushing the fence into the playhouse. We estimate the rock's dimensions to be 2 x 4 x 3 feet and weight to be about 1.8 tons.

**Figure 3.** Rock-fall damage to a vacant house at 1496 North 1550 East (Provo Fire Department photos). **A.** The rock bounced downslope, impacted and bent the red steel post, traveled over the chain link fence, impacted the lawn leaving a bounce mark, and entered through the back wall with an upward bounce trajectory. **B.** Looking through the back wall into the house. Once inside with an upward trajectory, the rock impacted the ceiling and traveled downward through an interior wall and then down through the floor into the garage below. **C.** Hole in the floor where the rock traveled into the garage below. As the rock traveled through the floor it pulled carpet into the garage below. **D.** The rock stopped inside the garage. The rock size is estimated to be 4 x 5 x 4 feet and broke through part of a garage door.

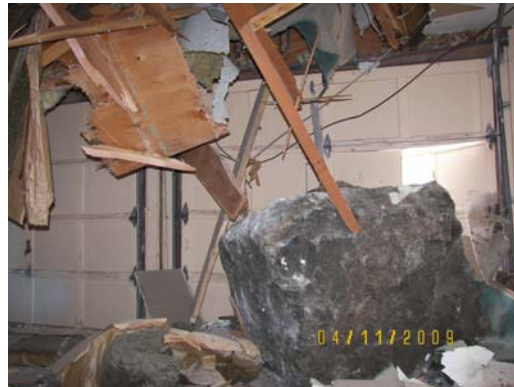
(D)

A rock larger than those shown in figures 3D and 4 stopped about 650 feet slope distance above the damaged house and playhouse. Rock-fall paths suggest the rock that damaged the playhouse broke from a corner of the rock that damaged the house about 400 feet slope distance above the affected structures. If the larger rock had stayed intact, the house may have sustained more damage and the rock may have had enough momentum to exit the garage and continue farther into the subdivision.

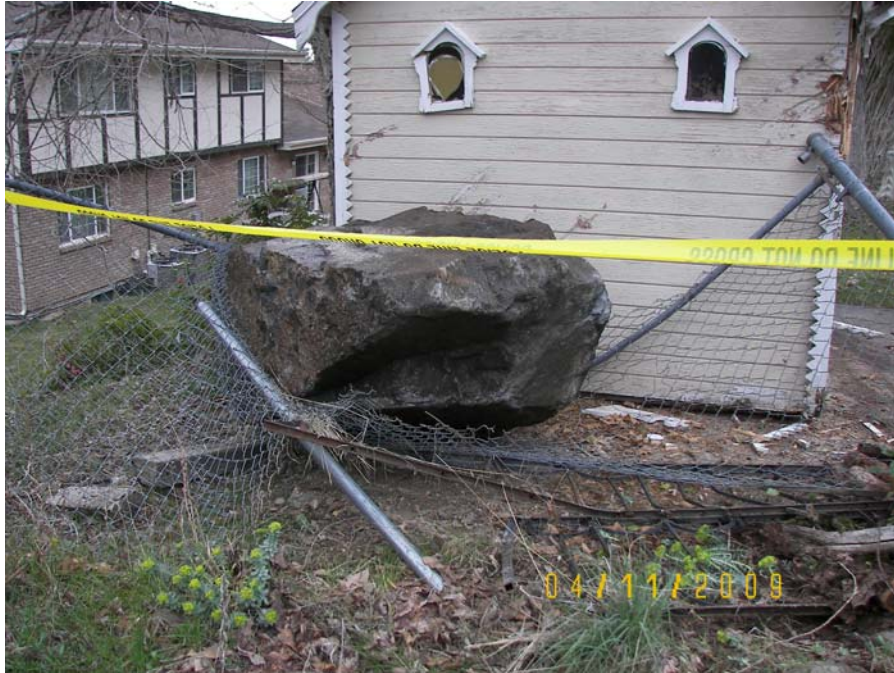
**Figure 4.** Rock-fall damage to chain link fence and playhouse at 1522 North 1550 East (Provo Fire Department photo). The rock size is estimated to be 2 x 4 x 3 feet.

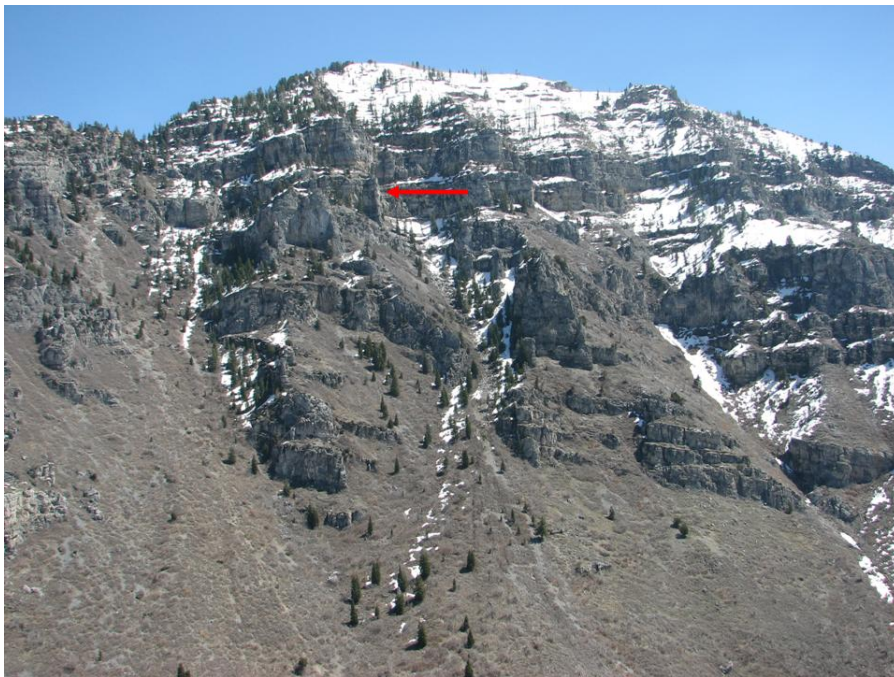
Y Mountain is a steep west-facing mountain front along the Wasatch Range above Provo. The cliff bands on the upper part of Y Mountain are divided into three Mississippian formations (Baker, 1972; Hintze, 1978), the Gardison Limestone, Deseret Limestone, and Humbug Formation (listed from oldest to youngest). The Gardison consists mostly of thin-bedded to massive limestone with abundant chert. The Deseret is primarily interbedded limestone and dolomite in thick beds with light- and dark-gray banding. The Humbug is composed of a thin- to thick-bedded limestone with interbeds of sandstone. These bedrock formations form a series of continuous and discontinuous cliff bands near the top of Y Mountain (figure 5).

The cliff bands on Y Mountain are extensive and an obvious rock-fall source. The number of cliff bands and their area (length and height) represent a large area of bedrock (figure 5) exposed to rock-fall triggering mechanisms that will continue to generate rock falls. These cliff bands are the source of prehistoric and historical rock falls.

**Figure 5.** West side of Y Mountain and extensive rock-fall source cliff bands. Steep, smooth mountain slopes below the cliff bands promote high rock-fall velocity and long runout distance. Red arrow points to the 2009 rock-fall detachment location.

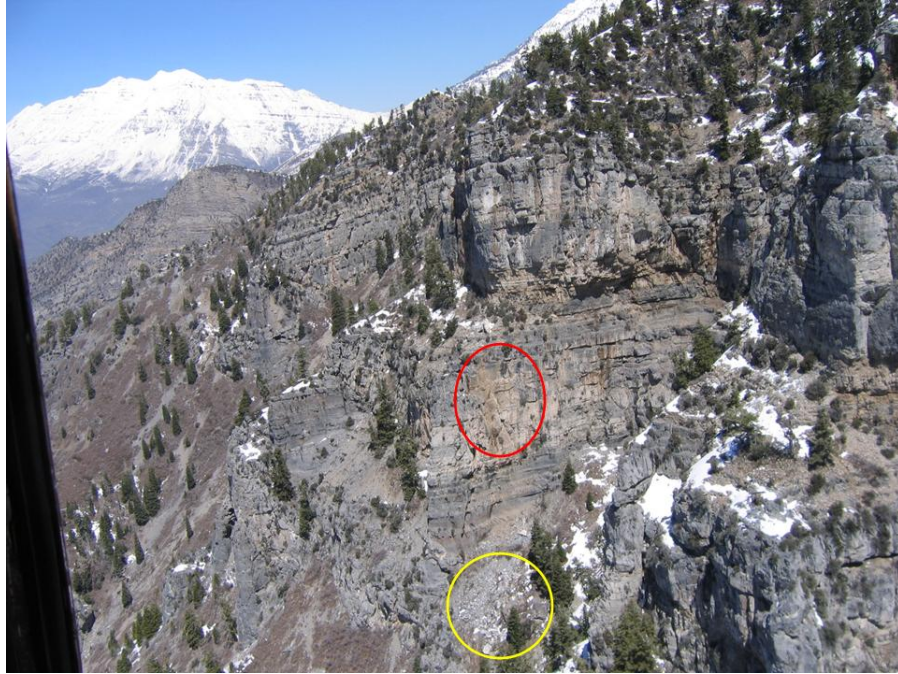
The rock fall initiated in Deseret Limestone (figures 5 and 6) at approximately 7,700 feet elevation. The limestone cliffs are massive beds broken by discontinuities or cracks that consist of joints, fractures, and bedding planes (figure 6). Weathering along these discontinuities weakens the rock mass and creates opportunities for triggering mechanisms such as frost and root wedging, rainfall, snowmelt, or earthquakes to initiate rock fall. The orientation and spacing of discontinuities determine the overall stability and generally the initial size and shape of rock fall produced. The limestone bedding planes are flat to gently dipping and joints are near vertical, widely spaced, and perpendicular to bedding planes. The orientation, spacing, and intersection of bedding planes and joints produce large, roughly equidimensional to rectangular rock-fall blocks. The rock-fall-detachment surface is above an undercut cliff face that likely

results from preferential weathering of thin bedded rock below massive thick-bedded rock (figure 6).

Rock-fall initiation can sometimes be attributed to a specific cause or mechanism, but not always. Rock falls are generally the result of the cumulative effects of weathering and other geologic processes, but may be initiated by discrete events like earthquakes or meteorological events. In this particular case, the rock fall occurred approximately 47 hours after a storm on April 8-9, 2009, delivered 1.3 inches of precipitation as snow at the Cascade Mountain Snotel site (MesoWest, 2009), about 3 miles southeast of Y Mountain. The storm was followed by above-freezing temperatures at the Snotel site and air temperatures were above freezing at the time of the rock fall. Valley precipitation at the Provo Brigham Young University National Weather Service reporting station totaled 0.63 inches of precipitation as rain for the April 8-9 storm (National Weather Service Forecast Office, Salt Lake City, 2009). A specific triggering mechanism is not apparent, but the April 11, 2009 rock fall may be related to snowmelt following the April 8-9 storm and water infiltrating into fractures may have increased pore pressures and the potential for rock fall. Undercutting of the cliff face (figure 6) is an on-going process that contributes to rock-fall potential.

**Figure 6.** Rock-fall detachment surface (red circle), photo taken 9 days after April 11, 2009. Rock debris impacted the talus slope below the cliff band (yellow circle). Cliff face undercutting is apparent below the detachment surface.

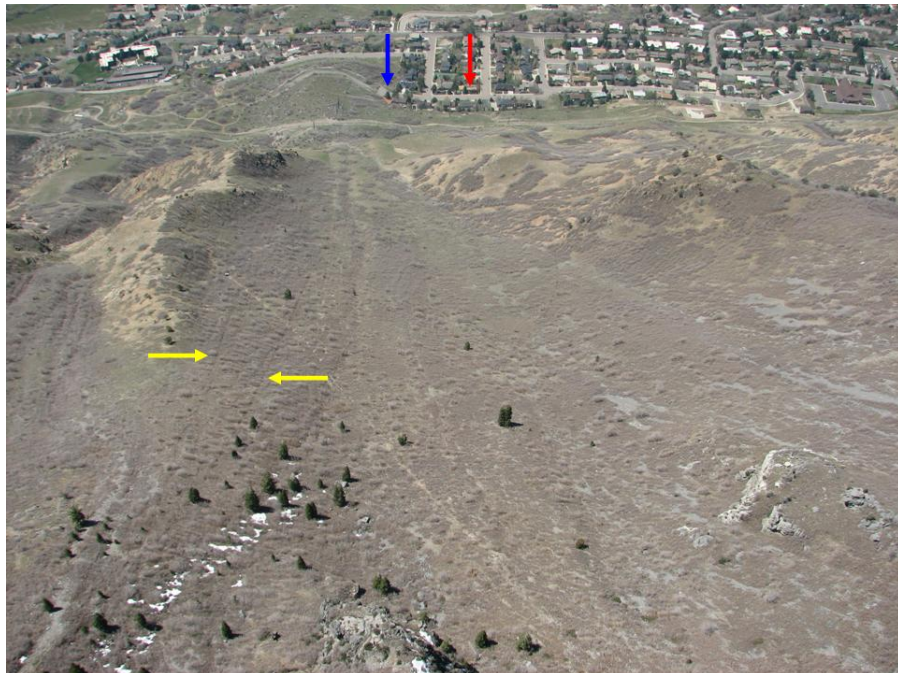
Following April 11, 2009, multiple fresh rock-fall paths were present on Y Mountain (figure 7, 8C, 8D). After detaching from the cliff face, rocks dropped vertically and then impacted the steep talus slope below, churning up talus, soil, and vegetation (figure 6). The rock debris then traveled down a small talus-lined gully. Freshly deposited rock was observed on the talus slope and in the gully. Rock debris continued rolling and bouncing down the mountain flank creating multiple linear rock-fall paths, shown by fresh bounce marks, or impact craters, and damaged vegetation (figures 7 and 8). The vertical drop along the cliff face and the steep 37° talus slope and gully likely provided a high initial velocity to rock debris. The firm mountain slopes that range from 27° to 35° maintained rock debris momentum, promoting the long runout distance into the subdivision. The rock debris traveled approximately 2,500 vertical feet and 5,000 feet slope distance to reach the affected structures. The mountain slopes are part of a small drainage basin that funnels rock-fall debris onto the alluvial fan below (figure 7).

**Figure 7.** View downslope showing rock-fall paths on Y Mountain above the subdivision. Yellow arrows point to two of multiple April 11, 2009, rock-fall paths. Older rock-fall paths are also evident. Blue and red arrows point to houses impacted in 2005 and 2009 respectively (also see figure 9).

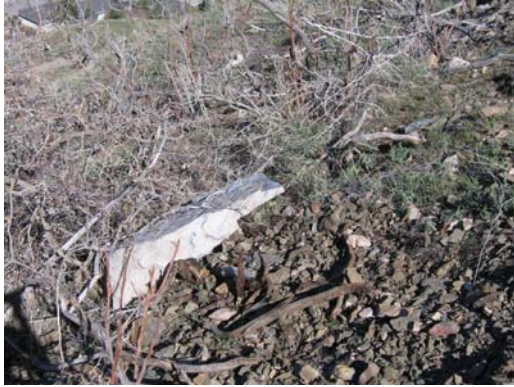
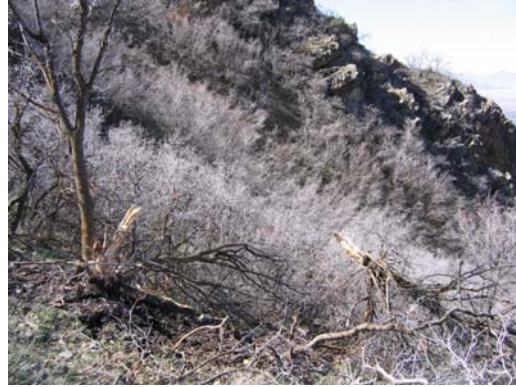
**Figure 8.** Rock-fall travel paths. **A.** A smaller rock that broke off a larger piece as it traveled downslope. **B.** Rock fall damaged oak brush. **C.** Multiple travel paths (yellow arrows). **D.** Multiple travel paths (yellow arrows) evident directly above the damaged house and playhouse.

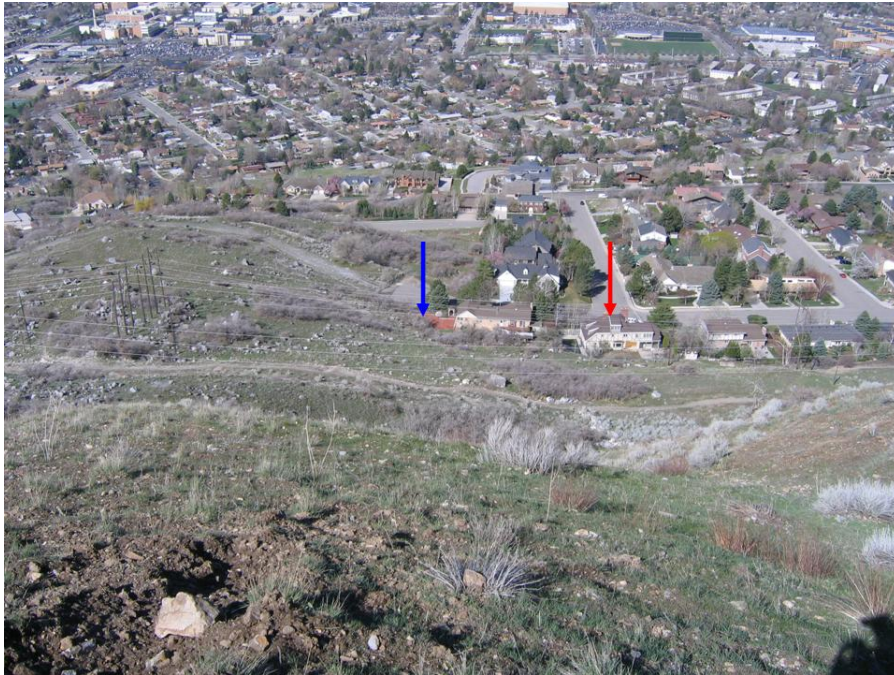
Many large boulders are present on the alluvial fan to the south and the slope above houses damaged in 2005 and 2009 (figure 9). Some of the boulders on the alluvial fan may have a debris-flow origin, but we believe most of these boulders have a rock-fall origin because they lie directly on the fan surface in a random pattern, rather than in a debris-flow-deposition pattern, where boulders are partially buried or concentrated along levees or lobe fronts. Many of the large boulders are equidimensional to rectangular and reflect the orientation and spacing of bedding planes and joints in the cliff bands above.

The average slope from the apex of the talus slope to the rock's resting place, known as the "shadow angle" (Evans and Hungr, 1993), is about 29° for the 2009 event, similar to the 28.5° shadow angle for the 2005 event (Christenson and Giraud, 2005). Minimum shadow angles are used to estimate maximum rock-fall runout distances, and typical minimum shadow angles for rock falls measured elsewhere are about 22° (Wieczorek and others, 1998). This indicates that rocks may potentially travel farther downslope than houses damaged in 2005 and 2009, and that the rock-fall hazard area includes parts of the subdivision to the west, as shown by Robison (1990). The runout distances and size of these large rocks on the alluvial fan and the slope above houses damaged in 2005 and 2009 events show the proximity of houses to the rock-fall hazard.

**Figure 9.** Previous guest house location destroyed by the 2005 rock fall (blue arrow) and the house damaged by the 2009 rock fall (red arrow). Rock-fall boulders on the alluvial fan left of the blue arrow and the slope above the impacted houses show the distribution and size of historical and prehistorical rock fall and the proximity of houses to the hazard.

The timing of rock falls cannot be predicted, but they are most common during and following storms and earthquakes, and during periods of freeze-thaw such as spring and fall. However, rock falls are possible at any time and typically occur with no warning. Residents should be informed they are in a rock-fall-hazard area, and that they may wish to hire a geological consultant to investigate the risk from rock falls to the neighborhood or to individual homes and the feasibility of rock-fall risk-reduction measures.
