Utah Geological Survey

Project: Investigation of the May 12, 2005, 1550 East Provo rock fall, Provo, Utah			
By: Richard E. Giraud, P.G., and Gary Christenson, P.G.	Date: 06-09-05		County: Utah
USGS Quadrangles: Orem (1088), Bridal Veil Falls (1087)	Section/Township/Range: Sections 32 and 33, R. 3 E., T. 6 S., SLBM		
Requested by: Robert Carey, DES Ed Scott, Provo City		Job number: 05-06

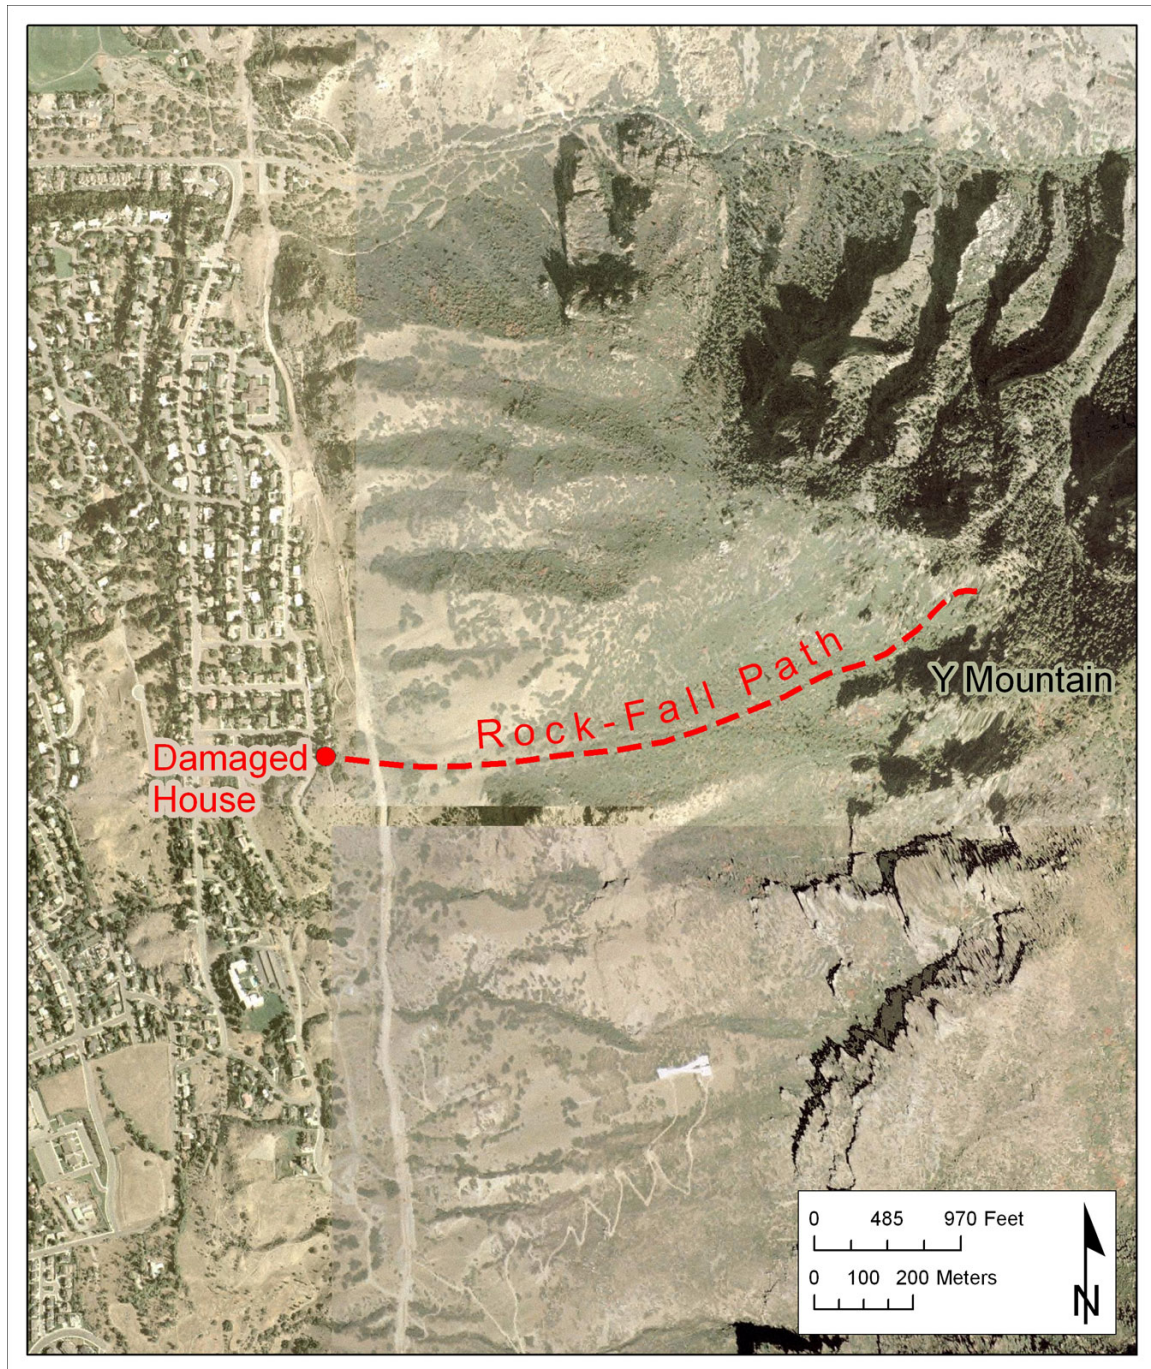
The rocks fell from a cliff band about 2,600 vertical feet above the guest house that was damaged (figure 2). We were unable to investigate the source area to look for unstable rocks. Abundant rock-fall sources are present all along the front of “Y” Mountain, and previous rock-fall debris throughout this neighborhood indicates the remaining house on the lot and adjacent houses are in a rock-fall-hazard area. This area is also within the rock-fall-hazard area mapped by Robison (1990). Unfortunately, the timing of rock falls cannot be predicted, although they are most common during and following storms and earthquakes, and during periods of freeze-thaw such as spring and fall. Therefore, although we were in a period of heightened hazard at

Figure 2. “Y” Mountain source area, the rock-fall path, and damaged house.

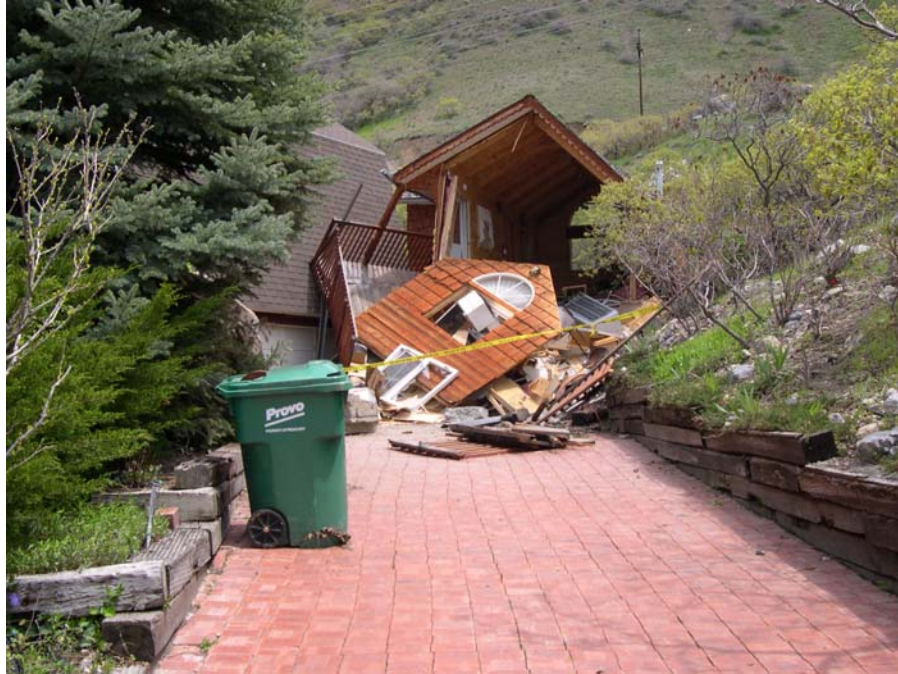
In the late afternoon of May 12, 2005, a rock fall released from a cliff band high on “Y” Mountain (figures 1 and 2) above Provo. One of the rocks severely damaged a guest house at 1468 South 1550 East in Provo (figure 3). No one was home at the time; the structure is likely a total loss. Some of the rocks crossed a buried Questar gas pipeline, and Questar personnel inspected the pipeline for damage.

Figure 3. Damage to the guest house. The damaging rock is on the left behind the trash can, against the base of the tree. Parts of the concrete house foundation are behind and to the right of the trash can.

Because the remaining house on the lot and adjacent houses are pre-existing older homes, we recommend that residents be informed they are in a rock-fall-hazard area, and that they may wish to hire a geological consultant to investigate, to the extent possible, the risk from rock falls to the neighborhood or to individual houses. A geologic consultant could also evaluate rock-fall risk-reduction protection measures such as upslope catchment structures and their cost.

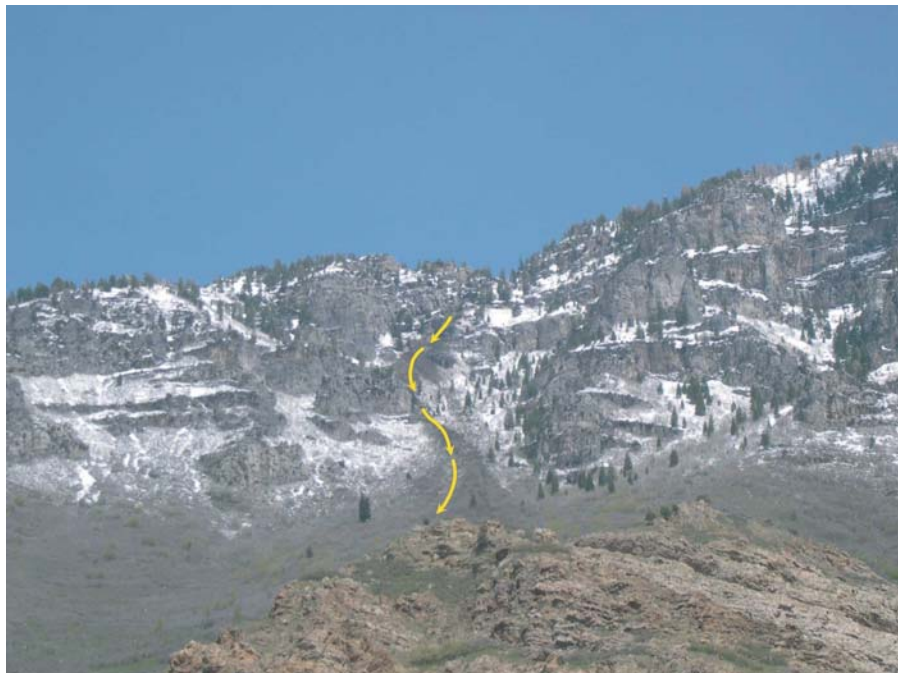
The rock fall occurred on “Y” Mountain, a steep mountain front along the southern Wasatch Range above Provo. The source of the rocks was an upper cliff band in the Mississippian Deseret Limestone about 2,600 feet above the house (figure 4; Hintze, 1978). Plentiful other source-area cliffs extend throughout the source area of this rock fall. The lower slope where the rocks came to rest is mostly colluvium, and the upper slope below the cliffs is talus. The average slope from the apex of the talus slope to the rock’s resting place, known as the “shadow angle” (Evans and Hungr, 1993), is about 28.5°. Minimum shadow angles are used to estimate maximum rock-fall runout distances, and typical minimum “shadow angles” for rock falls measured elsewhere are about 22° (Wieczorek and others, 1998). This indicates that rocks may potentially travel farther downslope and that the rock-fall hazard area includes parts of the neighborhood to the west as shown by Robison (1990).

Figure 4. View east to the rock-fall source area in the Mississippian Deseret Limestone on the north end of “Y” Mountain showing path of the rock fall (arrows) as indicated by dark soil and rock fragments on the snow surface.

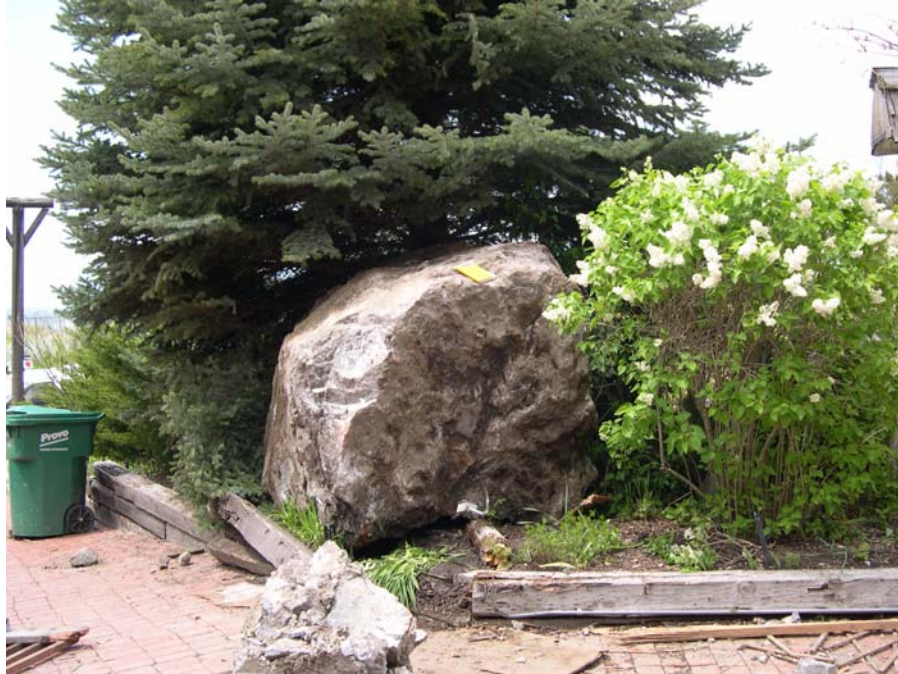
The rock that impacted the guest house measures approximately 7 x 5.1 x 4.5 feet (figure 5), and we estimate that it weighs about 13 tons. Many other rocks from the same rock fall were present on slopes below the cliff band in the runout track (figure 6) and on the slope just above 1550 East. The guest house was severely damaged (figure 3), but none of the other structures in the area were affected. The rock impacted and displaced the southwest concrete foundation corner of the house onto the driveway (figures 3 and 5). The west house wall was detached from the main structure and contents inside the house were damaged (figure 3). Impact craters (bounce marks; figure 7) were evident on the 20° slope directly above the house. The rocks traveled a total slope distance of over 1 mile (about 5,500 feet) and likely achieved a relatively high velocity and bounce height as they advanced down the slope. Abundant previously fallen rocks on the slope and among the homes in the area indicate that rock falls are relatively common on a geologic time scale in this area.

Figure 5. The rock that damaged the guest house. Part of the concrete house foundation wall is in the foreground.

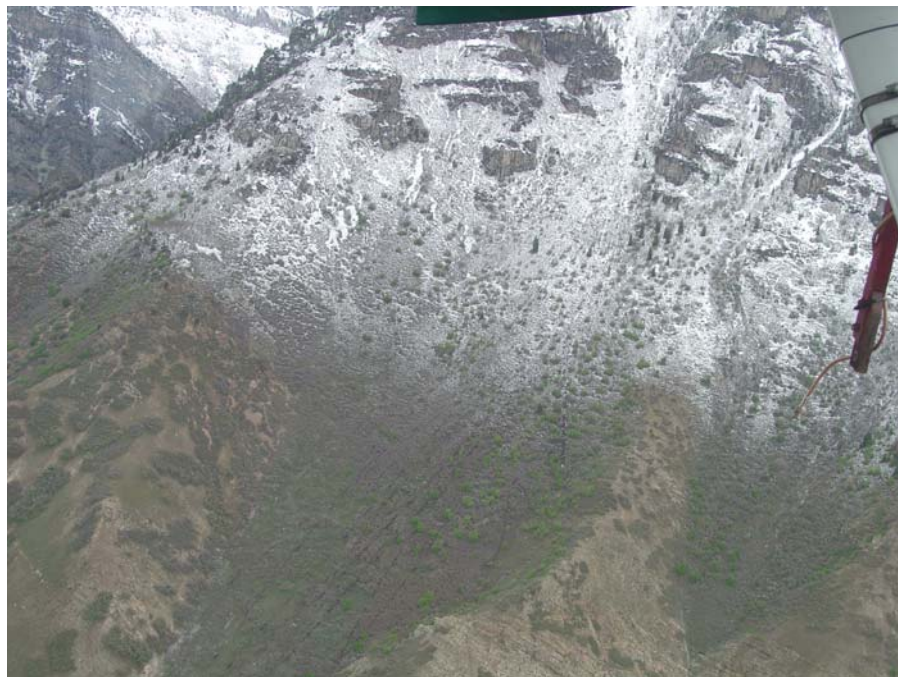
Figure 6. View of the rock fall runout track on May 17, 2005. Dark brown soil streaks show the path of rocks that traveled downslope. Recent snowfall obscures the runout track in the upper part of the photo (photo by Dave Bennett).

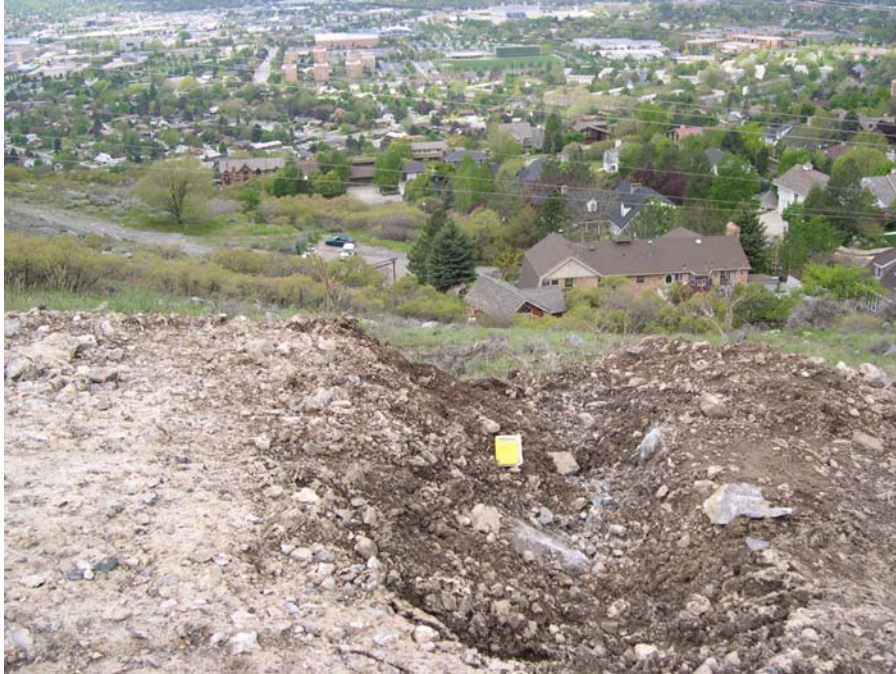
Figure 7. Impact crater (bounce mark) on the slope just above the guest house (yellow object is notebook for scale).
