Utah Geological Survey

Project: Investigation of the February 10, 2010, Rock Fall at 274 Main Street, Rockville, Utah			
By: Tyler R. Knudsen, P.G.	Date: March 9, 2010	County: Washington	
USGS Quadrangles: Springdale West	Section/Township/Range: Section 1, R. 11 W., T. 42 S., SLBM		
Requested by: Allen Brown, Mayor, Rockville City	Date report received at UGS: February 10, 2010	Job number: 10-1

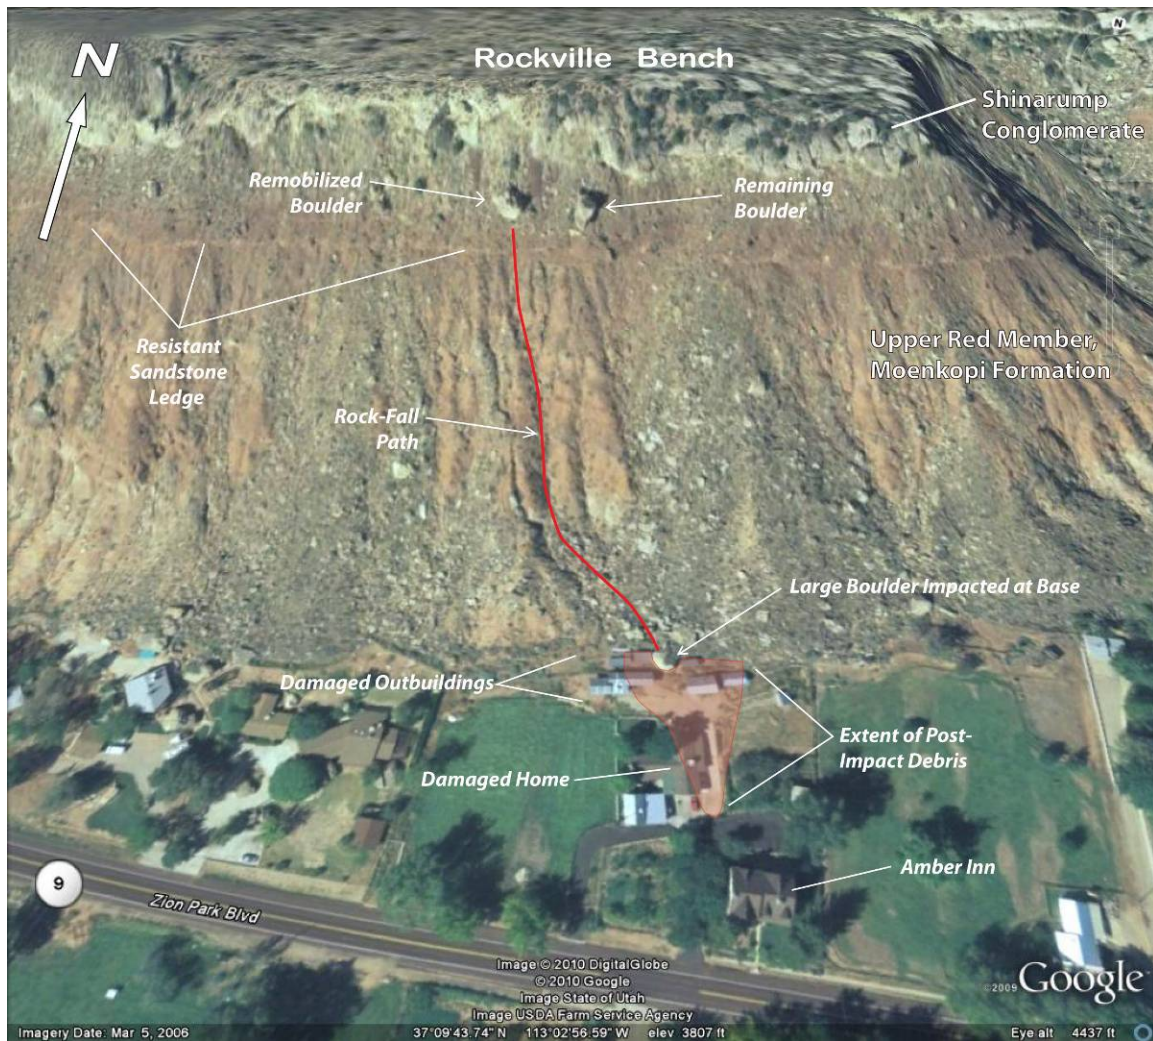
The rock fall consisted of a single remobilized sandstone talus boulder of the Shinarump Conglomerate Member of the Triassic Chinle Formation that had been resting just below the Shinarump cliff capping the Rockville Bench mesa (figure 2). The Shinarump outcrop is about 320 feet above the adjacent valley floor. The boulder had previously detached from the cliff, traveled a slope distance of about 40 feet, and came to rest on a 44° slope underlain by shale, siltstone, and sandstone of the upper red member of the Triassic Moenkopi Formation. A review of historical orthophotography shows the boulder had been at that position, 290 vertical feet above the slope's base, since at least 1993 (figure 5). Downslope-oriented parallel grooves in the boulder's detachment surface indicate that the rock fall initiated as a rockslide (figure 6). After sliding about 15 feet, the boulder fell over a resistant sandstone ledge that forms a small cliff about 12 feet high and began rolling down a shallow talus-lined gully. Near the bottom of the gully, the boulder deflected to the southeast, collided with an existing large boulder at the base of the slope, and shattered into numerous smaller fragments.

Figure 2. Google Earth image showing source area, rock-fall path, extent of post-impact debris field, and damaged structures.

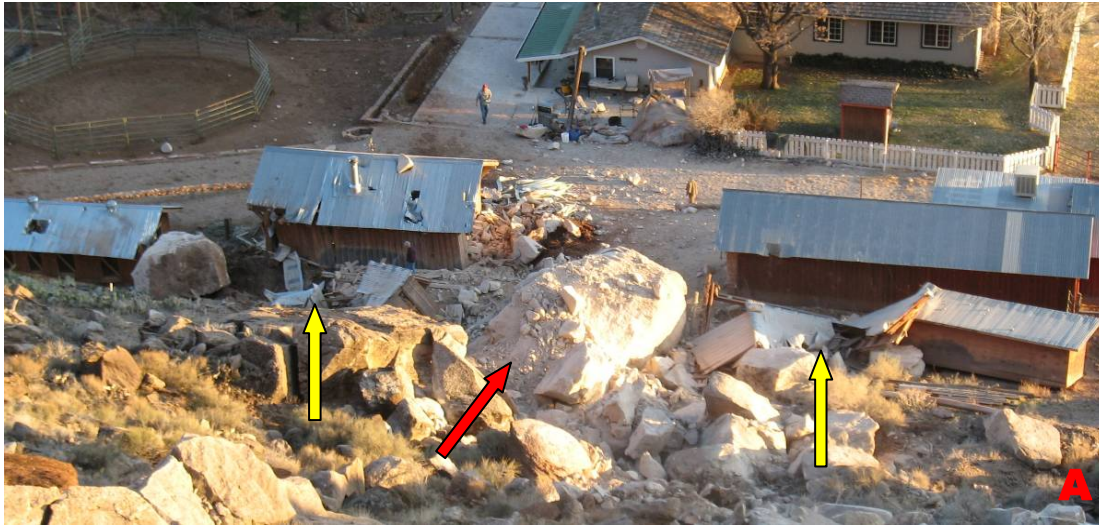
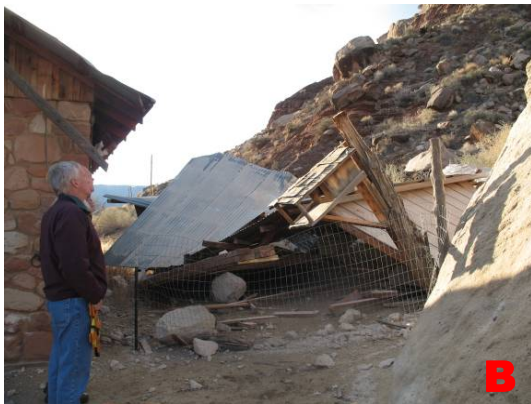
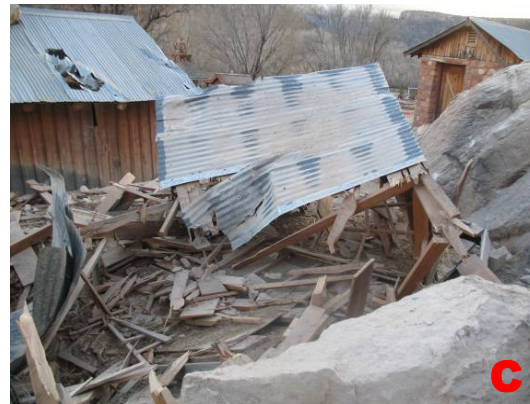
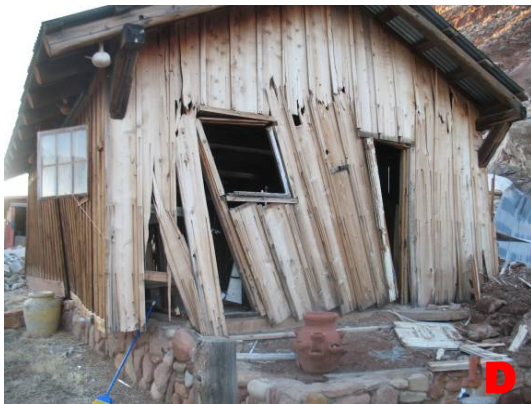
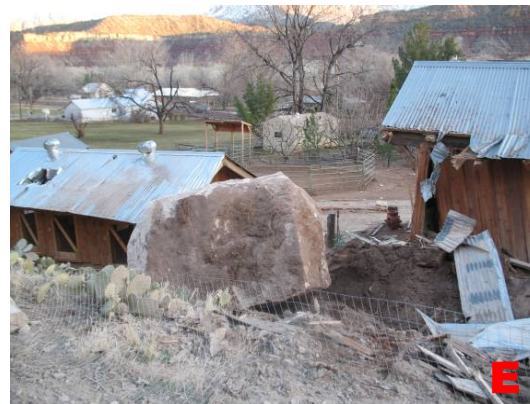
Debris from the impact damaged a private residence and several outbuildings near the impact site. Two small sheds immediately adjacent to the impact area were destroyed, and a larger wood-framed workshop was severely damaged and knocked off its foundation (figure 3). Three other outbuildings ranging from a small chicken coop to a more substantial wood and stone hay barn sustained moderate to light damage from falling and rolling debris. An approximately 3.5 x 3 x 1.7-foot boulder weighing an estimated 1.3 tons rolled through a mudroom on the east side of the house, broke through a glass doorway, exited through an exterior wall, and struck and severely damaged a vehicle parked in the driveway (figure 4). A second vehicle parked near the workshop was also heavily damaged. Both vehicles had been removed from the property by the time of our site visit.

We found the largest post-impact fragment about 50 feet from the impact site; it measured about 9 x 6 x 5 feet and weighed an estimated 20 tons (figure 3E). Most post-impact debris accumulated within a 75-foot radius of the impact site, but we found a few small (0.5- to 1-foot-diameter) fragments as much as 180 feet away. Based on our aerial-photo analysis, the size of the boulder's detachment surface, and amount of material observed at the bottom of the slope, we estimate the boulder was roughly rectangular with dimensions of about 21 x 17 x 17 feet and weighed an estimated 450 tons.

Figure 3. Impact area and damage to outbuildings. **A.** Large boulder (red arrow) at base of slope that broke up the rock fall. Yellow arrows show location of destroyed sheds. **B, C.** Destroyed sheds adjacent to impact area. **D.** Damaged workshop knocked off its foundation. **E.** Largest (9 x 6 x 5 feet) post-impact boulder that damaged a workshop (right) and shed (left).

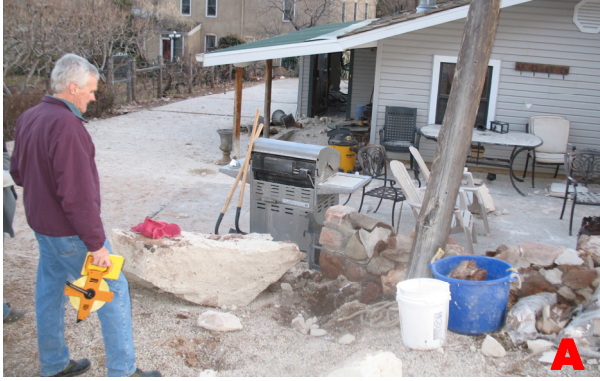
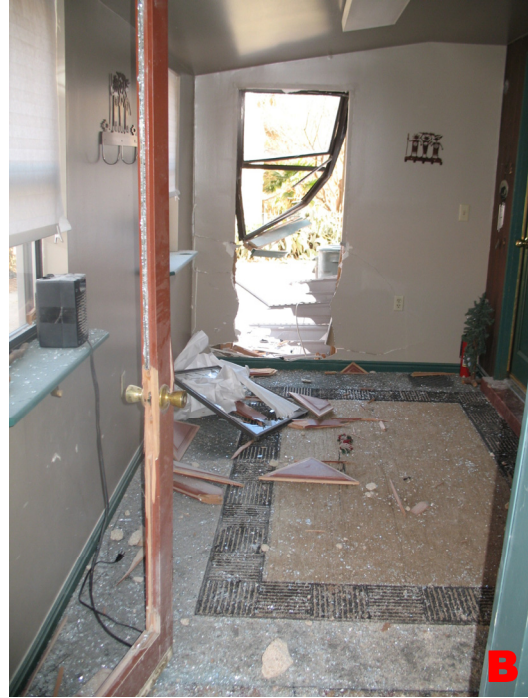
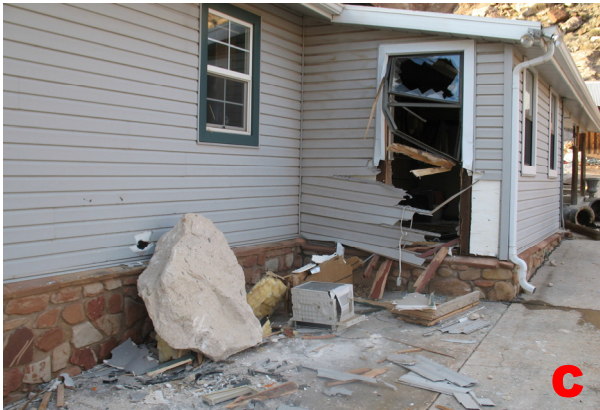
Figure 4. Rock-fall damage to the house at 274 Main Street. **A.** View downslope along path of rock that damaged the house. Narrowly missing a barbeque grill, the rock rolled through the entryway and mudroom on the left (east) side of the house. **B.** Looking through the mudroom where the boulder broke through a glass door, which is still on its hinges, and exited through an exterior wall and window. **C.** After exiting the mudroom, the rock collided with a parked car and came to a rest. The rock, estimated to be 3.5 x 3 x 1.7 feet, was later moved up against the house when the damaged car was removed.

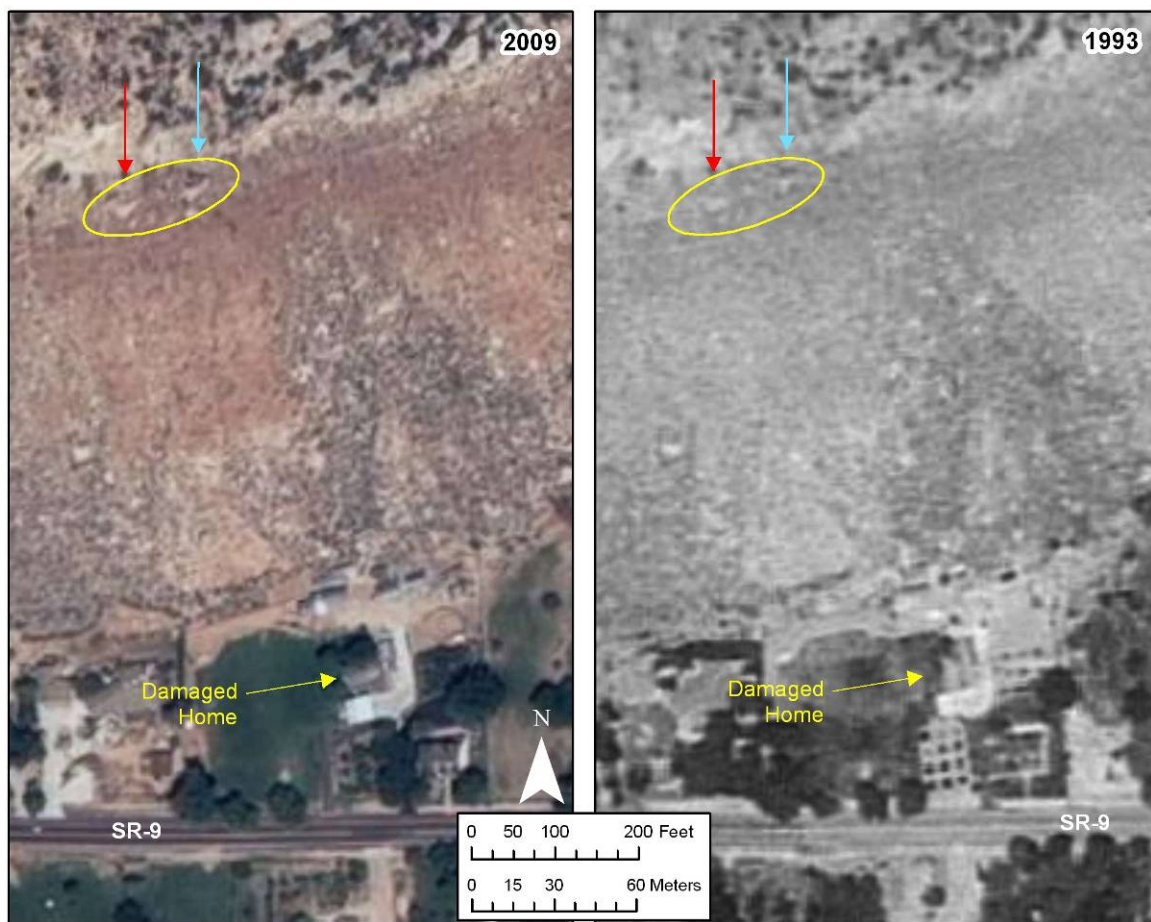
Figure 5. Comparison of 2009 NAIP and 1993 U.S. Geological Survey orthophotos showing the source area and damaged home. Both the 2010 rock fall (red arrow) and the boulder remaining on the hillside (blue arrow) are visible in the 2009 photo; although not as clear, the boulder pair also appears to be present in the 1993 photo.

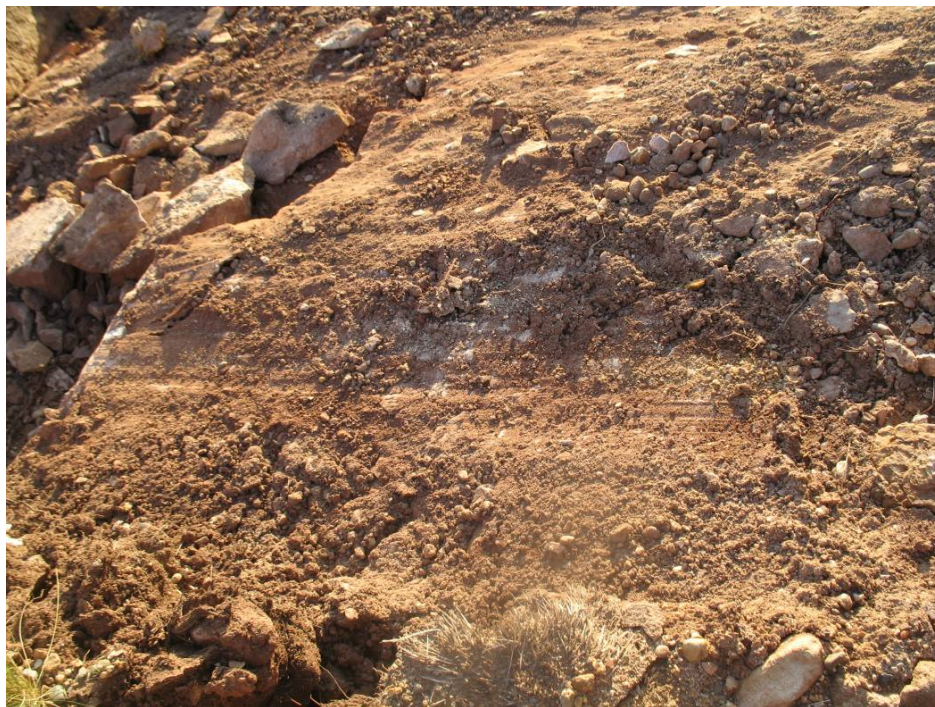
Rock falls typically result from the cumulative effects of weathering and other geologic processes, but may also be initiated by discrete triggers such as earthquakes or meteorological events. In this instance, no earthquakes were recorded at the time of the event, however, the rock fall occurred shortly after a prolonged period of rain on February 5-9, 2010, that produced 1.38 inches of precipitation at the Zion Canyon RAWS MesoNet station (MesoWest, 2010) about 4.5 miles northeast of Rockville. Station records show that 0.35 inch of rain fell the evening before the rock fall. Although it was not raining at the time of the rock fall, soil and rock slopes near the source area were still saturated when we visited the site approximately 9 hours after the rock fall occurred. Observation of the detachment zone revealed a zone of

saturation extending 1 to 2 feet inward from the outer perimeter of the boulder's footprint. Although saturation of the relatively weak siltstone and mudstone beneath the boulder likely affected the timing of the rock fall, the precise mechanism is unclear. Surface water may have eroded material out from beneath the boulder causing instability, or increased pore pressure within the silty and clayey material beneath and/or buttressing the boulder may have resulted in a reduction of cohesion and subsequent failure.

Figure 6. Slide plane and grooves (~5 feet long) in the detachment area; left is downslope.

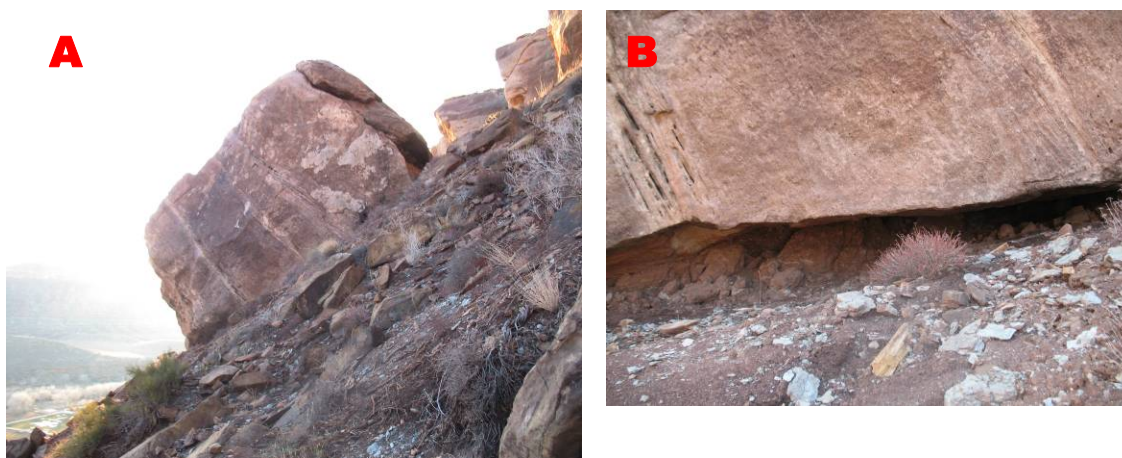
Disturbed and freshly deposited debris remaining in the rock-fall path appears to be stable and presents little hazard to structures below. However, a second large boulder, approximately 30 x 15 x 14 feet and weighing an estimated 470 tons, lies about 80 feet east of where the rock fall originated and appears similar to the boulder that rolled down the slope. The remaining boulder is also Shinarump Conglomerate talus and rests on a 44° slope of the upper

red member of the Moenkopi Formation (figure 7A). Inspection at the boulder's base revealed a 1- to 2-foot-wide undercut beneath the boulder's eastern edge where surface water has removed underlying shale and siltstone (figure 7B). This boulder is also visible in 1993 orthophotography (figure 5). The impacted house, the Amber Inn, and other structures at the base of the slope may be damaged if this boulder also moves downslope.

Figure 7. Remaining boulder above damaged house. **A.** Rock resting on steep slope of mudstone and siltstone of the upper red member of the Moenkopi Formation; the rock is about 30 feet wide in this view to the west. **B.** Void space (~1 foot high) created by surface erosion extending 1 to 2 feet beneath the eastern edge of the boulder.

The timing of rock falls cannot be predicted, but they are most common during and following storms and earthquakes, and during periods of freeze-thaw. However, rock falls are possible at any time and typically occur with no warning. Rockville residents should be informed they are in an area of high rock-fall hazard, and they may wish to hire a geological consultant to investigate the risk from rock falls and the feasibility of rock-fall risk-reduction measures relative to their properties.

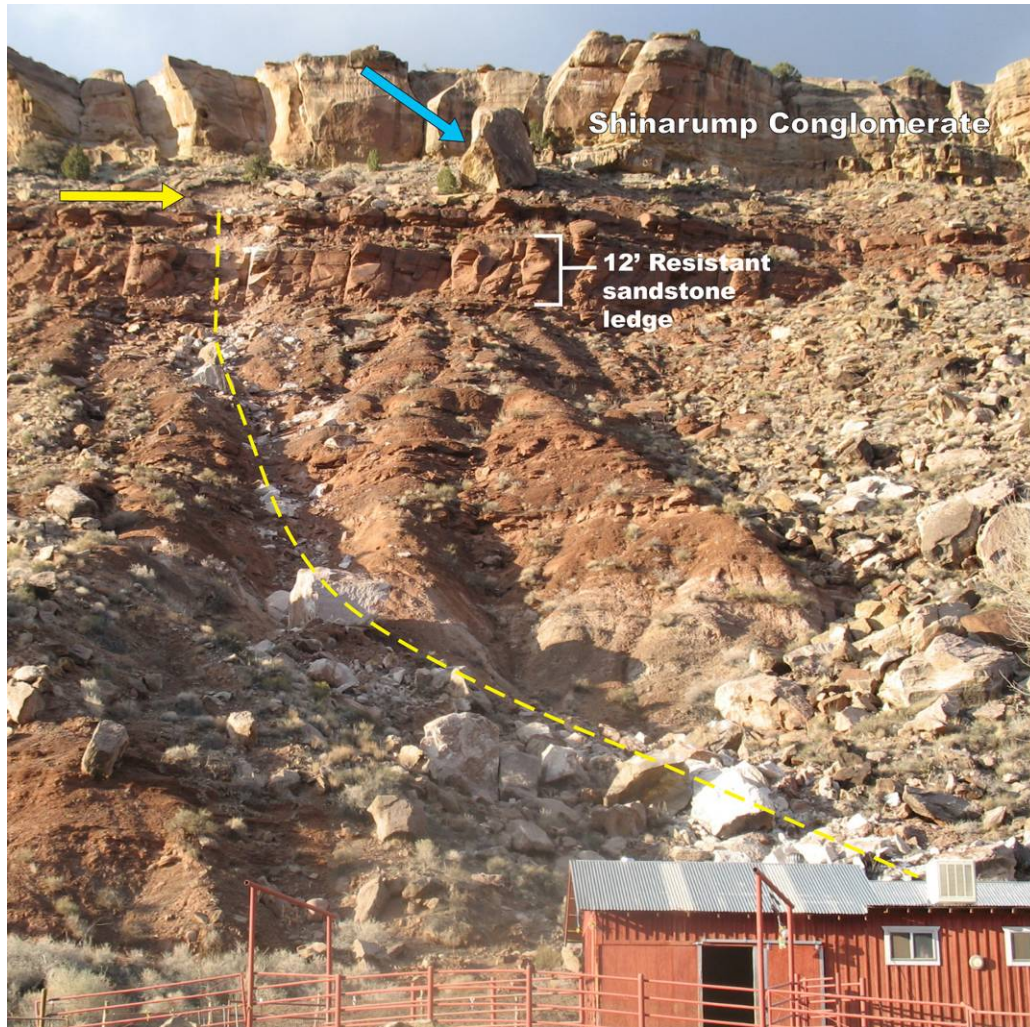
We observed a clear rock-fall path delineated by churned soil and vegetation, fresh rock deposition, rock gouge, and impact craters from the February 10, 2010, event (figure 8). After sliding from its resting place, the 12-foot vertical drop and average 38° slope along the gully bottom imparted a high initial velocity to the rock fall. Several large, freshly broken boulders in the rock-fall path likely include pieces broken off the falling/rolling boulder as well as shattered talus impacted by the moving boulder. Near the bottom of the slope, the boulder deflected slightly eastward either off the western gully wall or perhaps off another large talus boulder before striking a stationary rock at the base of the slope. The rock fall traveled a total distance of 500 feet before striking the boulder, and debris ejected by the impact traveled as much as an additional 180 feet. If the rock-fall boulder had stayed intact, the house may have sustained more damage, and the rock may have had enough momentum to impact the nearby Amber Inn on Main Street and/or other nearby structures.

Figure 8. View looking north to the rock-fall source area (yellow arrow) showing fresh rock fragments in the rock-fall path (dashed yellow line). Remaining talus boulder is shown with blue arrow.
