## Utah Geological Survey

Project: Reconnaissance of the 425 East South Weber Drive landslide, South Weber, Utah		
By: Richard E. Giraud, P.G.	Date: 04-05-05	County: Davis
USGS Quadrangles: Ogden (1345)	Section/Township/Range: SE $\frac{1}{4}$ NE $\frac{1}{4}$ and NE $\frac{1}{4}$ SE $\frac{1}{4}$ section 29, T. 5 N., R. 1 W., SLBLM	
Requested by: Boyd Davis, South Weber City Engineering		Job number: 05-03

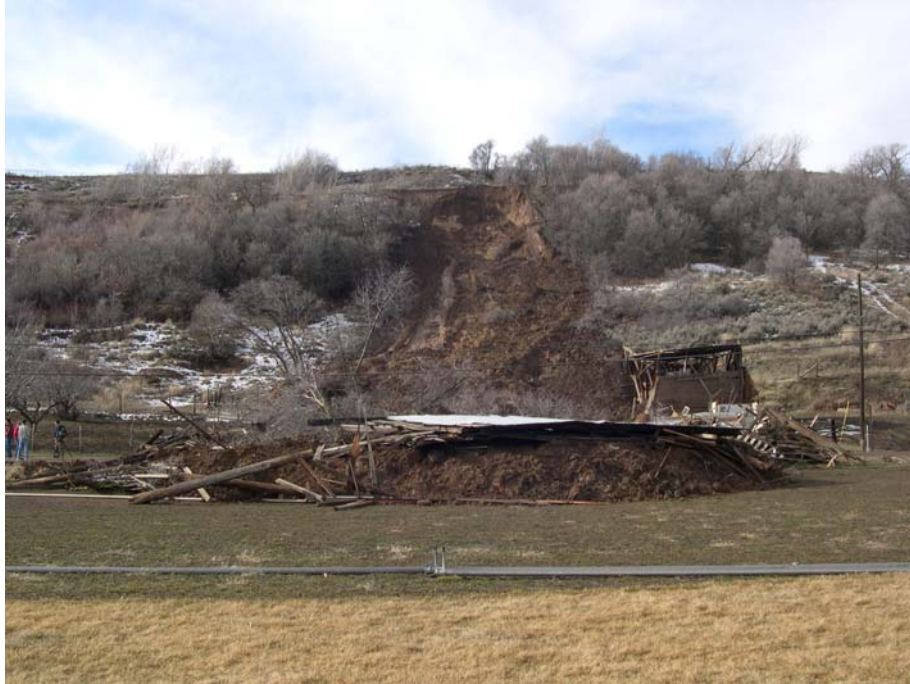
The 425 East South Weber Drive landslide occurred in the lower part of a northeast-facing slope on the edge of a bluff forming the south side of the Weber River valley (figure 2). The slope formed as the Weber River cut down into its former delta as Lake Bonneville receded after 16,000 years ago and the shoreline retreated to the present level of Great Salt Lake. The slope is approximately 200 feet high. The Davis-Weber Canal is about mid-slope and is a concrete canal with an impervious rubber liner. The demolished barn and State Route 60 (South Weber Drive) are at the base of the slope. The slope above the canal is about 80 feet high and has a gradient of 34%. Active shallow landslides in the slope above the canal locally override the southern canal bank. The slope below the canal is about 120 feet high and has an average gradient of 45%, but locally the gradient is up to 65%. Snow 1 to 3 inches deep covered approximately 40% of the slope above the canal and 20% of the slope below the canal on February 21, 2005.

**Figure 2.** View to the south showing the landslide main scarp in the Davis-Weber Canal embankment, the demolished barn (right foreground), and runout onto the field.

The landslide occurred shortly after 6 p.m., and demolished a barn, took out telephone poles, and blocked State Route 60 (South Weber Drive) (figures 2, 3, 4). The landslide is approximately 480 feet long and 80 feet wide at its widest point (figure 3) and between stations 305 and 310 on the Davis-Weber Canal. According to Nolan Birt (verbal communication, March 4, 2005), the barn owner who witnessed the event, the total landslide travel time was about a

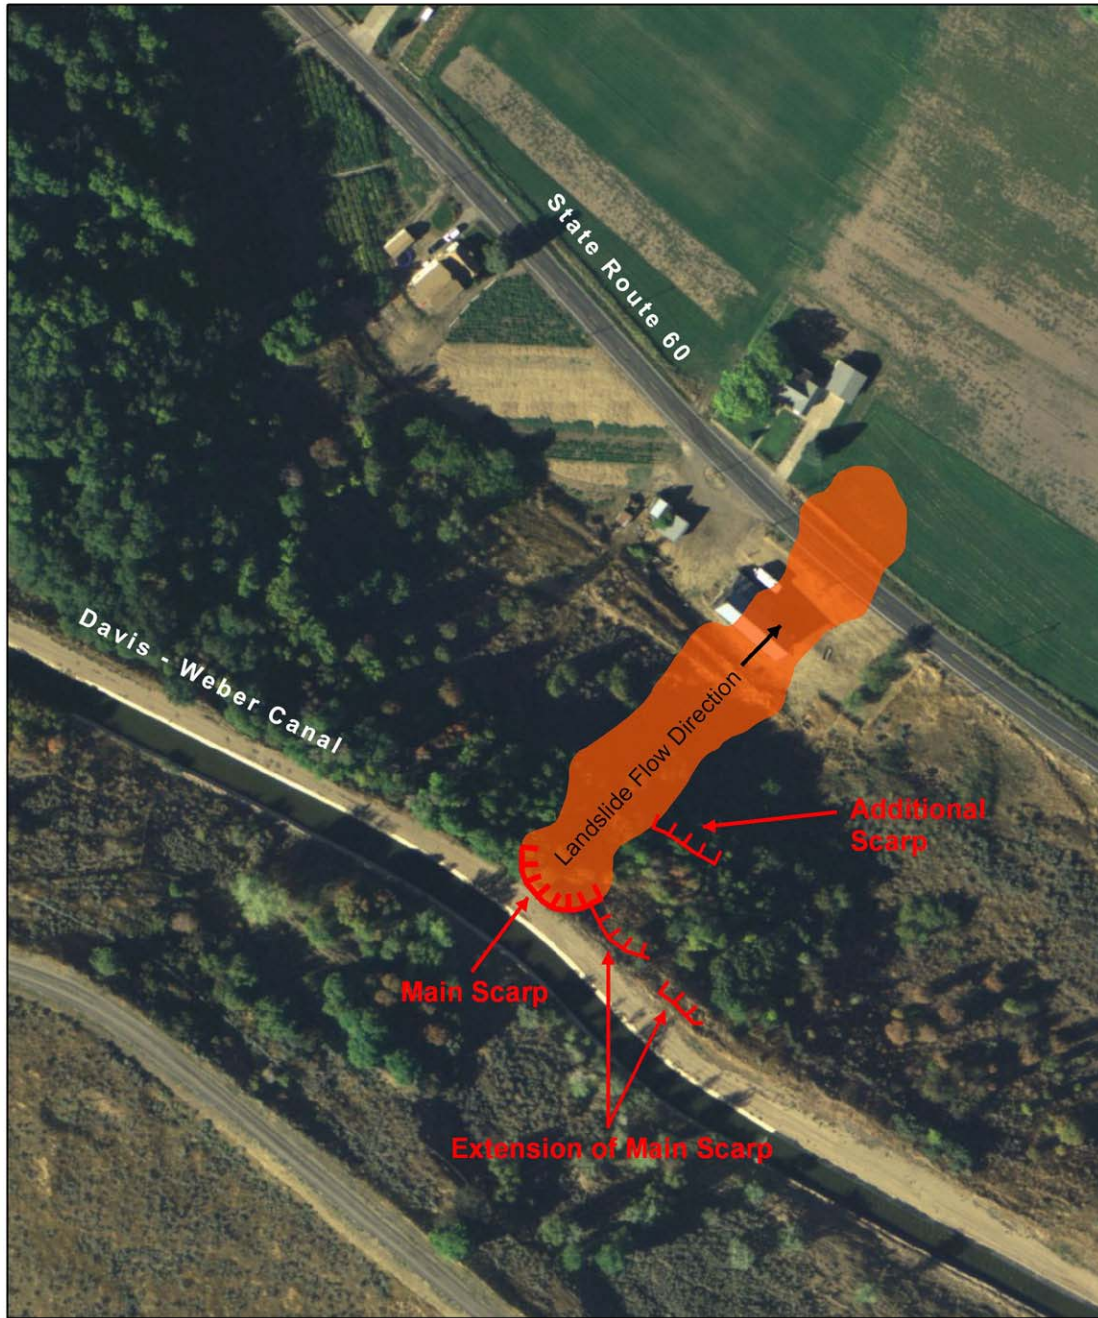
**Figure 3.** Image showing landslide flow direction, the Davis-Weber Canal, main scarp, other scarp, and runout beyond State Route 60 (South Weber Drive).

The steep landslide main scarp is in the canal and roadway embankment. Only 20-25 feet now separate the canal from the main scarp (figures 3, 5) and the canal is threatened by eventual retreat of the main scarp. The landslide main scarp has extended to the east (figures 3, 5) as adjacent pre-existing landslide deposits reactivated. Based on my observations, the landslide below the main scarp extension dropped approximately 10 to 12 inches between February 21 and March 4, 2005, indicating the slope east of the 425 East South Weber Drive landslide was still moving. Based on observations of the evacuated landslide main scarp area, the embankment fill was placed onto native slope materials and was not keyed into the underlying slope.

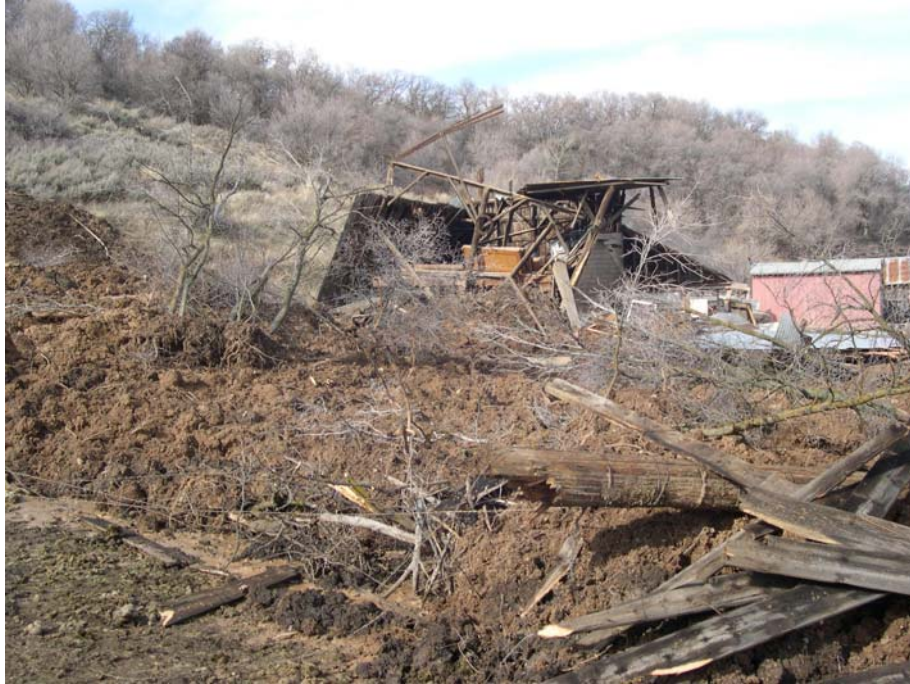
**Figure 4.** Looking across the lower part of the landslide at the demolished barn. The clump of trees in the foreground was rafted downslope on top of the landslide debris.

minute and the barn provided no resistance to landslide movement. Based on this approximate travel time, the estimated landslide velocity is about 8 feet per second, which classifies as very rapid landslide movement (Cruden and Varnes, 1996). The landslide is just below the Davis-Weber Canal and likely started moving as a rotational slide, but likely transformed into a rapid earth flow about midway downslope and ran out 150 feet beyond the toe of the slope across State Route 60 and onto a flat field. Grass, shrubs, and trees cover this northeast-facing slope. Some trees were rafted on top of the landslide debris (figure 4).

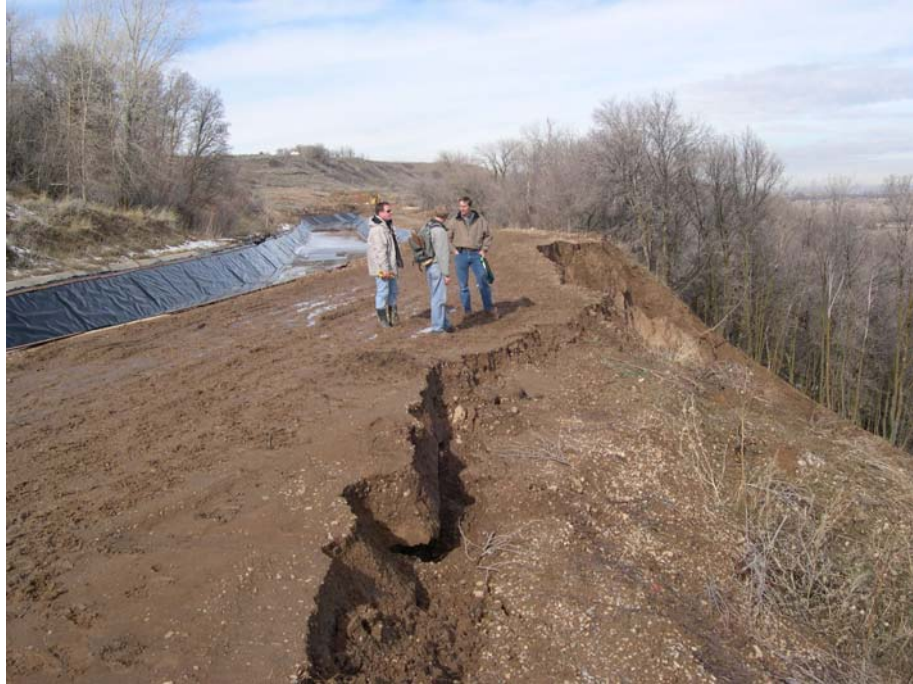
**Figure 5.** View west of the landslide crown, the Davis-Weber Canal, and the landslide main scarp. Eastward extension of the main scarp in the foreground indicates movement in the slope east of the landslide.

Several landslide hazards threaten the Davis-Weber Canal as a result of the 425 East South Weber Drive landslide. The most direct threat is from upslope retreat of the landslide main scarp, which could impact the remaining embankment and canal. Numerous shallow landslides are also present in the area, and movement of slopes directly east and west of the landslide also threaten the canal. Terracon (2005) estimated a factor of safety of about 1.0 for the slope below the canal at the landslide. Shallow active landslides in the slope above the canal are also a threat. Although all of the observed landslides are relatively shallow, deep rotational landslides must also be considered in hazard analysis. Earthquakes could trigger both shallow and deep landslides. If landslides impact the Davis-Weber Canal when the canal is conveying water, the potential exists for the canal to breach and cause widespread flooding and sediment deposition similar to the July 11, 1999, Davis-Weber Canal breach in Riverdale (Black and others, 1999).

- This slope should be reconstructed and stabilized prior to delivering water into this canal section, or the canal or water should be rerouted in the area.
- Risk-reduction measures may also be needed to stabilize landslides above and below the canal pending results of additional study and emergency reconstruction measures.
- Monitoring of inclinometers for landslide movement and ground-water levels in piezometers should be continued to assess changes in conditions following the landslide and to aid in stability assessment before, during, and after reconstruction.
- South Weber City should consider the landslide potential and hazards related to a possible canal breach when evaluating existing or future development near the base of the slope along the city's entire south side.
