Utah Geological Survey

Project: Reconnaissance of the April 9, 2006, 1650 East landslide, South Weber, Utah		
By: Richard E. Giraud, P.G. and Greg N. McDonald, P.G.	Date: 07-26-06	County: Davis
USGS Quadrangles: Ogden (1345)	Section/Township/Range: SW $\frac{1}{4}$ NE $\frac{1}{4}$ section 34, T. 5 N., R. 1 W., SLBLM	
Requested by: Ron Chandler, South Weber City Manager		Job number: 06-10

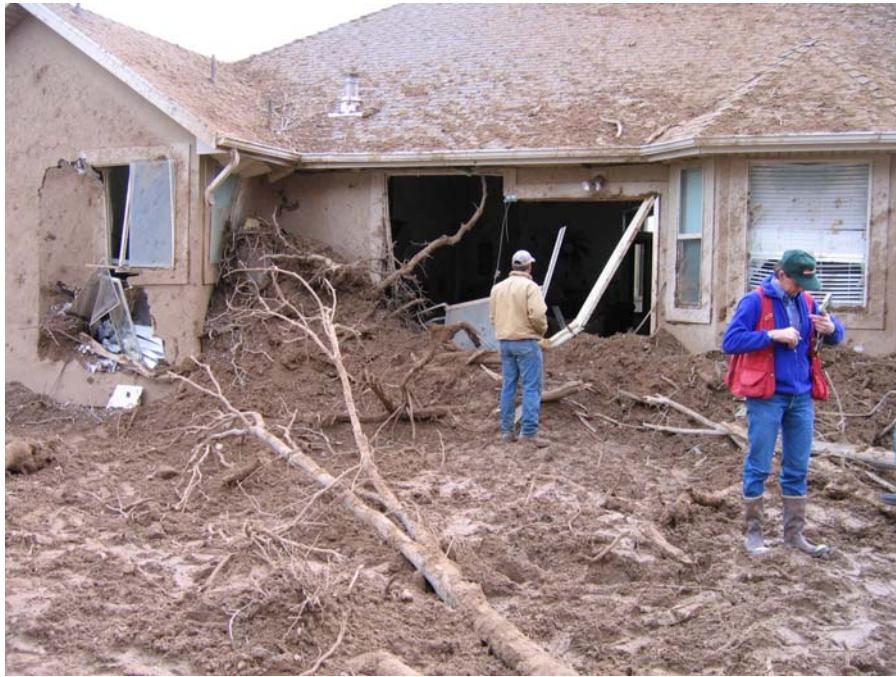
The landslide occurred around 9:30 p.m. on the evening of April 9, 2006. It flowed over and damaged the Davis-Weber Canal at the base of the slope, and impacted the back of the house at 1650 East 7687 South below the canal (figures 3 and 4). The landslide caused significant damage to the house, injured a child inside the house, and prompted evacuation of nearby houses. The purpose of our investigation was to determine the cause of the landslide, document physical characteristics of the landslide, and evaluate the remaining landslide hazard to aid South Weber City in determining when to allow evacuated residents to return and in assessing the long-term risk to development at the base of the bluff.

Figure 3. Landslide damage to the house at 1650 East 7687 South.

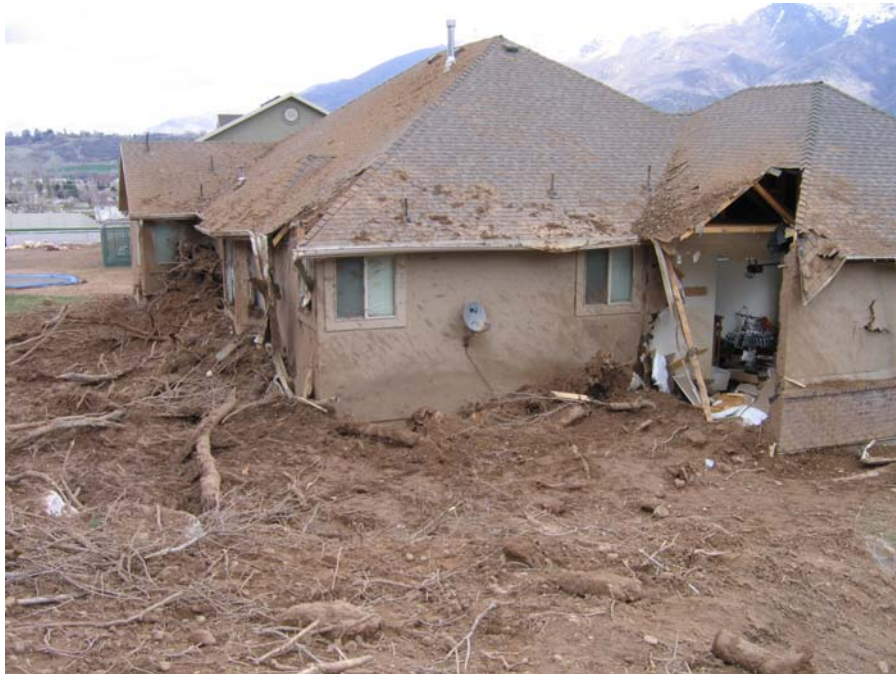
Figure 4. Damage to the house and garage at 1650 East 7687 South.

broke through the house and garage walls and a small volume of sediment and tree debris was deposited in the house. A child inside the house was injured and the landslide impacted with sufficient force to break part of the house foundation wall (figure 8). The impact to the back of the garage pushed a car and pickup out through the garage doors. The landslide broke windows at the adjacent house to the southwest at 1650 East 7701 South. The landslide also damaged the Davis-Weber Canal which had recently been enclosed in a concrete box culvert but was not yet covered with backfill (Ray, 2006) (figure 9). Water had not yet been turned into the canal for the irrigation season so obstruction to flow in the canal by the landslide was not an issue.

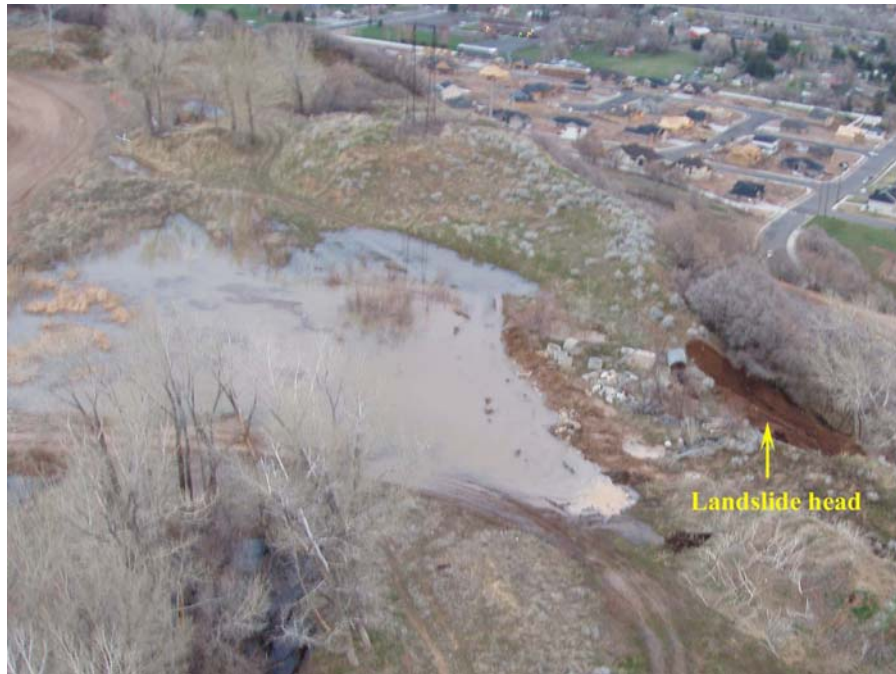
The 1650 East landslide was a rapid earth flow that started as a slide at the slope crest adjacent to a pond in a gravel pit (figures 2 and 5). The landslide main scarp extends a short distance back from the slope crest onto flat ground toward the pond in the gravel pit. The landslide is mostly a failure of fill pushed out of the gravel pit onto the upper slope to form a berm along the slope crest (figure 6). The landslide also involved native materials underlying and downslope of the fill. The slide at the crest mobilized into a flow that accelerated rapidly downslope, removing trees and crossing dirt roads, the canal, and a rock wall at the back of the lot before impacting the house at 7687 South 1650 East (figures 2 and 7). The landslide impact

Figure 5. View looking northwest at the pond in the gravel pit and the landslide head (arrow). A berm was placed between the pond and the landslide to prevent water from flowing onto the landslide. Photo taken on the morning of April 10, 2005, by Davis County Sheriff's Office personnel.

the pond (figure 5) also indicate the presence of perennial shallow ground water since surface-water runoff alone would not sustain this vegetation. Cottonwood trees growing along the slope crest also indicate shallow ground water (figure 6). Following the landslide, a soil berm was placed between the pond and the landslide to prevent pond water from flowing onto the landslide head (figure 5).

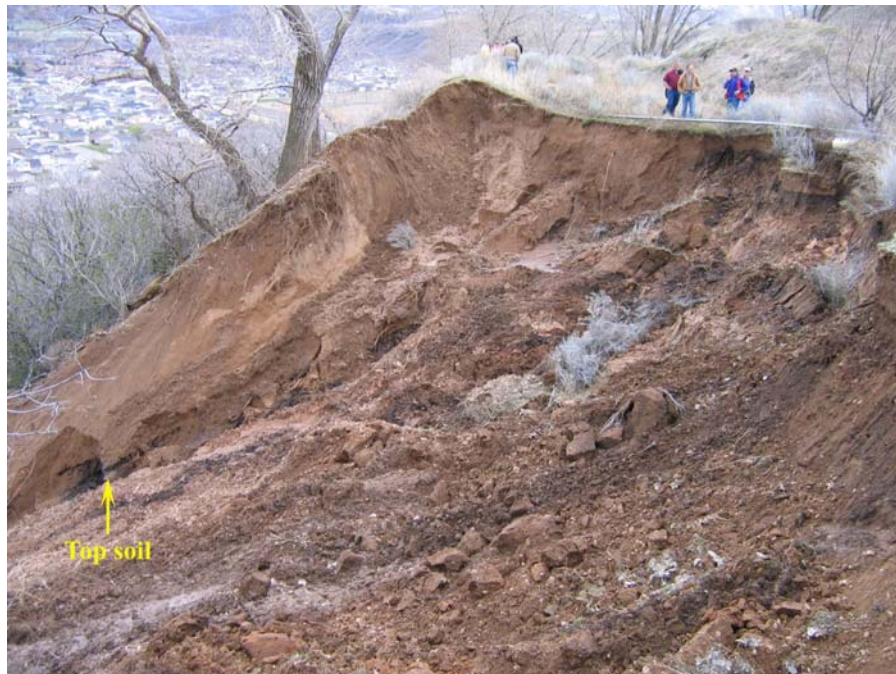
Figure 6. View to the southeast showing landslide main scarp and fill placed on the upper slope. Near the left edge of the photo, black top soil at the base of the scarp (arrow) underlying the brown fill is evident and indicates the original slope surface.

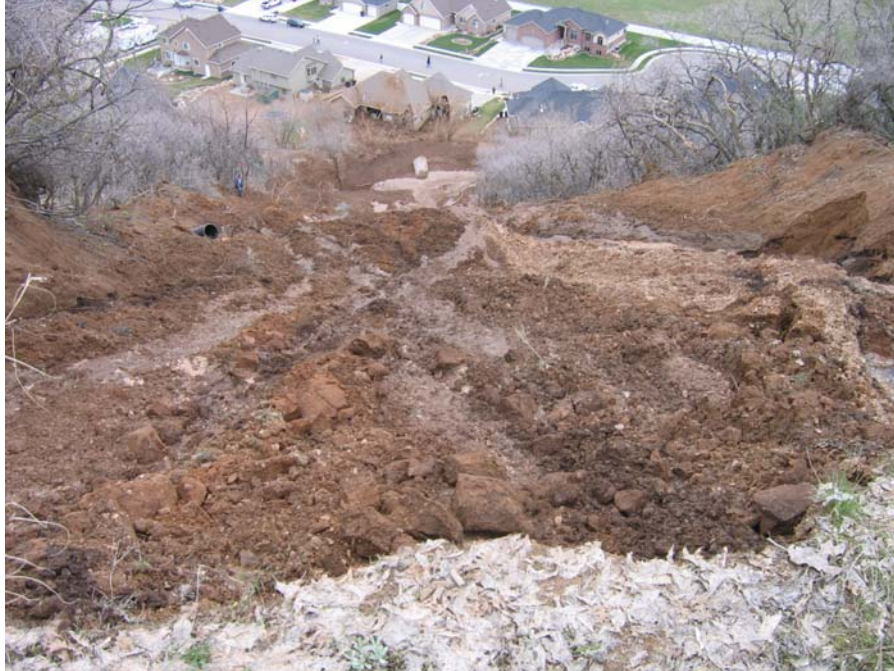
Figure 7. View looking down the landslide flow path at the damaged house at 1650 East 7687 South. The culvert in the lower slide path above the house was originally in the gravel pit. Subsequent water flow eroded the right side of the landslide.

The landslide likely moved initially as a shallow translational landslide but quickly transformed downslope into a rapidly moving earth flow. The landslide was about 80 feet wide and 600 feet long (figure 2). It initiated in the upper slope on gradients of as much as 60% (31°). The average gradient from the landslide main scarp to the impacted house is 45% (24°). The steep slopes accelerated the landslide downslope toward the subdivision. Some landslide material was deposited on the canal and canal access road (figure 9) and on dirt roads above the canal (figure 10), which reduced the landslide volume before impacting the house and likely reduced damage to the house. Following the landslide, water draining from the landslide crown and head eroded the right side of the landslide and flowed into the canal (figures 7 and 9).

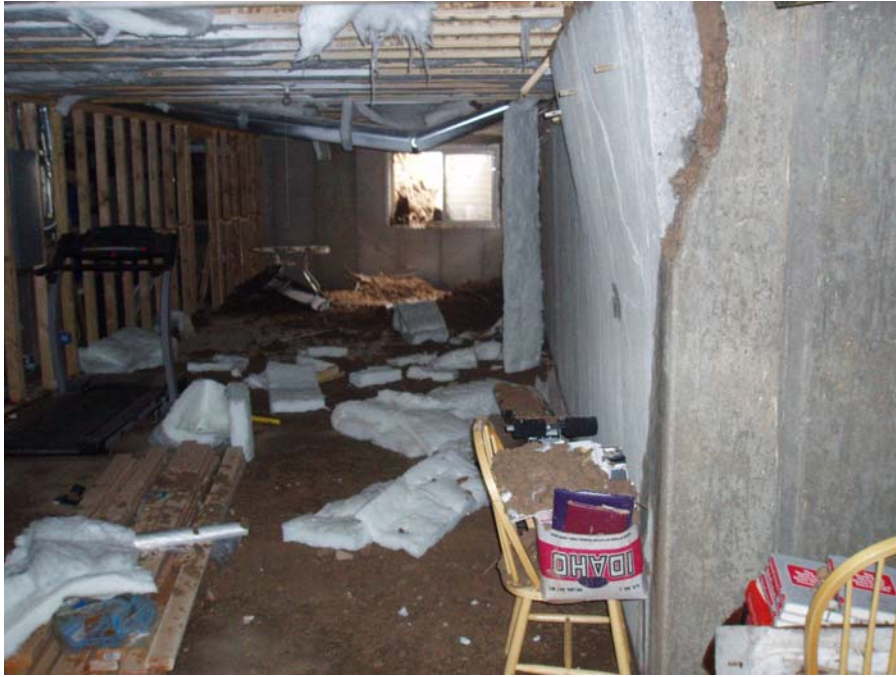
Figure 8. Basement at 1650 East 7687 South showing upper foundation wall (right side of photo) broken by landslide impact.

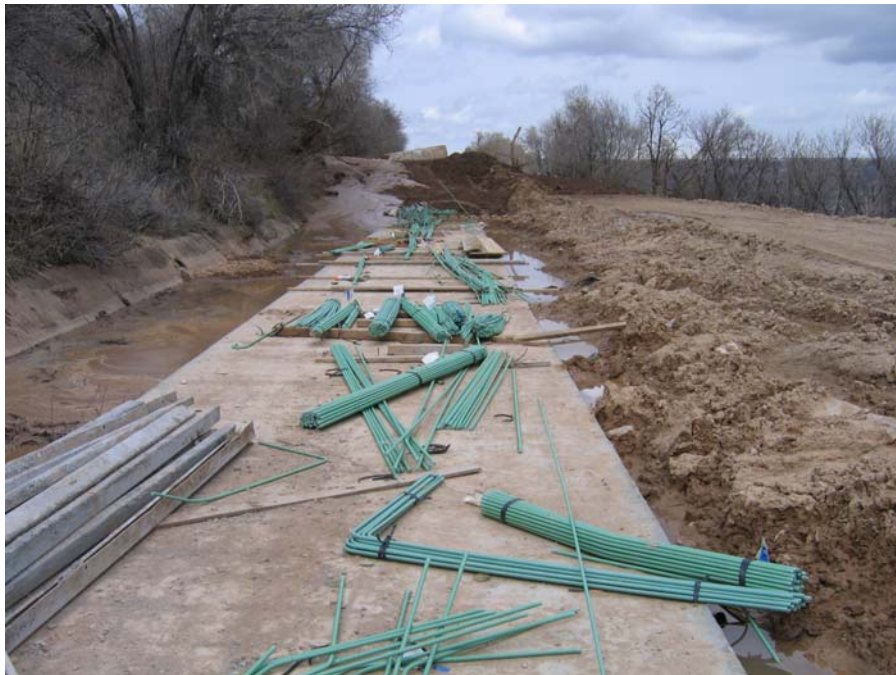
Figure 9. View looking northwest of Davis-Weber Canal showing landslide material deposited on the box culvert and canal access road. Following the landslide water and sediment flowed into the canal left of the box culvert.

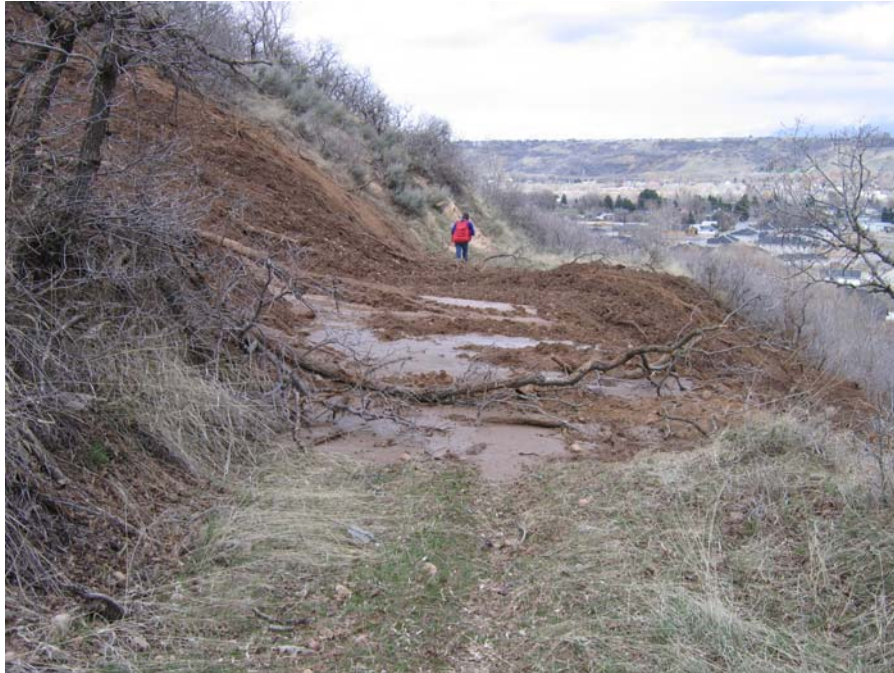
Figure 10. Landslide material deposited on a dirt road midslope above the Davis-Weber Canal.

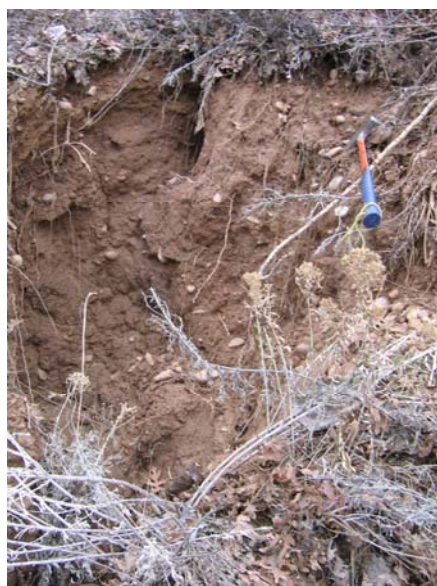
Several factors likely contributed to landslide movement. The fill placed along the slope crest added weight, loading the underlying weak native slope materials and promoting slope failure. The elevated pond level and related shallow ground water saturated part of the fill and native material in the upper part of the slope and triggered the April 9, 2006, landslide. Piping holes along the landslide flanks (figure 11) near the landslide head indicate active subsurface flow through the fill on the slope crest prior to the landslide. A major spring storm on April 4 through 6, 2006, resulted in 10 inches of snow (2.12 inches water) in South Ogden and 8 inches of snow (1.95 inches water) in Layton (National Weather Service, 2006). The subsequent snowmelt and runoff likely increased the pond-water level and ground-water level and saturated part of the fill along the slope crest. The steep slope, runoff of snowmelt water into the pond, shallow ground water, weight of embankment fill, and weak underlying materials probably all contributed to the landslide.

Figure 11. Piping holes in the upper slope near the landslide flanks. (a) Small piping hole near the landslide right flank. (b) Large piping hole adjacent to the landslide left flank.
