Utah Geological and Mineral Survey  
Report of Investigation

No. 195

CAUSES OF BASEMENT FLOODING  
ALONG 11800 SOUTH NEAR 3800 WEST,  
SOUTH JORDAN AND RIVERTON  
SALT LAKE COUNTY

March 1985

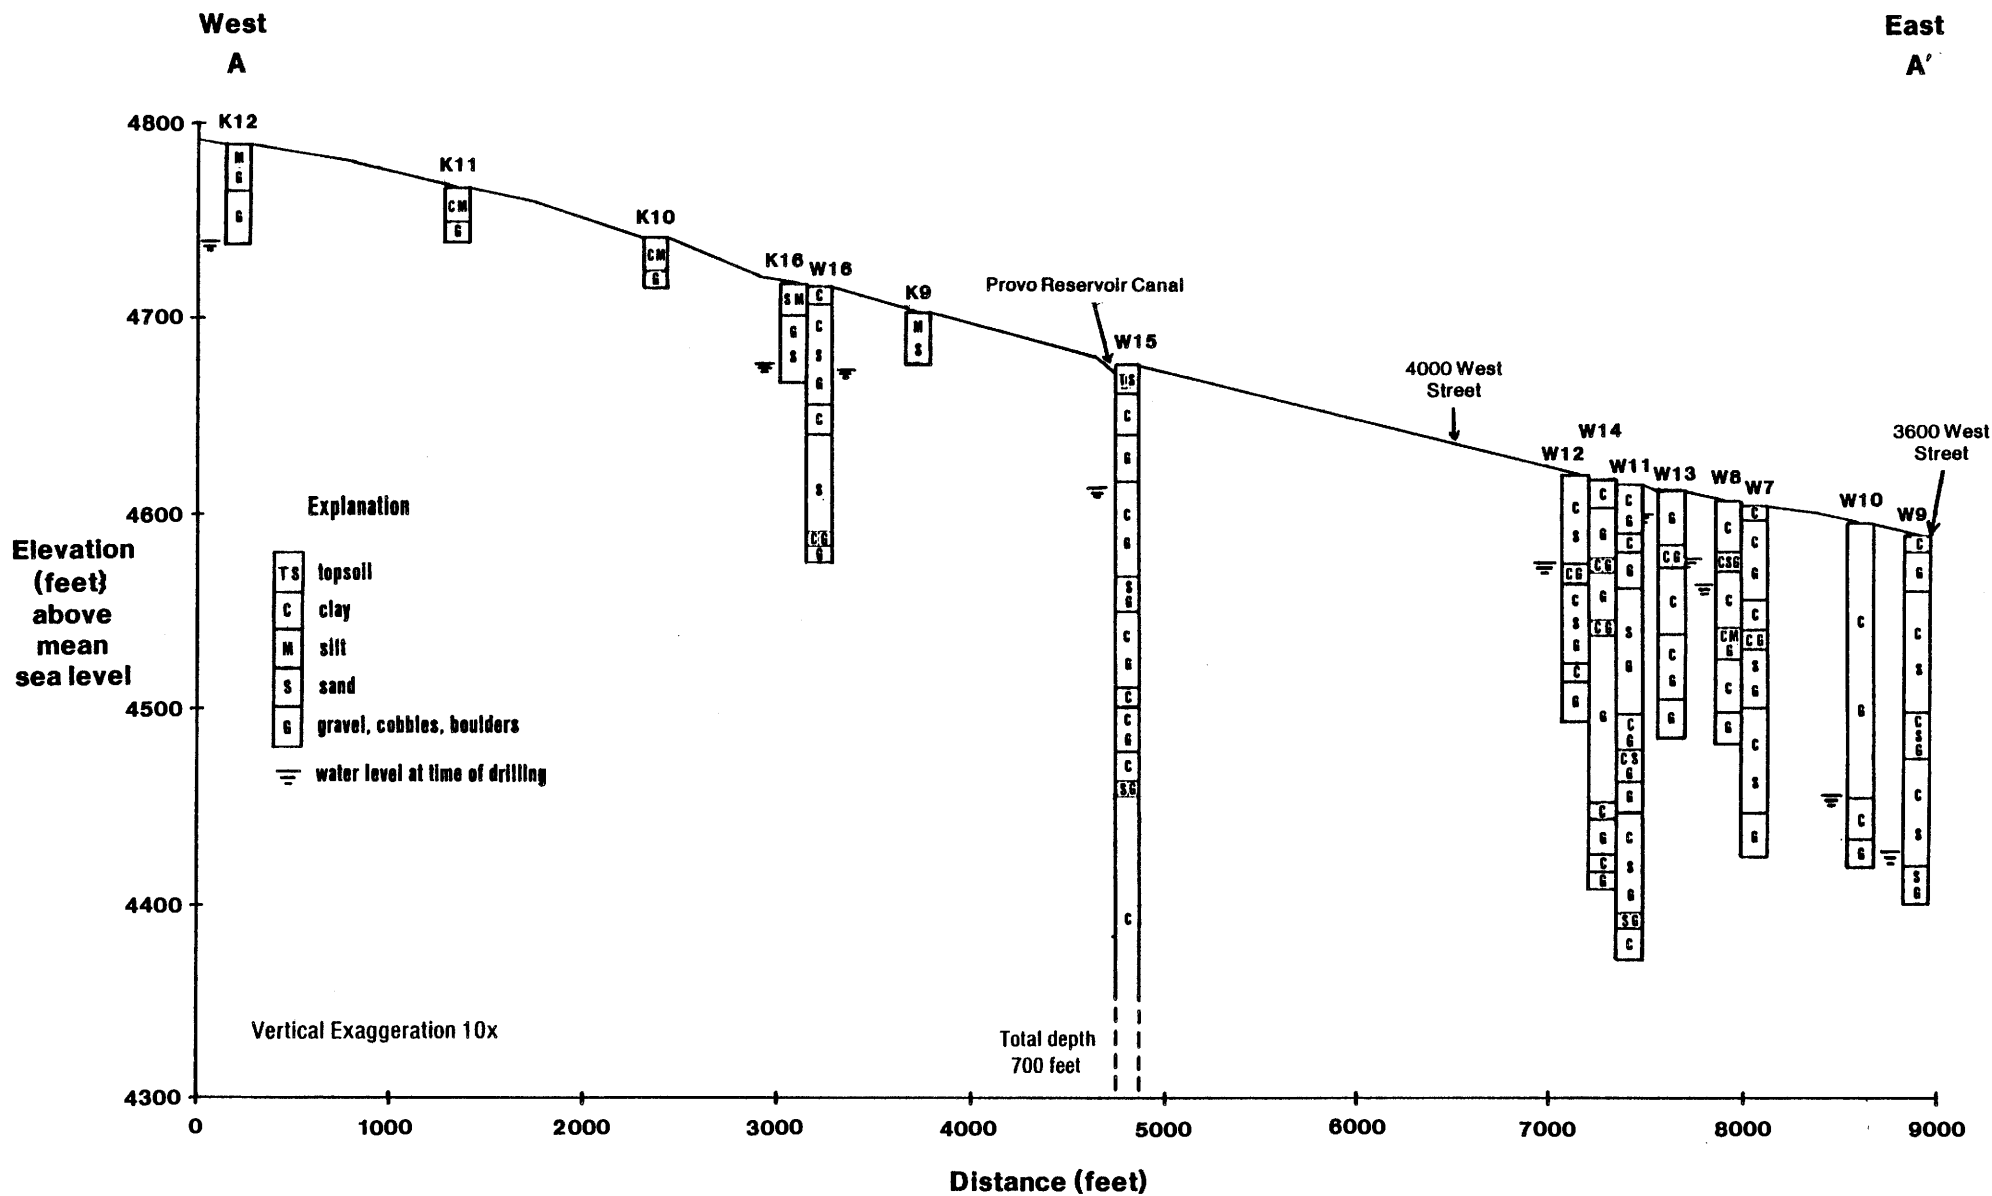
Figure 3. Geologic cross section A A' along 11800 South Street, Riverton-South Jordan (see fig. 1 for location).

Logs of water wells and Kennecott exploratory drill holes were used to construct geologic cross sections along 11800 South (fig. 3), 3800 West (fig. 4), and in the evaporation pond area (figs. 5 and 6). Locations of wells, drill holes, and cross sections are shown in figures 1 and 2. Logs of water wells shown in figures 3 and 4 were prepared by well drillers and are very generalized. These logs and U. S. Soil Conservation Service soil maps by Woodward and others (1974) indicate that near-surface soils in the pond and basement flooding area generally consist of silt and clay. They are underlain by interbedded gravel, sand, and clay with local thick beds of unknown lateral extent. Correlation of units between water wells was not possible because of the natural variability of soils, generally poor quality of logs, and distance between wells. Kennecott drill-hole logs shown in figures 5 and 6 are more detailed and accurate. The closer drill-hole spacing and 5-foot sample interval give a better indication of soil types. Soils in these drill holes

were also logged by trained soil technicians and classified according to the Unified Soil Classification System (appendix). Surficial soils are primarily clayey silt, sandy silt, and silty sand. At depths below 20 feet, sand and gravel predominate.

The homes being flooded along 11800 South are along a stream channel incised between lake deposits to the north and post-lake alluvial-fan deposits of Midas Creek to the south (Woodward and others, 1974). The channel is about 5 feet deep and is in the area of lowest topography between Bingham and Midas Creeks. To construct the Bowles and Callister homes, this channel was filled and drainage was diverted along 11800 South. Deposits more permeable than the surrounding silts and clays were probably present in the channel and were buried during lot leveling for home construction.

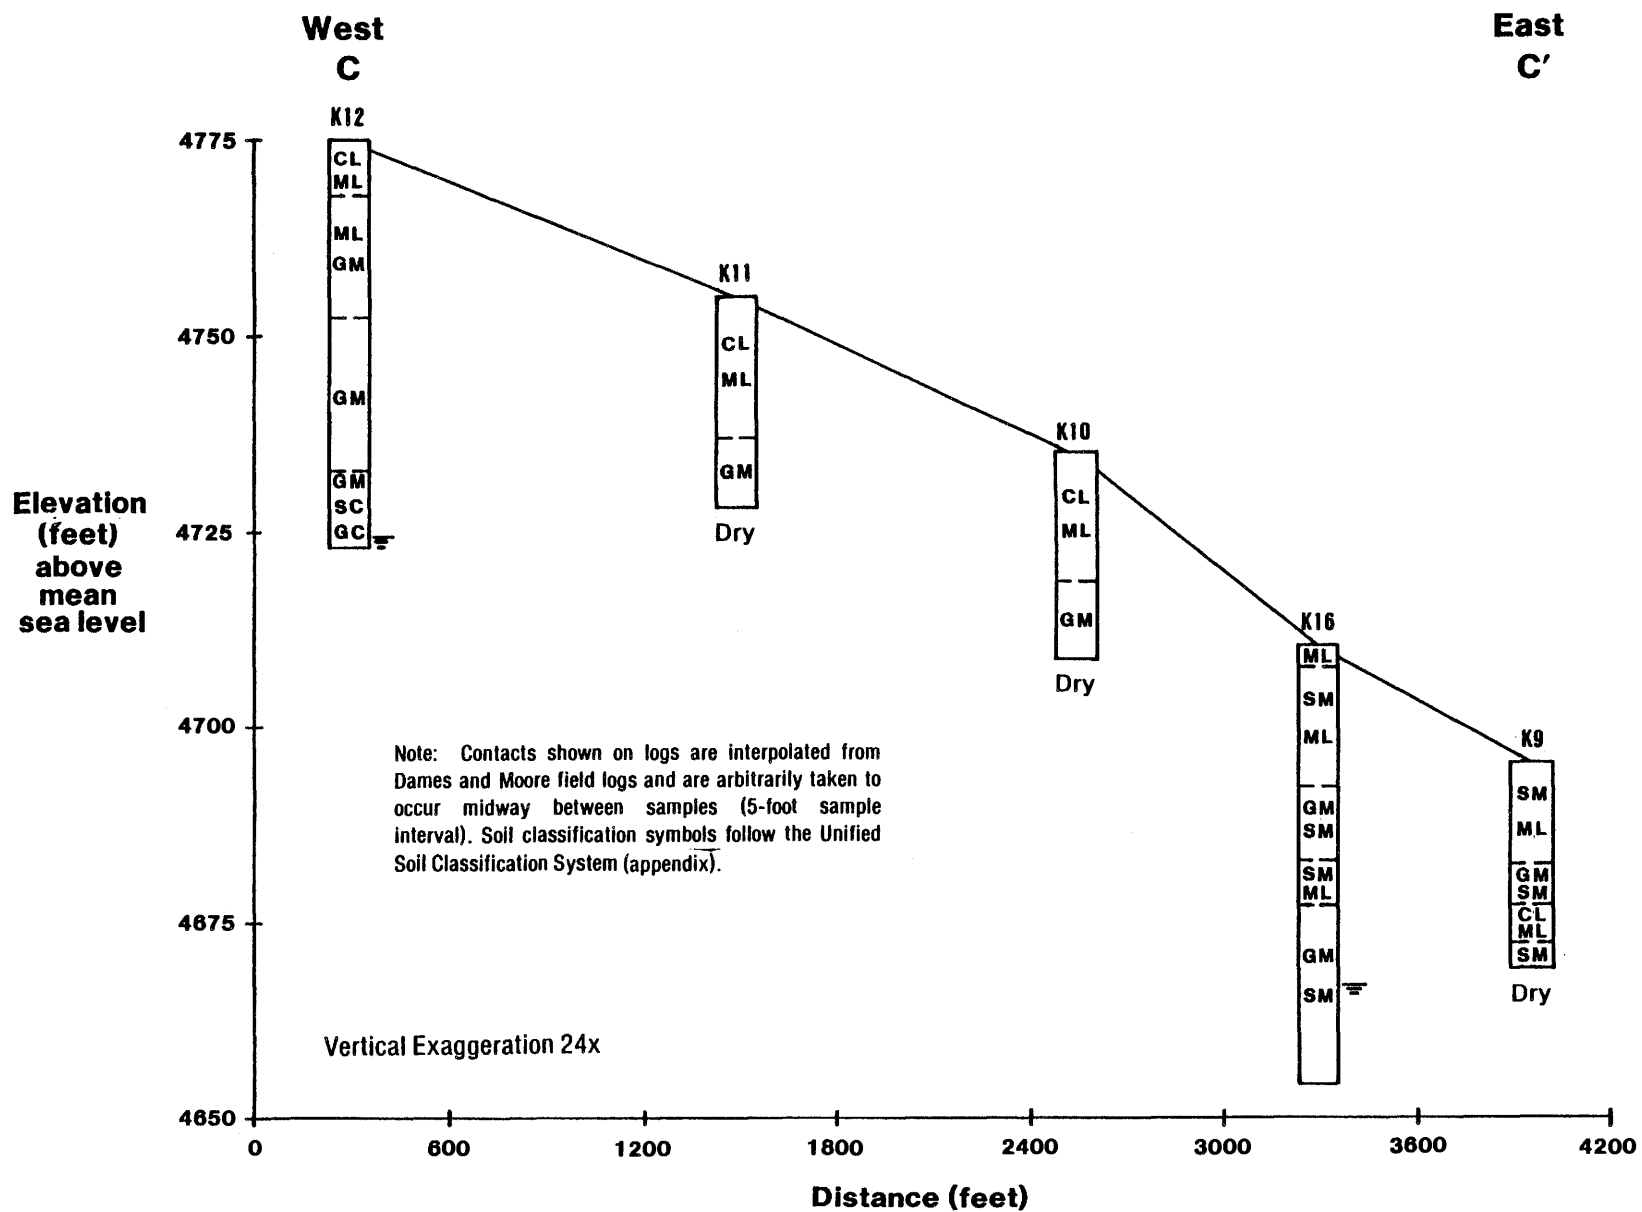
Figure 5. Geologic cross section C C' along south edge of Kennecott pond area (see fig. 2 for location).

The stratigraphy in the area is typical of shoreline and nearshore deposits of Lake Bonneville where an abundant source of sand and gravel was available. Laterally continuous fine-grained beds that may exist in the area would be the lake-bottom deposits laid down during the highest (Bonneville-level) stillstand of the lake. However, no thick clay beds representing such a deposit were encountered in the pond area. Such beds may either be present below the depth of exploration or absent in the area. Thick clay beds which may represent such deep-lake deposits are recorded at various depths in water wells east of the pond area.

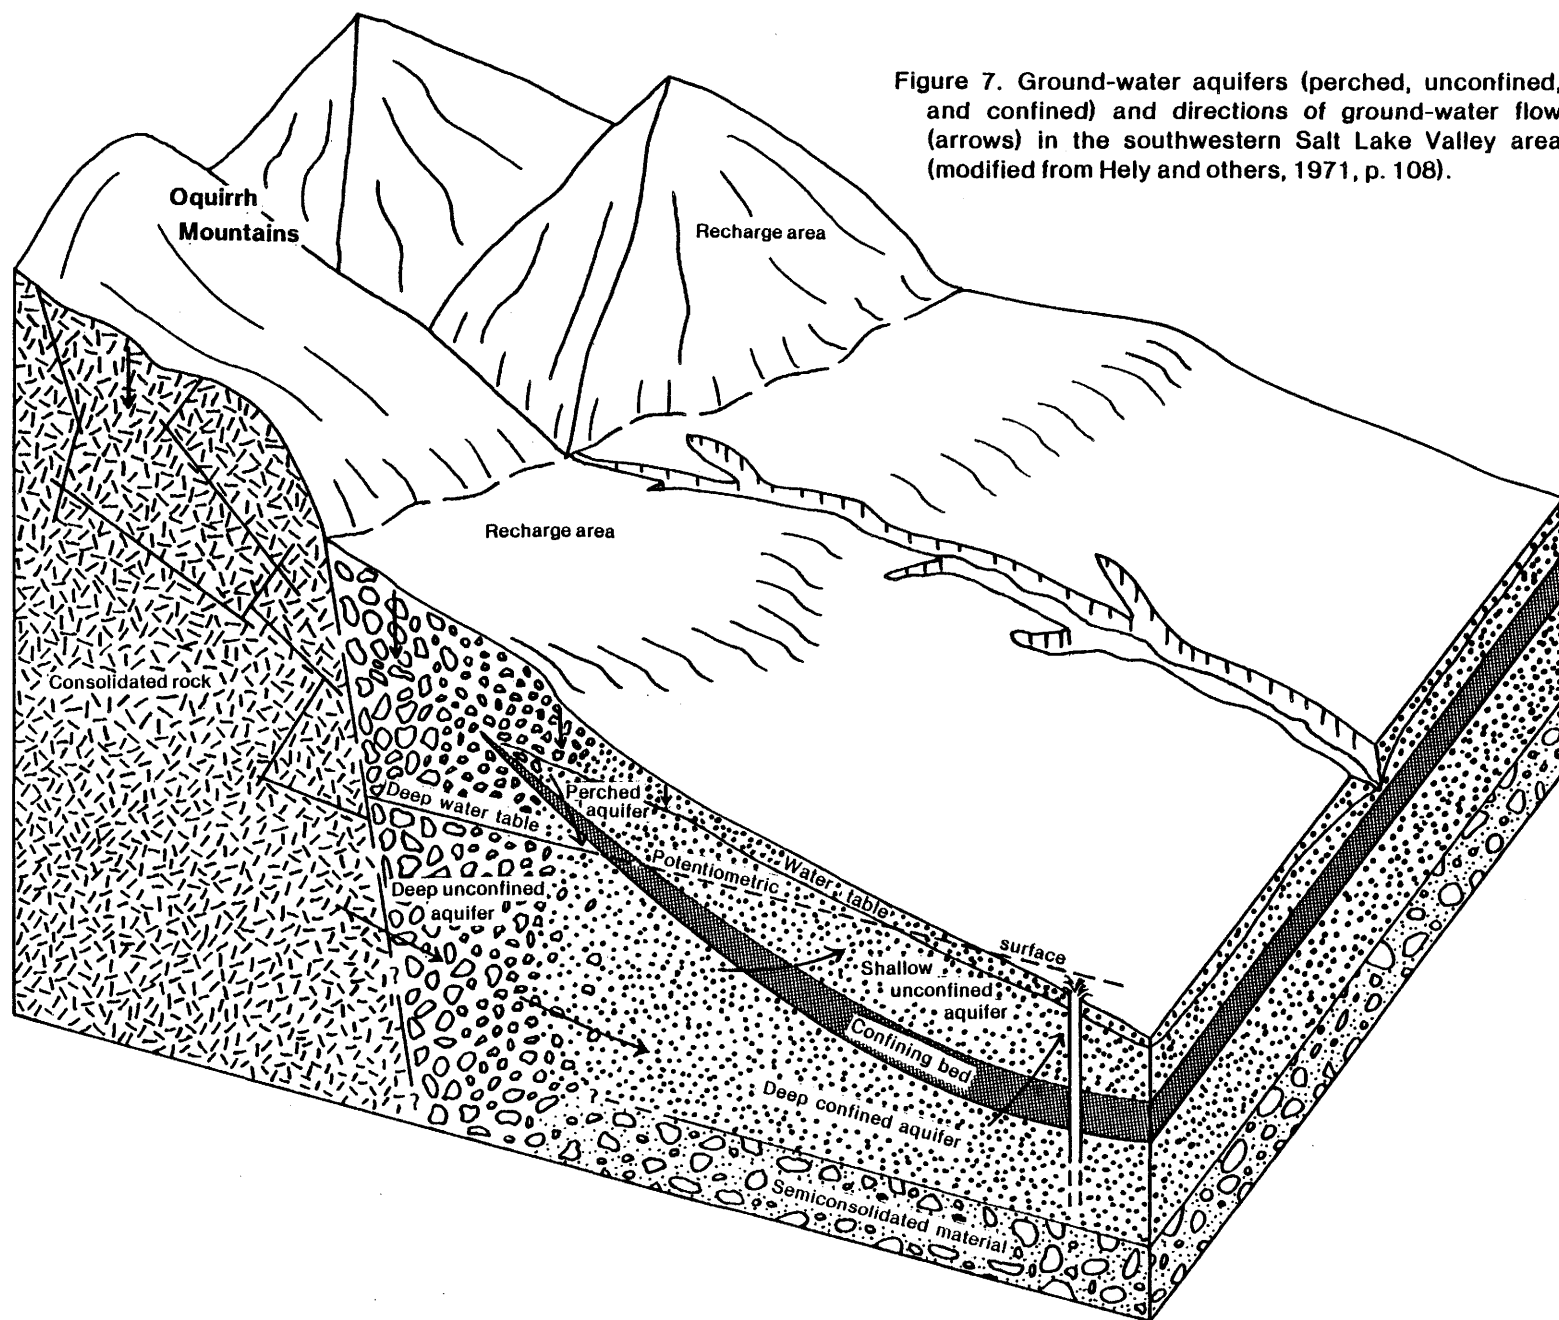
Figure 7. Ground-water aquifers (perched, unconfined, and confined) and directions of ground-water flow (arrows) in the southwestern Salt Lake Valley area (modified from Hely and others, 1971, p. 108).

occurs in: 1) a deep unconfined aquifer in gravelly deposits along the front of the Oquirrh Mountains, 2) a deep confined aquifer in the central valley in gravel deposits beneath clayey confining beds, 3) a shallow unconfined aquifer in the central valley above confining beds and coextensive with the deep confined aquifer, and 4) local perched aquifers (Hely and others, 1971). Flow occurs between the various aquifers as shown in figure 7. The deep unconfined aquifer is recharged from direct infiltration of water along the mountain front and flow from bedrock aquifers at depth. Eastward flow from the deep unconfined aquifer recharges the deep confined aquifer, and the elevation of the potentiometric surface of the confined aquifer is dependent on the amount of recharge. Both the shallow unconfined and perched aquifers are recharged from infiltration from surface sources (irrigation, stream flow, direct precipitation). As defined by Hely and others (1971), the distinction between these two aquifers is that the shallow unconfined aquifer also receives recharge from upward flow through leaky confining beds from the deep confined aquifer. The perched aquifer is above the potentiometric surface of the deep confined aquifer, and any movement of water from the perched aquifer is downward into the unsaturated zone above the deep aquifer or laterally into the adjacent shallow unconfined aquifer.

Both the deep confined and shallow unconfined aquifers are present in the area of basement flooding. Water well logs indicate substantial thicknesses of clayey material in the upper 100 feet act as confining beds to separate the two aquifers. All wells in the area tap the deep confined aquifer, and the potentiometric surface varies from 17 to 200 feet below ground surface (figs. 3 and 4). The wide range in water levels results from many factors, including: 1) depth of the well and perforated interval, 2) date and accuracy of measurement, and 3) location. Unpublished USGS monitoring-well data

indicate the potentiometric surface in the deep confined aquifer in February, 1983, to be 70 feet below the ground surface near the intersection of the Provo Reservoir Canal and 11800 South Street. By September 1984, the level had risen to 53 feet. At the Candalot home, the water level rose from 32 feet when the well was drilled in 1973 to near the ground surface in summer 1984. Water levels in other private wells along 11800 South Street also rose significantly in 1984, indicating an increase in recharge to the deep confined aquifer with an accompanying rise of the potentiometric surface.

Basement flooding is occurring as the water table in the shallow unconfined aquifer rises. No wells tap this aquifer in the area of basement flooding, and it is only known that the water table is above the basement floors. Shallow monitoring wells are present in the evaporation pond area to the west, and these indicate an absence of a shallow water table in either perched or shallow unconfined aquifers beneath the ponds. Hely and others (1971) show the approximate westward extent of confining beds to be along the western edge of the ponds, and Kennecott (1984b, p. 29) indicates that the confining beds may extend much further west. However, a drill hole to 95 feet (K15, fig. 6) in the evaporation pond area did not encounter any clayey confining beds, and most other holes to depths of 50 feet likewise encountered no clay. From these data, it appears that confining beds are absent in the upper 95 feet in this part of the pond area and that the water level (89.5 feet) recorded in the deepest drill hole (K15, total depth - 95 feet) may represent the water table in the deep unconfined aquifer.
