Report of Investigation

No. 198

TECHNICAL REPORTS FOR 1984

SITE INVESTIGATION SECTION

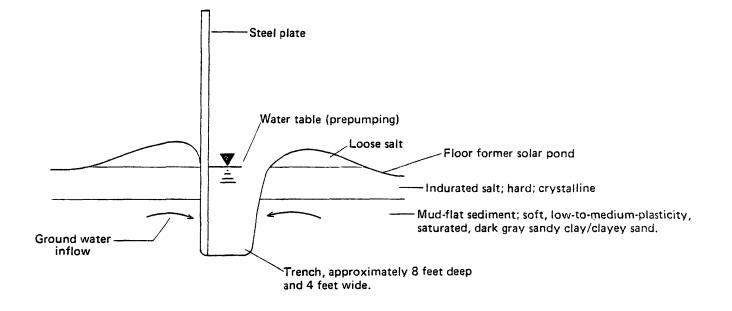
Schematic cross section of pond construction showing stratigraphy and water table.

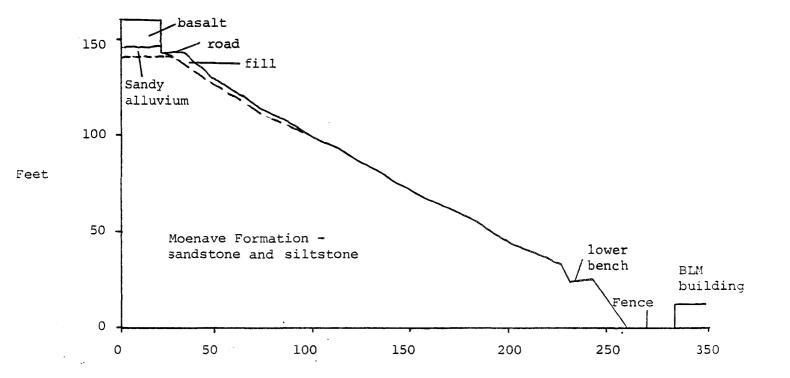
Diagrammatic (approximate scale 1 inch - 50 feet; no vertical exaggeration) cross section showing slope west of BLM building, St. George, Utah
