UTAH GEOLOGICAL AND MINERAL SURVEY  
REPORT OF INVESTIGATION

NO. 215

TECHNICAL REPORTS FOR 1986  
SITE INVESTIGATION SECTION

Compiled by  
William E. Mulvey

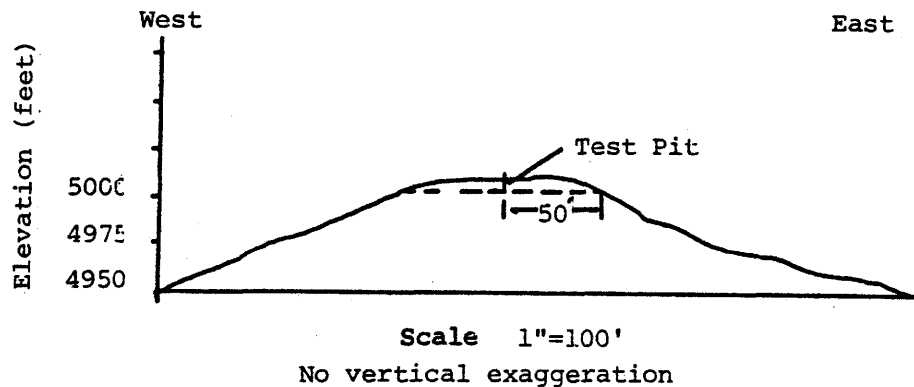
Profile across Lot 26 showing the horizontal distance from the test pit to the 35 percent or greater slopes.

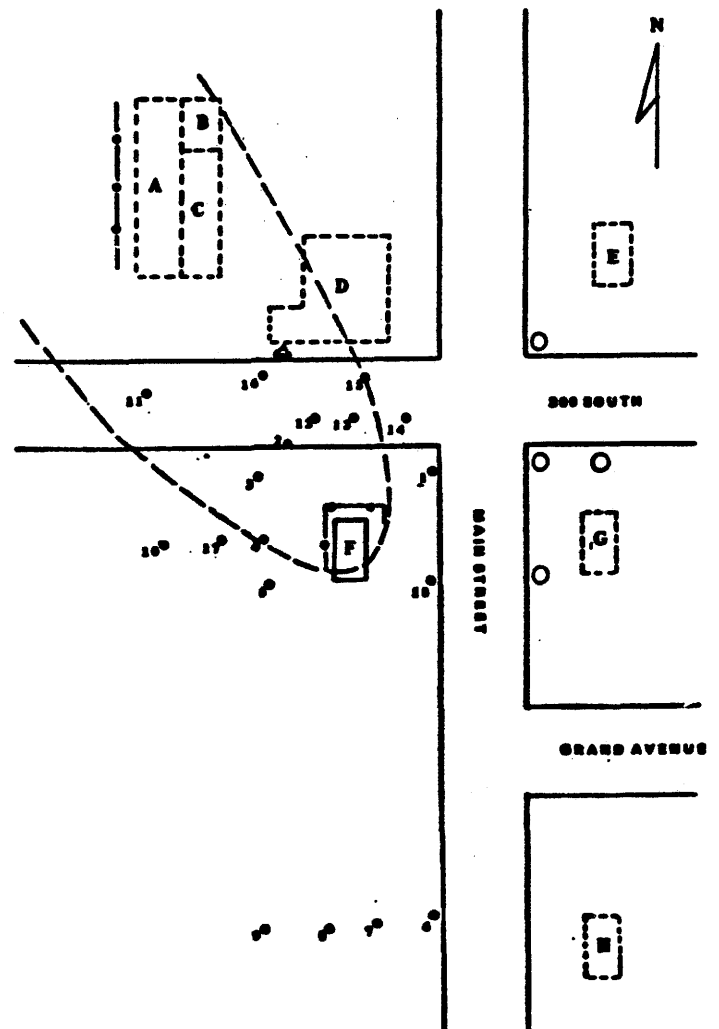
Diagrammatic representation of study area showing bore hole sites, buildings, and postulated gasoline plume.
