UTAH GEOLOGICAL AND MINERAL SURVEY

Report of Investigation 218

TECHNICAL REPORTS OF THE  
WASATCH FRONT COUNTY GEOLOGISTS  
JUNE 1985 to JUNE 1988

Compiled by  
Bill D. Black and Gary E. Christenson

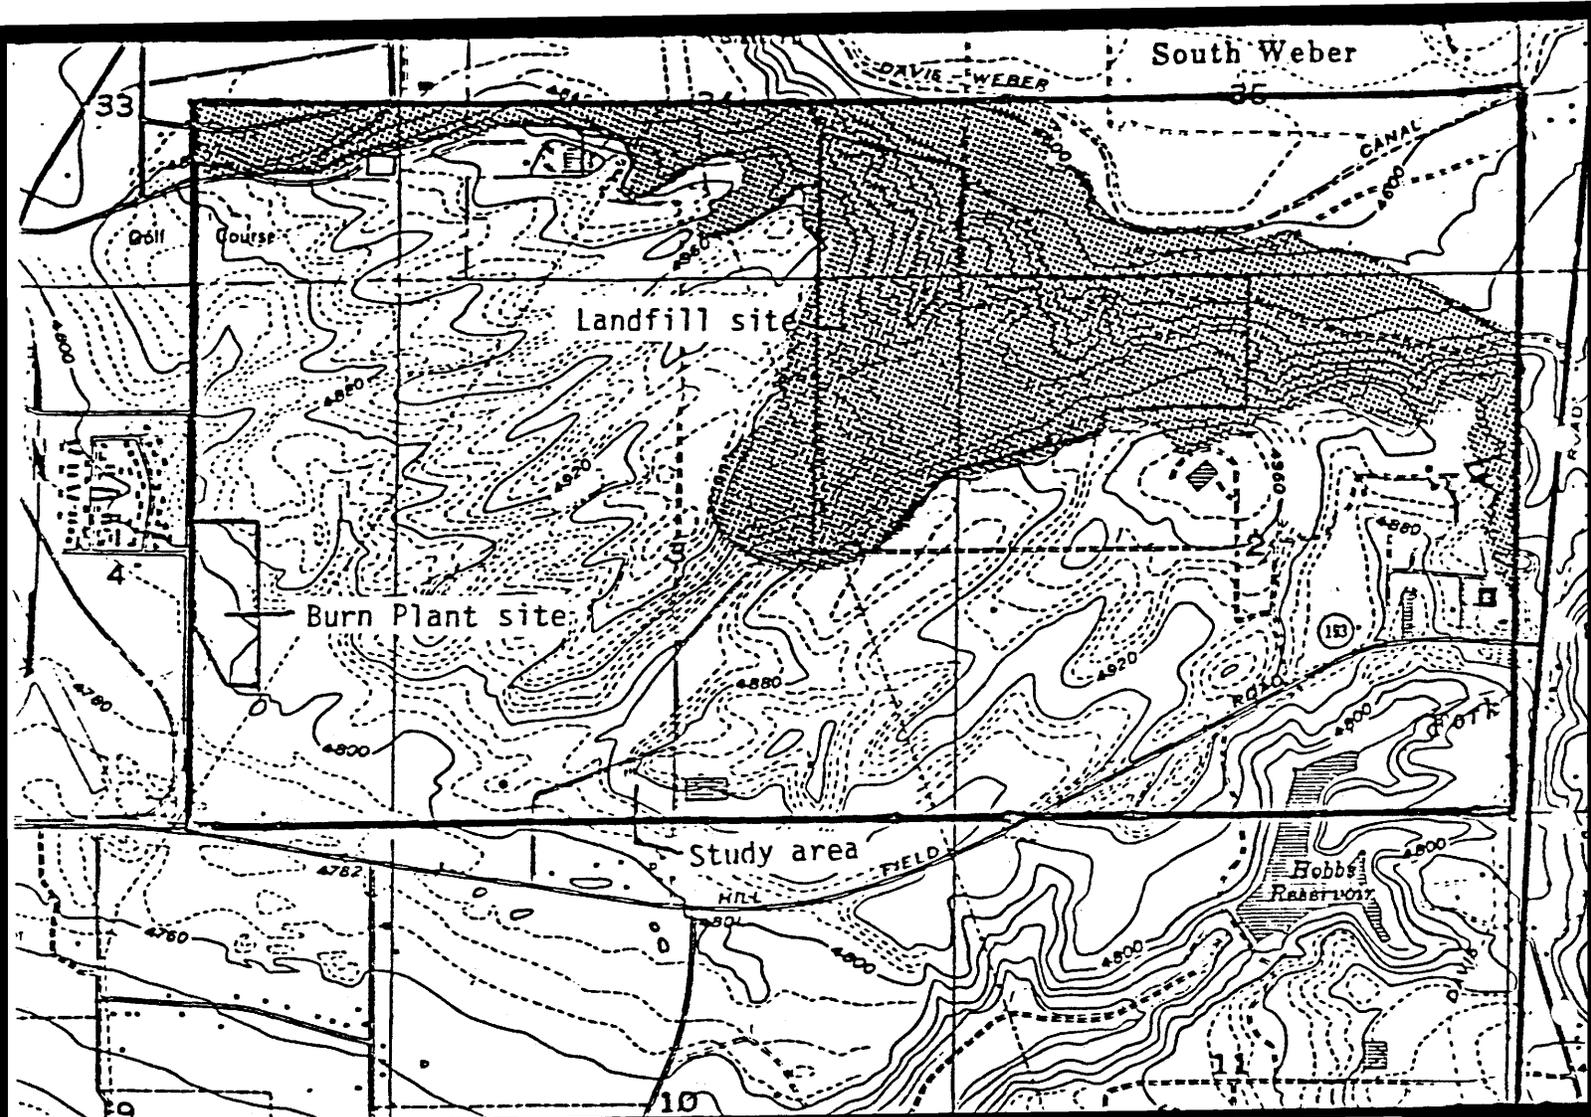
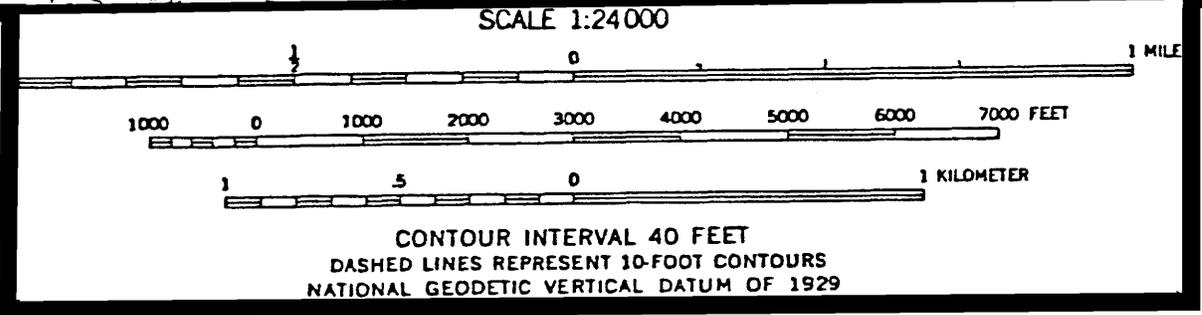
Figure 13. Areas of landslide hazard (stipled) in the NDRD site study area.

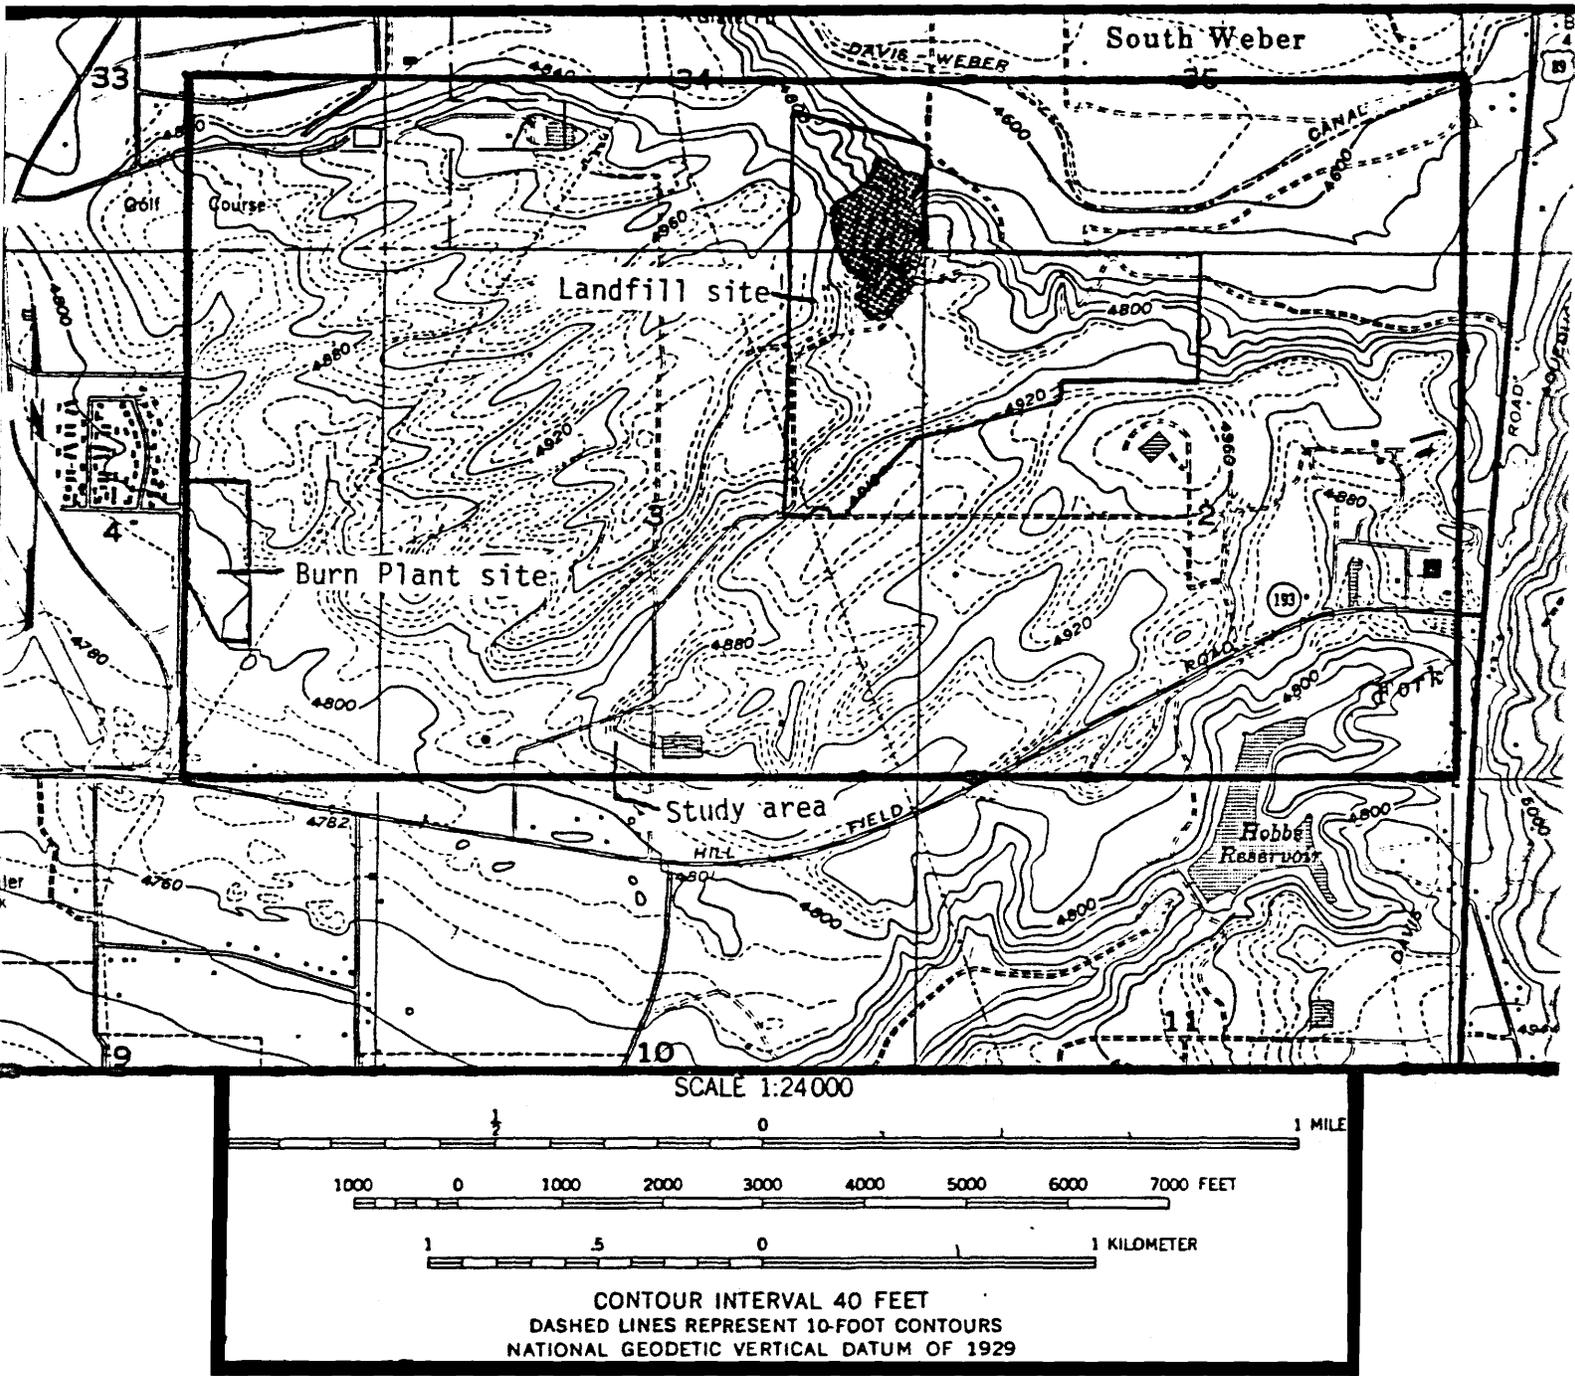
Figure 14. Recommended study area for stability of refuse fill, NDRD site study area, northern Davis County, Utah.

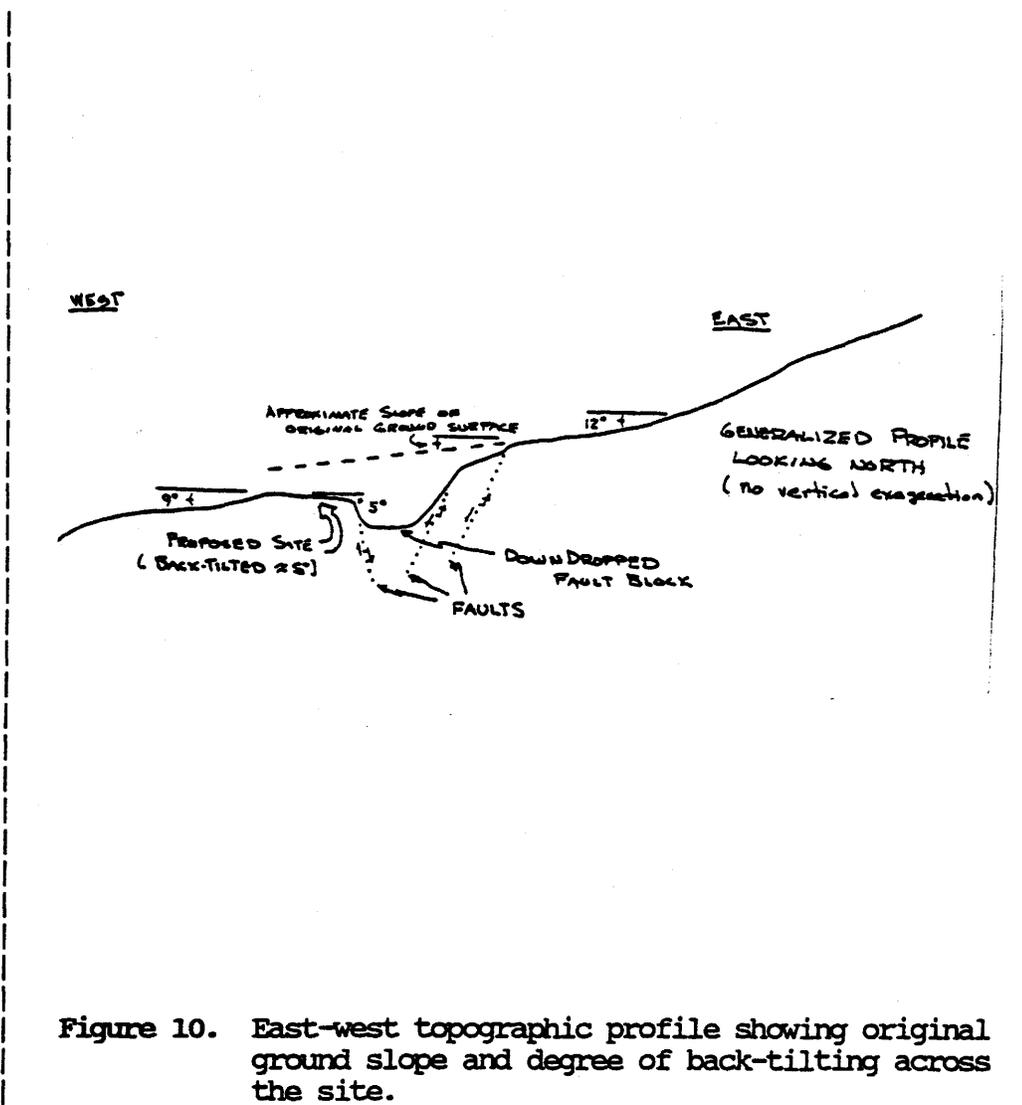
Figure 10. East-west topographic profile showing original ground slope and degree of back-tilting across the site.

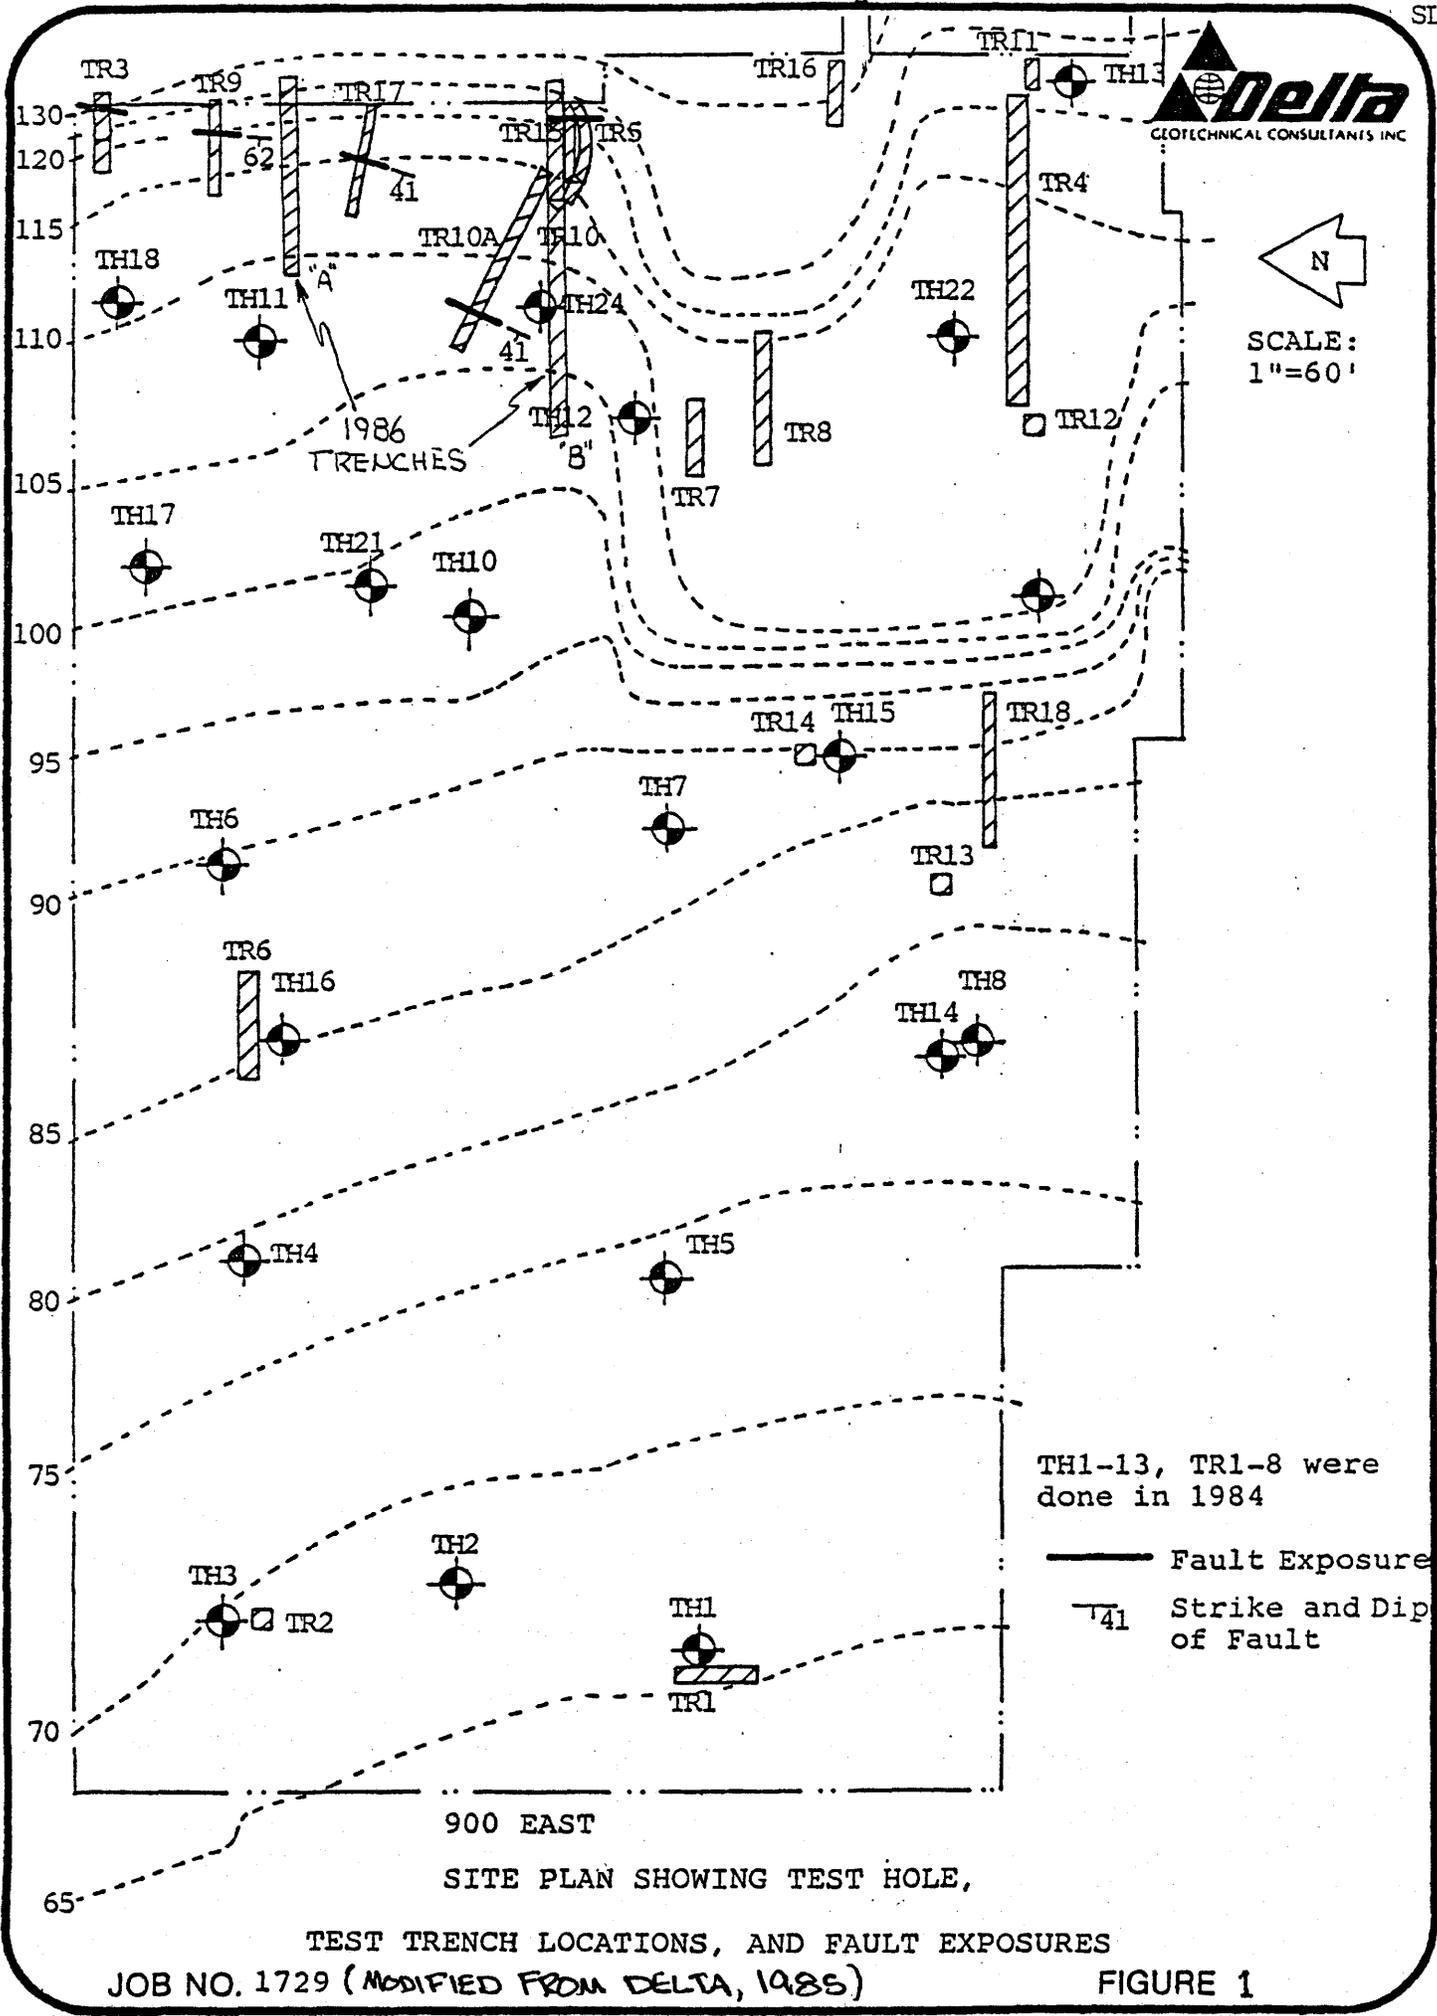
SITE PLAN SHOWING TEST HOLE,  
TEST TRENCH LOCATIONS, AND FAULT EXPOSURES  
JOB NO. 1729 (MODIFIED FROM DELTA, 1985) FIGURE 1
