TECHNICAL REPORTS FOR 1996 APPLIED GEOLOGY PROGRAM

*compiled by
Bea H. Mayes*

REPORT OF INVESTIGATION 231 1997
UTAH GEOLOGICAL SURVEY
a division of
UTAH DEPARTMENT OF NATURAL RESOURCES

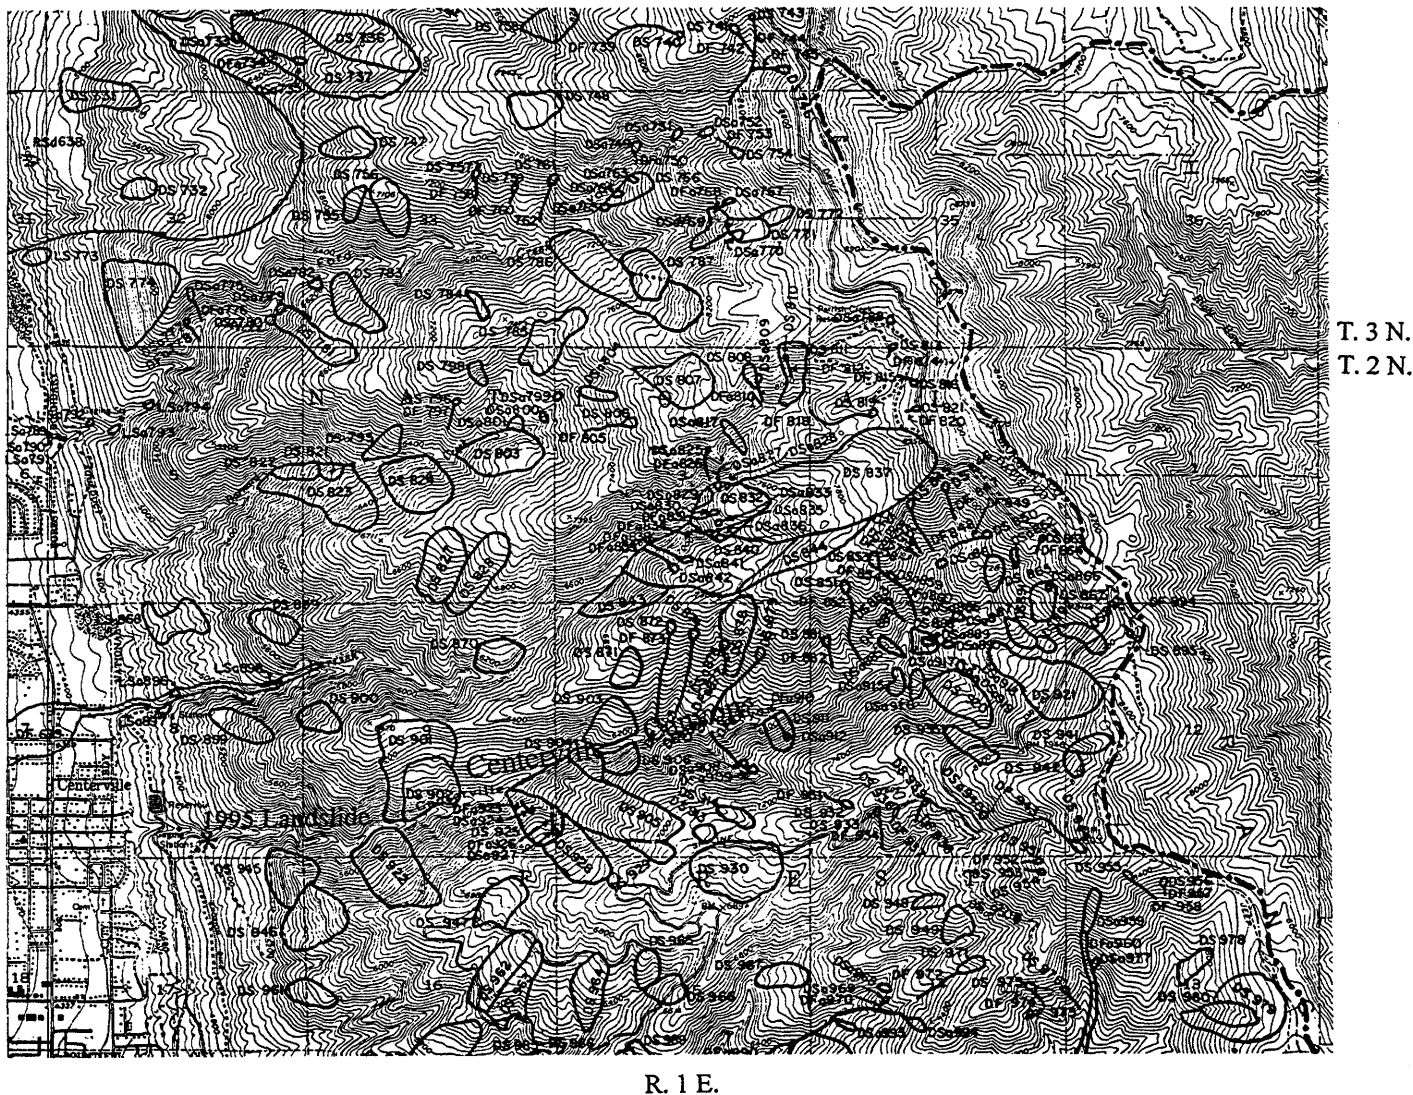
Attachment 1. Map showing landslides in the Centerville area, Davis County, Utah.

The majority of historical landslides that were active in 1983-85 in the upper part of Centerville Canyon and are visible on 1989 aerial photographs showed little evidence of continued movement at that time. Only the smaller of these remained unvegetated, possibly suggesting that they may still have been active in 1989. Because thick vegetation obscures other landslides, no determination could be made regarding their condition although the vegetation indicates a lack of major activity.

I also visited a landslide in the mouth of Centerville Canyon (attachment 1) that was active as recently as 1995 (Hylland, 1995). With the exception of minor erosion and raveling of cobbles and boulders from its steep sides, I observed no evidence of significant changes in the landslide since 1995. Upslope of the main scarp I observed no tension cracks or direct evidence of headward (upslope) expansion of the landslide. I observed a small sliver of vegetated soil that had detached from the scarp in the uppermost part of the slide. Although I believe it is likely that this material will eventually slide downslope, its volume is too small to dam the stream or generate a debris flow.

In conclusion, my investigation suggests that the debris-flow hazard in Centerville Canyon or other canyons affecting Centerville has not significantly changed in recent years. Because Centerville Canyon is a "pristine" canyon with much debris accumulated along its channel, it retains the potential to generate large debris flows. The relatively low gradient of the canyon's channel, as compared to other nearby drainages, may partly explain the accumulation of debris in the channel and the lack of historical debris flows which have reached the mouth of the canyon. The adequacy and location of the existing debris basin and risk to homes both above and below the basin should be evaluated because of the debris-flow potential of the canyon. One measure to consider is locating a flood-

/debris-flow-hazard-reduction structure near the mouth of the canyon upstream of existing development.

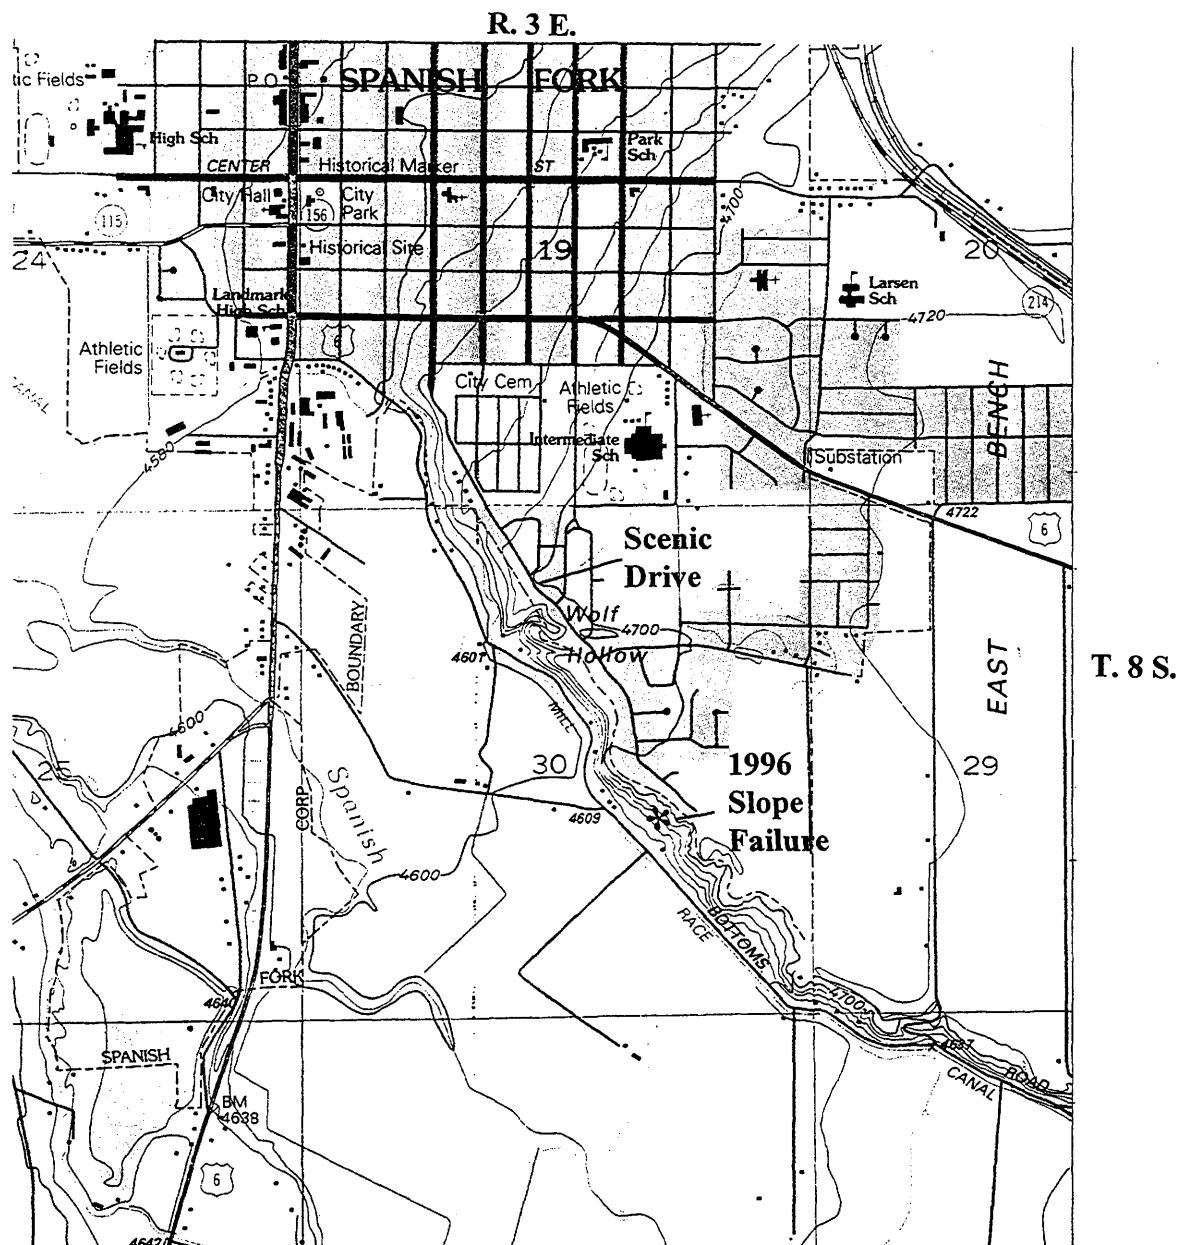
The slope failure that initiated on September 8 occurred in a terrace in the lower part of the bluff. The toe of the terrace is approximately 6 to 10 feet high and has been modified and cut to allow construction of a hay barn. The terrace slopes gently southwest but is locally flat. The terrace ranges from about 70 to 100 feet wide and rises about 15 feet from southwest to northeast where it intersects the base of the steeply sloping upper part of the bluff. The entire bluff is about 80 feet high. The slope failure is approximately 25 feet wide and 100 feet long and cuts the entire width of the terrace.

On the following day, September 9, I observed discharge continuing from a 3-foot-diameter soil pipe at the upslope scarp of the failure and from other smaller soil pipes in the walls of the failure zone and near the toe of the terrace. These smaller soil pipes that now intersect the wall of the failure zone likely acted as feeders to the main soil pipe which had collapsed. The smaller soil pipes range from 4 to 12 inches in diameter. In addition to the secondary piping, surficial sloughing and minor slumping were observed near the lower part of the failure zone and along the walls of the main failure zone. Some sloughing was observed at the base of the upper steeply sloping part of the bluff.

Based on the description given by the eyewitness and my observations made in the field on September 9, I believe the main slope failure resulted from rapid enlargement and collapse of a pre-existing soil pipe which "daylighted" at the toe of the terrace. Enlargement was induced by high rates of ground-water flow in the pipe caused by a shallow, probably rising water table in the terrace. Rapid erosion, sloughing, and possibly undercutting formed a void in the face of the terrace at the point of discharge. The overlying dry terrace soils formed a bridge with sufficient strength to allow continued enlargement and upslope progression of the void beneath the terrace surface. This void then collapsed, initiating sloughing in the walls of the collapse. This process may have repeated several times.

Although measures taken by Spanish Fork may have reduced the immediate risk of damage to the home upslope of the failure, these actions do not preclude the potential for additional failure of the bluff. I recommend that the upper slope be monitored for evidence of instability including cracks, sagging, or tilting. I also recommend that a geotechnical engineer evaluate the long-term effectiveness of the buttress in restoring the lateral support removed by the failure of the terrace and lower half of the upper part of the bluff.

In addition, further evaluation of the piping hazard in the bluff is needed. Piping and spring discharge appear to have been major contributors to this most recent slope failure and were likely

contributing factors to past slope failures elsewhere on the bluff. In my opinion, the potential for ongoing piping, collapse, and associated slope failure will remain until ground-water conditions that result in the springs near the base of the bluff are changed. I believe a ground-water study is an essential first step in finding a long-term solution to this problem. In the interim, I recommend that the bluff be monitored, especially following heavy rains or rapid snowmelt, for evidence of piping and above-average discharge from springs that might indicate imminent instability. Homeowners above the bluff should consider drainage improvements to avoid collection and infiltration of runoff and a reduction in landscape irrigation.

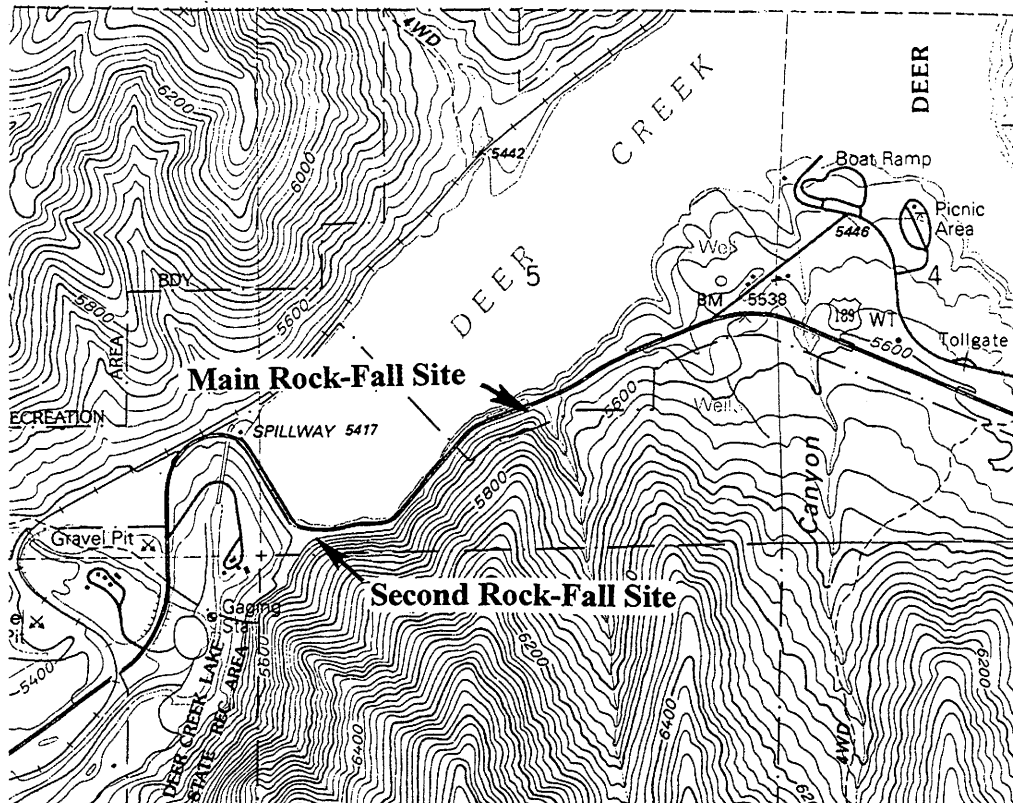
Attachment 1. Location of rock falls that occurred December 11, 1996 on State Route 189, Wasatch County, Utah.

The source of the rock fall was the lower part of a northwest-facing rock-cut slope on the southeast side of the highway. The rock fall occurred along the northeastern end of a continuous cut slope that extends southwest about 1,500 feet. The rock types where the slope failure occurred include yellow- to rust-stained, olive-gray cherty limestone and tan sandstone of the Permian-Pennsylvanian Oquirrh Formation (Baker, 1964). Bedding dips moderately east at the rock-fall site. The rock mass is faulted and intensely sheared, and fracture surfaces are covered by calcite and manganese (pyrolusite) mineralization. The source area for the rock fall was the lower part of the cut slope where the rock mass is intensely brecciated beneath a low-angle west-dipping fault. The rock is so intensely brecciated, altered, and weathered in this area that it can be easily excavated by hand. Rock-fall debris consisted of numerous cobble- to boulder-sized fragments of limestone and sandstone. The largest boulders measured between 5 and 6 feet in maximum dimension, but the majority of the debris measured less than 18 inches in size.

The rock fall was likely the result of long-term physical weathering along the numerous fractures in the rock mass and poor rock-mass quality in the near-vertical rock cut. Because the rock fall was preceded by at least one cycle of warm and cold weather that included sub-freezing temperatures at night and precipitation, the failure was likely triggered by cycles of ice growth and melting that loosened the rock mass. One open tension crack was observed behind a thin column-like panel of rock on the southwest side of the rock-fall zone. The crack was open approximately 1 inch on the southwest side but closed on the northeast side of the approximately 3-foot-wide panel. The hinge-like opening of the fracture may indicate an ice-growth wedging mechanism.

During my field reconnaissance, a second, smaller rock fall occurred about 2,500 feet to the southwest along a similar north-facing rock-cut slope that resulted in some rock-fall debris spilling onto the highway (attachment 1). I observed that the source area of this rock fall was wetter than surrounding areas, possibly indicating that water- or ice-filled open cracks had been present behind the fallen rock.

Although I found no evidence to suggest a threat of imminent further failure, I predict that rock-slope failures will continue along the entire cut northeast of Deer Creek Dam that may, at times, block the highway. I recommend that, in addition to monitoring of the area 100 feet southwest of the main rock-fall area discussed above, that the entire cut be periodically monitored for evidence of imminent failure.
