# TECHNICAL REPORTS FOR 1997 APPLIED GEOLOGY PROGRAM

REPORT OF INVESTIGATION 236  
UTAH GEOLOGICAL SURVEY

March 1998

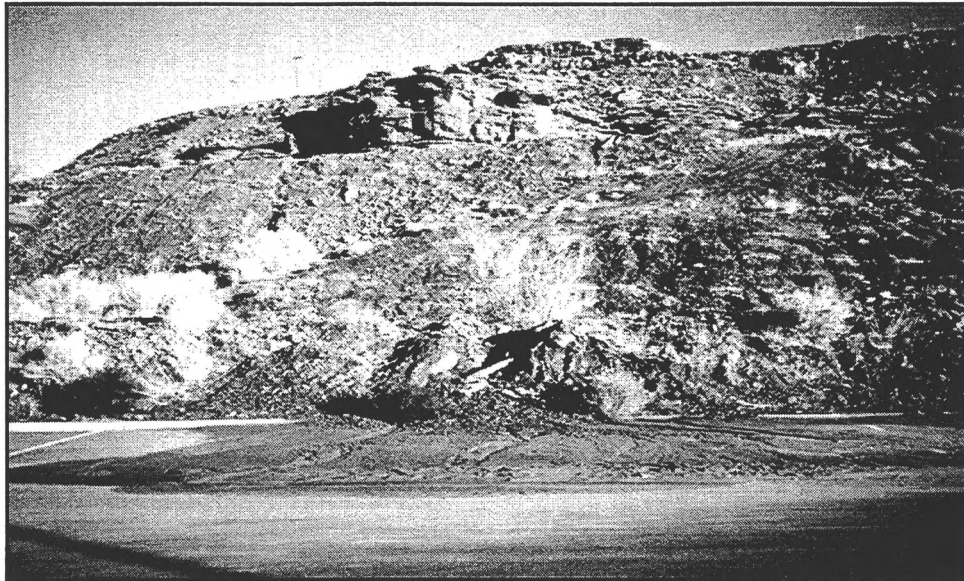
**Attachment 2.** Breached drainage canal north of the St. George City Building; sediment deposited in parking lot by flood waters (location **B** attachment 1).

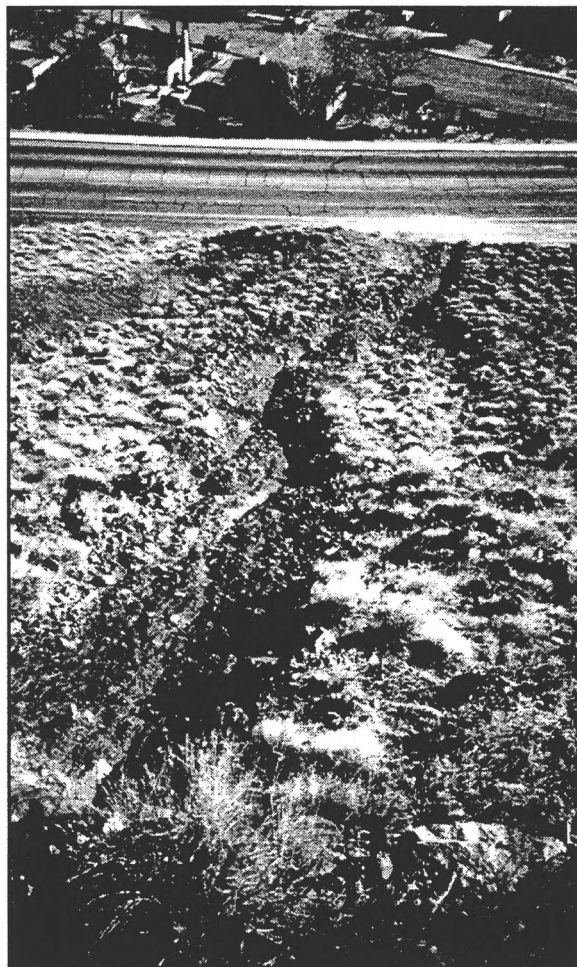
**Attachment 3.** Gully eroded into the east side of West Black Ridge by storm runoff cascading from the airport bench (location **C** attachment 1).

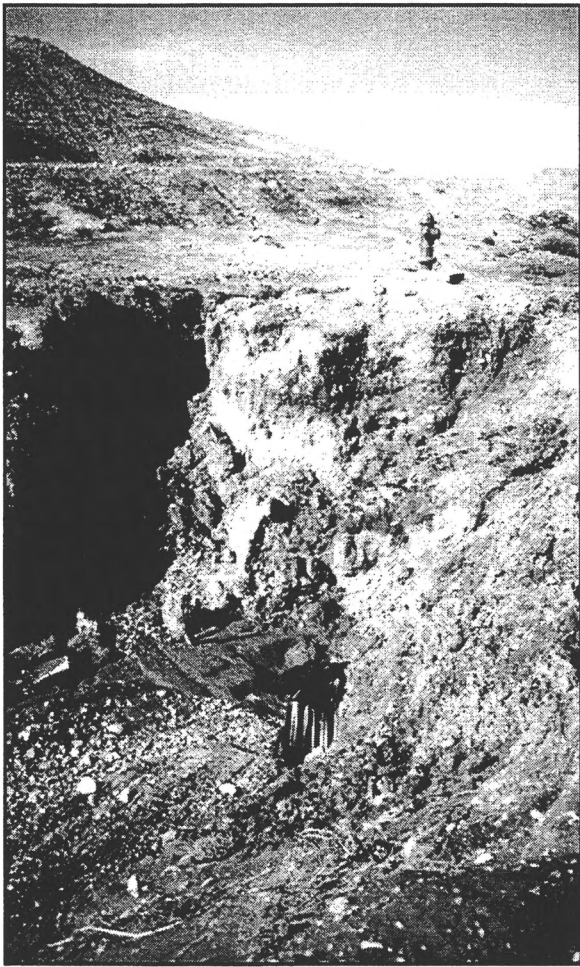
**Attachment 4.** Erosion produced by storm runoff in an area of new construction in southwestern St. George.

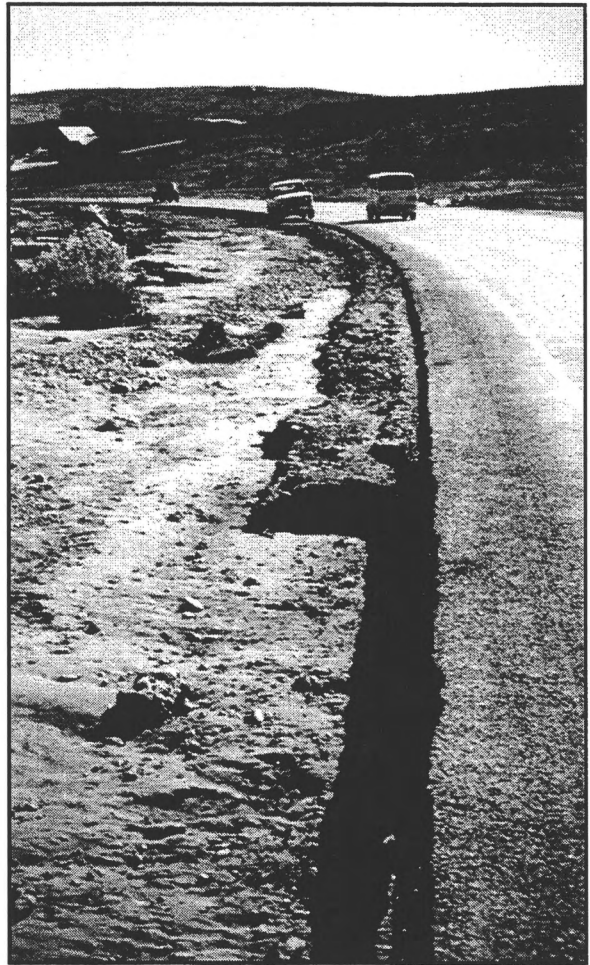
**Attachment 5.** Section of Dixie Drive flooded when the Santa Clara River overtopped its banks (location F attachment 1).

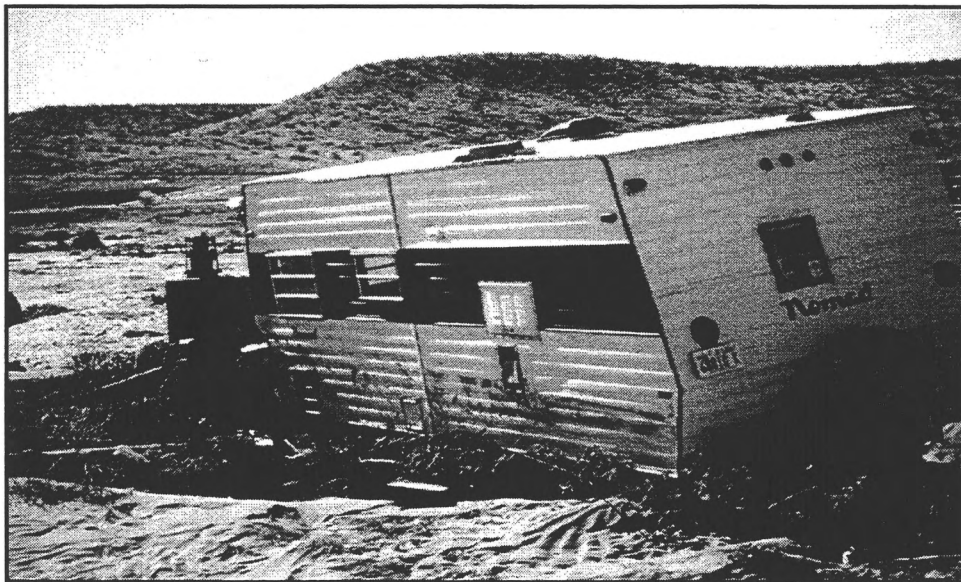
**Attachment 6.** Trailer at a riding stable along Dixie Drive damaged by flood waters from the Santa Clara River (location G attachment 1).

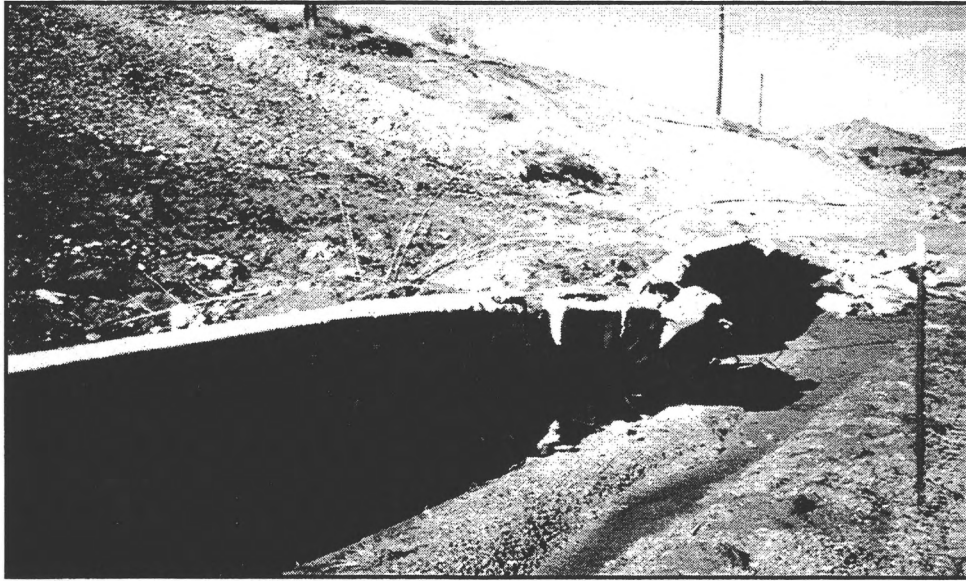
The landslide at the southeast end of the Santa Clara Bench adjacent to the city Little League baseball field is clearly active. The concrete retaining wall at the toe of the slide is freshly broken

**Attachment 7.** Broken retaining wall at the toe of the Santa Clara Little League field landslide (north end); water draining from the landslide is flowing in a shallow ditch in front of the wall.

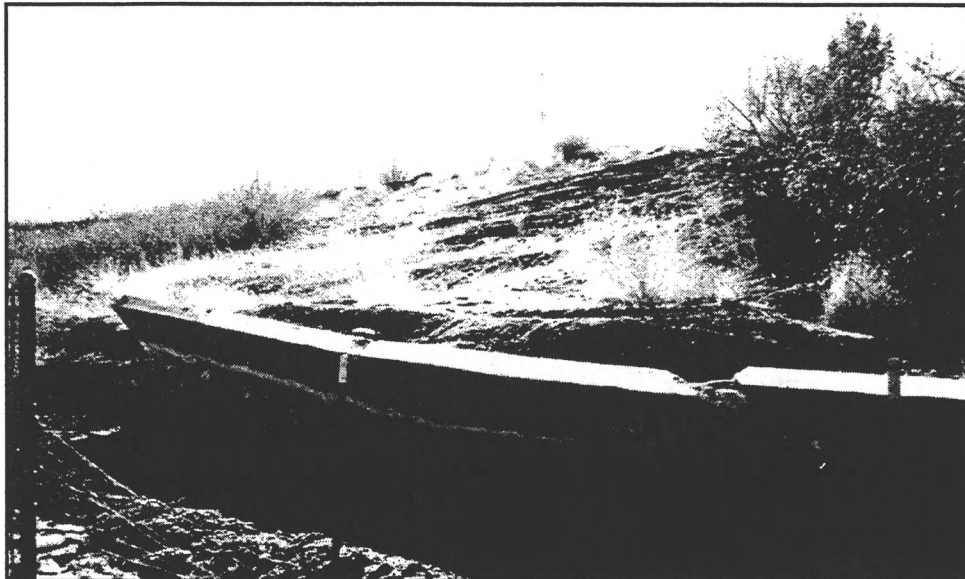
**Attachment 8.** Tilted retaining wall at the toe of the Santa Clara Little League field landslide (south end).

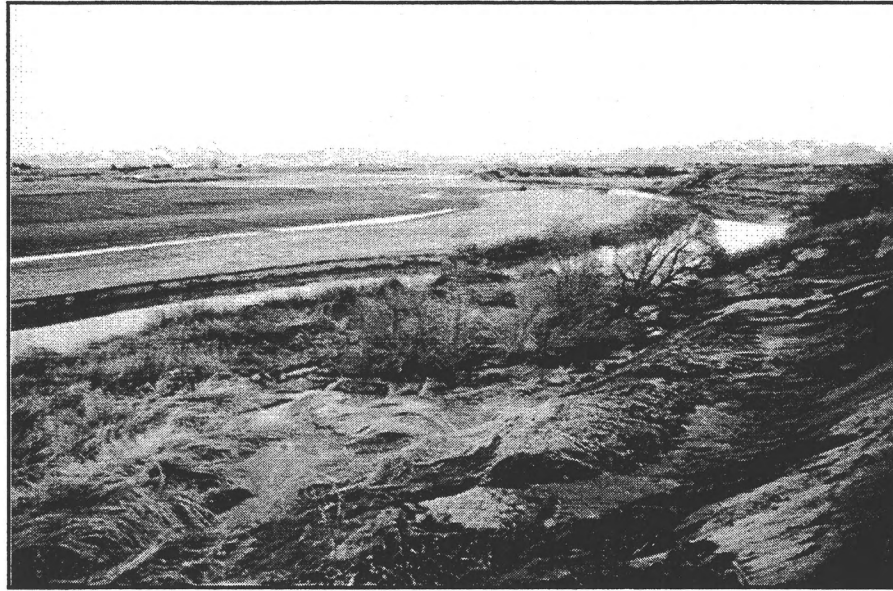
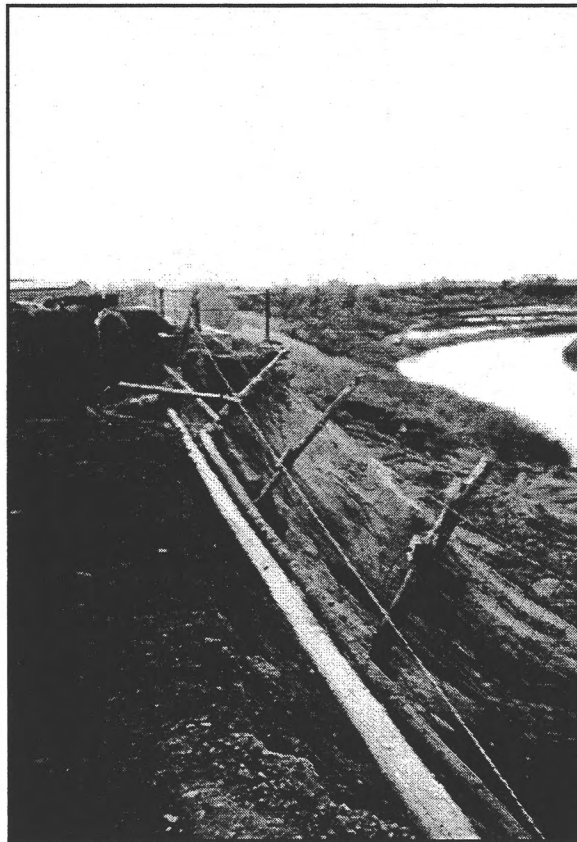
The landslide caused the Bear River to deflect to the west around the zone of accumulation that pushed out more than midway into the river. Eventually the river will erode the foot of the slide, where it has pushed into the original river channel, as river levels rise in the late spring. Until then, some erosion may continue on the opposite (west) bank of the river. As the foot of the slide is eroded, the main body of the slide may continue to slide downslope into the river, but this will likely occur gradually. Some sloughing may also continue in the steeply sloping scarp area and this may eventually completely undermine the watering trough unless it is relocated or its foundation reinforced from below.

Attachment 2. Photographs of the January 3, 1997 landslide along the Bear River, Honeyville, Utah. Top photograph is a view to the north-northwest. Zone of accumulation extends into the river about 75 feet. Landsliding partially blocked the river causing it to be deflected to the west and erode the opposite bank. Bottom photograph shows damage to a fence and watering trough above the main scarp of the landslide. Fence posts are suspended in air and the watering trough foundation is partly overhanging as a result of landsliding. View is to the south.

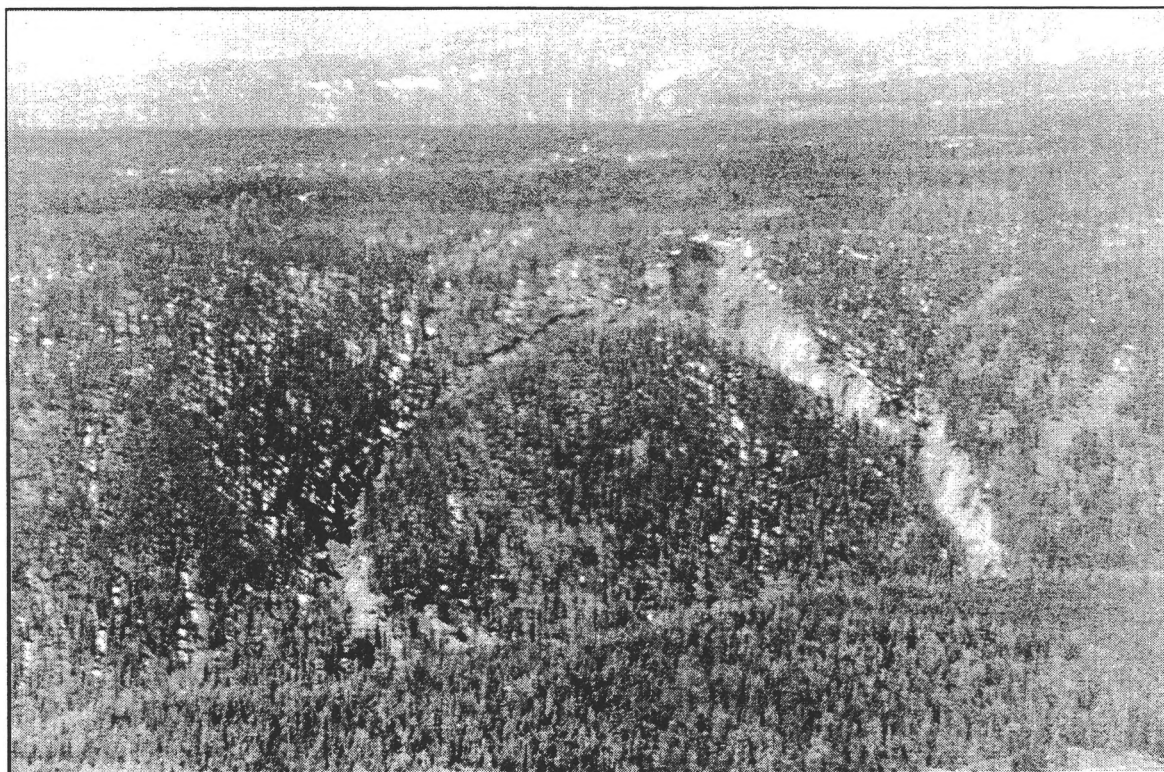
Attachment 3. Westward view of erosional ravines (photo by Mike Royce, Utah Highway Patrol; May 19, 1997).

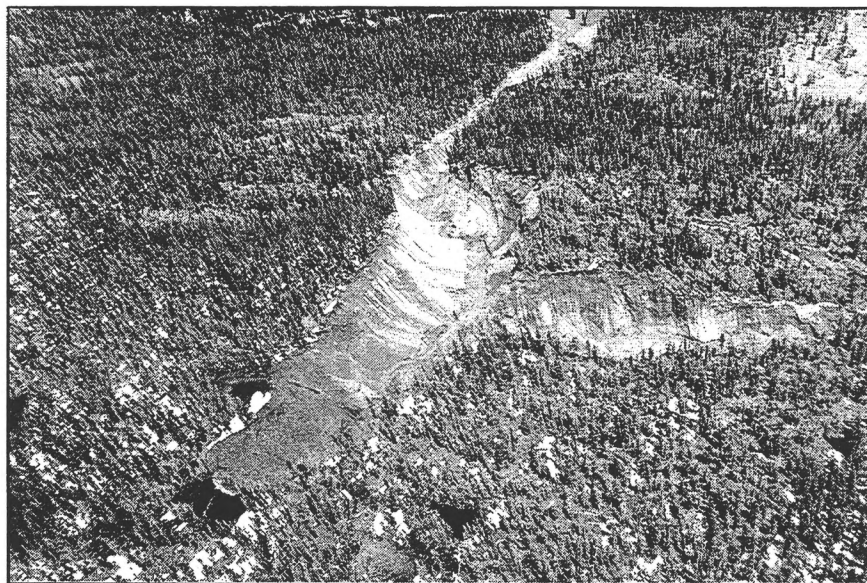
Attachment 4. Eastward view (looking down slope) of head area of ravines showing capture of flow in the southern (right) ravine by the northern (left) ravine (photo by Mike Royce, Utah Highway Patrol. May 19, 19, 1997).

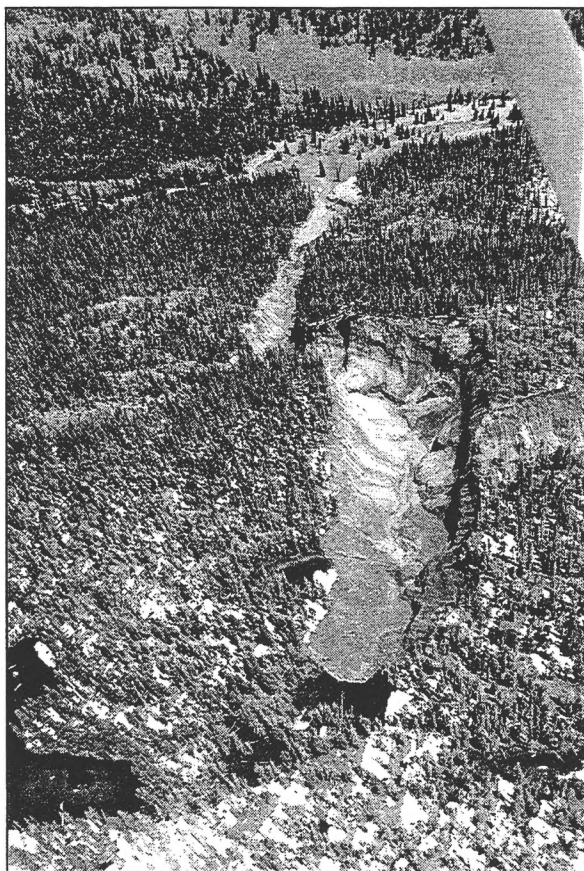
Flow from the breach in the Mosby Canal initially flooded marshes on Mosby Mountain, which were probably already full from spring snowmelt and were overflowing into existing drainages into Dry Fork Canyon. The additional overflow from the marsh area caused by water from the canal breach was concentrated initially in at least two places as evidenced by the two major ravines cut into the hillside (attachments 2 and 3). The southern ravine was later beheaded by the northern one, which ultimately captured all of the flow (attachment 4). Enlargement of the northern ravine continued until the canal was repaired and flow was reduced (attachment 5). The ravine is presently about 250 feet deep at its deepest point, up to 500 feet wide, and about 2,400 feet long. About 1.5 million cubic yards of material was removed from the two ravines and deposited onto the flood plain of Dry Fork (attachment 5).

Attachment 5. Eastward view (looking down slope) of northern ravine and alluvial fan deposited on the flood plain of Dry Fork (photo by Mike Royce, Utah Highway Patrol, May 19, 1997). By May 20, the head of the ravine had migrated northward into pond in lower left corner of photo.

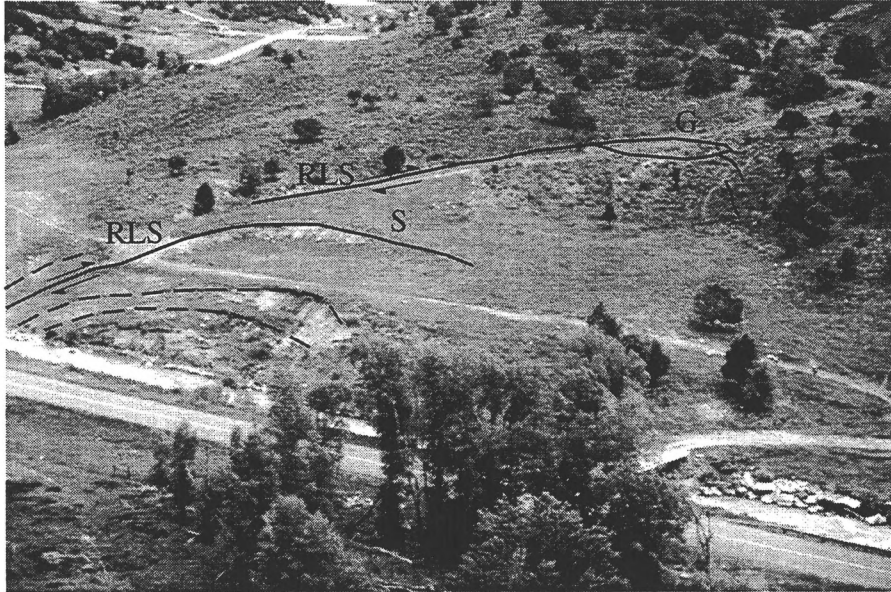
**Attachment 2.** Oblique view of landslide along Chalk Creek. Active landslide features (solid lines) include the scarps bounding the graben (G), right-lateral scarps (RLS), and main scarp of the uppermost slump (S). The extent of recent movement of the lower slumps and lower part of right-lateral scarp (dashed lines) is uncertain. Traces of all features are approximate and representation of ground cracks near graben is schematic. View is to the east.

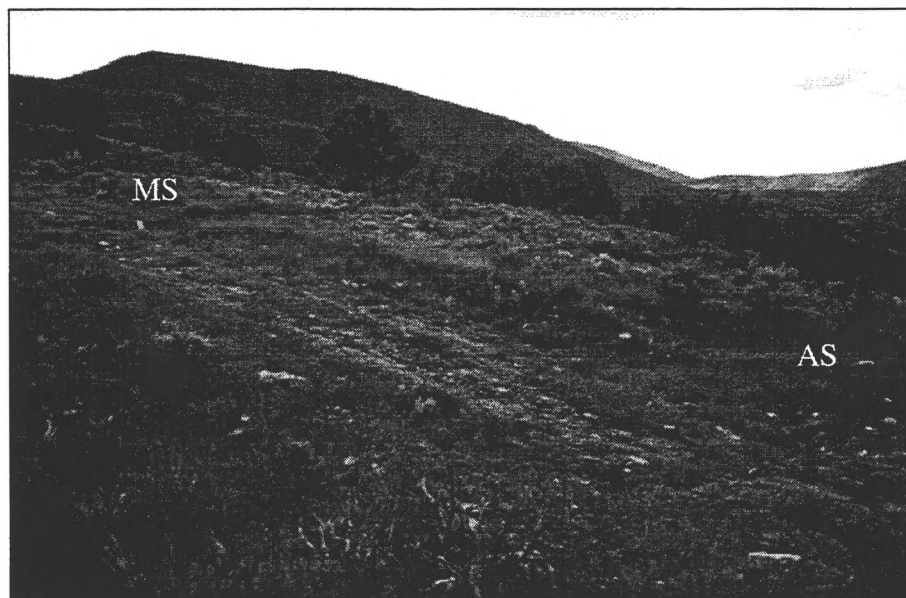
**Attachment 3.** Southwest-trending graben at head of landslide. Graben is 135 feet long and 44 feet across along the centerline of the jeep road (center of photograph). Main scarp (MS) is generally less than 2 feet high and horizontal separation across the scarp locally exceeds 1 foot. Antithetic scarp (AS) merges with the right-lateral scarp northeast of jeep road. Scarps merge to the southwest. Field book (below 'MS') shown for scale. View is to the southwest.

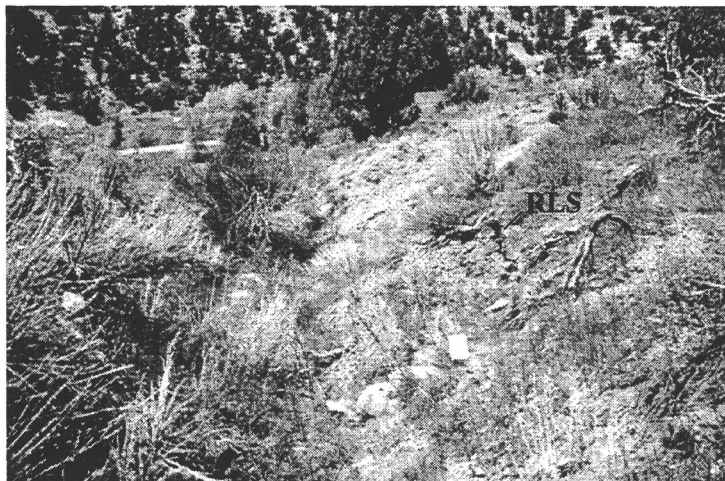
**Attachment 4.** Downslope view of active right-lateral scarp from point where it merges with antithetic scarp of graben. Scarp (RLS) can be followed about 195 feet downslope along northeastern (right side) bank of the dry wash. Field book is about 7-1/2 inches long. View is to the northwest.

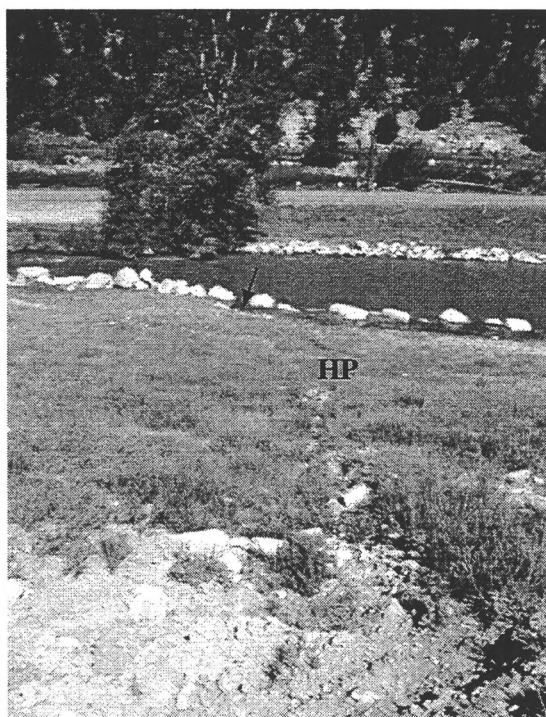
**Attachment 5.** Downslope view of internal, active right-lateral scarp. Note outward deflection in the boulder line of about 3 to 4 feet along the edge of the creek where the scarp intercepts Chalk Creek (arrow). Right-lateral scarp bifurcates about two-thirds the distance to the creek. Also note the hinge point (HP) about midway to the creek. Southeast (upslope) of this point, the ground surface is downdropped on the left side of the scarp, but to the northwest (downslope) the ground surface is heaved upward on the left side. View is to the northwest.

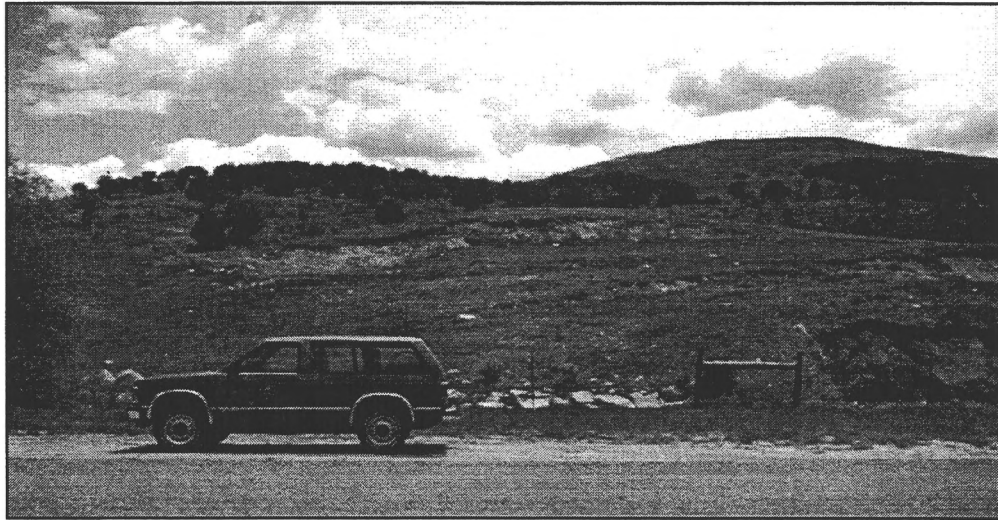
**Attachment 6.** View of slumps in lower part of landslide along Chalk Creek. View is to the southeast.

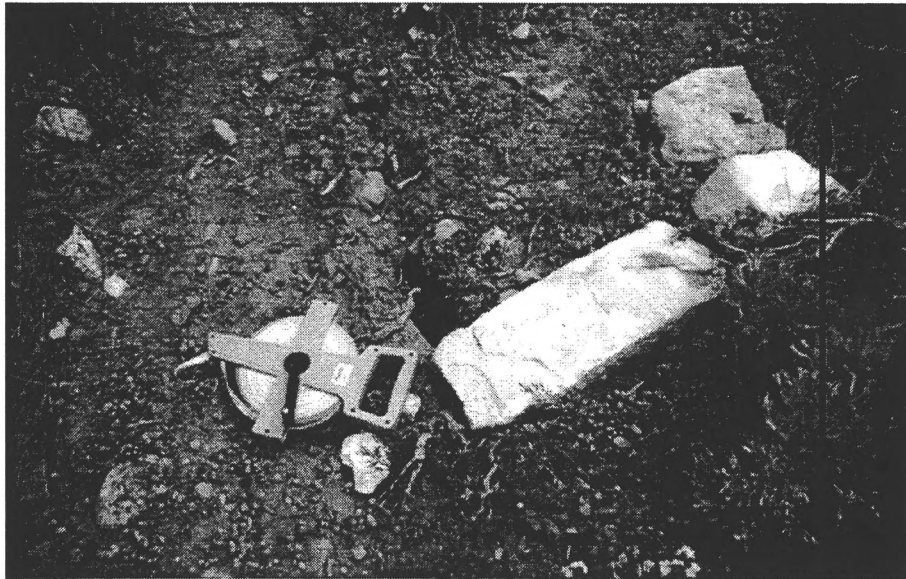
Horizontal separation across the main scarp and a ground crack west of the graben was measured during both my visits on May 28 and June 4. During the seven days between the measurements, scarp separation at the southernmost point where the main scarp intersects the jeep road increased 4-1/2 inches. The corresponding finite linear strain (Baum and others, 1988) over the time interval was about 47 percent, yielding an average strain rate of about 7 percent per day. The average daily extension across the scarp was about 0.6 inches per day indicating a slow rate of sliding. Separation across the ground crack (attachment 7) also increased by 1/8 inch over the time period. The corresponding finite linear strain over the time interval was 4 percent, yielding an average strain rate of 0.6 percent per day. The average extension across the crack was about 0.02 inch per day indicating a very slow rate of sliding. Because extension was not measured at all scarps and cracks downslope, the estimated rates of movement are lower bound values.

**Attachment 7.** Separation across a ground crack downslope and west of the graben. Separation across the crack increased from 3-1/8 inches on May 28 to 3-1/4 inches on June 4.

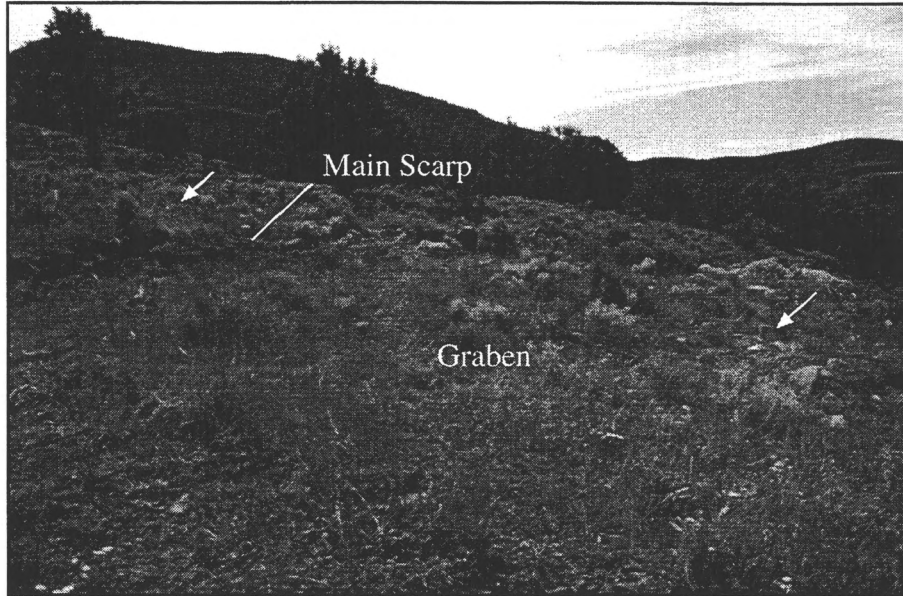
**Attachment 8.** Stakes installed by Utah Geological Survey to monitor movement of landslide. Upslope stakes (arrows) span main scarp of the graben. Although separation across the main scarp locally increased by as much as 4-1/2 inches over the period between May 28 and June 4, subsequent surveying by Summit County has indicated no discernable movement of the slide despite periodic heavy rain. View is to the southwest.

The possibility that continued movement could divert or dam Chalk Creek, although low, warrants monitoring of landslide activity until it is shown to be suspended. The ongoing weekly monitoring of the UGS survey stakes by Summit County should be adequate to determine whether the slide continues to move during the summer. I also recommend that if the June survey data show that movement of the slide has suspended, the stakes be surveyed occasionally after intense rainstorms. Recurrent movement is possible in the future, particularly in the late winter and spring. If no movement is indicated over the next year, the slide can be considered dormant (no movement over a period of a year, however the conditions for renewed movement remain) (Cruden and Varnes, 1996).

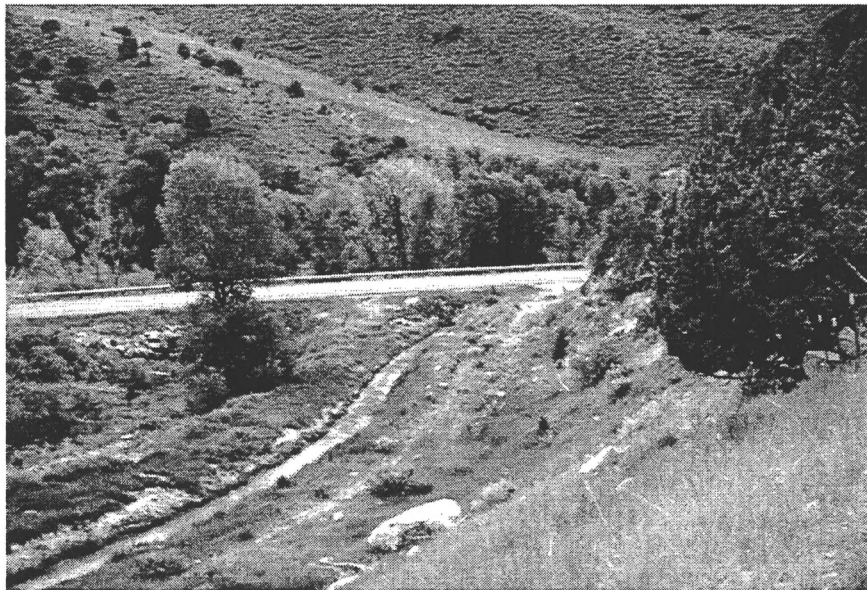
**Attachment 9.** View to the southwest of Big Robinson irrigation ditch northwest of road. Bridge and landslide are to the left of photograph on opposite side of road. Instantaneous movement of the landslide in excess of 20 or so feet could dam creek, forcing the creek to flow across the road and flood this area. Water would eventually spill over the road and re-enter the creek channel.

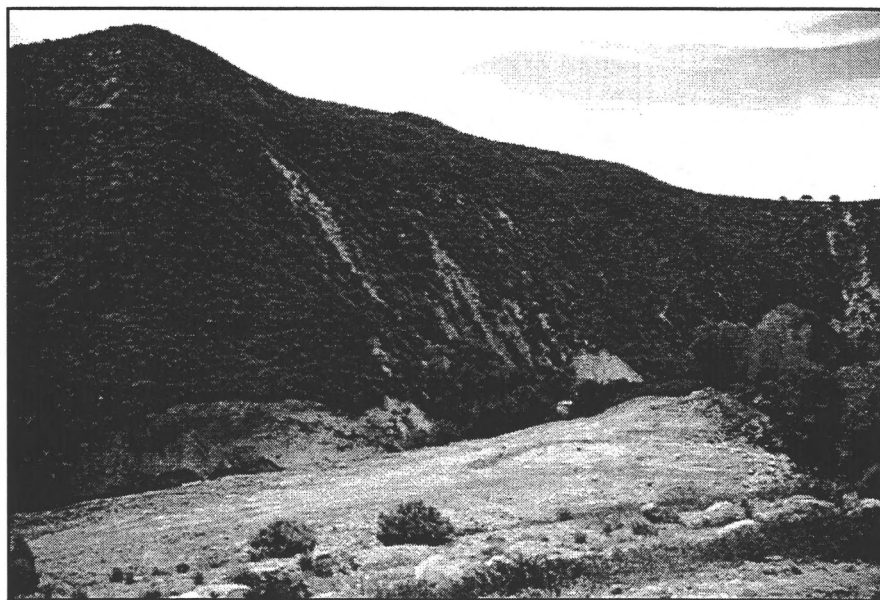
**Attachment 11.** View to the west of The Narrows. Chalk Creek cuts a narrow canyon through this area about 3/4 mile downstream of the landslide. Note oversteepened cut banks at the base of steep colluvial slope and evidence of debris sliding. A landslide-induced breakout flood could rapidly cut into the steep slope and cause further debris slides that, if large enough, could dam the creek in this area.

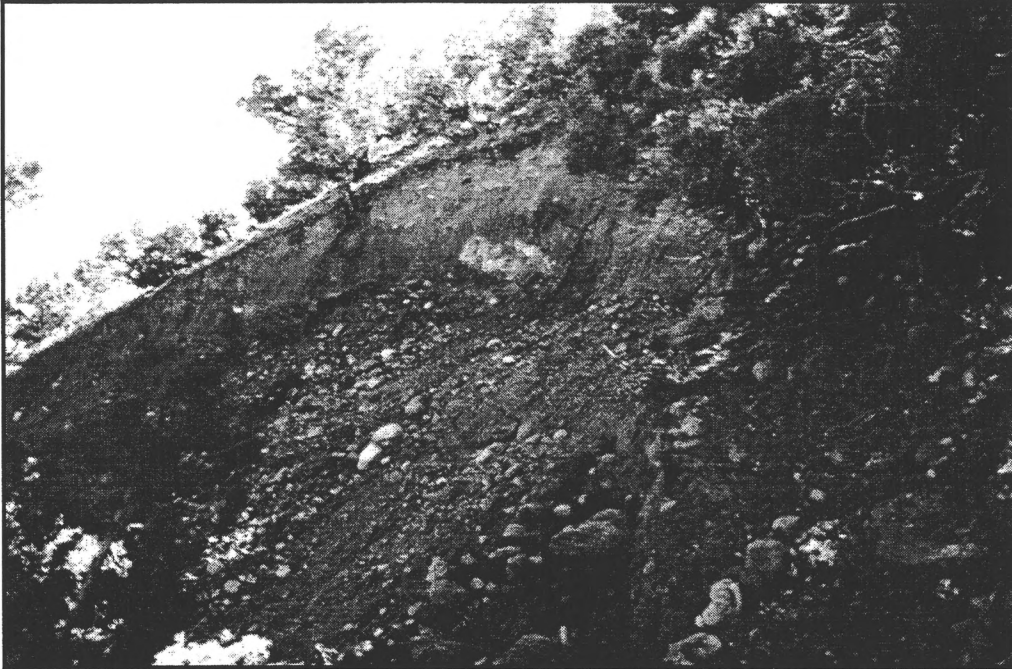
Attachment 3. Discontinuous main scarp of northern part of landslide. Crown (top) of scarp is about 60 feet below crest (top) of mesa. Colluvium upslope of scarp is likely destabilized by removal of lateral support. Note that the steepness of the slope is likely a contributing factor to the failure.
