TECHNICAL REPORTS FOR 1999 APPLIED GEOLOGY PROGRAM

Report of Investigation 244 February 2000
UTAH GEOLOGICAL SURVEY
a division of
Utah Department of Natural Resources

**TECHNICAL REPORTS FOR 1999
APPLIED GEOLOGY PROGRAM**

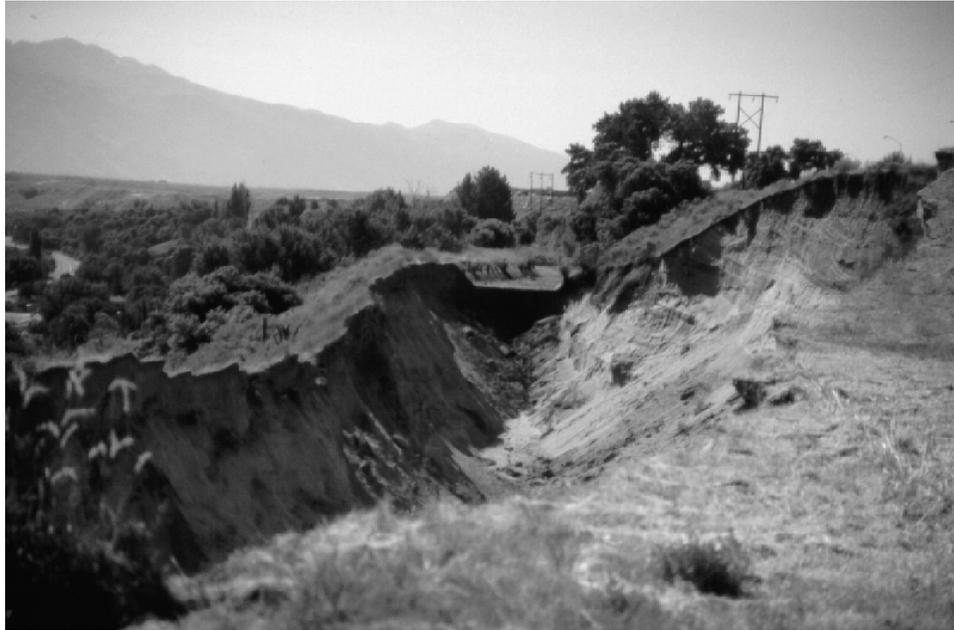
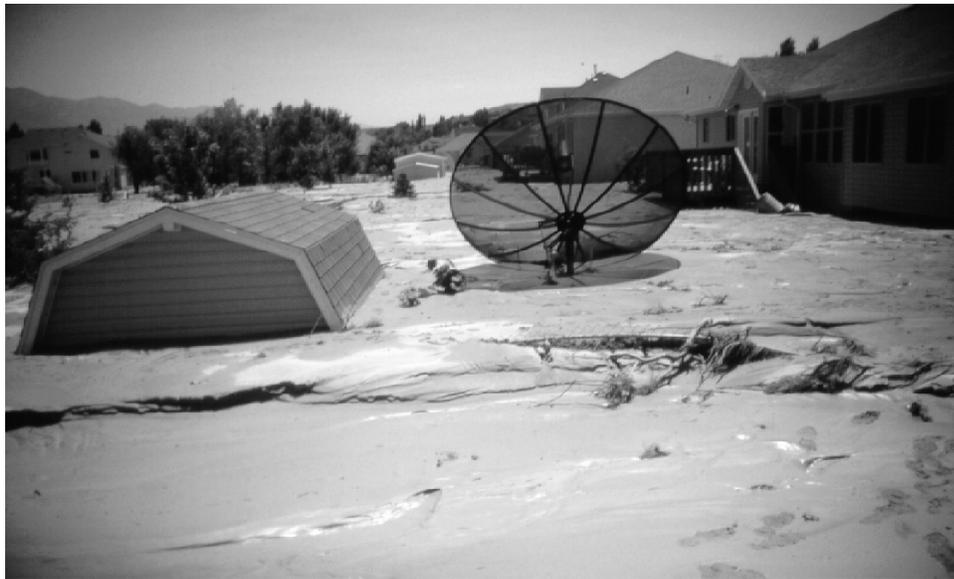
Cover photos: Views of breached canal and backyards in the Pinebrook subdivision in Riverdale the morning after the July 11, 1999 Davis-Weber Canal failure. Photograph credits: Bill Black.

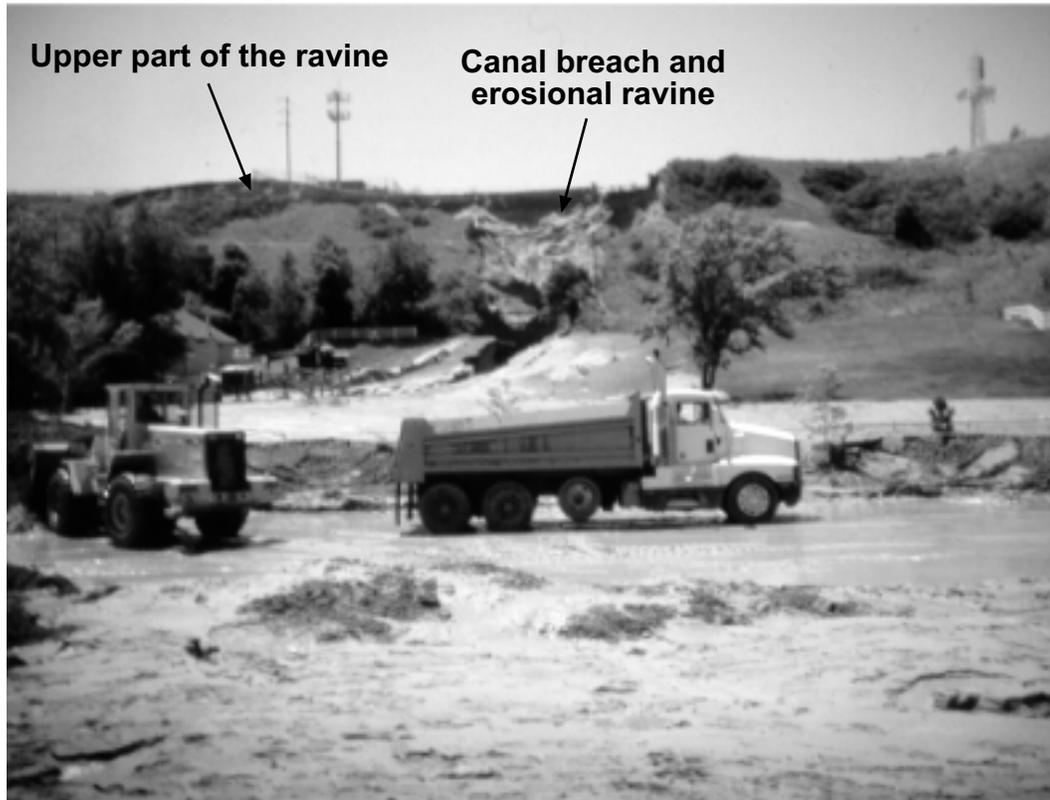
At the breach, water from the canal initially flowed downslope, eroded an outlet channel down the hillside, and began flooding the area at the base of the hill. Once the outlet was cut, continued flow as the canal drained caused headward erosion upstream, undercutting the canal and

Materials exposed in the post-failure erosional ravine are chiefly granular, non-cohesive, fine sand and silty sand (bedded and locally cross-bedded) capped by a discontinuous layer of rounded gravel and overlying loess or eolian sand. The ravine exposes few silt and clay layers, except near the downstream end below the canal where thin (1-2 inch [2-5 cm]) discontinuous layers of low-plasticity clay are present. A lower clay layer also formed a prominent erosion-resistant bench in the outlet. These clay layers showed evidence of seepage from perched ground water above them in our visit on July 20.

Attachment 2. West view of the July 11, 1999, Davis-Weber Canal breach. An erosional ravine 390 feet long, 60 feet wide, and 40 feet deep is in the background. Headward erosion (to the south) during the flood produced the upper part of the ravine.

Riverdale city officials and the Utah National Guard are considering immediate measures to repair slopes in and around the erosional ravine to improve slope stability and remove hanging debris. Any such measures must be designed and monitored by qualified geotechnical engineers. We recommend the canal company also consider measures to prevent water (such as seasonal spring flow or runoff collected along the canal length) from spilling from the canal breach. We further recommend maintaining free-flowing drainage through the area so that no water ponds on the slope, and regularly inspecting re-graded slopes for evidence of movement and seepage, particularly in wet seasons and after periods of increased precipitation.

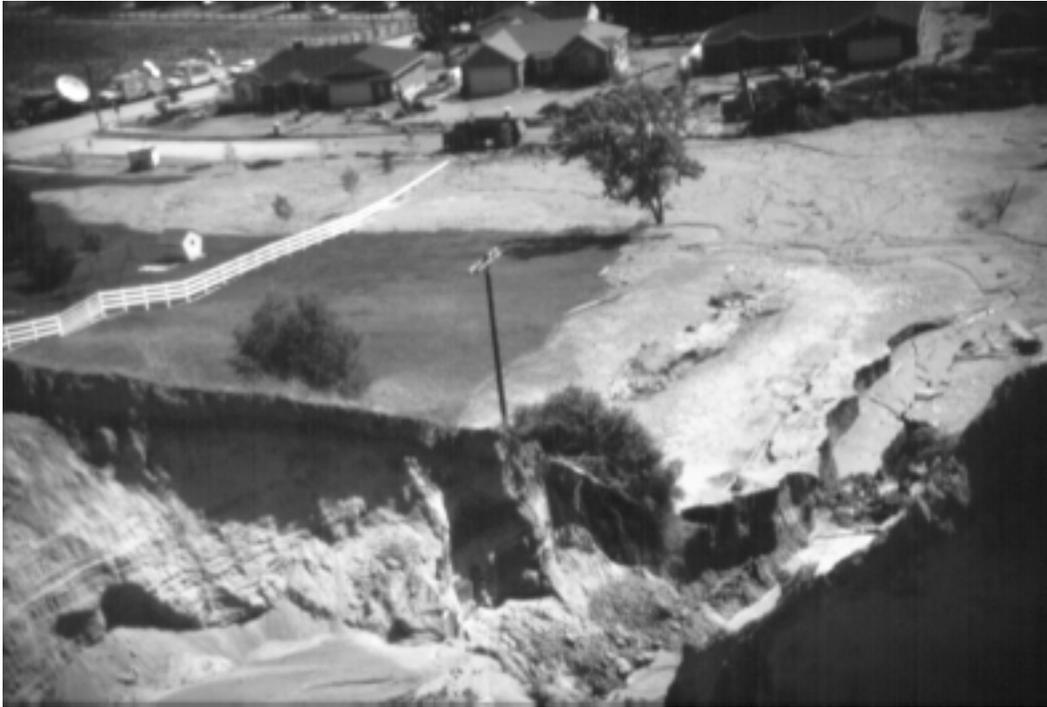
Attachment 3. East view of the outlet and sediment deposited in the Pinebrook subdivision from the July 11, 1999, Davis-Weber Canal breach.
