TECHNICAL REPORTS FOR 2000-01 GEOLOGIC HAZARDS PROGRAM

REPORT OF INVESTIGATION 250
UTAH GEOLOGICAL SURVEY
a division of
Utah Department of Natural Resources

TECHNICAL REPORT SITES 2000-01

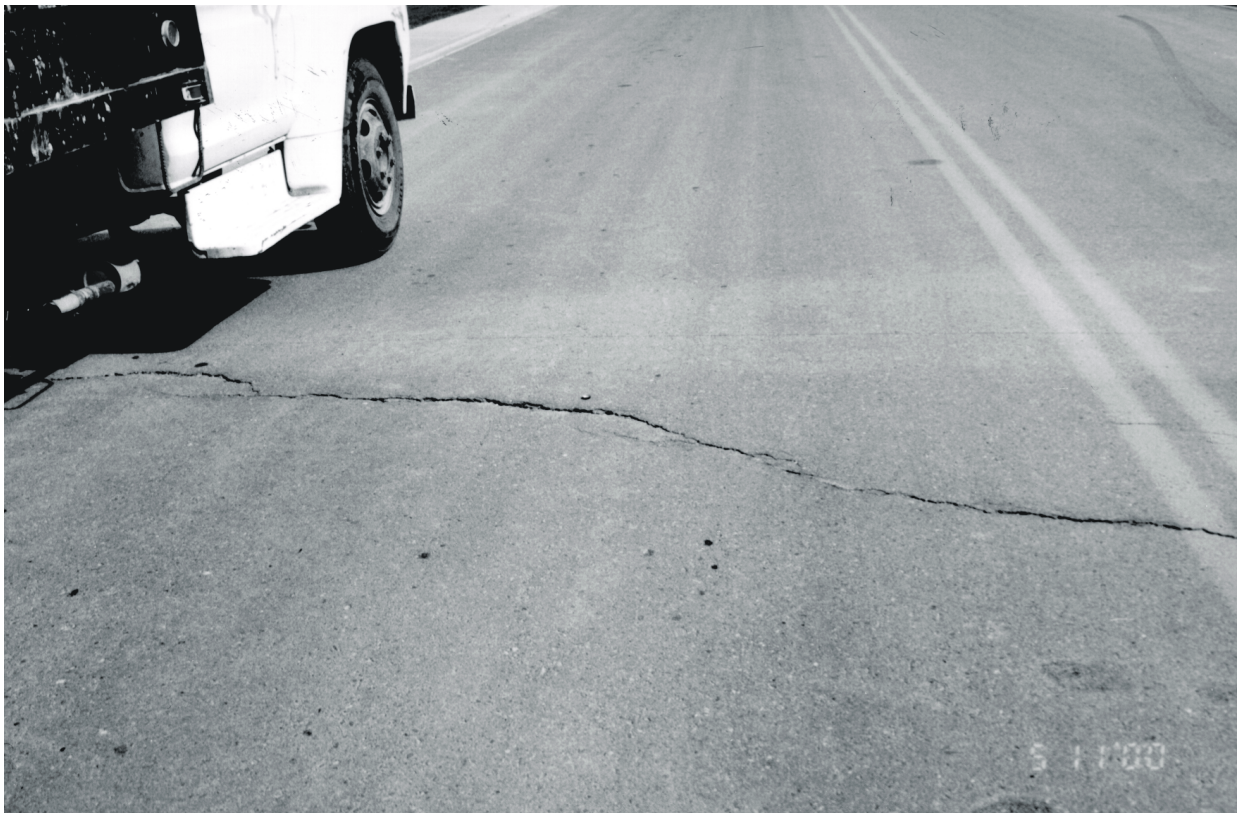
Attachment 2
Job number 00-07

The most prominent subsidence feature is a section of 2100 West roughly 25-35 feet across that has dropped as much as a few inches from original grade in a relatively uniform manner (attachment 2). This area of collapse and associated cracks in the asphalt is relatively concentric around the asphalt patch in the road where the water line was repaired. Adjacent curbing/gutters along both sides of the street have also subsided and are low spots containing ponded water at the time of the investigation.

Attachment 2. Subsidence-related crack along 2100 West.

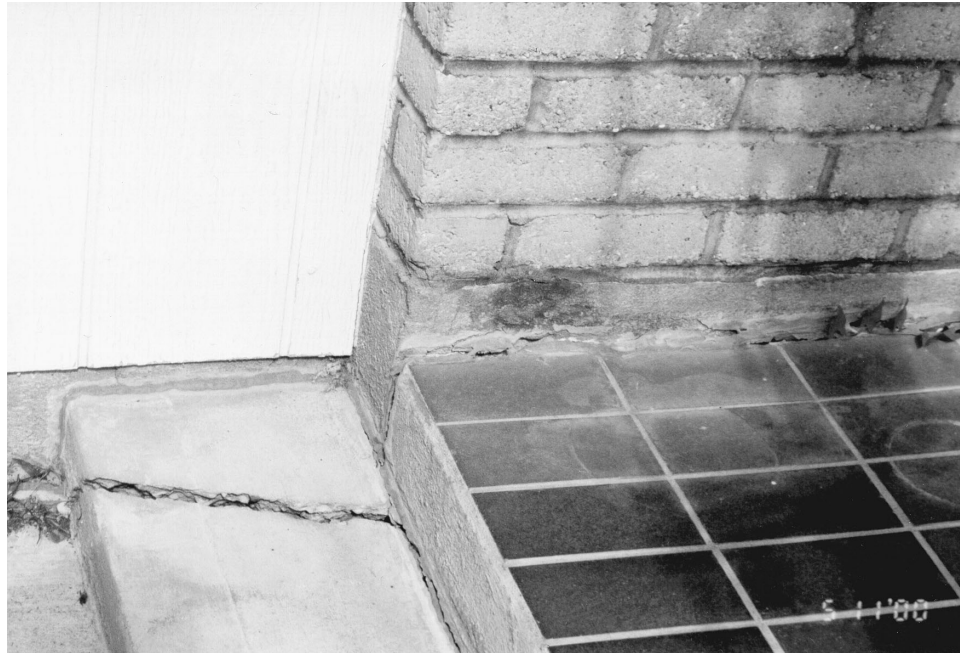
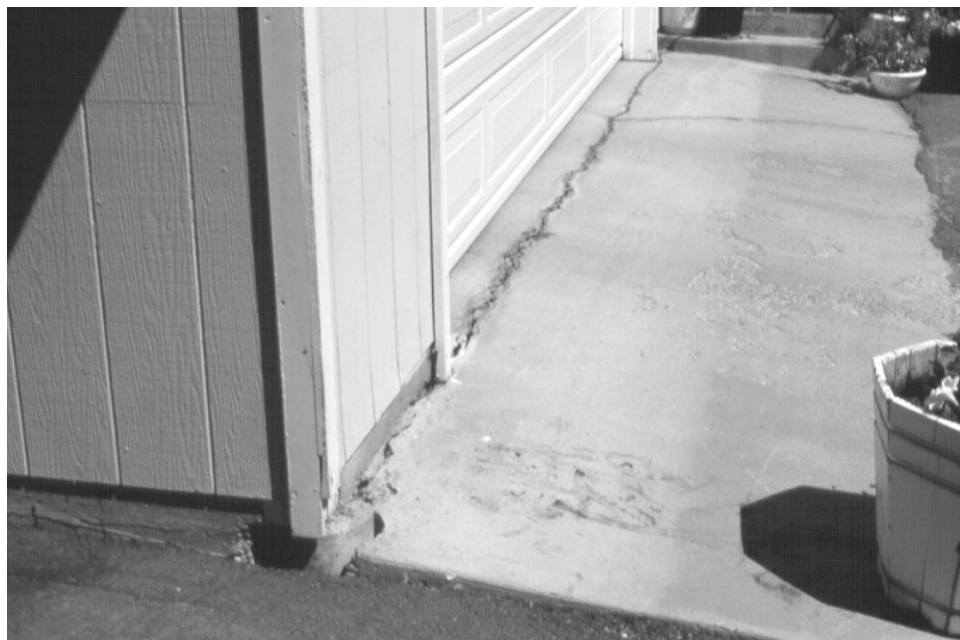
Attachment 3
Job number 00-07

Subsidence-related damage at 592 South included cracks/gaps within a concrete driveway slab and along the front porch where it meets the house (attachment 3). The sidewalk in front of the house in the vicinity of the water-line repair, as well as a walkway leading from the driveway to the front porch, are down-dropped and tilted eastward toward the street. Sections of this sidewalk and walkway have recently been repaired (uplifted). Some cracks had been previously caulked, and this recent subsidence has separated the caulking indicating recurrent subsidence. Most gaps are about an inch or less in width while downward displacement may be as much as a few inches in places. The inside of the house was not inspected during our site visit, but no interior damage has been reported to the city.

Attachment 3. Porch (top) and driveway (bottom) at 592 South showing cracks and eastward tilting of concrete.

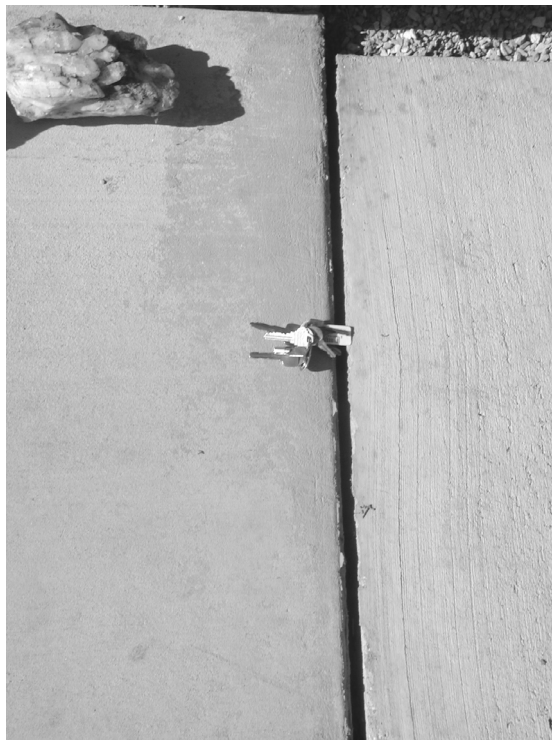
My inspection of the house showed damage typical of that caused by collapsible soil. Exterior sidewalks and a concrete patio pad are cracked and appear to be pulling apart with the direction of movement toward the east (back of the house) (figure 2). The garage floor is cracked and also tilted to the east. According to the owner, who accompanied me on my inspection, the previous homeowner had seven concrete piers installed along the east side of the garage to remediate tilting in that area. I observed the top of one of the piers in the garage floor. The current owner stated that the company that installed the piers told her they poured five cubic yards of concrete into one of the holes drilled for a pier.

Figure 2. Pull apart between sidewalk as the slab on the left moves to east.

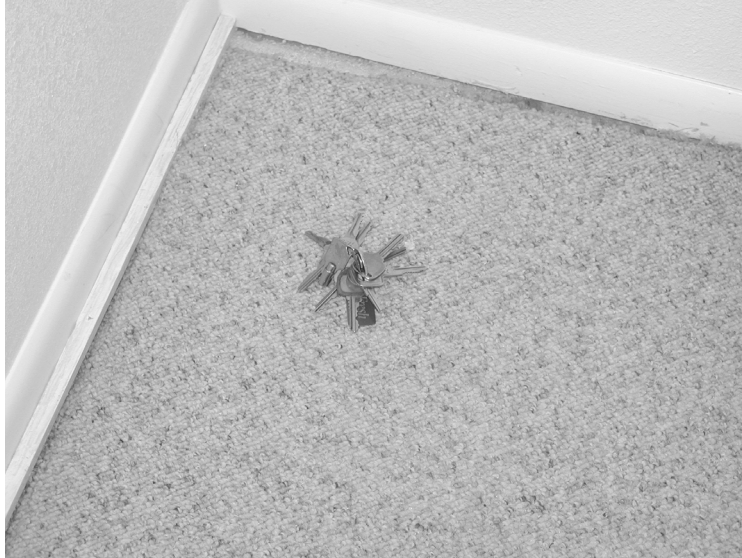
Inside the house, the floor of a bedroom on the east side adjacent to the garage is noticeably tilted to the east, and in a closet on the west side of the bedroom, the carpet is pulling away from the adjacent wall (figure 3), again indicating movement to the east.

Figure 3. Carpet pulling away from an interior closet wall as the concrete floor slab tilts to the east (right).

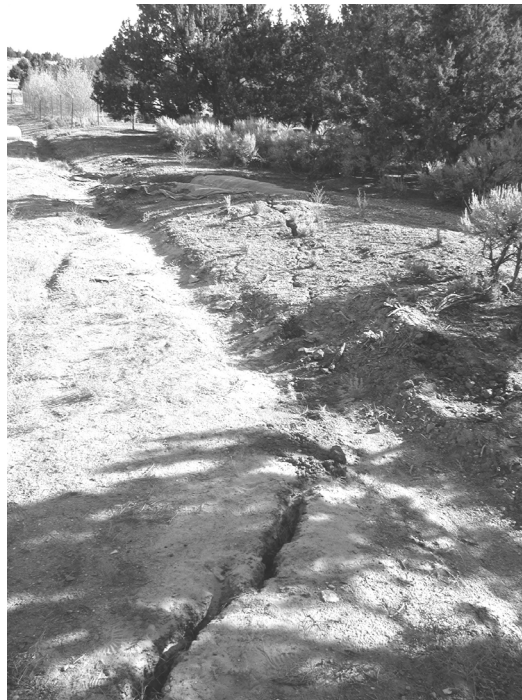
Cracks in interior walls are minimal, but I observed two cracks at wall corners. Outside, on the east side of the house, I observed a large arcuate crack in the yard (figures 4 and 5) that appears to delineate an area of subsidence. At the time of my inspection, the crack was approximately 30-40 feet long, up to three inches wide, and at its farthest point, about 30 feet from the house. The ends of the crack terminate at or near the house. Wastewater is disposed in a septic tank and drain field on the east side of the house near the center of the area of subsidence

Figure 4. Crack on east side of the house, near or above the septic-tank drain field. View to the north.

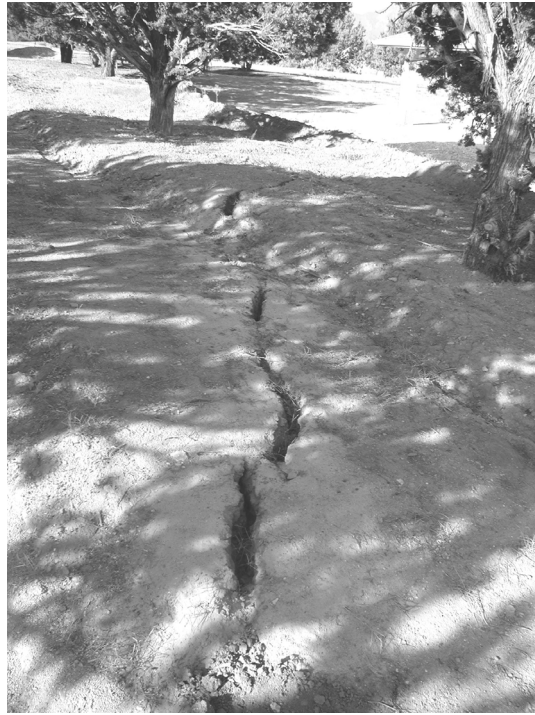
Figure 5. Crack on east side of the house near septic tank. View to the northeast.

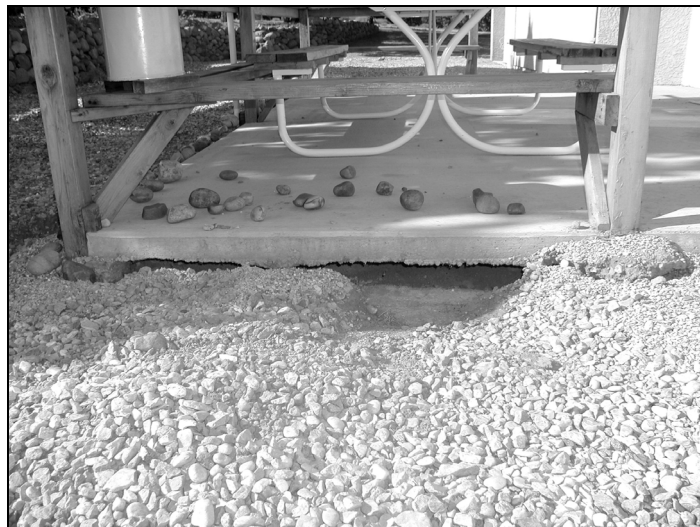
A small concrete pad next to the house and just west of the septic tank is tilted to the east toward the septic tank. The pad provides support for an air conditioning unit, and the tilting has necessitated propping up the east end (septic tank side) of the unit to prevent it from being suspended in the air by the piping that leads into the house. Immediately south of the septic tank, a concrete patio attached to the east side of the house has become suspended in the air as soil has collapsed from beneath it. My inspection showed 4 to 6 inches of free space beneath the south, east, and north sides of the patio (figures 6 and 7).

Figure 6. Void space beneath concrete patio slab due to soil collapse. View to the south.

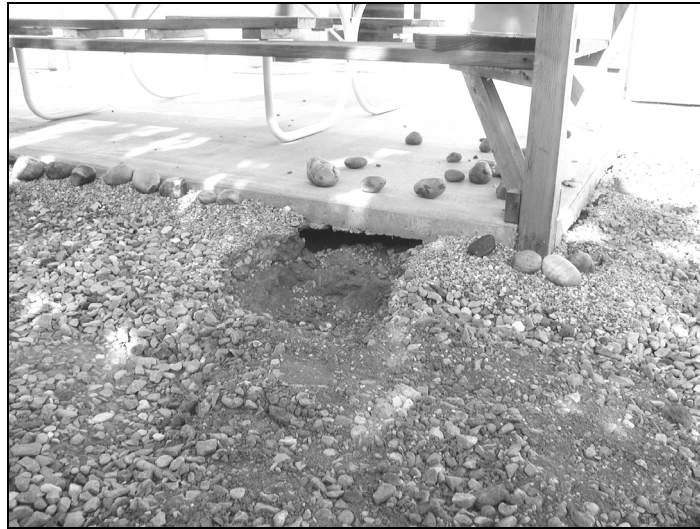
Figure 7. Void space beneath concrete patio slab due to soil collapse. View to the west.

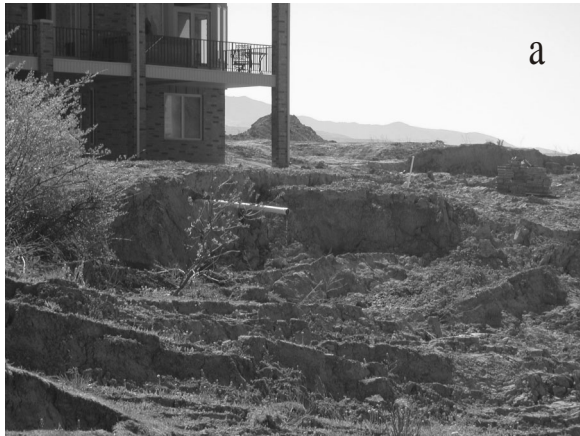
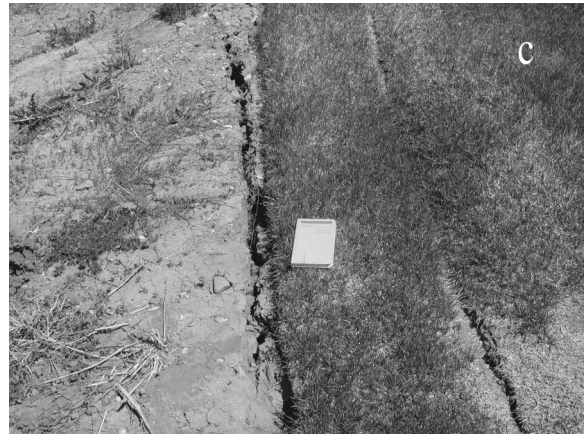
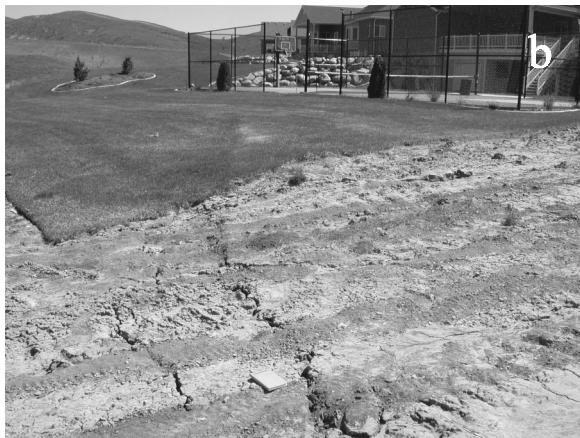
Figure 2. Main scarp zone of the Frontier Drive landslide. (a) View to the southeast of main scarp at lot 49 (6815 N.). (b) View to north of main scarp zone near lots 44 and 45. (c) View to the north of main scarp-ground cracks along west edge of lot 43.

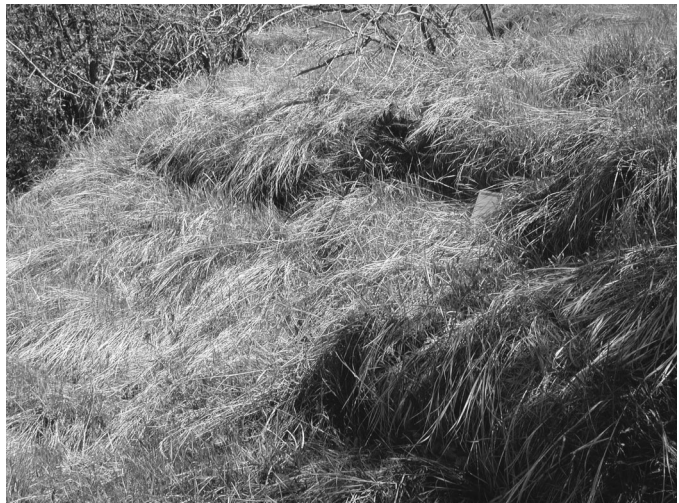
Figure 3. Toe of the Frontier Drive landslide. Overriding thrusts form stair-stepped geometry in lower slope. View is to the northeast. Field book measures about 9 inches in height.

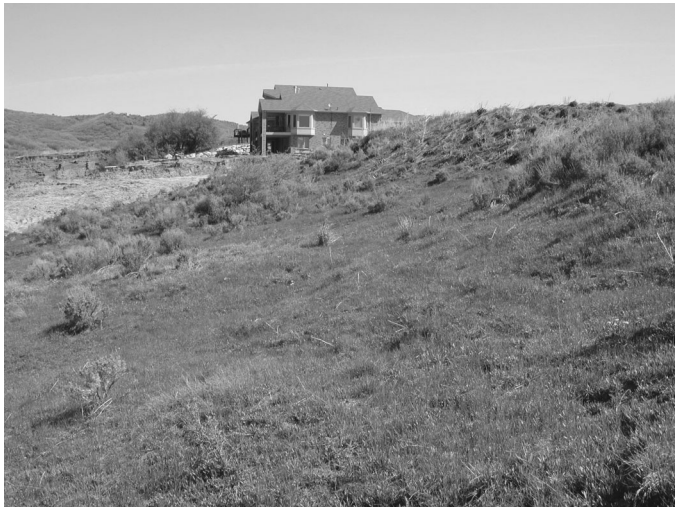
Figure 4. Scarp of pre-existing landslide (vegetation-covered slope on right) south of the Frontier Drive landslide. View is to the north. House in background is on lot 49 (6815 N.).

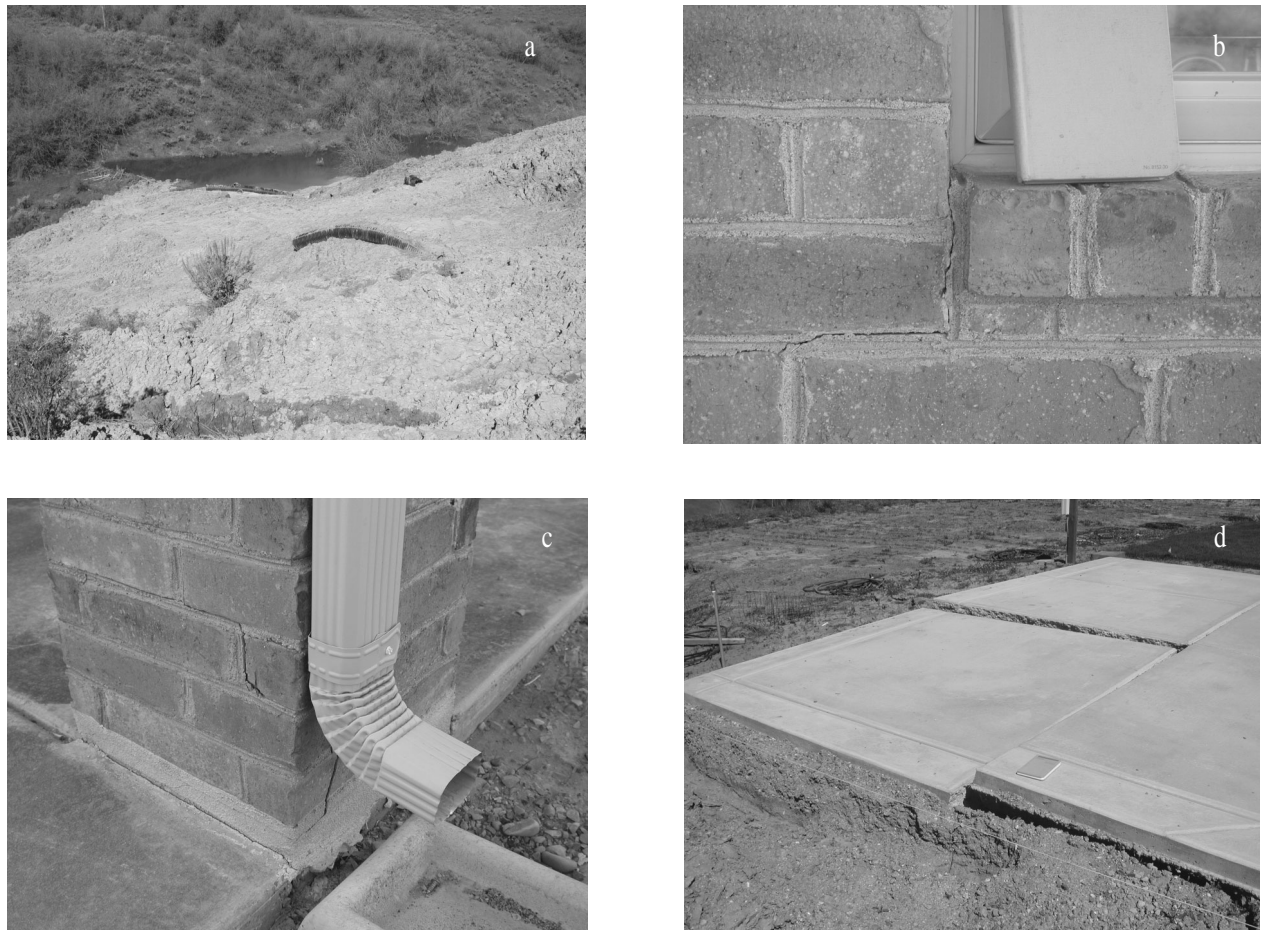
Landsliding has affected seven residential lots and common-area open space west of Frontier Drive. The most damage occurred to lots 48 (6825 N.) and 49 (6815 N.). Figures 6a through 6d show some of the damage. Table 3 summarizes the building and lot damage caused by the landslide.

Figure 6. Damage caused by the Frontier Drive landslide. (a) Severed and segmented storm drain pipe downslope of lot 49. (b) Stair-stepping crack in wall of house on lot 49 (6815 N.). (c) Cracking of brick veneer of porch column of house on lot 49 caused by downslope movement (d) Damage to concrete patio or pad on lot 46 (6855 N.).

Lot Number, Address or Parcel Description	Description of Damage
Storm drain pipe easement - open space parcel - common area (south of lot 49)	Storm drain pipe severed (figure 6a) and released water which caused accelerated landsliding, erosion, and perhaps earth flow. Ground surface along easement severely disrupted.
Lot 49 - 6814 N.	Main scarp zone underlies western part of house. Cracking of exterior brick walls on west and north (figure 6b) and porch column brick veneer (figure 6c), and of concrete patio. Tilting of patio and porch. Horizontal displacement of porch column. Severe disruption to ground surface in entire rear lot. Perimeter foundation drain pipe currently exposed in main scarp zone. Minor cracking inside house near structural beam.
Lot 48 - 6827 N.	Severe disruption to ground surface in western part of rear lot.
Lot 47 - Vacant	Main scarp zone crosses western part of lot.
Lot 46 - 6855 N.	Cracking, settlement, and tilting of concrete pad or patio (figure 6d). Main scarp zone crosses westernmost edge of lot.

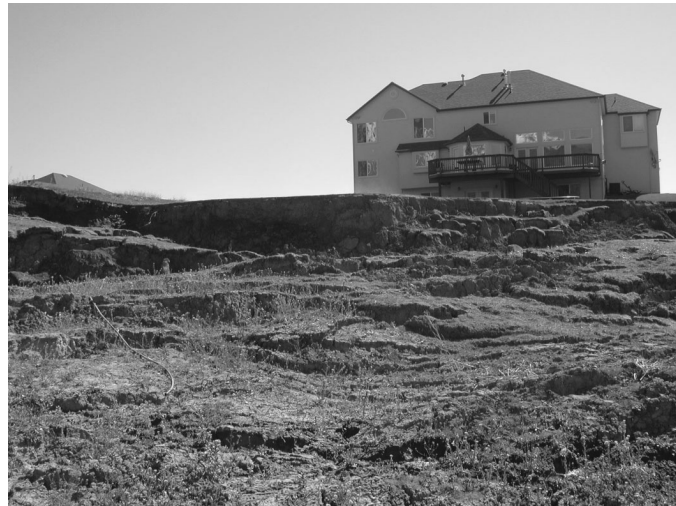
Landslide movement continued throughout the period of this investigation (May 11, 2001 through June 25, 2001). Figure 7 shows cumulative displacement (movement) for this period at six survey stations in the main scarp zone. The survey stations measure stretching (extension) across the main scarp zone. The data show movement at the four northernmost stations (on or near [west of] lots 44 through 47). Field observations suggest movement possibly occurred at the other two southern stations (on lots 48 and 49), but the measurements indicate that the movement, if any, was less than the accuracy of the measurement technique. The maximum average rate of movement declined from a slow rate in early May to a very slow rate in late June. The absence of any significant movement in the main scarp zone in the southern part of the landslide may be due to the ability of the numerous minor scarps downslope of the main scarp zone (figure 8) to accommodate movement.

Figure 8. Minor scarps (in foreground below main scarp) in the upper part of the Frontier Drive landslide. View is to the east-northeast. House in background is on lot 48 (6827 N.).
