MOVEMENT HISTORY AND PRELIMINARY HAZARD ASSESSMENT OF THE HEATHER DRIVE LANDSLIDE, LAYTON, DAVIS COUNTY, UTAH

Richard E. Giraud
Utah Geological Survey

REPORT OF INVESTIGATION 251 MARCH 2002
UTAH GEOLOGICAL SURVEY
a division of
UTAH DEPARTMENT OF NATURAL RESOURCES

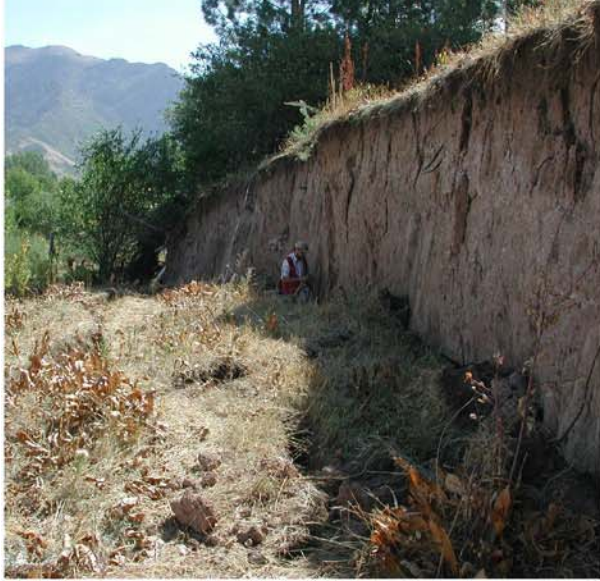
The most prominent landslide features are the main scarp and graben at the head and a transverse toe ridge and ground cracks at the toe in and adjacent to South Fork Kays Creek. The main scarp is 1,350 feet long (figure 2) and up to 9.5 feet high. Figure 3 shows the character of the main scarp. Most of the main scarp follows a pre-existing arcuate slope crest suggesting the movement in 2001 was a reactivation of a prehistoric landslide. However, the western end of the scarp (a 400-foot length west of 1369 E. Heather Drive and north of the church at 1325 E. Cherry Lane) does not follow the pre-existing arcuate slope crest, suggesting the 2001 landslide enlarged beyond the limits of the prehistoric landslide. The east and west ends of the main scarp turn downslope and terminate midslope. Ground cracks and lateral shearing that would define right and left flanks did not develop, likely due to the limited amount of downslope movement. Displacement along the main scarp and associated ground deformation in the head of the landslide damaged houses and lots from 1369 to 1445 E. Heather Drive and 1456 Tartan Way (figure 2). The lot at 1456 Tartan Way is quite large and includes the area between the creek and the lots north of Heather Drive (figure 2). Small grabens formed in the landslide head north of the church and from 1381 through 1393 E. Heather Drive (figure 3c).

Figure 3. Main scarp of the Heather Drive landslide. (a) Main scarp north of the church (1325 E. Cherry Lane) on September 5, 2001; the scarp is 9 feet high, view looking east. (b) Main scarp at 1369 E. on August 29, 2001; the scarp is 9.5 feet high, view looking southeast. (c) Main scarp (at left) at 1381 E. on August 27, 2001; graben in foreground, view looking west. The house was moved off the landslide on August 28, 2001. (d) Main scarp at 1456 Tartan Way on September 5, 2001; quadrilateral stakes in center of photograph, view looking southwest.

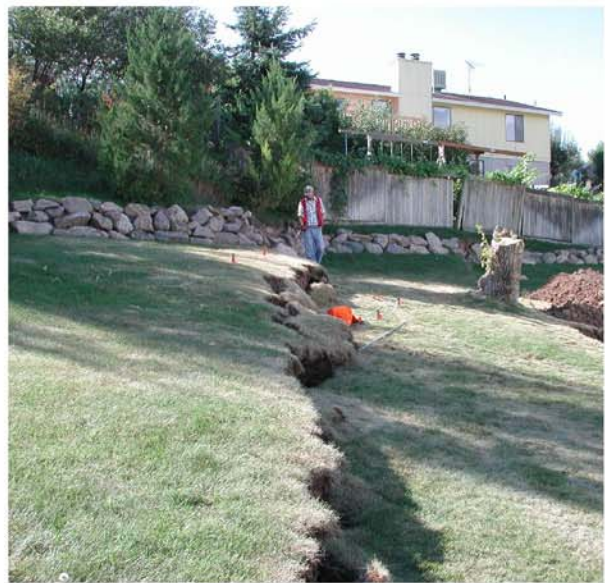
(d)

As main-scarp development progressed downslope of 1445 E. Heather Drive onto 1456 Tartan Way in mid-August, a quadrilateral (Baum and others, 1988 [figures 2, 3d]) was installed across the scarp to measure possible right-lateral shearing along a suspected landslide flank. Figure 6b shows cumulative measured extension across the quadrilateral stakes from August 24 to October 3, 2001. The quadrilateral diagonals AD and BC have nearly equal displacements indicating little right-lateral shear along the scarp. These diagonal displacements and displacements perpendicular to the scarp (AC and BD) indicate landslide movement in a northwest direction. The quadrilateral data also show that nearly all landslide movement stopped by August 31.

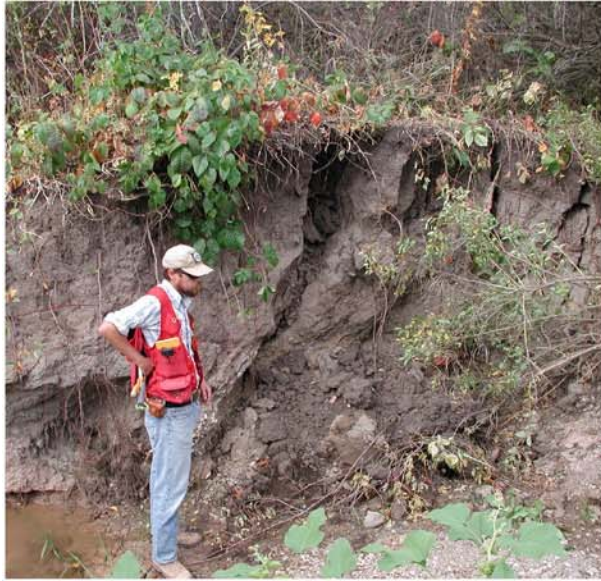
Landslide toe features in and adjacent to the creek consist of several ground cracks in the south creek bank at landslide monitoring point T1 (figure 2), transverse ground cracks along the south creek bank at T2, and vertical heave of the creek bed west of T2. The approximate location of the landslide toe, based on deformation patterns, is shown in figure 2. The vertical heave of the creek bed is part of a small east-west transverse ridge (figure 4a) with parallel axial ground cracks (figure 4b) approximately 70 feet long west of T2. Clean well-sorted channel sands along the transverse ridge axis also display ground cracks (figure 4c). Based on the relative positions of vertically heaved channel gravel deposits and the creek water level (figure 4d), the creek bed was uplifted 1.5 feet. Several ground cracks are present in the western portion of the main body of the landslide, but relatively few ground cracks are present elsewhere, suggesting movement mainly as an intact mass.

Figure 4. Landslide toe deformation features in and adjacent to South Fork Kays Creek. (a) Bulge of transverse ridge, view looking west on September 5, 2001. A large ground crack is formed along the ridge axis. (b) Parallel ground cracks developed along transverse ridge axis, view looking east on September 5, 2001. (c) Ground cracks developed in sand bar adjacent to the creek on August 29, 2001, rock hammer for scale. (d) Vertical heave of the creek bed and incision into underlying silt and clay on September 12, 2001. The channel-bed gravel above the rock hammer handle is 1.5 feet above the current creek bed.

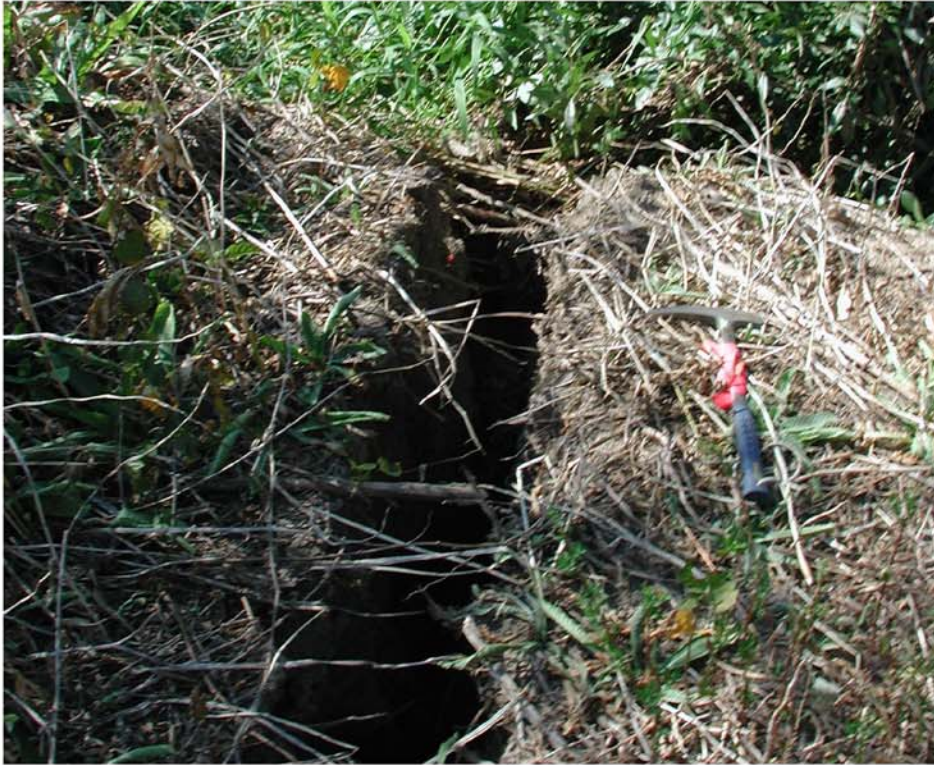
Figure 7. Ground crack in the south bank of South Fork Kays Creek on August 27, 2001. Crack width is 6 inches.

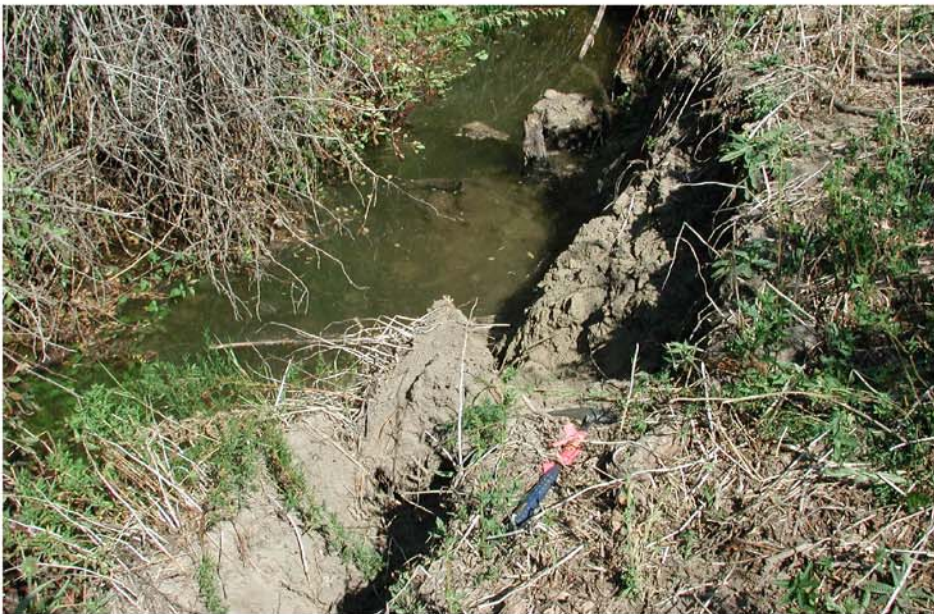
Figure 8. Toppling of the south bank into South Fork Kays Creek on August 27, 2001. Landslide movement is from right to left, view looking upstream to the east, rock hammer for scale.

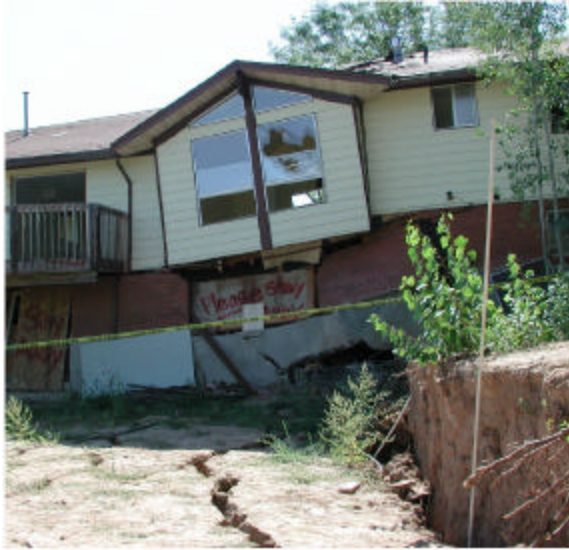
Figure 9. Building damage caused by Heather Drive landslide. (a) House at 1369 E. Heather Drive straddling the main scarp on August 26, 2001, view looking southeast. The house was demolished on August 27, 2001. (b) Basement and foundation at 1423 E. Heather Drive straddling the main scarp on September 5, 2001, view looking northeast. The house was moved off the foundation on August 25, 2001. (c) House at 1417 E. Heather Drive on the landslide head on August 28, 2001; view looking northeast. A splay of the main scarp caused substantial distress to the house and attached garage. (d) Front yard and house at 1393 E. Heather Drive (blue house on right) on the landslide head on August 27, 2001; view looking west along Heather Drive and the main scarp. The house was demolished on August 30, 2001.

Movement of the Heather Drive landslide severely damaged houses and lots (figure 9). Landslide movement damaged six houses at 1369 E., 1381 E., 1393 E., 1417 E., and 1423 E. Heather Drive, and 1456 Tartan Way (figure 2). Three of these houses were demolished due to landslide-related damage (1369 E., 1393 E., and 1417 E. Heather Drive) and three were moved off the landslide (1381 E. and 1423 E. Heather Drive and 1456 Tartan Way). The main scarp crossed the lots of 1431 E. (a garden lot) and 1445 E. Heather Drive, but did not damage the house at 1445 E. A small ground crack formed in the back yard at 1651 N. Emerald Drive, but did not significantly damage the lot.

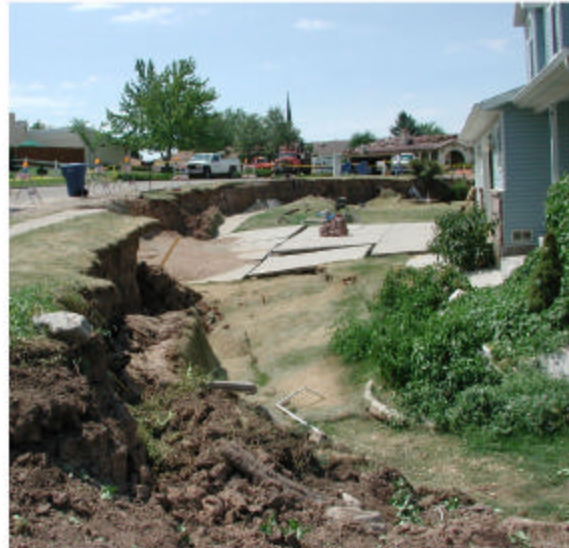
(d)

middle of the landslide (figures 3a, 3b, 3c, and 9d) and decreased toward the east (figure 3d) and west.
