ACTIVE LANDSLIDES

IN THE CREEKSIDE DRIVE AREA, MOUNTAIN GREEN, MORGAN COUNTY, UTAH, BETWEEN JUNE 2005 AND DECEMBER 2006

REPORT OF INVESTIGATION 260
UTAH GEOLOGICAL SURVEY
a division of
Utah Department of Natural Resources
2007

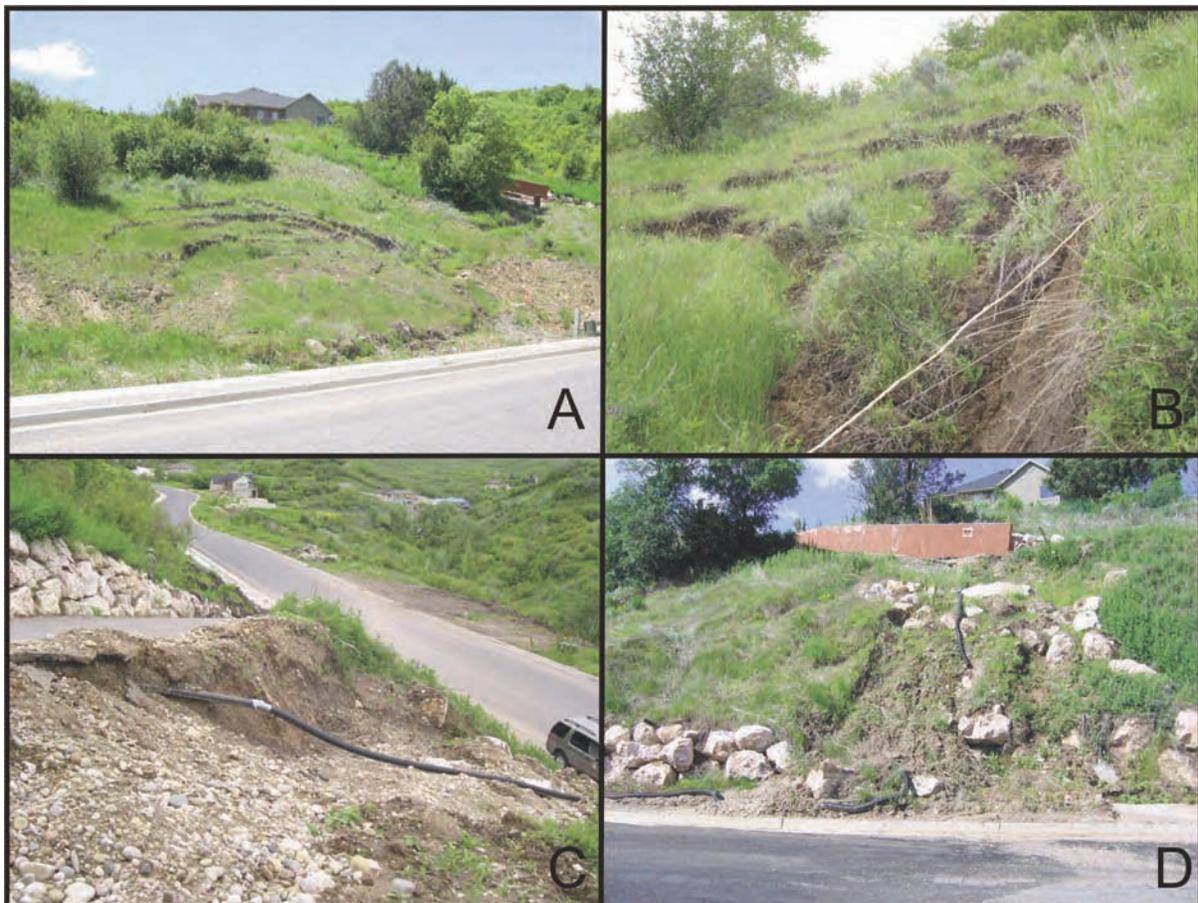
Three small, shallow slides (figures 5 and 6) on or straddling the Creekside Drive landslide included two in a cut slope directly above Creekside Drive, and a third in a cut slope upslope of the house on the head of the main slide. In June 2005, ground-deformation features associated with these three slides were the most discernable features within the limits of the main landslide. The two landslides along Creekside Drive damaged the driveway, displaced rock walls, severed a buried drainpipe, and threatened other buried utilities (figure 5). The upper slide folded and displaced sod in the backyard, displaced (nearly intact) a small

Figure 5. Small shallow slides on or straddling the Creekside Drive landslide. (A) View to the southwest of small shallow landslide in cut slope near boundary between lots 21 and 22. (B) View to the southeast of main scarp zone showing stretched white electric line. (C) View to the west of main scarp and west flank of small landslide between driveway at 6023 N. and Creekside Drive. Main-scarp offset severed drainpipe in 2005 (repaired in photograph). (D) View to the southwest of slide in photograph C in June 2006. Note new damage to drainpipe and displaced material burying sidewalk. Small rock wall on left was continuous across slide in 2005.

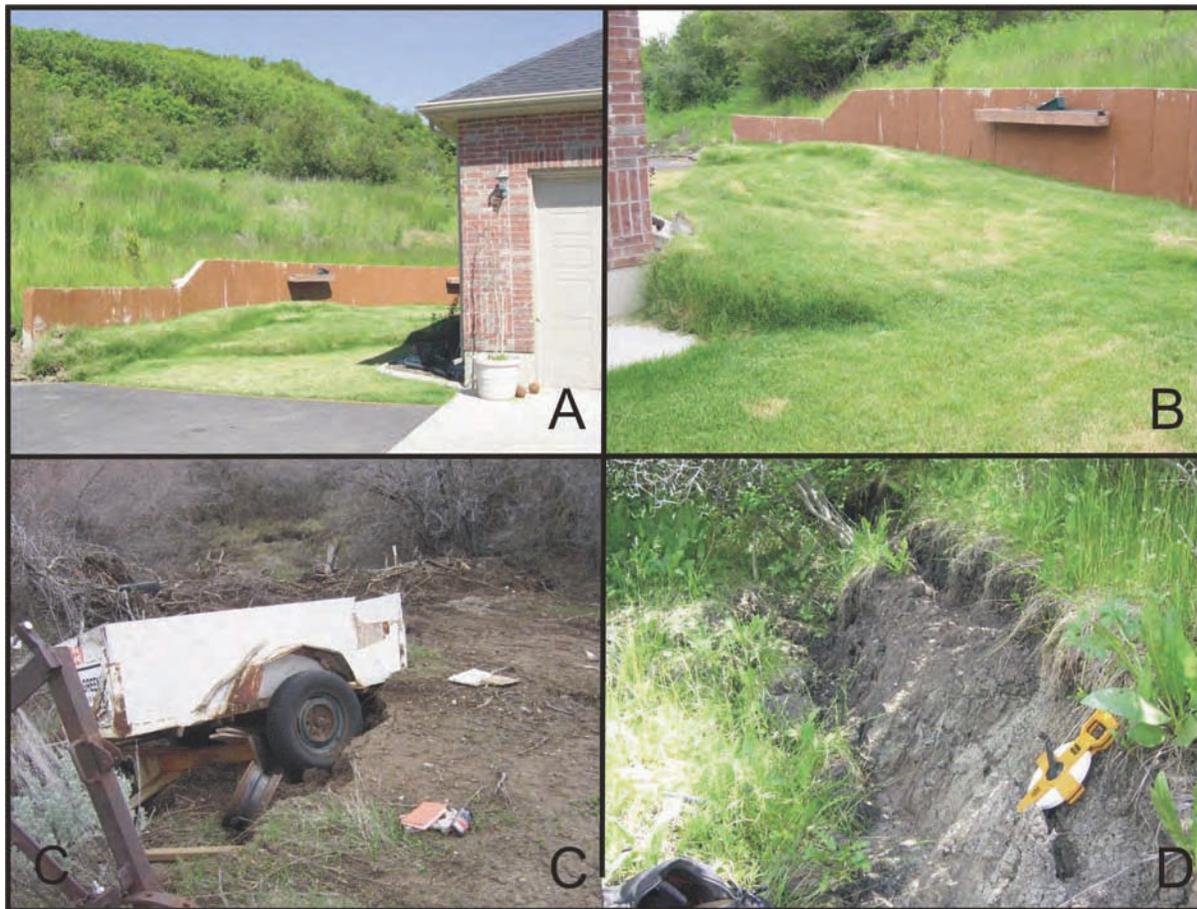
retaining wall, and possibly caused some of the damage to the house (figure 6A, 6B). By early June 2005, the toe of the upper slide was in contact with a garage attached to the house (figures 6B and 7). Table 2 summarizes the approximate dimensions, relief, and average slope of the slides.

Figure 6. Landslide deformation features possibly associated with the upper shallow slide in head of Creekside Drive landslide. (A) View to the west of toe thrust system in backyard at 6023 N. Creekside Drive. Shallow soil and sod are folded and displaced between retaining wall and garage. (B) View to the southeast of northern corner of toe thrust system. (C) View to the south of scarp on lot 20. Abandoned trailer is dropped down about a foot due to offset on scarp. (D) View to the east of scarp on lot 21. Scarp height on June 10, 2005, was about 3.4 feet.

Upslope of the retaining wall, the upper slide consisted of a zone of scarps and ground cracks. Locally, the uppermost (main) scarp was not necessarily the scarp with the greatest offset (figure 6D). The northwestward extension of the main scarp zone onto the adjacent lot (figure 6C) and beyond any well-defined toe features in the landscaped areas upslope of, or adjacent to, the house is problematic, suggesting the scarps were not caused solely by small local landsliding upslope of the house at 6023 N. Creekside Drive. Instead, the scarps may be due to movement of the deep-seated landslide and a shallower, but unconfirmed, slide within the main slide with a toe near Creekside Drive (see queried surface of rupture in figure 4).

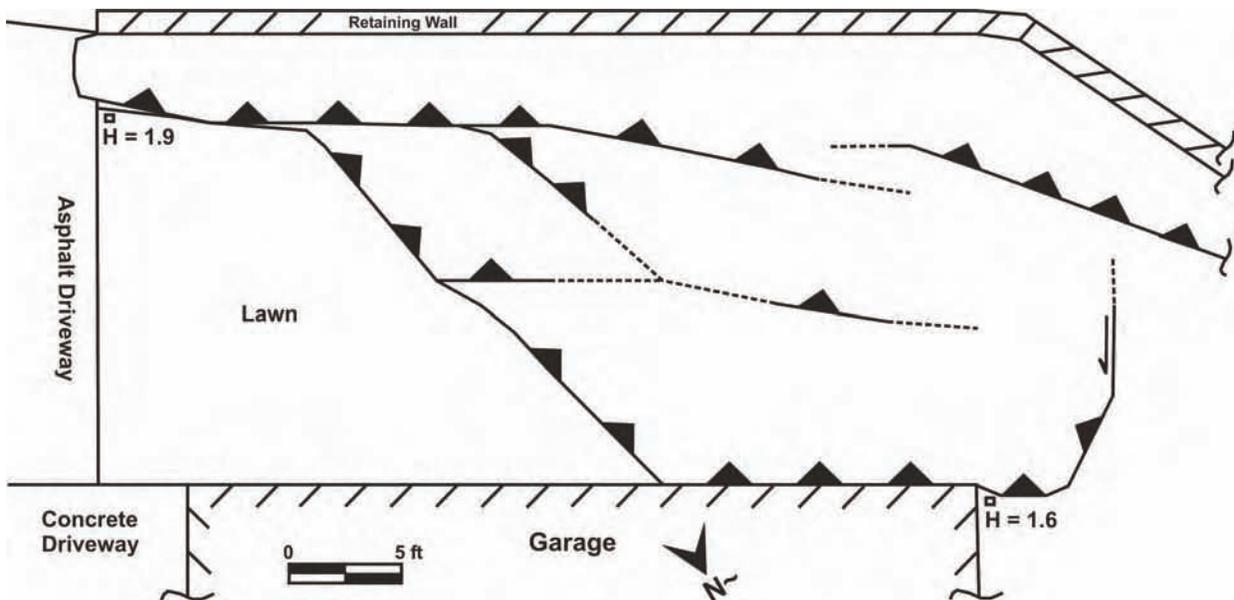
Figure 7. Detailed sketch (plan view) of toe thrust system in backyard at 6023 N. Creekside Drive. Squares indicate height of folds (in feet). Triangles on upthrown side of thrusts. Dashed lines indicate decreasing offset toward thrust tip. Mapped on January 26, 2007.

The concrete retaining wall between the scarps and the toe thrust system remained mostly undamaged throughout 2005 with only a single high-angle crack near the center of the thrust system. The integrity of the retaining wall suggests that (1) it was either displaced uniformly downslope atop underlying thrusts associated with the small shallow upper slide, or (2) uniform movement (yielding) of the wall at a rate faster than the movement of the garage associated with deep-seated landsliding was the cause of the thrusts in the backyard. In support of the latter case, the thrusts and folds exist mostly between the retaining wall and the attached garage (figure 7). Thus, the toe thrust system may be the result of

shortening between the retaining wall and the garage caused by a faster movement rate of the wall relative to the garage. Therefore, a separable upper, small shallow slide may not exist, but rather, all the landslide deformation features upslope of the house may reflect deep-seated movement and differential movement rates in the upper part of the slide.

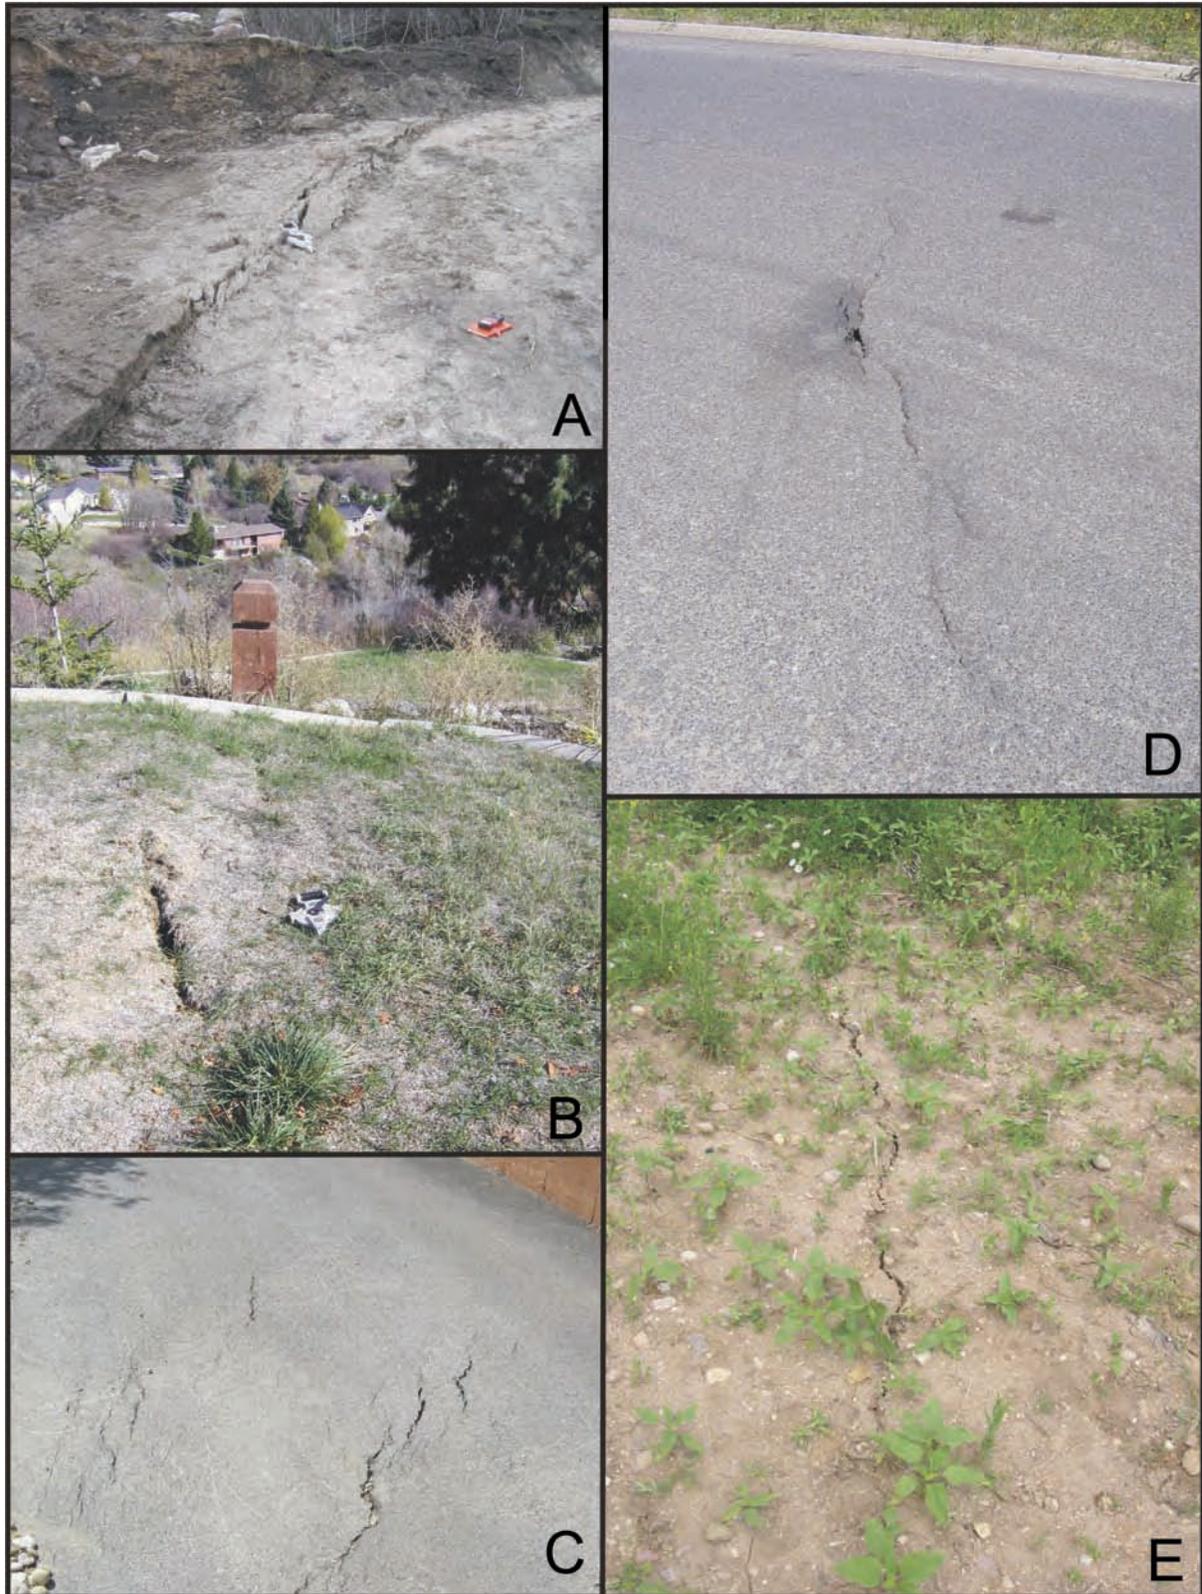
Ground-deformation features that defined the perimeter of the Creekside Drive landslide in 2005 were limited to three clusters of en echelon right-stepping cracks along the left flank (figure 8) and the main scarp zone. The three separate clusters of cracks defining the left flank of the slide were:

1. a right-stepping shear crack zone in the northwest part of the lawn at 6023 N. Creekside Drive that offset landscaping curbstones (figure 8B),
2. en echelon cracks in the lower driveway at 6023 N. Creekside Drive (figure 8C), and
3. right-stepping cracks in and abutting (to the north) Creekside Drive (figure 8D, 8E).

By 2006, features defining the upper left flank of the landslide were better developed and included a continuous shear crack on lot 20 that joined the main scarp zone (figure 8A).

Figure 8. Ground-deformation features defining the left flank of Creekside Drive landslide. (A) View upslope (to southwest) of left-lateral shear crack on lot 20. (B) View downslope (to northeast) of right-stepping ground cracks in lawn north of house at 6023 N. Creekside Drive. (C) View to southeast of en echelon, right-stepping cracks in lower driveway at 6023 N. Creekside Drive. Note two parallel crack zones. (D) View downslope (to north) of road crack in Creekside Drive. (E) View downslope (to north) of ground crack in fill on western part of lot 1 (6006 W. Creekside Drive).

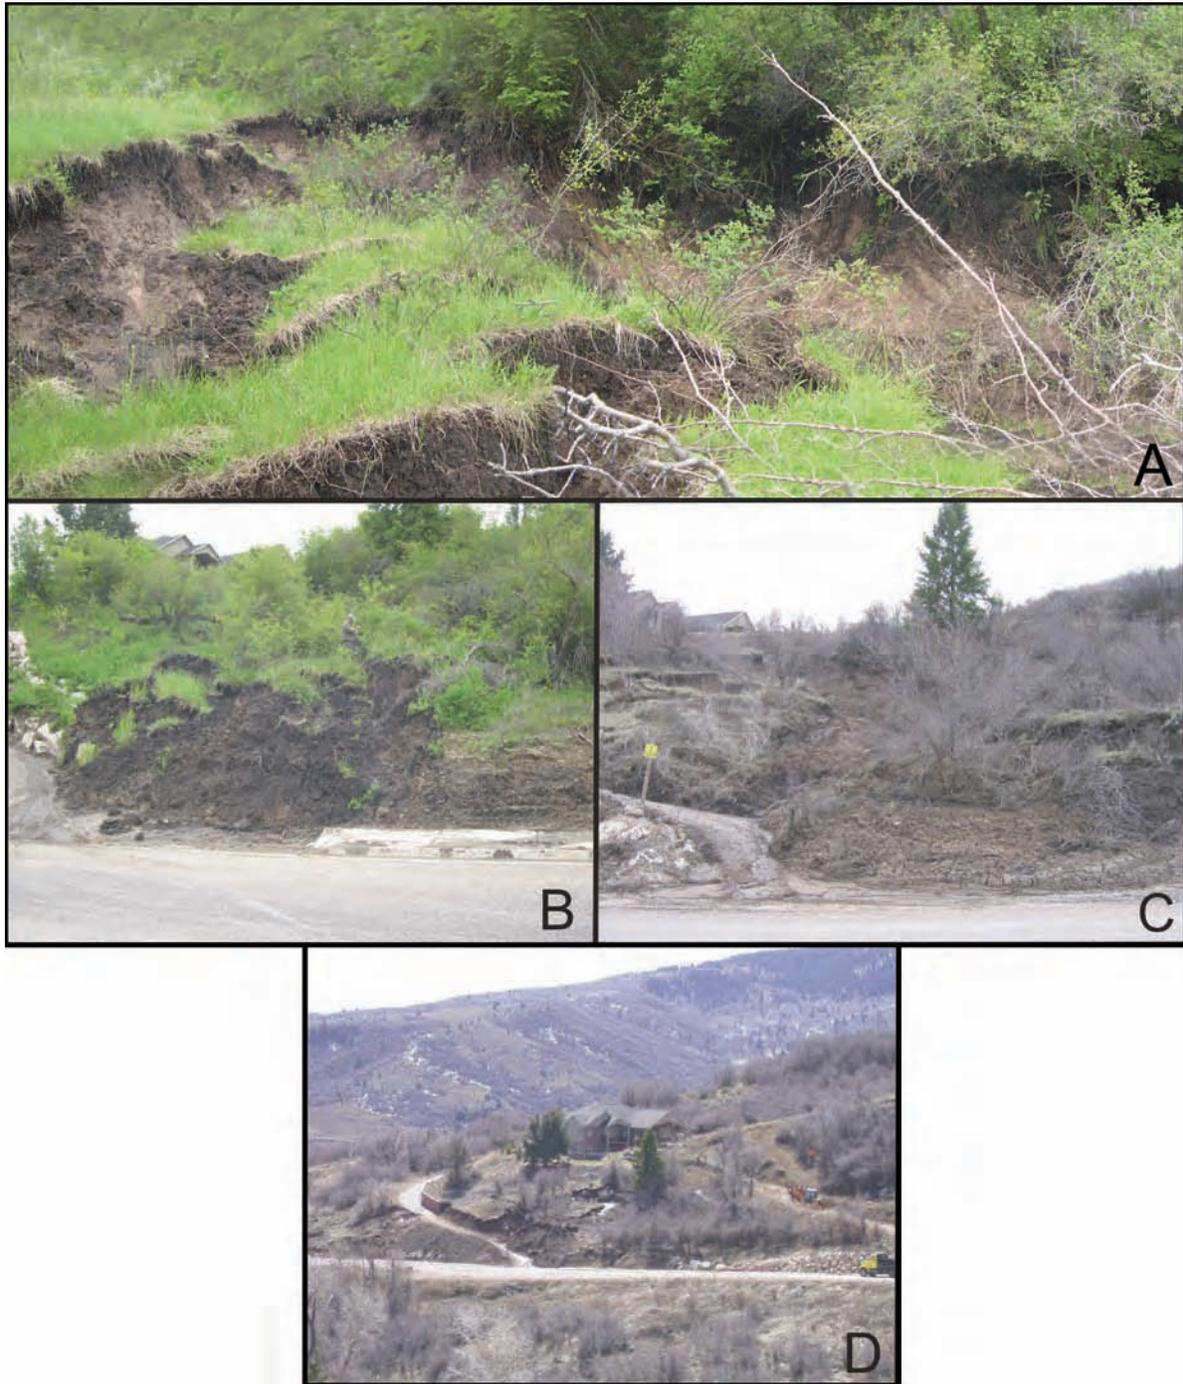
A small companion slide occurred along the property line between lots 20 and 21 directly northwest of the Creekside Drive landslide, mostly on a natural slope covered by deciduous trees. On lot 21 (the 6023 N. Creekside Drive property), the southeastern part of the slide displaced a rock wall on the upslope side of the lower driveway. The main scarp of the landslide crossed a natural slope upslope of the driveway and Creekside Drive. The head of the landslide (figure 9A) was characterized by relatively shallow, displaced earth blocks that were locally backtilted. Small trees on the blocks were displaced, rotated, or toppled. A steep scarp bounded the upper part of the west flank of the landslide that locally exceeded 10 feet in height. Table 3 summarizes the approximate dimensions, relief, and average slope of the slide. On the southeast side of the landslide a

Figure 9. Landslide near boundary between lots 20 and 21 directly northwest of the Creekside Drive landslide. (A) View to the southwest of landslide head in June 2005. Note that upper part of the slide is in a natural slope. Displaced and rotated soil blocks and toppled trees in foreground. (B) View to southwest of landslide toe in June 2005. (C) View to southwest of toe in April 2006. Lower part of landslide had changed to an earth flow by 2006. Note displaced soil on lower driveway. (D) View to south of landslide in January 2007. Abandoned house at 6023 N. Creekside Drive (lot 21) in background.

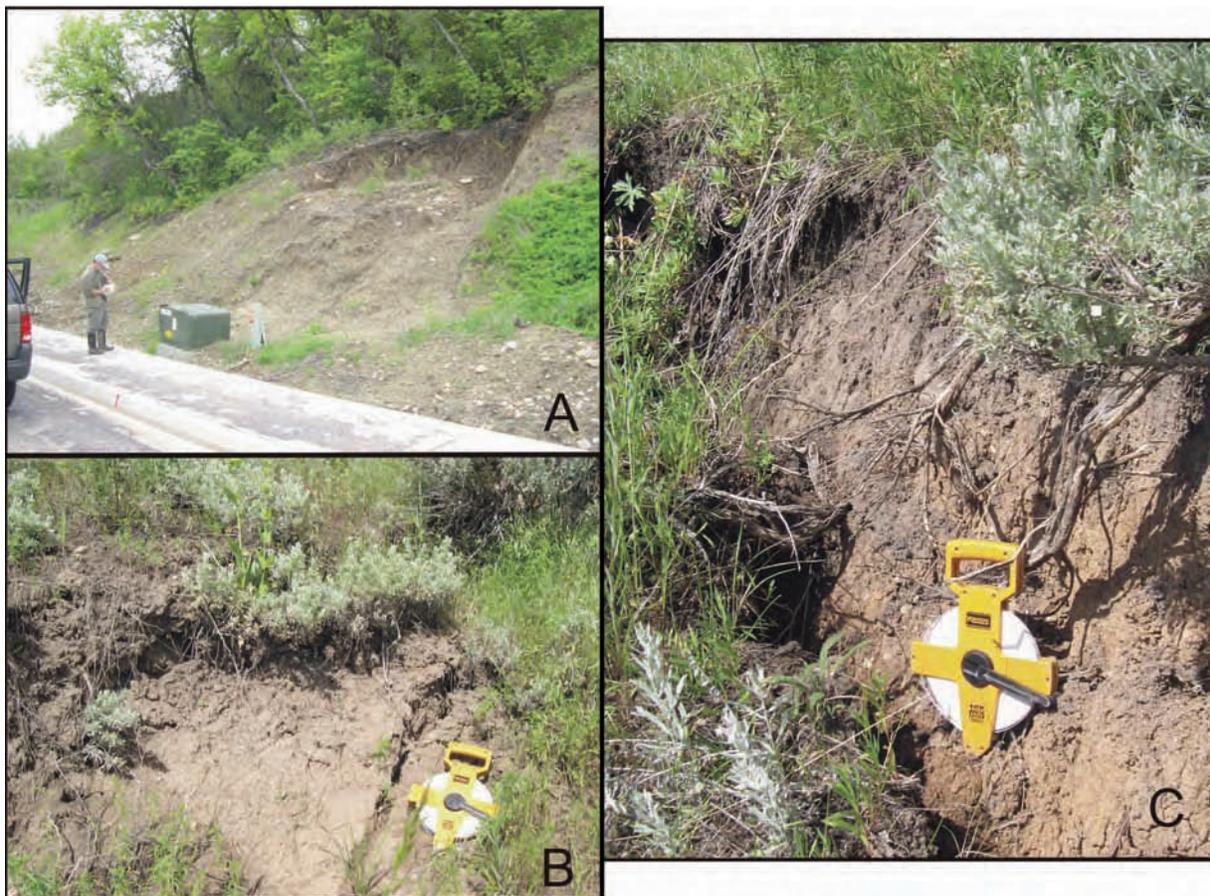
Figure 10. Other small landslides along Creekside Drive. (A) View to the south of small cut-slope landslide along northwestern Creekside Drive. (B) and (C) Main scarp zone of small landslide area east of River View Circle. Lower part of landslide was in cut slope, but main scarp crossed the natural slope upslope of the crest of the cut slope. The landslide consisted of two small abutting slides. Photographs taken in June 2005.

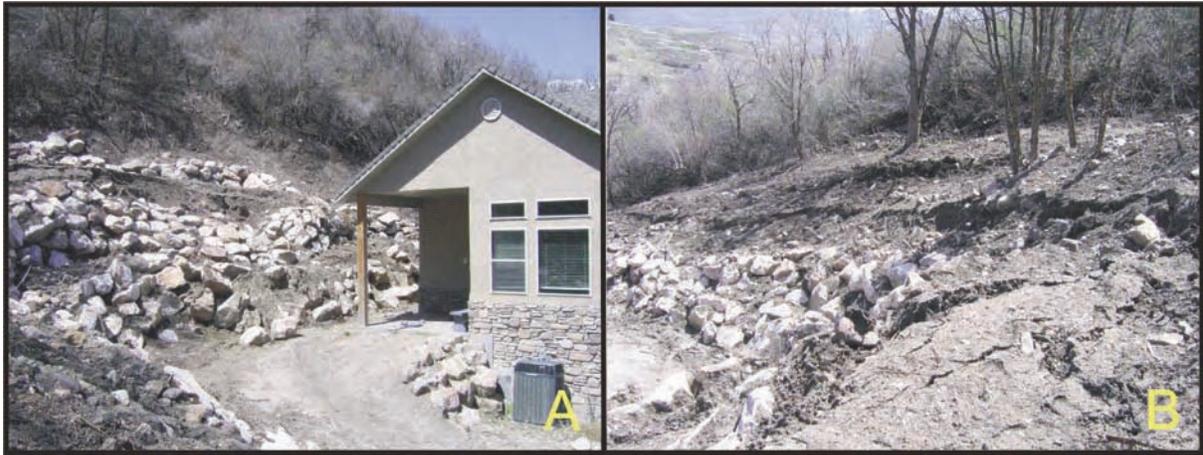
In addition to the landslides described above, six other landslides were identified in 2006. Two of the slides, the Cascade Drive and Lot 18 landslides, were large enough to affect parts of one or more lots. Four small slides included two in cut slopes and two in embankment fills. Table 4 summarizes the approximate dimensions, relief, and average slope of some of the slides. In addition, a rock wall at 6067 N. Creekside Drive failed in April (figure 11).

Figure 11. Rock-wall failure in April 2006 at 6067 N. Creekside Drive. (A) View to the west of rock-wall failure in backyard. (B) View to the east of the failure southeast of house.

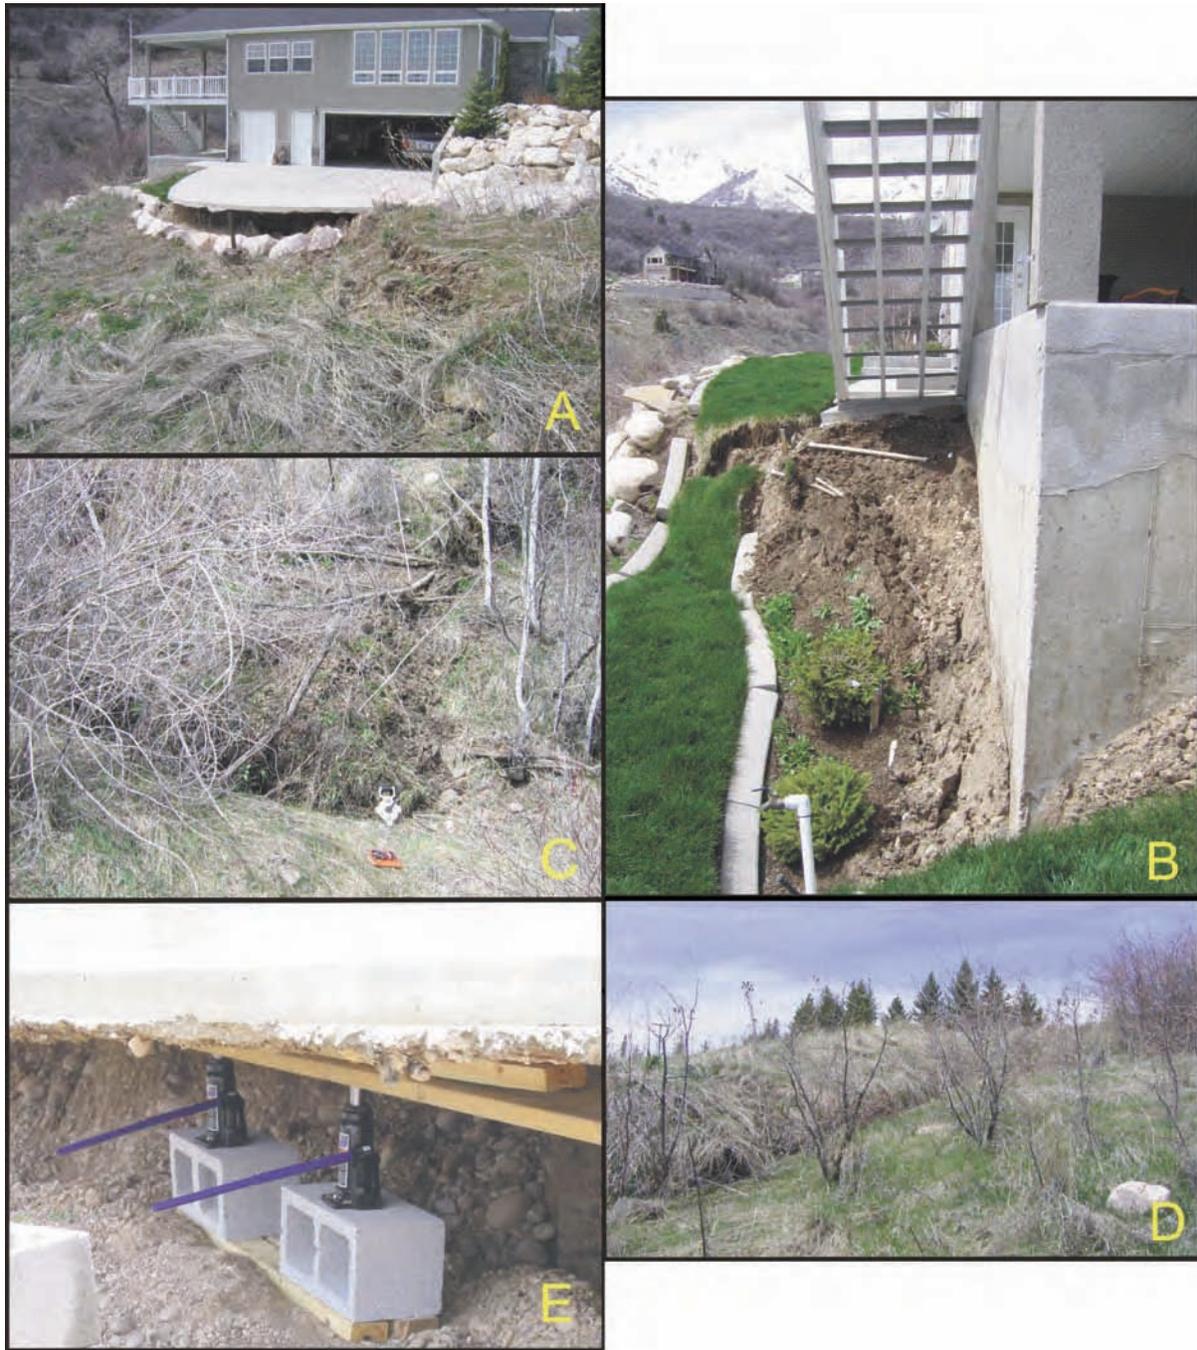
Figure 13. Ground-deformation features and damage caused by movement of the Cascade Drive landslide, lots 192 and 193 (5813 Cascade Drive). (A) Main-scarp offset left part of concrete driveway slab suspended about 2.4 feet above ground. (B) View to the northwest of main-scarp offset, about 5 feet, at the southeast corner of house at 5813 Cascade Drive. (C) View to the north of the toe of the landslide on lot 192. Landslide debris is thrust atop the Gordon Creek flood plain. (D) View to the northwest of the left (east) flank of landslide on lot 192. (E) Jacks used to support suspended concrete driveway slab in May 2006.

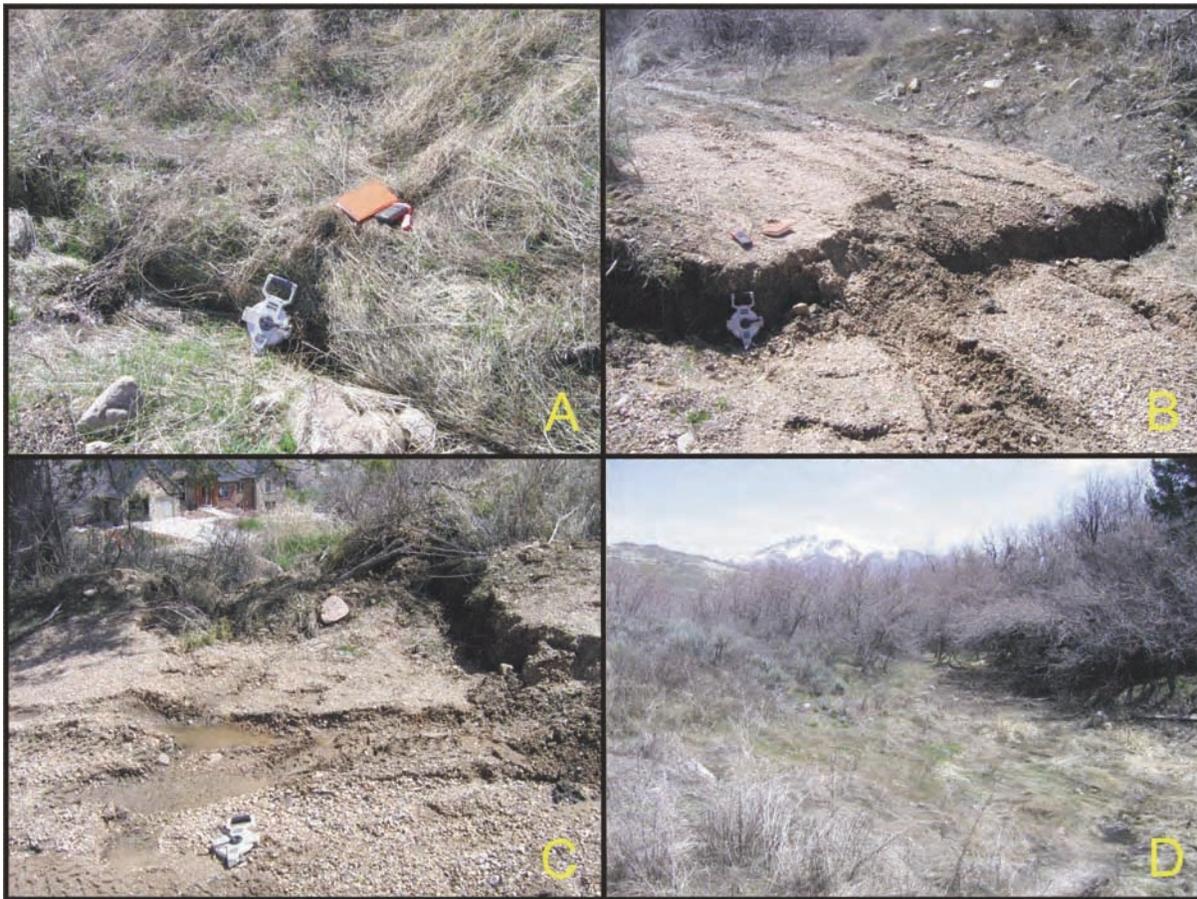
Ground-deformation features consisted of a continuous main scarp, toe, and right-flank shear zone (figure 16). Additional features included irregular ground cracks and small scarps that extended to the southeast of the slide's right flank. The main scarp was arcuate in shape and concave to the northeast. The scarp reached a maximum height of about 4.3 feet, but where it crossed a dirt access road (figure 16B) it was only about 1.5 feet high. At the main scarp crossing of the access road, a minor antithetic scarp defined a small graben that was about 7 feet wide (figure 16C). Directly to the west, the main scarp formed a zone of two parallel north-east-facing scarps that were between 2 and 2.5 feet high. On the right side of the landslide, the toe of the landslide consisted of two stacked low-amplitude folds indicating that the surface of rupture splayed into two closely spaced thrusts. The lower fold occurred along the edge of the sidewalk and was less than a foot high (figure 16A). A second fold occurred near the base of a local steep slope less than 3 feet upslope of the lower fold. The two folds merged together to the southeast. On the northwest side of the slide, the toe was less distinct, and was poorly defined by a slight oversteepening at the base of a cut slope along the road. A well-defined right-flank shear trended roughly perpendicular to Creekside Drive between the toe and the main scarp.

Figure 16. Ground-deformation features in and abutting the Lot 18 landslide. (A) Folded shallow soils at toe of landslide. (B) Offset of access road by main scarp. Scarp height ranged between 1.3 and 1.6 feet near road. (C) View to the northeast of small graben where head of slide crosses access road. Graben is about 7.1 feet wide. (D) View to the east of back-tilted surface on large, deep-seated, pre-existing landslide southeast of Lot 18 slide.

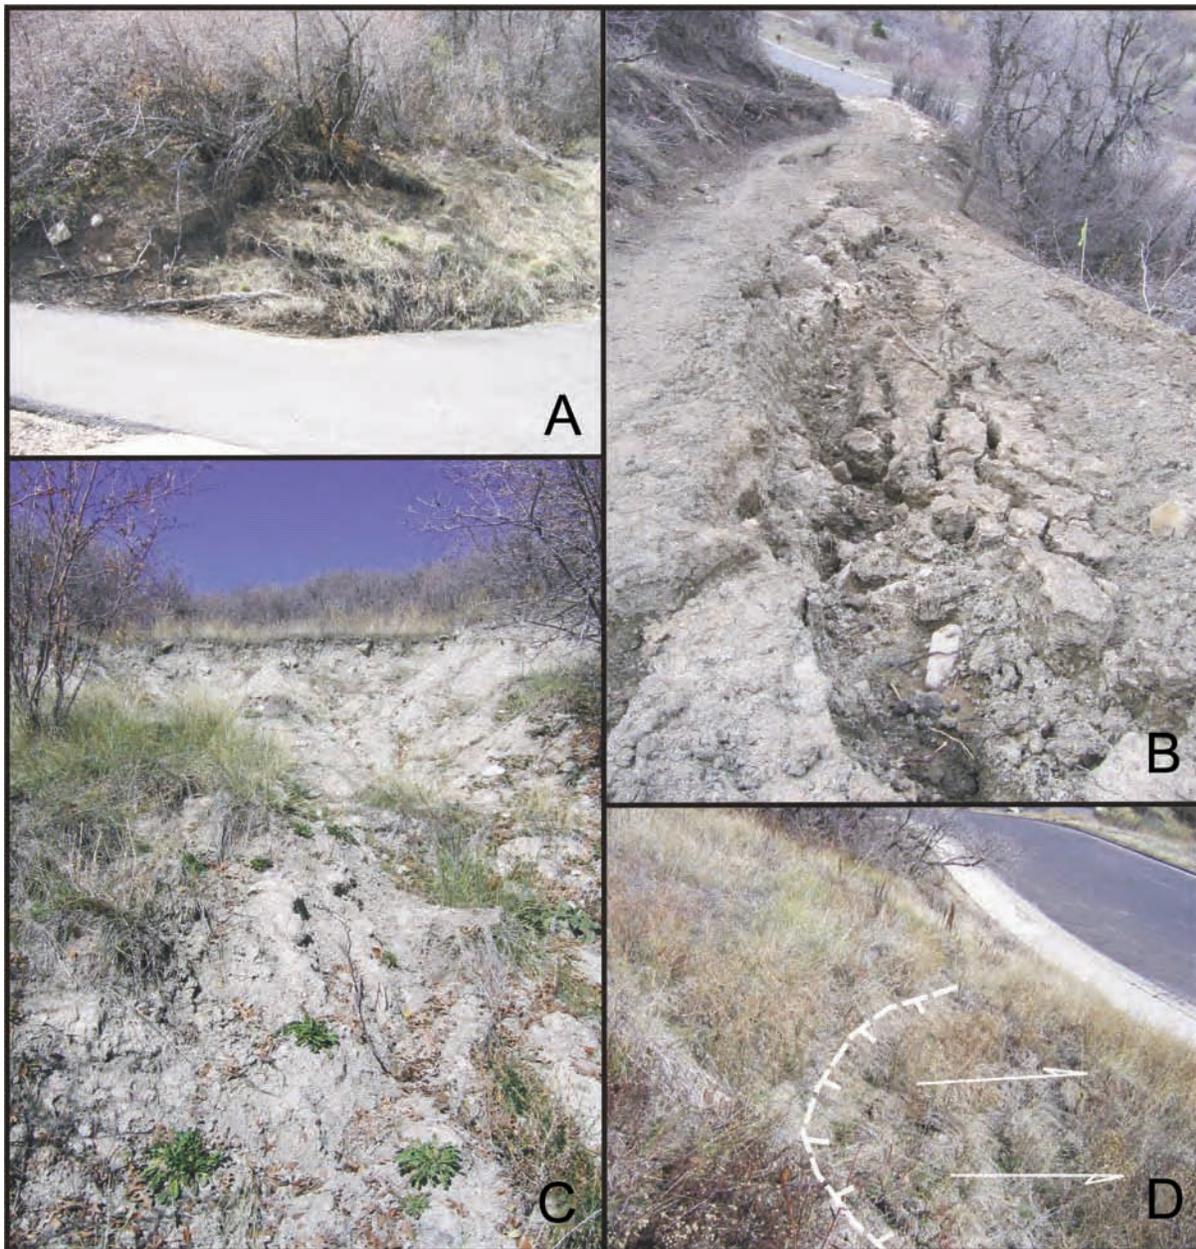
Four other small landslides were identified in 2006 (figure 17). The smallest occurred in a small driveway cut slope at 6067 N. Creekside Drive (lot 19) (figure 17A). The small rotational earth slide displaced material several feet onto the driveway and formed a scarp several feet high. A second landslide resulted from the partial failure of an embankment fill on the downslope (north) side of the lower access road on lot 20 (figure 17B). Two other small landslides occurred near the intersection of Creekside Drive and Wasatch Drive. The first, a small complex earth slide-earth flow formed in a southeast-facing embankment (figure 17C, table 4) consisting of fill from local soils and Norwood Tuff debris. The landslide was about 31 feet wide at its head, but narrowed downslope (table 4). On the lower east side, a narrow, earth-flow lobe extended 38 feet downslope from the remainder of the slide. Another small slide (figure 17D, table 4) occurred

Figure 17. Other small landslides in 2006. (A) View to the west of a small slide in a driveway cut slope at 6067 N. Creekside Drive. (B) View to the northwest of the head of an embankment failure in the lower part of the access road on lot 20. (C) View upslope (to the north) of landslide in an embankment near Wasatch Drive. (D) View to the east of the head of a small slide in cut slope along Wasatch Drive. Dashed hachure line is approximate main scarp. Arrows show approximate movement direction.

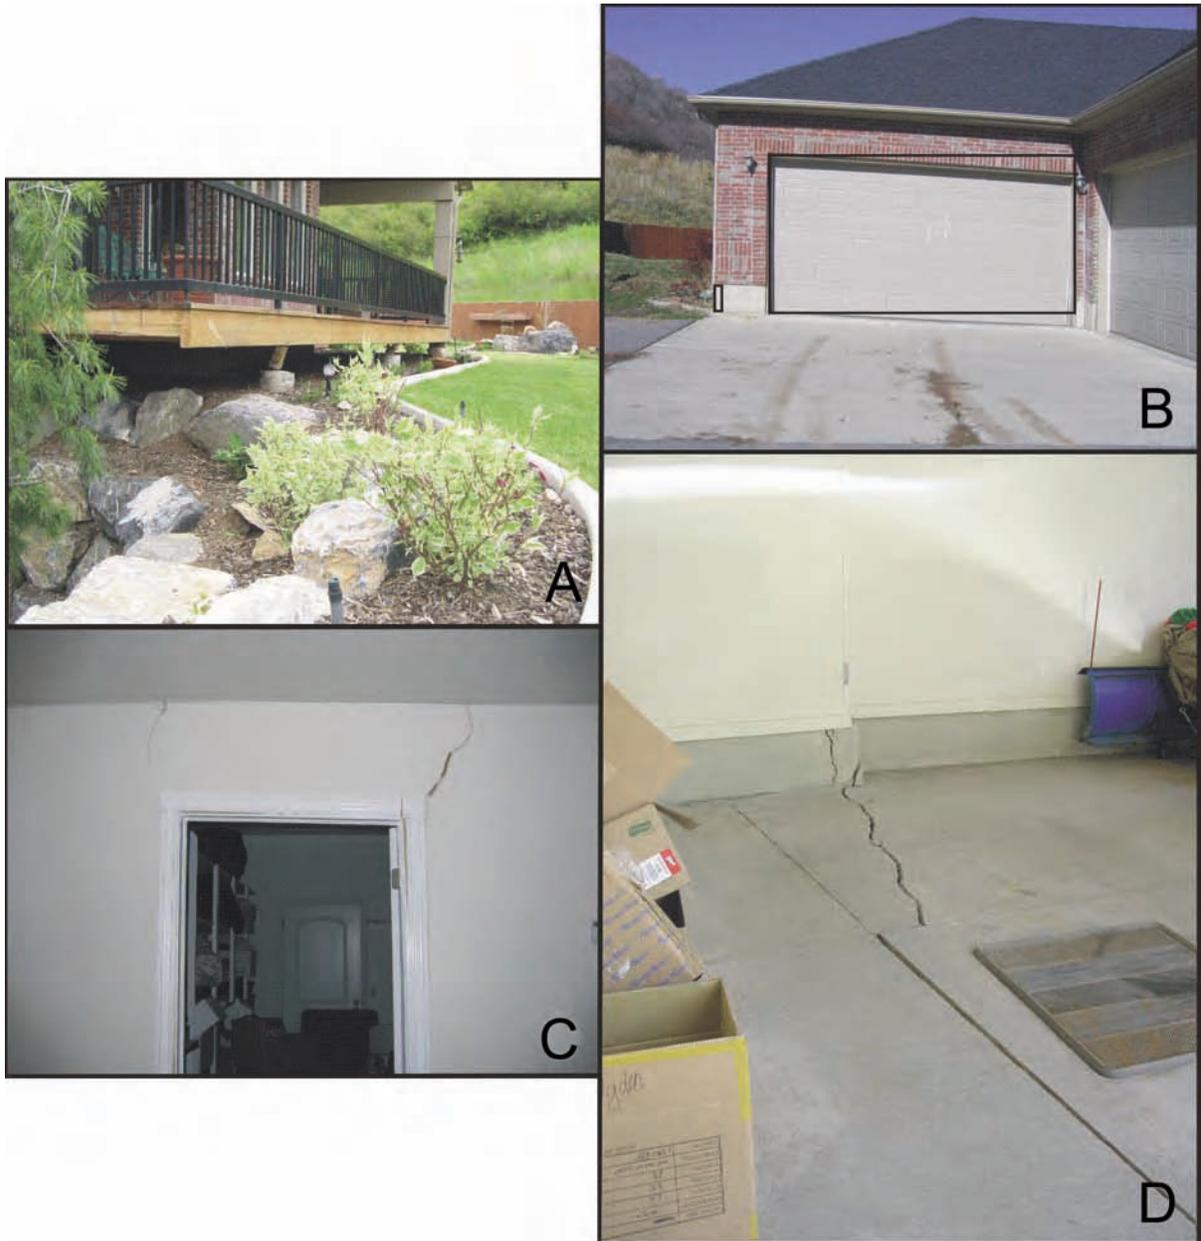
By mid-June 2005, damage to the house at 6023 N. Creekside Drive was severe, and partly limited the use of the property (figure 20). Cracks were pervasive in both the interior and exterior of the house. Most of the damage to the house was outside the limits of where the backyard shallow toe thrust system was in contact with the attached garage and thus was likely due to ground deformation caused by deep-seated landsliding, specifically stretching in the head of the Creekside Drive landslide. By April 2006, the damage to the house had become so severe that the house was voluntarily

Figure 20. Damage to house at 6023 N. Creekside Drive. (A) View to the south of sheared (tilted) porch posts on west corner of house. (B) View to the northwest of distortion to attached garage by late 2006. Rectangles added to show distortion. (C) View to the east-southeast of interior damage to wall and doorframe in basement of house. (D) View to the northeast of separation (left of mat) and garage floor/foundation wall crack.

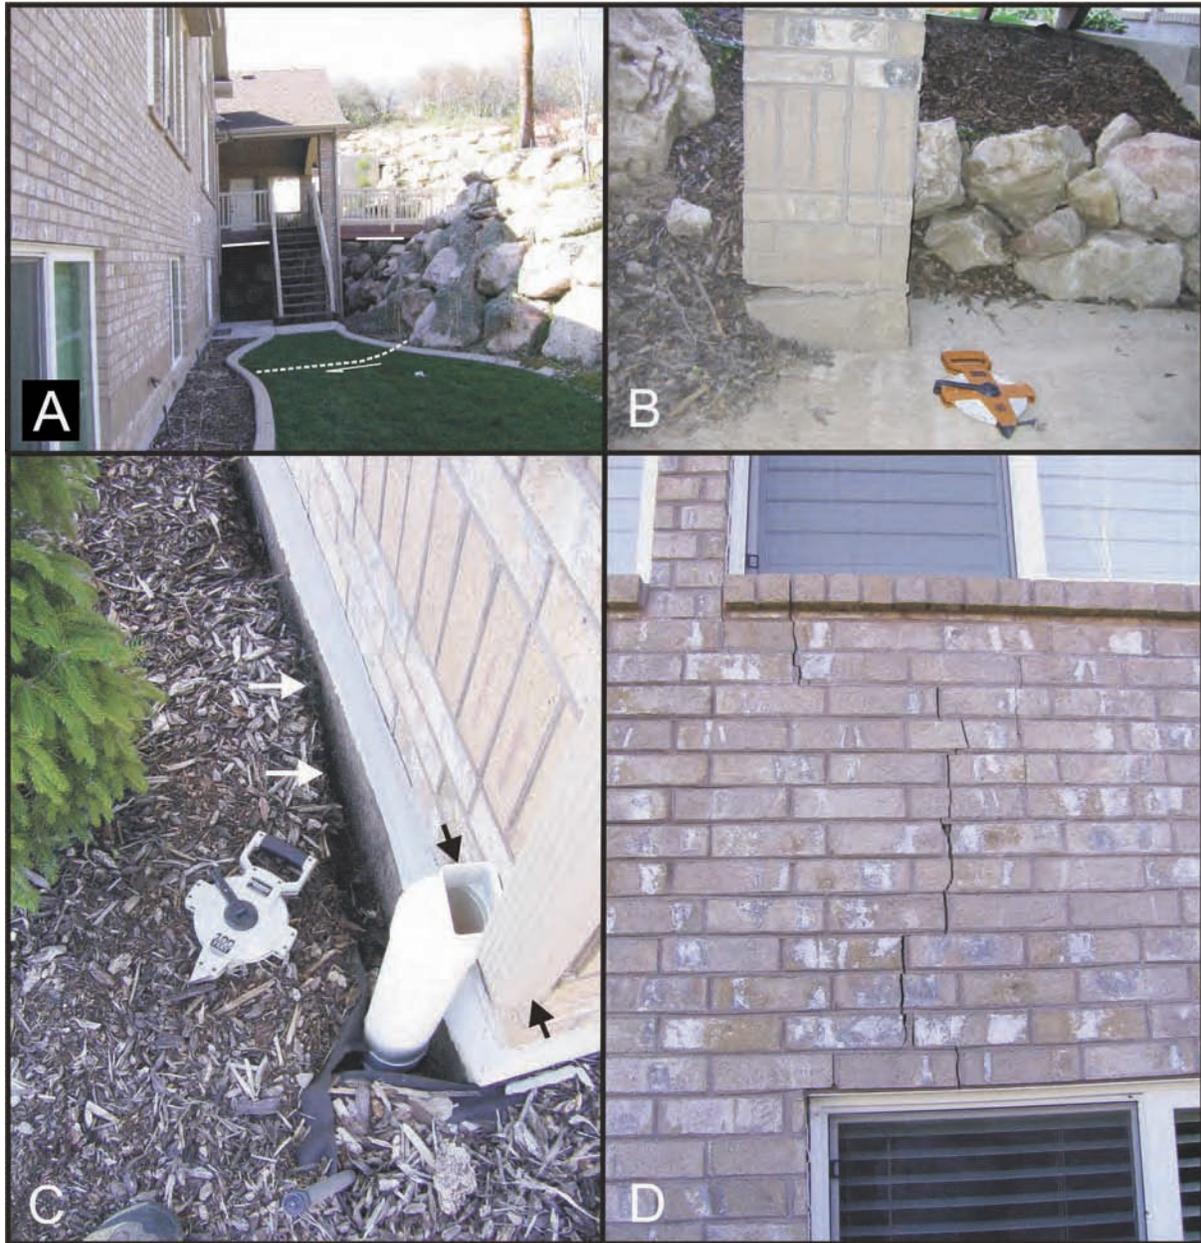
By June 2005, damage had also occurred to the house at 5983 N. River View Circle (figure 21). Damage included buckling of a back porch and attached walkway (figure 21A), including rotation and cracking of the porch posts (figure 21B) and cracks in the northwestern wall (figure 21D). By late April 2006, a separation gap was well developed along the northeast edge of the house (figure 21C).

Figure 21. Damage to house at 5983 N. River View Circle. (A) Buckling of back porch and walkway due to landslide movement. Solid white lines added to help visualize porch deformation. Dashed line shows approximate right flank of the Creekside Drive landslide. Arrow indicates movement direction. (B) Rotation and cracking of porch support column. (C) Gap (white arrows) between soil and northeast wall of house. Note offset of downspout drainpipe and inlet pipe (black arrows) in late April 2006. Both were connected in August 2005. (D) Cracking in northwest wall of house, likely where right flank of slide intercepts it.

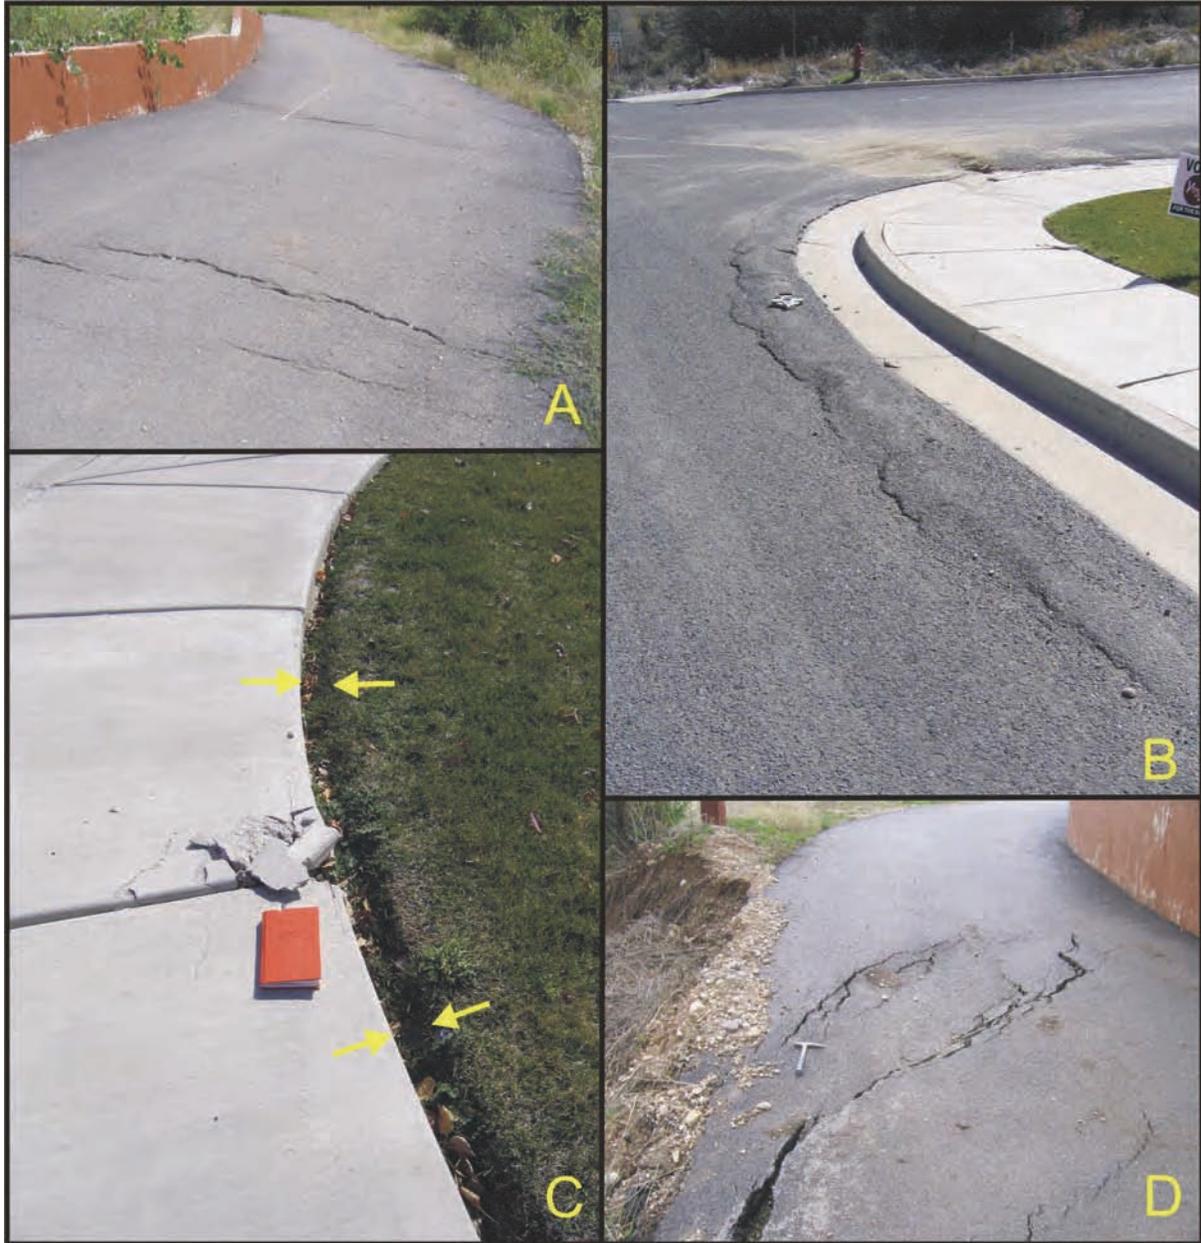
Figure 22. Pavement distress caused by movement of the Creekside Drive landslide. (A) Transverse cracks in upper part of driveway at 6023 N. Creekside Drive. (B) Road damage at intersection of Creekside Drive and River View Circle. See text for additional information. (C) Detail view of sidewalk damage on B and gap between sod and sidewalk (arrows). (D) Driveway damage at 6023 N. Creekside Drive near the intersection of the left flank of the Creekside Drive landslide and the main scarp of the small slide in cut slope.

Pavement distress consisted of mostly cracking of asphalt road and driveway surfaces, and concrete driveways, sidewalks, and curb and gutter elements (figure 22). Most of this occurred on and directly abutting the Creekside Drive landslide. Additional cracking outside the limits of the main landslide, particularly in the River View Circle area, may be due to expansive soils.
