UTAH GEOLOGICAL AND MINERAL SURVEY

REPORT OF INVESTIGATION

NO. 208

TECHNICAL REPORTS FOR 1985  
SITE INVESTIGATION SECTION

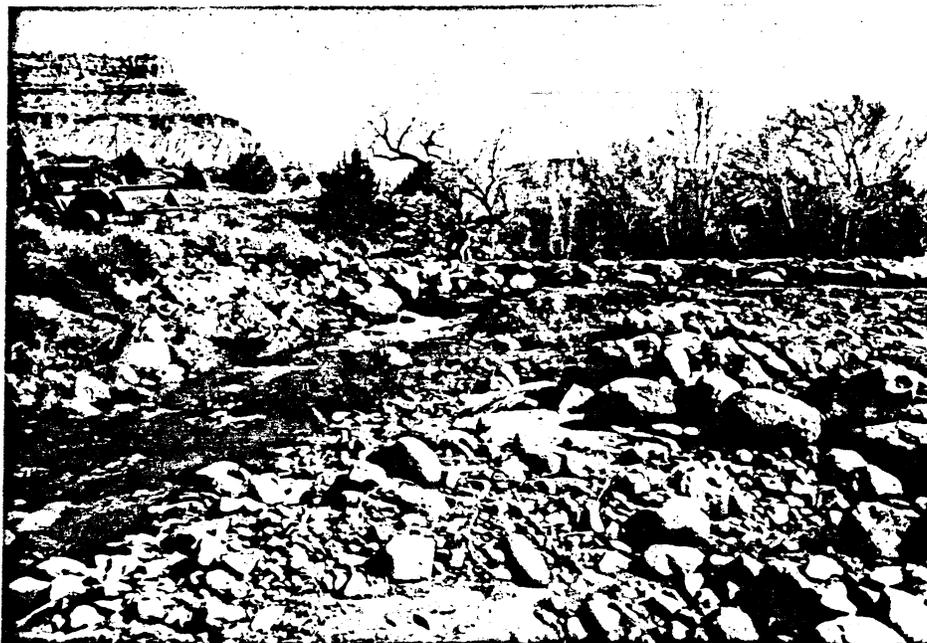
Photograph of the diversion dam on North Creek,  
Washington County, Utah.
