# TECHNICAL REPORTS FOR 1998 APPLIED GEOLOGY PROGRAM

compiled by  
Greg N. McDonald

Report of Investigation 242      March 1999  
UTAH GEOLOGICAL SURVEY  
*a division of*  
Utah Department of Natural Resources

**TECHNICAL REPORTS FOR 1998  
APPLIED GEOLOGY PROGRAM**

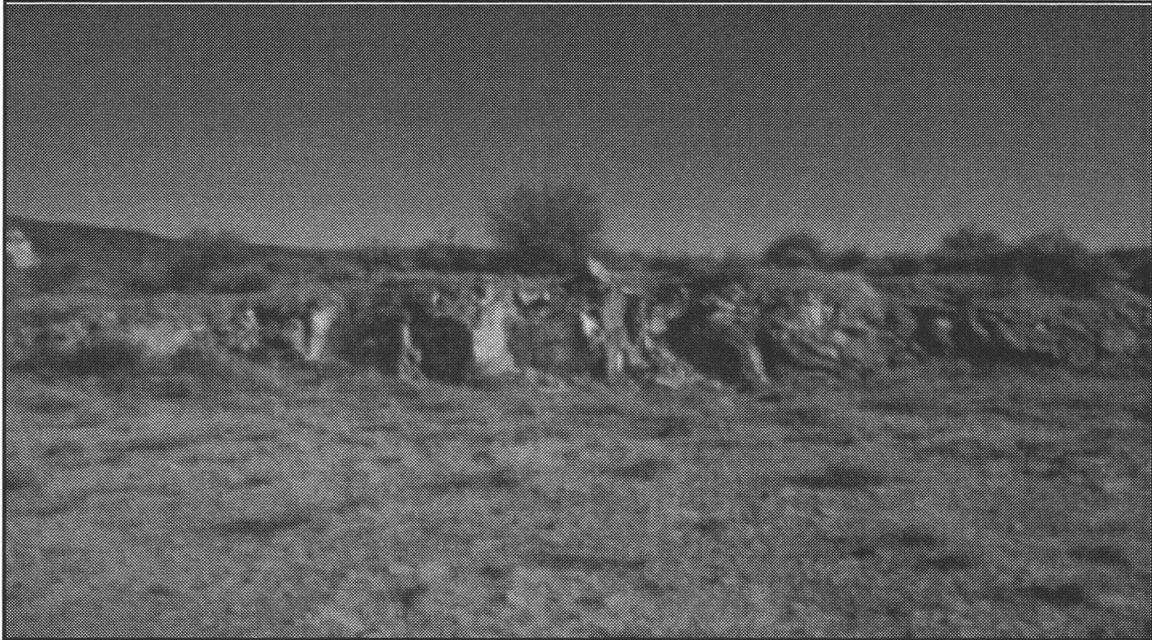
Attachment 3. Outcrop of jointed Navajo Sandstone in an old construction cut on Winchester Hills Phase 8; note shallow depth of soil over bedrock at this location. View is to the south.

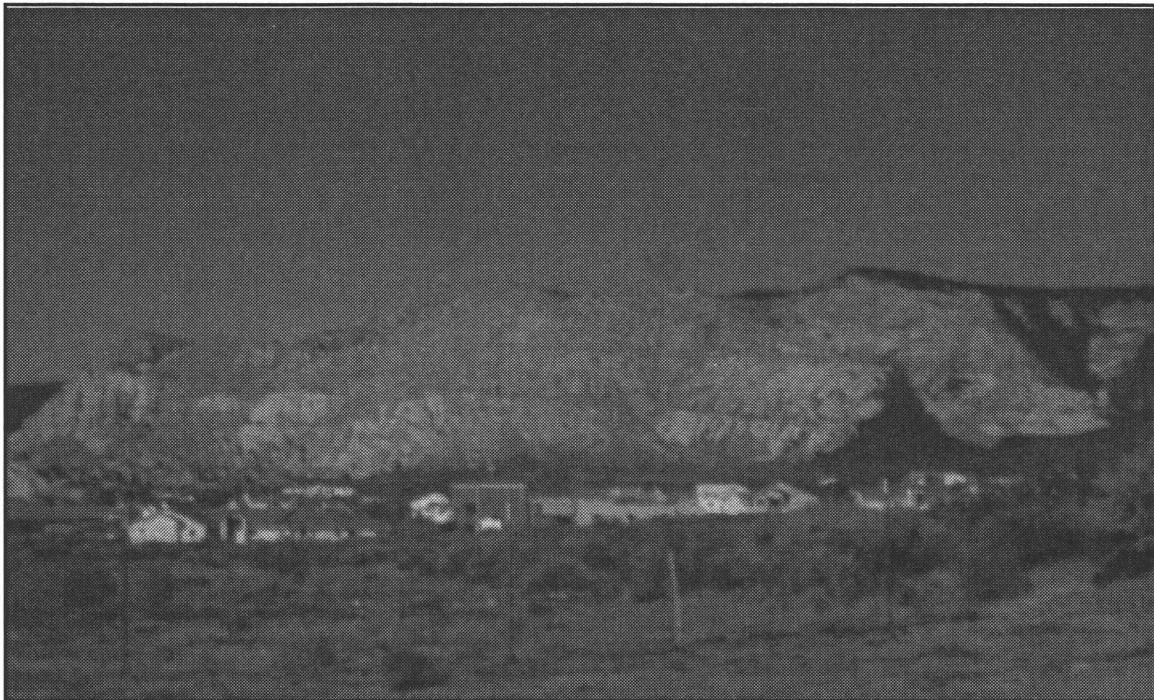
Attachment 4. Highly jointed Navajo Sandstone exposed along Lava Ridge north of the Winchester Hills development. The Navajo also crops out within and therefore underlies the subdivision.

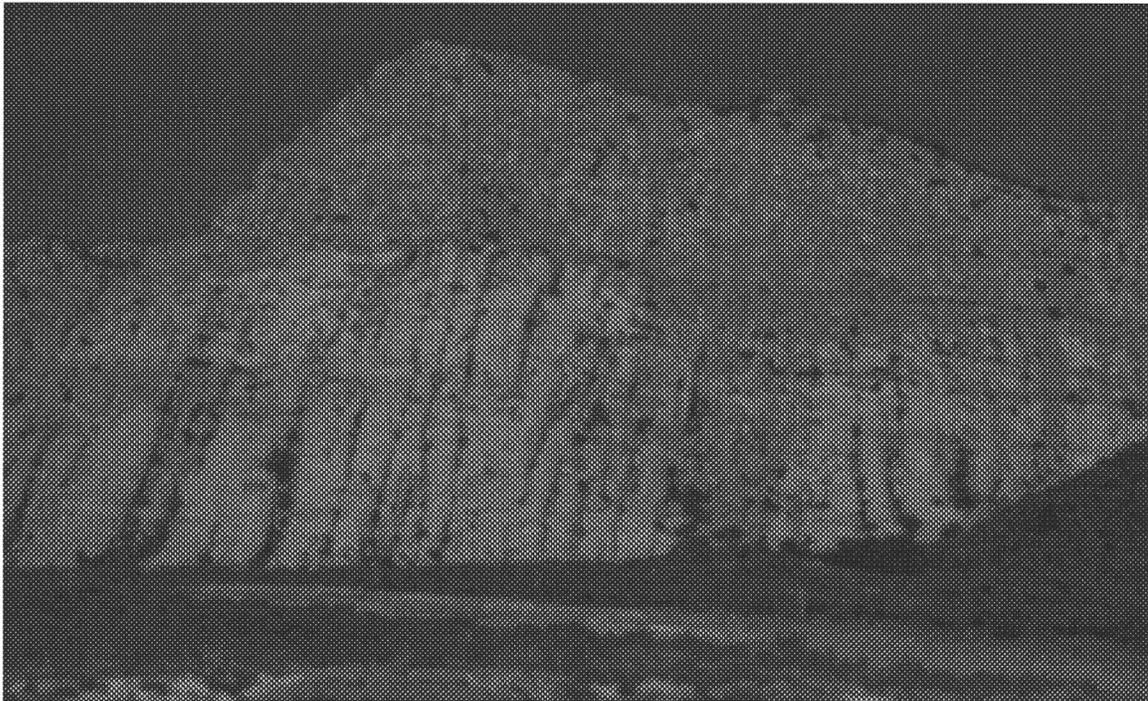
Attachment 5. Joints in the Navajo Sandstone along Lava Ridge immediately north of the Winchester Hills development. View to the northeast.

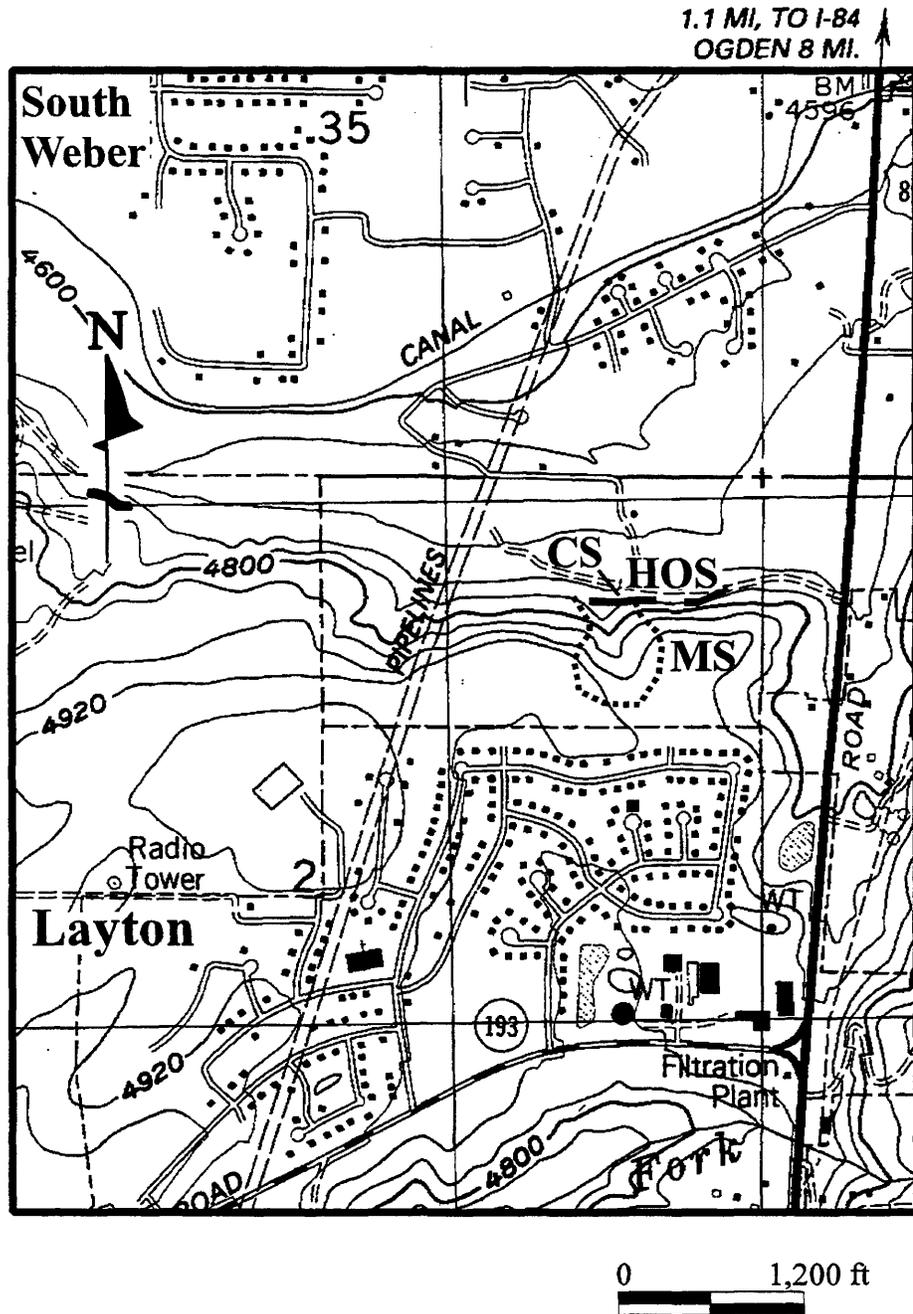
The western cut slope truncates the drainage southwest of the subdivision and leaves the channel hanging atop the cut slope posing both flooding and erosion hazards. The drainage upslope of the cut slope drains an area about 7 acres in size. Thus, an intense rainstorm that drops an inch of rain in a short period of time delivers about 0.6 acre-feet of water to the area. A percentage of this likely flows across the ground surface to the channel and, given the current position of the hanging channel, would likely cause erosion in the upper cut slope and local flooding at the base of the bluff.

Attachment 1. Location map showing prominent features in the vicinity of the Hidden Oak subdivision (HOS). Two homes exist atop the north-facing bluff in the Meadowood subdivision (MS). Two cut slopes (CS) exist at the base of the bluff. The western cut slope severs the mouth of the unnamed drainage (approximate limits shown by dashed line) and leaves the channel hanging about 20 feet atop the cut slope.

In addition, I concur with Strata's (1996b) recommendation that cut slopes greater than 8 feet high at the base of the bluff should have engineered retaining-wall systems. At present, most of the cut slopes exceed this height. Because excavation at the base of the bluff could induce shallow damaging landslides, proposed retaining-wall systems should be designed to increase slope stability as well as impede erosion. The retaining-wall design should not only protect against cut-slope failures but should also consider the downslope movement of potential shallow landslides that toe in the cut slope and have thrust angles subparallel to the slope. Proper engineering of the retaining-wall systems may not be possible until after the detailed investigation described above, as determined by the design engineer. Because of the importance that the retaining walls perform adequately, measures should be taken to ensure the walls are constructed according to design specifications. One way to do this is to require the design engineer to send a letter to South Weber City confirming the walls were constructed according to design specifications.

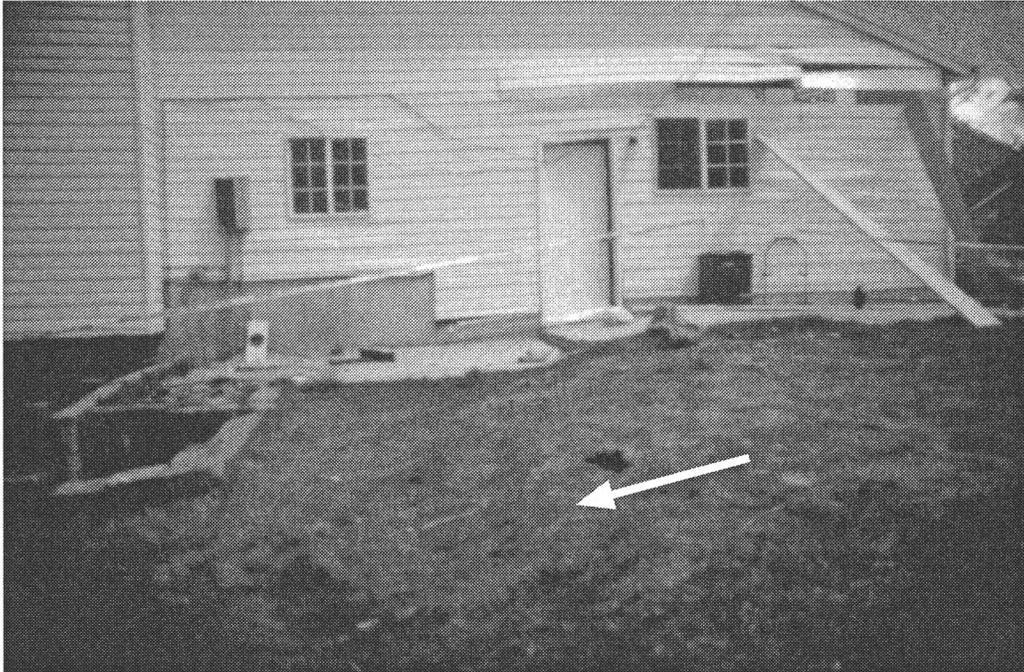
Attachment 3. Landslide damage on April 27, 1998, to house on lot 105. Arrow points to scarp position in lawn. View is to the east.

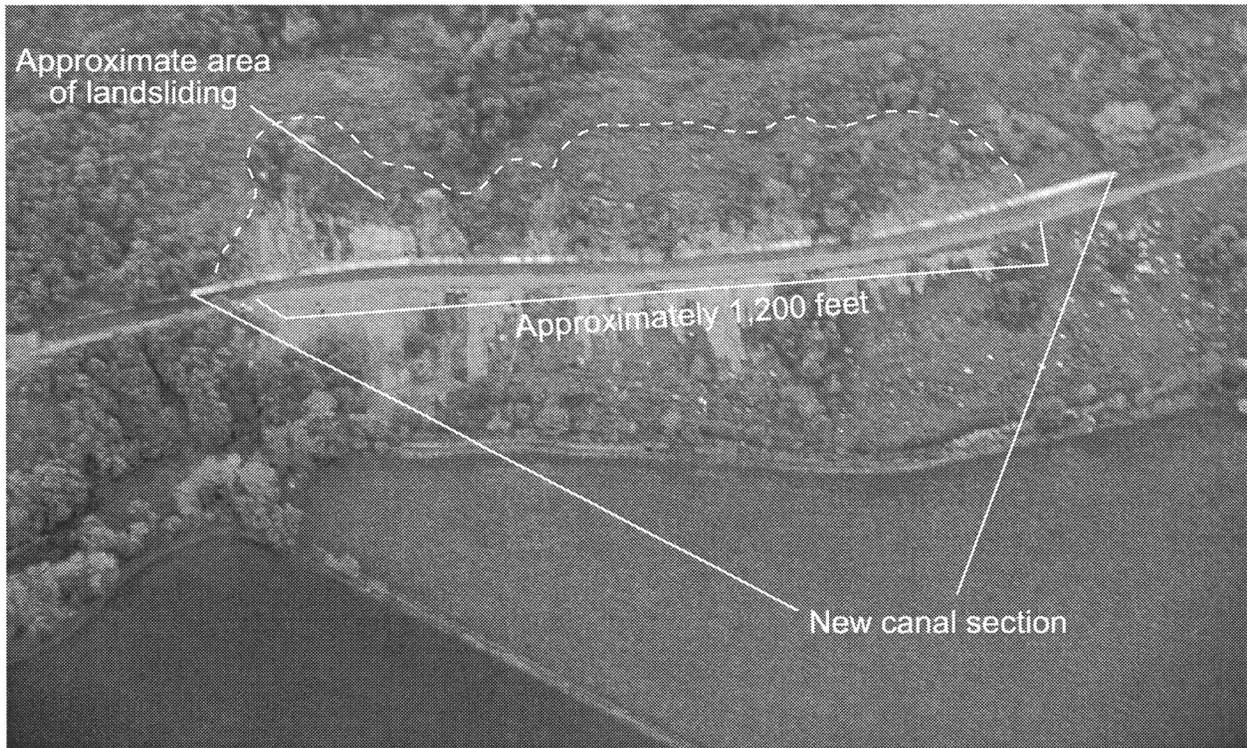
**Attachment 2.** Oblique aerial view of the 1998 landslide along the Davis-Weber canal in South Weber. A section of the canal was replaced in 1996, and nearly corresponds to the area of landsliding. Numerous scarps and ground cracks are evident on the slope in this area. Shallow earth sliding is occurring off the toe of the landslide.

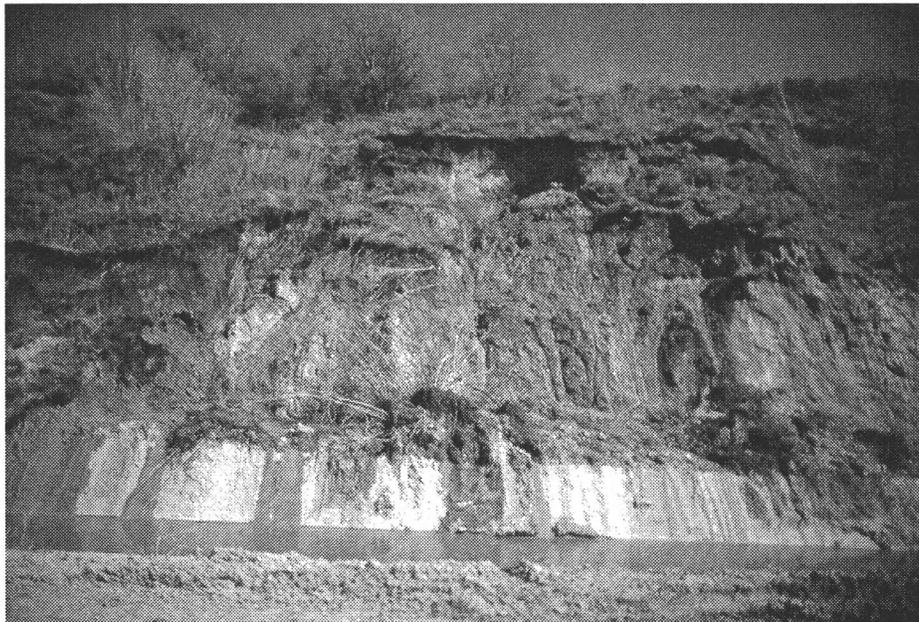
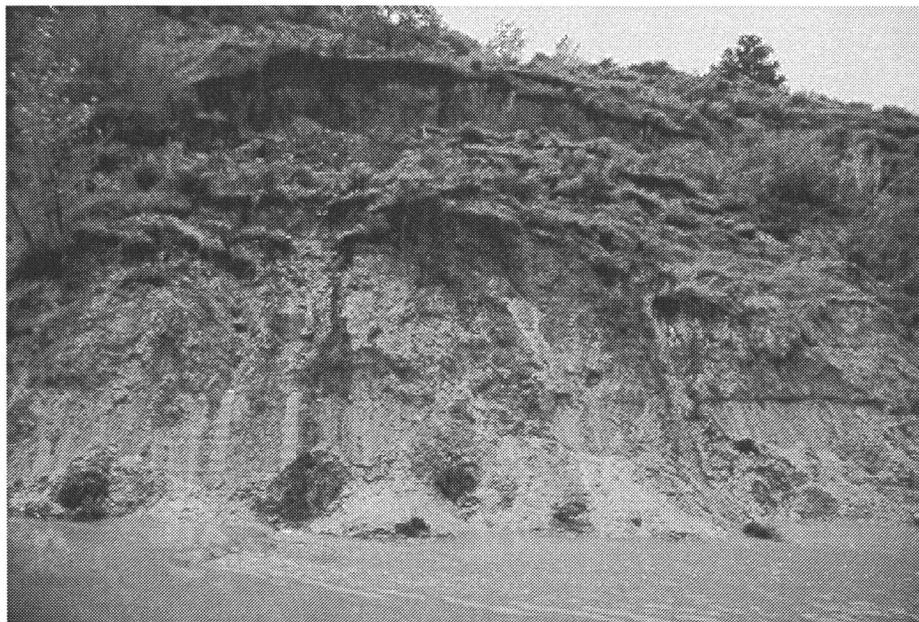
**Attachment 3.** South views of shallow earth sliding on the right (eastern) flank of the 1998 landslide in South Weber on May 1 (top) and May 11 (bottom). The Davis-Weber canal is in the foreground.

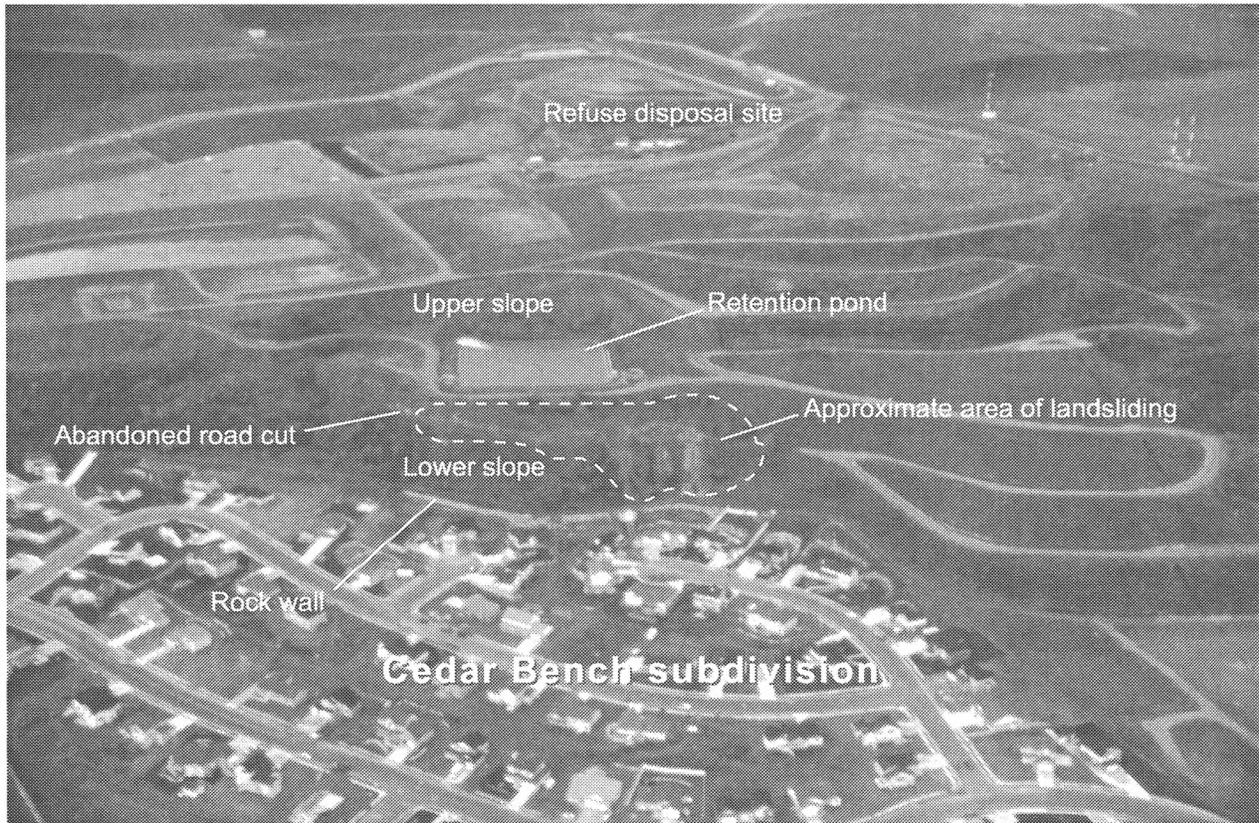
**Attachment 2.** Oblique aerial view looking south at the 1998 landslide near the Cedar Bench subdivision. Shallow earth slides are present on the lower slope below the retention pond and above the abandoned road cut. Earth slides and flows are present below the road cut to the toe of the slope.

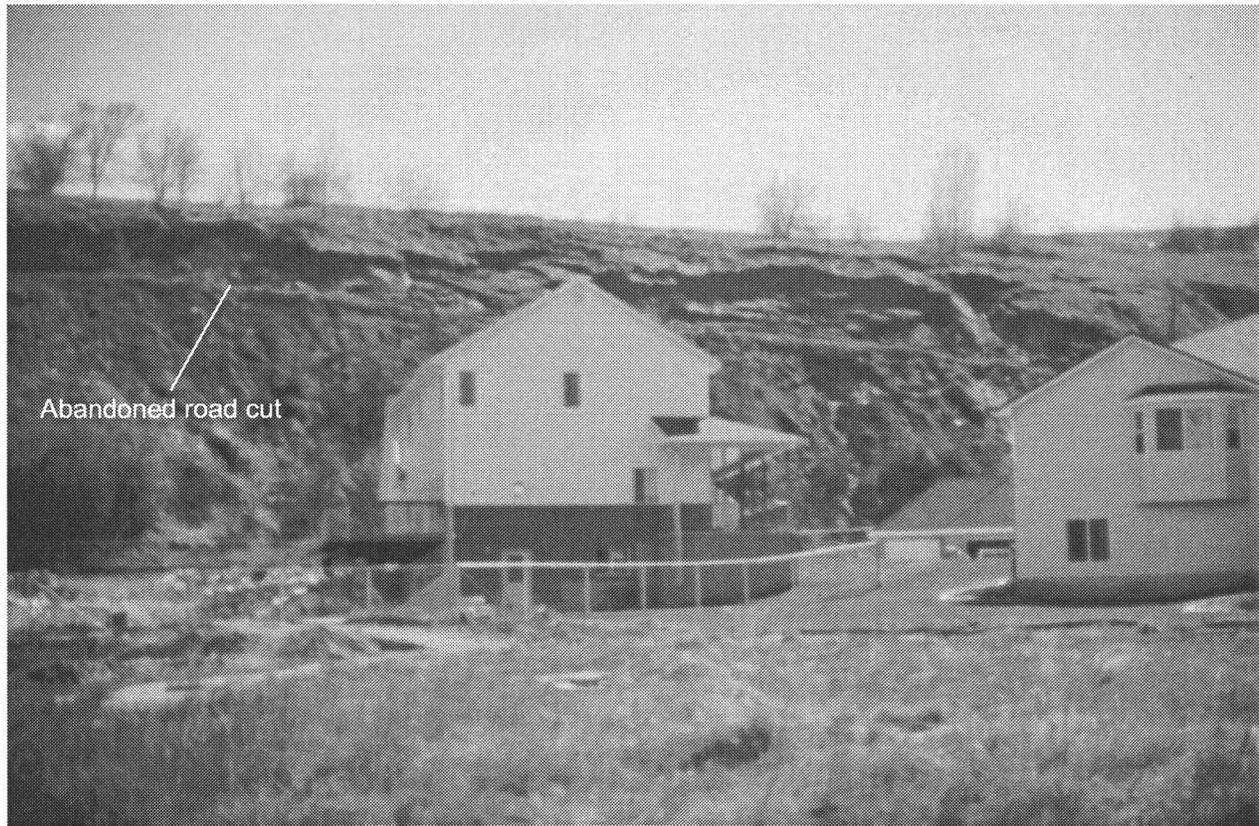
**Attachment 3.** South view of lower slope behind the Cedar Bench subdivision. Shallow earth slides are above and below the abandoned road cut.

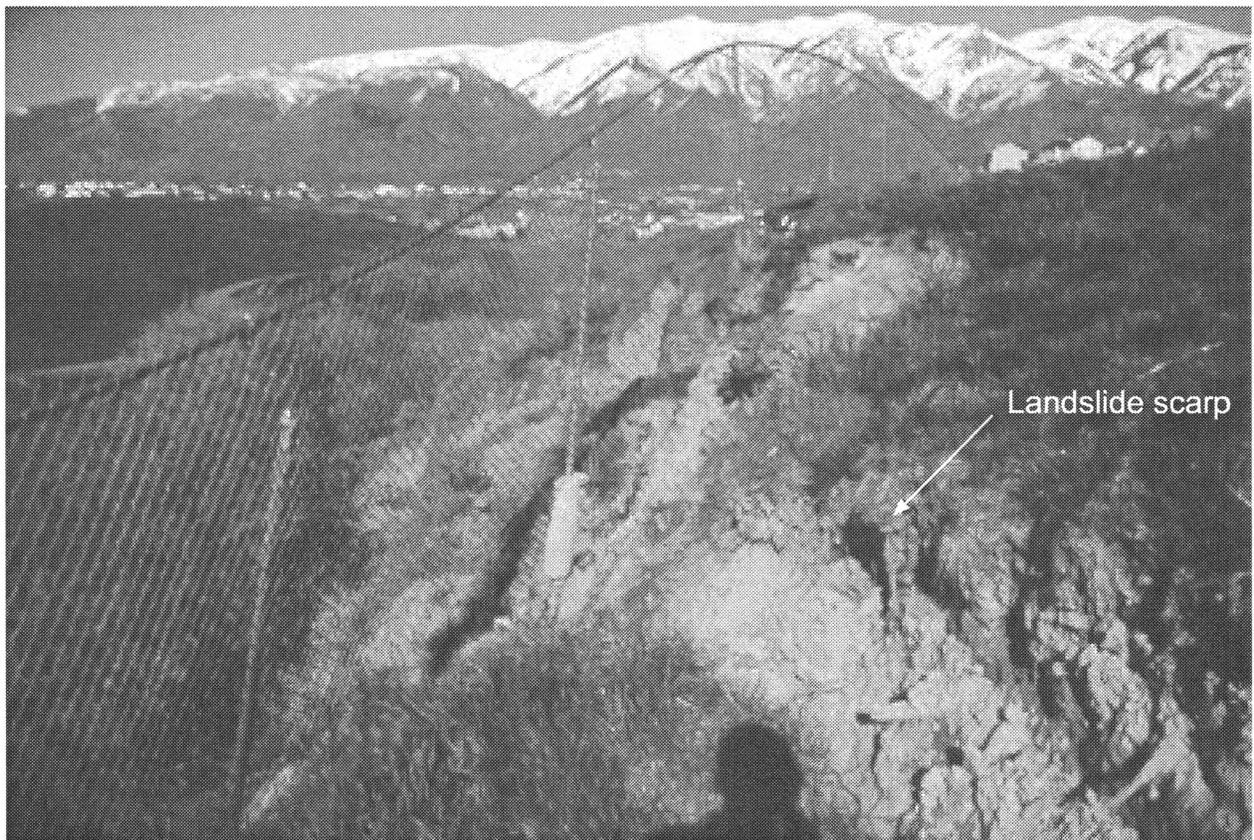
**Attachment 2.** South Fork Kays Creek landslide main scarp, showing damage to chain-link fence and lawn. Arrow points to scarp. The area left of the scarp has dropped down and moved to the left. View is to the east on April 29, 1998.

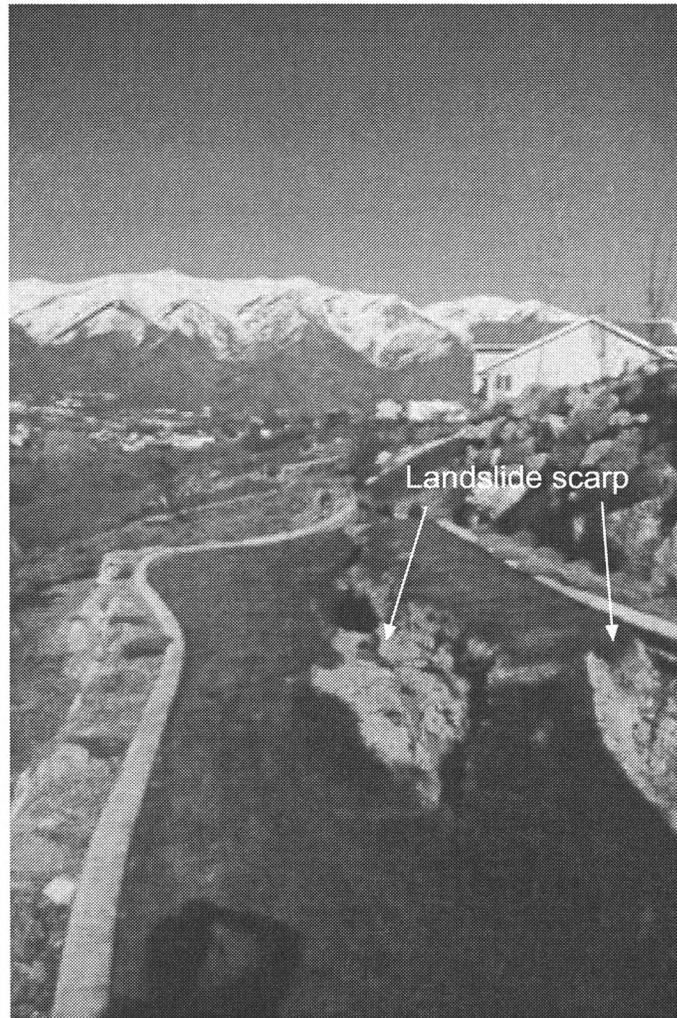
**Attachment 3.** South Fork Kays Creek landslide main scarp, showing damage to lawn. Arrows point to main scarp. The area left of the scarp has dropped down and moved to the left. View is to the east on April 29, 1998.

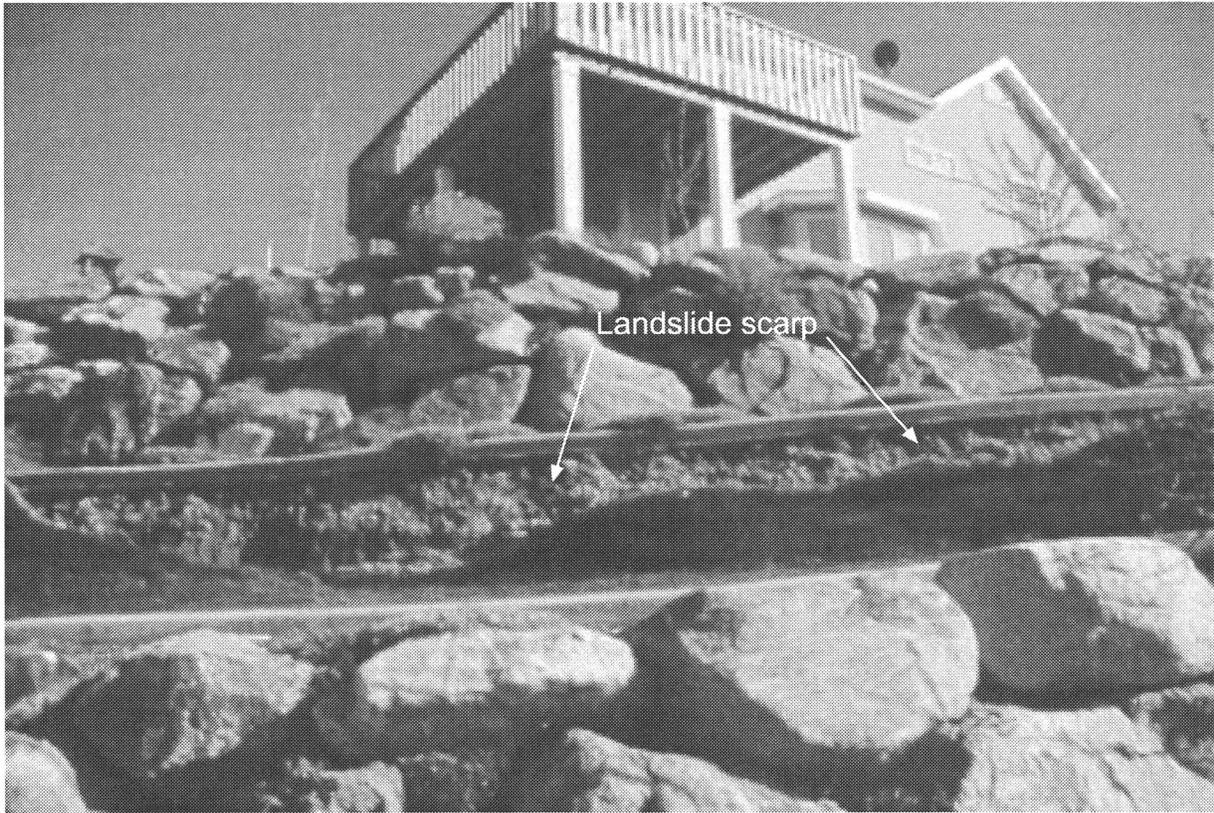
**Attachment 4.** South Fork Kays Creek landslide main scarp, showing damage to landscaping. Arrows point to main scarp. The area in front of the scarp (foreground) has dropped down relative to the area behind the scarp (background). View is to the east on April 29, 1998. The house at 1543 North 1050 East is in the background.

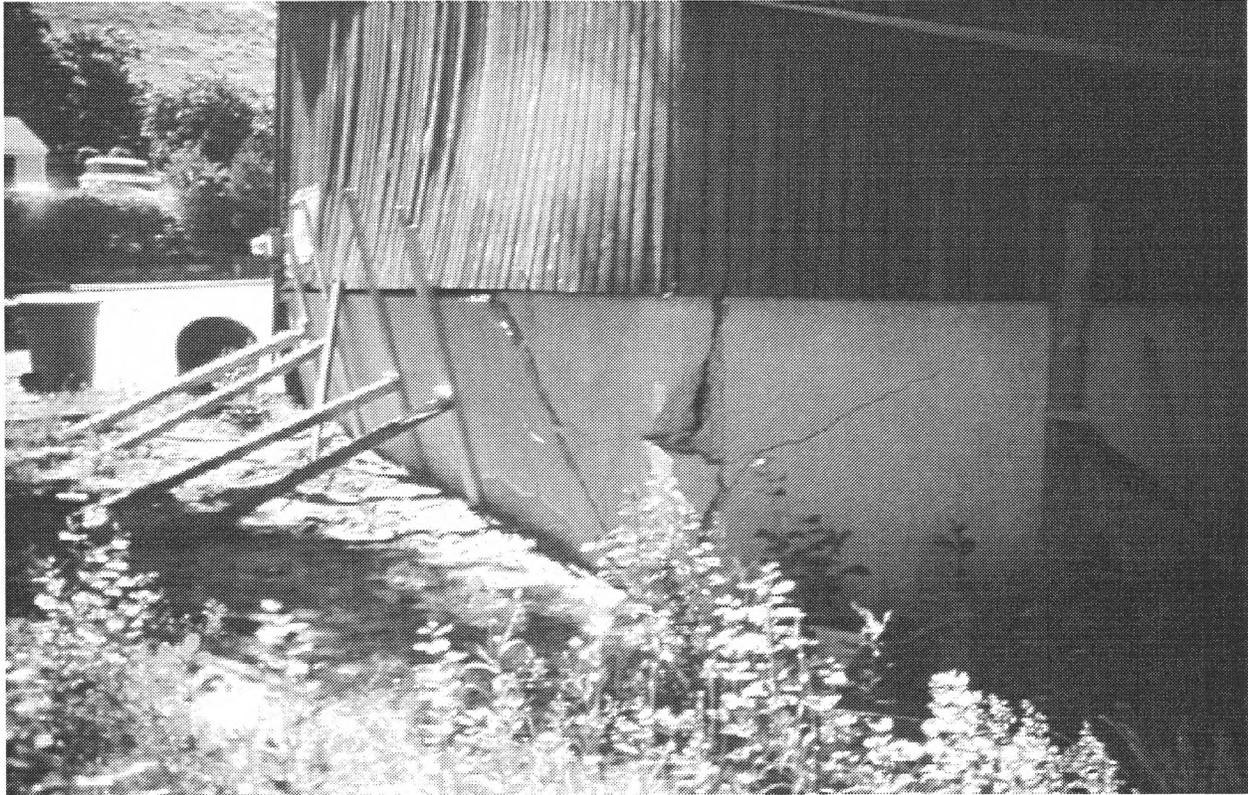
**Attachment 3.** Building distress in the north foundation wall of the house at 160 South Springhill Drive. View is to the southeast on July 6, 1998.

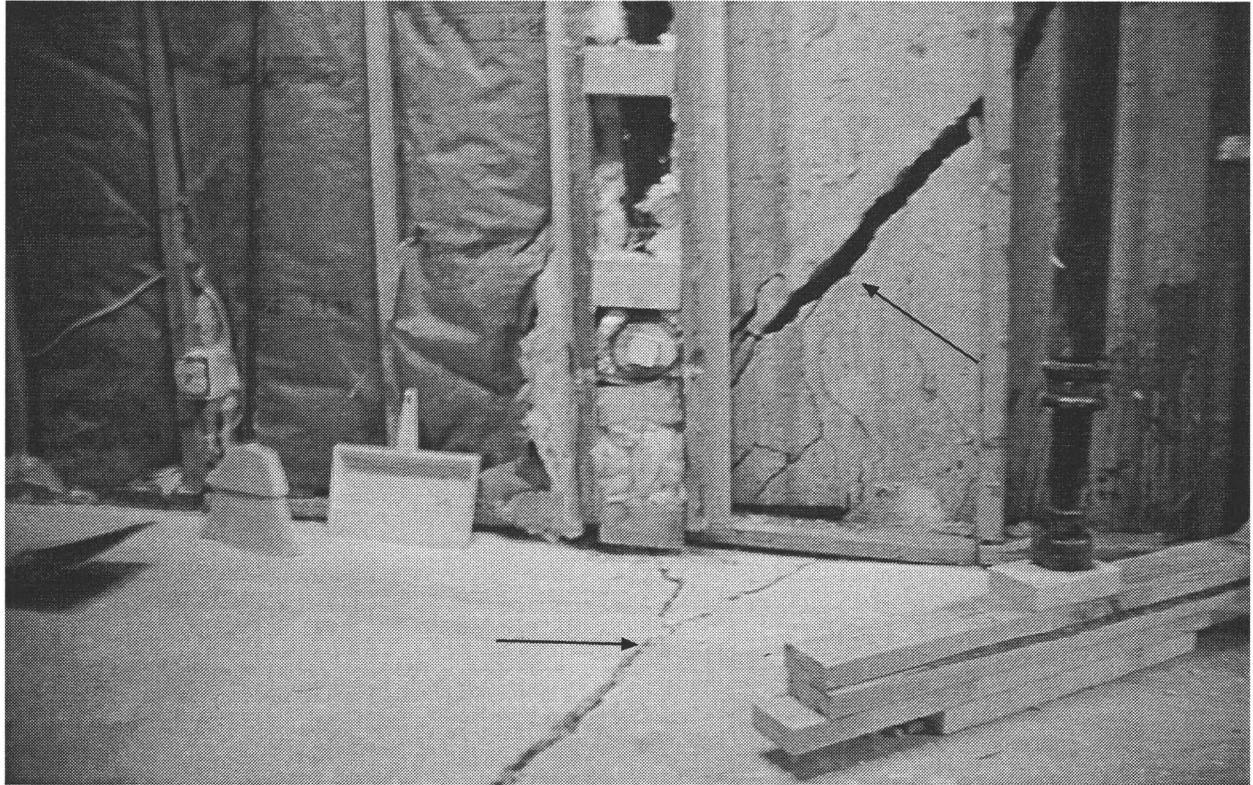
**Attachment 5.** Building distress in the south interior concrete foundation wall and floor at 410 Springhill Circle. Arrows point to cracks in the foundation wall and floor. View is to the south on July 1, 1998.

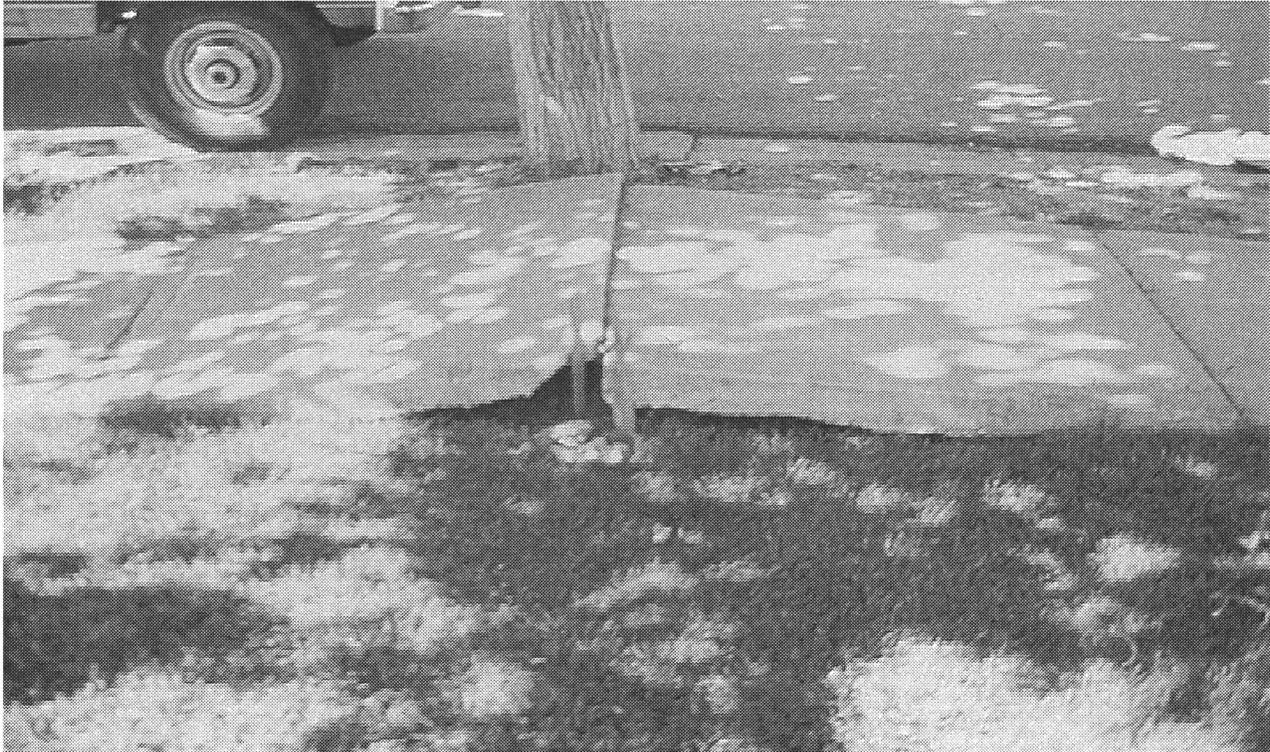
**Attachment 6.** Uplift of sidewalk caused by apparent contractional ground movement at 191 South Springhill Drive. View is to the south on July 1, 1998.

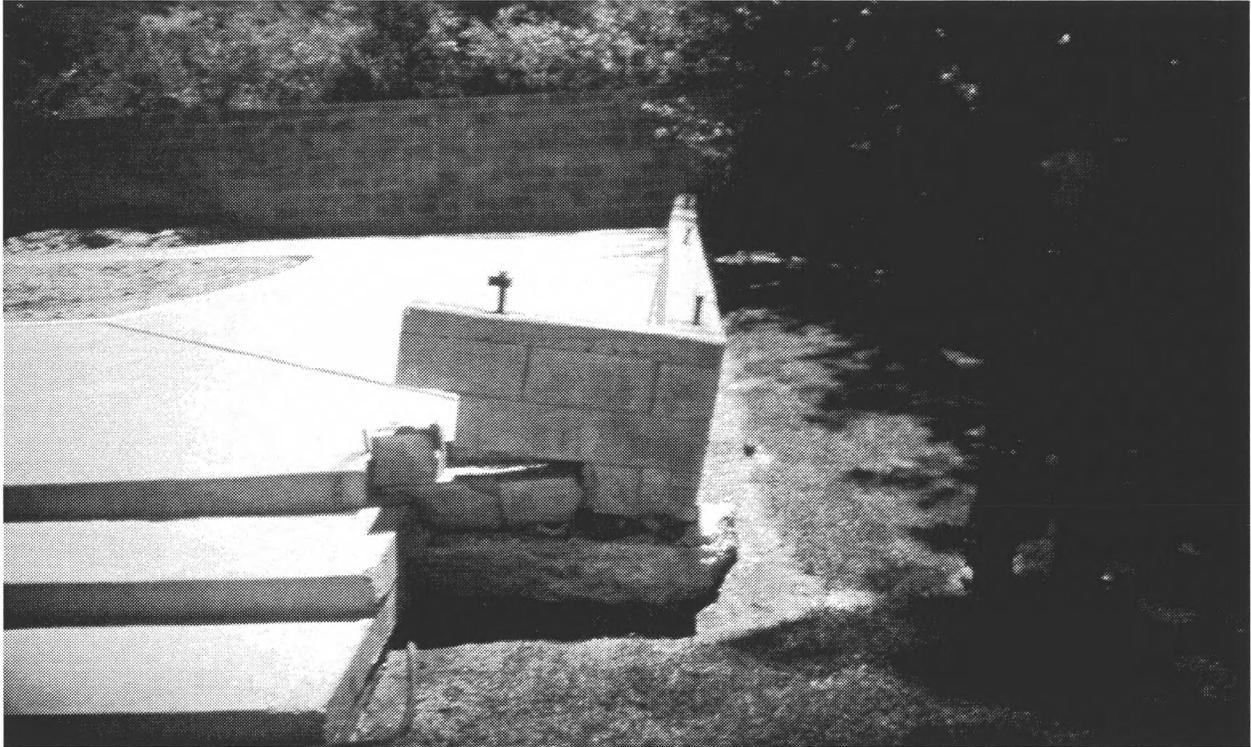
**Attachment 7.** Deformed cinder block retaining wall in the back yard of 402 Springhill Circle. View is to the south on July 6, 1998.

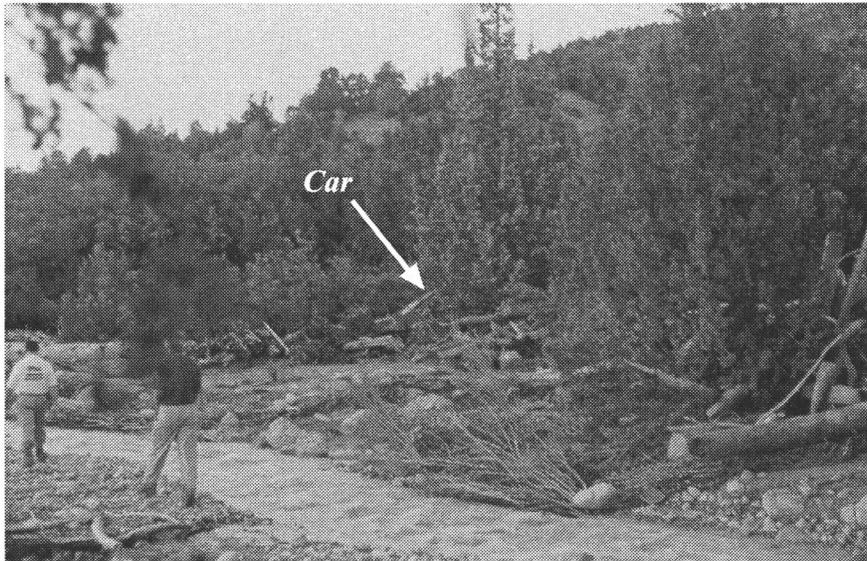
**Attachment 2.** A car belonging to campers was washed downstream and left stranded atop a mound of debris near the mouth of Canal Canyon on July 22.

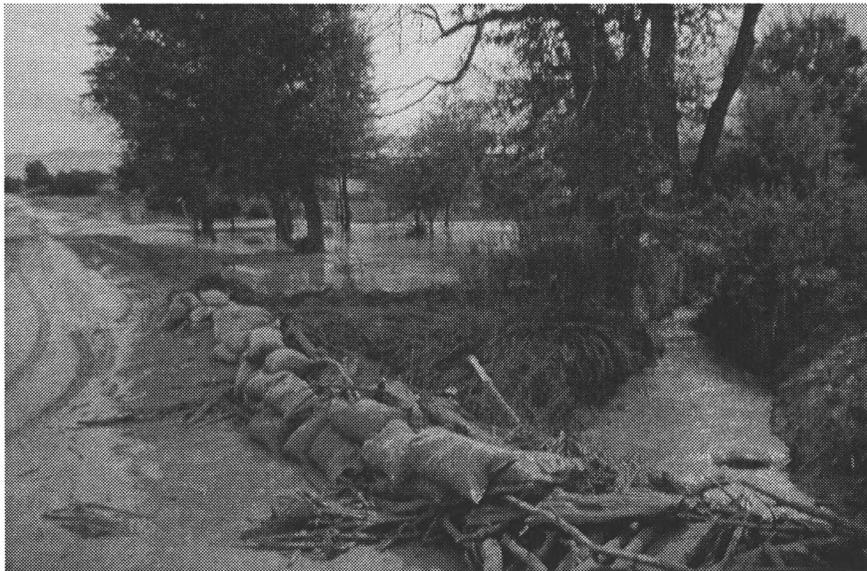
**Attachment 3.** Residual mud deposited during July 22 flooding of property adjacent to an irrigation ditch crossing the southern part of Spring City. The ditch flows from Canal Creek.

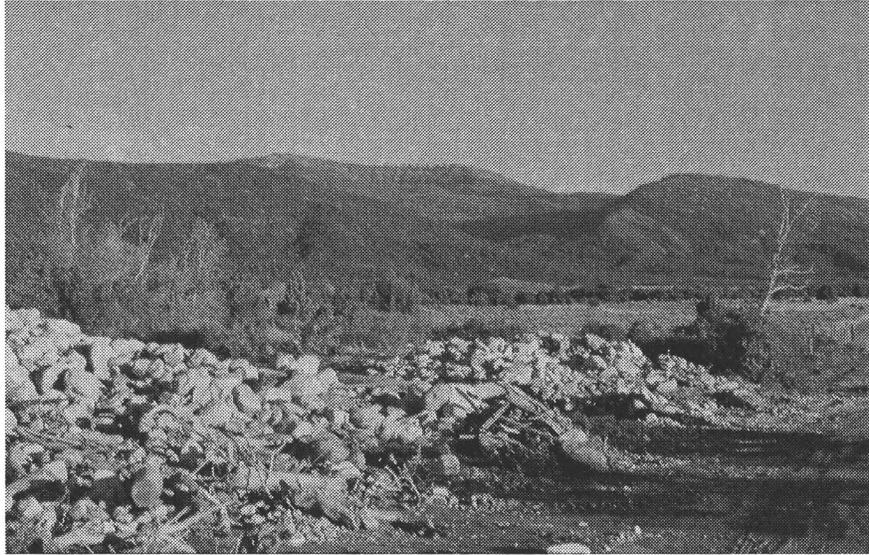
**Attachment 4.** Southeast view of Horseshoe Mountain at the head of Canal Canyon. Bouldery debris in the foreground was removed from Canal Creek by emergency-response teams after the July 22 flood.

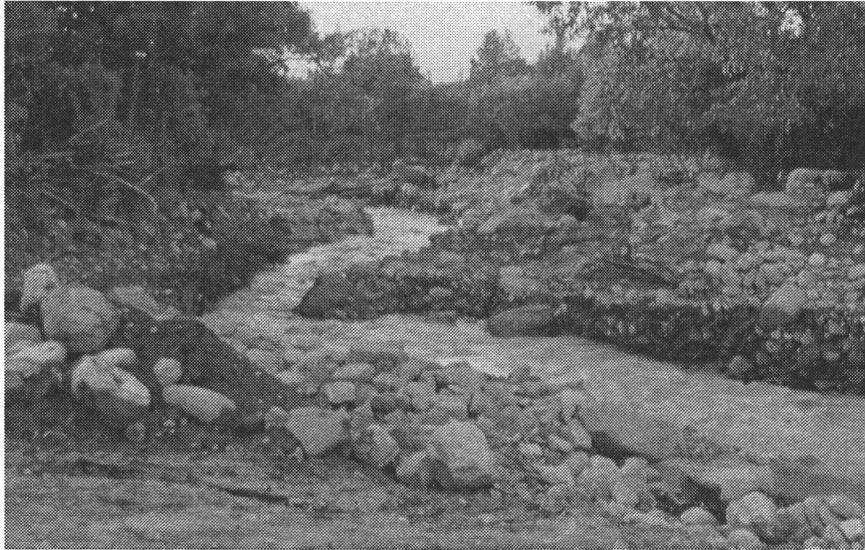
**Attachment 6.** Bouldery alluvial deposits in the incised flood plain of Canal Creek at the canyon mouth.

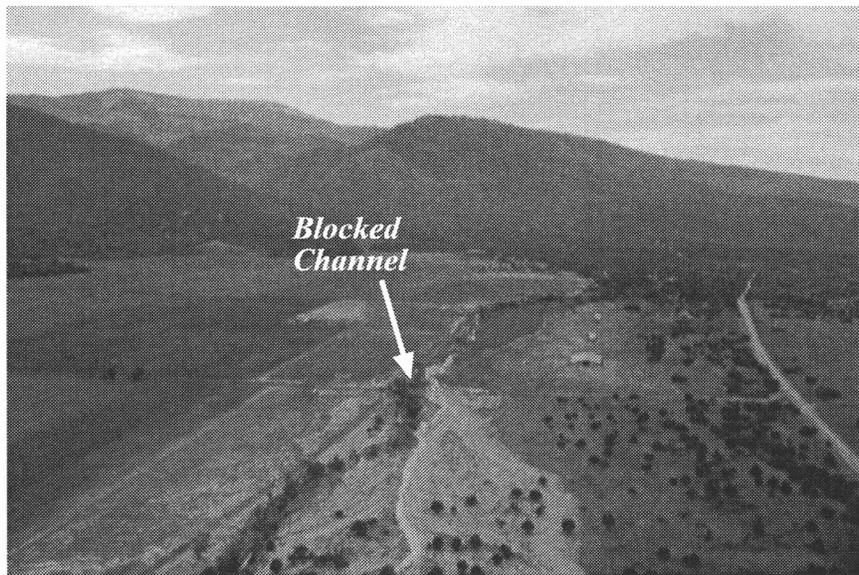
**Attachment 7.** Sheet flooding on Canal Creek on July 22 downstream of a channel blocked by debris, about 3 miles (5 km) southeast of Spring City.

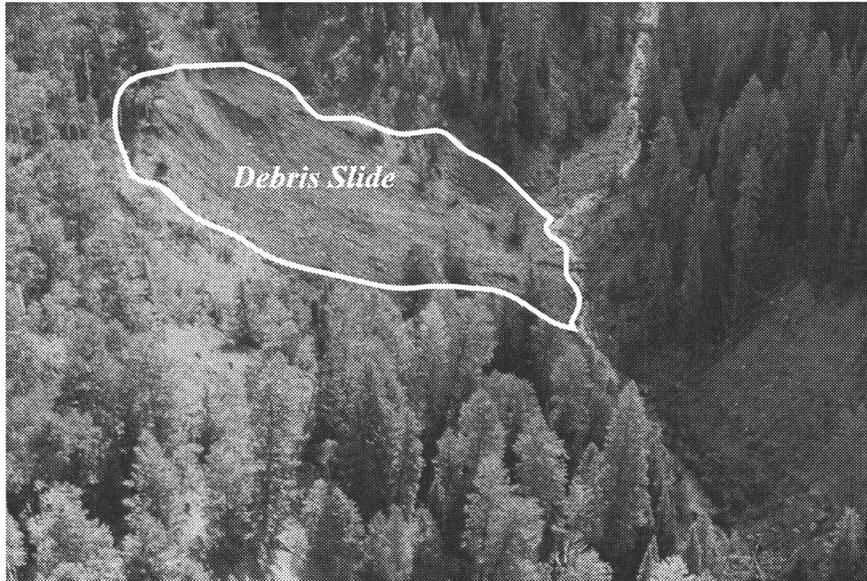
**Attachment 8.** A typical debris slide in upper Canal Canyon that was active during the July flooding. The creek is deflected around the slide toe, but material appears to have been rapidly eroded from the channel. No evidence exists of a landslide dam or ponding at this location.

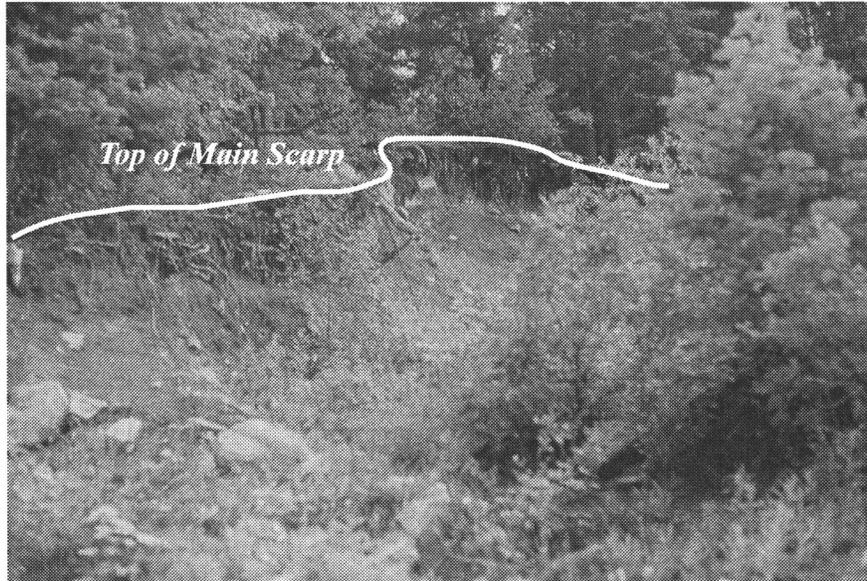
**Attachment 9.** The main scarp of an active slump near Canal Creek. The scarp is about 10 feet (3 m) high at this location. Most of the movement on the main scarp apparently predates the recent torrential rainfall, but a smaller secondary scarp downslope (not visible in this photo) recently moved.

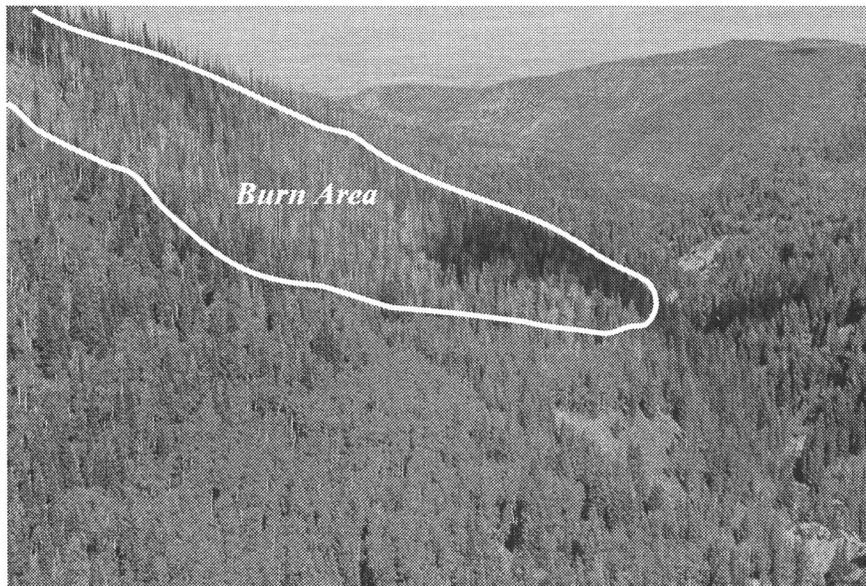
**Attachment 11.** Area of a controlled burn conducted in 1996 or 1997 on the slopes of upper Canal Canyon. Although burned areas are susceptible to slope instability, this area was stable during recent torrential rainfall.

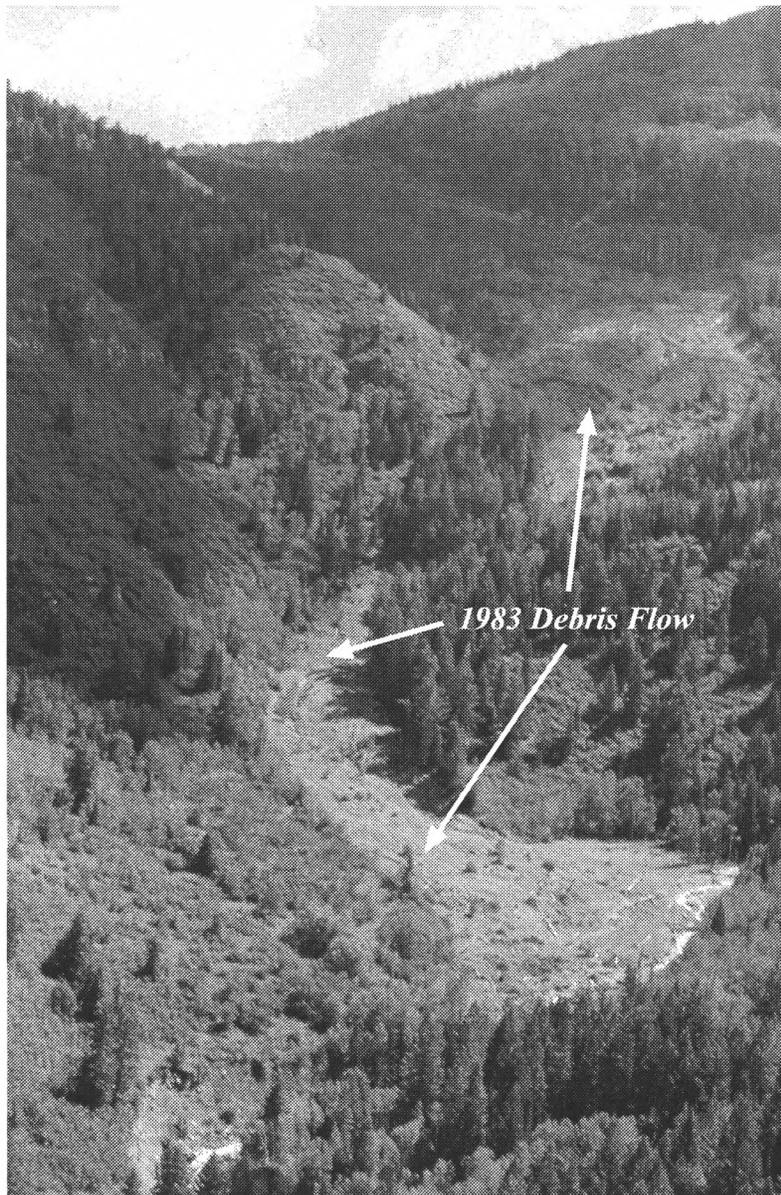
**Attachment 12.** An inactive debris flow on the flank of Knob Mountain above Oak Creek. Movement occurred during a period of rapid snowmelt in 1983.
