TECHNICAL REPORTS FOR 2002–2009 GEOLOGIC HAZARDS PROGRAM

COMPILED BY ASHLEY H. ELLIOTT

Report of Investigation 269
Utah Geological Survey
a division of
Utah Department of Natural Resources
2010

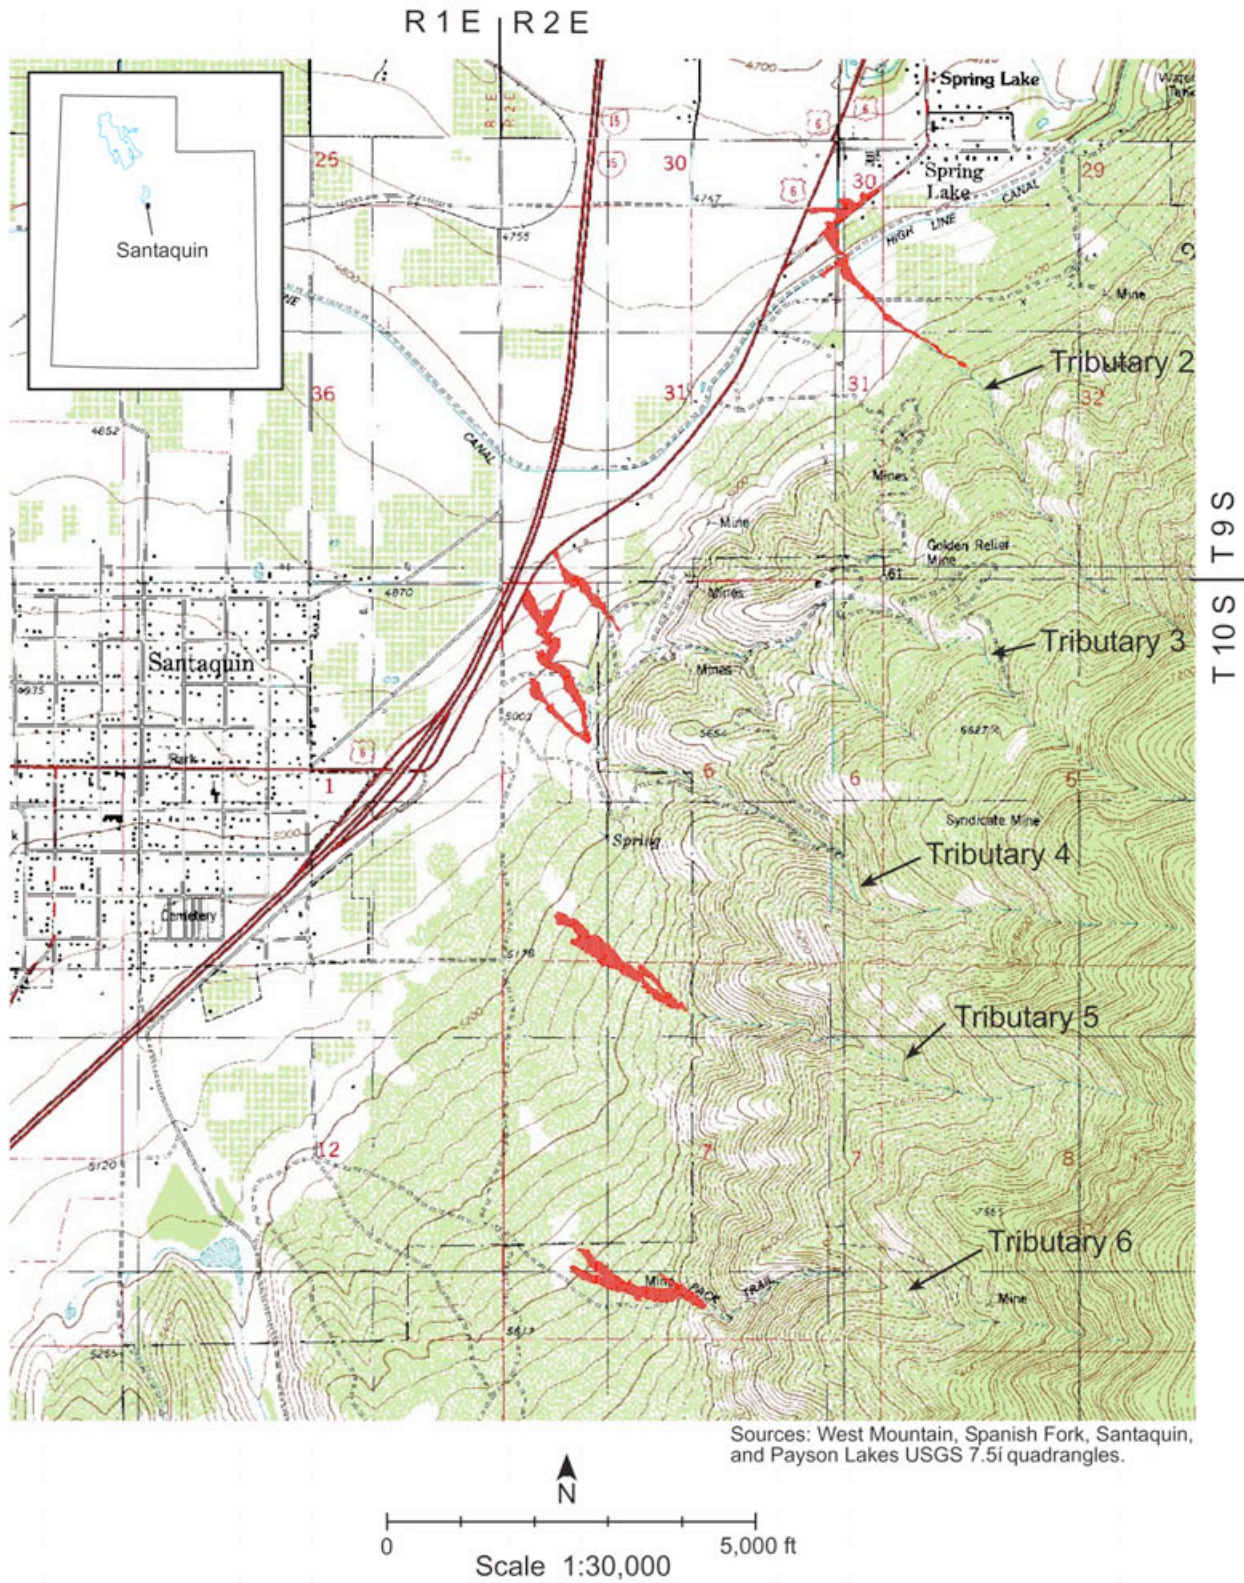
Figure 1. Approximate extent of September 12, 2002, debris-flow deposits and alluvial-fan flooding (red).

- The debris flows were triggered by intense thunderstorm precipitation on the upper burned slopes of Dry Mountain, which eroded soil by sheetwash and rilling. Runoff rapidly concentrated into channels, eroding and bulking sediment to a debris-flow sediment-water concentration. The flows continued to grow by accumulating channel sediment until they reached the canyon mouths where they spread out and deposited debris on alluvial fans.

- Water-repellent soils and diminished vegetation in the tributaries caused by the Mollie fire contributed to the debris flows of September 12, 2002. Because it takes several years for soil and vegetation in burned watersheds to recover to pre-burn conditions, the short-term debris-flow hazard will be heightened for several years.

- The guidelines and recommendations outlined in Pietramali (2002), Solomon (2001), Rasely (2001), and U.S. Forest Service (2001, 2002) BAER reports to manage the debris-flow hazard should be followed.

- A debris-flow hazard existed before the fire and will remain after the drainage basin vegetation recovers to pre-burn conditions. Therefore, measures will also need to be taken to reduce the long-term non-fire-related debris-flow hazard.

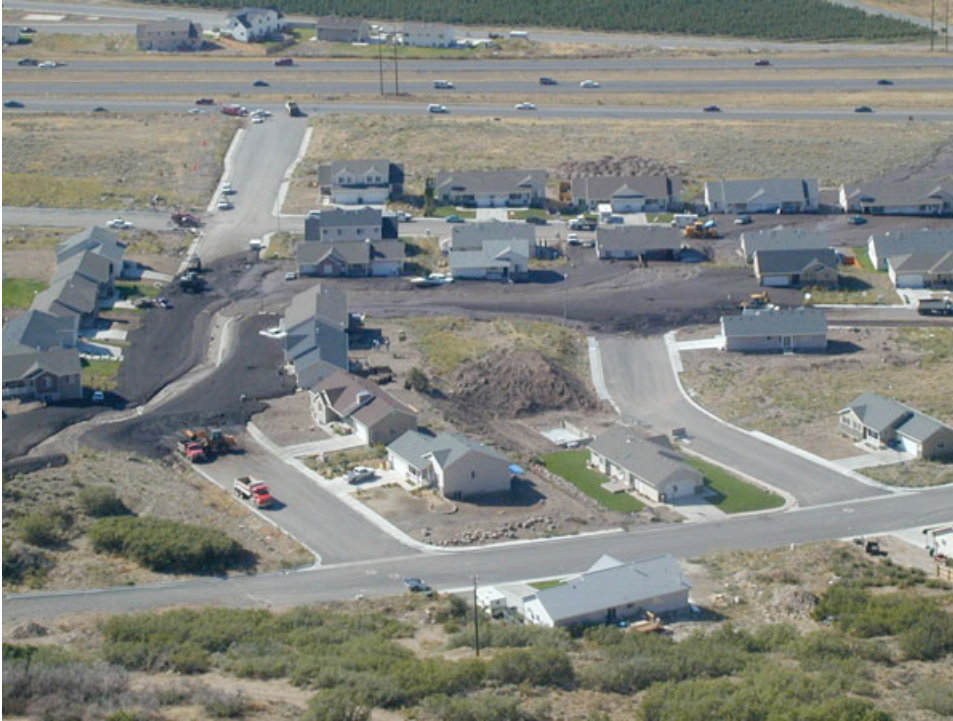
(a) View looking west of tributary 4 north deposit in Santaquin subdivision.
 Photo by Dale Deiter, U.S. Forest Service.

The debris flow from tributary 4 was the most damaging of the five. When the flow reached the mouth of tributary 4, it split into two lobes. The larger, north lobe flowed through the Santaquin subdivision causing substantial property damage (figure 4a, figure 5). Most of the north lobe did not follow city streets but established a direct path down the alluvial fan. Subsequent floodwater traveled down roadways. The south lobe flowed down an undeveloped portion of the fan and deposited debris on a newly excavated subdivision road south of the existing development.

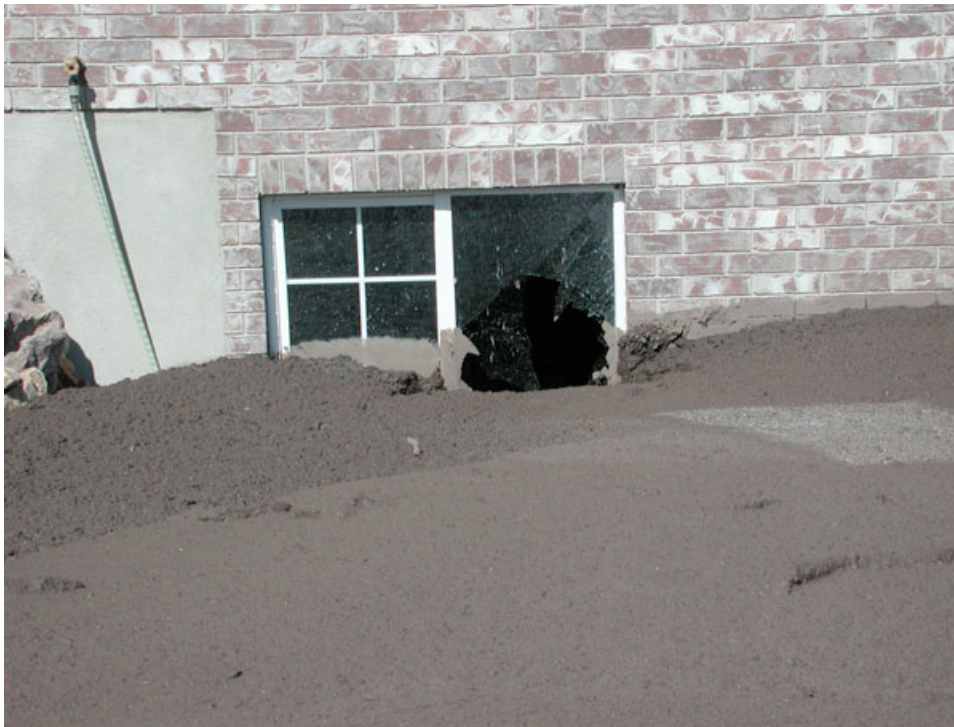
(b) The debris-flow impact broke through this basement window of a house on Apple View Street.

Figure 5. Debris-flow/flooding damage in Santaquin subdivision.

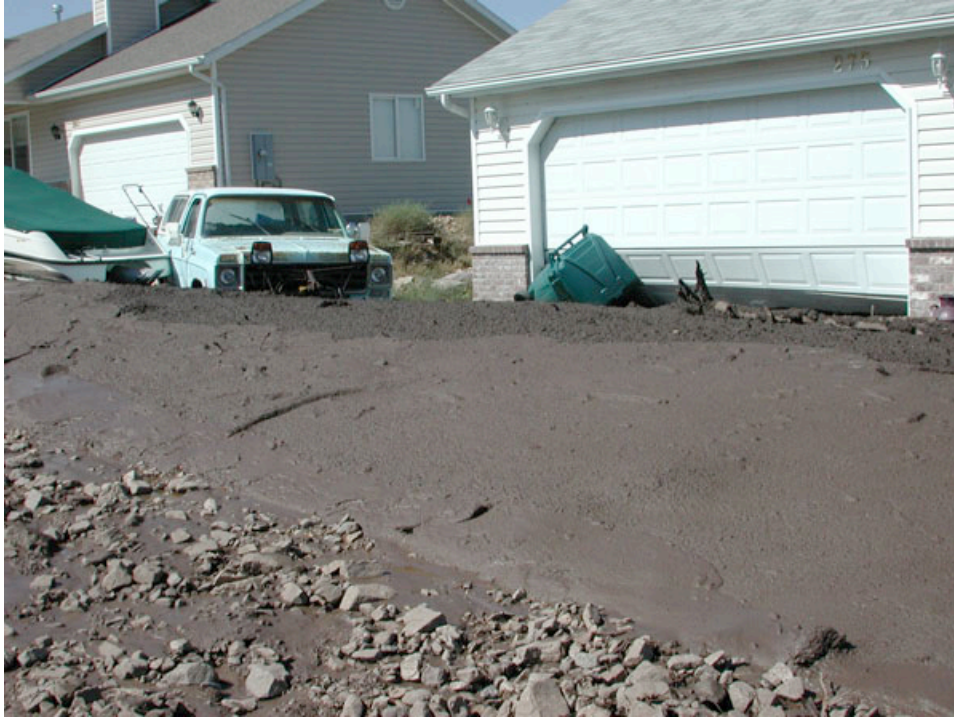
(c) Debris-flow damage to garage doors of house on Peach Street.

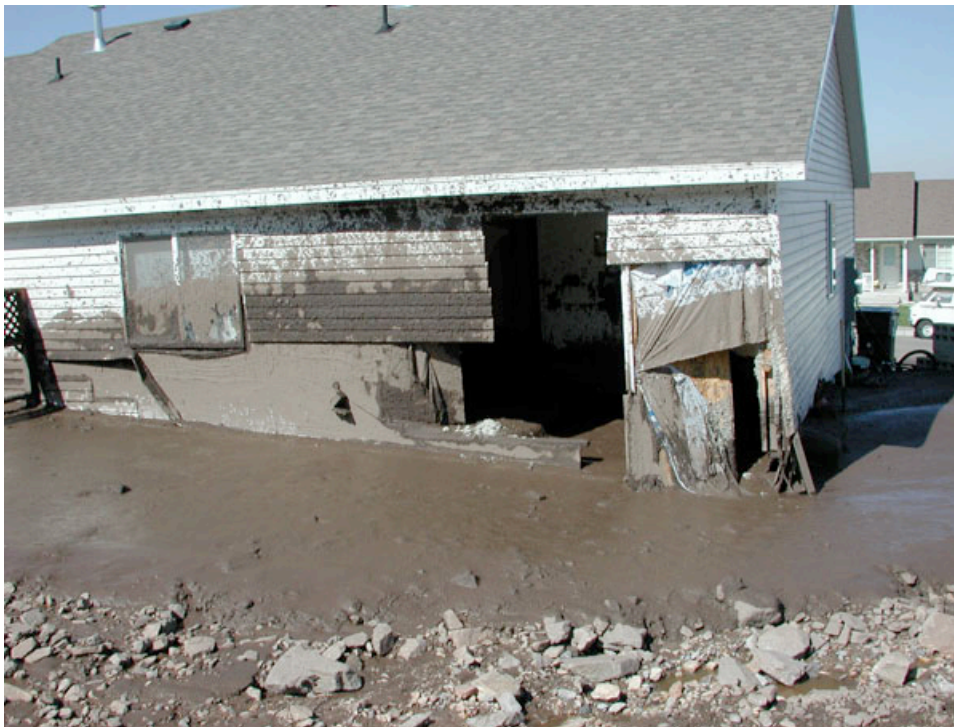
(d) Debris-flow damage to the back wall of house on Peach Street.

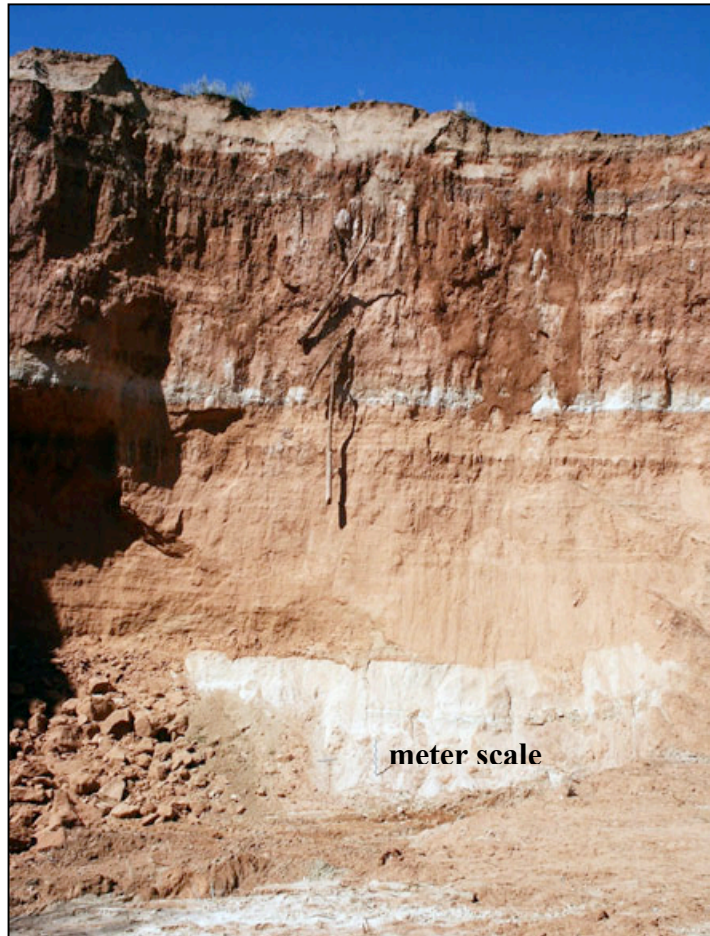
Figure 1. This approximately 60-foot-high arroyo wall failed on March 12, 2005, creating an earth-fall landslide that buried one child and partially buried two others. Alternating layers of sand, silty sand, and silty clay comprise the majority of the stream cut.

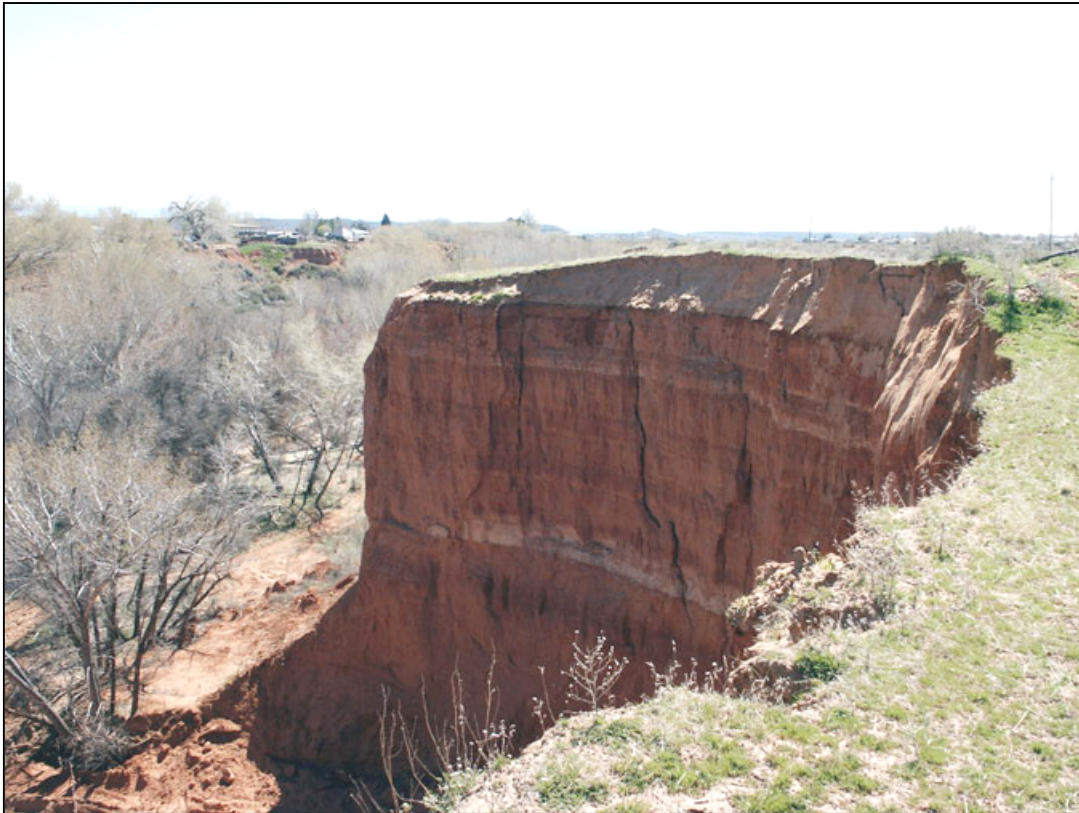
Figure 4. Deep, vertical cracks parallel to the arroyo wall along which a section of the wall detached creating an earth-fall landslide.

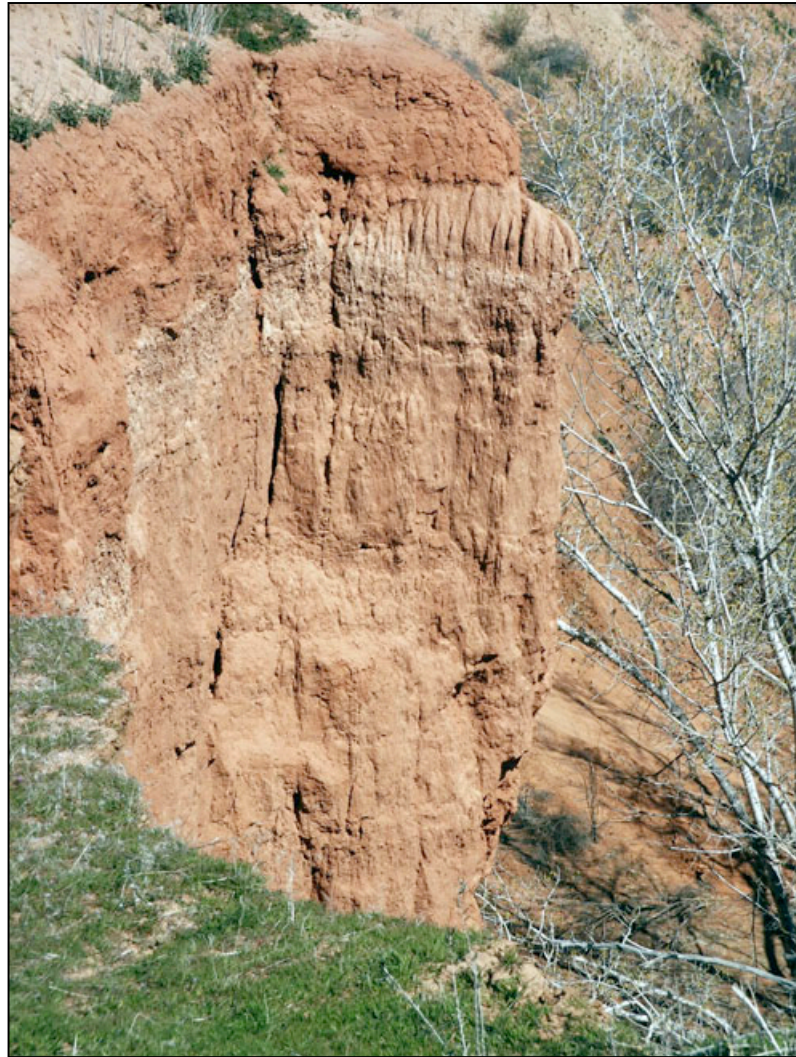
Figure 5. Vertical cracks parallel to the arroyo wall in an area adjacent to the landslide that has not yet failed; such cracks are typical where arroyo walls are vertical.

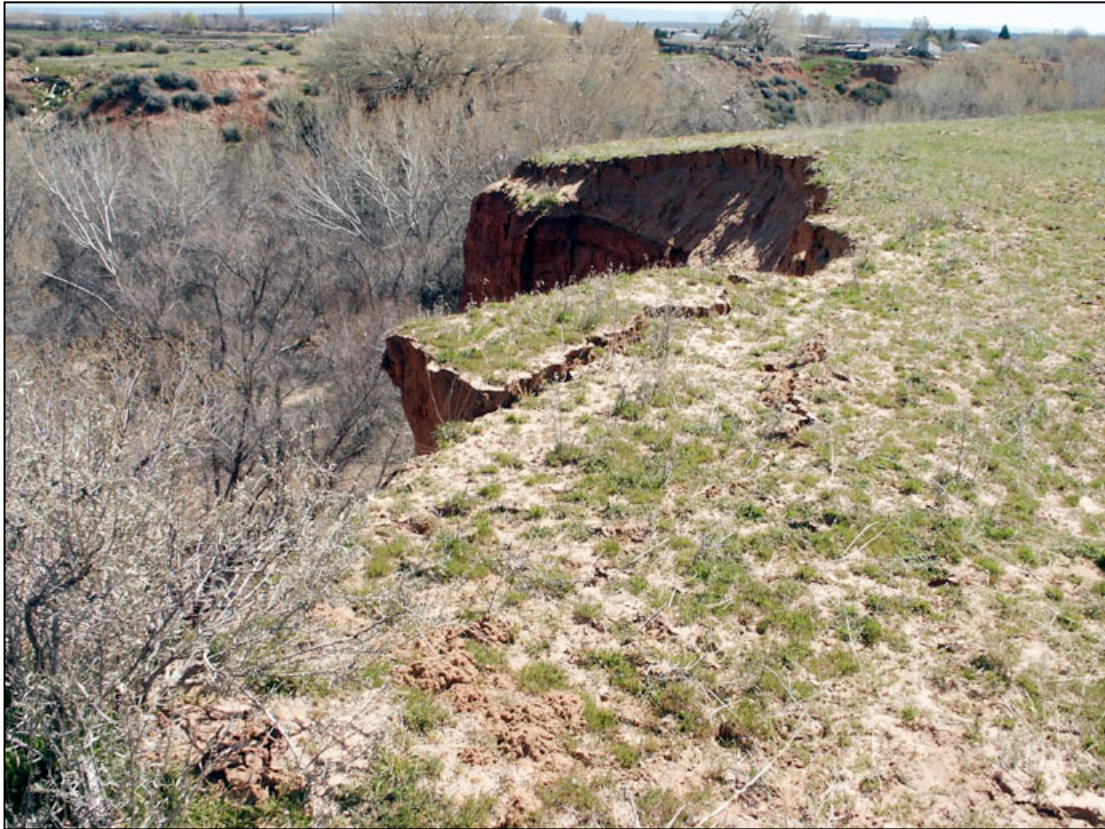
Figure 6. *Partially detached section of the arroyo wall where additional failure is imminent.*

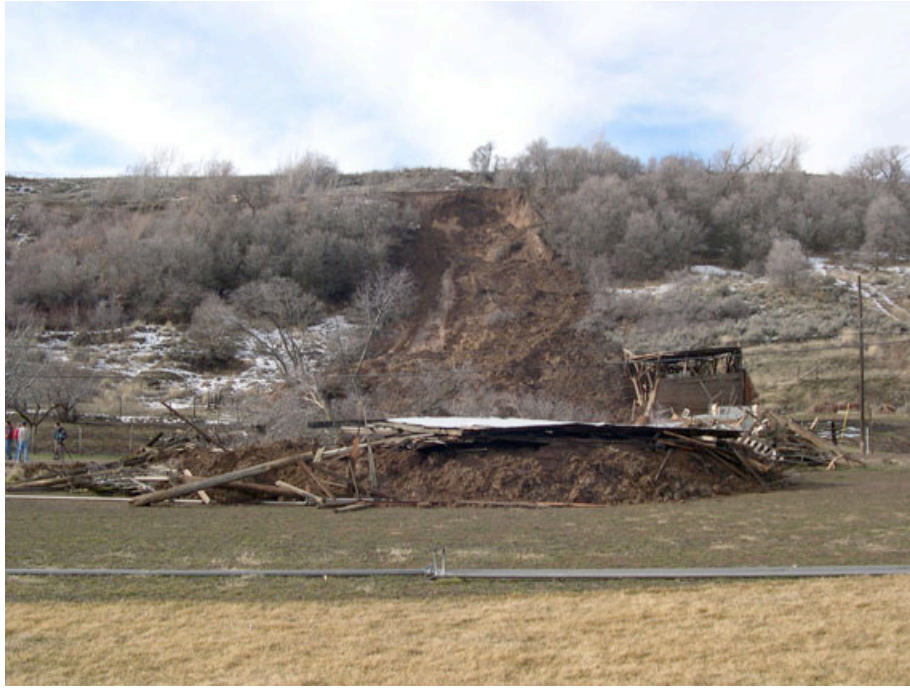
Figure 2. View to the south showing the landslide main scarp in the Davis-Weber Canal embankment, the demolished barn (right foreground), and runout onto the field.

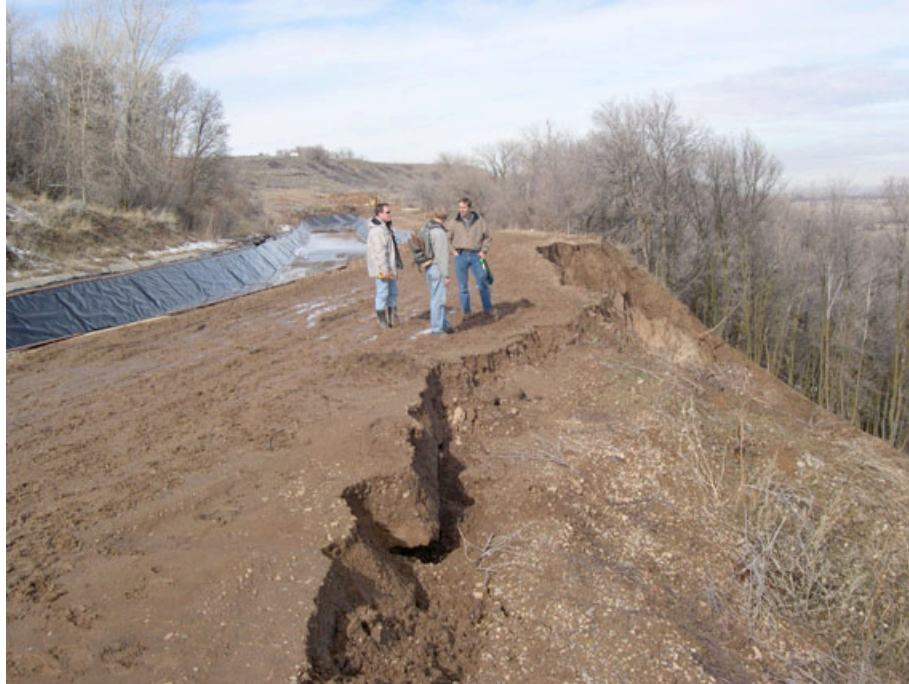
Figure 5. View west of the landslide crown, the Davis-Weber Canal, and the landslide main scarp. Eastward extension of the main scarp in the foreground indicates movement in the slope east of the landslide.

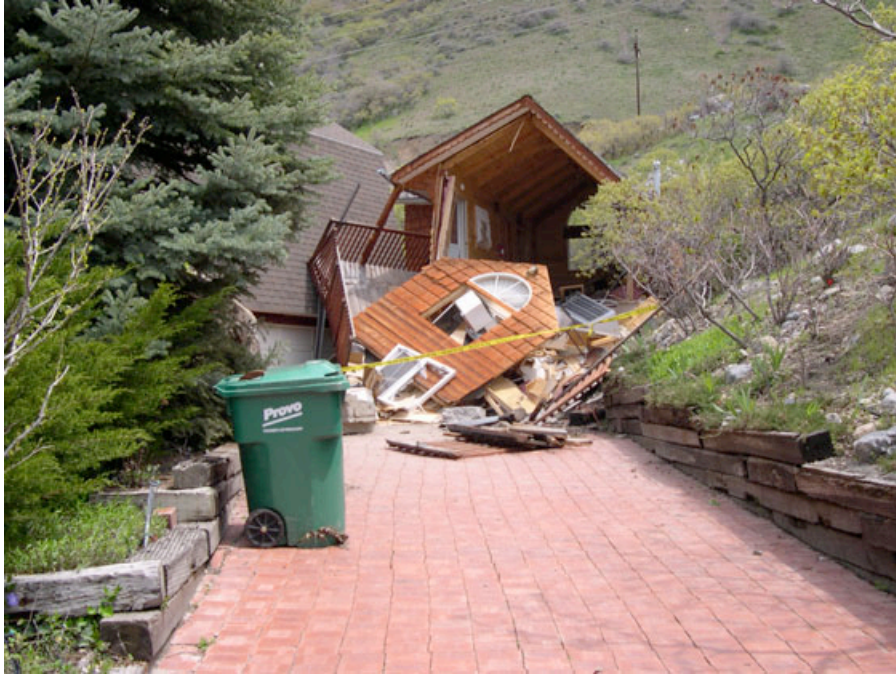
Figure 3. Damage to the guest house. The damaging rock is on the left behind the trash can, against the base of the tree. Parts of the concrete house foundation are behind and to the right of the trash can.

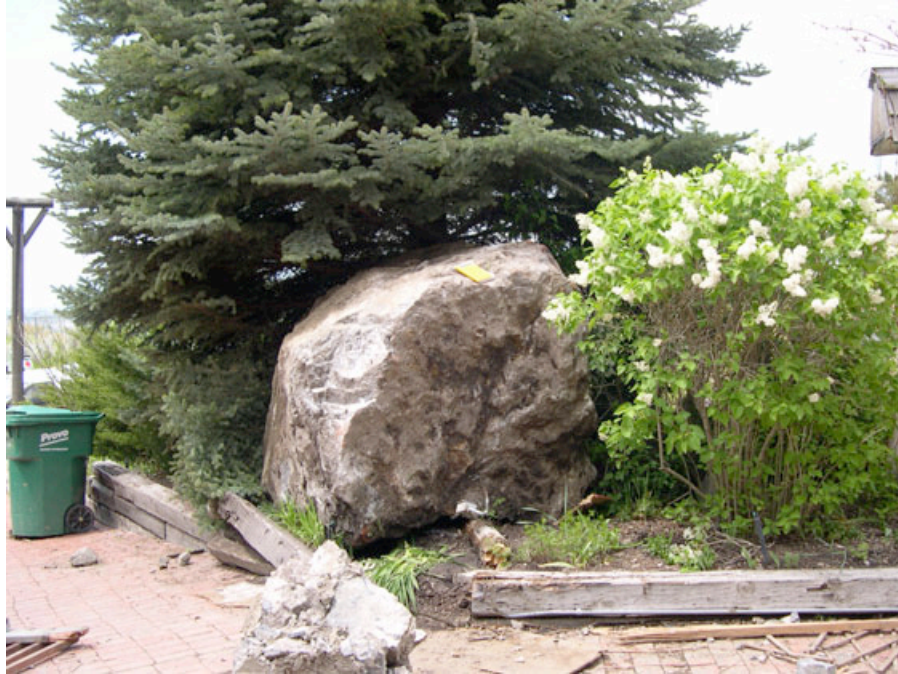
Figure 5. The rock that damaged the guest house. Part of the concrete house foundation wall is in the foreground.

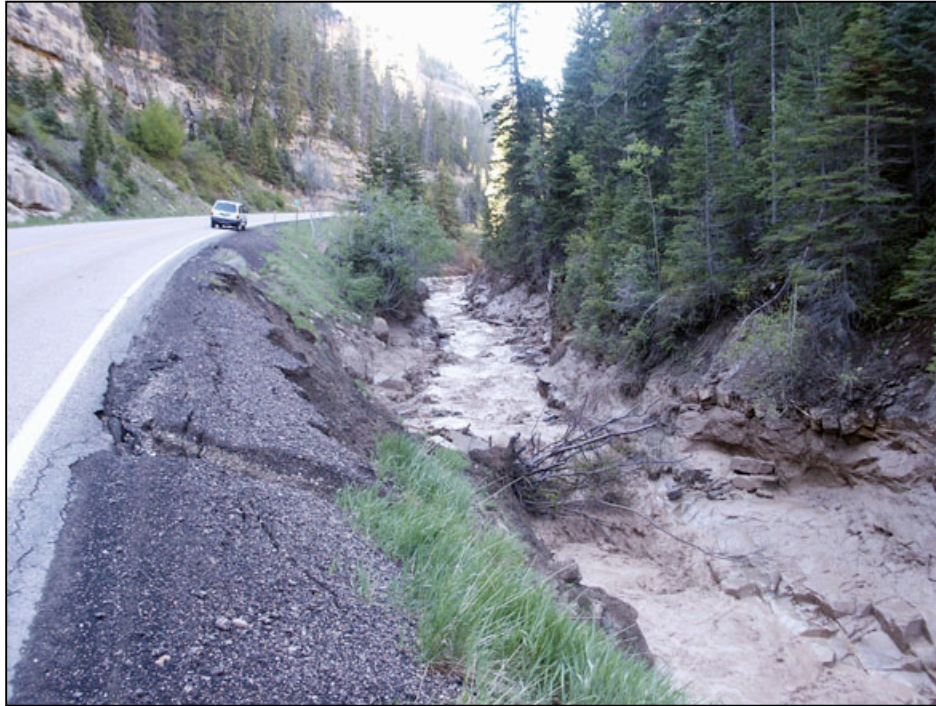
Figure 4. Small slope failure in the roadbed of SR-14 caused by undercutting and erosion of the stream bank by the Black Mountain debris flow.

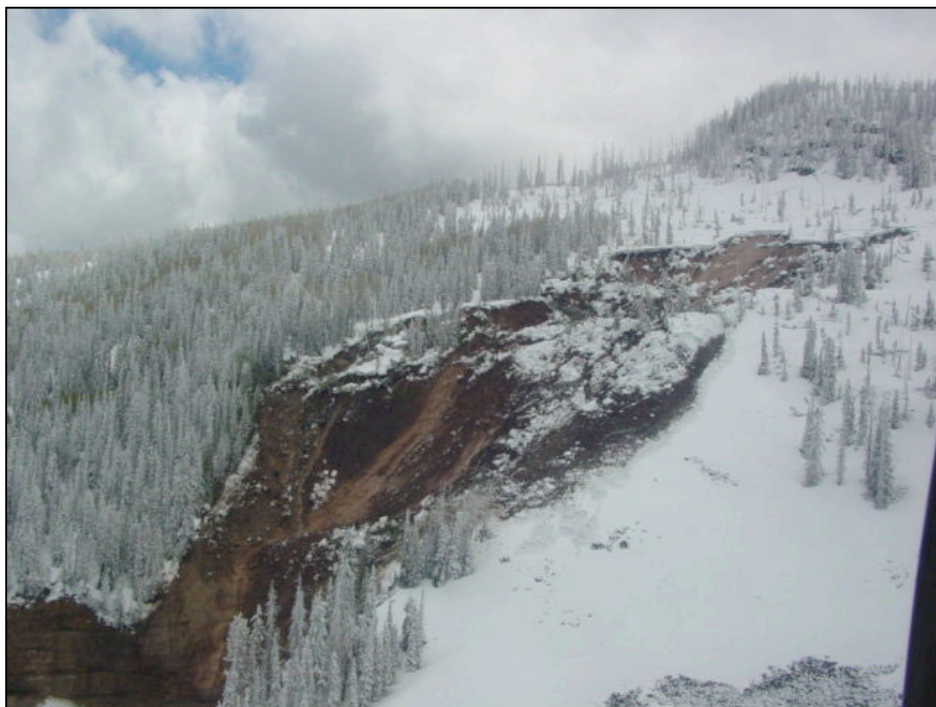
Figure 5. Detached slide mass on Black Mountain from which the Black Mountain debris flow originated (UHP photograph).

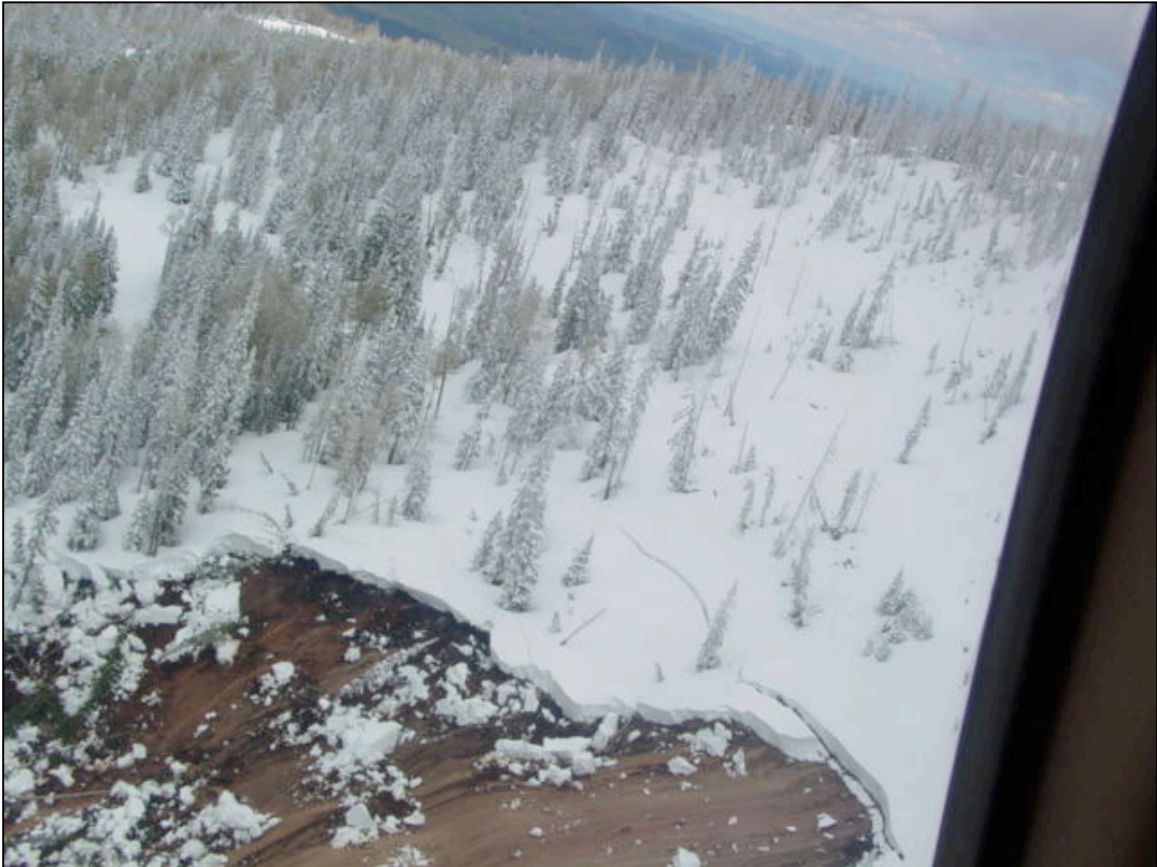
Figure 6. Cracks in the snow upslope from and parallel to the crown scarp of the landslide on Black Mountain from which the Black Mountain debris flow originated (UHP photograph).

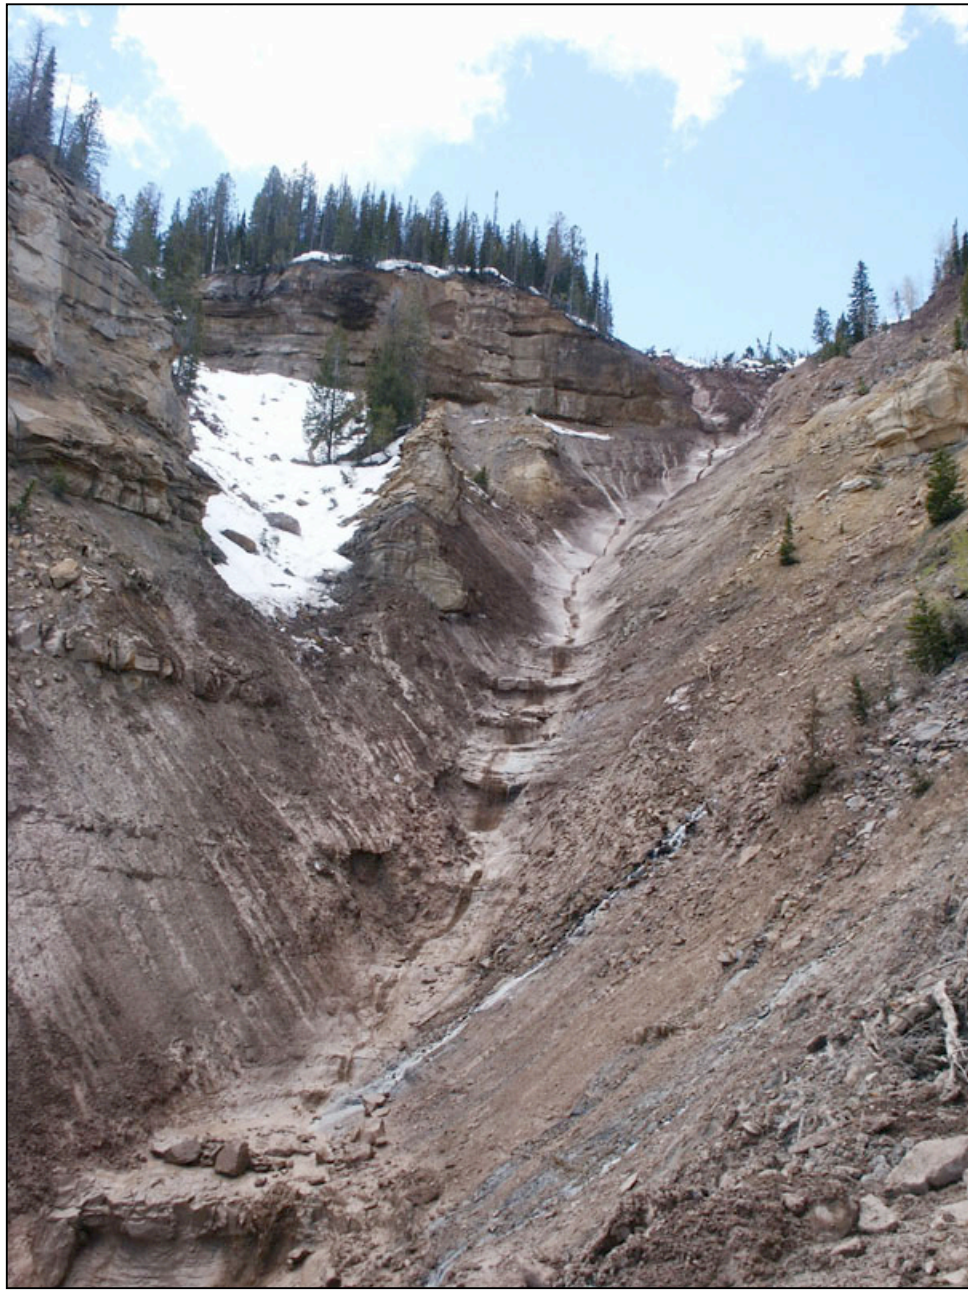
Figure 7. *Headwaters of the un-named drainage on Black Mountain scoured to bedrock by the passage of the Black Mountain debris flow (photograph taken from observation point shown on figure 1).*

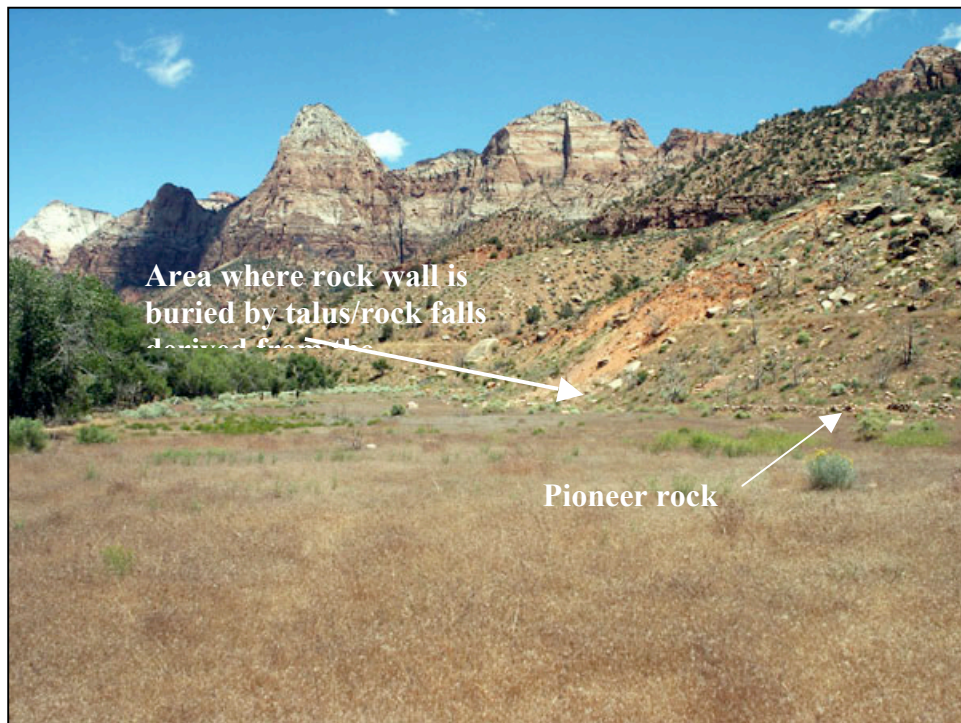
Figure 8. *Pioneer rock wall at the base of the slope is buried by talus/rock falls adjacent to the landslide, but has not been displaced by the landslide toe indicating the landslide rupture surface is shallow at the toe and does not extend beneath the wall.*

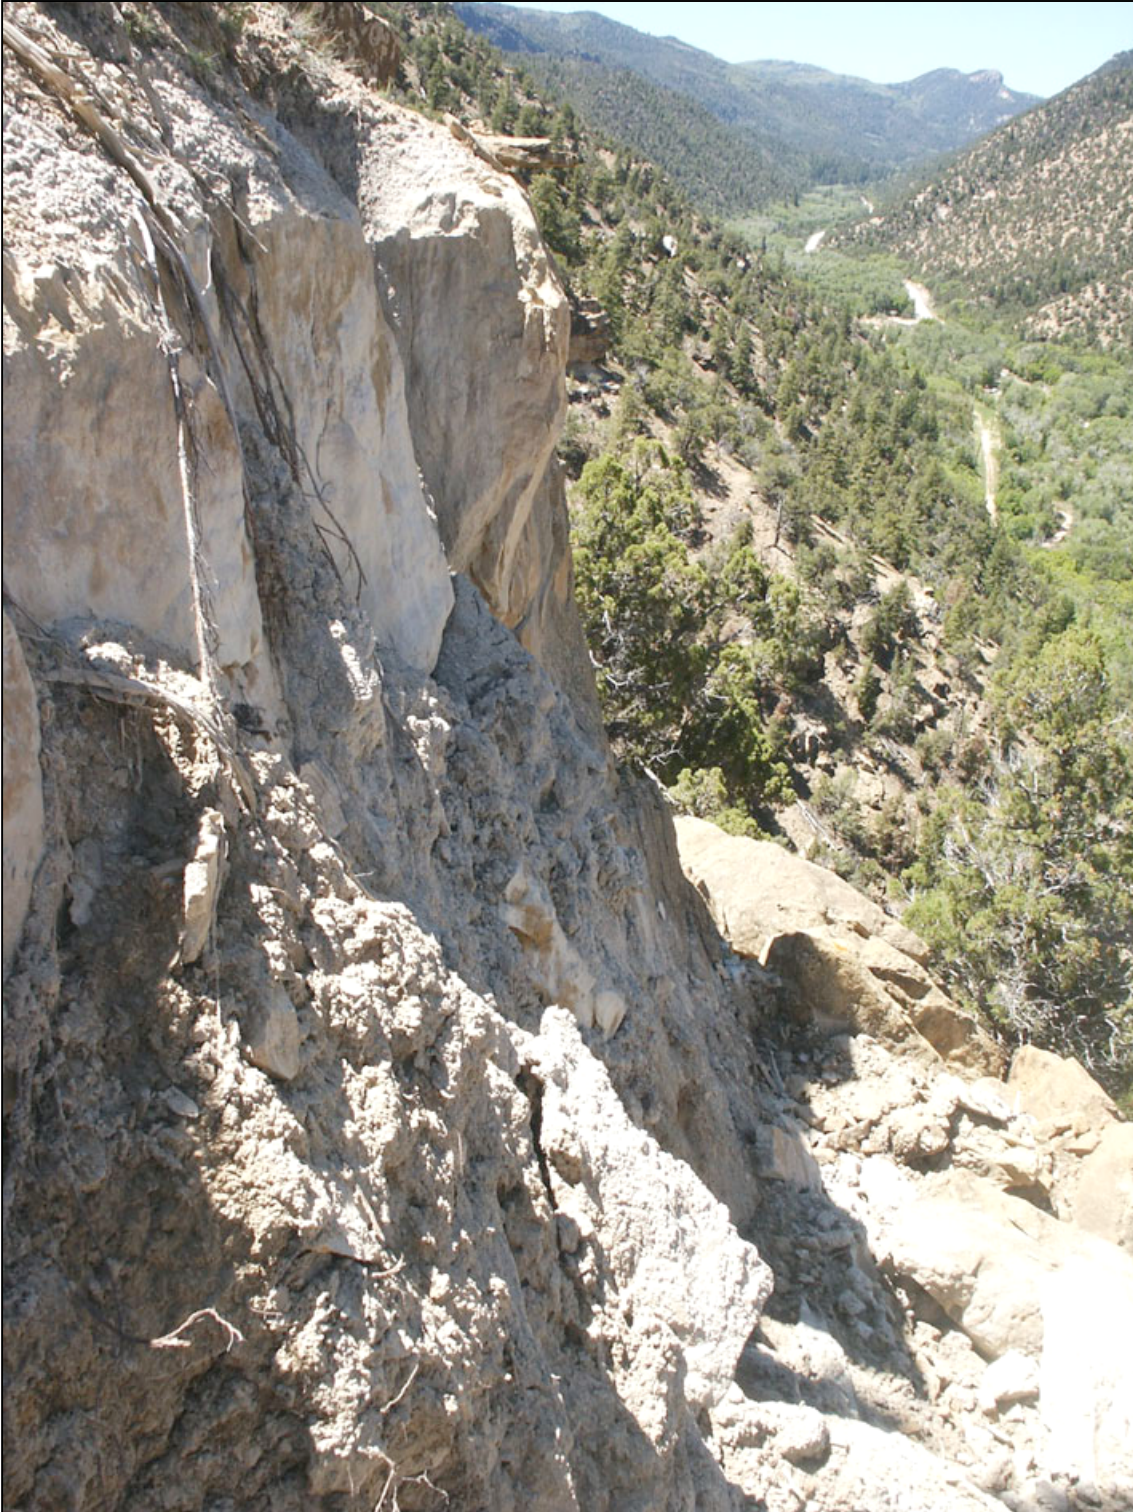
Figure 3. *Approximately 15-foot-high sandstone ledge with thin interbedded shale lenses on the east side of Parowan Canyon where a rock topple initiated the rock fall that damaged the Parowan City penstock. The ledge is approximately 360 feet above the canyon bottom.*

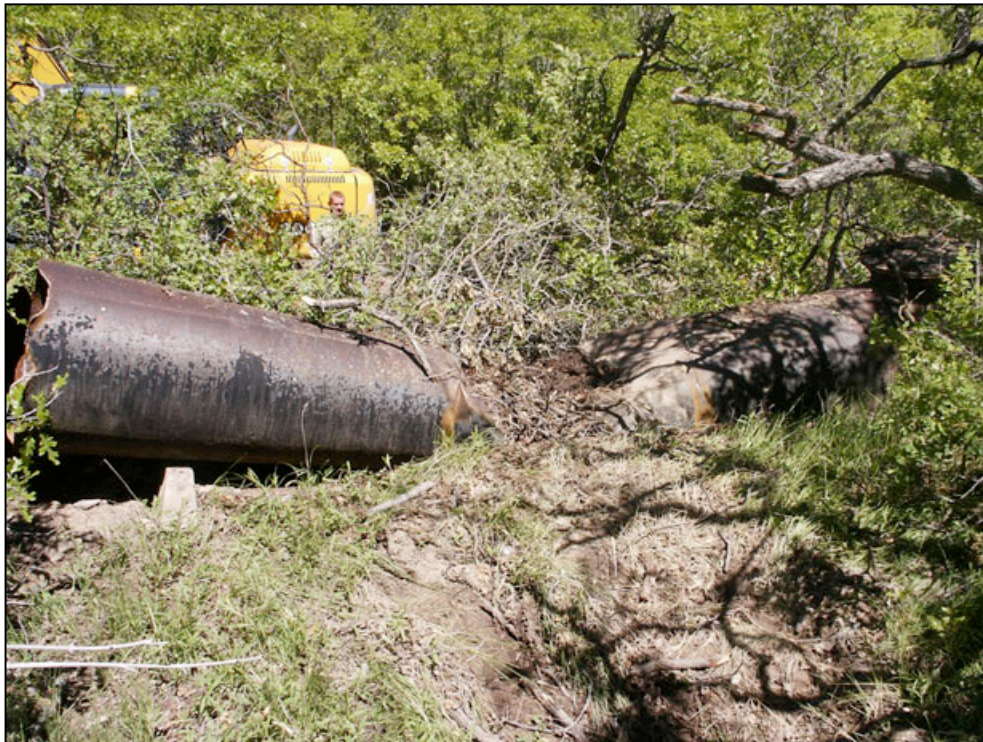
Figure 7. Ruptured Parowan City penstock where it was struck by a second rock-fall boulder weighing approximately 10 tons. After striking the penstock, the boulder continued toward Parowan Creek for an additional approximately 50 feet.

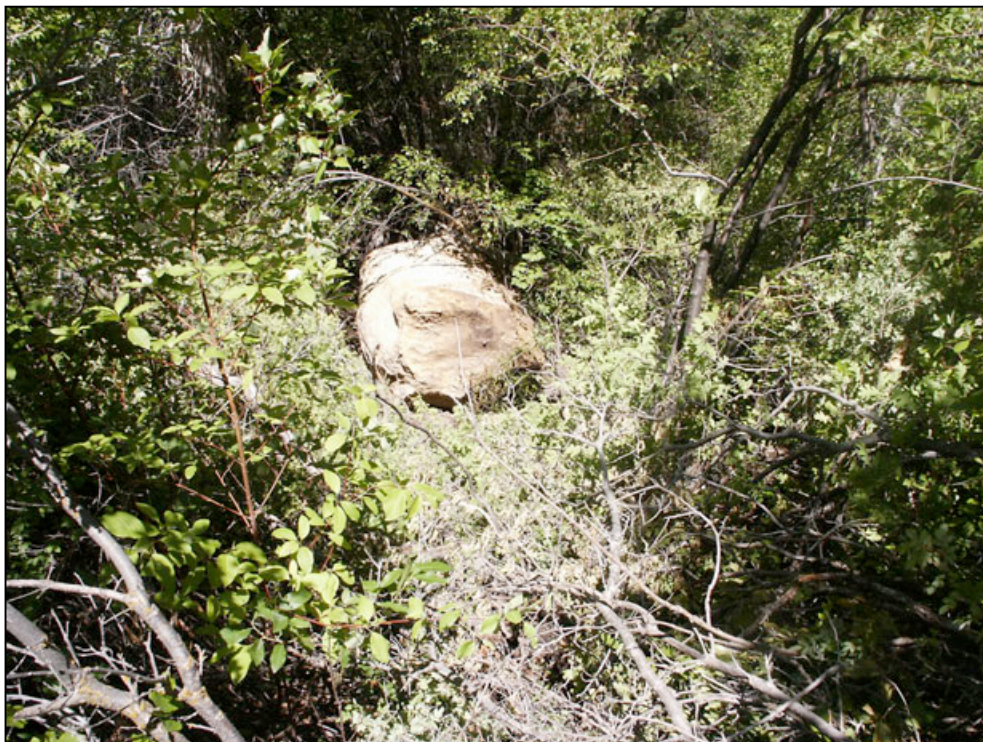
Figure 8. After striking the Parowan City penstock, this approximately 10-ton rock-fall boulder came to rest in dense riparian vegetation along Parowan Creek.

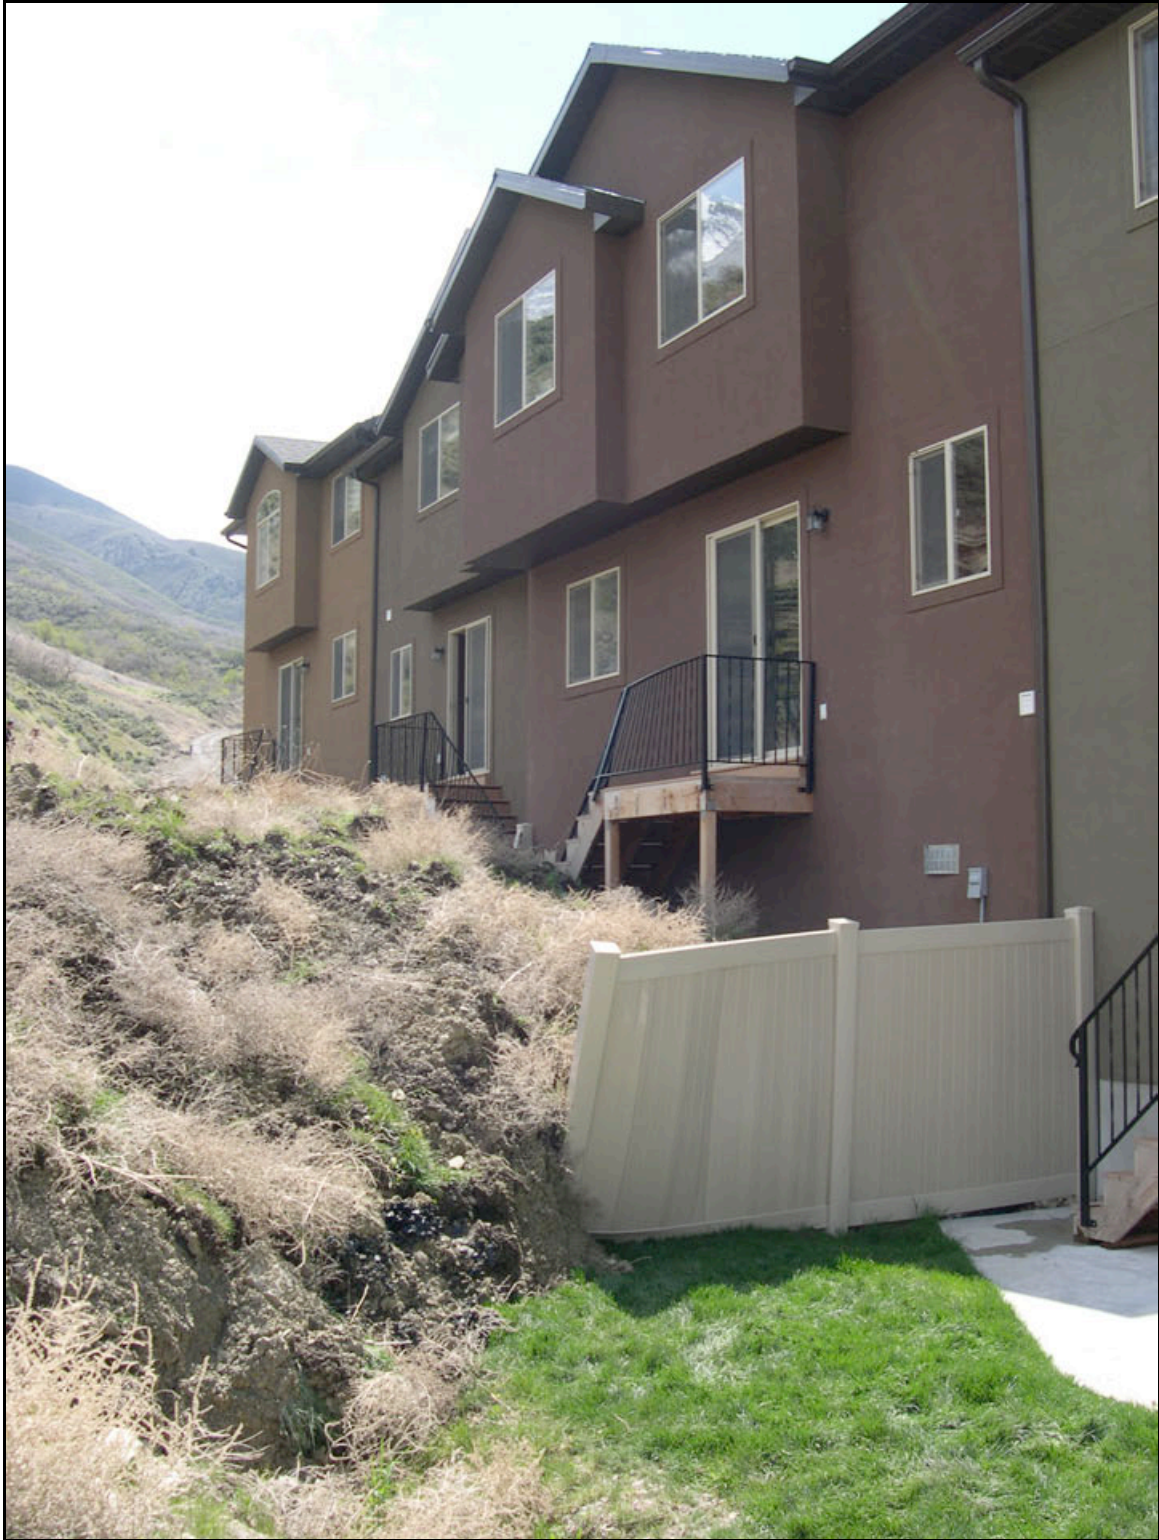
Figure 5. View of the disrupted soil at toe of the landslide and damage to back of townhouse on April 29, 2005.

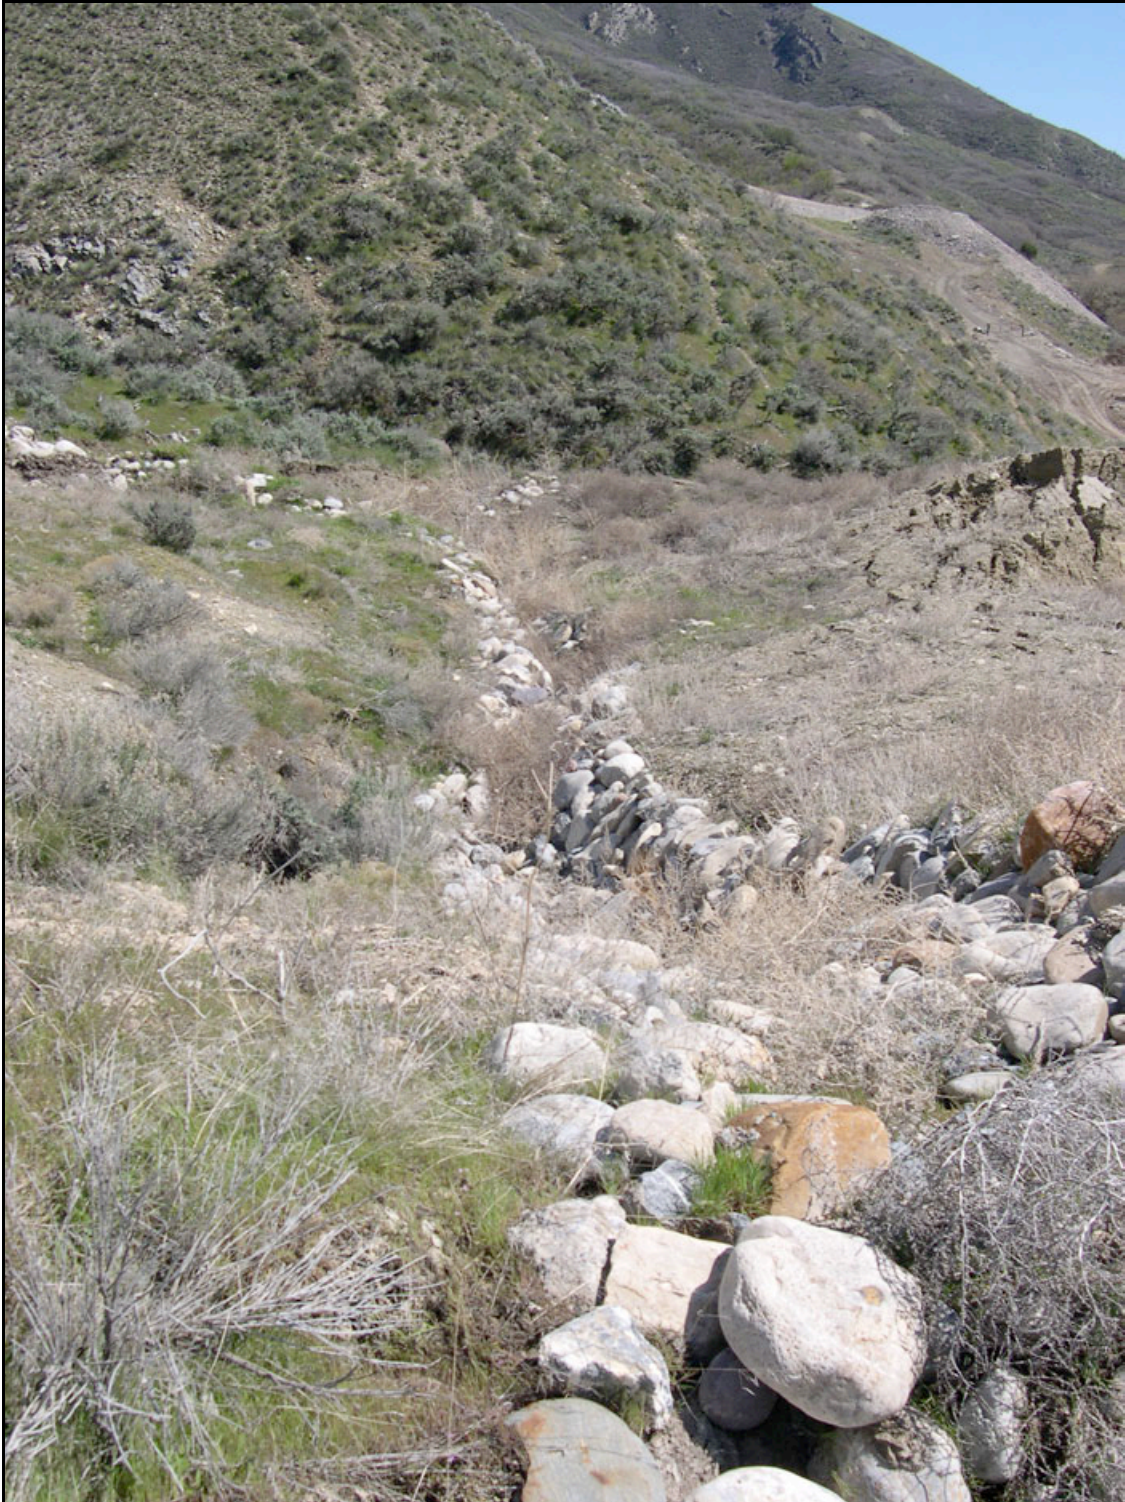
Figure 6. View of relatively intact, translated blocks near the middle of the landslide. Cobble-lined drainage ditch that was originally atop cut slope is translated downslope but relatively undeformed.
