TECHNICAL REPORTS FOR 2002–2009 GEOLOGIC HAZARDS PROGRAM

COMPILED BY ASHLEY H. ELLIOTT

Report of Investigation 269
Utah Geological Survey
a division of
Utah Department of Natural Resources
2010

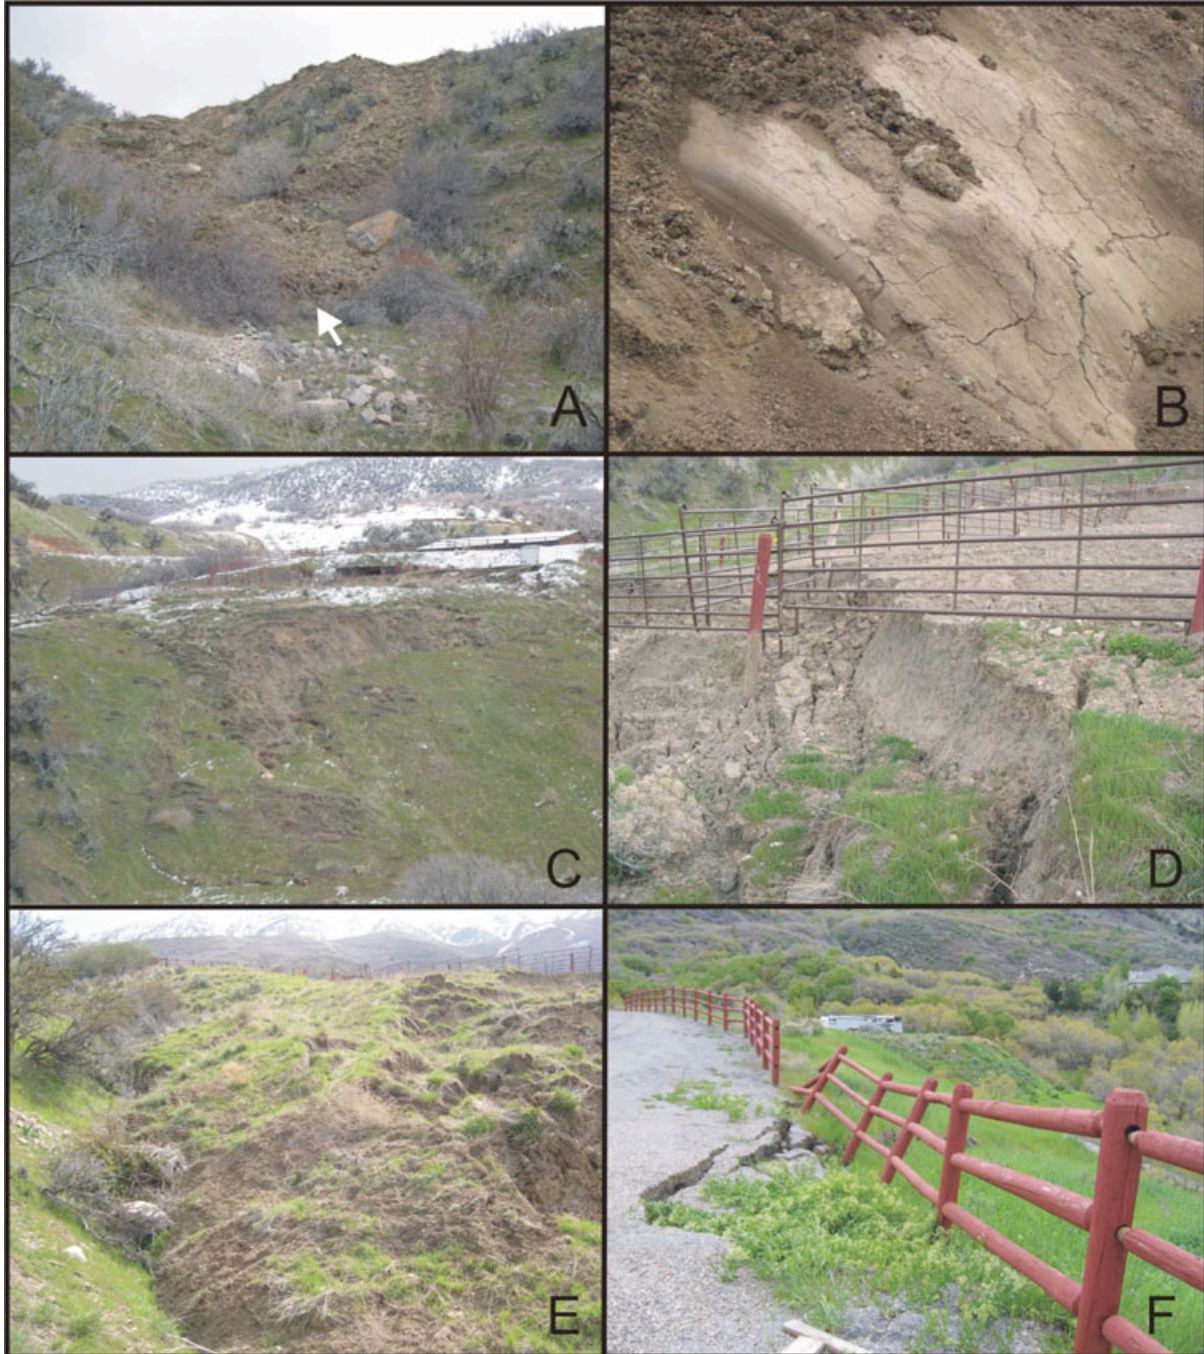
Figure 6. Ground deformation in the main landslide, March 17 to May 12, 2005. (A) View to the northeast of earth-flow toe (arrow) on March 17. (B) Slickensided clay in north part of landslide on March 17. (C) View to the north of south part of landslide on March 29. (D) View to the northwest of large internal scarp that crossed horse corral on April 18. (E) View to the northeast of north edge of landslide on April 18. (F) View to the east of damage to fence due to offset of main scarp of south part of landslide on May 12.

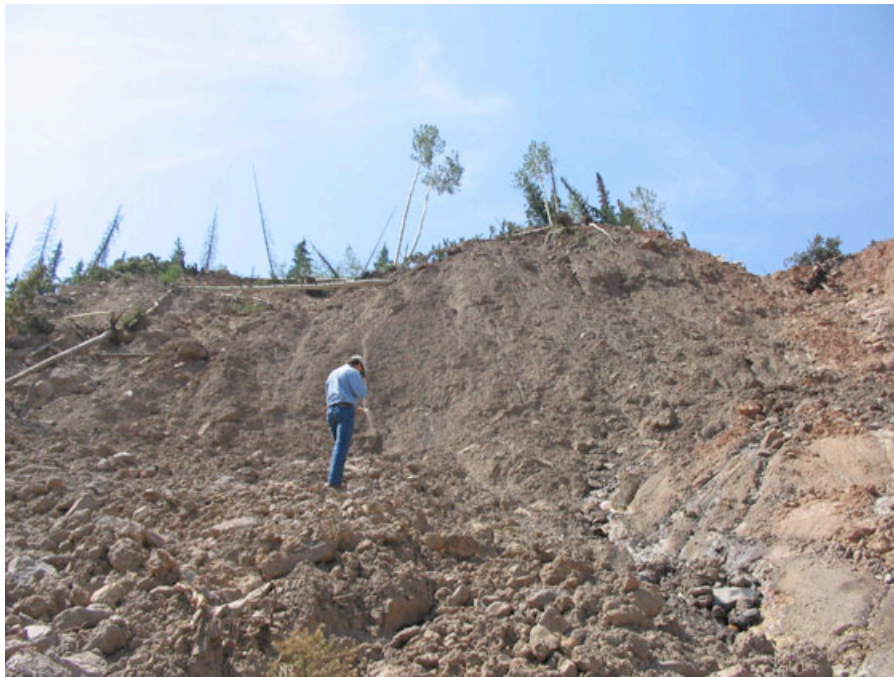
Figure 6. View is from the evacuated area of the lower landslide toward the remaining upper landslide. The upper landslide lies on a steep rupture surface.

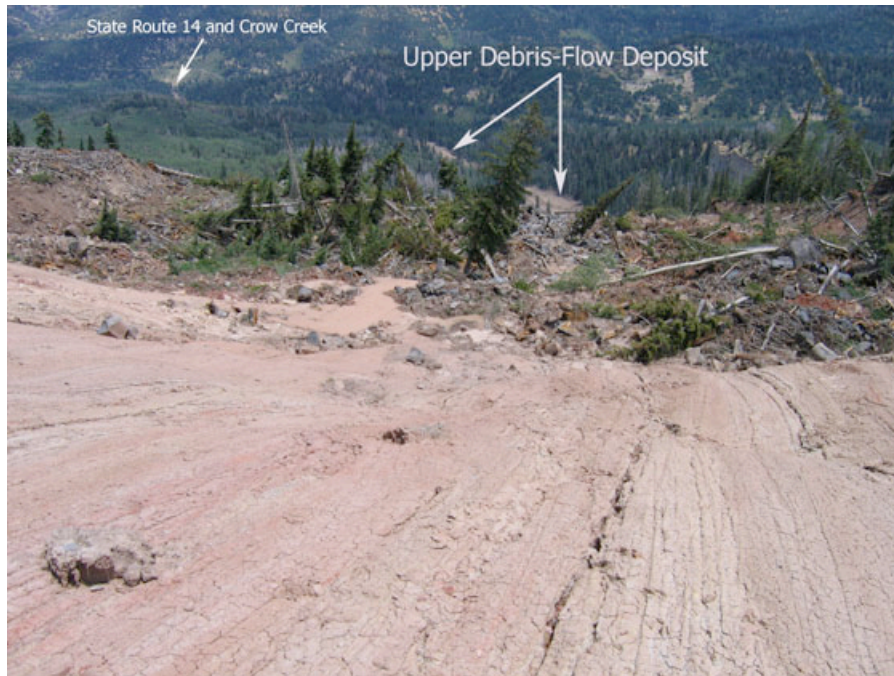
Figure 7. View from the landslide main scarp toward Crow Creek and SR-14. The main scarp is covered with slickensides. The debris-flow path and deposits are evident in the unnamed tributary stream valley to Crow Creek.

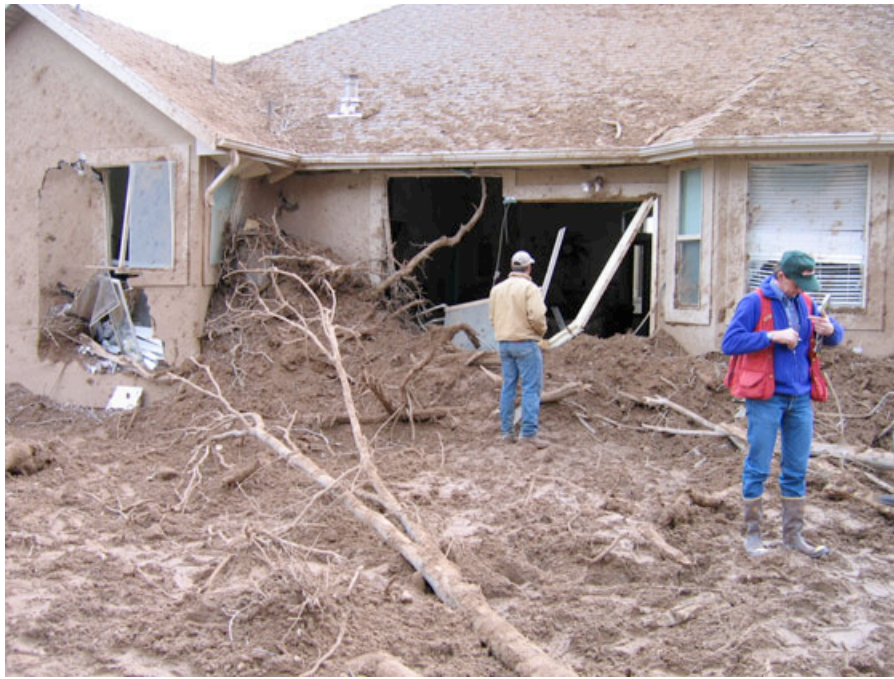
Figure 3. Landslide damage to the house at 1650 East 7687 South.

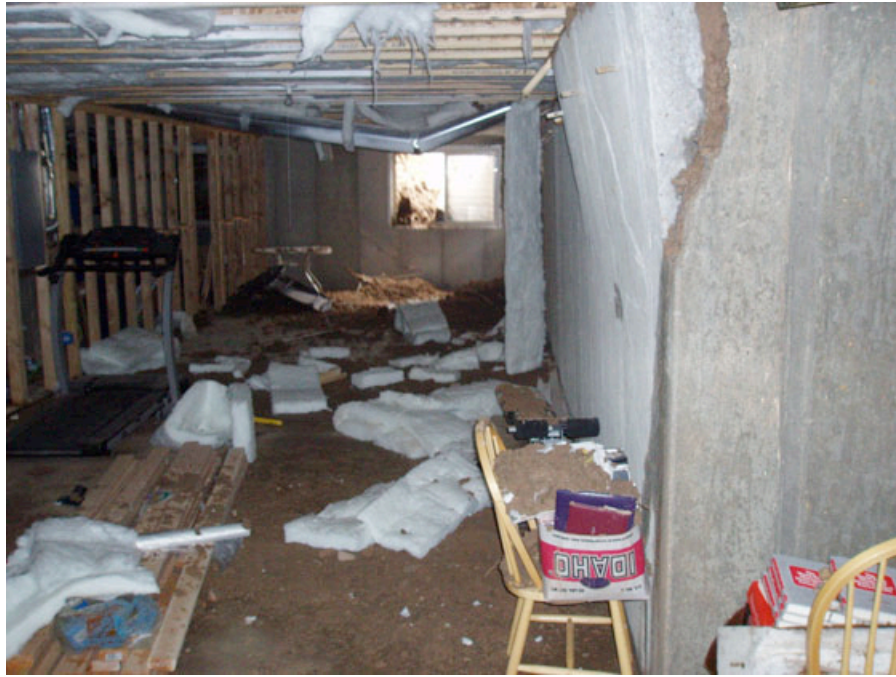
Figure 8. Basement at 1650 East 7687 South showing upper foundation wall (right side of photo) broken by landslide impact.

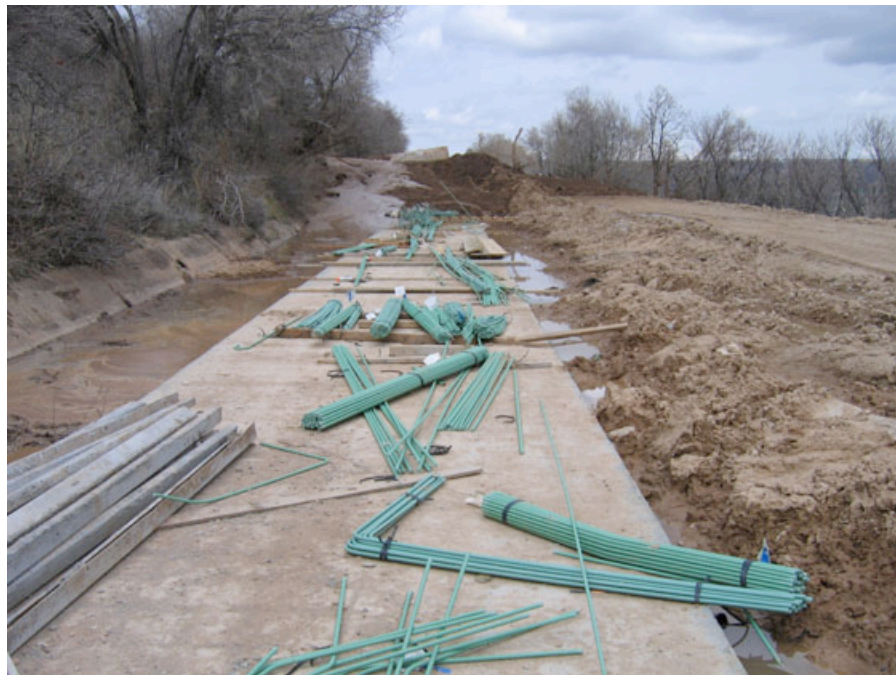
Figure 9. View looking northwest of Davis-Weber Canal showing landslide material deposited on the box culvert and canal access road. Following the landslide water and sediment flowed into the canal left of the box culvert.

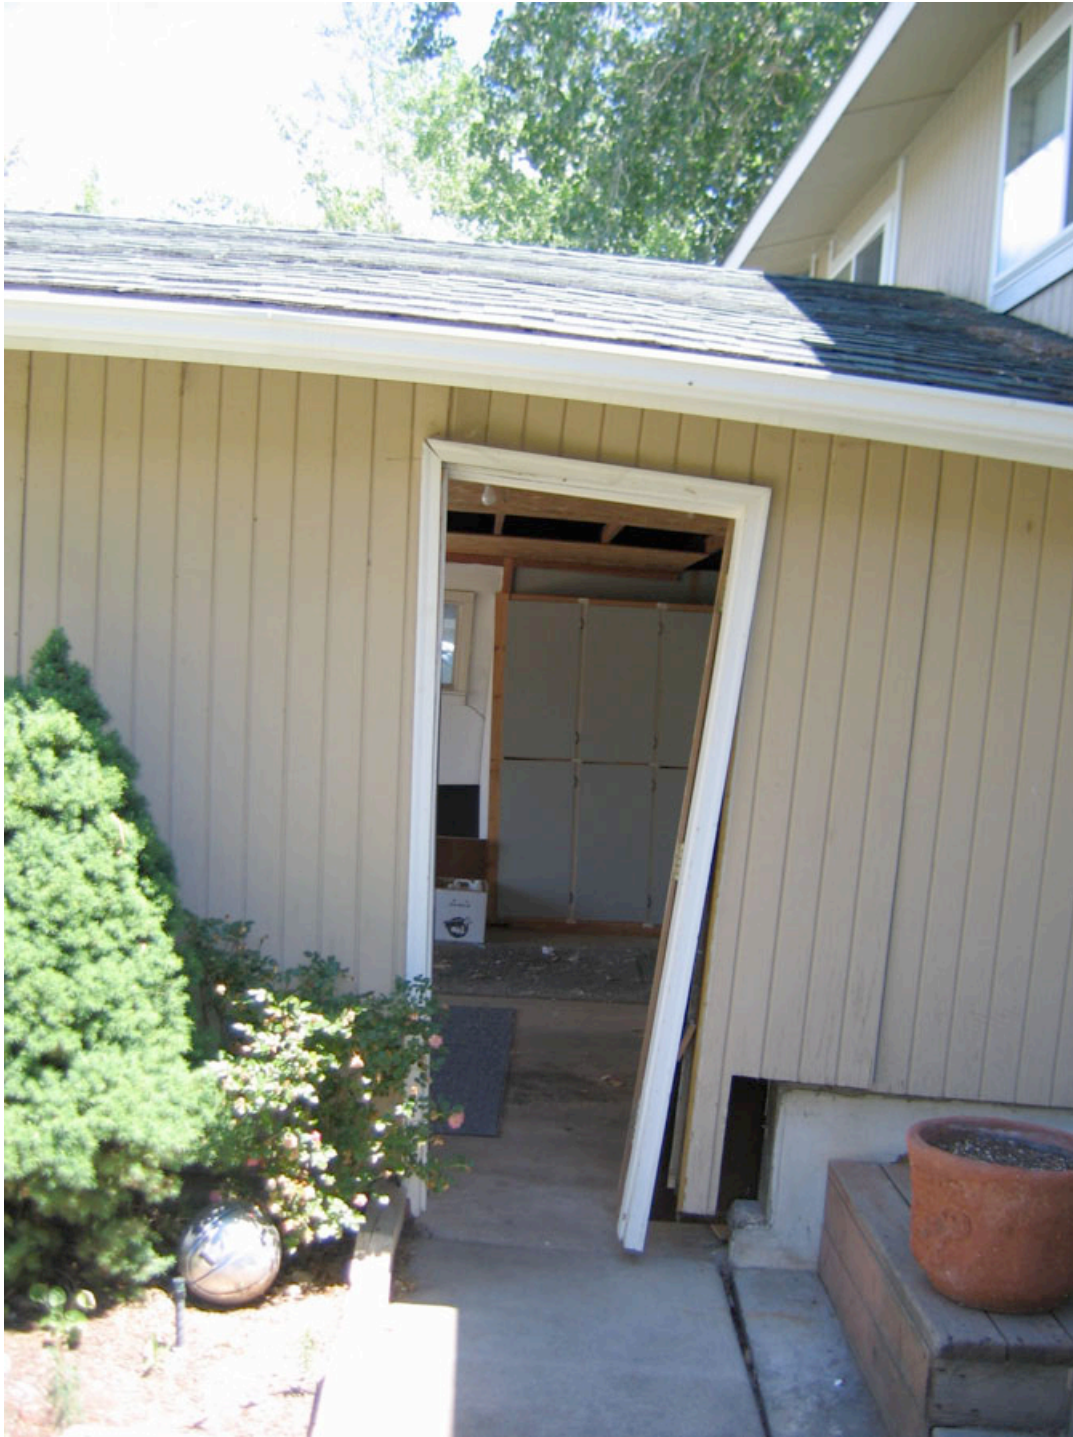
Figure 3. Damage to garage attached to a house at 157 South Valley View Drive. House was subsequently demolished. Photograph taken in June 2006.

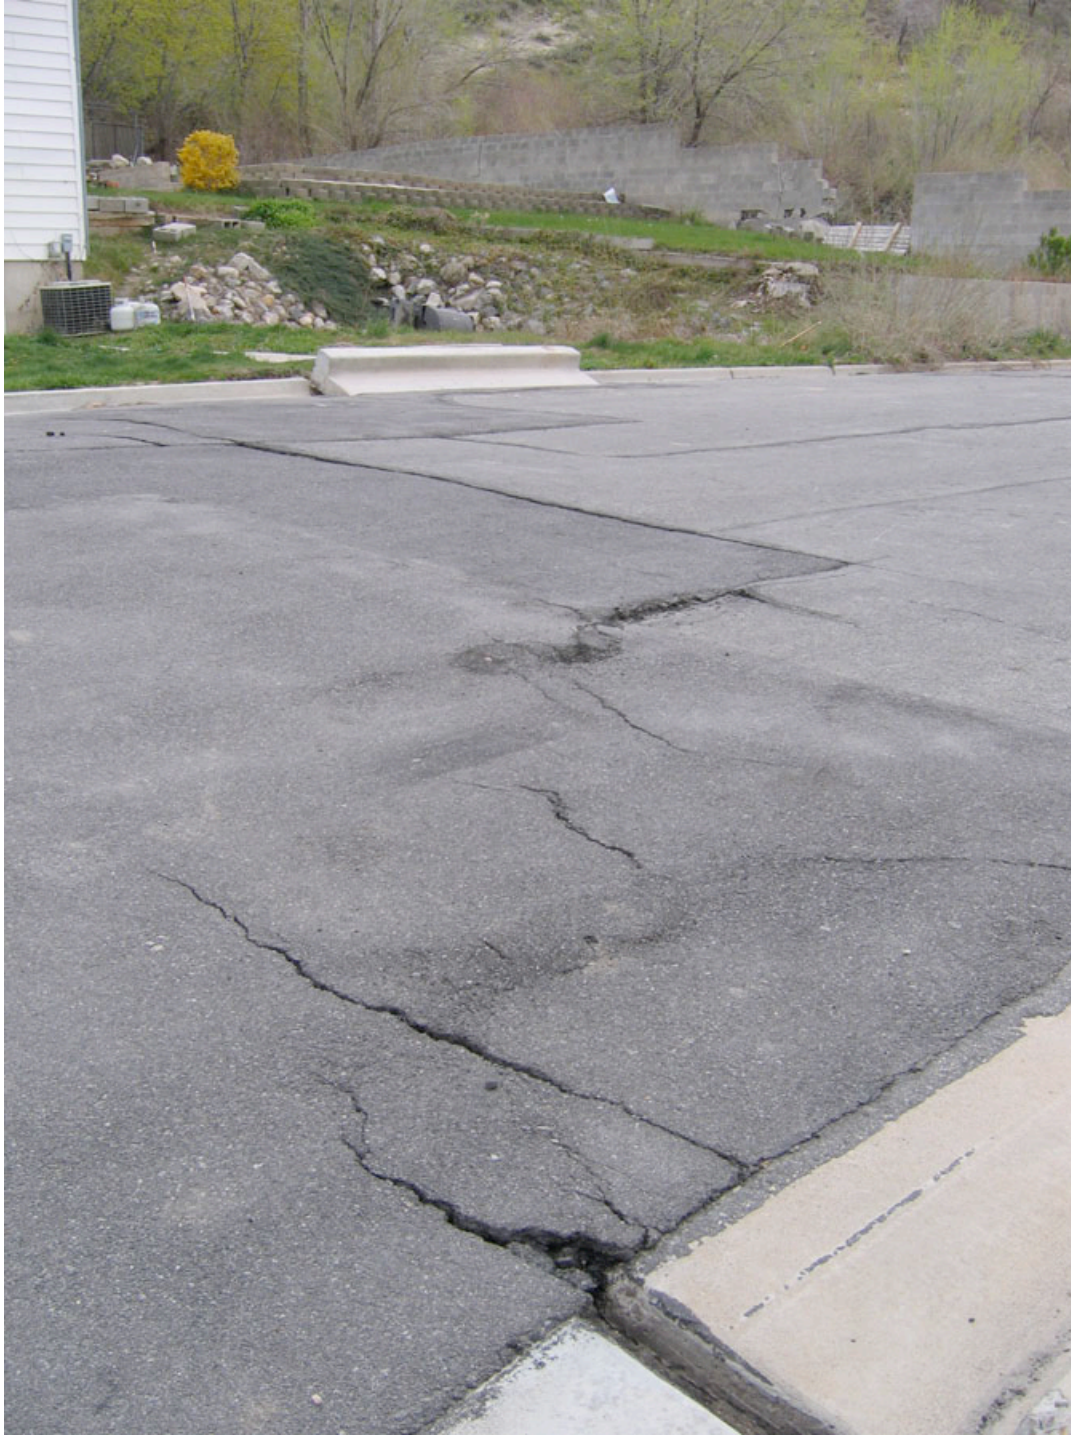
Figure 4. Road damage to south end of Springhill Drive along south-flank shear zone. View is upslope and to the southeast. Tilted and displaced curb and gutter visible on opposite side of road. Ground on left side of photograph is moving downslope (toward bottom-left edge of photograph). Photograph taken in May 2008.
