INVESTIGATION OF THE FEBRUARY 10, 2010, ROCK FALL AT 274 WEST MAIN STREET, AND PRELIMINARY ASSESSMENT OF ROCK-FALL HAZARD, ROCKVILLE, WASHINGTON COUNTY, UTAH

by Tyler R. Knudsen

REPORT OF INVESTIGATION 270
UTAH GEOLOGICAL SURVEY
a division of
UTAH DEPARTMENT OF NATURAL RESOURCES
2011

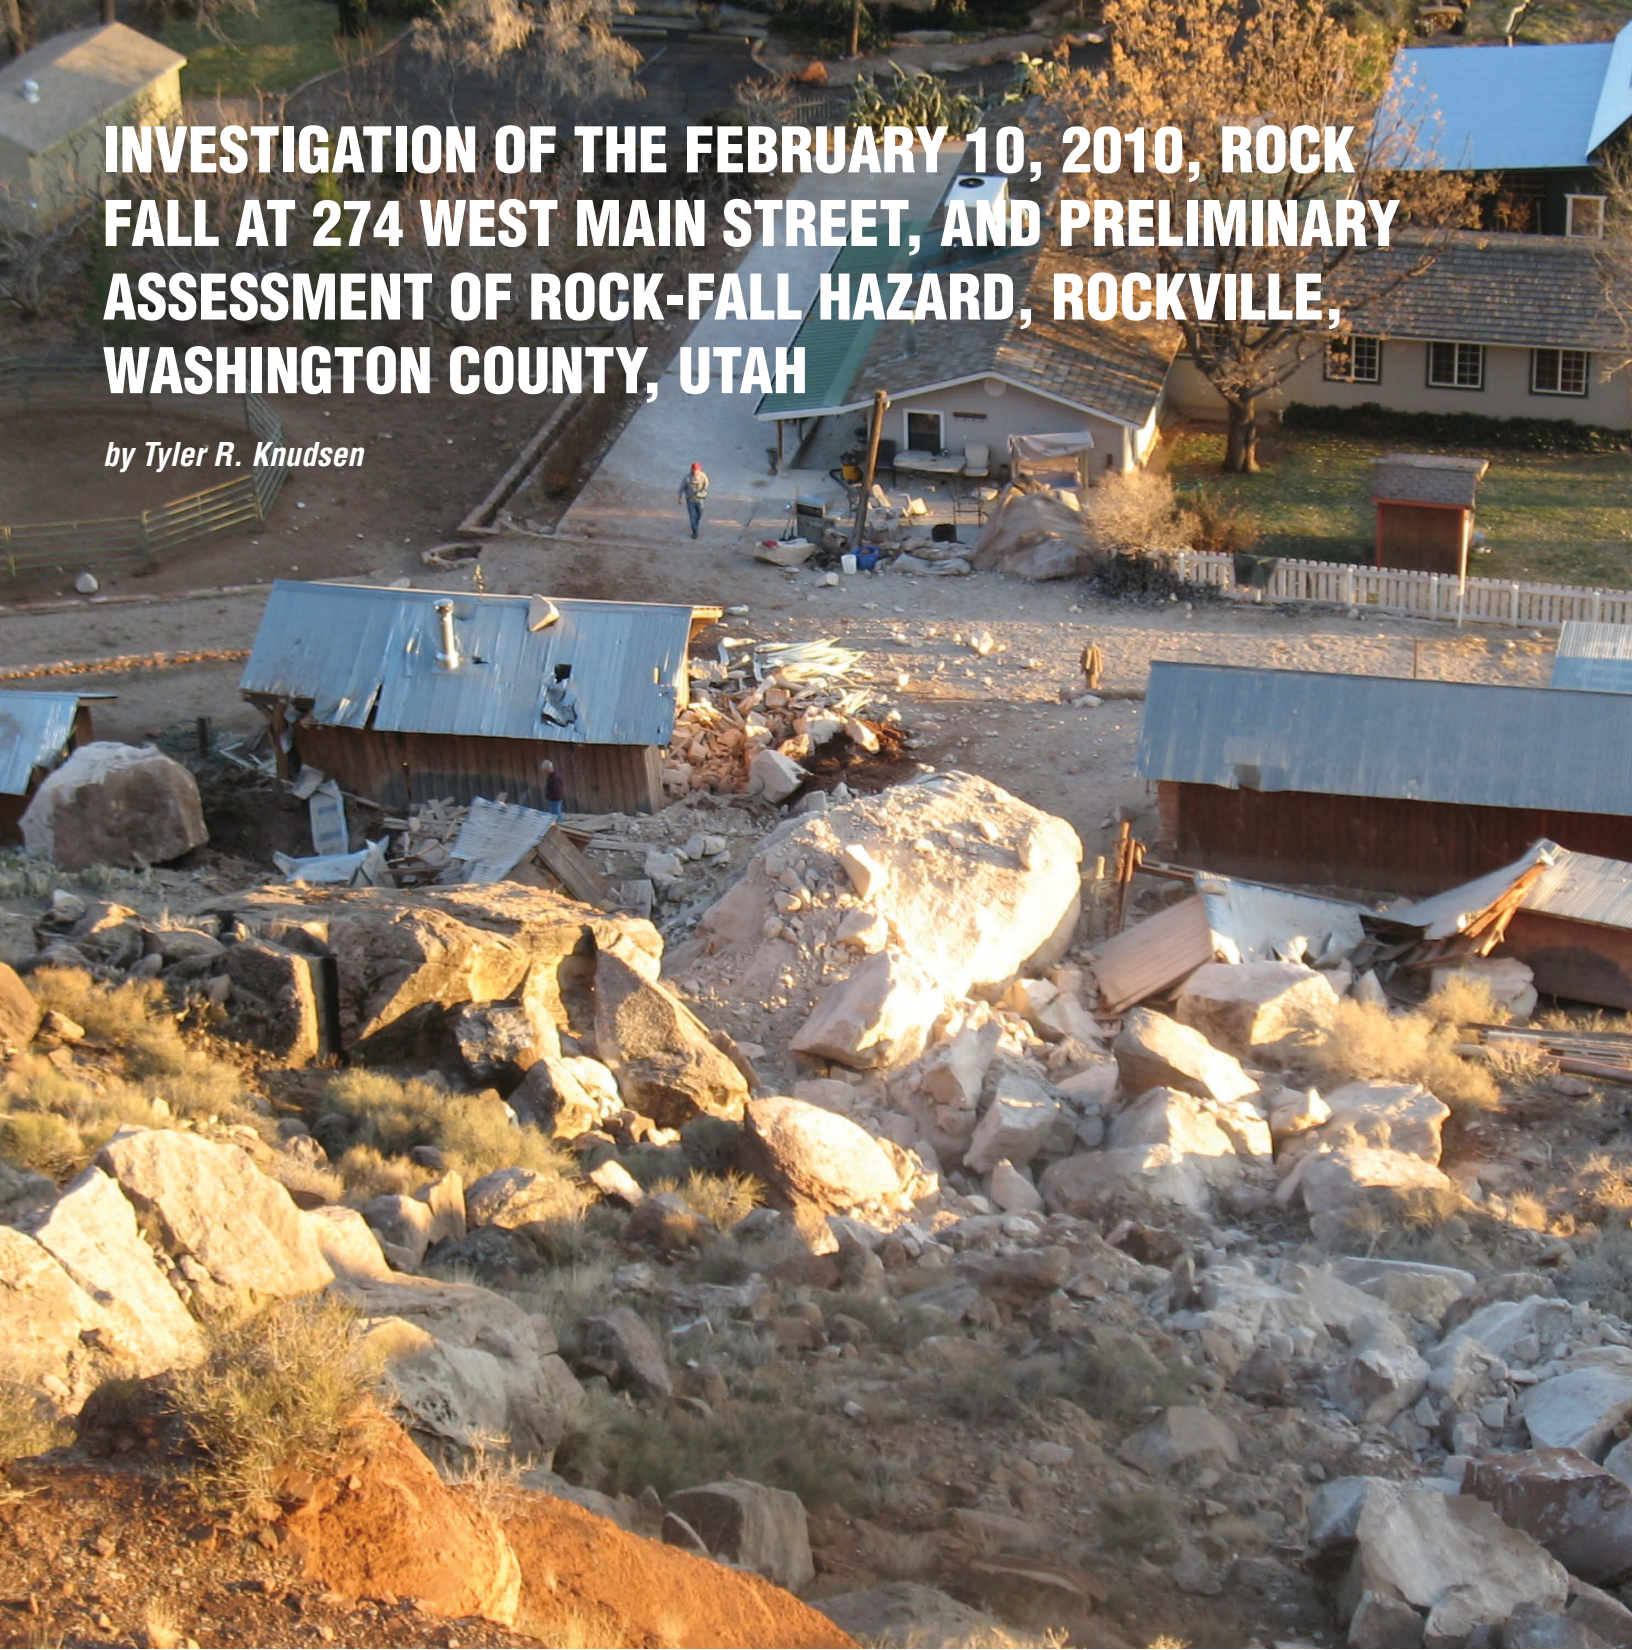
Cover photo: View downslope toward the property damaged by debris from a large rock fall on February 10, 2010, in Rockville, Utah. Had the previously fallen boulder (large boulder covered with pulverized rock in photo center) not been present to break up the rock-fall boulder, this property and nearby properties may have incurred more severe damage.

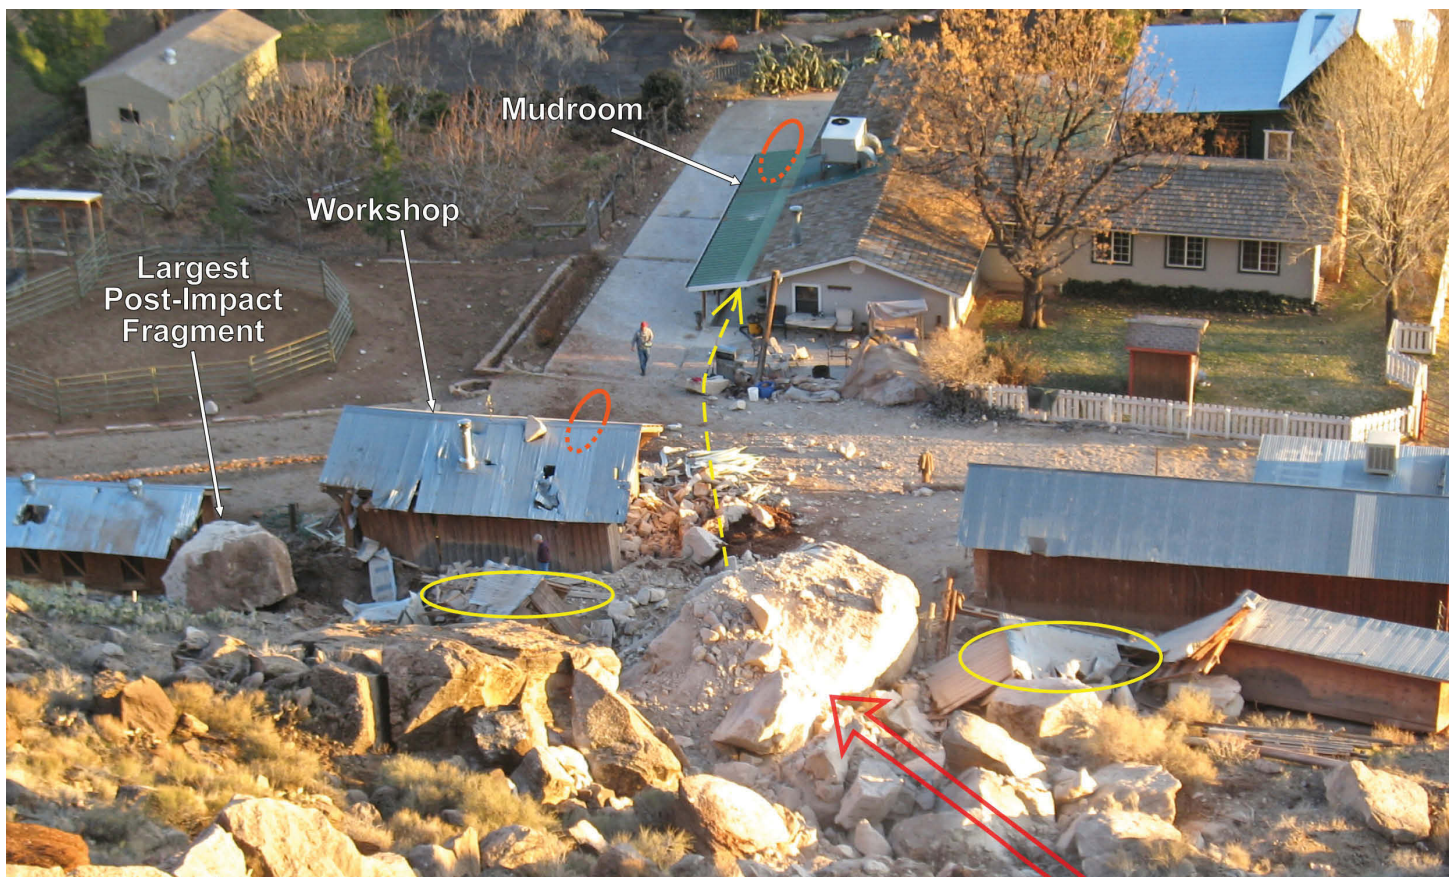
Figure 4. View to south of impact area and property damage at 274 West Main Street; photo taken on February 10, 2010. Red arrow indicates the path traveled by the rock-fall boulder to the area of impact with a previously fallen boulder. Yellow ellipses show locations of destroyed sheds. Red ellipses show the approximate locations of damaged vehicles before they were removed. Yellow dashed arrow shows travel path of a large fragment that damaged the house and a parked vehicle.

estimated 20 tons (figures 4 and 5D). Most post-impact debris accumulated within a 75-foot radius of the impact site, but I found a few small (0.5- to 1-foot-diameter) fragments as much as 180 feet away.

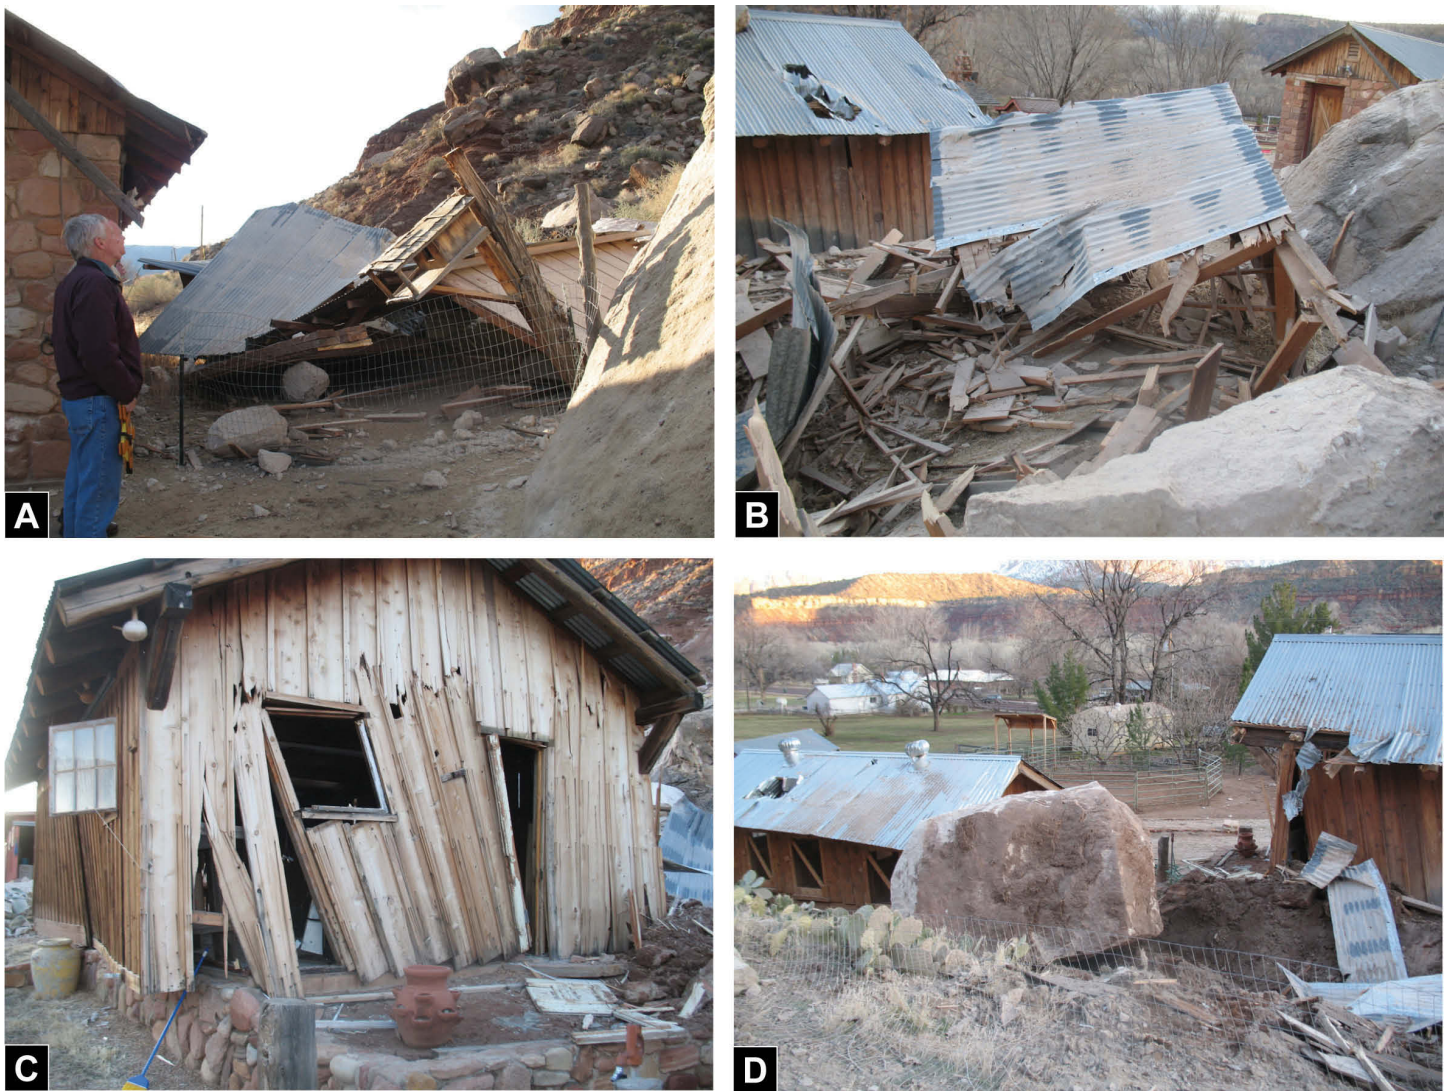
Debris from the impact destroyed two small sheds immediately adjacent to the impact area, and a larger wood-framed workshop was severely damaged and knocked off its foundation (figures 4 and 5). Three other outbuildings ranging from a small chicken coop to a more substantial wood and stone hay barn sustained moderate to light damage from falling and rolling debris. A 3.5 x 3 x 1.7-foot boulder weighing an estimated 1.3 tons rolled through the mudroom on the east side of the house, broke through a glass doorway, exited through an exterior wall, and struck and severely damaged a vehicle parked in the home's driveway (figures 4 and 6). A second vehicle parked near the workshop was also heavily damaged by debris. Both vehicles had been removed from the property by the time of my site visit.

Figure 5. Damaged outbuildings at 274 West Main Street; photos taken on February 10, 2010. **A., B.** Destroyed sheds adjacent to impact area. **C.** Damaged workshop knocked off its foundation. **D.** Largest (9 x 6 x 5 feet) post-impact boulder that damaged a workshop (right) and shed (left).

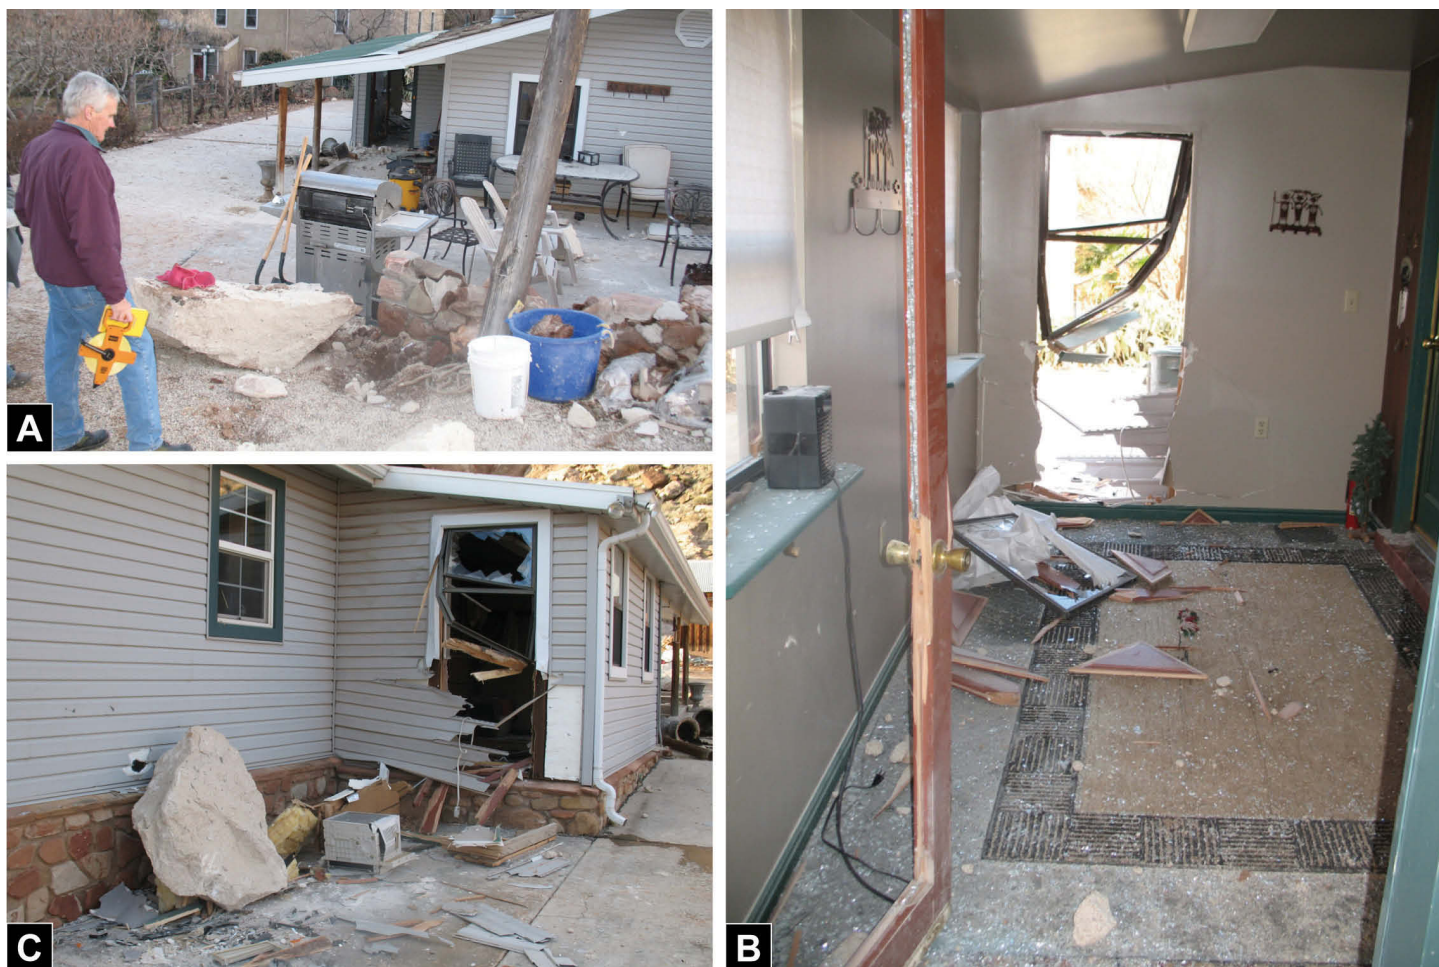
Figure 6. Rock-fall damage to the house at 274 West Main Street; photos taken on February 10, 2010. **A.** View downslope along path of the rock that damaged the house. Narrowly missing a barbecue grill, the rock rolled through the entryway and mudroom on the left (east) side of the house. **B.** Looking through the mudroom where the boulder broke through a glass door, which is still on its hinges, and exited through an exterior wall and window. **C.** After exiting the mudroom, the rock collided with a parked car and came to a rest. The rock, estimated to be 3.5 x 3 x 1.7 feet, was later moved up against the house when the damaged car was moved.

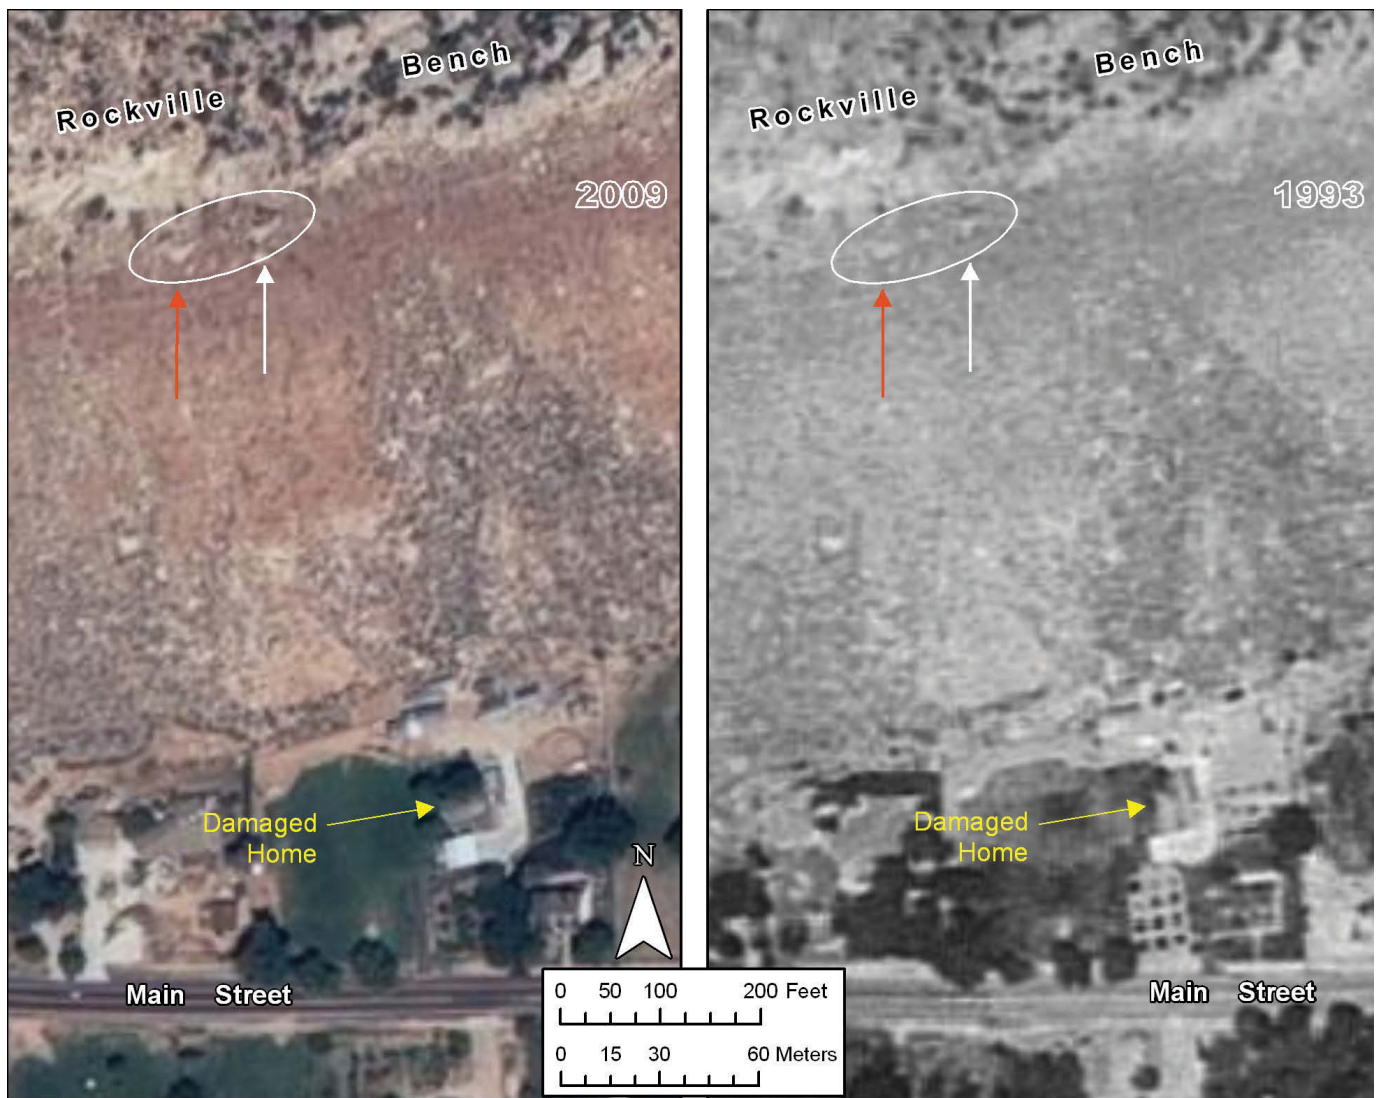
visible in 1993 orthophotography (figure 7). The impacted house at 274 West Main Street, the Amber Inn (244 West Main Street), and other structures at the base of the slope may be damaged if this boulder also moves downslope. Additionally, the Shinarump Conglomerate cliff face from which the boulders were initially derived is also a potential source of future large, damaging rock falls.

Figure 7. Comparison of 2009 NAIP and 1993 U.S. Geological Survey orthophotos showing the source area and damaged home at 274 West Main Street. Both the February 2010 rock fall (red arrow) and the boulder remaining on the hillside (white arrow) are visible in the 2009 photo; although not as clear, the boulder pair also appears to be present in the 1993 photo.

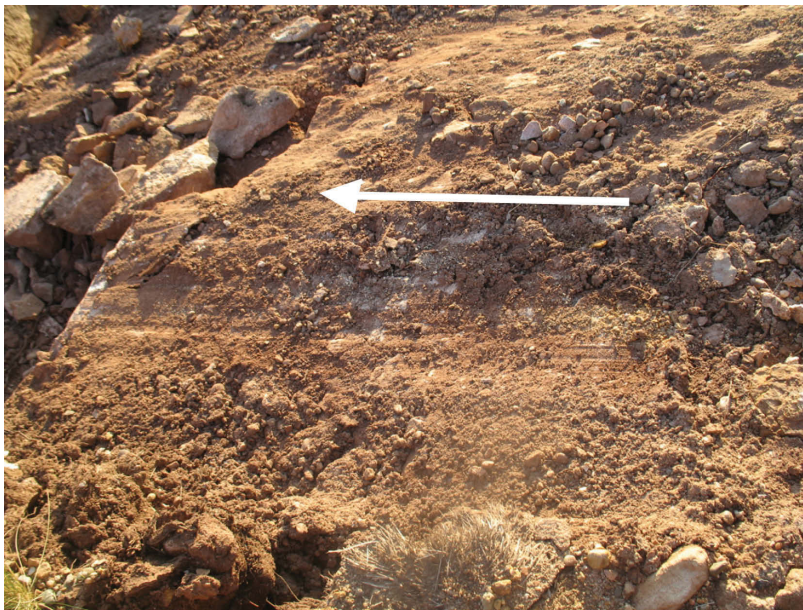
Figure 8. Parallel grooves (~5 feet long) in the detachment area of the February 10, 2010, rock fall; photo taken on February 10, 2010; arrow indicates direction of travel.

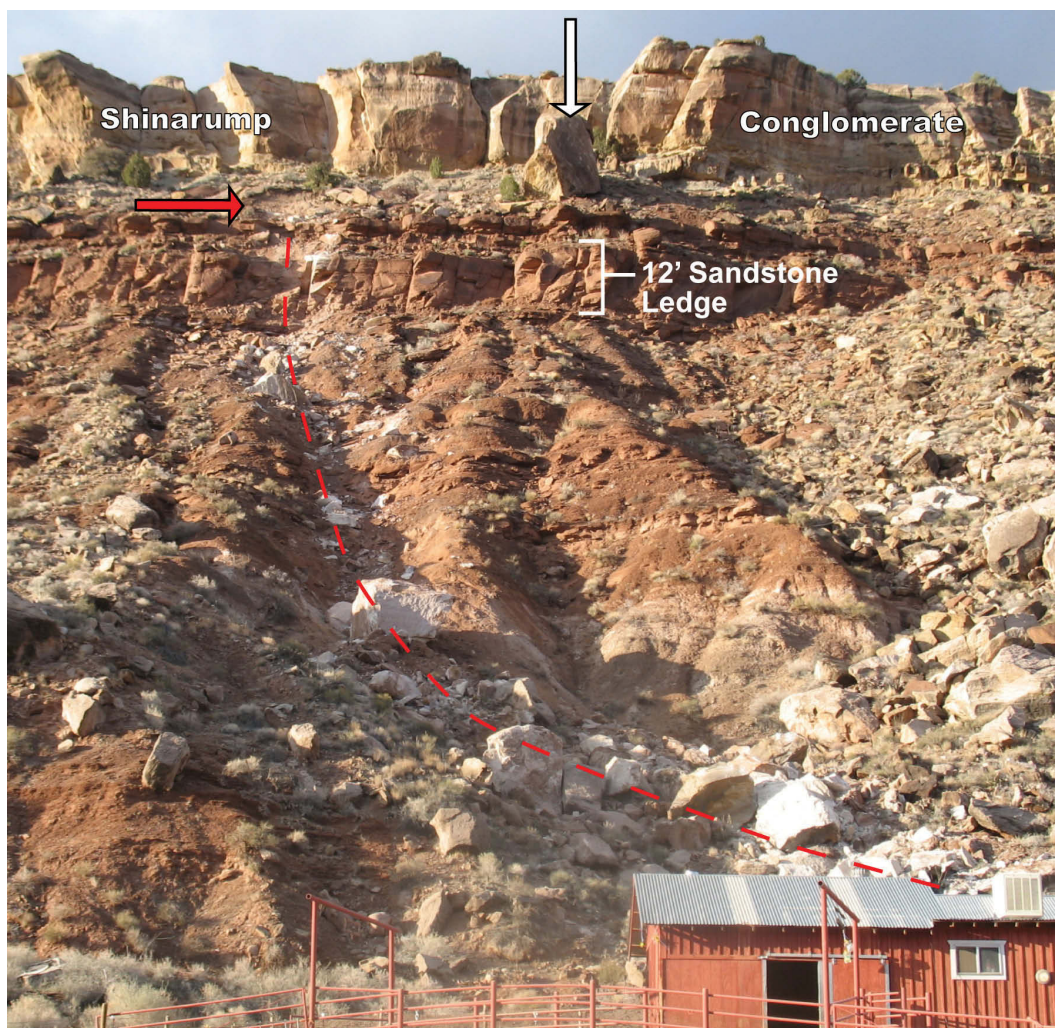
The rock fall created a clear rock-fall path delineated by churned and crushed soil and vegetation, fresh rock deposition, rock gouge, and impact craters (figure 9). The 12-foot vertical drop and the average 38° slope along the gully bottom imparted a high initial velocity to the boulder. Several freshly broken smaller boulders in the rock-fall path likely include pieces broken from the falling/rolling boulder as well as talus crushed by the moving boulder. Near the bottom of the slope, the boulder deflected slightly eastward either off the western gully wall or perhaps off another talus boulder before striking a large, stationary boulder at the base of the slope. The rock-fall boulder traveled a total distance of 500 feet before striking the stationary boulder. If

Figure 9. View looking north to the February 2010 rock-fall source area (red arrow) showing fresh rock fragments in the rock-fall path (dashed red line); photo taken on February 10, 2010. Remaining talus boulder is shown with white arrow.

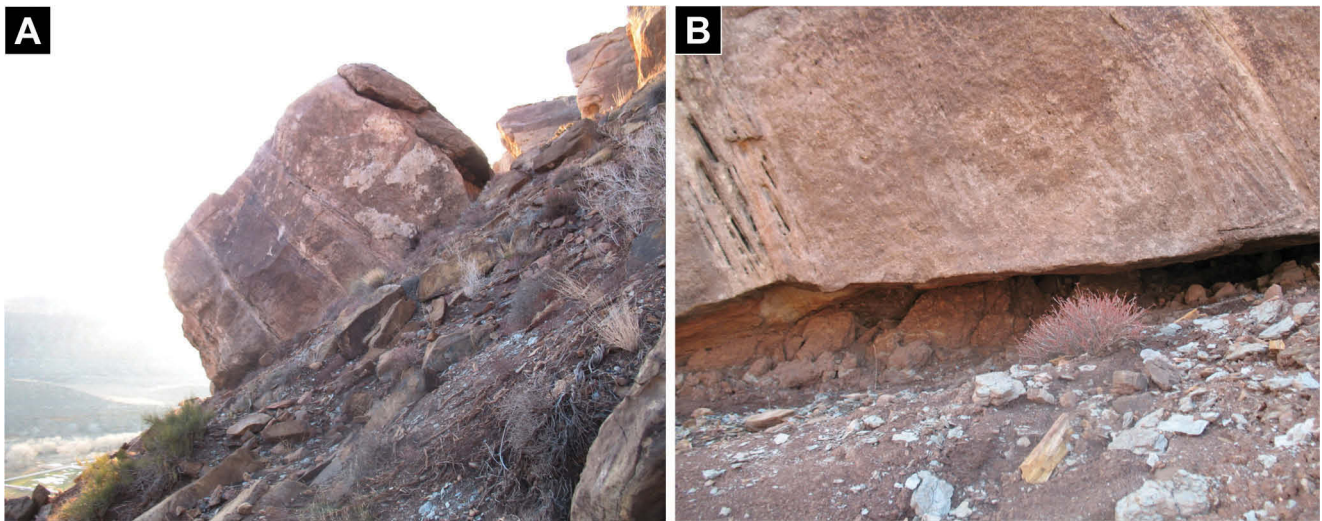
Disturbed and freshly deposited debris remaining in the rock-fall path appeared stable at the time of my reconnaissance and presents little hazard to structures below. However, a second large boulder, approximately 30 x 15 x 14 feet and weighing an estimated 470 tons, lies about 80 feet east of where the February 10th rock fall originated and appears similar to the boulder that rolled down the slope. The remaining boulder is also Shinarump Conglomerate talus and rests on a 44° slope of the upper red member of the Moenkopi Formation (figure 10A). Inspection of the boulder's base revealed a 1- to 2-foot-wide undercut beneath the boulder's eastern edge where surface water has eroded underlying shale and siltstone (figure 10B). This boulder is also

Figure 10. Remaining boulder above the damaged house at 274 West Main Street; photos taken on February 10, 2010. **A.** Rock resting on steep slope of mudstone and siltstone of the upper red member of the Moenkopi Formation; the rock is about 30 feet wide (view to the west). **B.** Void space (~1 foot high) created by erosion extending 1 to 2 feet beneath the eastern edge of the boulder.

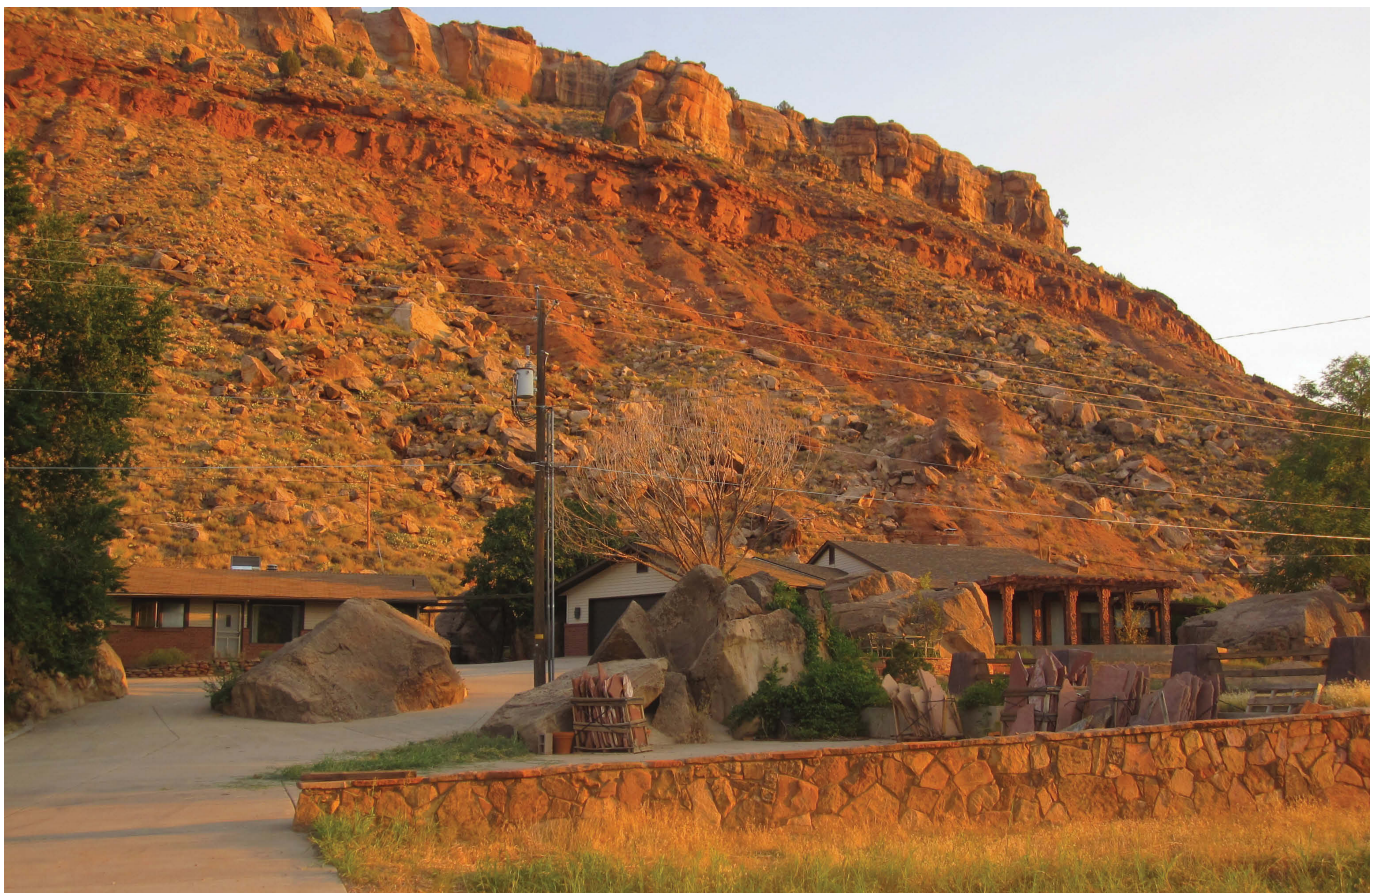
Figure 11. Large talus boulders litter the southern slope of Rockville Bench and adjacent residential area; photo taken on September 29, 2010.

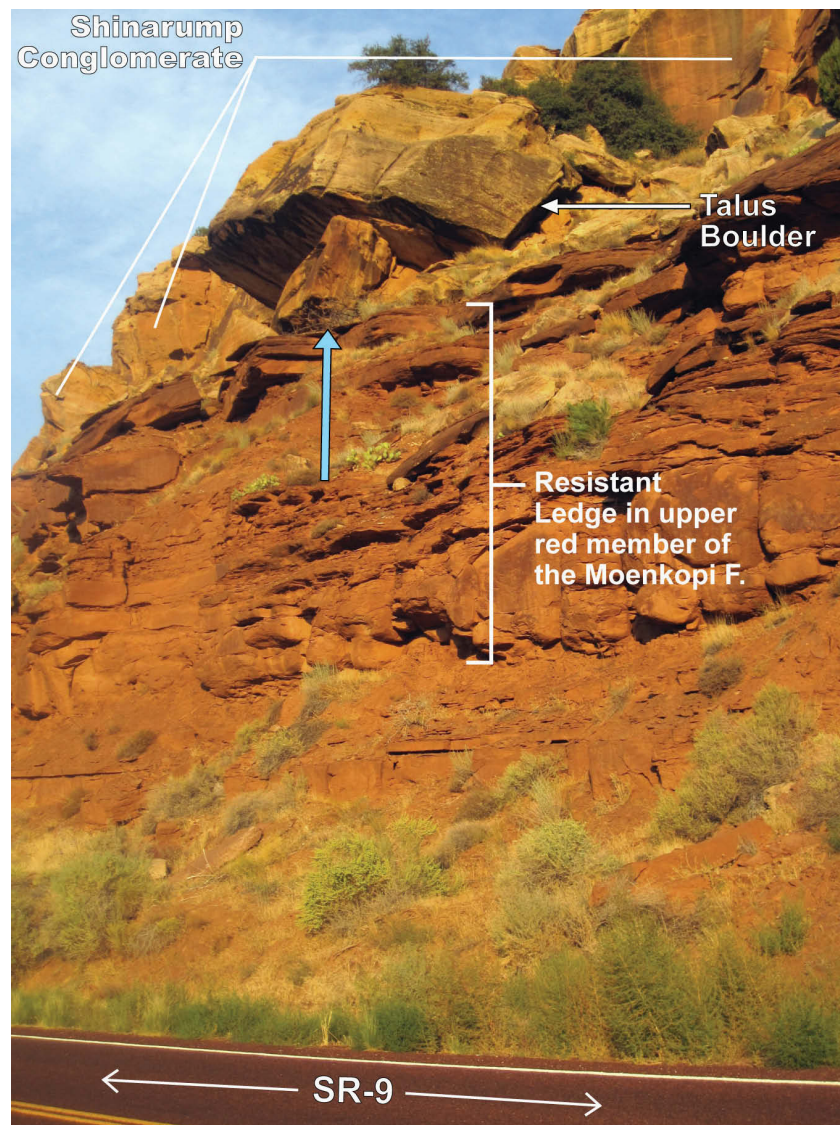
may also remobilize. Several precariously perched talus boulders are evident on the steep slope above Rockville (figure 12).

Figure 12. Example of a large, precariously balanced talus boulder of Shinarump Conglomerate near the eastern end of Rockville; photo taken on September 29, 2010. Boulder measures approximately 32 x 20 x 20 feet and is tenuously held in place (about 95 vertical feet above SR-9) by a much smaller talus boulder (blue arrow).

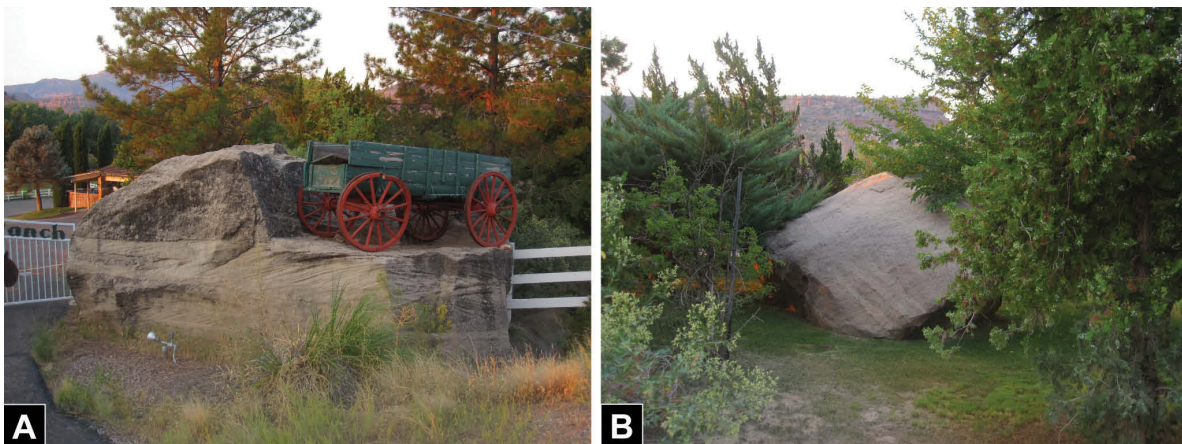
Long-time Rockville residents reported that the Shinarump boulder near the entrance to the Rock-N-River Ranch south of State Route 9 (SR-9; figures 2 and 13A) is a 1976 rock fall (Dan McGuire, former Rockville Mayor, verbal communication, 2010). No other details of the 1976 event are available. The tabular

boulder is about 20 x 17 x 10 feet. During a reconnaissance visit, I noticed a second large Shinarump boulder (~18 x 10 x 10 feet) (figure 13B) about 50 feet to the west that may have been part of the same rock fall.

Figure 13. Rock-fall boulders at the Rock-N-River Ranch. Both photos taken September 29, 2010; views are to the south. **A.** Approximately 20 x 17 x 10-foot boulder that reportedly rolled across SR-9 in 1976. **B.** Approximately 18 x 10 x 10-foot boulder lying about 50 feet to the west that may have fallen at the same time.

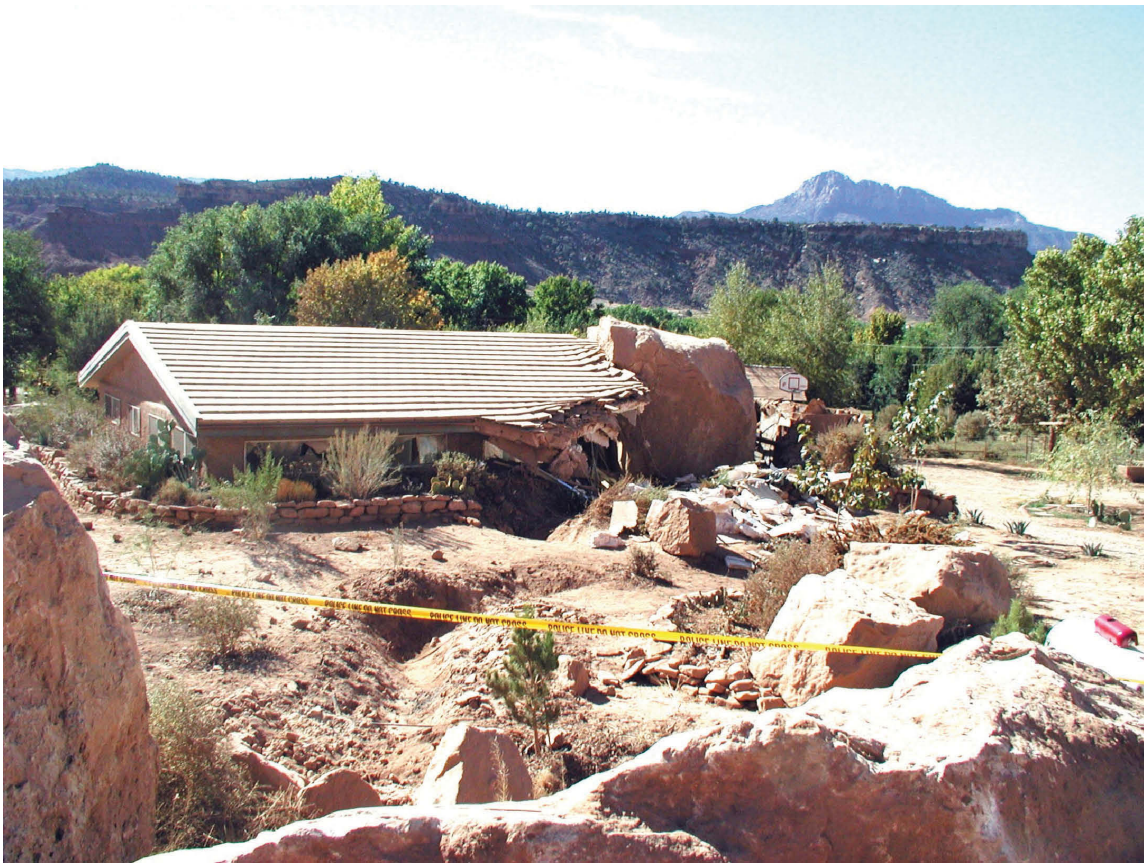
On October 18, 2001, a large boulder estimated to weigh about 300 tons released from the Shinarump cliff north of Rockville and impacted and severely damaged a home at the corner of Terry Lane and De Mille Road (200 North Center Street; figures 2 and 14; Lund, 2002). The homeowner, sleeping inside at the time, narrowly escaped injury. The boulder was part of a larger rock fall consisting of several Shinarump boulders, at least one of which was larger than the boulder that impacted the home.

Figure 14. Rockville home at 200 North Center Street struck by an estimated 300-ton rock-fall boulder on October 18, 2001. Photo courtesy of Bill Lund.

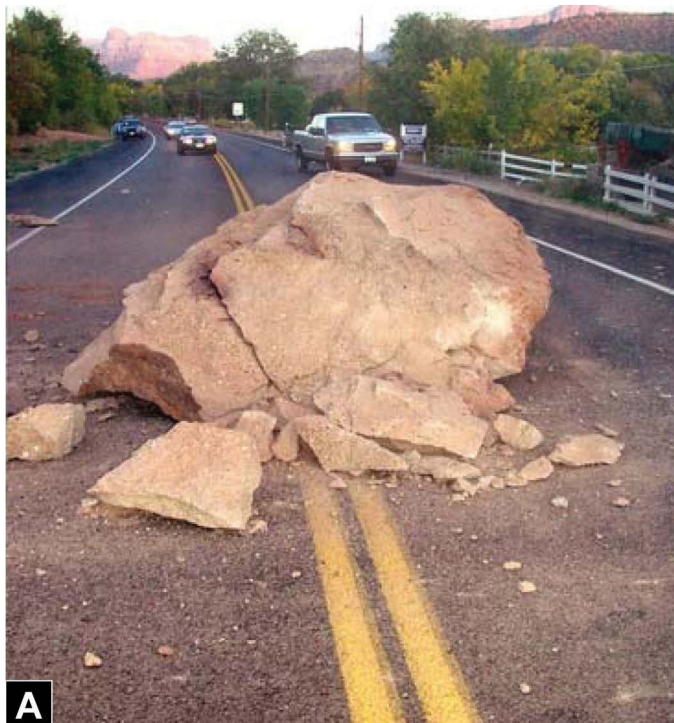
Figure 15. October 24, 2002, rock fall in Rockville. Photos courtesy of Jim Harlan, ZionEventPhotos.com. **A.** Rock-fall debris on SR-9 centerline, view is toward the east. **B.** View to south of rock-fall debris and impact crater in highway shoulder.

and came to rest on the centerline of SR-9 (Main Street) just north of the Rock-N-River Ranch (figures 2 and 15). Fortunately, the highway was clear of traffic and no injuries occurred. Traffic was blocked on Main Street for a few hours until the debris was removed. The only documentation of this event is photos taken by a local photographer. From the photos, I determined the exact location where the boulder came to rest, and that the boulder was composed of Shinarump Conglomerate. Rising dust in several of the photos indicates the boulder originated from near the top of the bench. A probable rock-fall path is discernable on 2003 aerial photography (figure 16), and also supports a source near the base of the Shinarump cliff, although it remains unclear if it originated from the cliff or as remobilized talus.

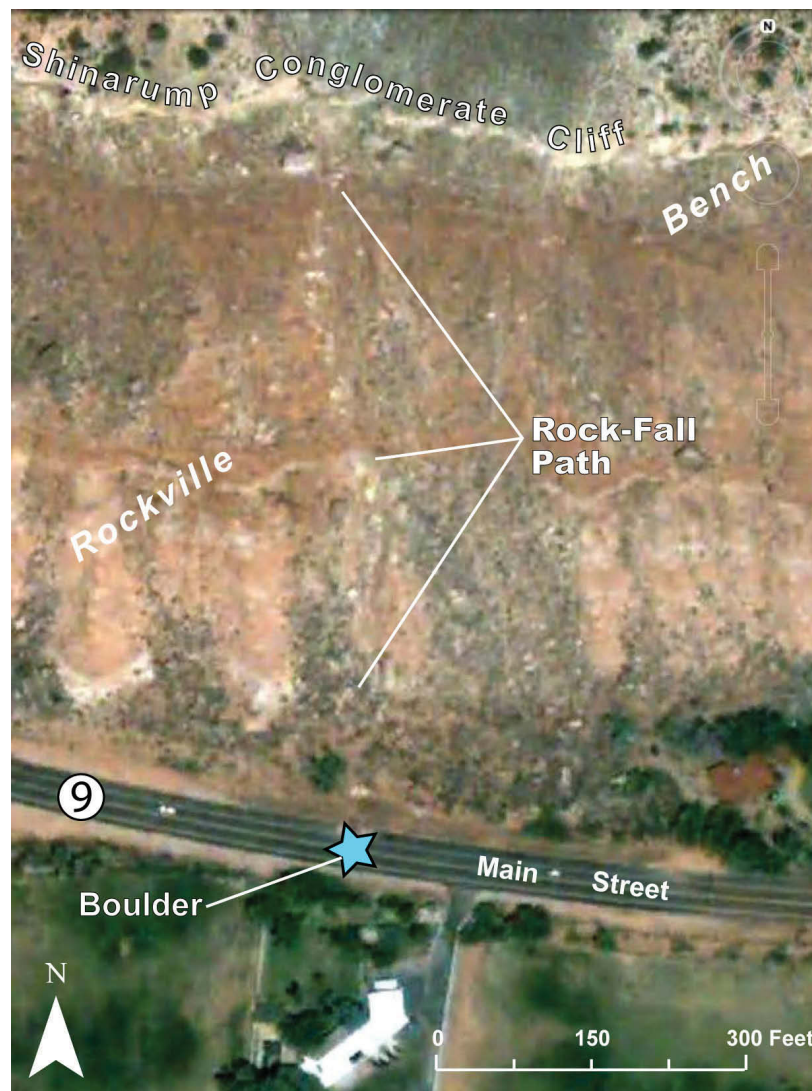
Figure 16. 2003 Google Earth image showing where the October 24, 2002, rock fall impacted SR-9. Note fresh rock fragments delineating the probable travel path.

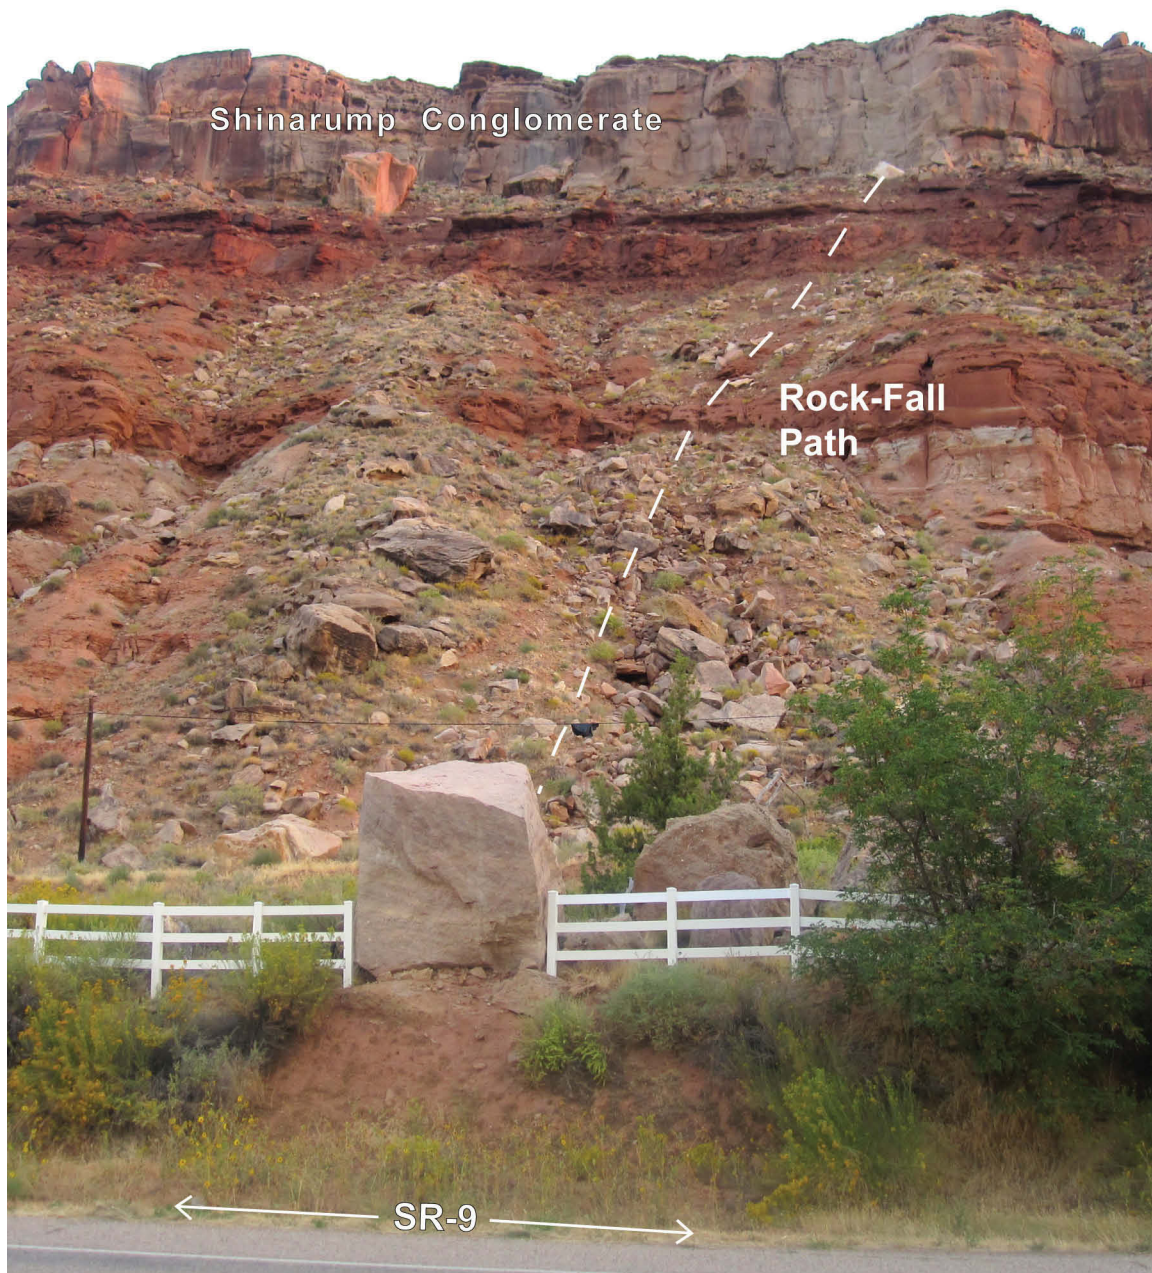
In late spring of 2007, a Shinarump boulder measuring approximately 9 x 9 x 8 feet fell from Rockville Bench and damaged a newly installed vinyl fence (figure 17) within 150 feet of the 1976 and 2002 rock falls (figure 2). Although

the largest boulder stopped about 20 feet north of SR-9, local resident Jeff Ballard reported that a passing motorist collided with a smaller fragment that had reached the highway, causing substantial damage to the vehicle. Fresh-looking rock fragments, still visible in September 2010, indicate a source near the base of the Shinarump cliff (figure 17).

Figure 17. Rock-fall boulder deposited in late spring of 2007 that damaged a vinyl fence; photo taken on September 29, 2010. Fresh-looking rock fragments delineate the probable travel path.

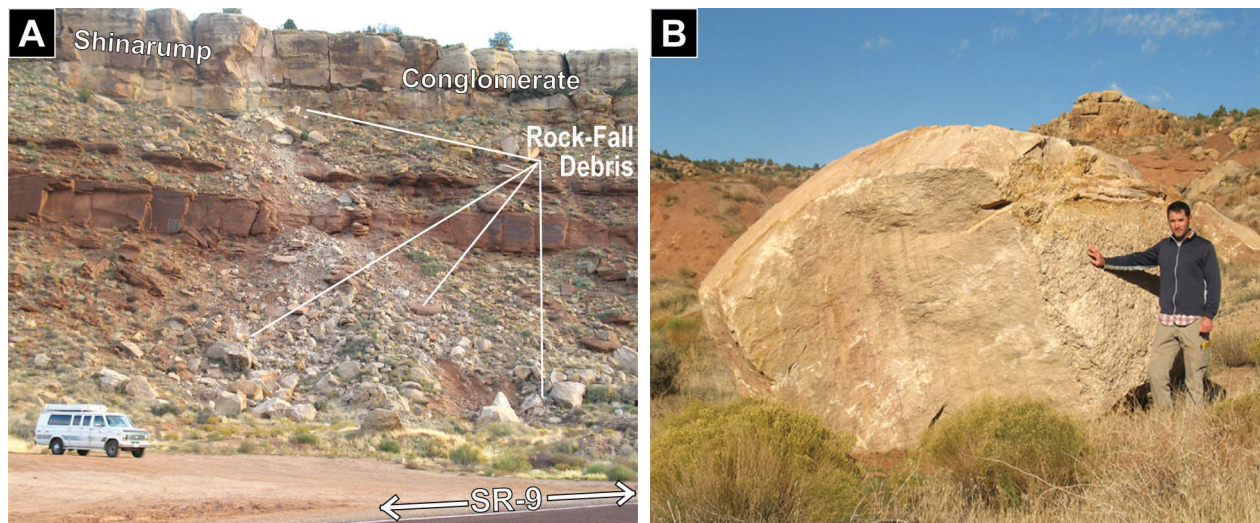
On the morning of November 2, 2010, a large mass of Shinarump Conglomerate detached from near the top of Rockville Bench east of the Rockville cemetery (figure 2). The rock mass broke apart into hundreds of smaller pieces that cascaded down the slope (figure 18A). At least 15 individual fragments measured approximately 4 x 4 x 5 feet or larger; the largest fragment measured 13 x 10 x 8 feet and weighed an estimated 78 tons (figure 18B). A single 13 x 8 x 6-inch rock shard came to rest within 20 feet of SR-9. No infrastructure was damaged by the rock fall.

Figure 18. Photos taken five days after the November 2, 2010, rock fall in east Rockville, near the Rockville cemetery. **A.** Fresh-looking rock fragments indicate the extent of the debris field. **B.** Largest rock-fall fragment measured 13 x 10 x 8 feet and weighed approximately 78 tons.

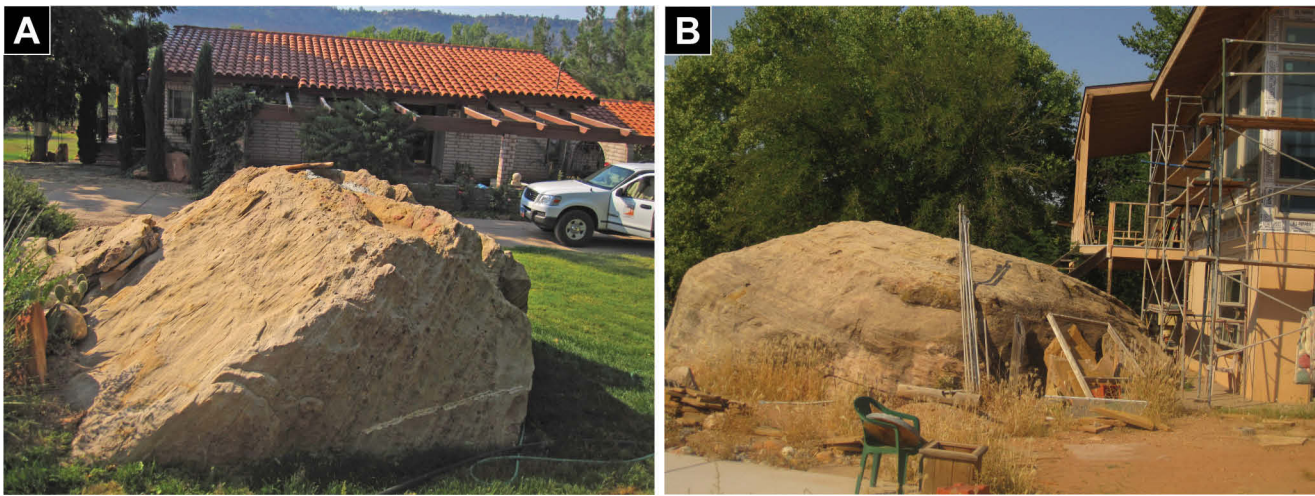
Figure 20. Isolated boulders of Shinarump Conglomerate that are too far from the Rockville Bench to have been deposited as rock fall in recent times. They are most likely either cliff-retreat deposits or flood deposits that do not represent the extent of the present-day rock-fall hazard. Boulder locations are shown on figure 2.

There are several large boulders of Shinarump Conglomerate up to 30 feet in long dimension near the center of town about 0.25 mile from the nearest Shinarump outcrop on Rockville Bench (figures 2 and 20). The shadow angle measured for the boulders is less than 15°. Similar large isolated boulders found in lower Zion Canyon by Lund and others (2010) were thought to either be talus/cliff-retreat deposits left isolated by canyon widening or flood deposits. However, the possibility that the Zion Canyon boulders could be remnants of infrequent but catastrophic fin-collapse or rock-avalanche events sourced from the roughly 2000-foot-high vertical canyon walls could not be excluded. Thus, Lund and others (2010) classified the area surrounding the boulders with a "low probability, high hazard" designation. The anomalous Rockville boulders are most likely old cliff-retreat

deposits that fell from Rockville Bench at a time when the bench was positioned much farther south, with a possibility that they are flood deposits that emanated from a small, unnamed drainage to the north. The relatively thin Shinarump Conglomerate overlying the easily erodible Moenkopi Formation and the comparatively low height of Rockville Bench are not conducive to anomalously large rock-fall runout distances; therefore, I conclude that the isolated boulders do not represent the limit of the current rock-fall-hazard area in Rockville. Biek and others (2004) reported additional cliff-retreat deposits consisting of Shinarump boulders on an abandoned terrace about 0.5 mile west of town.
