# RECONNAISSANCE OF LANDSLIDES AND PRELIMINARY LANDSLIDE HAZARD ASSESSMENT ALONG A PORTION OF BROWNS PARK ROAD, DAGGETT COUNTY, UTAH

by Gregg Beukelman and Ben Erickson

**REPORT OF INVESTIGATION 271**  
**UTAH GEOLOGICAL SURVEY**  
*a division of*  
**UTAH DEPARTMENT OF NATURAL RESOURCES**  
**2012**

*Cover Photo: View of Browns Park Road damaged from one of five landslides in lower Jesse Ewing Canyon, Daggett County, Utah*

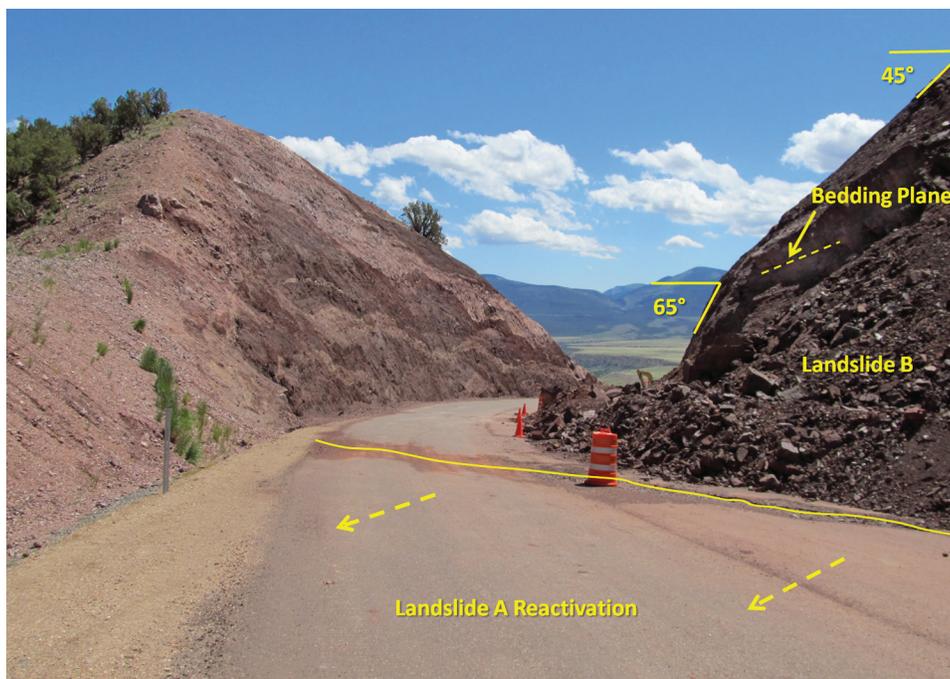
**Figure 3.** Browns Park Road looking south. Landslide A, a partial reactivation of a preexisting landslide, is shown in the foreground (yellow line marks landslide scarp and arrows show approximate direction of movement). At right is debris from Landslide B, a translational rockslide that blocked the southbound (downhill) lane of the roadway. Behind the debris is intact shale and silty sandstone bedrock showing bedding planes (one bedding plane highlighted by dashed yellow line) that are dipping out of the slope. The slope angle of the western road cut was measured as 45 degrees (1H:1V) in the upper part of the slope and about 65 degrees (1/2H:1V) near its base. Photo taken on June 21, 2011.

About 18.2 miles east of the Browns Park Road intersection with U.S. 191, we observed distress of the asphaltic concrete roadway pavement and a cut slope during our reconnaissance (figures 3 and 5). The distress included an approximately 195-foot-long, arcuate-shaped landslide scarp and abundant pavement cracking. Vertical offset across the scarp consisted of warping of the pavement at the scarp's northern end and pavement cracking on its southern end (figure 3). Vertical offset of the pavement was about 9 inches on the north and 6 inches on the south. Maximum deformation near the apex of the scarp, which extended approximately 29 feet west of the roadway into its cut slope, produced less than one foot of vertical offset of older landslide debris.

Landslide A is a partial reactivation of a preexisting, deep-seated, rotational rockslide. Conditions that may have led to reactivation include the assumed reduction of material strength along the surface of rupture during previous movements and increased pore water pressure along that surface. Evidence for groundwater movement along the rupture surface was observed along the southern margin of the preexisting landslide where its flank is marked by a light-colored, 4- to 6-inch-wide zone just above the marginal shear boundary of the slide that may reflect preferential groundwater movement that resulted in bleaching or mineral precipitation.

To fully understand the preexisting rockslide and its relation to Landslide A, the UGS recommends a more detailed investigation by a Utah-licensed engineering geologist and/or geotechnical engineer with significant experience in landslide investigation and mitigation. This investigation should address, at a minimum, the surface and subsurface geology; delineate ground-movement areas; define the surface of rupture; determine and monitor groundwa-

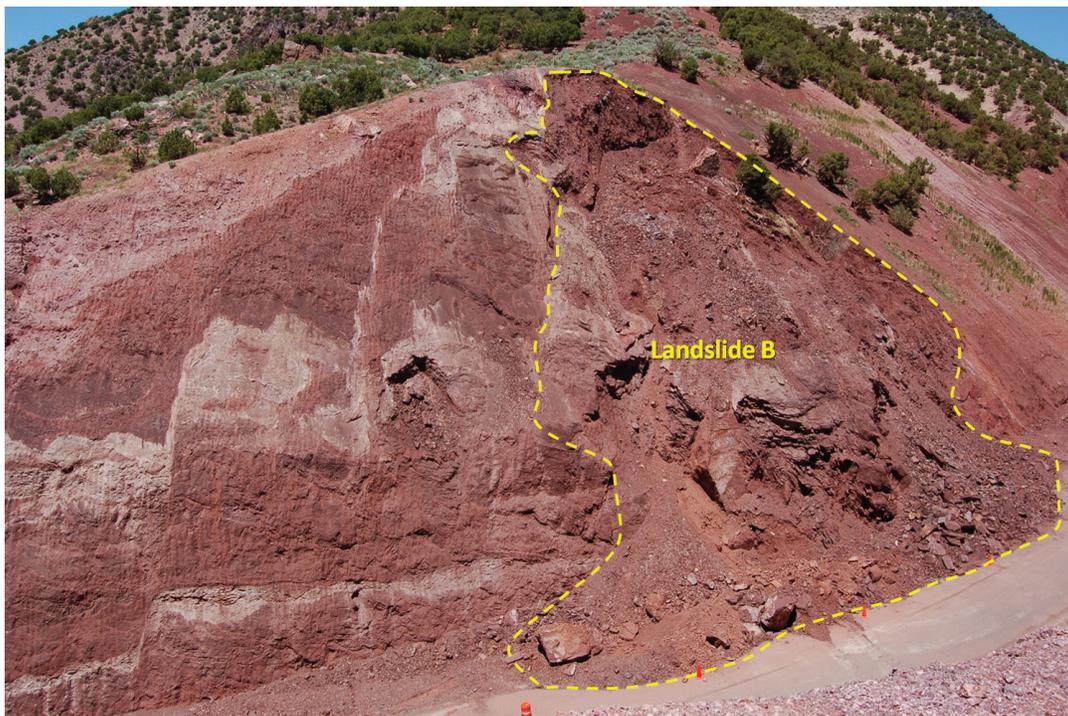
**Figure 4.** Western cut slope of roadway through cut showing Landslide B. Browns Park Road with one lane blocked in the foreground. Bedrock is Upper Jesse Ewing Canyon Formation shale and silty sandstone. Numerous steeply dipping normal faults are marked by offset of light-colored beds in left part of photo. Photo taken on June 21, 2011.

Landslide B is a translational rockslide that occurred adjacent to, and southwest of, Landslide A. This slide extends from the roadway to the top of the road cut slope; it is about 150 feet wide at the road elevation, and 50 feet wide at the crest of the cut slope (figures 4 and 5). During our reconnaissance, debris from this landslide blocked the southbound lane of Browns Park Road, limiting traffic to one lane. James Olsen, Daggett County Road Department, stated that landslide movement began in 2010, became much more significant in spring of 2011, and finally resulted in failure of nearly the entire height of the slope during the early part of the first week of June 2011 (figures 3, 4, and 6). Rockslide materials consist of dark red-brown silty sandstone and shale with interbedded silicified conglomerate. Based on road-cut exposures south of the rockslide, abundant near-vertical faults cut these materials (figure 4) resulting in intensely fractured bedrock that weathers to gravel-sized fragments. Daggett County Road Department personnel reported that fresh bedrock cobble-sized blocks that fall from the road cut typically weather to a soil-like material within a month. During the rockslide, a resistant sandstone bed approximately halfway up the slope slid downslope 5 to 15 feet while breaking into blocks more than 6 feet long on all sides with fresh, unweathered surfaces (figure 4).

Landslide B is a rockslide in the east-facing slope of a through cut excavated as part of the road realignment. The weak nature of geologic materials, including the presence of east-dipping, faulted, intensely fractured, and deeply weathered shale and silty sandstone likely contributed to landsliding. Local bedding-plane orientation and its relation to cut-slope angles produced out-of-the-slope bedding dip conditions (figure 3) in the vicinity of Landslide B. Although the triggering mechanism is unknown, elevated pore water pressure along bedding planes in the shallow subsurface resulting from a wet winter and spring and recent moderately intense rain events are likely contributing factors. Evidence for failure along bedding planes includes exposures along the southern margin of the rockslide where the angle of the surface of rupture coincides with the dip of the bedding planes.

Landslide B movement appears to have occurred on bedding planes that locally dip out of the slope. In addition, bedrock conditions, including intense fracturing and deep weathering, locally produce material that behaves more like soil or very weak rock than intact bedrock and is unstable on steep slopes. Possible methods of stabilizing this rockslide include reducing the road cut slope angle or using mechanical stabilization. Mitigation design should include an analysis of materials comprising the slope and their strength, discontinuity, and weathering parameters.

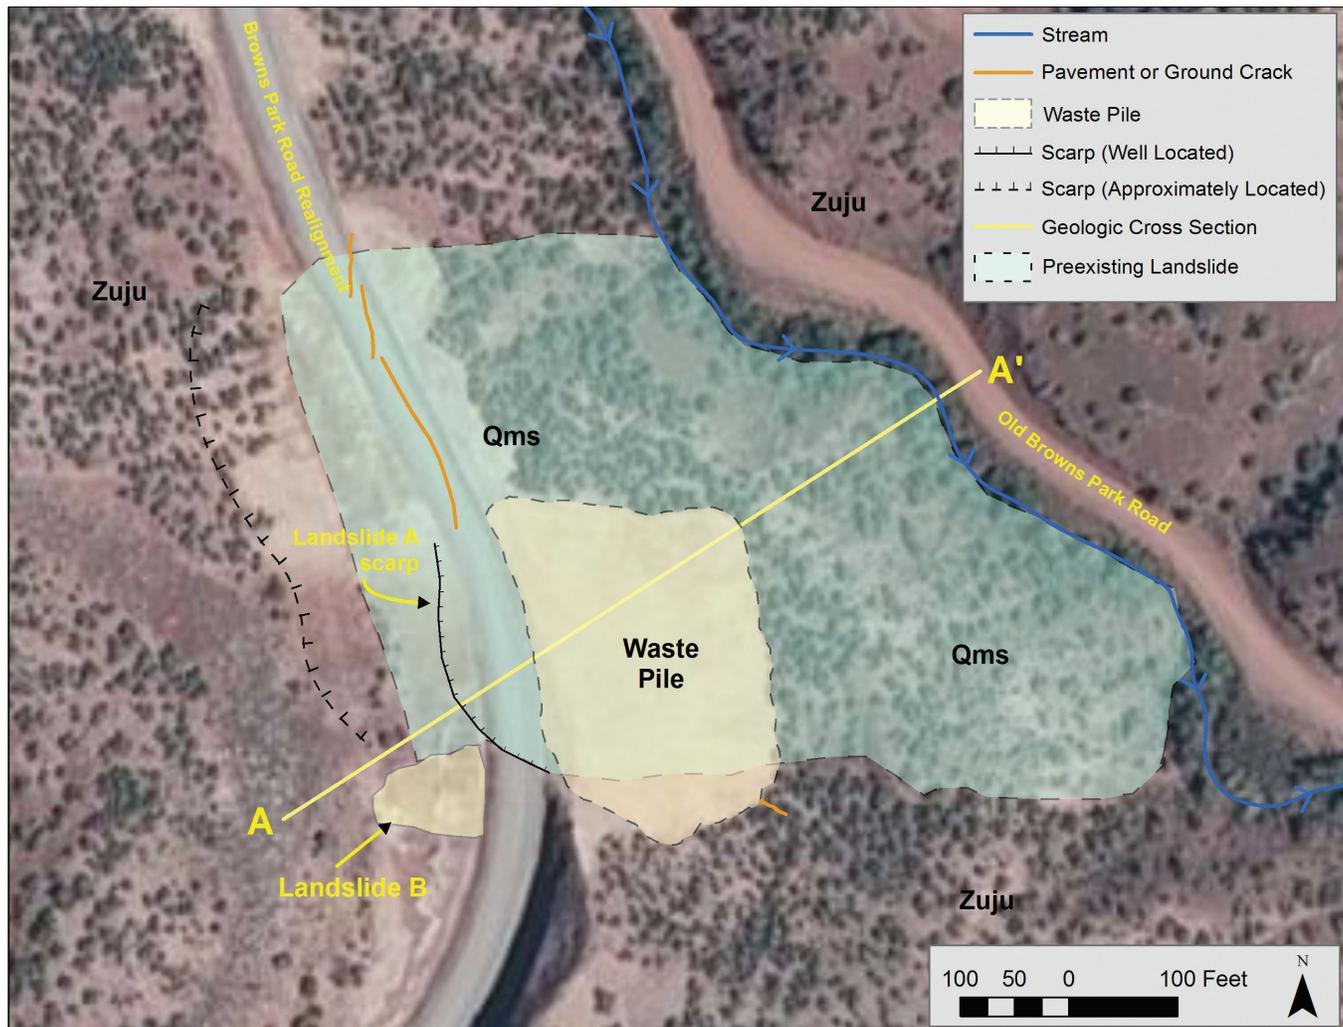
**Figure 5.** Map of preexisting landslide, Landslide A scarp, and waste pile. Geologic cross section A–A' is shown on figure 8. Geologic units include landslide debris (Qms) and Upper Jesse Ewing Canyon Formation shale interbedded with quartzose and lithic sandstone (Zuju). Bedrock geology from Sprinkel (2006) and landslide and waste pile extents from this reconnaissance. Base from 2009 National Agriculture Imagery Program.

5, 7, and 8) activities. The waste pile has dimensions of about 300 feet north to south, 200 feet east to west, and is up to 30 feet thick. Waste material was placed on top of a rotated surface developed by prior movement of the large preexisting landslide discussed above. In addition to the recent pavement distress related to scarp formation in the vicinity of the waste pile (figure 3), longitudinal pavement cracking with very slight vertical offset extended approximately 260 feet north from the waste pile. With the exception of a small ground crack near a small drainage that bounds the landslide to the south below the waste pile (figure 5) that may be related to this landslide, no landslide flank or toe features were observed. The observed features suggest an incipient partial reactivation of the preexisting landslide that has not developed to the point of full failure.

GIS analysis of the surface topography that existed prior to road construction suggests the base of the main scarp of the preexisting landslide was about at the current base of the cut slope (figure 5). Such a configuration would allow surface water runoff from both the cut slope and roadway to intercept the surface of rupture of the preexisting land-

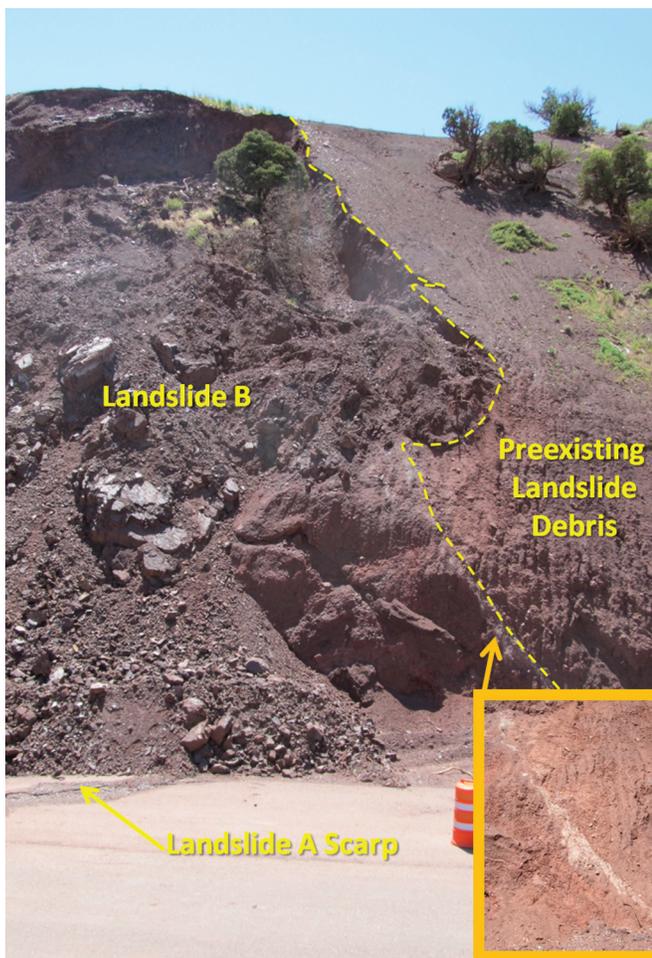
**Figure 6.** Contact between Landslide B and preexisting landslide debris. Exposure in western road cut slope along Browns Park Road. Inset shows discoloration of material along right flank shear plane of preexisting landslide low on cut slope. Photo taken on June 21, 2011.

The northern extent (left flank) of Landslide B appears to be limited by the presence of preexisting landslide debris, as Landslide B extends only to the southern margin of the preexisting landslide (figure 6). This configuration may be

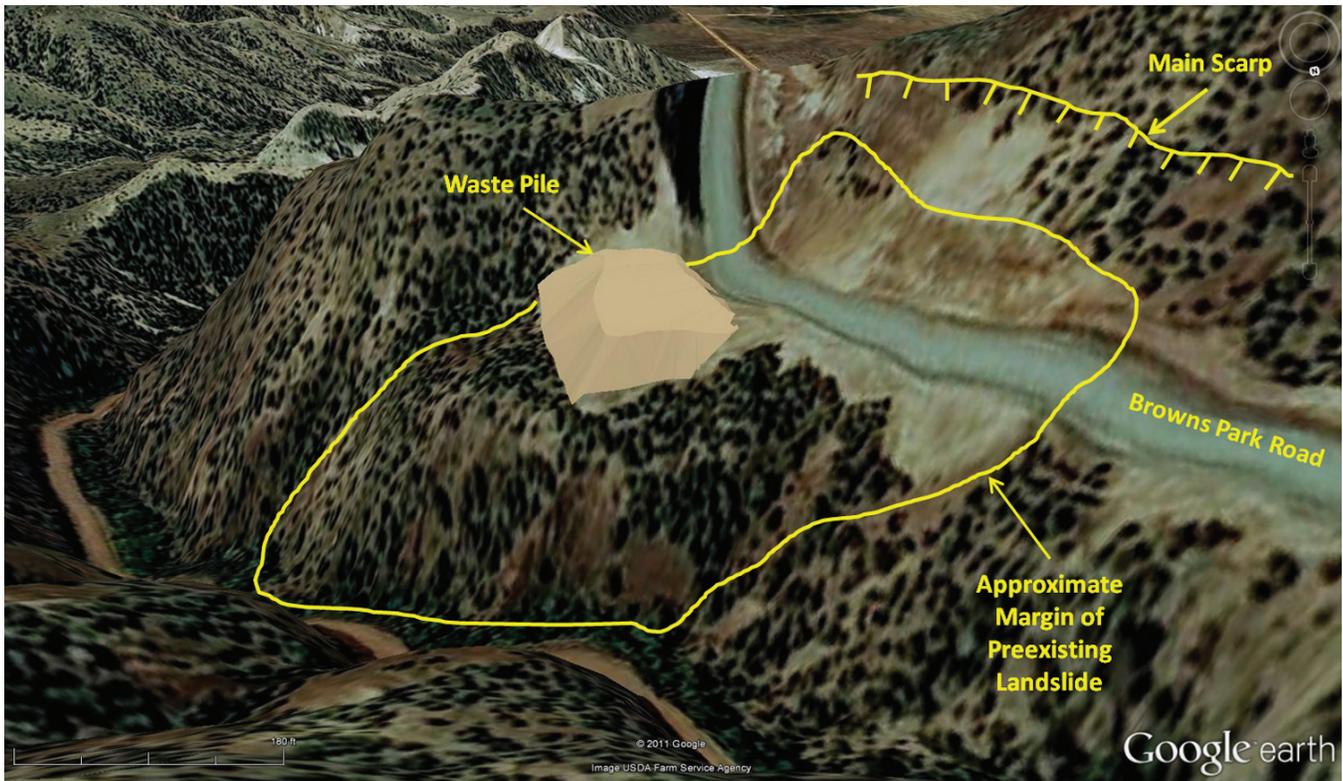
**Figure 7.** Oblique view, looking south, of preexisting landslide and waste pile. Waste pile was constructed on top of a back-tilted surface created during previous landslide movement. Google Earth image from 2009 National Agriculture Imagery Program.

Anthropogenic activities that may have contributed to the movement of Landslide A include placement of the waste pile on a back-tilted surface developed during earlier movement of the preexisting landslide, and modification of the upper portion of the landslide slope during the road realignment. Based on topographic data collected during

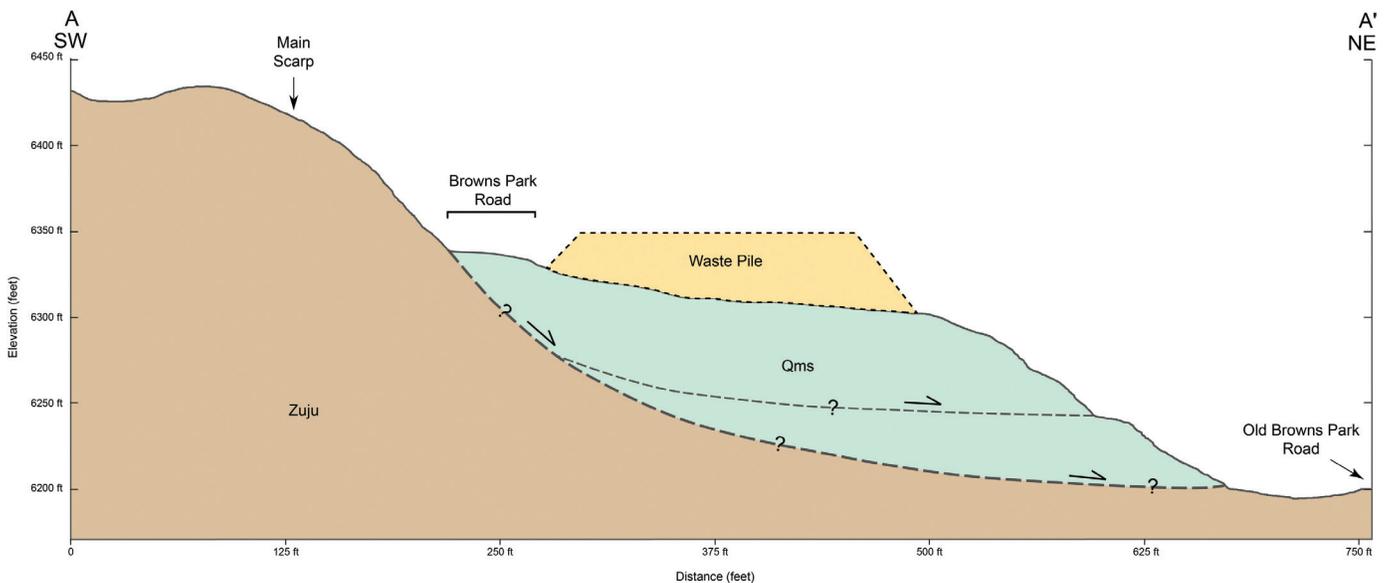
**Figure 8.** Geologic cross section of preexisting landslide. Surface profile based on DEM of the pre-road realignment landscape. Bounds of preexisting landslide (Qms) and waste pile are from geologic mapping conducted during this reconnaissance. Landslide (Qms) overlies intensely fractured and weathered shale, sandstone, and siltstone with minor lenses of silicic conglomerate (Zuju). See figure 5 for cross section line location.

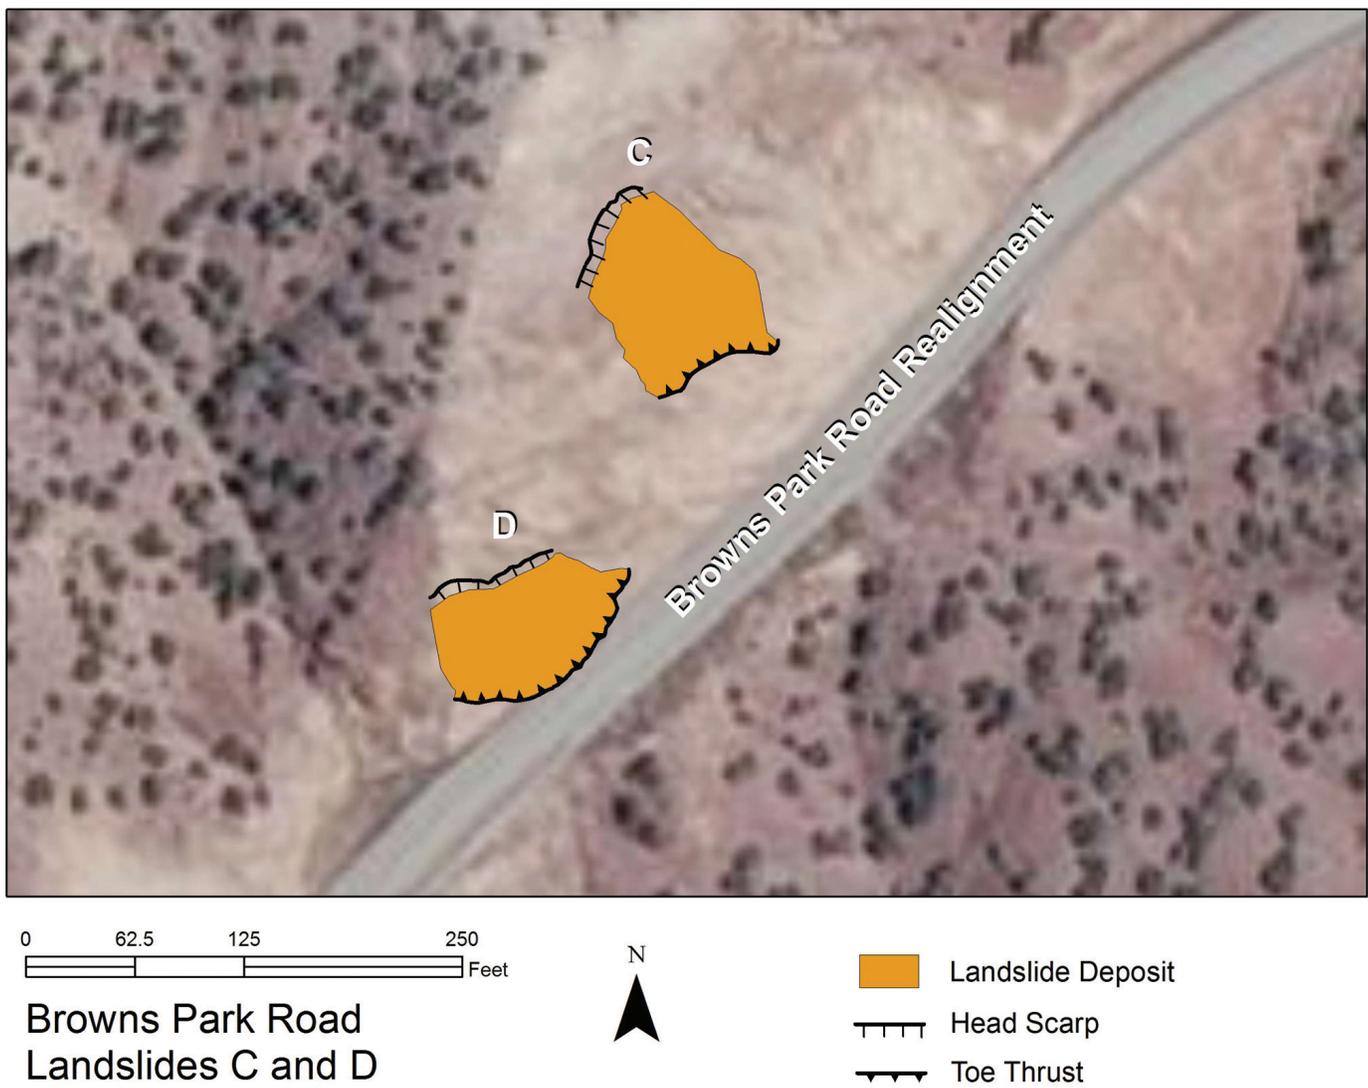
Landslide D is also a translational rockslide on the same cut slope as Landslide C, about 110 feet farther to the southwest and 40 vertical feet lower (figure 9). Landslide D extends downslope a maximum of about 70 feet from its main scarp and ranges in width from about 76 feet at its main scarp to about 120 feet near its toe (figure 11). The main scarp is about 3 feet high and exposes the same dark red-brown silty sandstone as we observed in Landslide C. We measured a bedding plane at the main scarp having a strike and dip of  $N55^\circ W, 42^\circ SW$ . The toe of the landslide filled the road drainage ditch and impacted the guardrail.

**Figure 9.** Locations of Landslides C and D. Both landslides are translational rockslides on a  $34^\circ$  (1.5H:1V) cut slope above Browns Park Road. Landslide D impacted a guardrail and filled the small roadside drainage ditch. Base from 2009 National Agriculture Imagery Program.

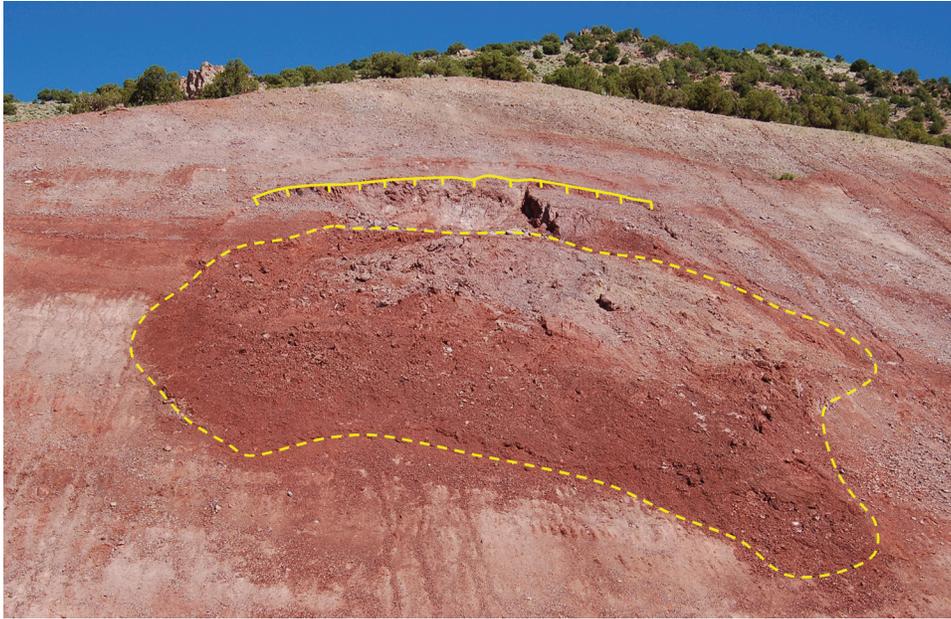
In addition to Landslides A and B, we investigated three south-facing cut-slope failures during our reconnaissance. Landslides C and D are on a cut slope about 18.6 miles from U.S. 191 (figures 2, 9, 10 and 11). The slope extends about 250 feet above the roadway at an angle of about  $34^\circ$  [1.5H:1V]. Landslide C is a translational rockslide near the middle of the slope that extends about 120 feet from its main scarp down slope to a well-developed toe thrust about 40 feet above the roadway (figure 10). The width of this rockslide ranges from about 68 feet at the main scarp to about 90 feet near the toe. The main scarp is about 13 feet high and exposes dark red-brown silty sandstone and silicified conglomerate with bedding-plane strike and dip of about  $N55^\circ E, 65^\circ SE$ . At the time of our reconnaissance, Landslide C had not affected the roadway. Although much

**Figure 10.** Landslide C main scarp and deposits on road cut slope. Hachured yellow line marks main scarp and dashed yellow line shows approximate boundary of landslide deposits. Photo taken on June 22, 2011.

Landslides C through E involve material similar to that at Landslide B. However, the relations between the orientation of bedrock bedding planes and slope angles differ, and thus do not result in the same out-of-the-slope bedding dip conditions observed at Landslide B. The lack of out-of-the-slope bedding dip conditions may have limited the downhill extent of these relatively small rockslides that have not, or have only marginally, impacted the roadway. Landslides C through E occurred on south-facing slopes as bedding-plane failures of more competent rock. Once mobilized, movement extended into more weathered materials downslope. Depending on conditions of the bedrock involved, their position on the slope, and climatic conditions, these landslides may impact the roadway in the future. Continued raveling of material above the landslides will result in headward expansion, but given the relation between surface cut-slope angles of about 34° (1.5H:1V) and the dip of bedding planes (42° to 65° [1H:1V to 1/2H:1V]), large-scale failure of the entire slope is not anticipated under the current conditions. However, as exposed materials continue to weather and with a reoccurrence of extreme precipitation events, future large-scale landsliding cannot be ruled out. Under current conditions, and at the discretion of Daggett County, mitigation of existing and future failures of these slopes may likely be limited to ongoing slope and road maintenance.

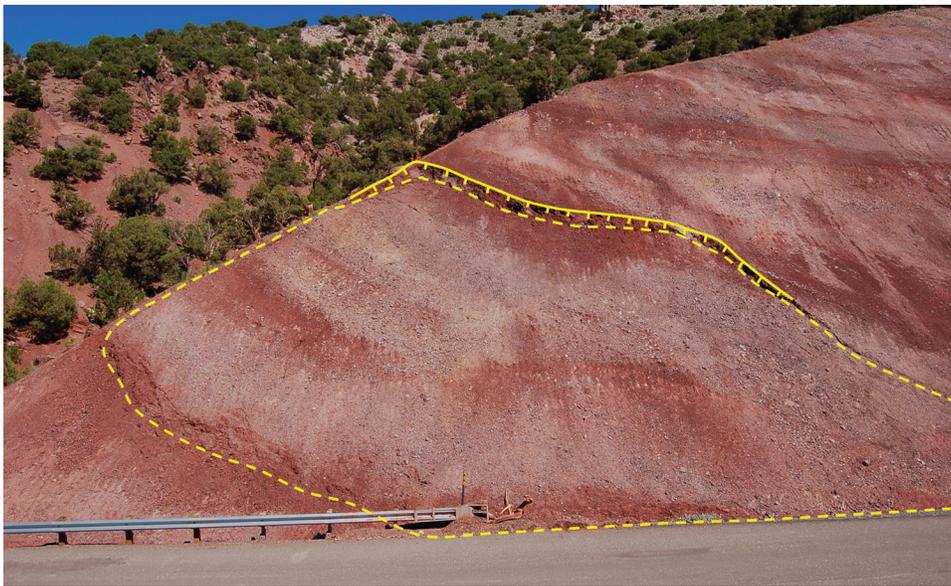
**Figure 11.** Landslide D main scarp and a part of its deposits on road cut slope. Landslide deposits filled a small roadside ditch and covered a portion of a guardrail. Hachured yellow line marks main scarp and dashed line shows approximate boundary of landslide deposits. Photo taken on June 22, 2011.

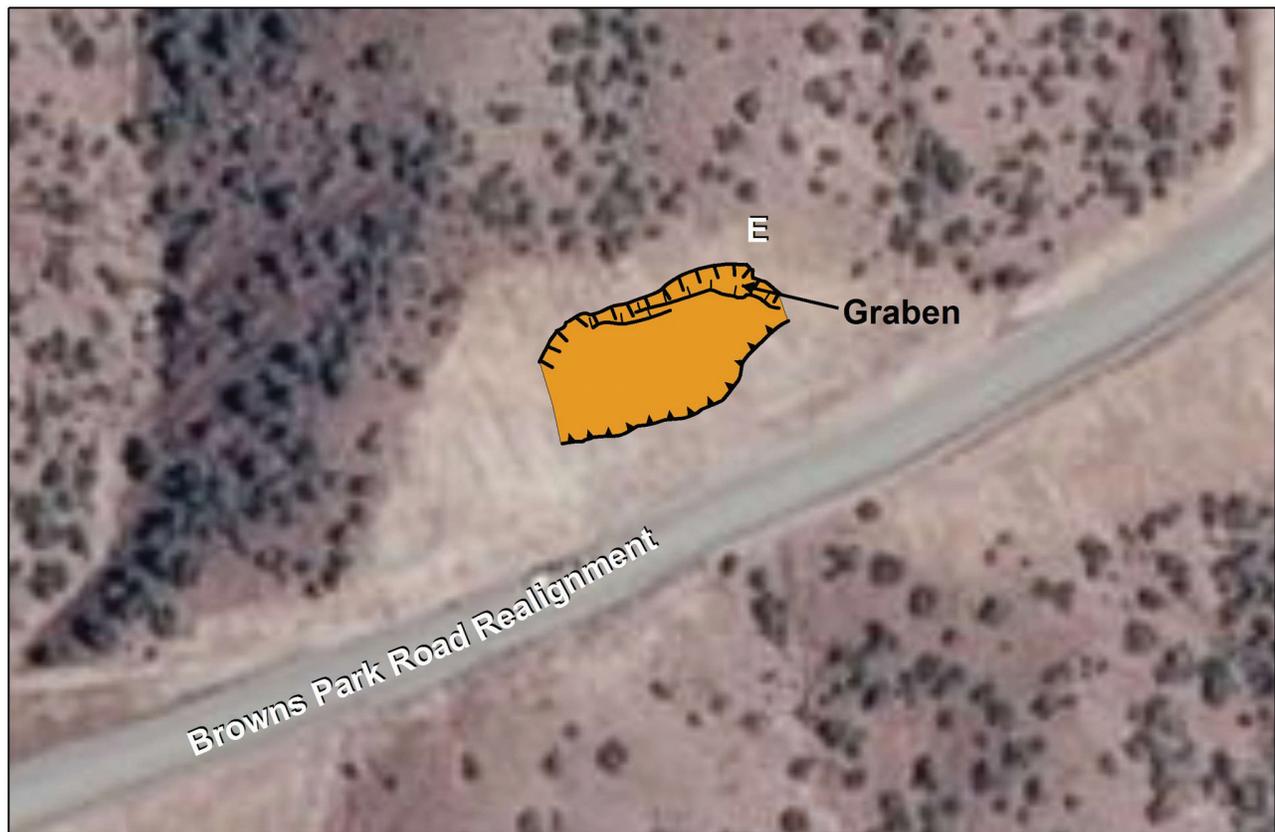
Landslide E is a rockslide, located about 18.8 miles along Browns Park Road from its intersection with U.S. 191, that occurred on a 65-foot-high cut slope with a slope angle of approximately  $34^\circ$  (1.5H:1V) (figures 2, 12 and 13). The rockslide occupies a large portion of the cut slope, and has a well-developed main scarp and associated graben extending about 140 feet across the slope face (figure 12). The rockslide extends downslope approximately 75 feet to a small toe thrust about 45 feet above the roadway (figure

**Figure 12.** Location of Landslide E. Landslide E is a translational rockslide that failed along bedding planes and affected a road cut slope above Browns Park Road. Base from 2009 National Agriculture Imagery Program.

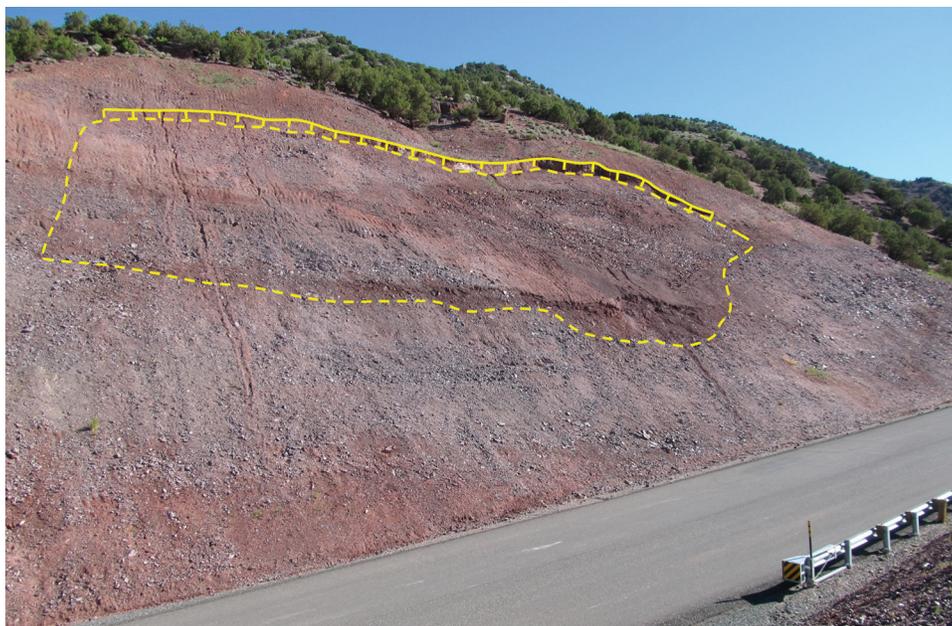
13). The main scarp is a maximum of 5 feet high and exposes intensely fractured and weathered silty sandstone and silicified conglomerate. Movement appears to have occurred along bedding planes. Although no discontinuity data were collected at this landslide, observations suggest that bedding planes dip slightly steeper than the slope itself and strike near perpendicular to the direction of the maximum slope angle. This relation resulted in a limited downslope extent of landslide movement. The dimensions of the rockslide deposits are approximately 140 feet wide, 30 feet long, and an average of about 3 feet deep.

**Figure 13.** Landslide E on upper part of road cut slope. Yellow hachured line marks main scarp and dashed line shows approximate boundary of landslide deposits. Photo taken on June 22, 2011.

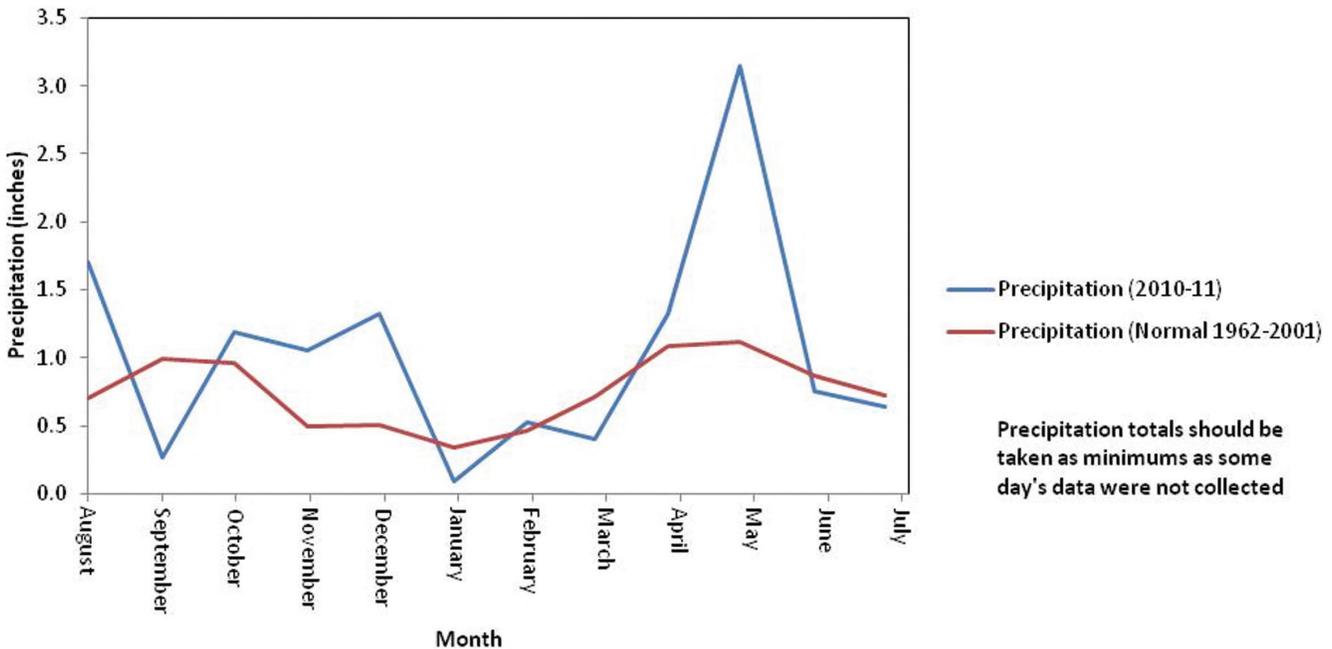
As elsewhere in Utah, the fall, winter, and spring of 2010–11 were unusually wet in the vicinity of the landslides. Between August 2010 and June 2011, the Jarvie Ranch weather station operated by the National Weather Service, approximately 2.5 miles southwest of the landslides, received 6.24 inches of precipitation, which is 148% of normal (Utah Climate Center, 2011) (figure 14). In addition to the wet seasonal conditions, Utah Climate Center (2011) data record two intense rain events that moved through the area in the latter part of May 2011 (figure 15). From May 15 to May 21, 1.91 inches of rain was recorded and from May 29 to May 31, 0.90 inches of rain fell.

Figure 14. Monthly precipitation totals recorded at Jarvie Ranch weather station. Recent precipitation data are from August 2010 through June 2011 (Utah Climate Center, 2011). Normal precipitation is the monthly average from 1962 to 2001 (Western Regional Climate Center, 2011).

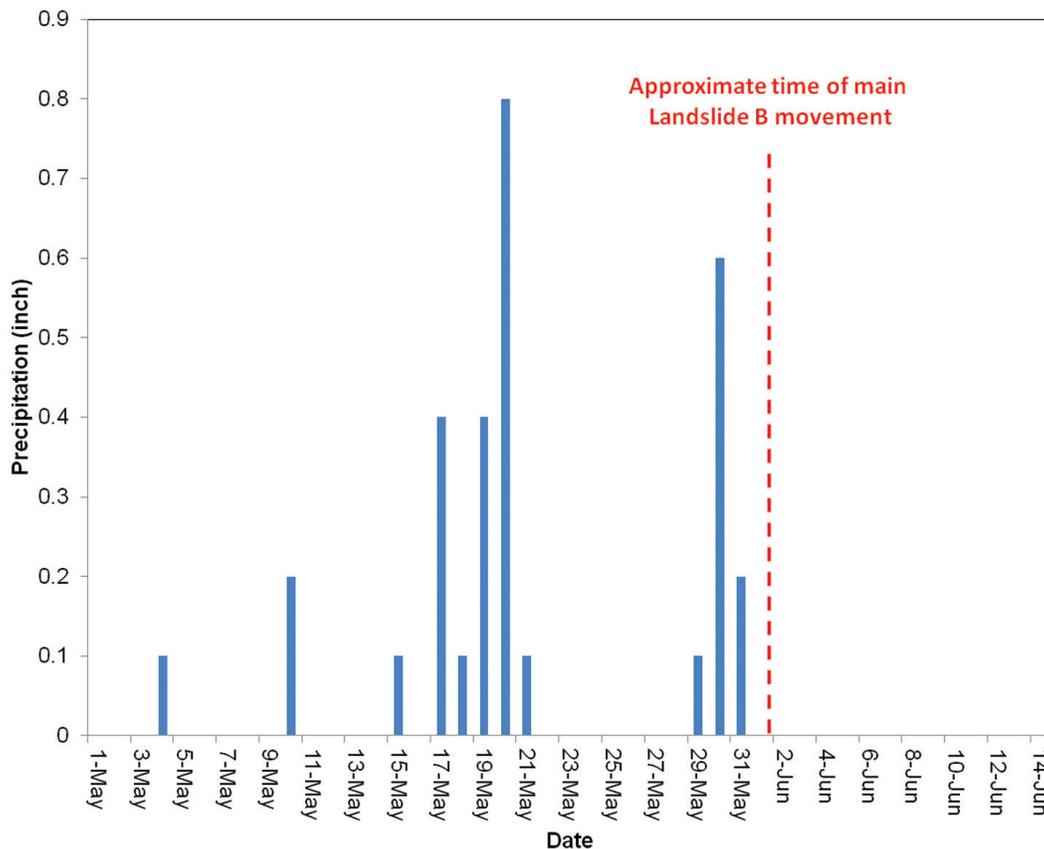
**Figure 15.** Daily precipitation data for May and early June 2011. Data from the Jarvie Ranch weather station (Utah Climate Center, 2011).
