INVESTIGATION OF THE AUGUST 24, 2019, CABLE MOUNTAIN ROCK AVALANCHE, ZION NATIONAL PARK, UTAH

by Jessica J. Castleton and Ben A. Erickson

REPORT OF INVESTIGATION 281
UTAH GEOLOGICAL SURVEY
a division of
UTAH DEPARTMENT OF NATURAL RESOURCES
2019

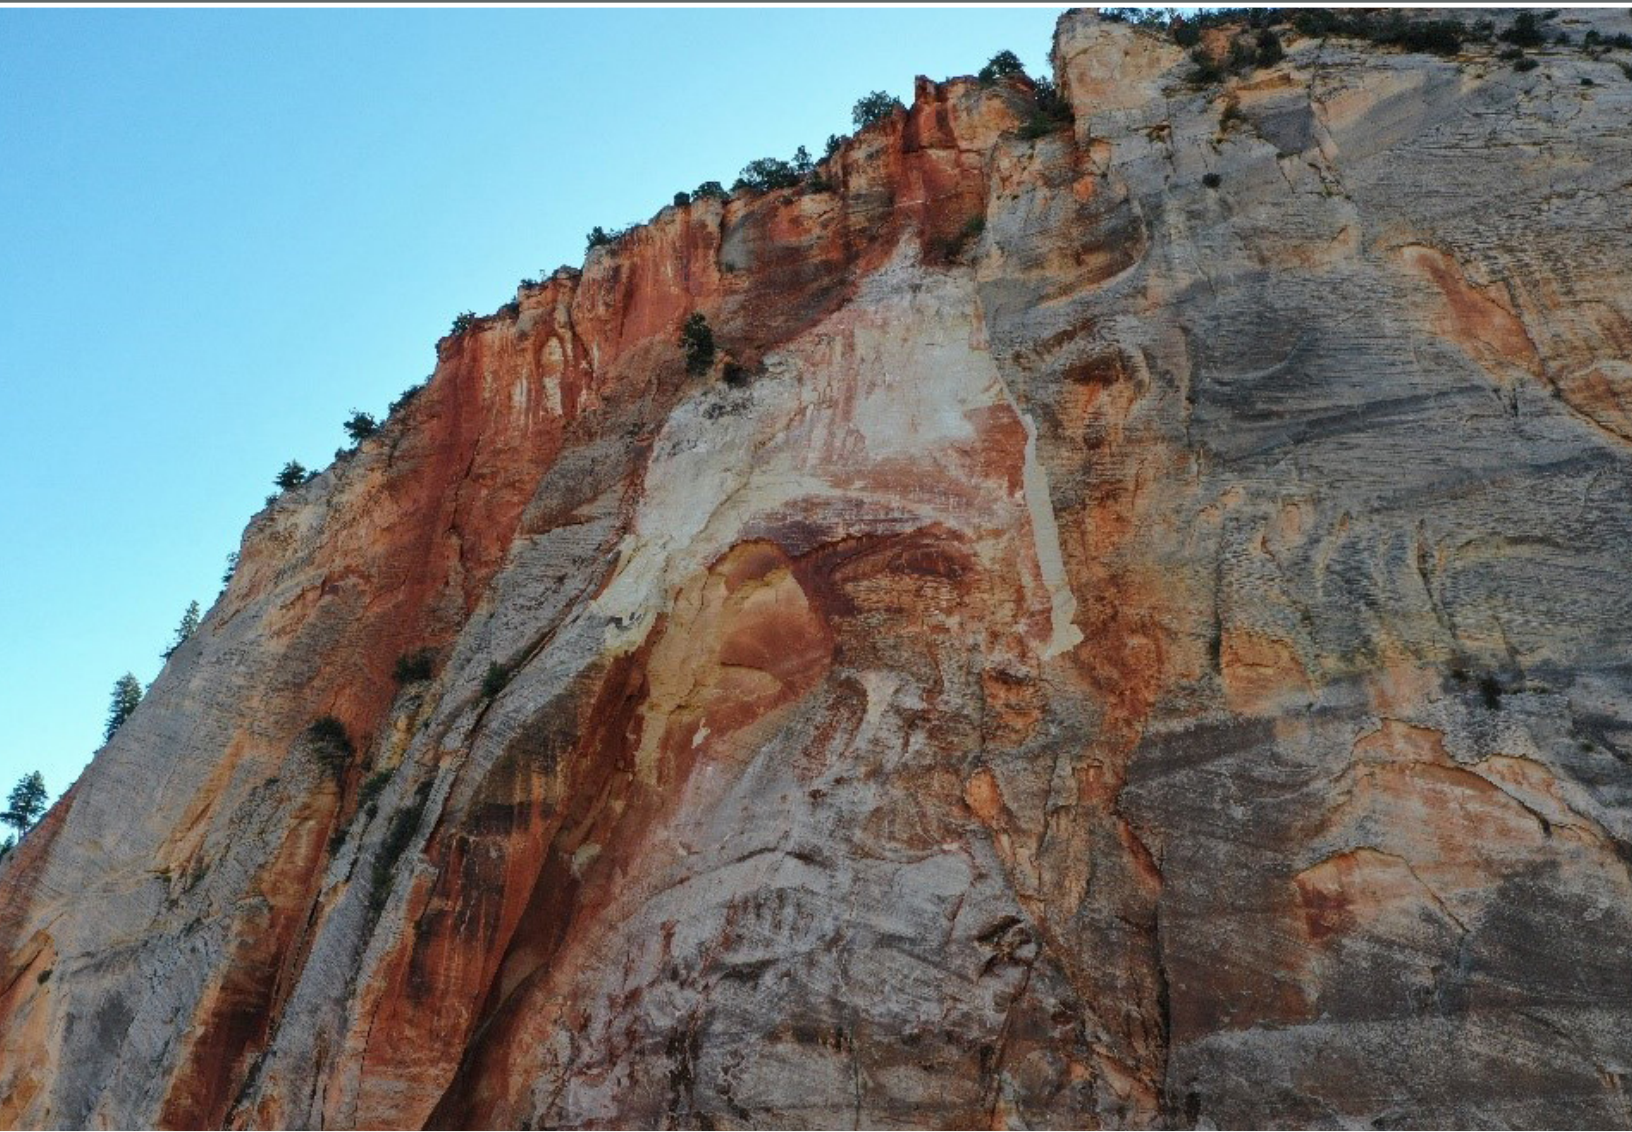
Cover photo: Cable Mountain rock avalanche scar, photo date September 25, 2019.

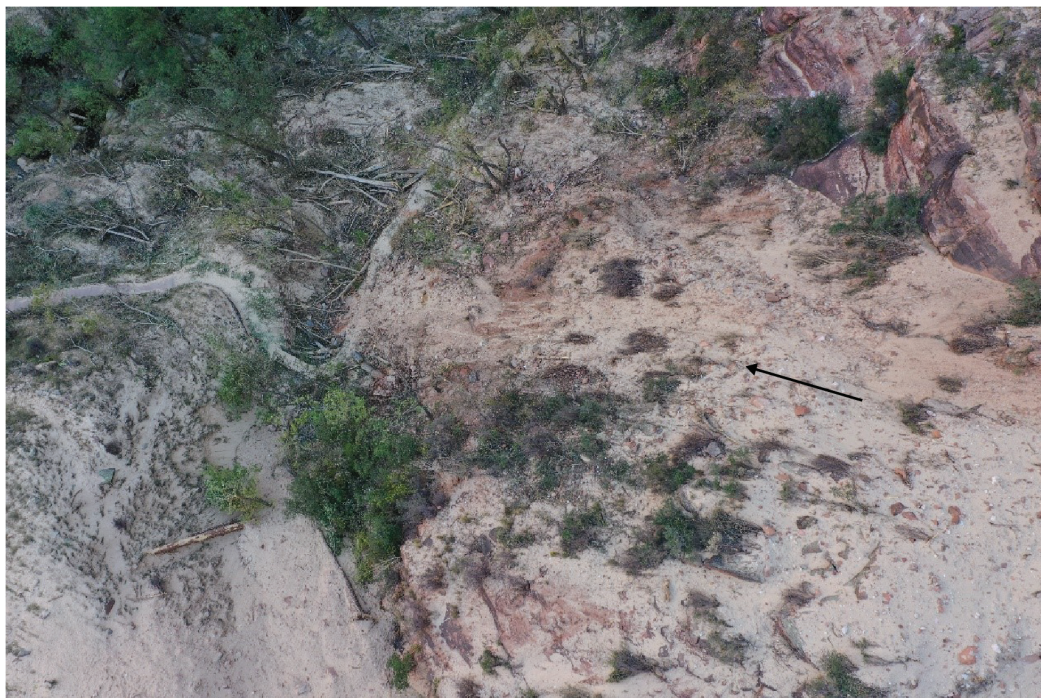
a very small rock avalanche. A rock avalanche is defined as the transformation of a rock slide (in itself characterized by limited disintegration) into a deeply disintegrated, rapid, and catastrophic flow of rock (De Blasio, 2011). The particles had a flow-like quality (figure 2) and the force of this event uprooted and entrained trees and damaged heavy-duty excavation equipment. The East Rim trail was severely damaged, but fortunately, was closed due to previous rockfall that occurred in January 2019. Three hikers on the Weeping Rock trail sustained non-life-threatening injuries. At the request of the National Park Service, Utah Geological Survey (UGS) geologists conducted a site reconnaissance on August 26, 2019. An additional investigation, including high-resolution photographs and video collected with a small unmanned aircraft system (sUAS), was conducted October 24–25, 2019. Data were also collected to help assess the stability of a prolific rockfall area that has repeatedly damaged the nearby Hidden Canyon trail.

Figure 2. sUAS photograph showing the flow direction (indicated by the vegetation and arrow) and broken and entrained trees in the Cable Mountain rock avalanche debris deposit. Photo date: October 24, 2019.

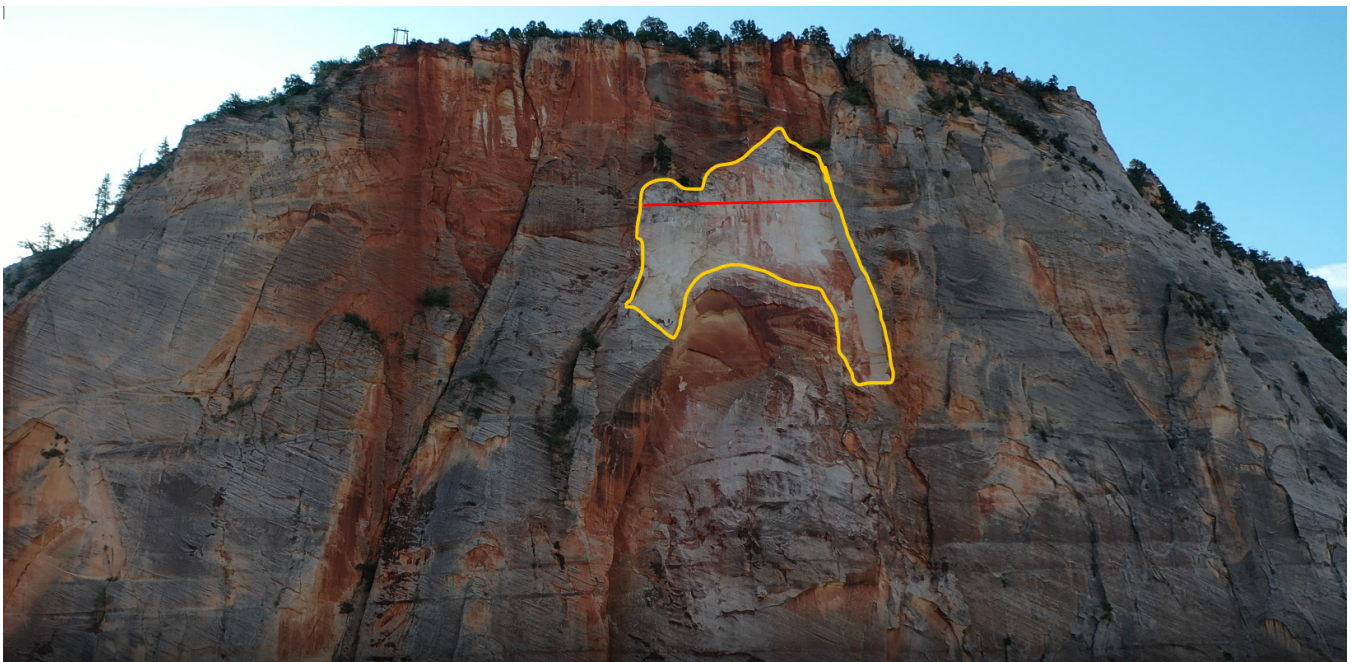
thickness of the rock slab that fell was approximately 16 feet (5 m), which is a conservative estimate based on measurements of the source area, where thickness is easily determined. The actual thickness likely varied and is difficult to determine without pre-event high-resolution DEM data. Lidar elevation data collected in 2015 for the area is not accurate enough on vertical cliff faces like the source area location. The rock slab that fell measured approximately 197 feet (60 m) horizontally and 243 feet (74 m) vertically, as measured on the longest axes. The rock avalanche volume was calculated to be 435,712 cubic feet (12,338 m³), which classifies the event as a very small rock avalanche (De Blasio, 2011). The rock mass was approximately 31,292 tons, based on the approximate specific gravity of Navajo Sandstone. The range of specific gravity values reported for sandstone in the American Geological Institute (AGI) Geoscience Handbook (AGI, 2006) is 2.28–2.37. The average is 2.33, which we round to 2.3 to reflect the fact that the value used is an estimate and was not determined specifically for rock at this site. Given the above assumptions regarding the shapes of the rock mass and boulders and their specific gravity, we consider our volume and mass estimates accurate to $\pm 15\%$ (after Lund and others, 2014).

Figure 3. Cable Mountain rock avalanche source area outlined in yellow; the scar measures approximately 133 feet at the red line based on the orthomosaic image. The volume of the rock avalanche was calculated to be 435,712 cubic feet (12,338 m³), with a corresponding mass of approximately 31,292 tons. Photo date: October 24, 2019.

tation for August 2019, as reported at the weather station located at the Zion Human History Museum, was 0.19 inches (4.8 mm; Utah Climate Center, 2019; these data indicate that measurements for one to nine days in August may be missing). The overall precipitation average for August is 1.54 inches (39.2 mm). The mean temperature for August 2019 was 85.10°F (29.5°C; Utah Climate Center, 2019), and the average August temperature since record keeping began in 1904 is 81.60°F (27.5°C). Rock slabs on cliff faces, such as the slab that failed above Weeping Rock, bulge and move with daily heating and cooling cycles. Rockfall events can be triggered on the warmest times of day and year (Collins and Stock, 2016). The rock slab was partially detached from the main cliff face by multiple vegetation-filled cracks around the edges of the slab.

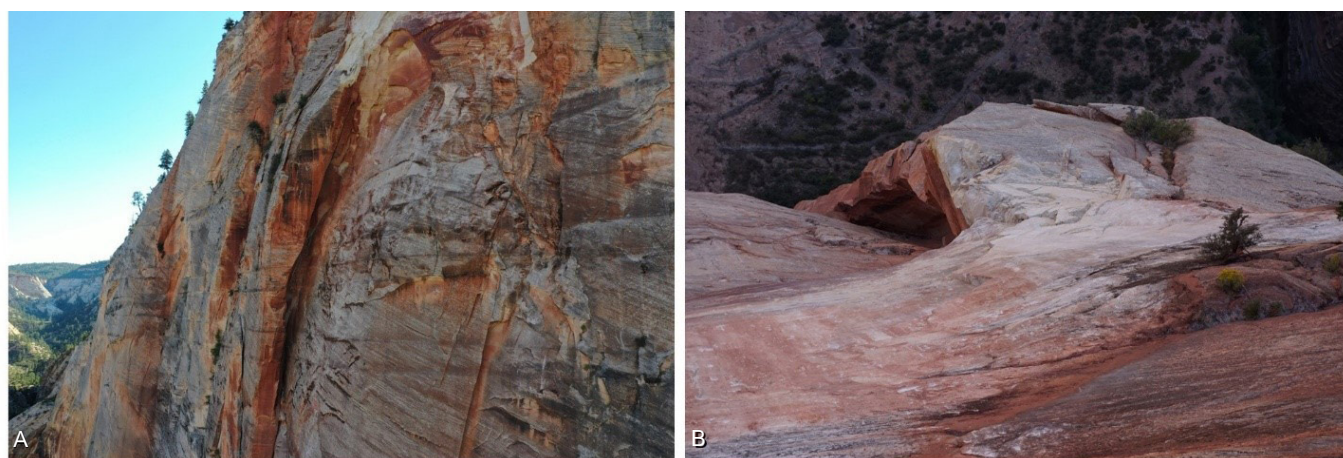
Another large rock slab having void space behind it, like the slab that fell, is located to the northeast on the Cable Mountain cliff face. This slab was investigated due to its proximity to the failed slab's scar; however, fractured rock slabs that pose a rockfall hazard are located all along the cliff face. The acquired sUAS imagery data show these large rock slabs are highly fractured and semi-detached, bulging away from the cliff face. Vegetation commonly fills fractures (figure 4). The cliff face is highly jointed, fractured, and has many areas of alcoves, arches, and slabs (figure 5). These slabs are unstable and may fall at any time. The area near the August 24, 2019, rockfall scar, especially on the lower left side, is highly fractured and possibly unstable, posing a high rockfall hazard. Potential rockfall triggering events occur more frequently in areas that have highly variable daily temperatures, where frost weathering can occur, and during intense precipitation, seismicity, and high temperature events; however, slabs can detach from cliffs with no warning or identifiable trigger mechanism.

Figure 4. *A.* sUAS photo showing the void space between the rock bulge and the main cliff face of Cable Mountain. *B.* Photo from the top of Cable Mountain showing significant rock bulging and fractures filled with vegetation. (photo credit: Tyler Knudsen) Date of photos: October 24, 2019.

A large rock slab with void space behind it, like the slab that fell, is located northeast on the Cable Mountain cliff face, adjacent to the August 24, 2019, rockfall scar. The acquired sUAS imagery data show this large rock that is highly fractured and semi-detached from the main cliff. The area near the rockfall scar, especially on the lower left side, is highly fractured and possibly unstable, posing a high rockfall hazard.

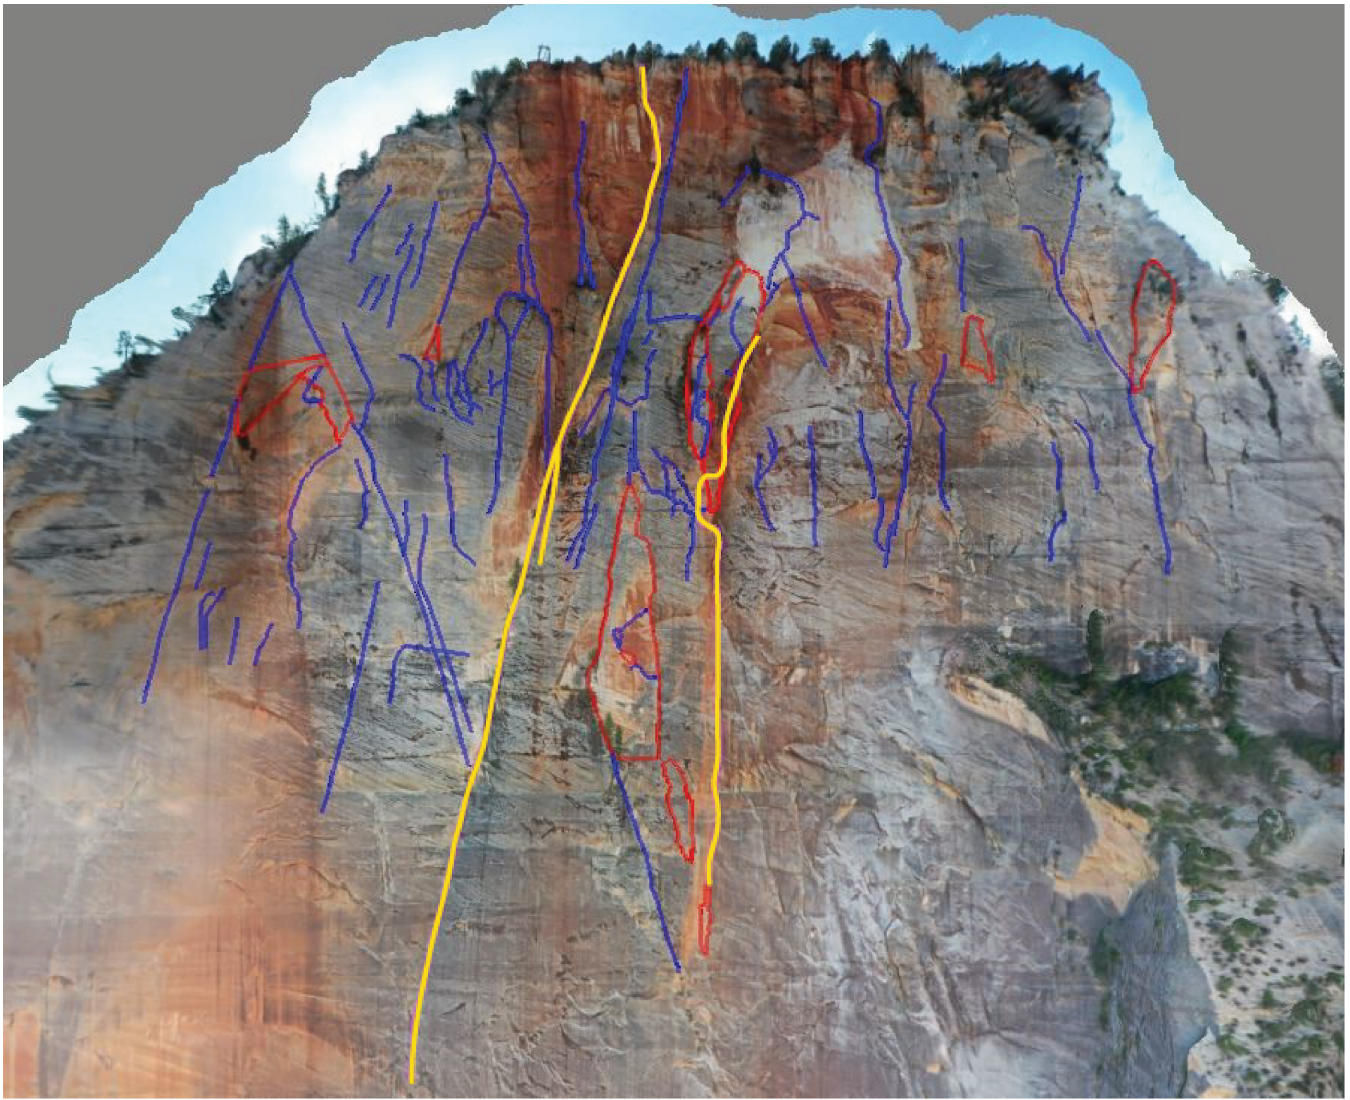
Figure 5. Orthomosaic image of Cable Mountain created from sUAS imagery using Agisoft Metashape software. The red polygons indicate sandstone blocks that are highly fractured. The blue lines indicate prominent fractures on the cliff face. The yellow line indicates a large fracture on the cliff face, the longest of which measures approximately 968 feet, based on the orthomosaic image.

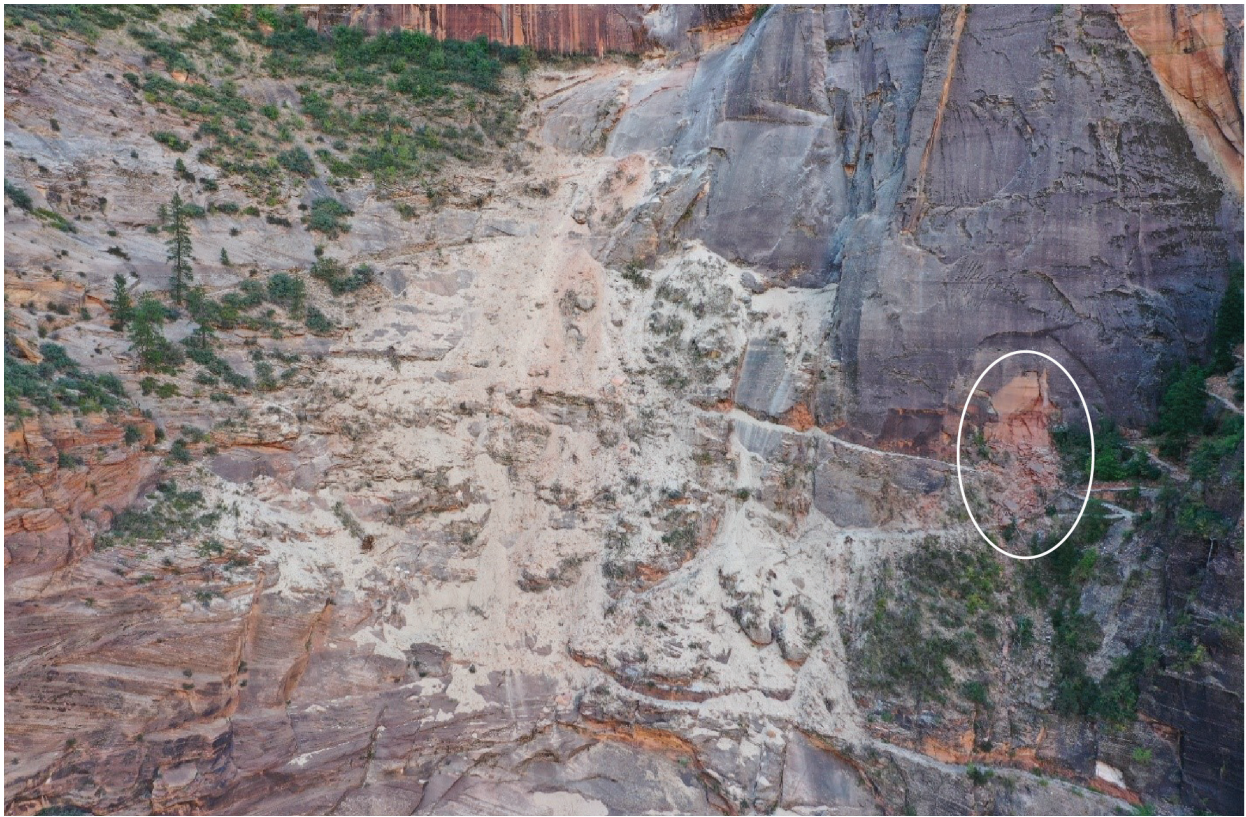
Figure 6. Sandy debris containing rock fragments and vegetation covers the East Rim trail. A rockfall that occurred on January 19, 2019, is also visible in the right center of the photo (circled reddish scar above switchback). This rockfall measures approximately 41 feet wide and 54 high, based on the orthomosaic image. Photo date: October 24, 2019.

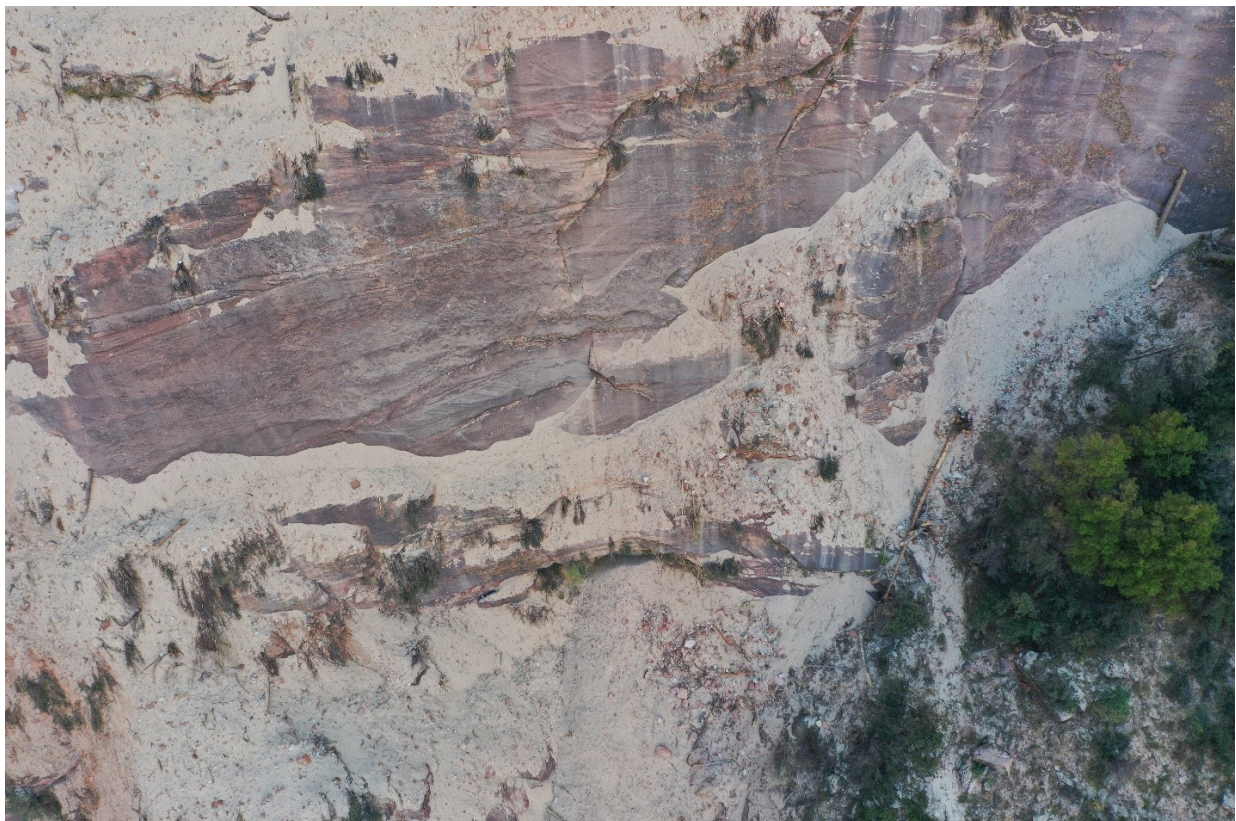
Figure 7. Rock avalanche debris on the East Rim trail, showing rocks and trees entrained in the sandy deposit. Photo date: October 24, 2019.

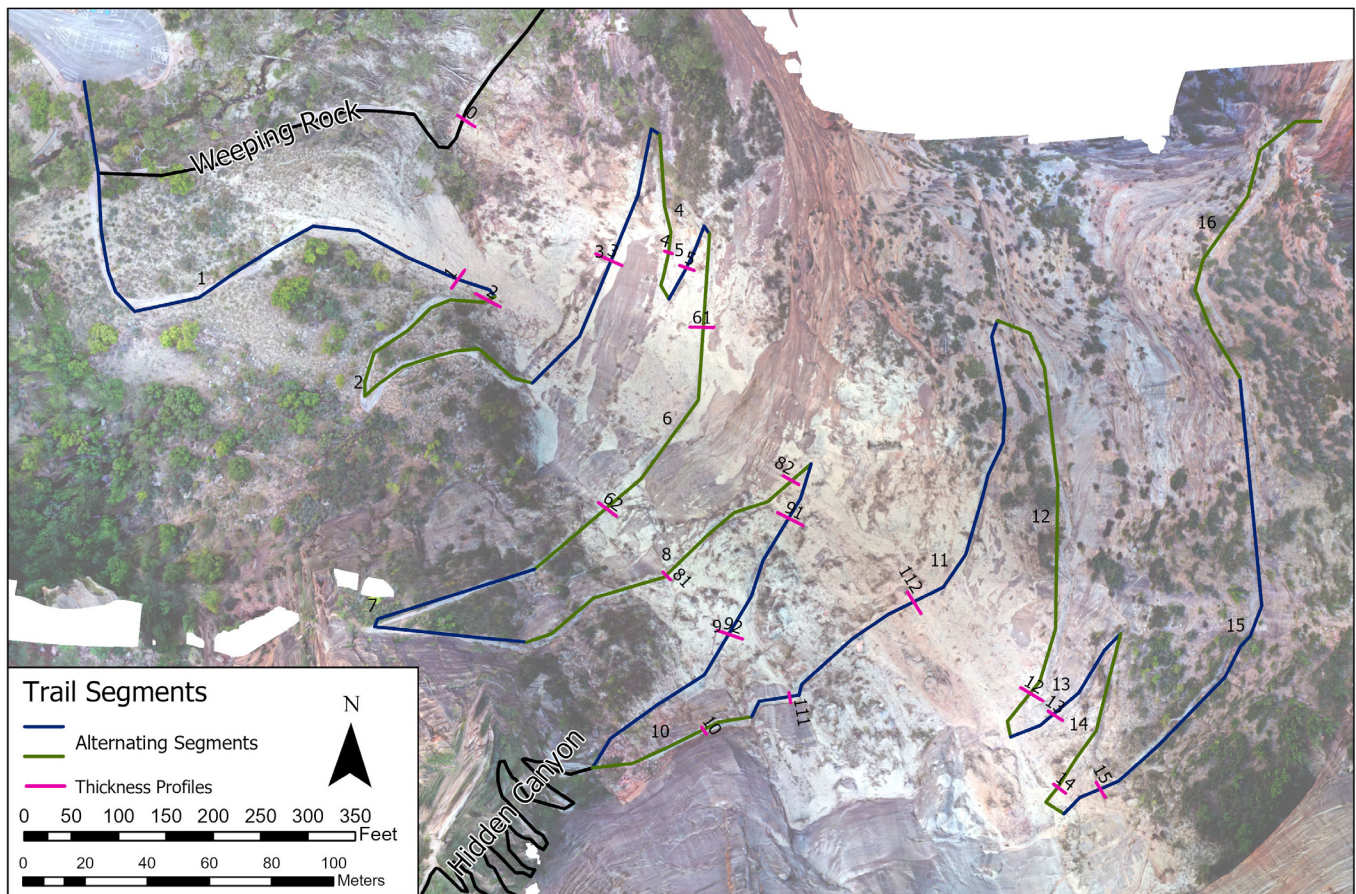
sUAS imagery was obtained to assess the conditions of the East Rim and Hidden Canyon trails after multiple recent rockfall events have impacted them. The East Rim trail above the Weeping Rock trailhead consists of a series of switchbacks that ascend the steep slope at the base of Cable Mountain. The trail was significantly impacted by the latest rock avalanche. The East Rim trail has 12 switchbacks over 1.07 trail miles (1.72 km) of which approximately 0.7 trail miles (1.12 km) were covered in debris (figures 6 and 7). Approximately 0.06 trail mile (0.09 km) of the Weeping Rock trail was covered in debris. The debris is sand- to boulder-size material (with larger boulders measuring approximately 9 feet [2.7 m] by 8 feet [2.8 m] [boulder measured on the orthomosaic model just upslope of trail segment 11, figure 8]) with entrained vegetation, including large trees. The switchbacks were assigned numbers for each segment for the purpose of estimating the debris thickness as shown on figure 8. Thickness of the debris deposited on the trail for each profile location is listed in table 1.

Figure 8. East Rim trail broken into segments shown as alternating blue and green lines. Selected locations for thickness profiles are shown in dark red. Shown on orthomosaic created from sUAS imagery.

Table 1. Estimated thickness of debris deposited on the East Rim trail at profile locations shown on figure 8.

Profile number	Estimated thickness of debris
0	3.28 feet (1 m)
1	8.2 feet (2.5 m)
2	3.28 feet (1 m)
3	3.28 feet (1 m)
4	1.6 feet (0.5 m)
5	3.28 feet (1 m)
6	3.28 feet (1 m)
62	3.28 feet (1 m)
81	1.6 feet (0.5 meter)
82	4.9 feet (1.5 m)
91	3.28 feet (1 m)
92	3.28 feet (1 m)
111	1.6 feet (0.5 m)
112	3.28 feet (1 m)
12	trail scoured and is 1.6 feet (0.5 m) lower than original grade, unable to determine thickness
13	1.6 feet (0.5 m)
14	0.82 feet (0.25 m)
15	trail possibly scoured and is 0.82 feet (0.25 m) lower than original grade, unable to determine thickness

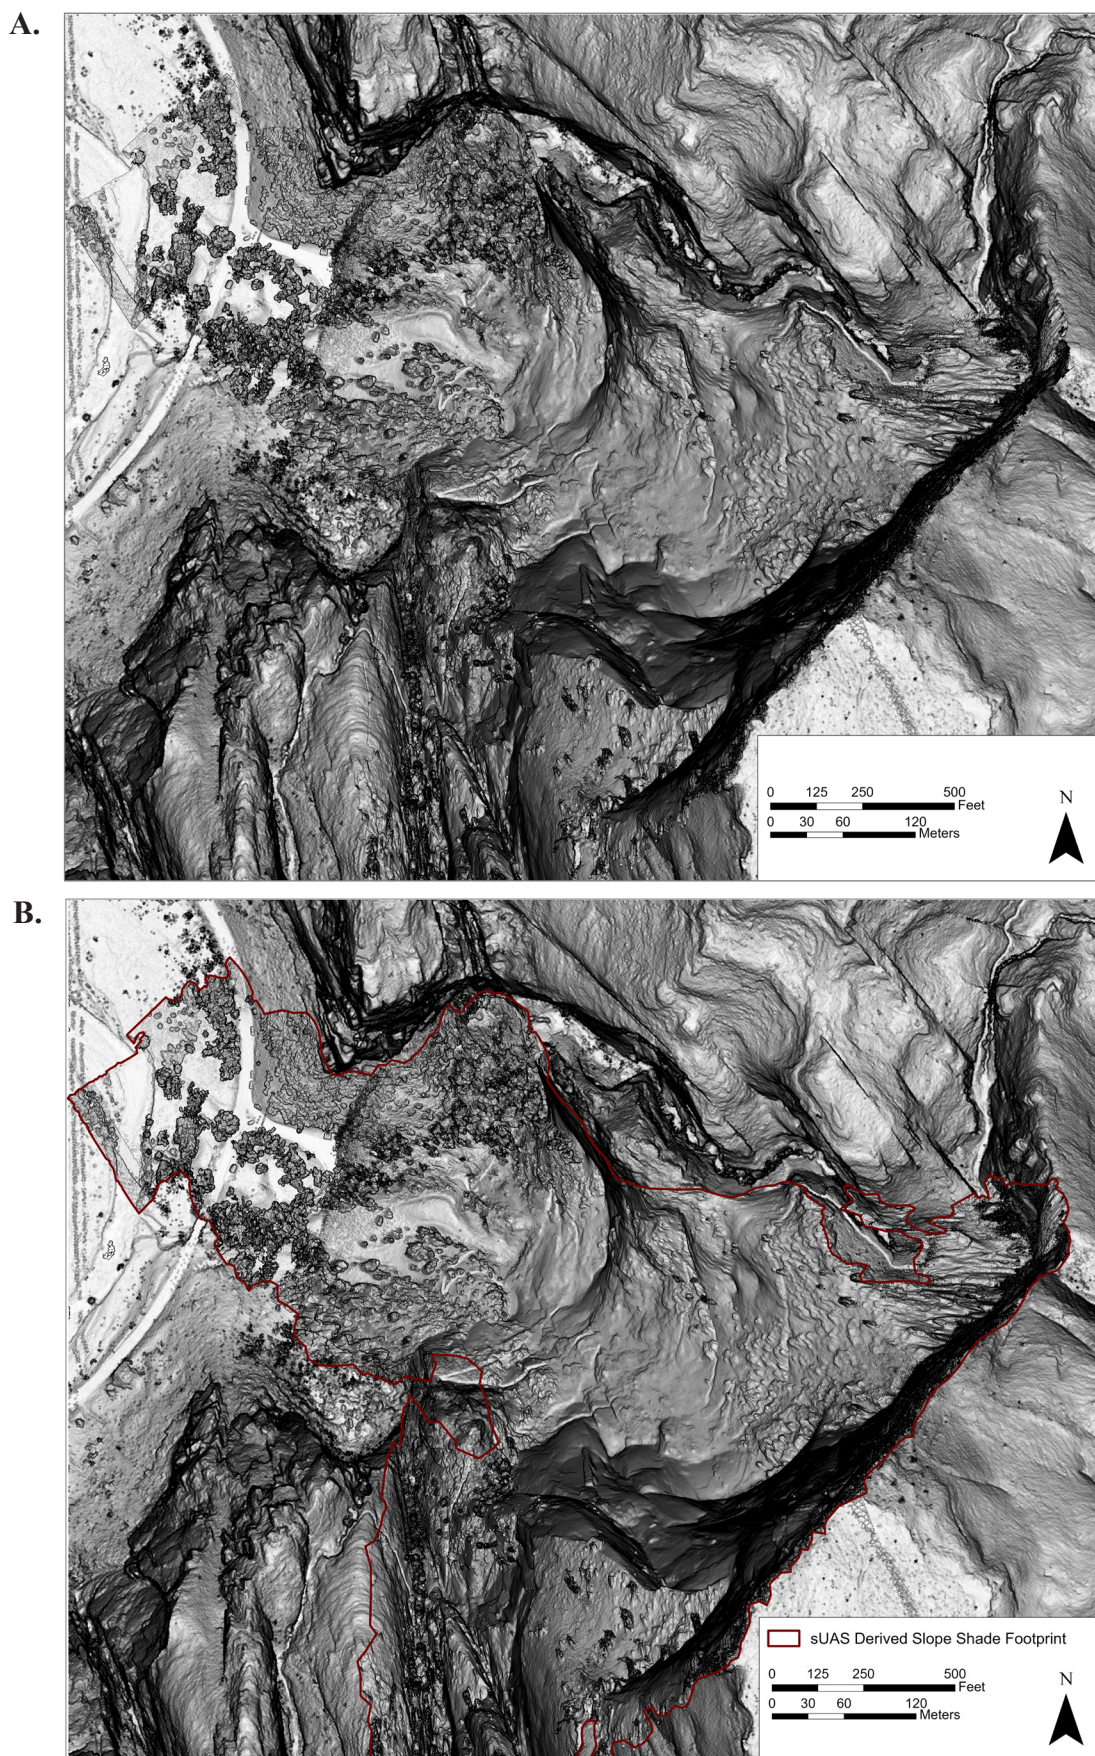
Zion National Park and the U.S. Geological Survey acquired 1-meter lidar elevation data (AGRC, 2015) for the park in 2015. A slope shade created from this data shows the East Rim trail before the rock avalanche (figure 9). A 0.3-meter-resolution slope shade created using the acquired sUAS data shows the areas where the trail is covered by debris (figure 9).

Figure 9. *A.* The East Rim trail is visible in the 2015 1-meter lidar (AGRC, 2015). *B.* The slope shade created from the sUAS imagery data shows where the trails have been covered by debris from the Cable Mountain rock avalanche.

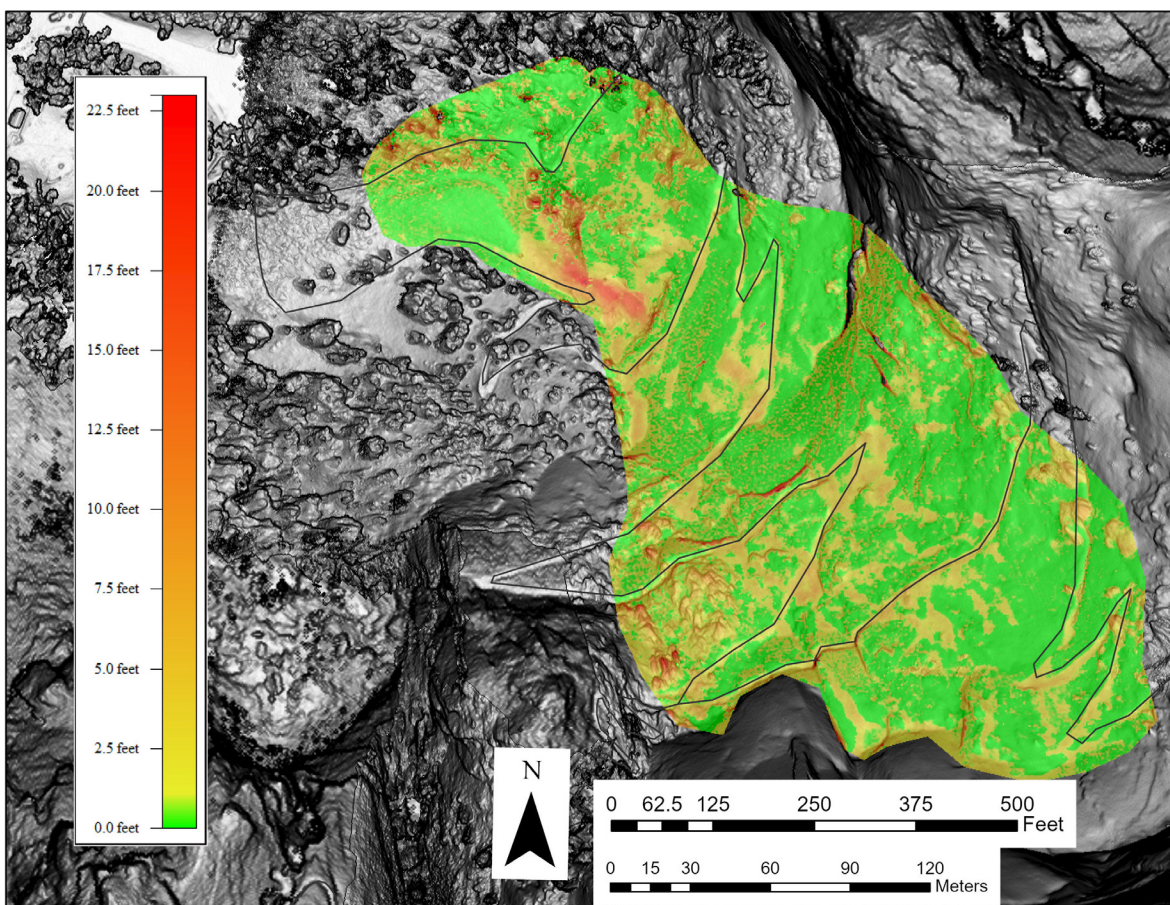
Using differencing between the 2015 lidar elevation data (AGRC, 2015) digital terrain model (DTM) and the sUAS model, we were able to estimate deposition depths (figure 10). Much of the area shows no depositional change, as shown in green. Areas where deposition depths exceed 1 foot (0.3 m) are shown in yellow and orange. Areas of high deposition, shown in red, are scattered throughout the area; however, many of the high-deposition areas are the result of trees or

cliff faces that distort the data. The area of high deposition north of the first switchback in a drainage that extends down slope to the Weeping Rock trail is considered to be an actual estimate of depositional accumulation. According to the model made from sUAS data, the deposition in the channel exceeds 20 feet (6 m) of material.

Figure 10. Differencing result comparing the 2015 lidar elevation data and sUAS model data showing estimated debris deposit depths. The base imagery is a combination of the sUAS model and 2015 lidar DTM. The dark gray line is the East Rim trail system in the area.

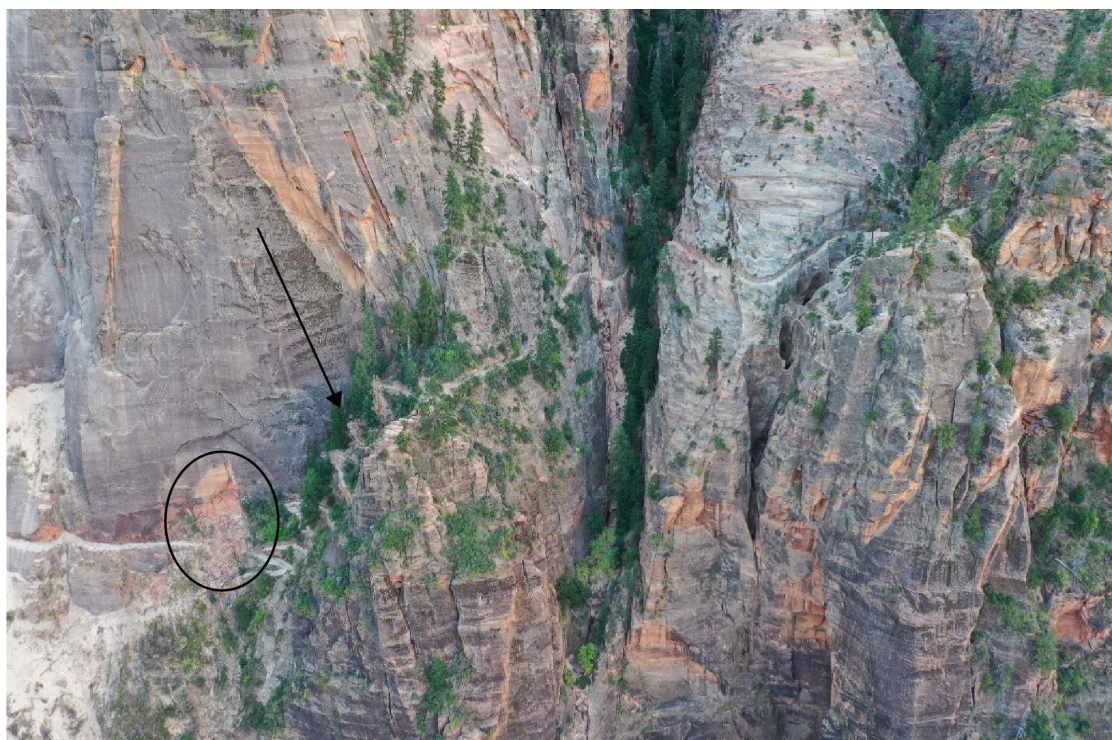
The Hidden Canyon trail (figure 11) appears to be mildly affected by the Cable Mountain rock avalanche with settlement of sand and dust. Part of this project was to collect imagery of the Hidden Canyon rockfall scar (figure 12). The scar appears to show evidence of an event similar to the recent Cable Mountain rock avalanche at a smaller scale. The rock located to the north of the scar is extremely fractured and has a very high future rockfall hazard. At least five rockfalls occurred in Hidden Canyon from July to November 2018 (personal communication, Zion National Park).

Figure 11. sUAS image showing the Hidden Canyon trail switchbacks (arrow), the January 19, 2019, rockfall (circled), and the proximity to the Cable Mountain rock avalanche debris (lower left corner). Photo date: October 25, 2019.

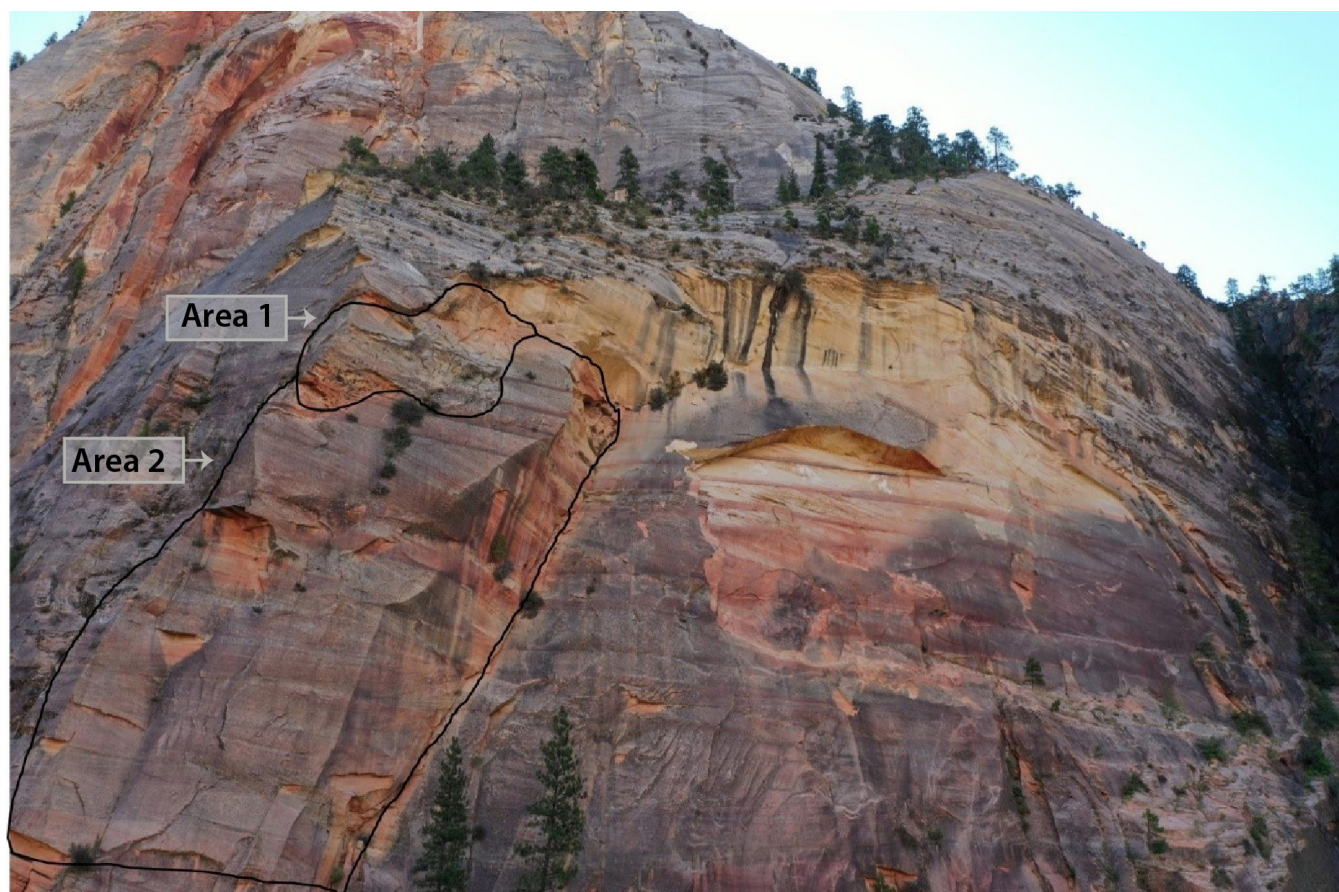
Figure 12. Hidden Canyon rockfall scar. The rock to the north (left) of the scar is highly fractured (area 1) and a larger slab with a long vertical fracture (area 2, the bottom of this slab is not shown in the photo and the line at the base is inferred) is below area 1. Photo date: October 24, 2019.
