# **THE ORIGIN AND EXTENT OF EARTH FISSURES IN ESCALANTE VALLEY, SOUTHERN ESCALANTE DESERT, IRON COUNTY, UTAH**

**SPECIAL STUDY 115  
UTAH GEOLOGICAL SURVEY**  
*a division of*  
**Utah Department of Natural Resources**

The Utah Geological Survey investigated five earth fissures that formed in Escalante Valley in southwestern Utah. The fissures were discovered after a warm winter storm on January 8-12, 2005 caused flooding in the valley, and infiltrating floodwater and sheetwash enlarged the fissures. The fissures range in length from about 100 meters (330 ft) to more than 400 meters (1300 ft), and form a discontinuous nine-kilometer-long (5.6 mi) generally north-trending zone roughly centered on the community of Beryl Junction. In places, the floodwater eroded gullies along the fissures that were up to three meters (10 ft) wide and two meters (6.6 ft) deep. Local residents reported that floodwater flowed into the fissures for a period of a day or more during the height of the flooding, and that vortices formed in the floodwater over some fissures.

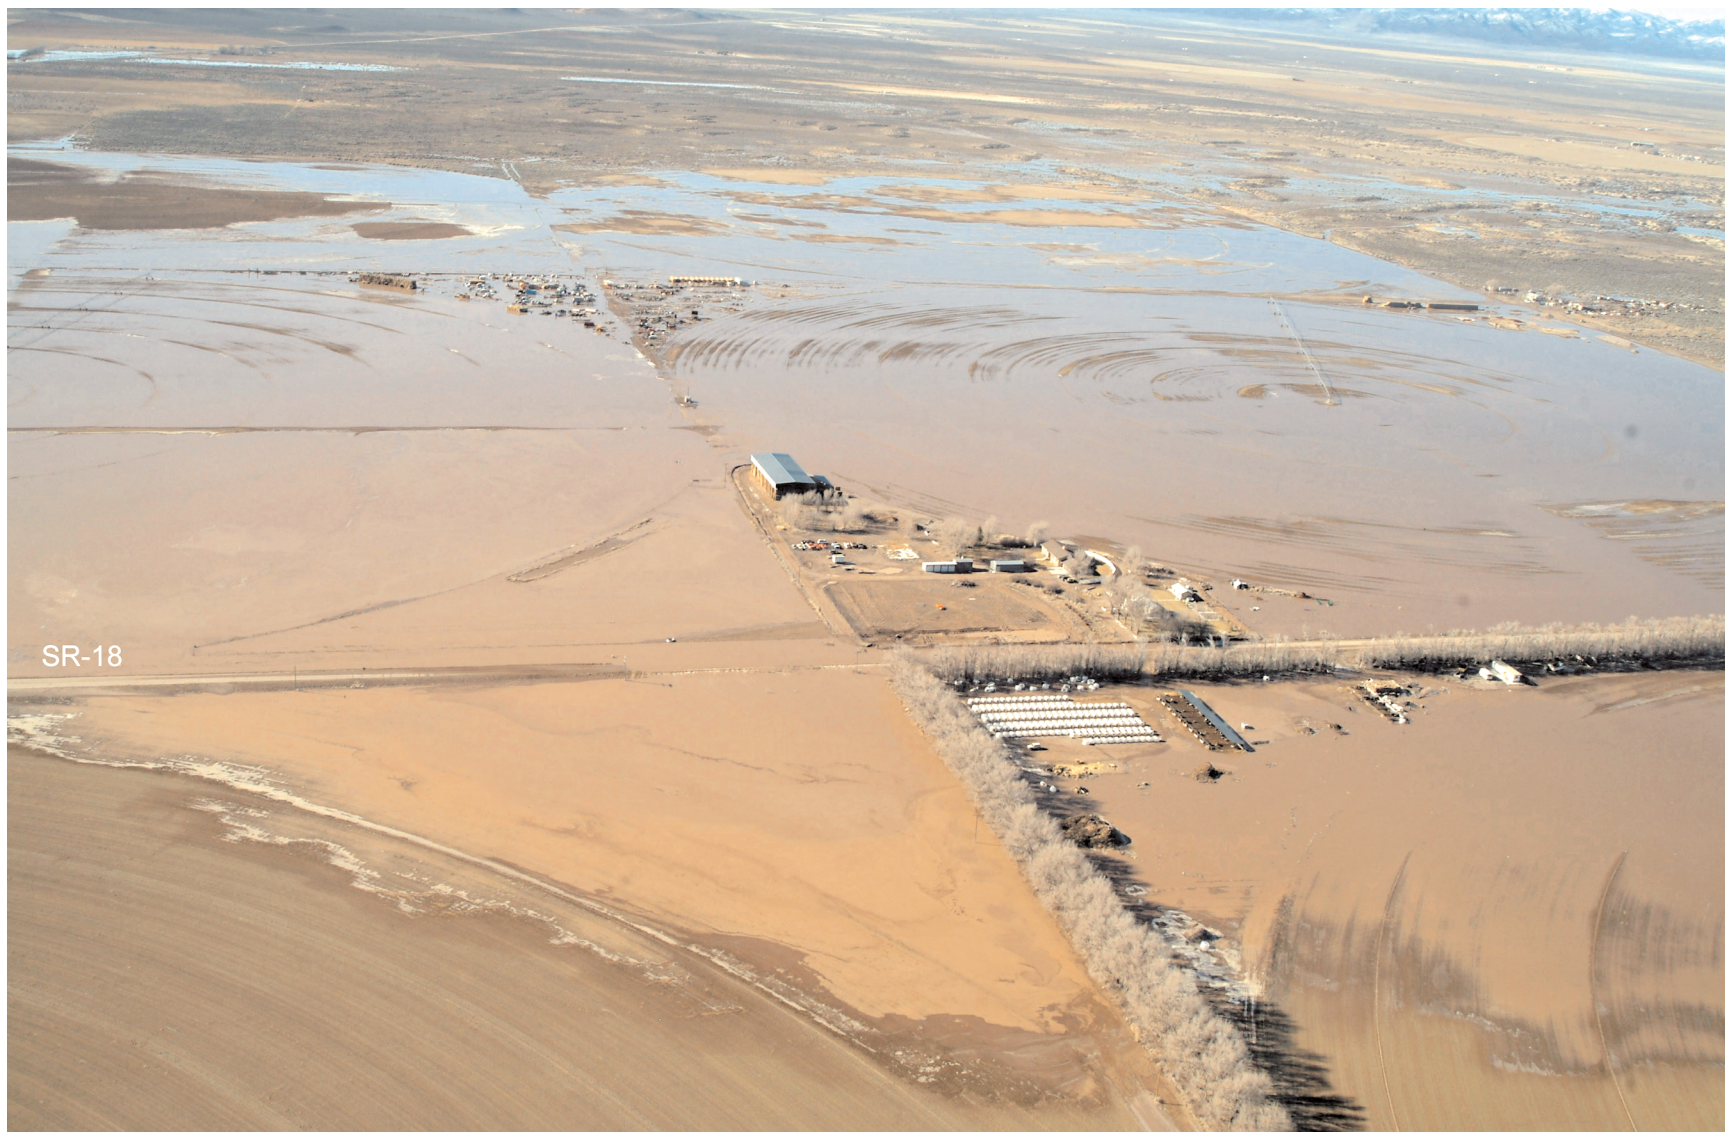
The January 2005 flood in Escalante Valley resulted from much greater than normal flows in Shoal and Spring Creeks, which enter the valley at its south end near the town of Enterprise (figure 1). Neither creek has a stream gage, so maximum stream flows during the flood are unknown. Both drainages are ephemeral, flowing only in response to increased precipitation or snowmelt. Typically, water flowing in the drainages quickly infiltrates into the coarse alluvial-fan deposits that have accumulated where the streams enter Escalante Valley, but during periods of high flow, the water continues down gradient to the north and spreads across the valley. Mower and Sandberg (1982) documented flood conditions on Shoal Creek in 1975 that exceeded 5.5 cubic meters per second (200 cfs), and floodwaters extended as far north as Beryl Junction, approximately 16 kilometers (10 mi) north of where the creek enters the valley. The extent of flooding in January 2005 exceeded that of 1975, with floodwaters reaching at least 7 kilometers (4.4 mi) north of Beryl Junction (figure 6).

Once floodwaters enter Escalante Valley, they quickly spread out and typically are only inches to a few feet deep. However, the valley is crisscrossed by a complex system of raised roadbeds, canals, ditches, and other impediments to flow that preferentially direct and concentrate the water into some areas while leaving other areas dry (figure 6). The result is a complex pattern of flooding and flood damage.

**Figure 6.** Aerial view showing the January 2005 flooding north of Beryl Junction at the intersection of SR-18 and 1200 North.

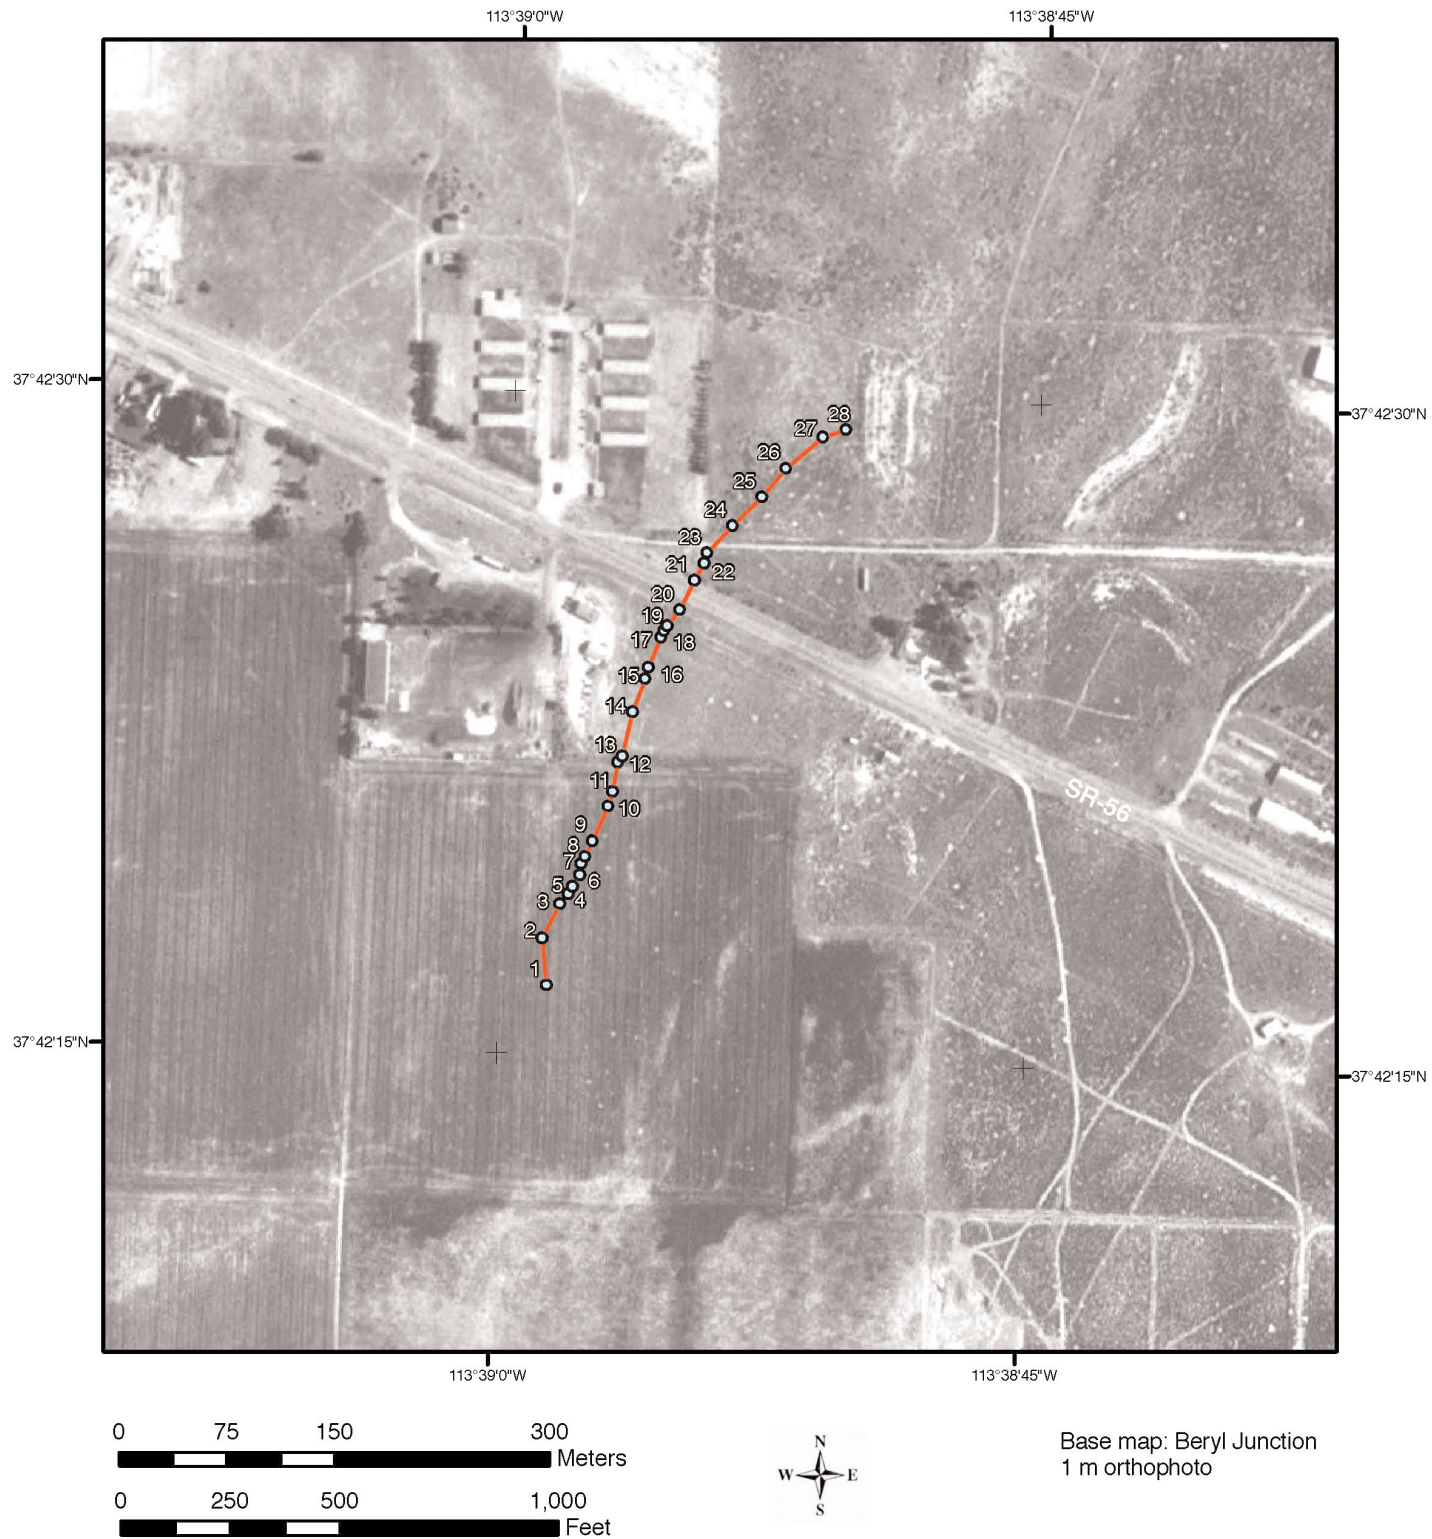
**Figure 8.** Map of the Beryl Junction earth fissure, showing GPS stations.

At its south end in an alfalfa field, the Beryl Junction fissure is a centimeter or less wide and exhibits no vertical displacement (BJ-1, appendix). Proceeding north, the fissure increases in width to a few centimeters and exhibits as much as 10 centimeters (4 in) of down-to-the-east displacement (BJ-2, appendix). Two piping holes created by infiltrating floodwater formed along the fissure at stations 8 and 9 (BJ-3, appendix). Due to the complex path followed by the floodwater through the valley, the alfalfa field was only partially flooded and the fissure was not inundated at its south end (Klayton Holt, landowner, verbal communication, 2005). However, as the fissure exited the field to the north and approached SR-56, floodwater ponding on the south side of the highway was directed westward until it encountered the fissure. The floodwater flowed into the fissure and quickly eroded the fissure walls. In places, the resulting gullies were up to 3 meters (10 ft) wide and 2 meters (6.5 ft) deep (BJ-4, appendix). Down-to-the-east displacement across the fissure in this area was 20 to 30 centimeters (8-12 in) (BJ-5, appendix).

Minimal or no floodwater reached the fissure north of SR-56, although sheetwash during periods of heavy precipitation likely did occur. North of SR-56, the fissure was typically a few centimeters or less wide and exhibited no vertical displacement (BJ-6, appendix). An exception occurred where the fissure crossed a graded dirt road (BJ-7, appendix; figure 8, station 23) and expanded to several centimeters wide. We do not know what part traffic on the road may have played in enhancing the width of the fissure. At its north end (figure 8, station 26), the fissure was again a centimeter or

less wide before terminating (BJ-8, appendix). Between stations 26 and 27 (figure 8), no evidence of fissuring was evident. Between stations 27 and 28 a linear hairline crack marked what might be the northern extent of fissuring. However, this area was covered by an extensive system of polygonal mud cracks that obscured evidence of fissuring.

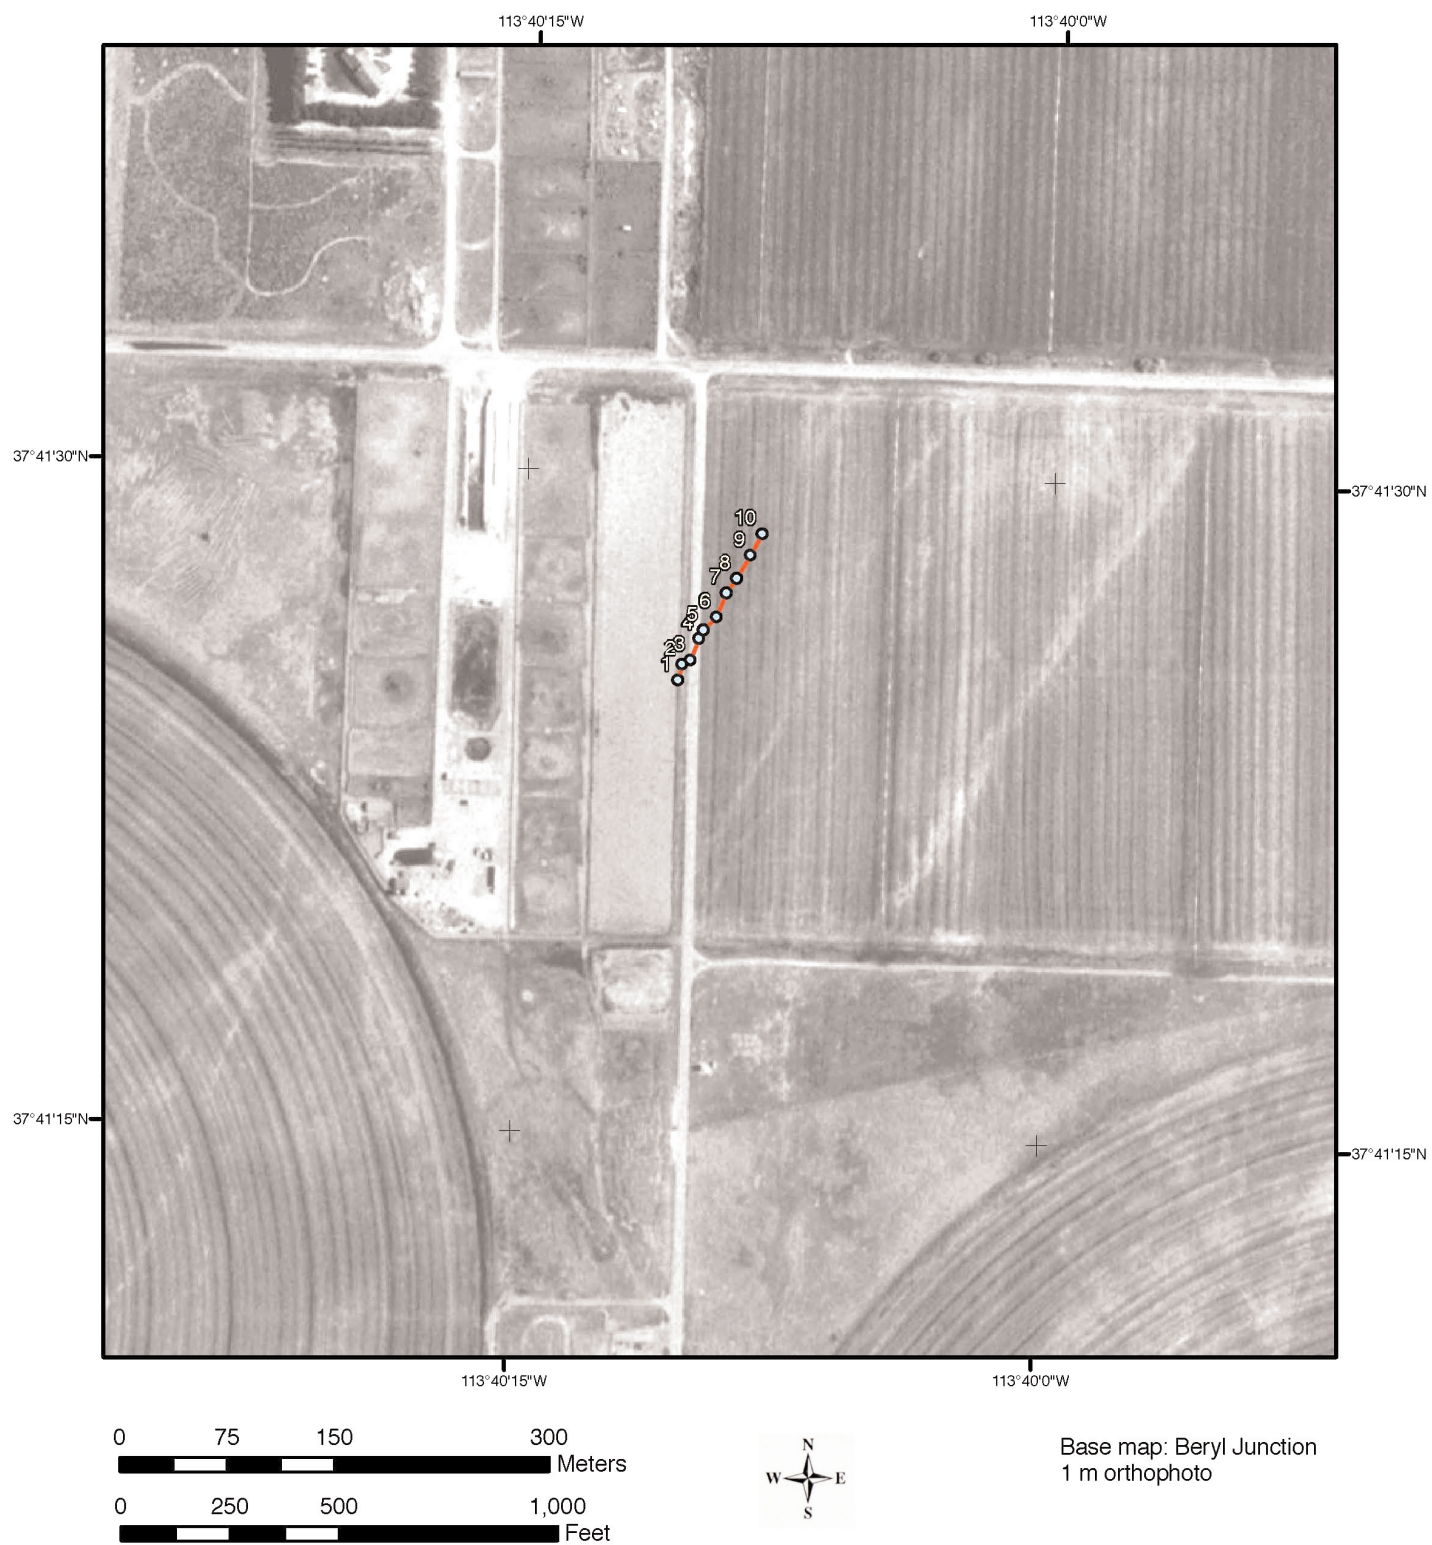
**Figure 9.** Map of the Holt earth fissure, showing GPS stations.

At its south end, the Holt earth fissure was a few centimeters wide and showed no evidence of vertical displacement (H-1, appendix; figure 9, station 1). A short distance to the north, infiltrating floodwater increased the fissure width to several centimeters. The floodwater-enhanced fissure damaged 500 West Street (H-2, appendix; figure 9, station 3), causing the landowner to repair the road with sand, thus indicating that the fissure was sufficiently wide and/or deep to impair vehicle traffic. Upon entering the field, the fissure exhibited a few centimeters of down-to-the-east vertical displacement, and at station 5 (figure 9), floodwater draining into the fissure created a piping hole that measured 3.1 meters (10.2 ft) long, 1.5 meters (4.9 ft) wide, and 1.2 meters (3.9 ft) deep (H-3, appendix). The feedlot employee report-

Beyond the piping hole, the fissure was typically a few centimeters wide, and locally consisted of two or more sub-parallel strands that created a zone up to 2 meters (6.5 ft) wide (H-4, appendix). The fissure showed little or no evidence of vertical displacement, and before terminating at its north end was reduced to a narrow crack a centimeter or less wide (H-5, appendix; figure 9, station 10).

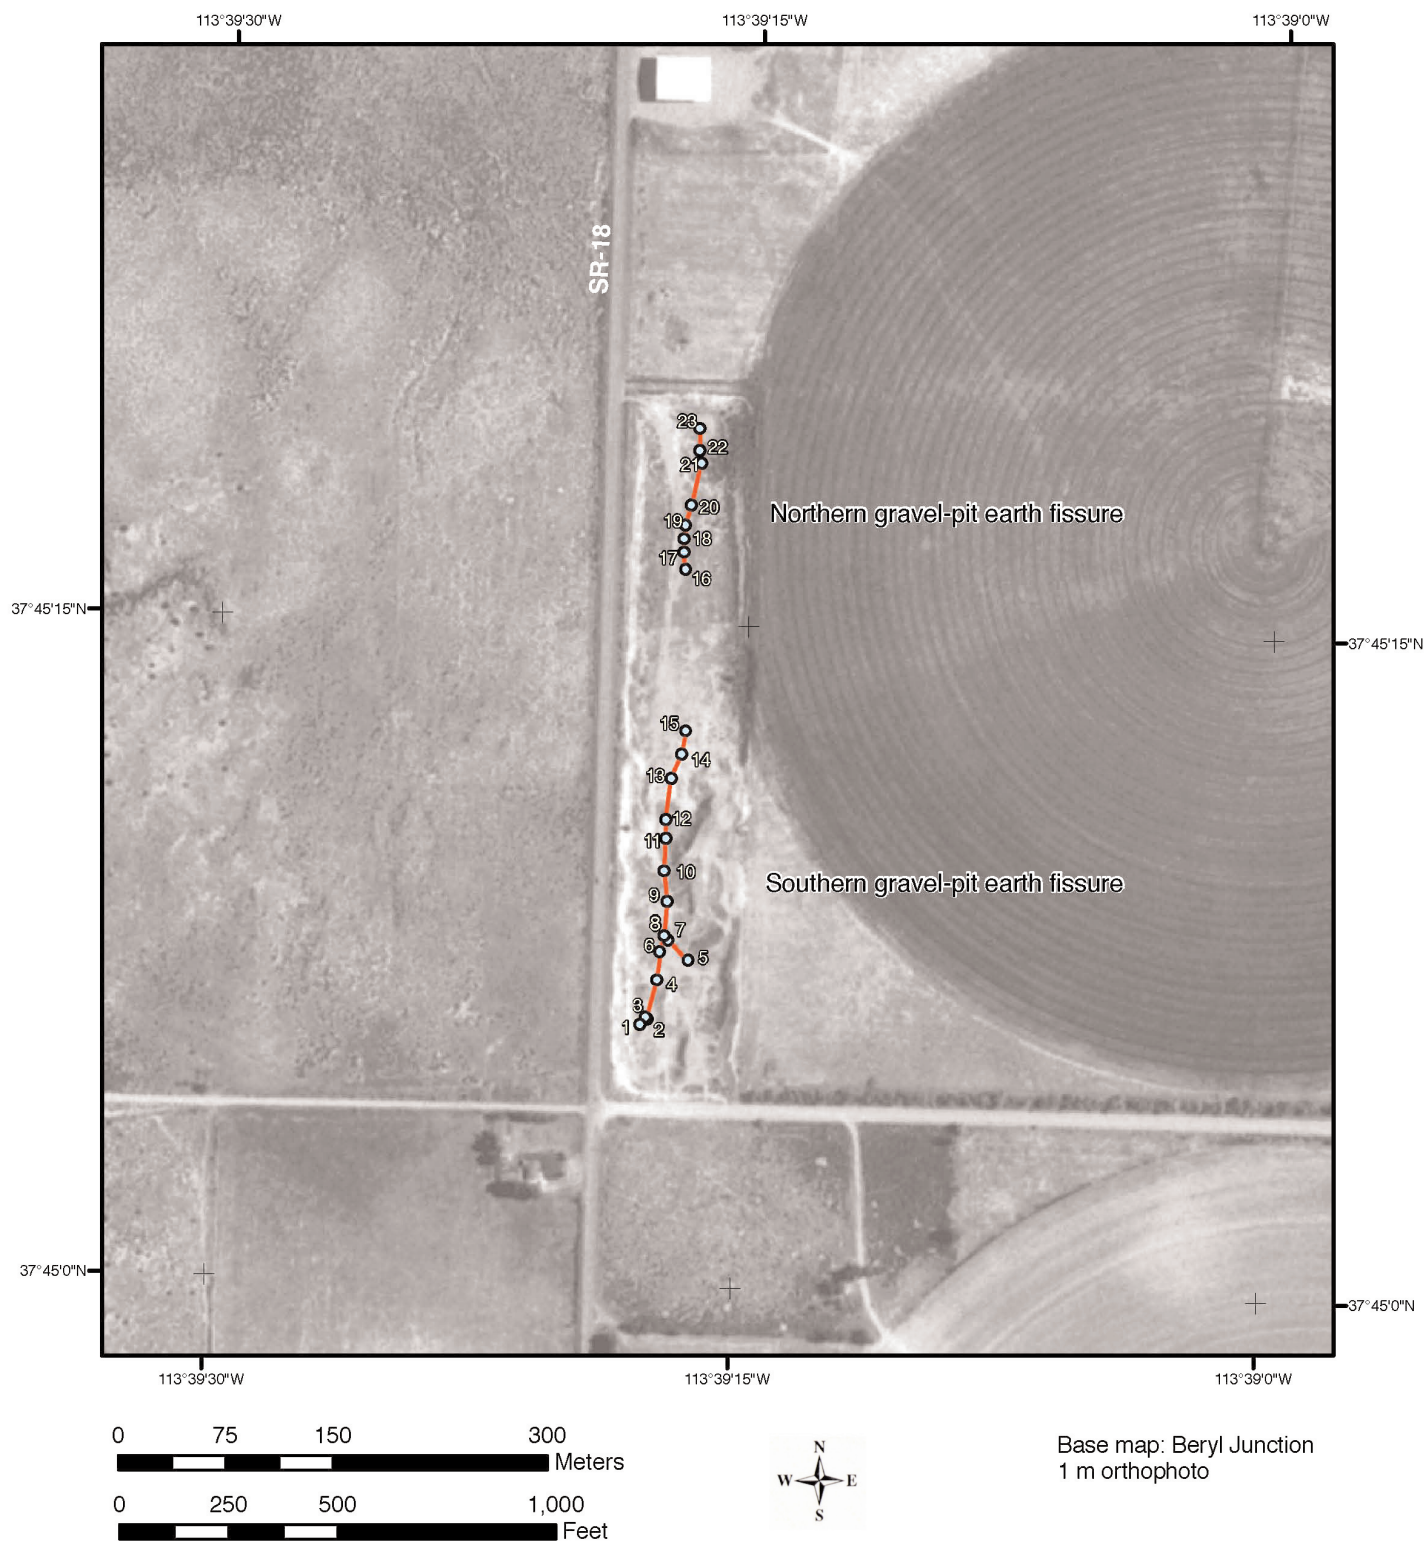
**Figure 10.** Map of the gravel-pit earth fissure, showing GPS stations.

The southern gravel-pit earth fissure is 214 meters (702 ft) long and is expressed as isolated and interconnected centimeter-scale depressions along its northern half, and as a continuous, linear, eroded crack, up to 1.5 meters (4.9 ft) wide and several decimeters deep along its southern half. In the deepest part of the gravel pit, floodwater infiltrated and eroded the fissure, locally forming piping holes and areas of ground collapse up to 1.5 meters (4.9 ft) wide (GP-1 and GP-2, appendix). The south end of the fissure bends to the southwest and continues up the eroded gravel pit wall for 11 meters (36 ft) (figure 10, station 1), as evidenced by centimeter-scale depressions (GP-3, appendix). The aligned depressions extend to a few meters below the approximate elevation of floodwater that filled the gravel pit during the January storm. At the north end of the south fissure, a moderately eroded crack less than about 2-15 centimeters (0.8-6 in) wide and up to several centimeters deep extends across the gravel pit floor and along the flank of a gravel mound within the pit (GP-4, appendix; figure 10, station 11). The crack is remarkably linear, with the exception of a minor Y-shaped branch toward the southeast, approximately 65 meters (213 ft) north of the southern end of the fissure (figure 10, stations 5 and 7). At this location, a minor, 25-meter-long (82 ft) crack oriented N. 45° W. intersects the main crack system. The subsidiary crack is a few centimeters wide and is expressed as centimeter-scale depressions at its southwest end.

The northern gravel-pit earth fissure is 100 meters (328 ft) long and is expressed as isolated centimeter-scale depressions in sandy artificial fill along the south half of the fissure

(GP-5, appendix; figure 10, station 16) and as a continuous crack extending across a deeper part of the gravel pit along the remainder of its length (GP-6, appendix; figure 10, station 20). Floodwater has eroded the crack to a depth of approximately 1 meter (3.3 ft) where the fissure continues northward across a north-facing, approximately 2- to 3-meter-high (6.6-10 ft) embankment within the gravel pit (GP-6 and GP-7, appendix). The northernmost part of the fissure consists of a 5- to 10-centimeter-wide (2-4 in) parallel-sided crack at least a meter deep (GP-8, appendix), transitioning to isolated centimeter-scale depressions along the northernmost wall of the gravel pit. In a manner similar to the southern fissure, the depressions do not continue above the estimated high-water mark of floodwater in the gravel pit. West of the main fissure in the deepest part of the gravel pit, desiccation cracks less than 5 centimeters (2 in) wide by 5 centimeters (2 in) deep form polygons approximately 2 meters (6.6 ft) wide in clay-rich deposits along an eroded east-facing embankment within the gravel-pit (GP-9, appendix). Based on a lack of erosion by floodwater and their limited extent, we conclude that the desiccation cracks formed post-flooding and are unrelated to the earth fissures extending across the entire gravel pit.

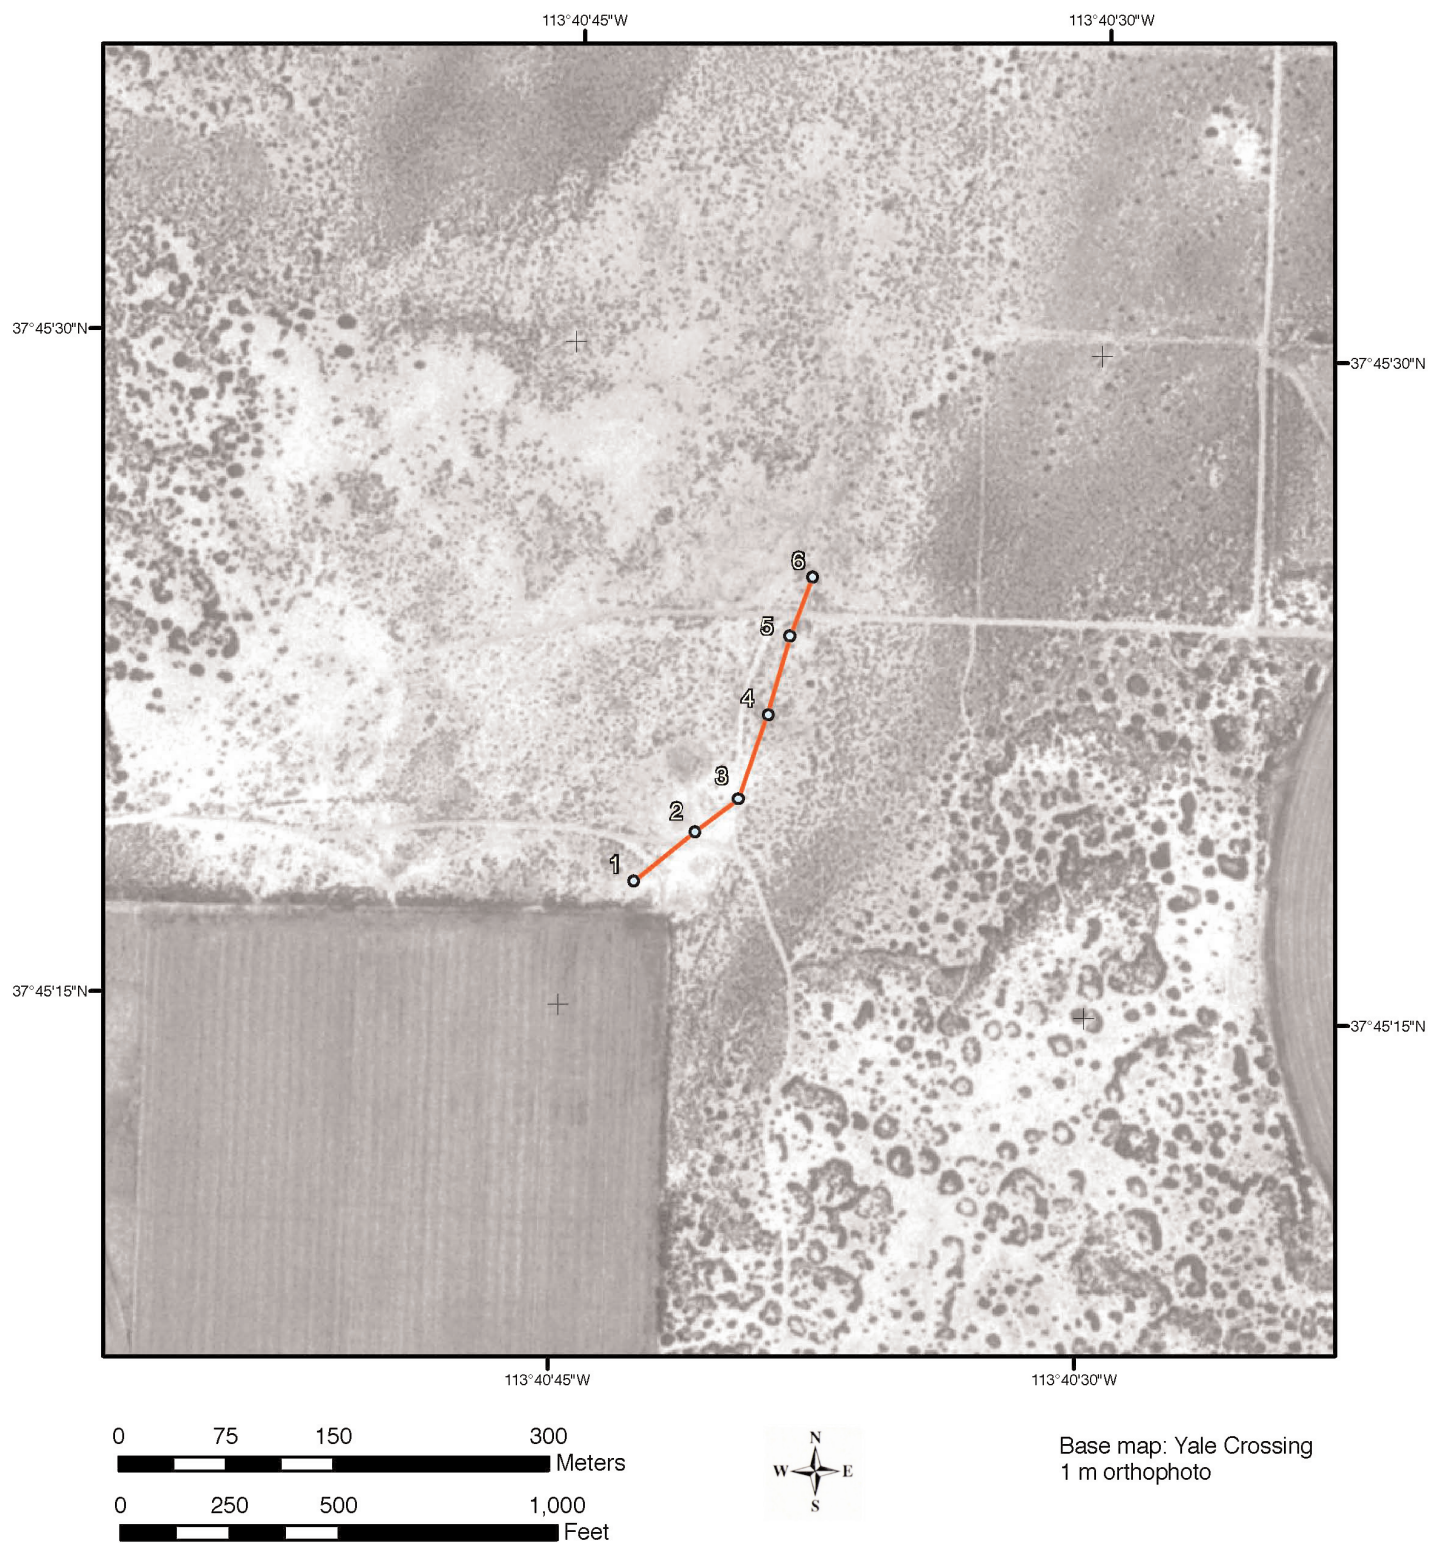
**Figure 11.** Map of the Bossardt earth fissure, showing GPS stations.

At its southern end, the Bossardt fissure is less than 3 centimeters (1.2 in) wide and exhibits no vertical displacement. Highly desiccated clay-rich soils near its south end made the fissure difficult to identify. The fissure width gradually increases to the northeast; at 70 meters (230 ft) north of the south end of the fissure, near the intersection of two minor graded dirt roads (figure 11, north of station 2), floodwater has eroded the fissure, forming a piping hole measuring 0.5 meters (1.6 ft) long, 0.5 meters (1.6 ft) wide, and 0.3 meters (1.0 ft) deep (BF-1, appendix). Small-scale grabens 0.5 to 0.75 meters (1.6-2.5 ft) wide also formed at this location. North of the change in fissure direction (figure 11, station 3), the fissure increases in width and depth, achieving an average width of 0.30 meters (1 ft) and a maximum depth of 1.5 meters (4.9 ft; BF-2, appendix). One hundred meters (330 ft) from its south end the fissure has 3-4 centimeters (1.2-1.6 inches) of down-to-the-east vertical displacement. Infiltrating floodwater formed a piping hole measuring 2.0 meters (6.6 ft) long, 1.5 meters (4.9 ft) wide, and 1.0 meters (3.3 ft) deep about 190 meters (620 ft) from the south end of the fissure (BF-3, appendix). At 210 meters (690 ft) from its

south end, the fissure crosses another graded dirt road and then quickly narrows before disappearing into sand dunes 15 meters (50 ft) north of the road (BF-4, appendix).

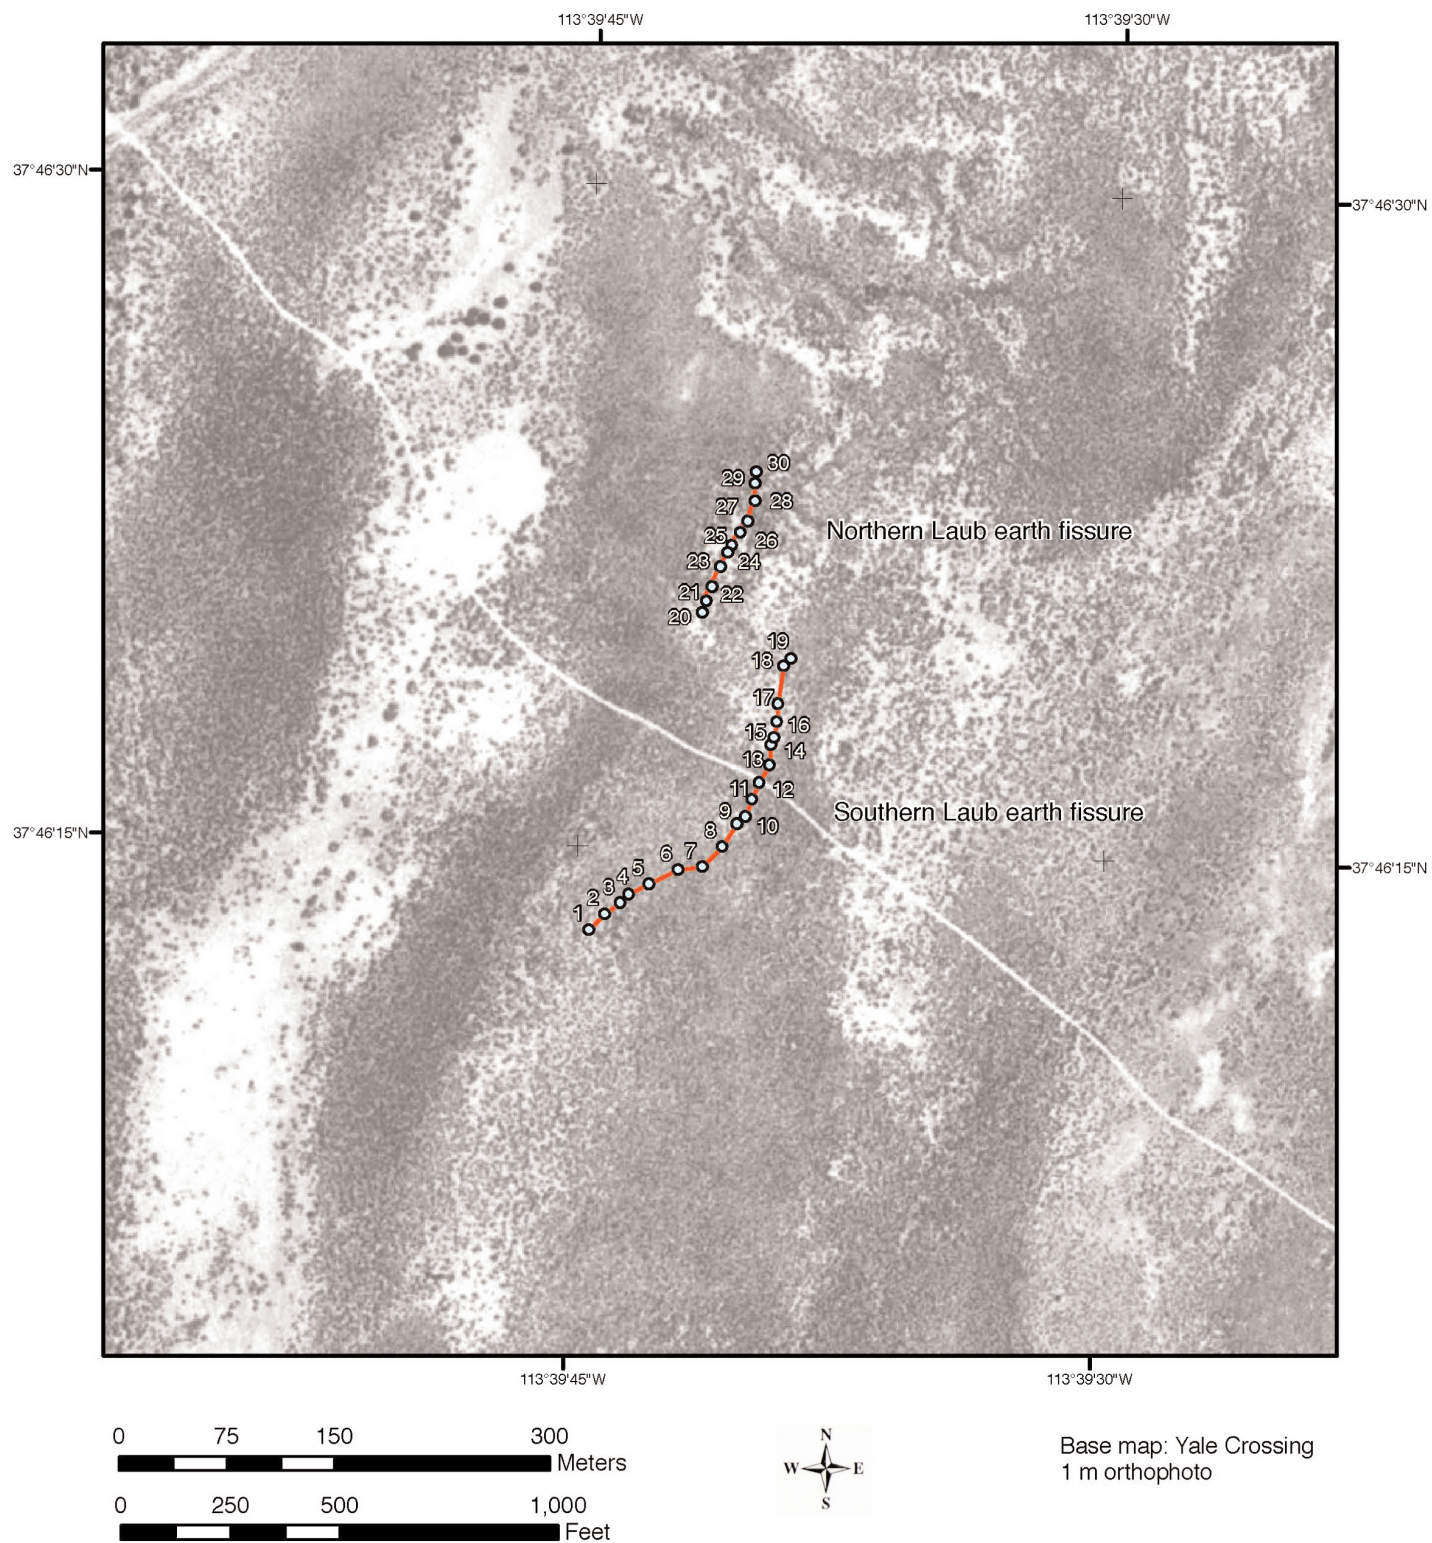
**Figure 12.** Map of the Laub earth fissure, showing GPS stations.

The southern Laub earth fissure is 256 meters (840 ft) long and shows three distinct changes in trend along its length. From its south end to station 6 (figure 12) the fissure trends N. 55° E. The fissure bends to the north at station 7 and then trends N. 30° E. between stations 8 and 13. From station 13 to the north end of the fissure at station 19 (figure 12) the fissure trends N. 5° E. The fissure crosses a two-wheel dirt track at station 12 (figure 12). From the dirt track/fissure intersection, it is 645 meters (2120 ft) to the southeast along the track to SR-18 (figure 7). The northern Laub earth fissure is 107 meters (351 ft) long, trending N. 25° E. along the southernmost 87 meters (285 ft) and north-south along the northernmost 20 meters (66 ft) (figure 12). The southern termination of the northern fissure (station 20, figure 12) is approximately 70 meters (230 ft) northwest of the northern termination of the southern fissure (station 19, figure 12).

At its south end, the southern Laub earth fissure began as a narrow crack that was difficult to distinguish from numerous desiccation cracks formed in the clay-rich soils of the area (L-1, appendix). Continuing northeastward, the fissure remained difficult to recognize to station 3 (figure 12), where infiltrating floodwater began to erode and enlarge the fissure (L-2, appendix). From that point northward the effect of floodwater on the fissure became increasingly pronounced (L-3, appendix), until at station 12 (figure 12), where the fissure crossed the dirt track, the fissure was 0.7 meters (2.3 ft) wide and 0.7 meters (2.3 ft) deep (L-4, appendix). Between stations 14 and 17 (figure 12), floodwater eroded three piping holes along the fissure; the largest hole measured 3.9 meters (12.9 ft) long, 0.8 meters (2.6 ft) wide, and 1.0 meters (3.3 ft) deep (L-5, appendix). Beyond station 17, the fissure showed progressively fewer effects of infiltrating floodwater until eventually terminating in an area of extensive polygonal mud cracks (L-6, appendix).

The northern Laub earth fissure consists of isolated, centimeter-scale depressions forming a linear trend. Near the center of the fissure, surface water infiltrated and eroded the crack, forming piping holes up to 0.4 meters (1.3 ft) long, 0.1 meters (0.3 ft) wide, and 0.7 meters (2.2 ft) deep (L-7, appendix; figure 12, station 25). Approximately 15 meters (49 ft) from the north end of the fissure, centimeter-scale depressions continue across the western end of an active sand dune,

indicating erosion by surface water (L-8, appendix; figure 12, station 29). The north and south ends of the fissure were difficult to identify due to the abundance of wind-blown silt and sand that likely mask potential hairline cracks. We found no evidence for vertical displacement across the fissure.

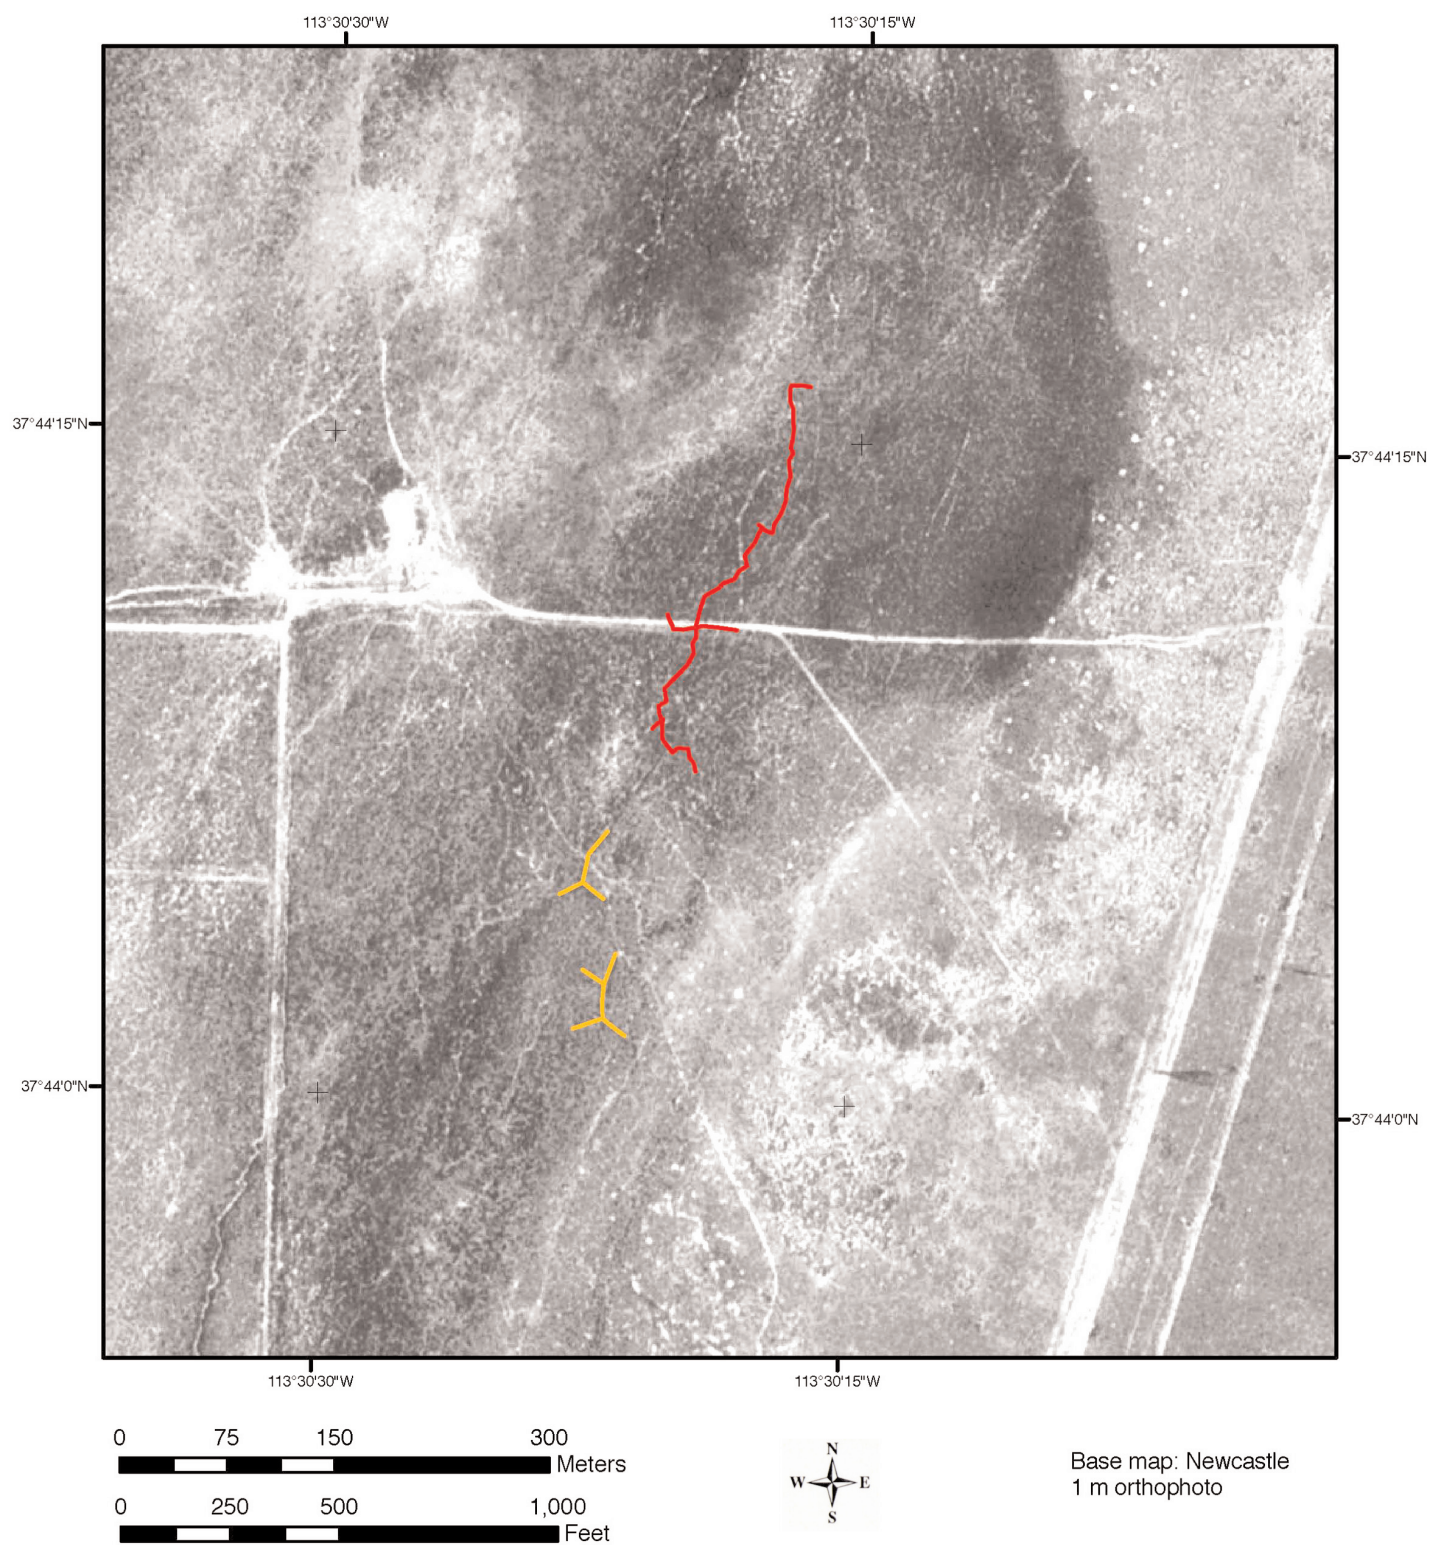
The ground cracks have multiple segments and intersections, which are most apparent on the U.S. Geological Survey (USGS) Newcastle orthophoto quadrangle compiled from 1999 aerial photographs (figure 13), but are difficult to trace on the ground (GC-1, appendix). At one locality, the ground cracks cross and parallel a dirt track (GC-2, appendix). Christenson (1991) described the cracks as consisting of shallow, elongate closed depression, which may channelize local surface-water flow. Generally, the cracks have eroded shapes, and are up to 0.3 meters (1.0 ft) wide but only a few centimeters deep. Minor evidence of more recent erosion by surface water (perhaps during the flood of January 8-12, 2005) exists near the center of the zone of cracks, where depressions are up to 0.3 meters (1.0 ft) deep (GC-3, appendix). We found no evidence for vertical displacement across the cracks.

**Figure 13.** Map of ground cracks northeast of Newcastle. Red lines denote ground cracks investigated in field; orange lines are ground cracks inferred from 1 m aerial photography.

In contrast, the ground cracks northeast of Newcastle along the eastern margin of Escalante Valley are likely giant desiccation cracks. The crack traces are linear, segmented, intersecting, and continuous in a north-south direction (length-to-width ratio less than 4:1). In addition, the cracks are limited to clay-rich deposits within a local depression along Pinto Creek near the toes of alluvial fans derived from the Antelope Range. The varying physical properties of the cracks and landowner reports indicate cyclic behavior. In addition, the ground cracks exhibit no vertical displacement and have not evolved into large, continually eroding, linear crack systems. Rather, a network of subdued cracks generally less than a few centimeters deep has developed since the cracks were first noticed, possibly in the mid-1970s (Christenson, 1991). The initial drop in ground-water level due to pumping may have contributed to the formation of the ground cracks, as ground-water levels were relatively shallow (approximately 20 to 38 feet [6-11.5 m] during the late 1940s) prior to pumping. However, the current ground-water level (100-110 feet [30-33.5 m] during 2002) likely has no impact on the formation of the giant desiccation cracks due to its significant depth.

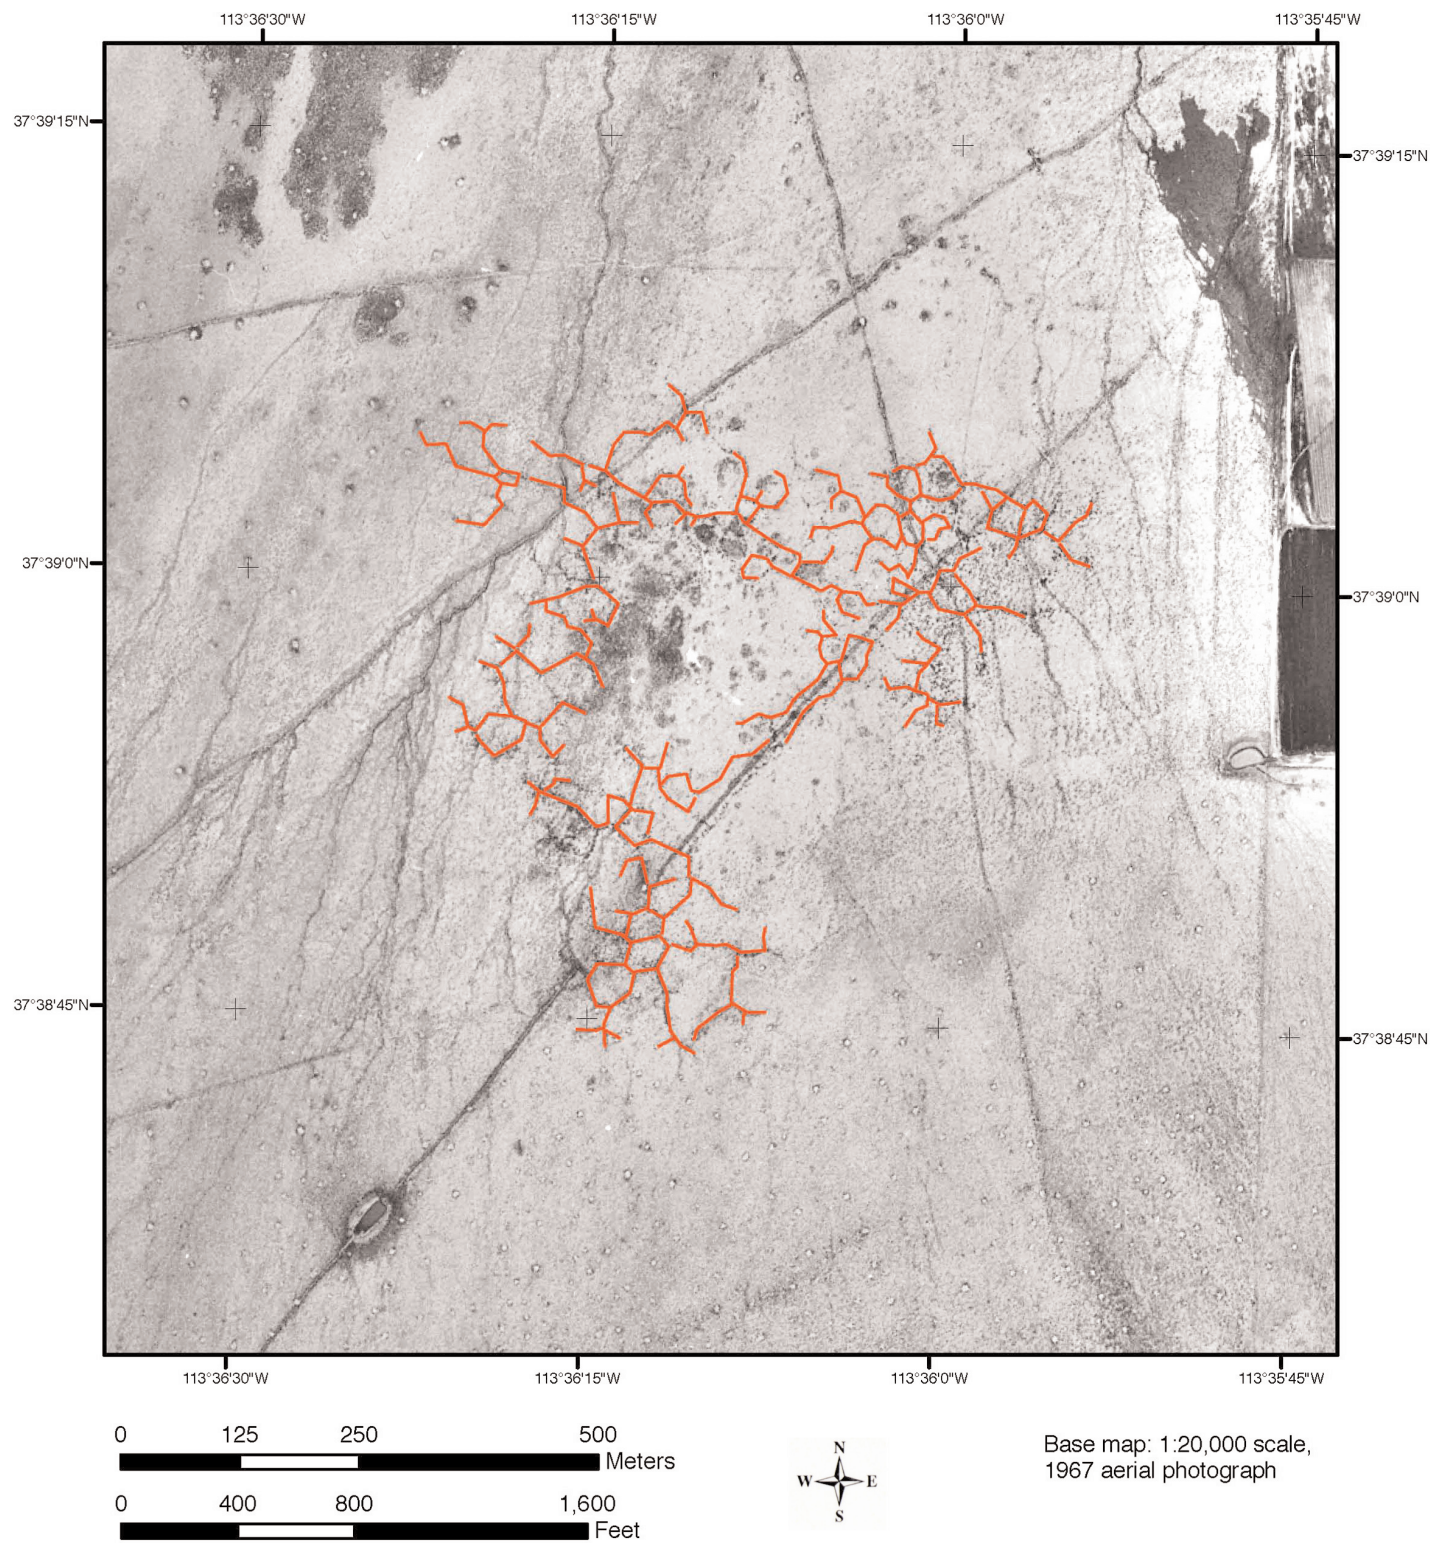
The giant desiccation cracks have 10- to 90-meter-long (30-300 ft) linear and intersecting traces that form an extensive network of polygons (figure 14). Most polygons are

composed of four to seven linear crack segments. We mapped 22 polygons that are completely closed or open on only one side, having an average width of 38 meters (125 ft) and a minimum-maximum range in width of 20 to 80 meters (65-260 ft). Based on our analysis of aerial photographs, we infer that as of 1967 the cracks had been eroded by surface water and covered with vegetation. Prior to 1999, the cracks may have been plowed, as they are not apparent on the USGS Newcastle orthophoto quadrangle.

**Figure 14.** Map of giant desiccation cracks southwest of Newcastle.
