# **THE ORIGIN AND EXTENT OF EARTH FISSURES IN ESCALANTE VALLEY, SOUTHERN ESCALANTE DESERT, IRON COUNTY, UTAH**

**SPECIAL STUDY 115  
UTAH GEOLOGICAL SURVEY**  
*a division of*  
**Utah Department of Natural Resources**

The Utah Geological Survey investigated five earth fissures that formed in Escalante Valley in southwestern Utah. The fissures were discovered after a warm winter storm on January 8-12, 2005 caused flooding in the valley, and infiltrating floodwater and sheetwash enlarged the fissures. The fissures range in length from about 100 meters (330 ft) to more than 400 meters (1300 ft), and form a discontinuous nine-kilometer-long (5.6 mi) generally north-trending zone roughly centered on the community of Beryl Junction. In places, the floodwater eroded gullies along the fissures that were up to three meters (10 ft) wide and two meters (6.6 ft) deep. Local residents reported that floodwater flowed into the fissures for a period of a day or more during the height of the flooding, and that vortices formed in the floodwater over some fissures.

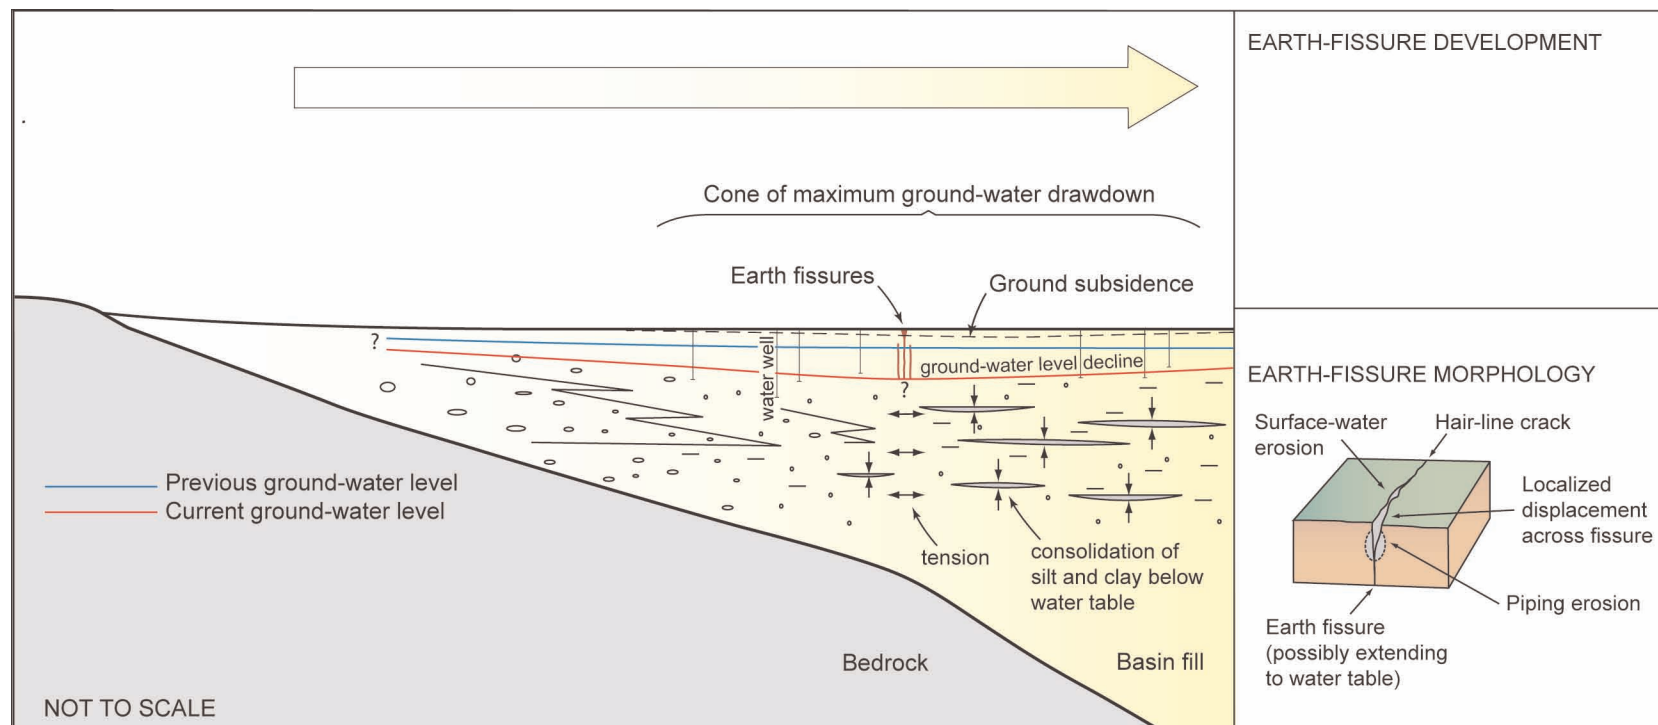
**Figure 16.** Schematic representation of earth-fissure formation, illustrating (a) differential compaction of an aquifer as a possible cause for earth-fissure development, and (b) the morphology of earth fissures at the ground surface.

Earth fissures form in response to horizontal tension that develops between parts of an aquifer that compact by different amounts following ground-water decline, for example, due to a lateral change in aquifer thickness or lithology (figure 16). The Escalante Valley earth fissures are aligned along the western edge of a large gravity low that defines a deep basin beneath Escalante Valley. The fissures are oriented subparallel to the gravity contours, which indicate an east-west increase in the gravity gradient and a relative shallowing of bedrock (and thinning of basin-fill alluvium) along the western flank of the basin. Thus, the Escalante Valley earth fissures may have formed due to the differential compaction of the Escalante Valley aquifer across the western margin of the basin. Differential compaction due to an east-west change in lithology may also have contributed to the earth-fissure development.
