CHARACTERIZATION AND HAZARD ZONATION OF THE MEADOW CREEK LANDSLIDE AFFECTING STATE ROUTE 9, PART OF THE COAL HILL LANDSLIDE COMPLEX, WESTERN KANE COUNTY, UTAH

by Francis X. Ashland, Greg N. McDonald, Lucas M. Shaw, and James A. Bay

SPECIAL STUDY 131
UTAH GEOLOGICAL SURVEY
a division of
UTAH DEPARTMENT OF NATURAL RESOURCES
2009

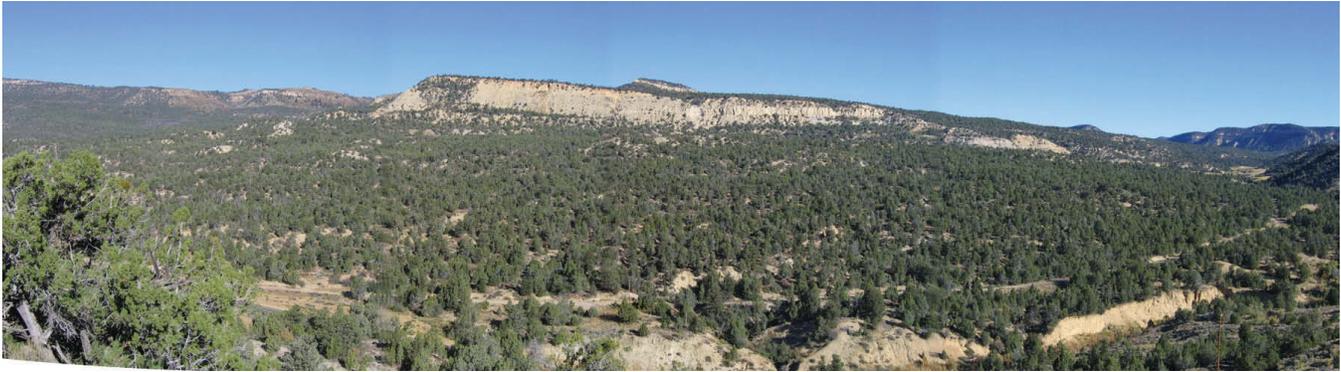
Figure 6. Panoramic view to the north of the Meadow Creek landslide from Coal Hill. Large escarpment in background is the main scarp.

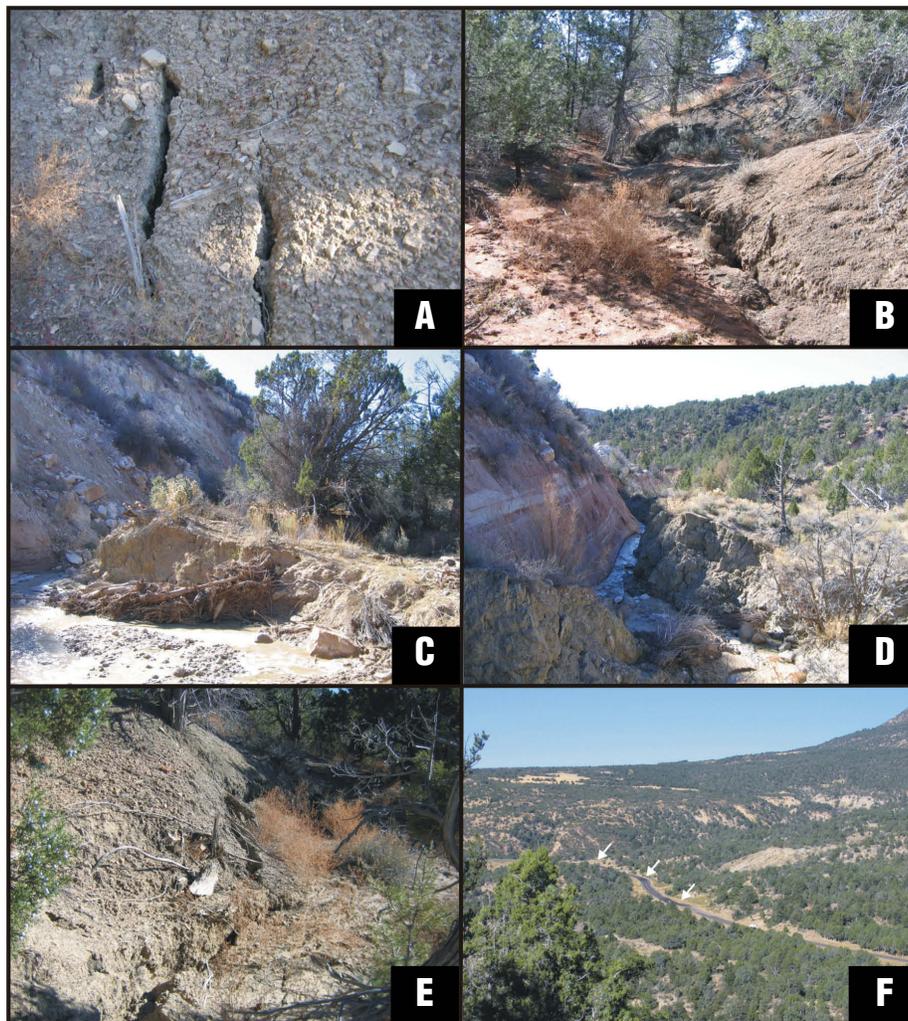
Landslide 1 is characterized by two well-defined shear zones on its flanks, numerous internal shear zones, and a variety of ground-deformation features. The head of the landslide consists of a series of en echelon or stepping scarps that extend upslope into the upper extensional part of the Meadow Creek landslide. The uppermost scarps in landslide 1 consist of reactivated, downslope-side, ridge-bounding scarps. Sinkholes commonly form along these scarps, suggesting local soil piping at locations where snowmelt and rainwater collects and infiltrates along them. Seasonal seeps are commonly present at the base of steep, downslope-facing, internal scarps, and local back-tilted surfaces are present in the head of landslide 1.

Figure 7. Ground deformation and road damage in landslide 1. (A) Left-stepping ground cracks that form part of the west-flank shear zone. (B) View to the south-southwest of part of the east-flank shear zone. Zone crosses photograph diagonally from lower right to center, then steps to right. In this area, low hummocks are folded debris above a thrust system. (C) Southeastern corner of landslide toe where it intersects east-flank shear zone. Meadow Creek is deflected about 43 feet (13 m) by landslide. (D) View to the west-southwest of toe where some landslide debris remains on south side of Meadow Creek (lower left corner). (E) View of typical offset on pre-existing scarp in head of landslide. (F) View to the west of damaged part of SR-9 (arrows point to darker asphalt patches) caused by movement of landslide 1. Photographs taken in October (F) and November (A-E) 2005.

characterized by an echelon, right- and left-stepping ground cracks, respectively. Movement in 2005 resulted in nearly continuous ground-crack zones along both flanks from the head to the toe of landslide 1. The east-flank shear zone intersects Meadow Creek where the toe of landslide 1E deflects the creek about 43 feet (13 m) (figure 7C). The west-flank shear zone intersects Little Meadow Creek a short distance upstream from a sinkhole that captures the entire creek flow. From that point the creek flows through a tunnel in landslide debris for about 210 feet (64 m) (plate 1). Doelling and Davis (1989) described this tunnel, suggesting that it has existed for at least 20 years (their field observations date from the mid-1980s).

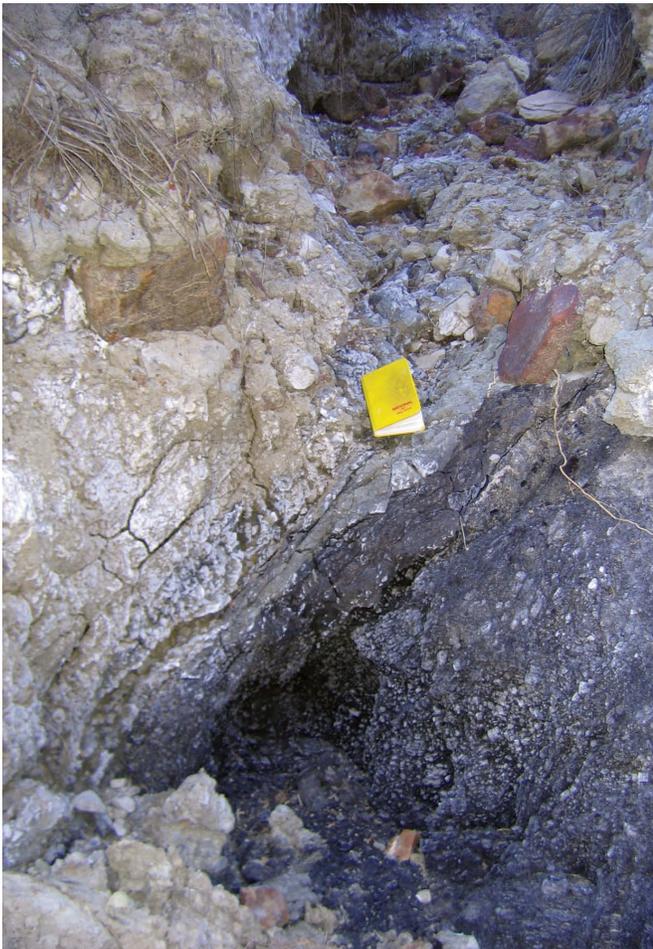
Figure 8. Exposure of carbonaceous shear zone in toe of landslide 1, suggesting that the landslide debris is partly derived from the Cretaceous Dakota Formation.

The lower part of landslide 1 is locally intensely deformed, characterized by numerous ground cracks and fissures, minor scarps, pressure ridges (folds), and ground tilting. Along Meadow Creek, slickensided, carbonaceous (coal-bearing) gouge is exposed in the toe thrust system (figure 8), suggesting that the surface of rupture of landslide 1, and likely also the main landslide, is at least in part in the Dakota Formation. Geologic mapping (Hylland, 2000) and subsurface data (Stouffer, 1964) indicate that the surface of rupture of many of the complex's landslides may have formed in bentonitic

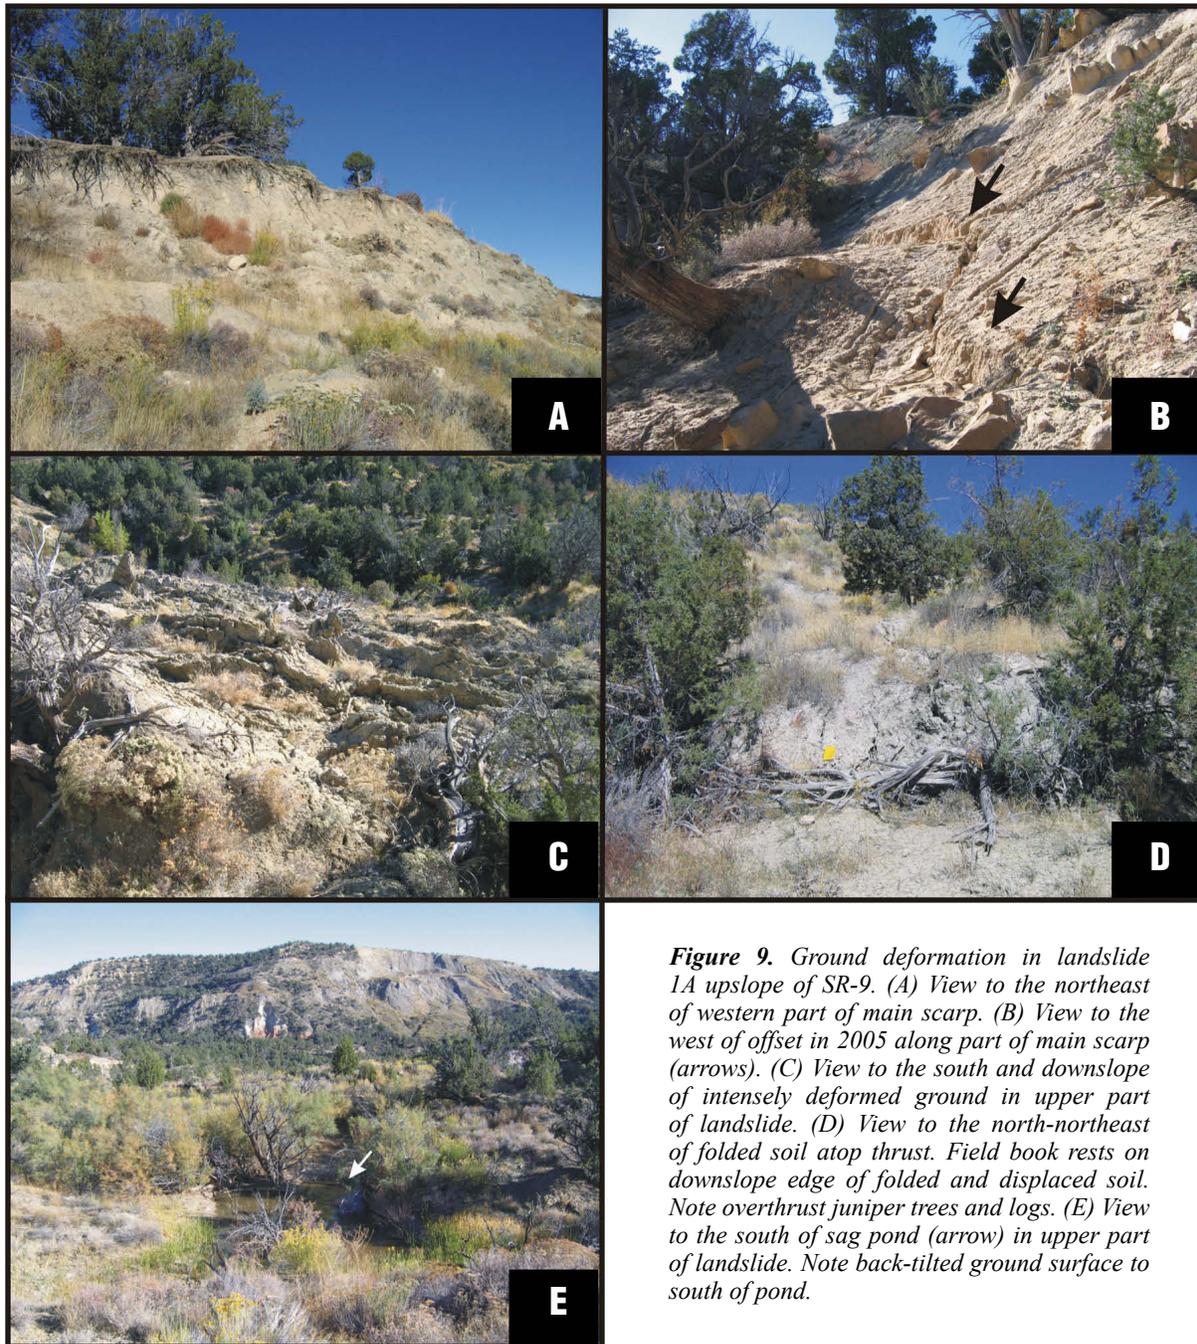
Figure 9. Ground deformation in landslide 1A upslope of SR-9. (A) View to the northeast of western part of main scarp. (B) View to the west of offset in 2005 along part of main scarp (arrows). (C) View to the south and downslope of intensely deformed ground in upper part of landslide. (D) View to the north-northeast of folded soil atop thrust. Field book rests on downslope edge of folded and displaced soil. Note overthrust juniper trees and logs. (E) View to the south of sag pond (arrow) in upper part of landslide. Note back-tilted ground surface to south of pond.

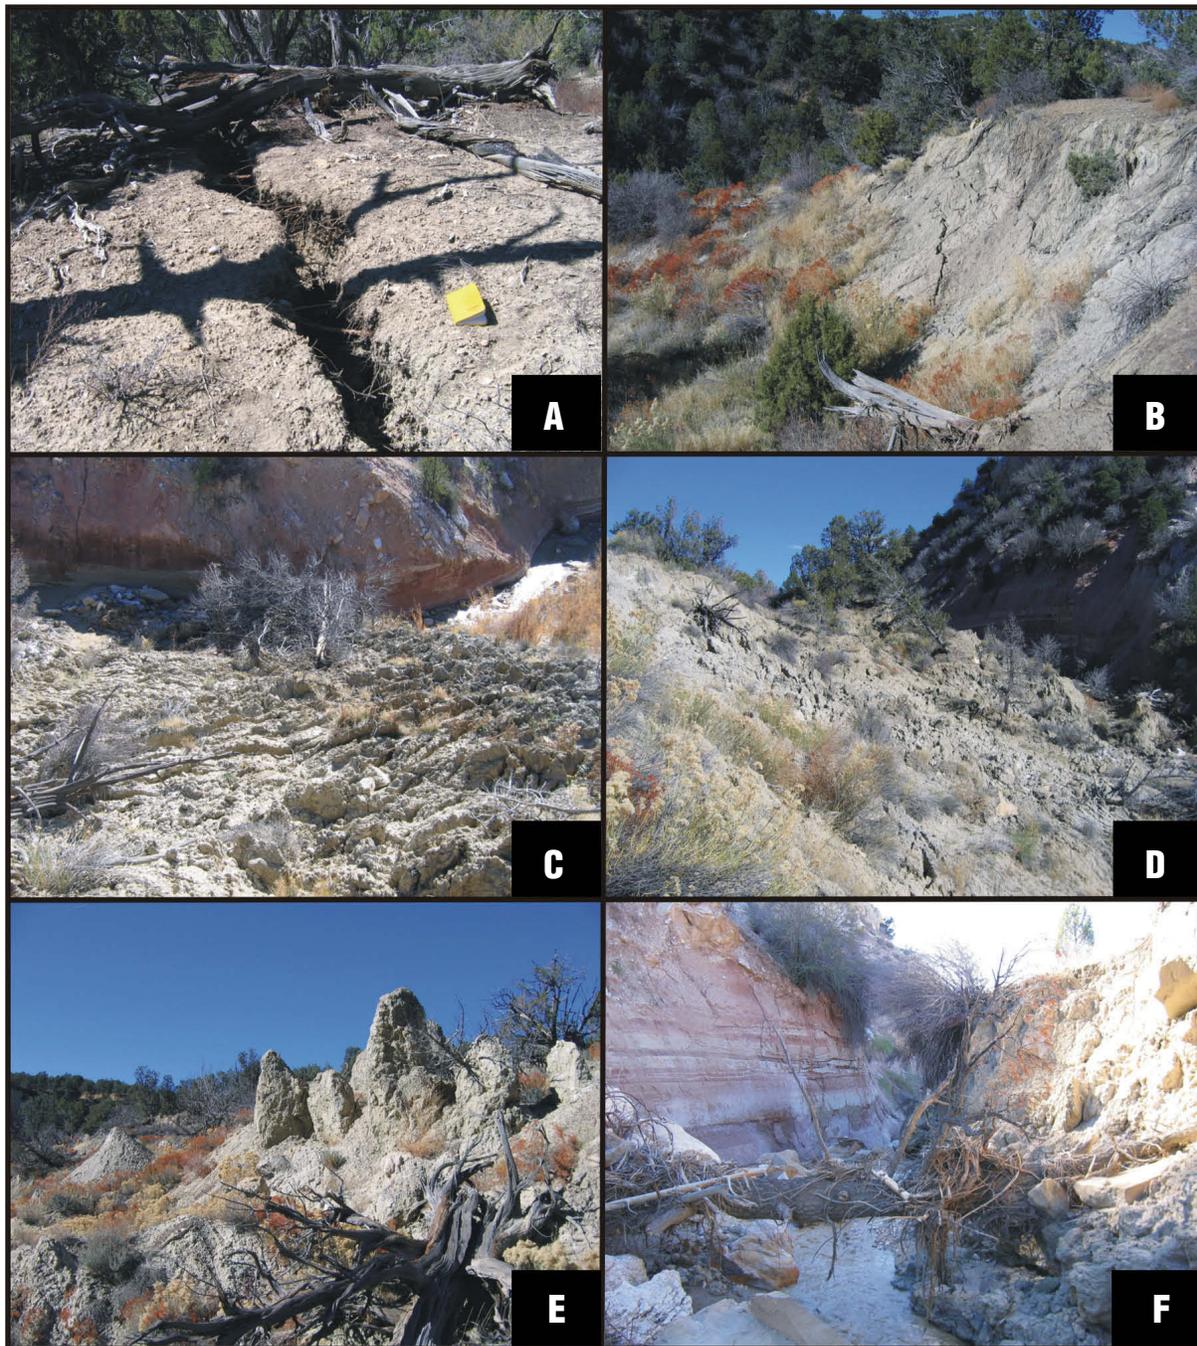
The other four slides (figure 10) in landslide 1 are downslope of SR-9 and former SR-15, and abut either Little Meadow Creek (landslides 1B and 1C) or Meadow Creek (landslides 1D and 1E). Landslide 1B is directly west of an incised drainage that crosses the western part of landslide 1 and flows into Little Meadow Creek. The landslide is characterized by a main scarp that locally exceeds 10 feet (3 m) in height. Landslide 1C is upslope of the lower part of the tunnel along Little Meadow Creek. Movement in 2005 resulted in offset and ground cracking along the main scarp of the slide (figure 10B). Landslide 1D is at the confluence of Little Meadow Creek and Meadow Creek and is characterized by intense ground deformation (figures 10C and 10D). Landslide 1E (figures 10E and 10F) is in the southeastern toe of landslide 1 and is characterized by locally intense ground deformation and a zone of scarps in its upper part. The 43-foot (13-m) deflection of Meadow Creek occurs at landslide 1E, and some, if not most, of the deflection is likely the result of local movement of this smaller slide rather than global movement of landslide 1. Stouffer (1964) documented deflection of Meadow Creek by landslide 1E, but did not quantify it.

Figure 10. Other smaller active slides in landslide 1. (A) Crown fissure above main scarp of landslide 1B. (B) View to the northwest of main scarp of landslide 1C and offset in 2005. (C) View to the south-southwest of intensely deformed part of landslide 1D. (D) View to the east of landslide 1D. (E) View to the west of broken soil blocks in lower part of landslide 1E. (F) View to the west-southwest and downstream of landslide debris (right) exposed in toe of landslide 1E along Meadow Creek.

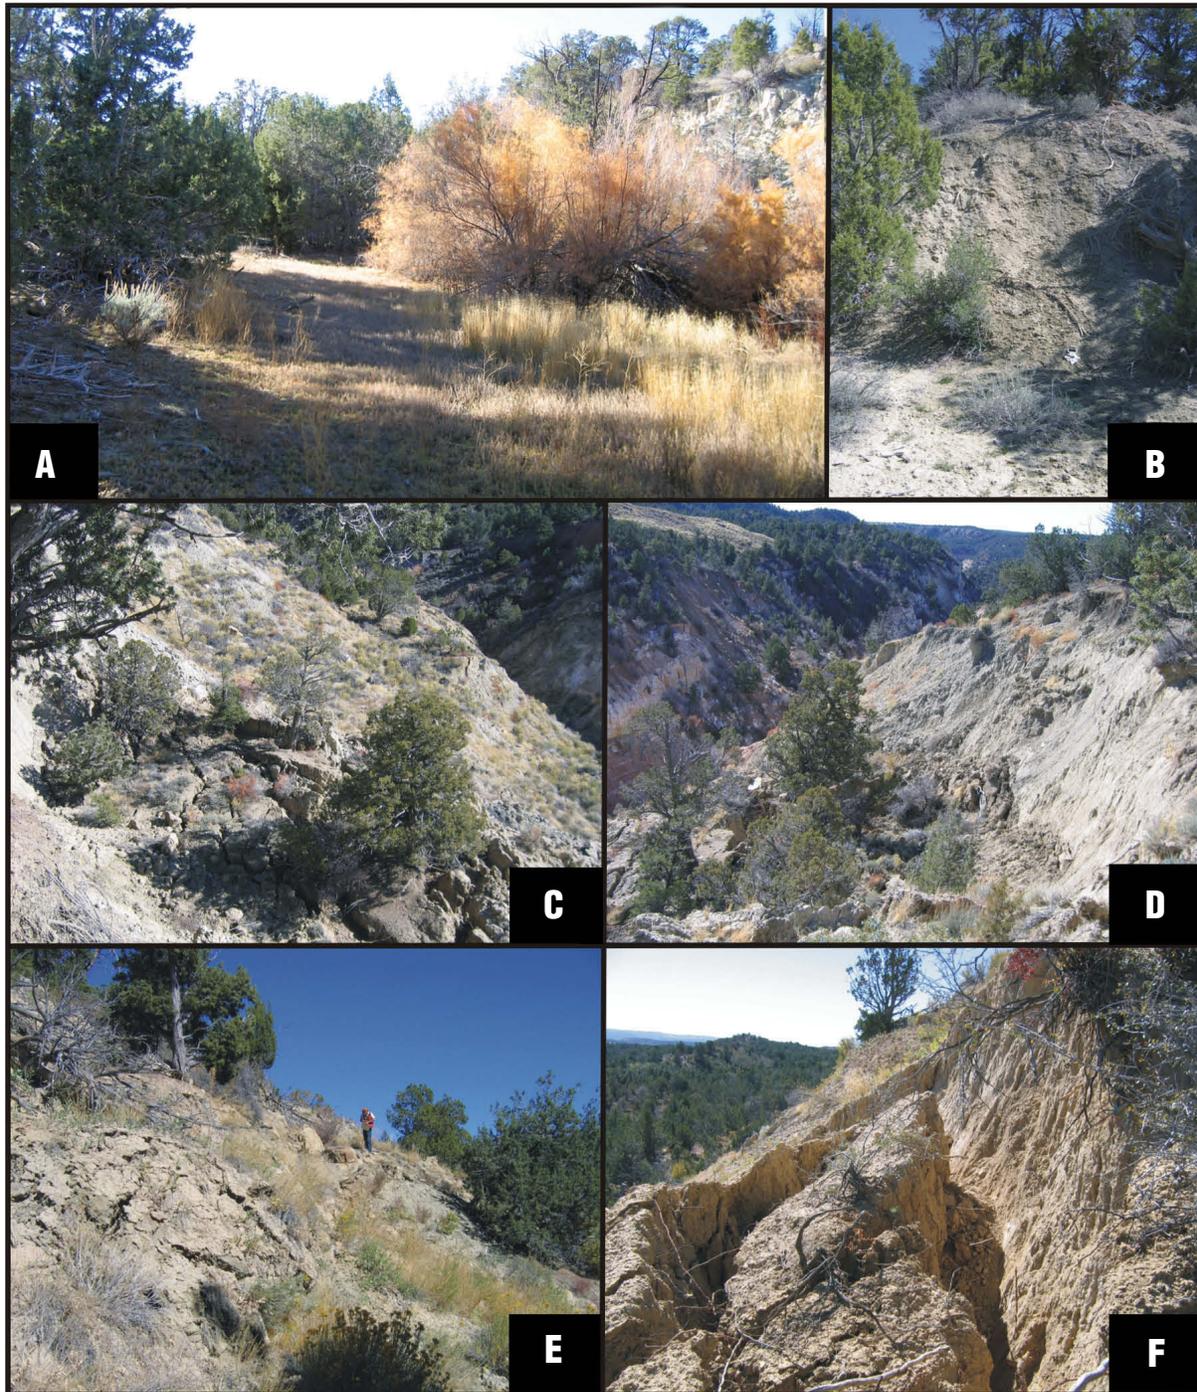
the probable toe of the landslide (figure 11B). Whereas offset on the main scarp occurred in 2005, translation of landslide debris at the toe appears to have been minimal. Instead, movement of the upslope part of the landslide may have resulted in ground tilting and folding at the toe with little, if any, translation. A reconnaissance downslope of the jeep road revealed no evidence of ground deformation indicative of deep-seated landsliding in 2005. However, damage to the SR-15 culvert (figure 12) across Little Meadow Creek suggests historical movement in this area, either of the southwestern part of the Meadow Creek landslide (the western part of the “creep

Figure 11. Other historical slides in the Meadow Creek landslide. (A) View to the west of back-tilted ground surface in eastern head of landslide 2. Sag pond exists along north edge of area to right of tamarisk (orange leaves). (B) Toe of landslide 2 northeast of Coal Mine Road. (C, D) Views of ground deformation in upper part of landslide 3. Ground surface was locally disrupted by movement in 2005. (E) View to the northeast of toe of active part of landslide 5. Lower active toe thrust in 2005 was in about the middle of historical landslide mapped by Hylland (2000). (F) View to the west of the main scarp of landslide 5. Most of the offset visible in photograph likely occurred in 2005.

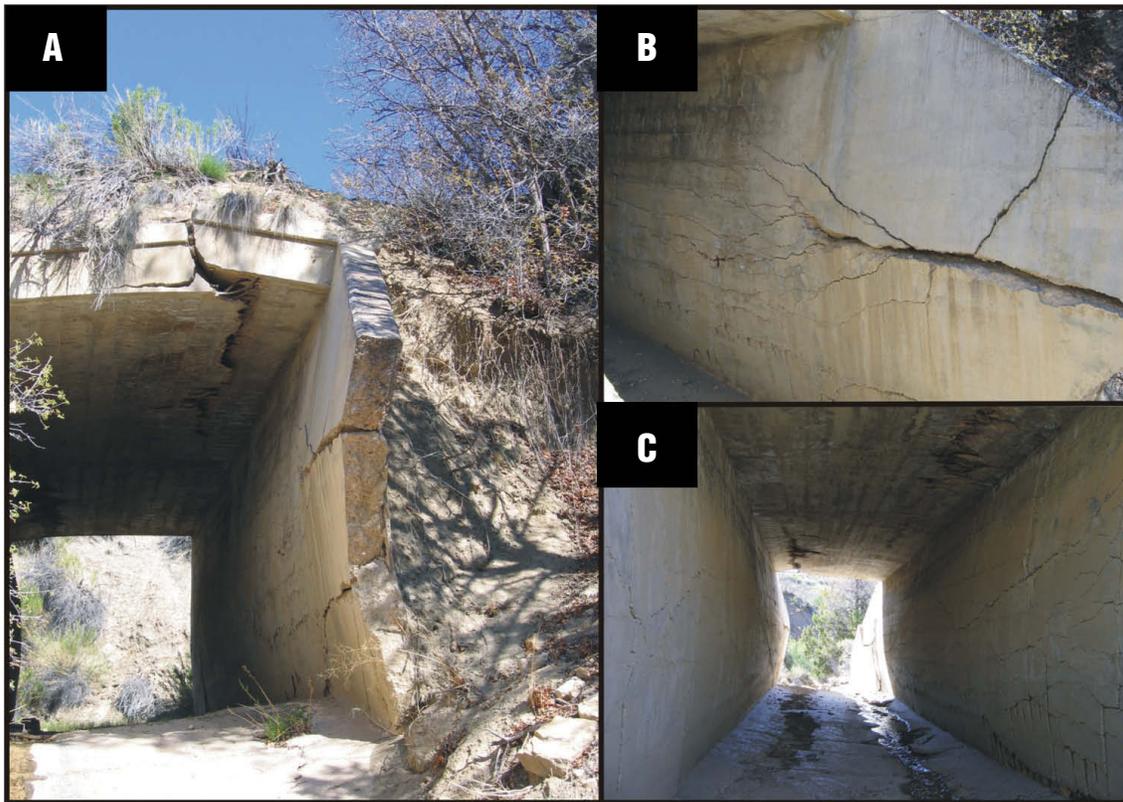
Figure 12. Damage to box culvert at abandoned SR-15 crossing of Little Meadow Creek. (A) View upstream showing damage to northeast wall of box culvert and upper deck. (B) Damage to northeast wall of box culvert. (C) View downstream of interior of culvert showing hourglass distortion of originally rectangular box culvert.

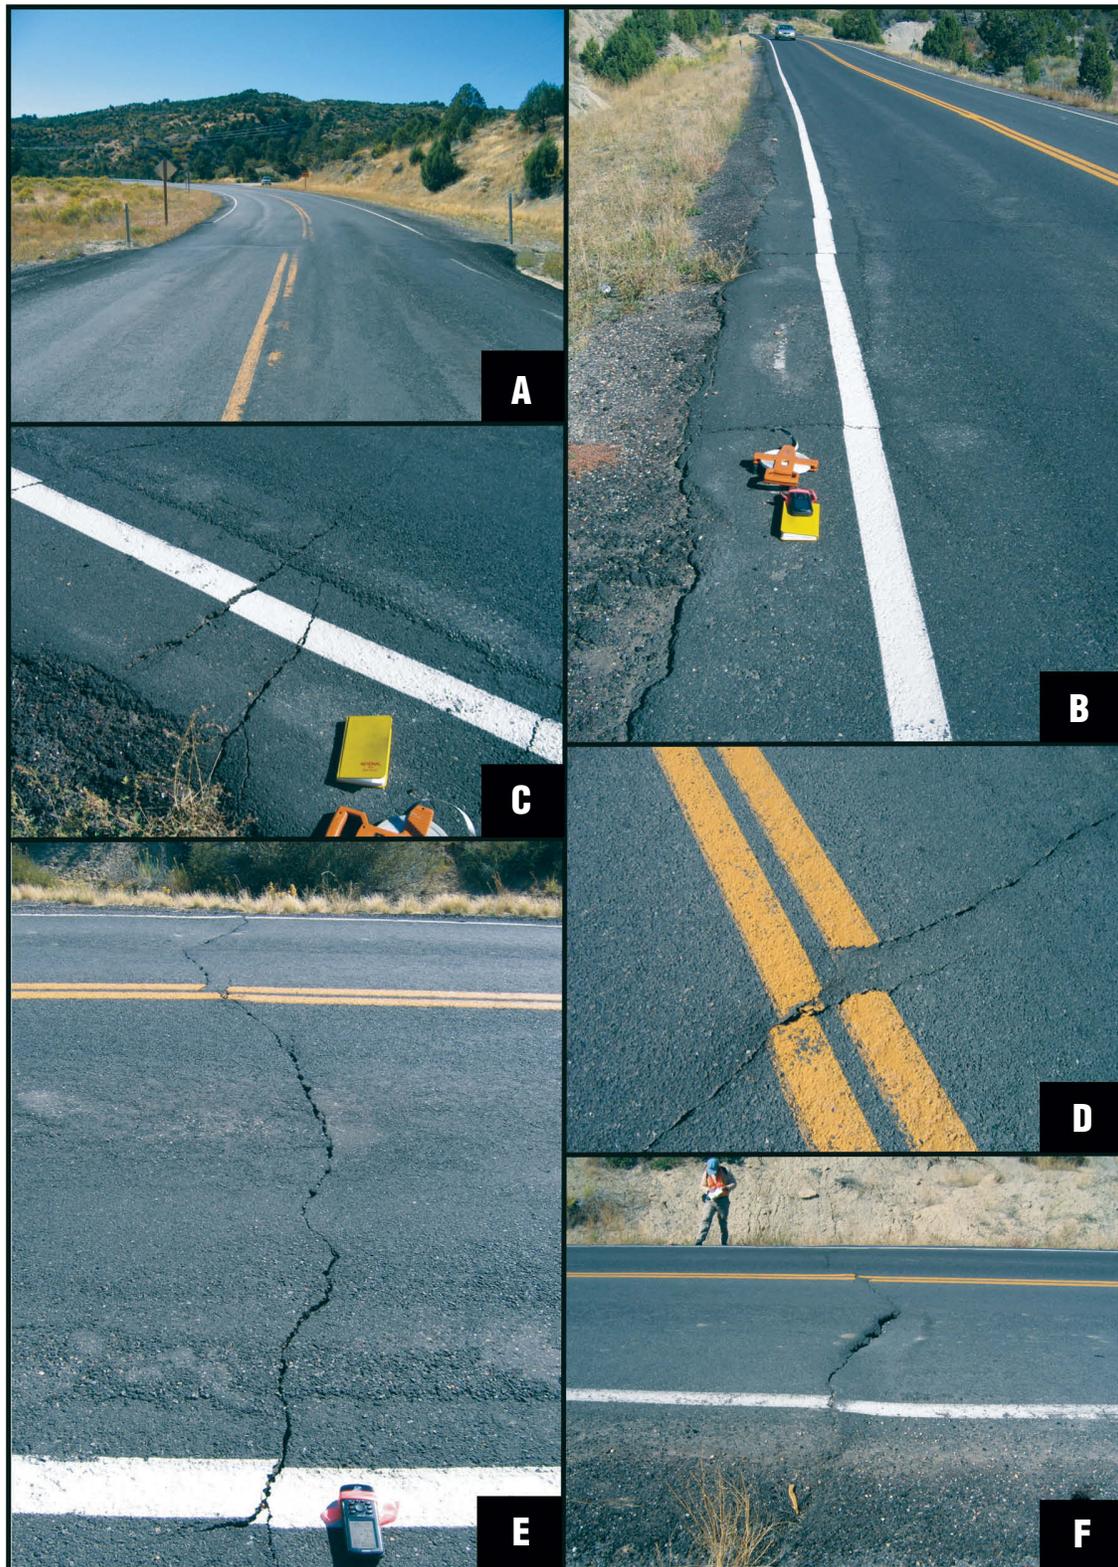
Figure 17. Damage to SR-9 near the west-flank shear zone of landslide 1 in October 2005. (A) View to the west of right-lateral offset (see center stripe) by west-flank shear zone. Offset of northern (right) white stripe on October 4, 2005, was 1.37 feet (0.42 m). (B) View to the east of small offset of northern white stripe by cluster of lateral shears. Three of four shears are right-lateral. (C) View of cluster of lateral shears in B. Note that lateral shear to left of field book does not cut new layer of asphalt. Maximum offset of white stripe is 0.8 inch (2 cm). (D) Offset of centerline stripes by right-lateral shear that bounds eastern edge of damage zone abutting west-flank shear zone. Offset of southern white stripe along edge of road (see F) is 1.9 inches (4.8 cm). (E) View to the south of the same right-lateral shear. Note horsetail splay at lower (northern) white stripe. (F) View to the north of same lateral shear as shown in D and E. Note damage to eastbound lane.

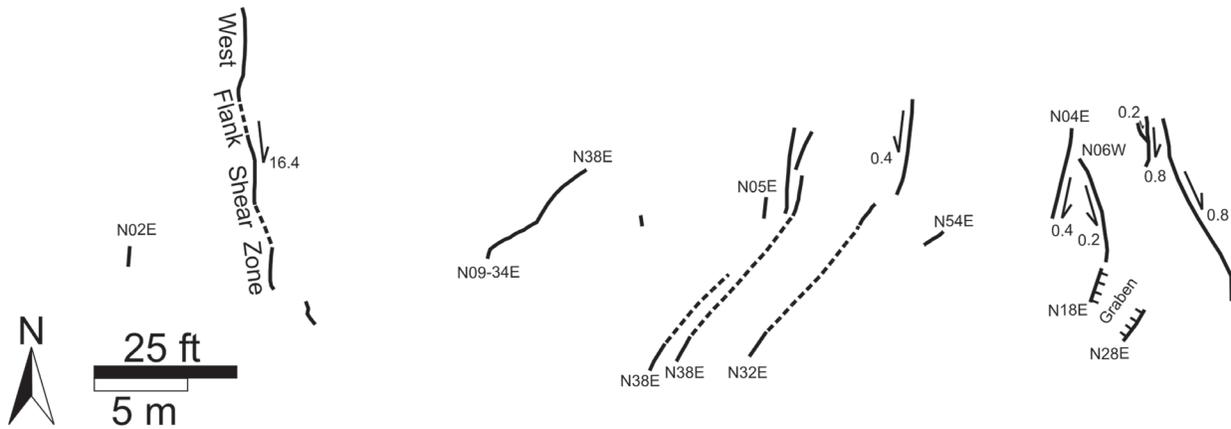
Figure 18. Sketch map of the damage zone near the west-flank shear zone of landslide 1 in October 2005. Arrows indicate lateral shears or shear zones. Numbers indicate amount of offset (in inches) of northern white stripe along edge of SR-9. Trends of road cracks indicated (e.g., N32E). Dashes show approximate continuity of some cracks mapped separately along the north and south edges of road. Hachures indicate small scarp with vertical offset. Small graben exists in eastern part of damage zone. Northern and southern limits of cracks approximately define the edge of highway pavement. See discussion in Field Methods section for limitations of mapping.

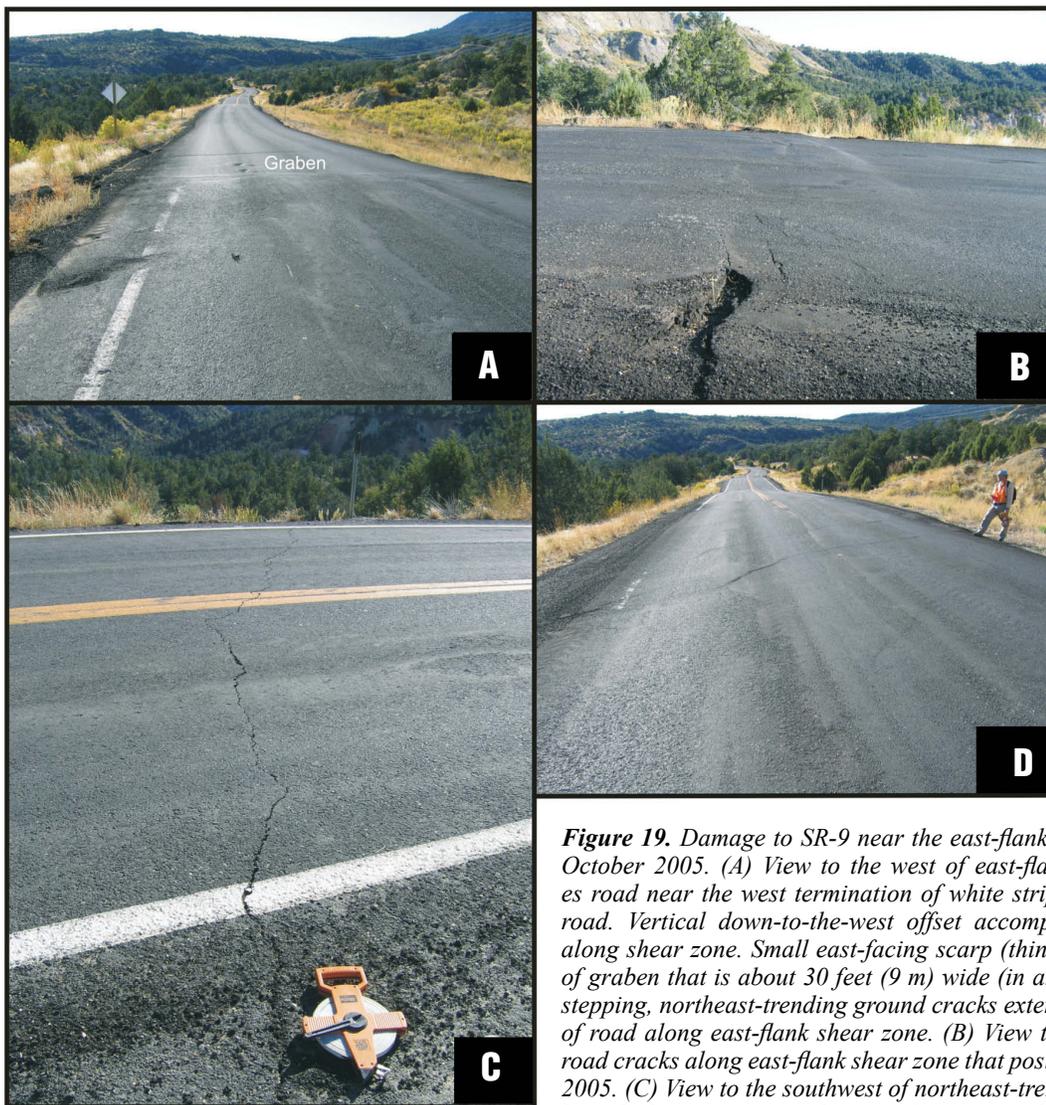
Figure 19. Damage to SR-9 near the east-flank shear zone of landslide 1 in October 2005. (A) View to the west of east-flank shear zone, which crosses road near the west termination of white stripe along south (left) edge of road. Vertical down-to-the-west offset accompanies left-lateral movement along shear zone. Small east-facing scarp (thin dark line) defines west edge of graben that is about 30 feet (9 m) wide (in an east-west direction). Right-stepping, northeast-trending ground cracks extend north and south from edge of road along east-flank shear zone. (B) View to the south of right-stepping road cracks along east-flank shear zone that postdate repair of SR-9 earlier in 2005. (C) View to the southwest of northeast-trending right-lateral shear that bounds damage zone on the west. (D) View to the west of northwest-trending, parallel road crack and monocline in western part of damage zone. Monocline defines a broad graben that extends about 240 feet (73 m) along SR-9 and is bounded on the east by the east-flank shear zone.

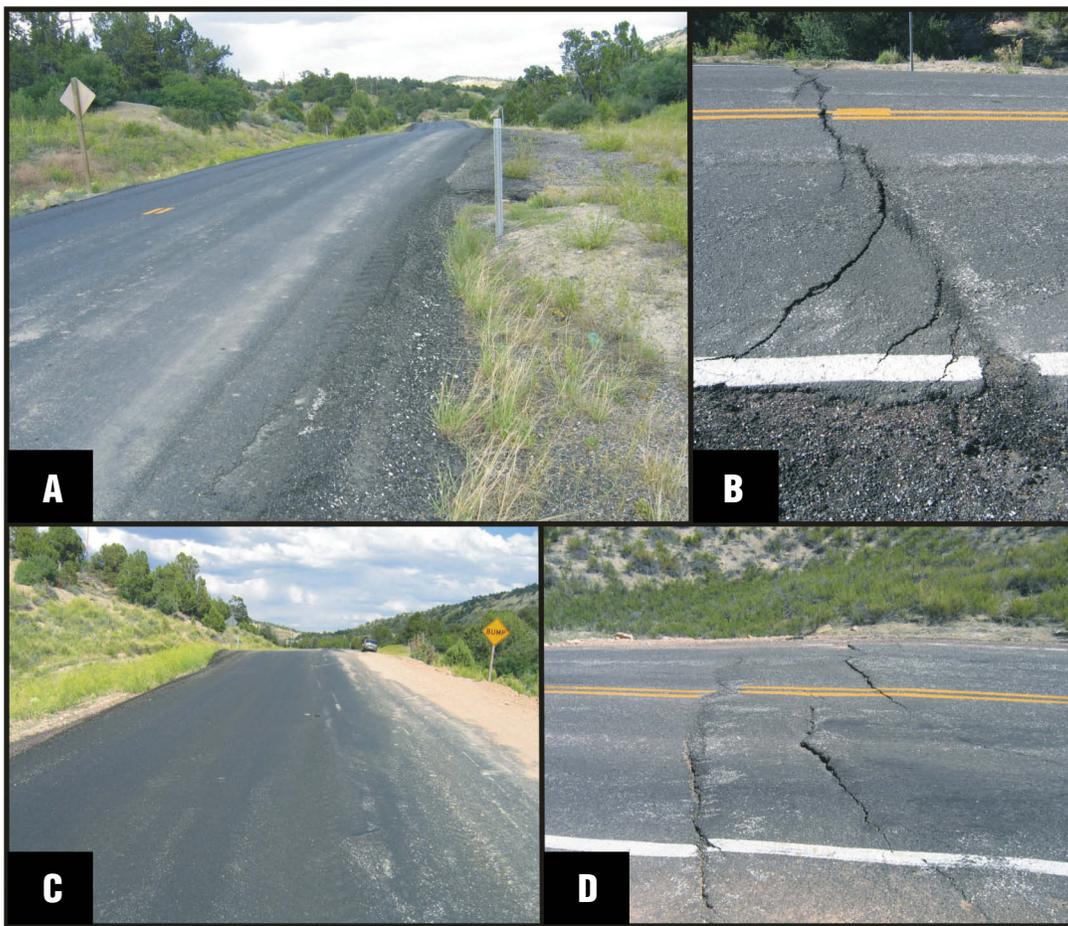
Figure 20. Additional road damage to SR-9 by May 2007. (A) View to the east where SR-9 crosses the west-flank shear zone. Note highway surface was recently repaved. Photograph taken on June 13, 2006. (B) View to the south of damage along west-flank shear zone on May 8, 2007. Measured horizontal offset of yellow striping was about 3 inches (8 cm). (C) View to the east where SR-9 crosses the east-flank shear zone. Note highway surface was recently repaved. Photograph taken on June 13, 2006. (D) View to the north of damage along east-flank shear zone on May 8, 2007. Measured horizontal offset of white stripe (lower left) was about 1.7 inches (4.2 cm).

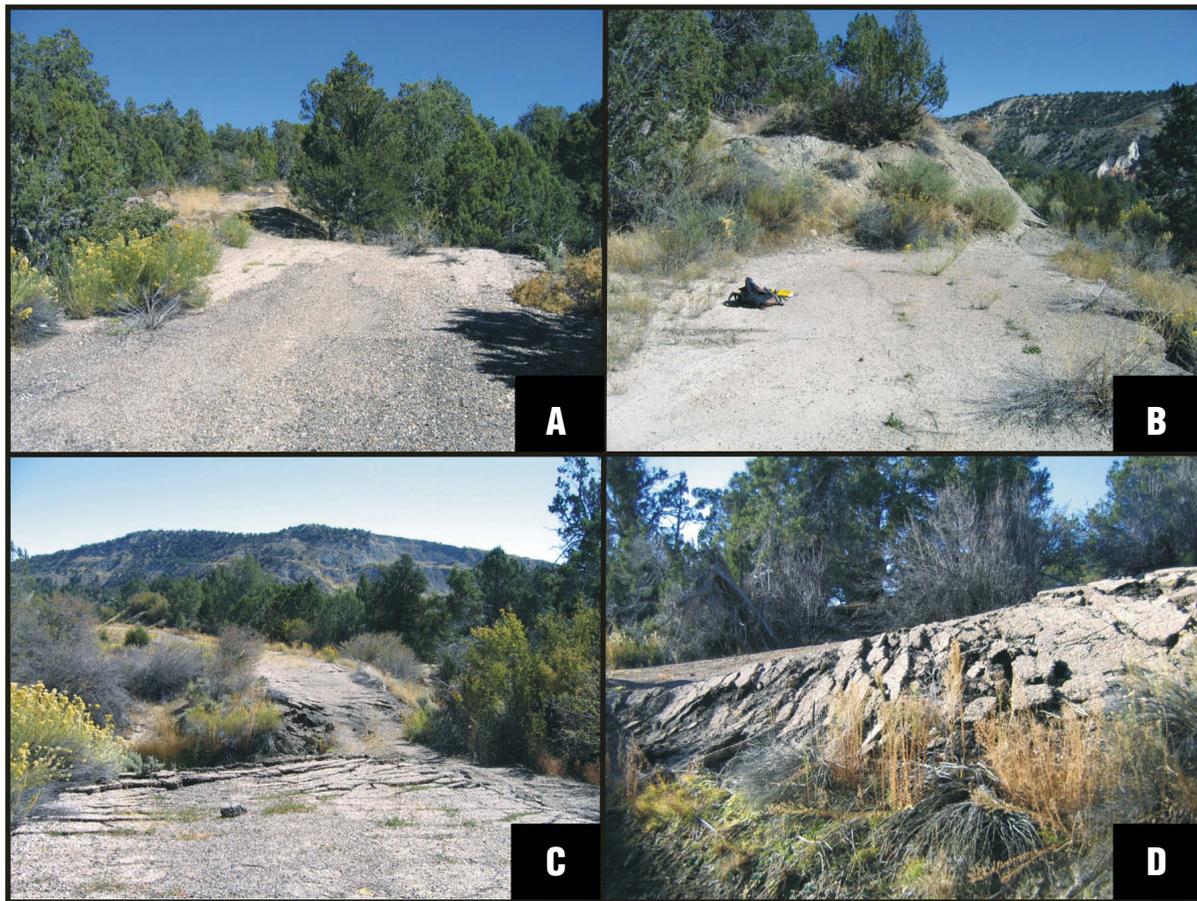
3) moved several inches per year toward Meadow Creek and noted that most of the movement occurred during the spring following snowmelt. Doelling and Davis (1989) measured 16-foot and 20-foot (5-m and 6-m) total offsets of abandoned SR-15 along the shear faults bounding landslide 1 on July 23, 1985. These measurements indicate an average annual rate of movement of between 9.1 and 11.4 inches per year (23–29 cm/yr). However, Doelling and Davis (1989) also indicated that movement amounts and road damage were greater during wet years such as 1983, when landslide 1 moved several feet. Doelling and Davis (1989) also documented that SR-9 was re-graded and resurfaced in the spring of 1985, at a cost of about \$150,000, but by September 10, 1985, the road was offset 1 inch and 1/2 inch (2 and 1 cm) on the west and east boundaries of landslide 1, respectively. By the summer of 1986, offset of the highway exceeded 1 foot (30 cm).

Figure 21. Offset and road damage to abandoned SR-15. (A) View to the east of left-lateral offset along the east-flank shear zone. (B) View to the east of right-lateral offset along a major internal lateral shear. (C) View to the east-southeast of road damage and right-lateral offset along the west-flank shear zone. (D) Detail of pavement damage at west-flank shear zone.
