GEOLOGIC HAZARDS OF THE BULLFROG AND WAHWEAP HIGH-USE AREAS OF GLEN CANYON NATIONAL RECREATION AREA, SAN JUAN, KANE, AND GARFIELD COUNTIES, UTAH, AND COCONINO COUNTY, ARIZONA

by Tyler R. Knudsen, Adam I. Hiscock, William R. Lund, and Steve D. Bowman

SPECIAL STUDY 166
UTAH GEOLOGICAL SURVEY 2020
UTAH DEPARTMENT OF NATURAL RESOURCES
in cooperation with the National Park Service

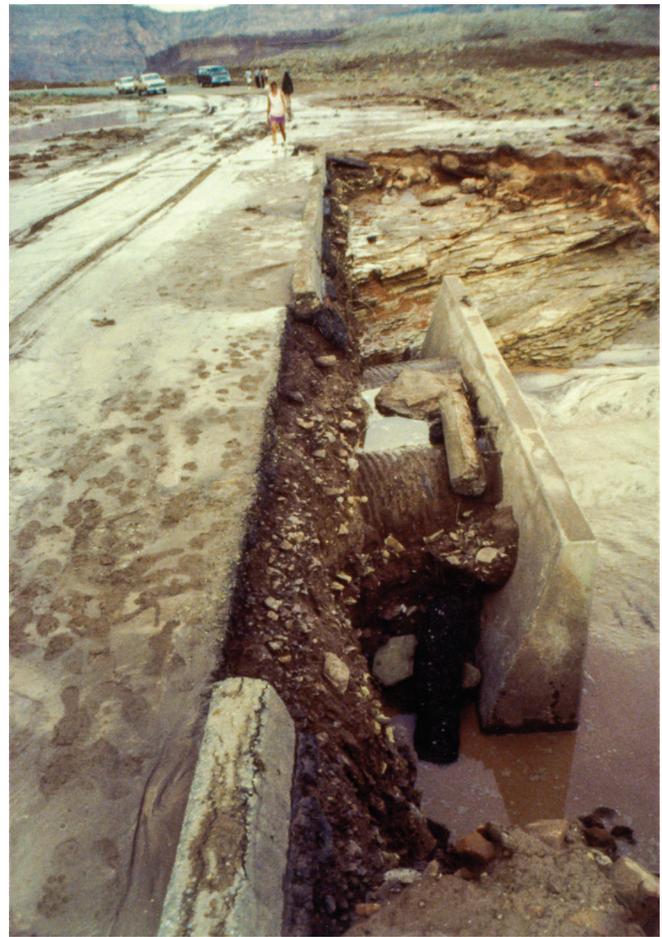
Figure 2. August 18, 1989, flash flood damage to Lees Ferry Road (photograph courtesy of the National Park Service).

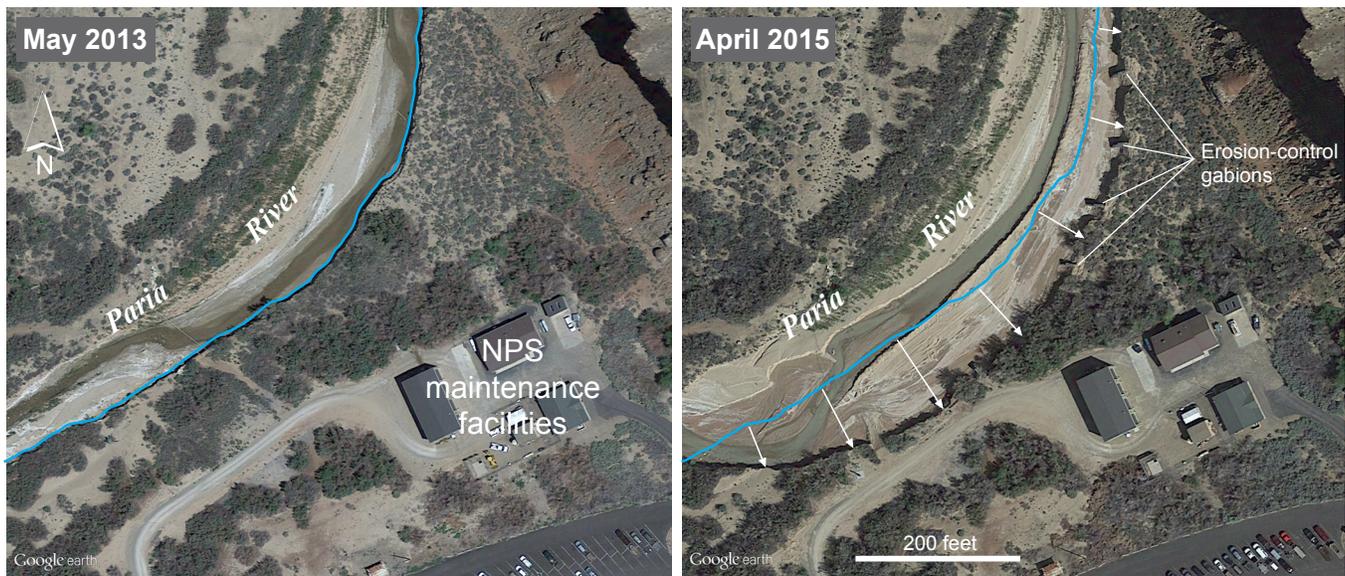
Figure 11. Comparison of Google Earth aerial imagery acquired in May 2013 and April 2015 showing as much as 100 feet of bank erosion along the Paria River near Lees Ferry. White arrows indicate change in river bank position from 2013 to 2015. Most erosion likely occurred during thunderstorm-induced floods during the fall of 2013 and 2014. Erosion-control gabions were constructed in fall of 2014 in an attempt to protect NPS maintenance facilities.

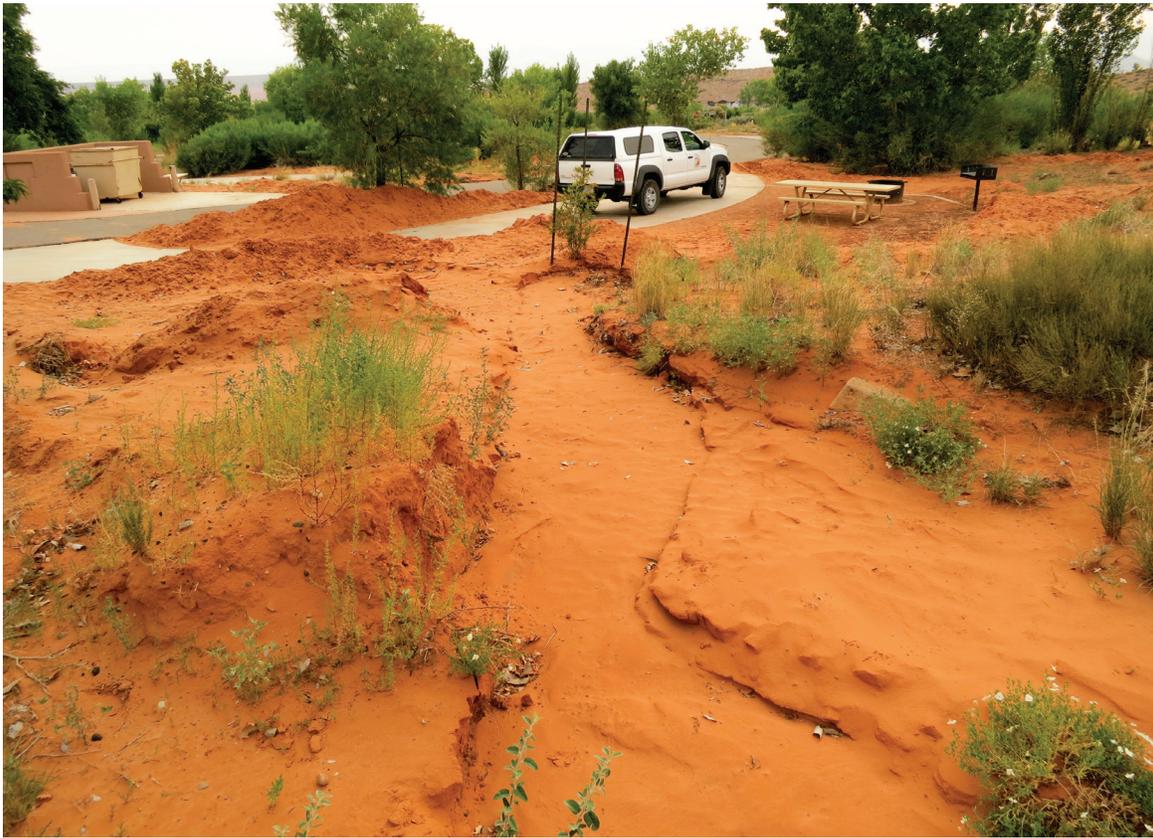
Figure 13. Example of a moderate flood-hazard area, where a small stream channel intersects the Bullfrog Campground. Although minor, such channels can carry substantial water and debris during thunderstorm-induced flash floods which can damage facilities and threaten visitor safety. Photo taken August 20, 2015.

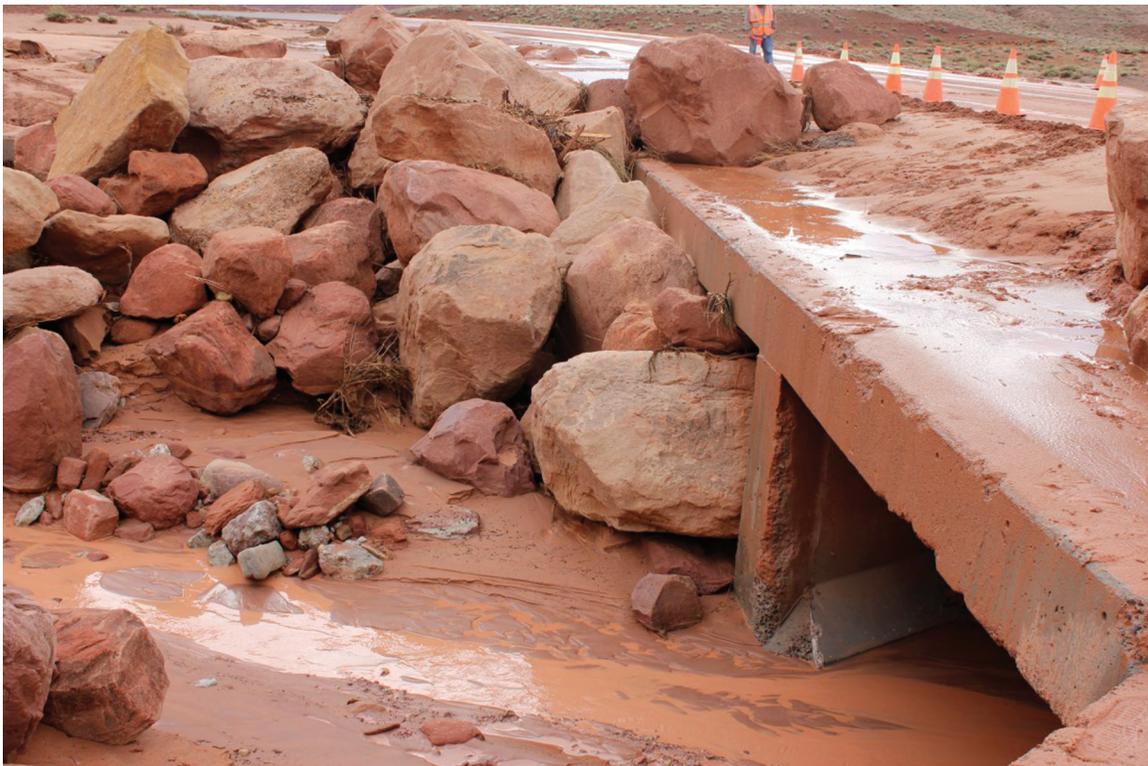
Figure 14. September 12, 2013, debris flow that deposited mud and car-sized boulders onto Lees Ferry Road. Photo courtesy of the National Park Service.

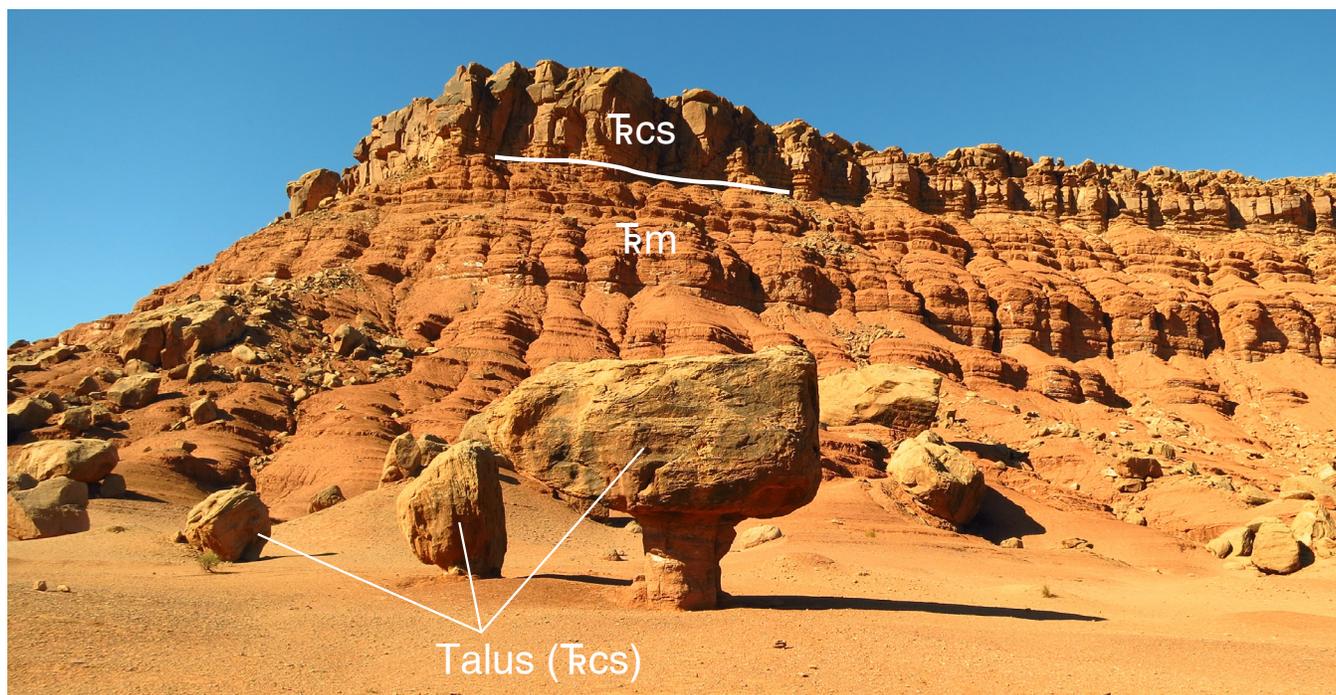
Figure 17. Very high rockfall-hazard area near Lees Ferry that is typical of many similar areas in the study area where softer bedrock units crop out on slopes below more resistant cliff-forming formations. Erosion of the underlying softer unit undercuts the more resistant unit, producing numerous rockfalls. Photo taken on November 17, 2014. T_{cs} = Triassic Shinarump Conglomerate, T_m = Triassic Moenkopi Formation.

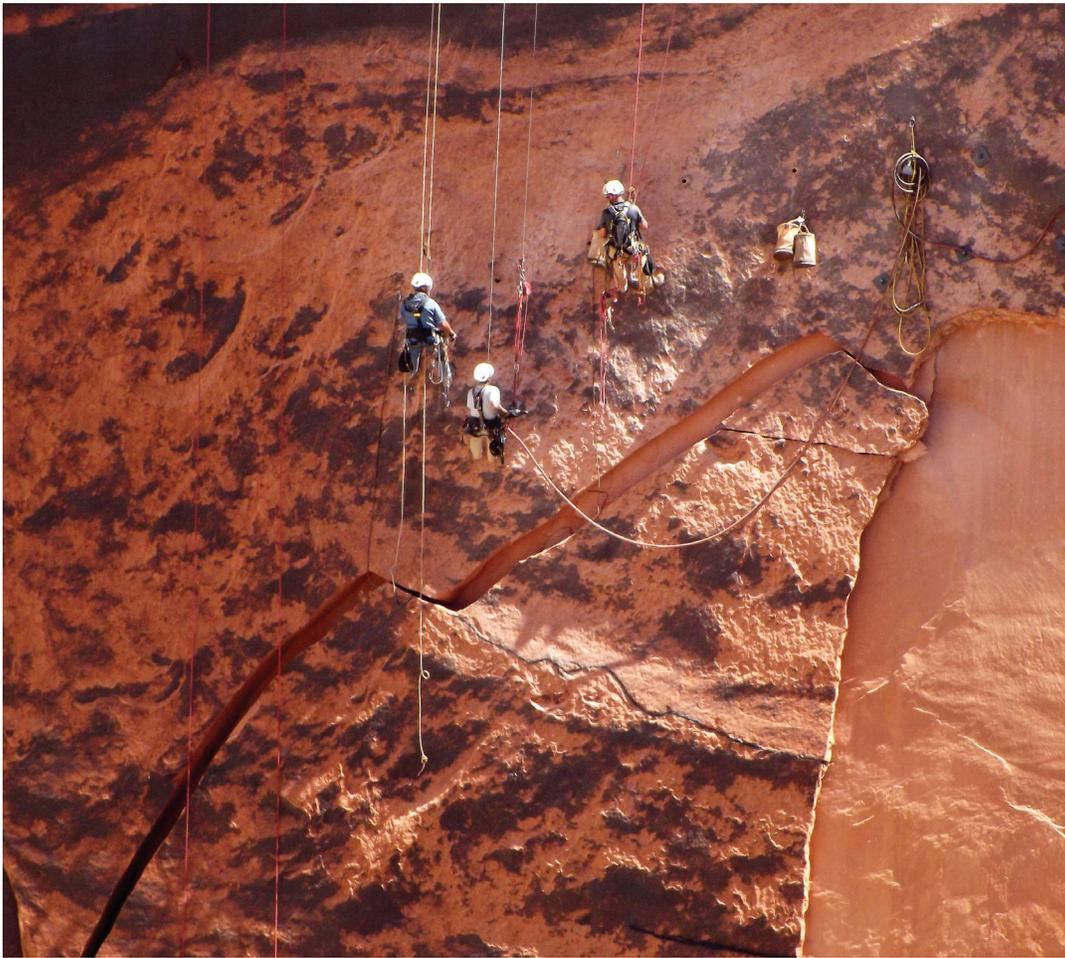
Figure 18. Work crew installs rock bolts on September 2, 2015, to help stabilize a large slab of Navajo Sandstone created by a secondary stress-relief joint near Glen Canyon Dam. Photo courtesy of Frank Talbot (franktalbot.net).

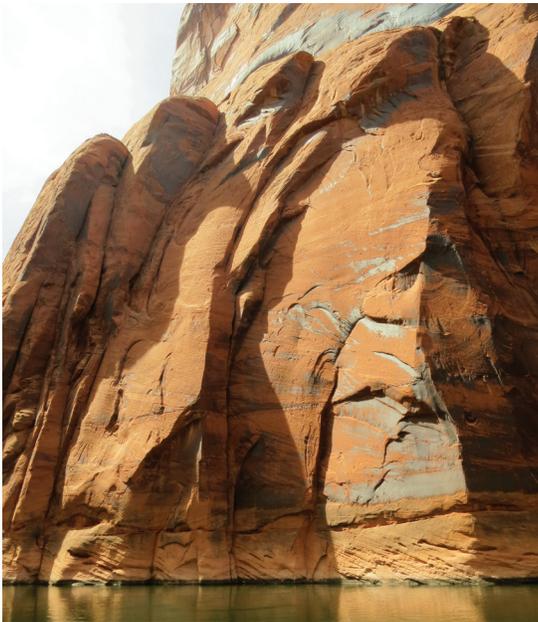
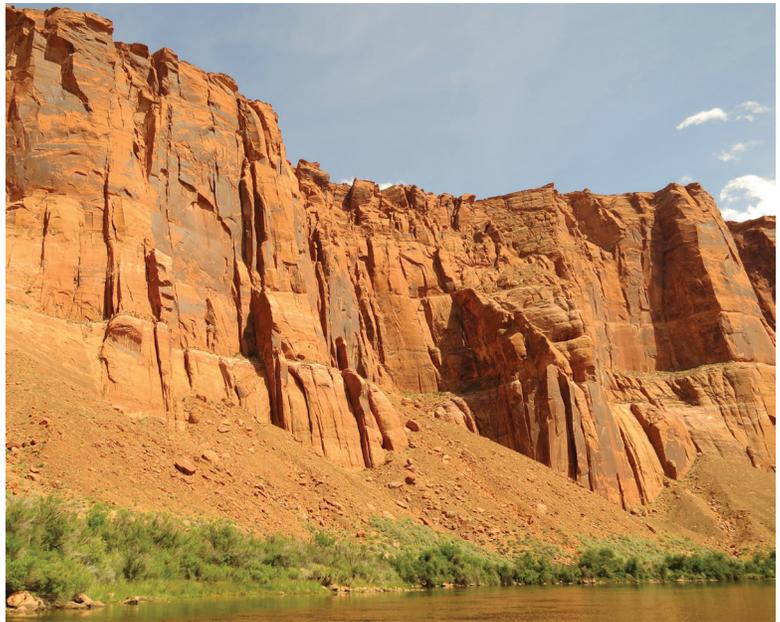
Figure 19. **Left:** Secondary stress-relief joints formed parallel to a Navajo Sandstone cliff face in Glen Canyon below Glen Canyon Dam. **Right:** Closely spaced primary joints (prominent joints in cliff face) intersect secondary stress-relief joints (normal to camera view and therefore not easily seen in this view) to produce abundant column- and wedge-shaped rock masses prone to collapse below the Horseshoe Bend Overlook in Glen Canyon. Large, unvegetated talus slopes below the cliff indicate a high rate of rockfall. Photos taken on August 13, 2015.

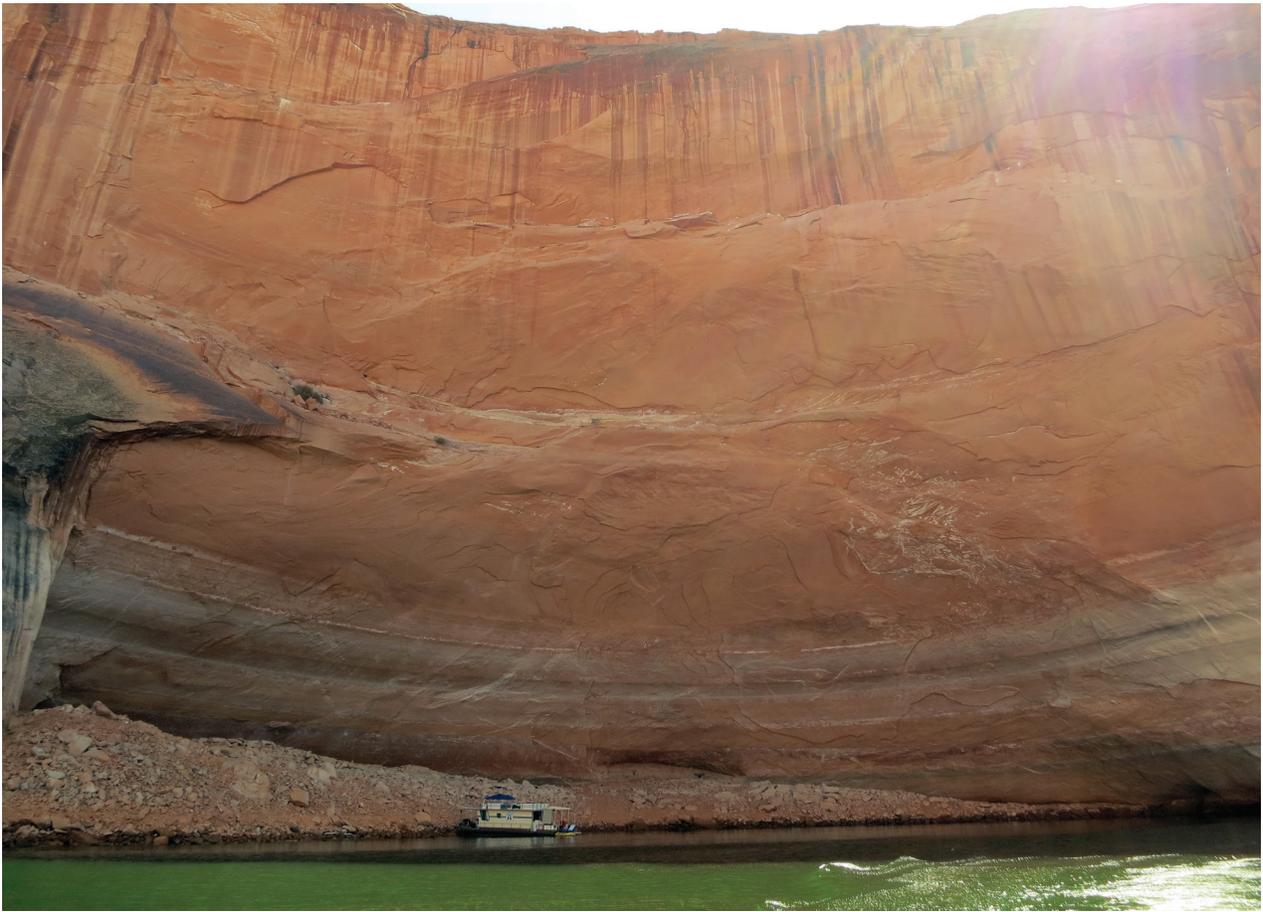
Figure 20. Houseboat anchored on talus deposits below a large alcove in Moqui Canyon. Although alcoves can provide shelter from sun and storms, they also produce abundant rockfall that can threaten life and property. Photo taken August 18, 2015.

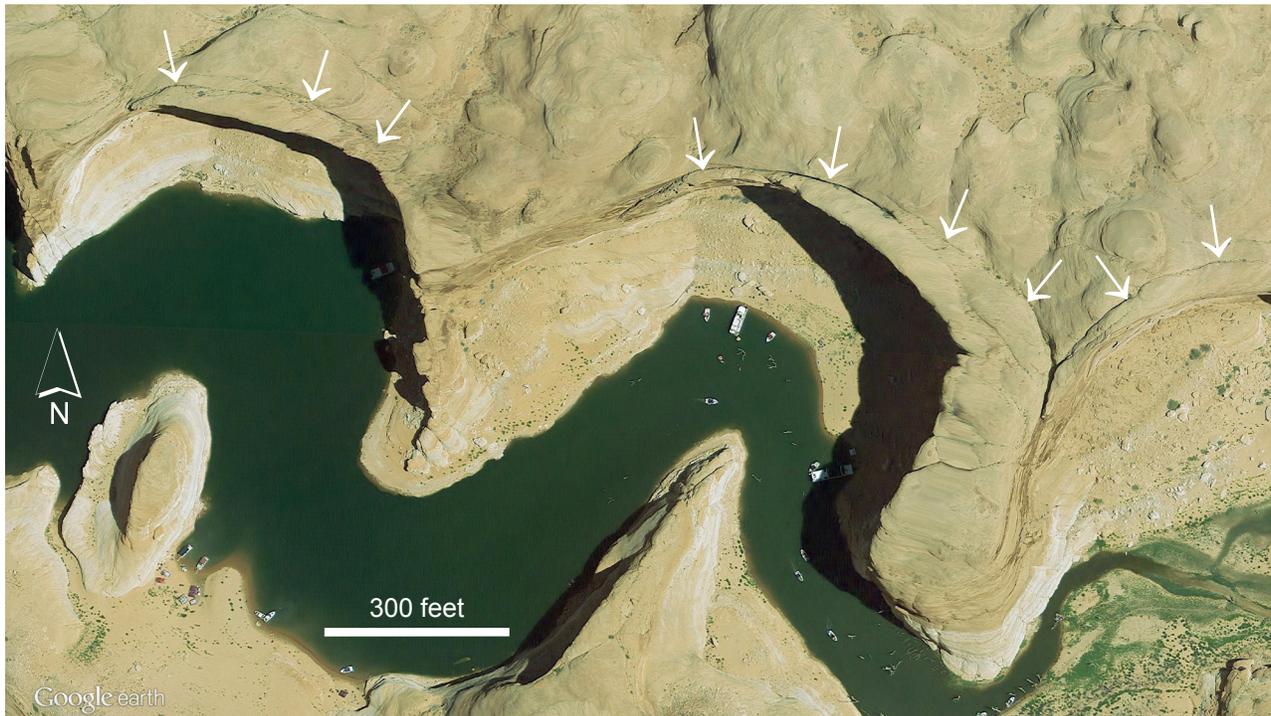
Figure 21. Curvilinear secondary joints (marked by arrows) developed above alcoves in Forgotten Canyon (June 2013 Google Earth image). Note boats in photo center moored beneath an alcove.

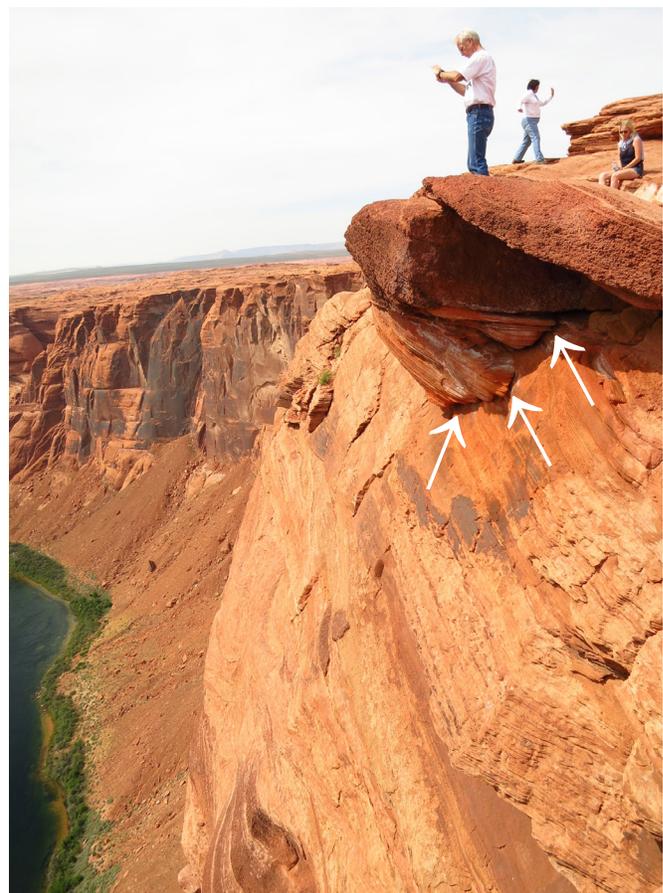
Figure 24. An open joint (indicated by white arrows) has partially detached a Navajo Sandstone block at Horseshoe Bend Overlook. View is to the north; photo taken May 11, 2015.

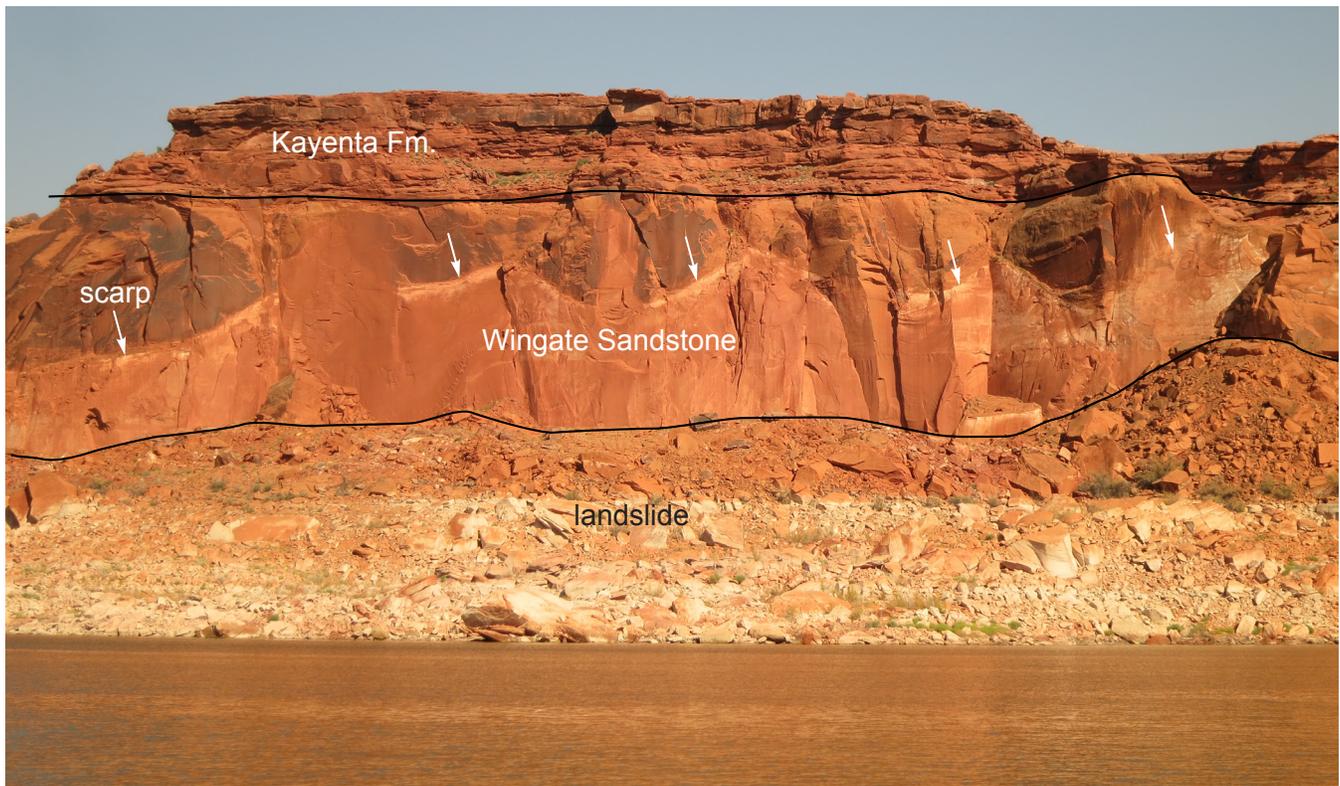
Figure 28. Talus mantles a landslide rooted in the Chinle Formation on the east side of Lake Powell's main channel near Good Hope Bay. The fresh scarp and a displaced high-water line indicate movement occurred after lake filling. Photo taken August 17, 2015.

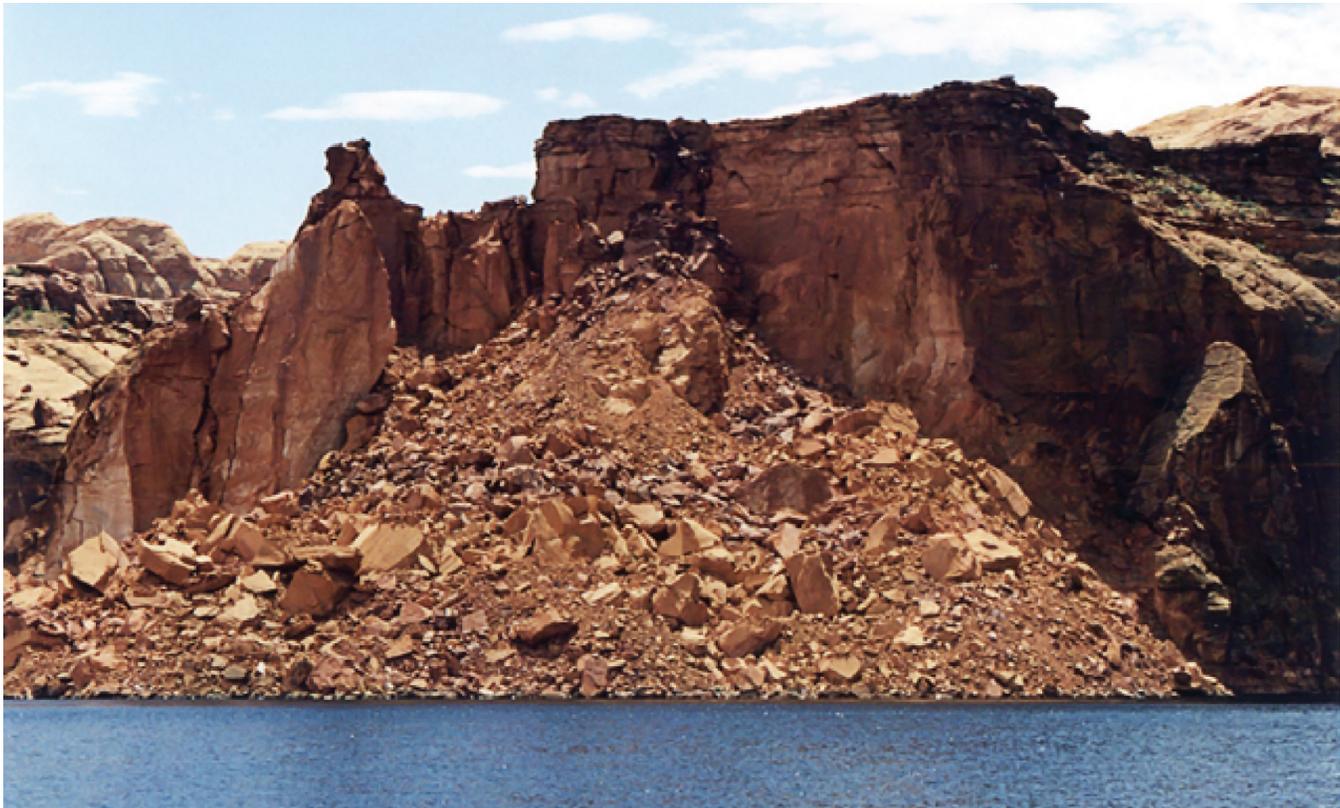
Figure 29. Massive collapse of Wingate/Kayenta cliff on the south side of the Ticaboo inlet. Photograph courtesy of Douglas Sprinkel, Utah Geological Survey.

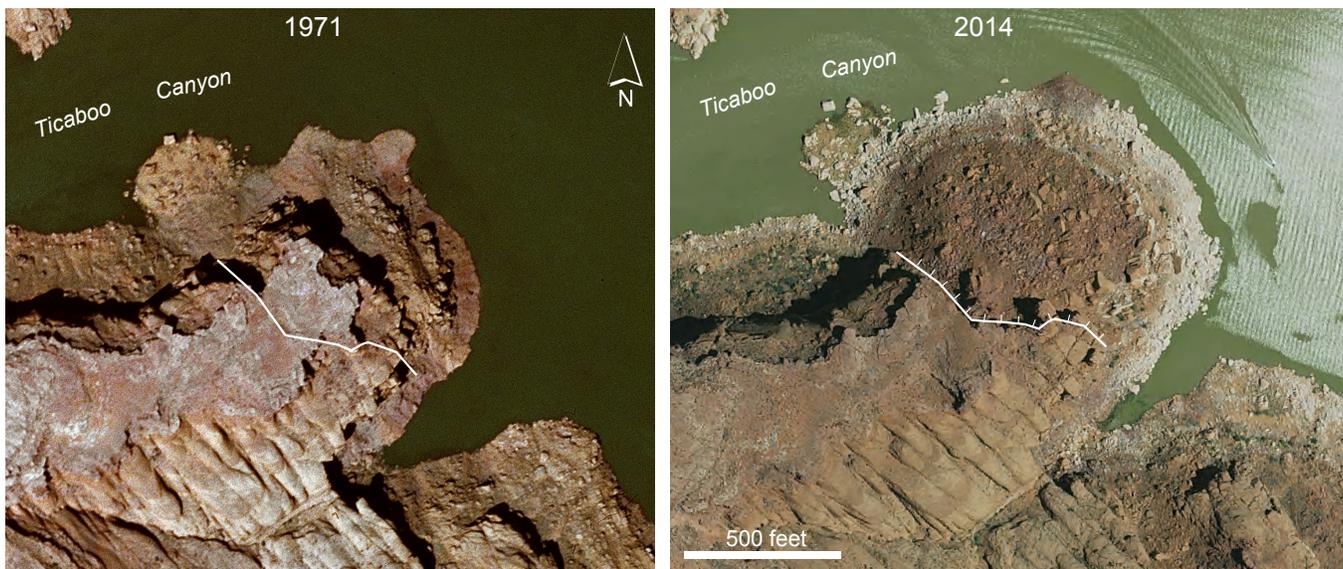
Figure 30. Sequence aerial photographs showing extent of cliff collapse at Ticaboo Canyon inlet. **Left:** 1971 aerial photograph (Defense Mapping Agency, 1971) shows the Wingate/Kayenta promontory still intact nine years before Lake Powell full pool is achieved. White line is approximate location of future main scarp. **Right:** Cliff collapse shown in 2014 National Agriculture Imagery Program (NAIP) orthophotography (Utah Automated Geographic Reference Center, 2016a); white line with hachures indicates the main scarp. The collapse likely occurred sometime between Grundvig's 1980 mass-movement reconnaissance—which makes no mention of the obvious collapse—and 1993 when the collapsed cliff appears on U.S. Geological Survey aerial photos (Utah Automated Geographic Reference Center, 2016b).

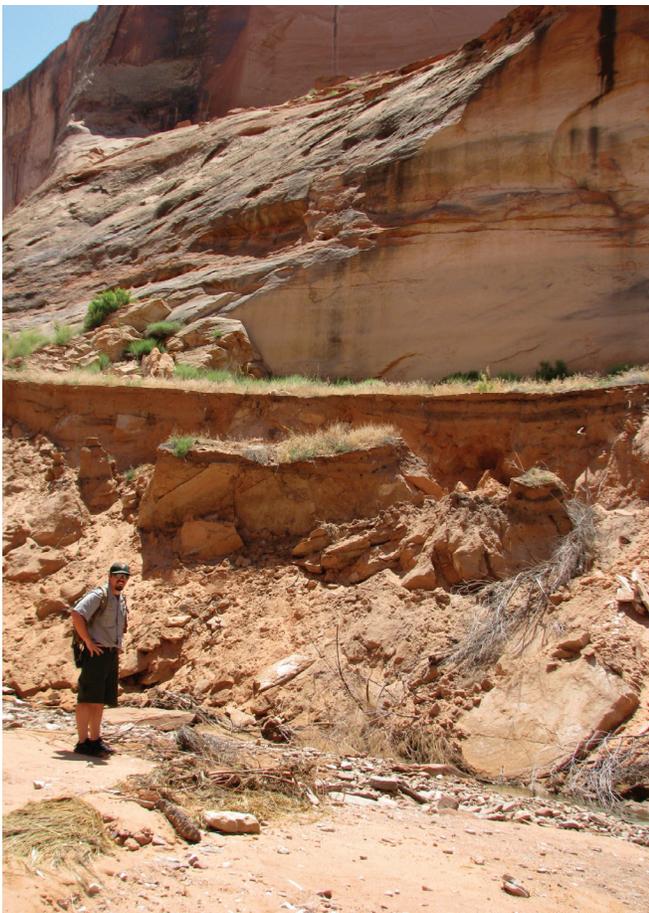
Figure 31. Wall of fine-grained delta deposits that suddenly collapsed after being undercut by flash-flood water on June 6, 2015, in Forgotten Canyon. Parts of a user-made trail that accesses the Defiance House ruin were damaged by the slumping. Such deposits are common in many tributary canyons near the mouths of streams entering a receding Lake Powell, and their rapid incision produces unstable vertical-walled channels prone to slumping. Photo courtesy of Valerie Reynolds, National Park Service.

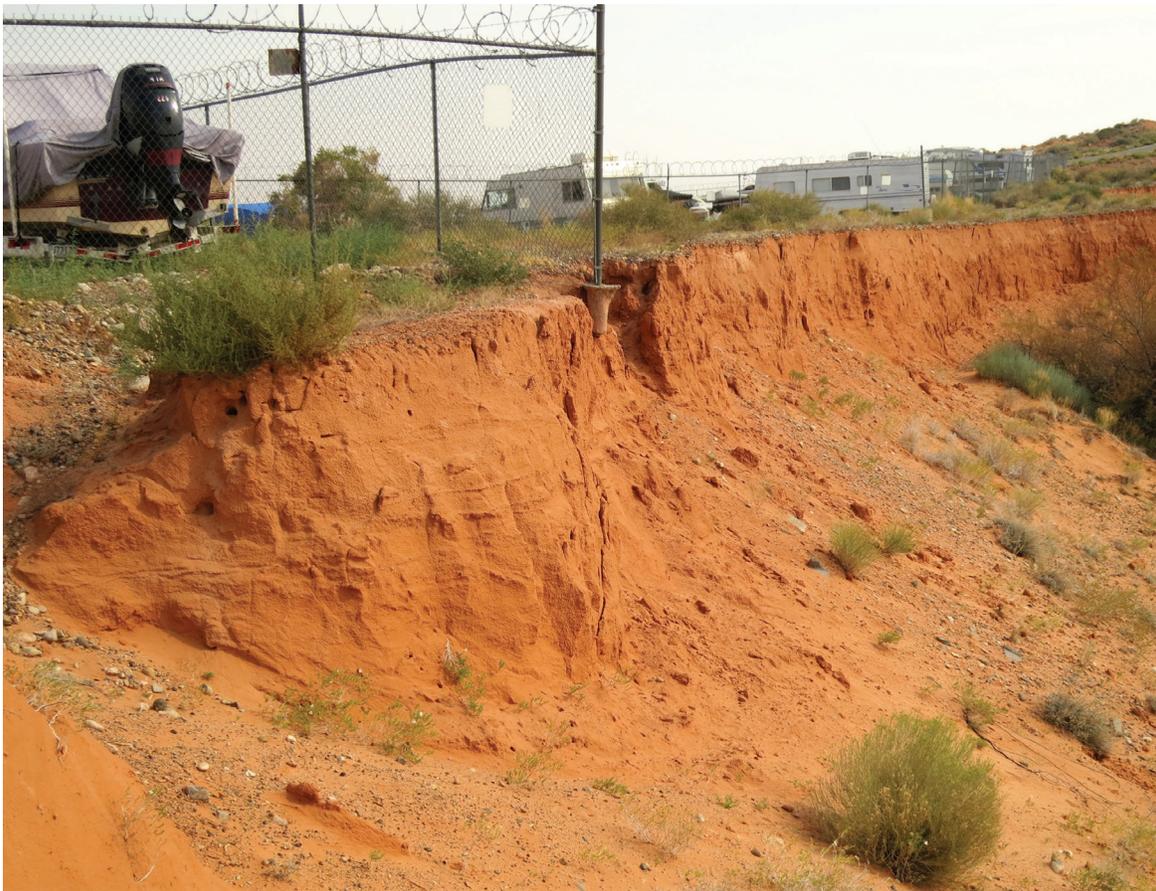
Figure 33. Headward erosion of fine-grained material near a boat storage yard at Bullfrog Marina. Photo taken on August 19, 2015.

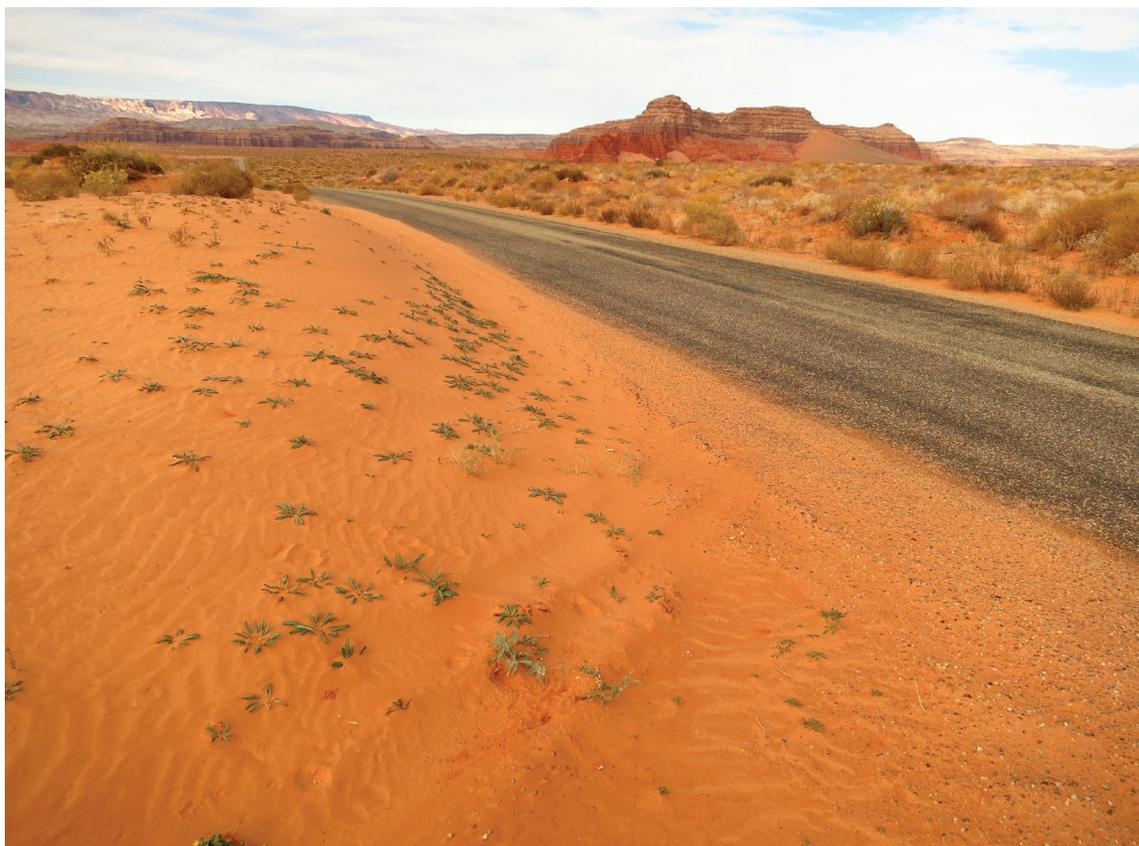
Figure 34. Migrating sand partially buries Bureau of Land Management Road 531 north of Bullfrog Marina. Photo taken on November 20, 2014.

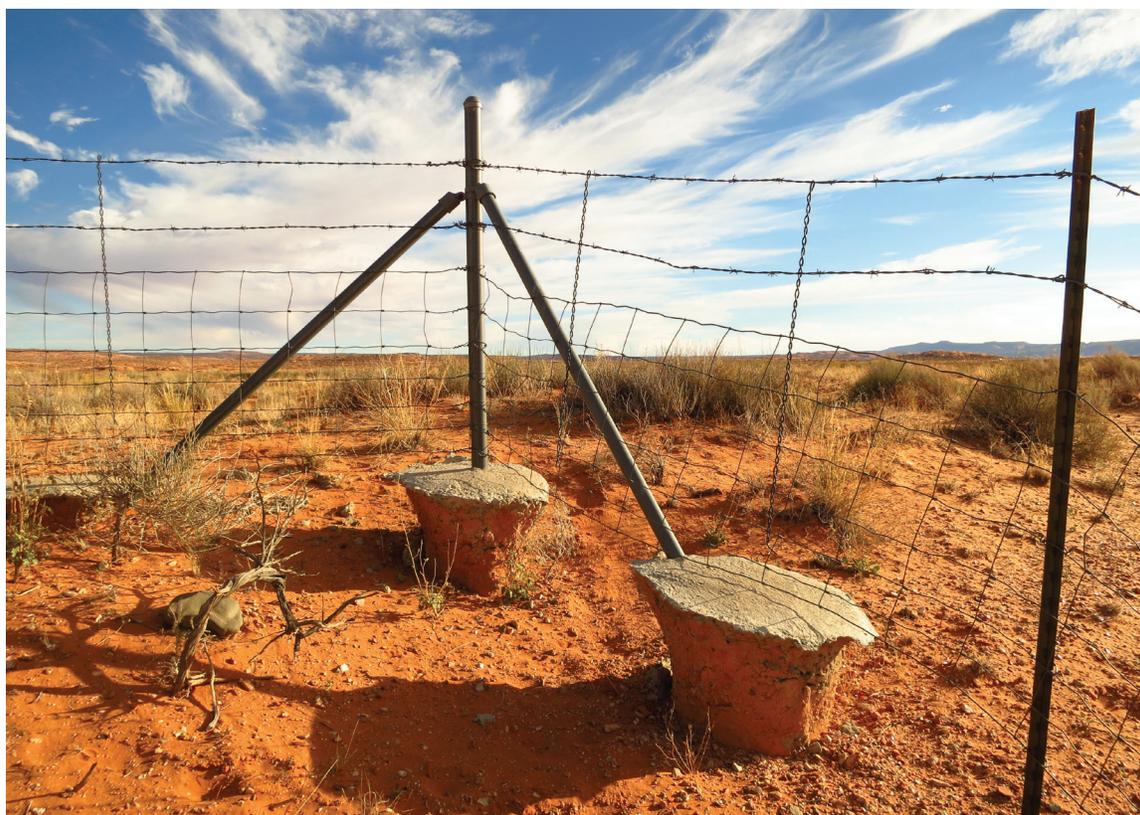
Figure 35. Exposed fence foundation near Halls Crossing due to wind erosion of sandy soils. Photo taken November 19, 2014.

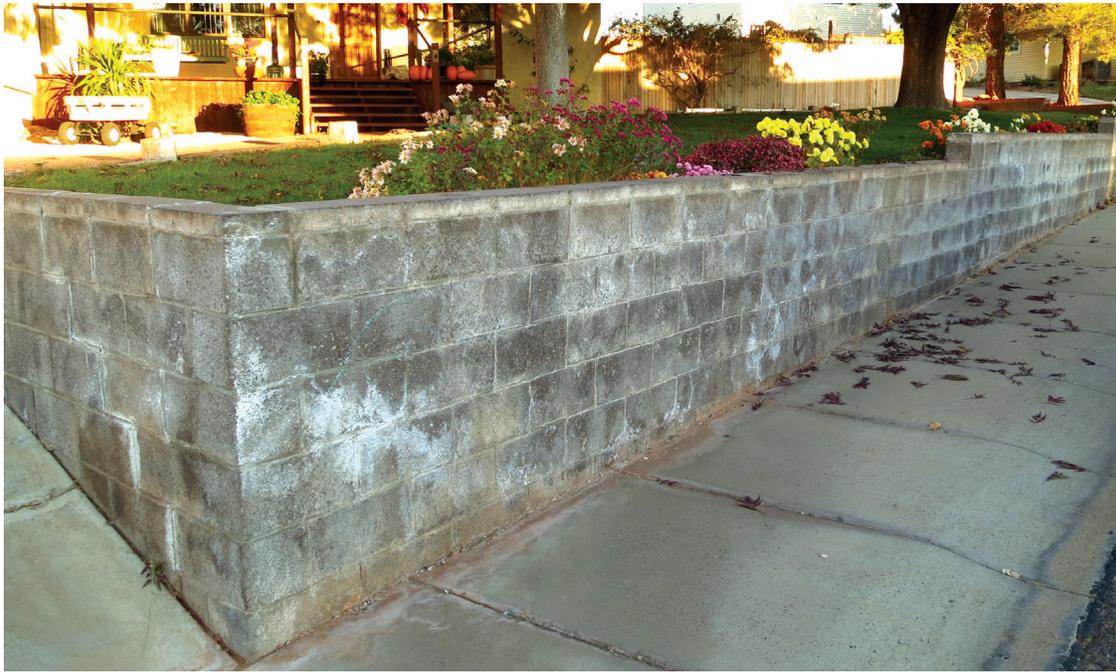
Figure 37. High-sulfate soils corrode a masonry block wall in Page, Arizona. Photo taken November 16, 2014.

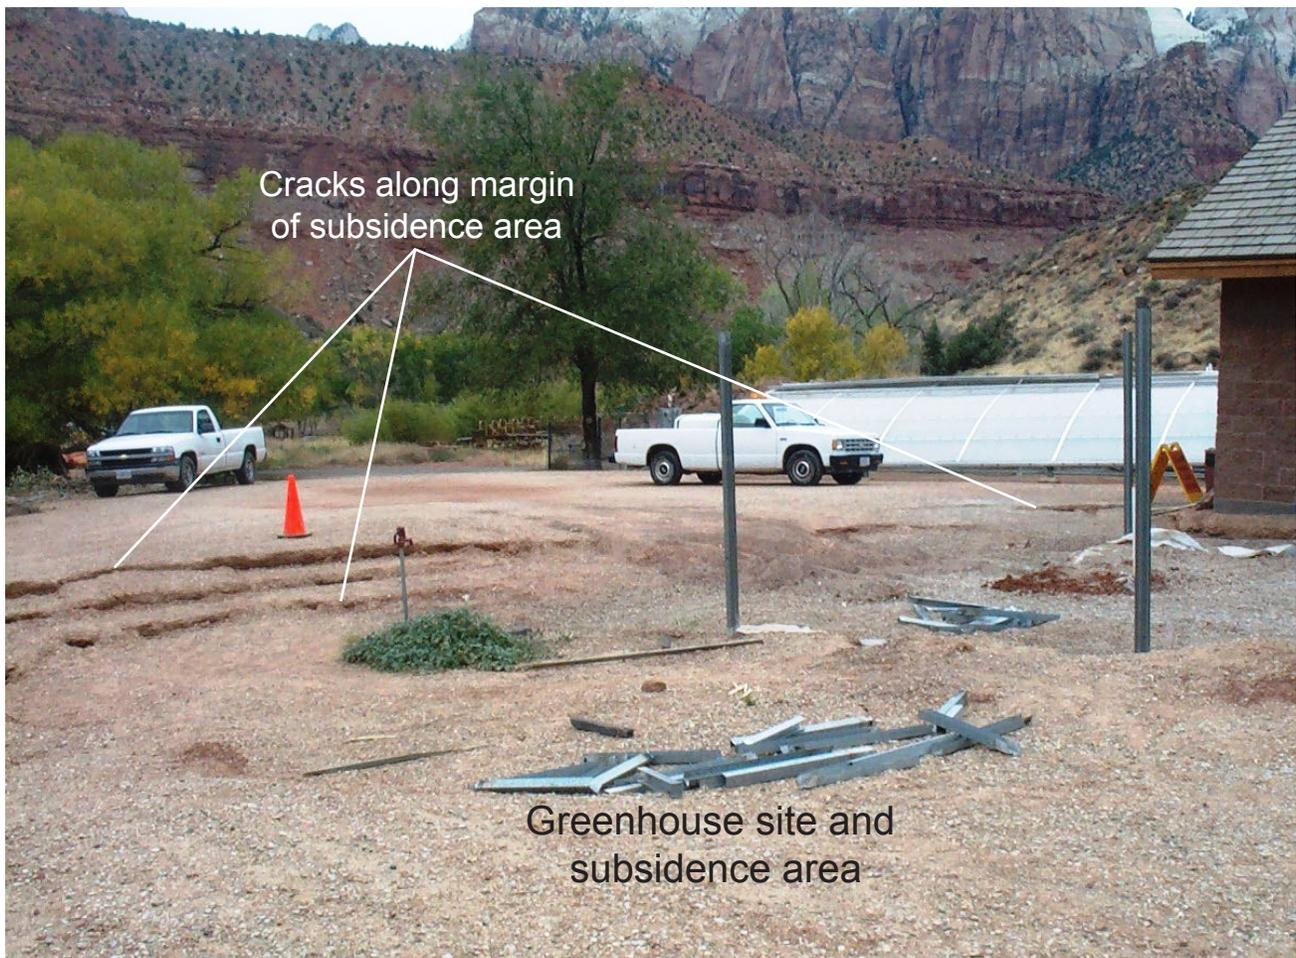
Figure 41. Site of Zion National Park greenhouse damaged by collapsible soils in 2001. Photo courtesy of the National Park Service.
