UTAH GEOLOGICAL AND MINERAL SURVEY

REPORT OF INVESTIGATION

GEOLOGIC EVALUATION OF A PROPOSED REGIONAL  
WASTEWATER TREATMENT PLANT SITE  
WASHINGTON COUNTY, UTAH

March 1986

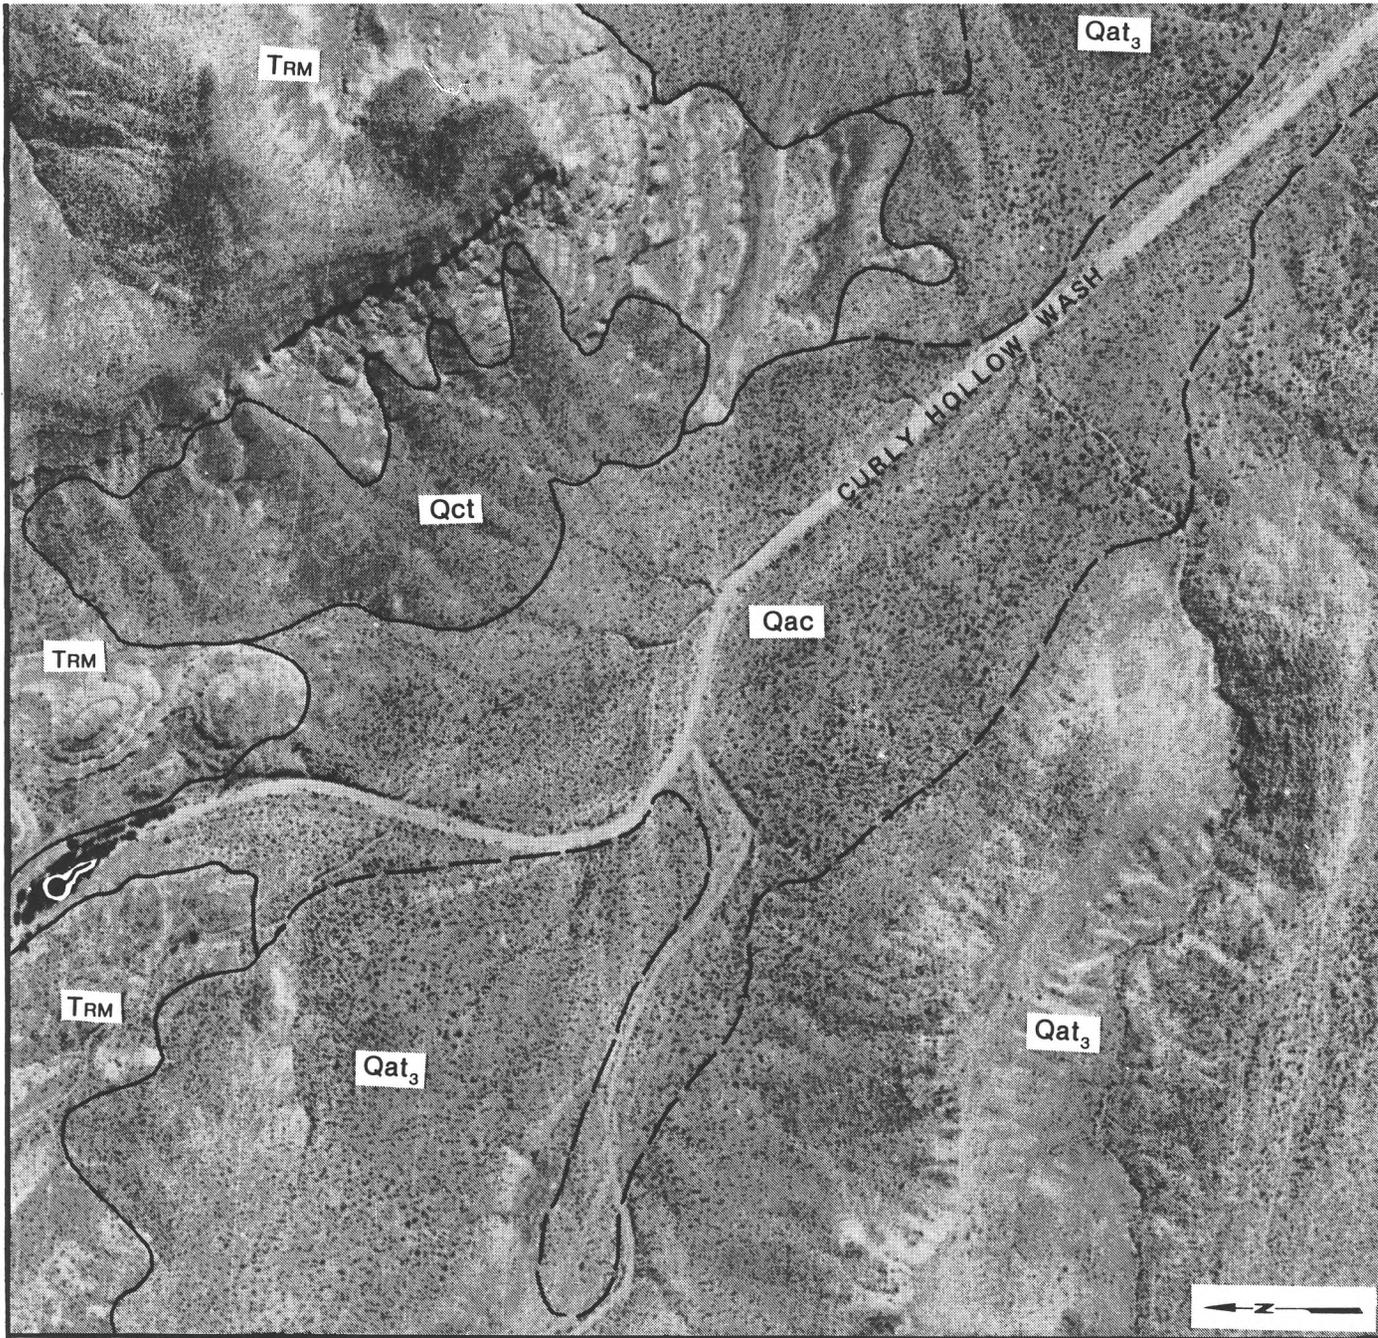
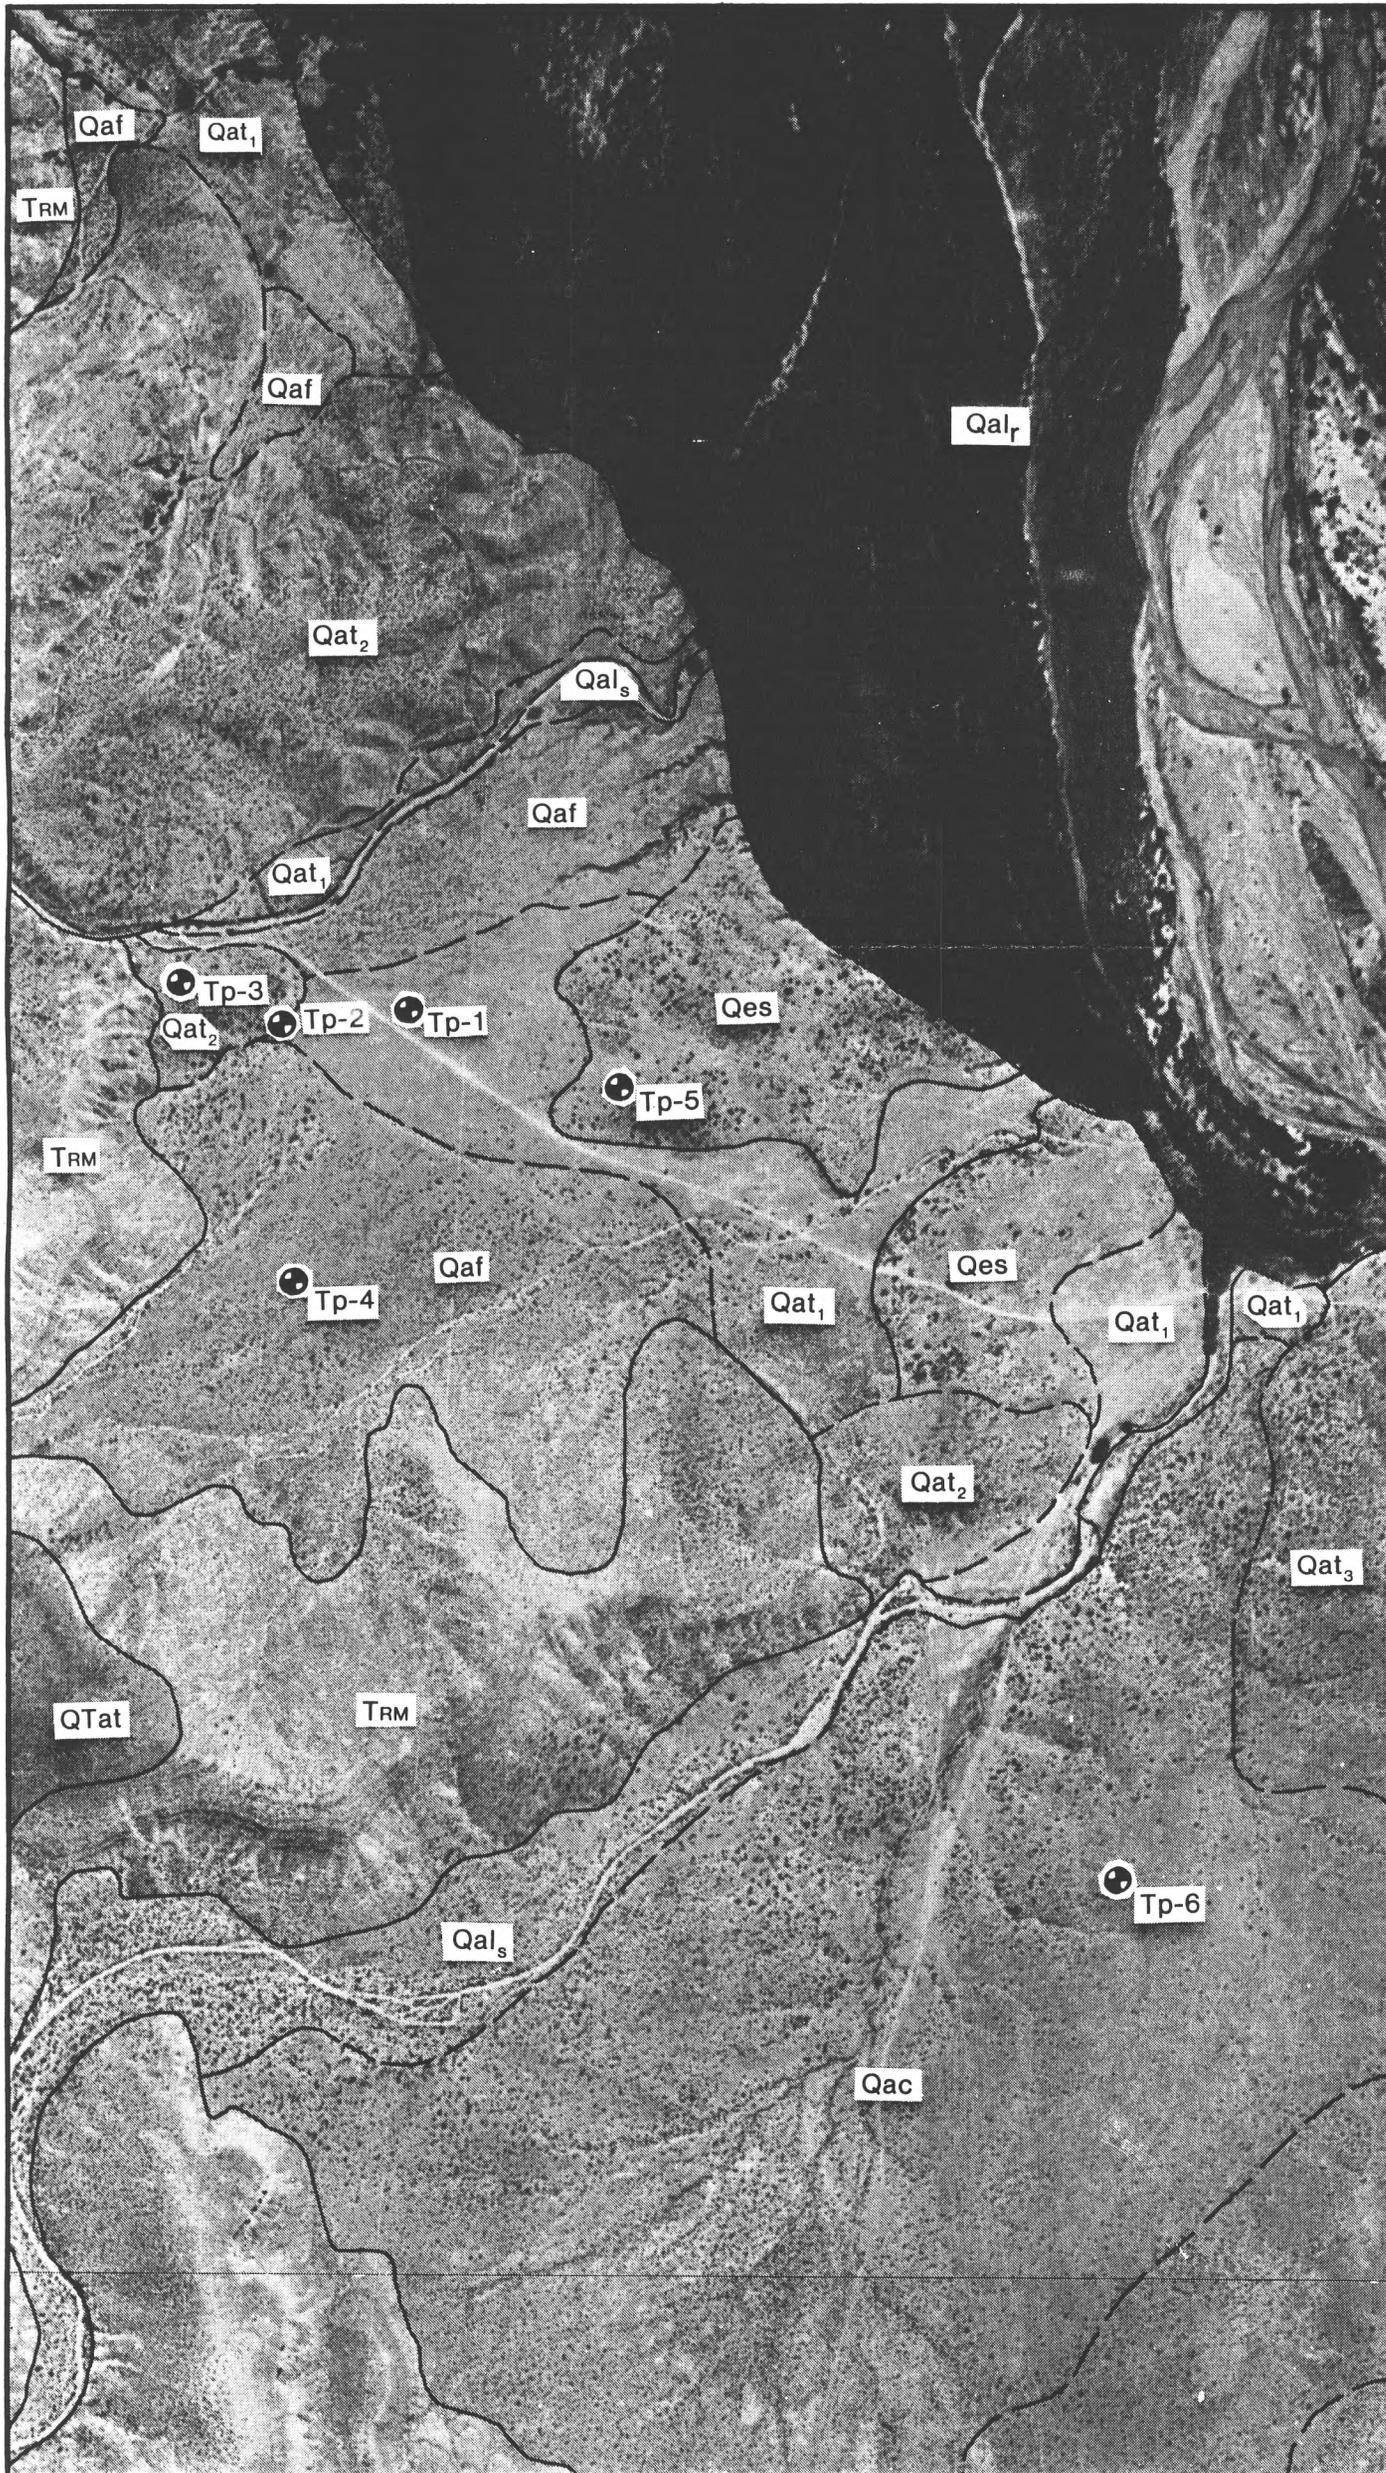
Figure 2. Geologic map of proposed wastewater treatment plant site southwest of St. George, Utah.

The Triassic Moenkopi Formation underlies the cliffs and upland areas along the north edge of the site (fig. 2). Five members of the Moenkopi Formation crop out in the St. George area, two of which are present at the site. They are the Middle Red Member and the underlying (older) Virgin Limestone Member. The Middle Red Member consists of gypsiferous brown to red shale and sandstone. It forms the cliffs near the west end of the site. The Virgin Limestone Member is comprised of dense, gray limestone with thin interbeds of yellow-brown shale and sandstone (Christenson and Deen, 1983). It forms moderate to steep slopes, but few cliffs, and crops out in the hills at the east end of the property. Because the Moenkopi Formation is easily eroded, good exposures are rare except on cliffs, and strike and dip measurements are difficult to obtain. However, bedrock in the area generally strikes to the northeast and dips about 25 degrees to the northwest. Where

Between the cliffs and the flood plain of the Virgin River a series of alluvial deposits have formed from detrital material derived from the Moenkopi Formation (fig. 2). With the exception of an older gravel terrace (QTat) at the top of the cliff, the deposits are believed to be of Quaternary age (0 to 1.6 m.y. B.P.). The older gravel terrace probably dates from the late Tertiary (1.6 to 23.7 m.y. B.P.) or early Quaternary (Hamblin, in press) and gives evidence of active downcutting on the Virgin River. Within the Quaternary deposits at the base of the cliff, three levels (ages) of stream terraces have been identified. The lowest terrace (Qat<sub>1</sub>) is closest to the Virgin River flood plain and, with the exception of the gullying at the flood-plain scarp and the incision of the ephemeral stream channels, is flat and undissected. The intermediate terrace (Qat<sub>2</sub>) is older, more eroded, and characterized by irregular, rolling topography. The highest terrace (Qat<sub>3</sub>) forms a narrow, east-west-trending ridge along the south edge of the property and an upland area at the west end of the site. Alluvial deposits (Qac) along Curly Hollow Wash and the middle unnamed wash may also be stream terraces, although a combination of colluvial slopewash and a thin layer of eolian material give them a relatively smooth surface and mask their true character. However, their elevation and general position relative to the other Quaternary deposits on site implies a probable correlation with the intermediate terrace deposits.

Six test pits were excavated to help characterize the unconsolidated geologic units at the site (fig. 2). Detailed soil logs are presented in the appendix, however, they should be considered only generally representative, because most of the geologic units are extensive and their composition may vary from place to place.

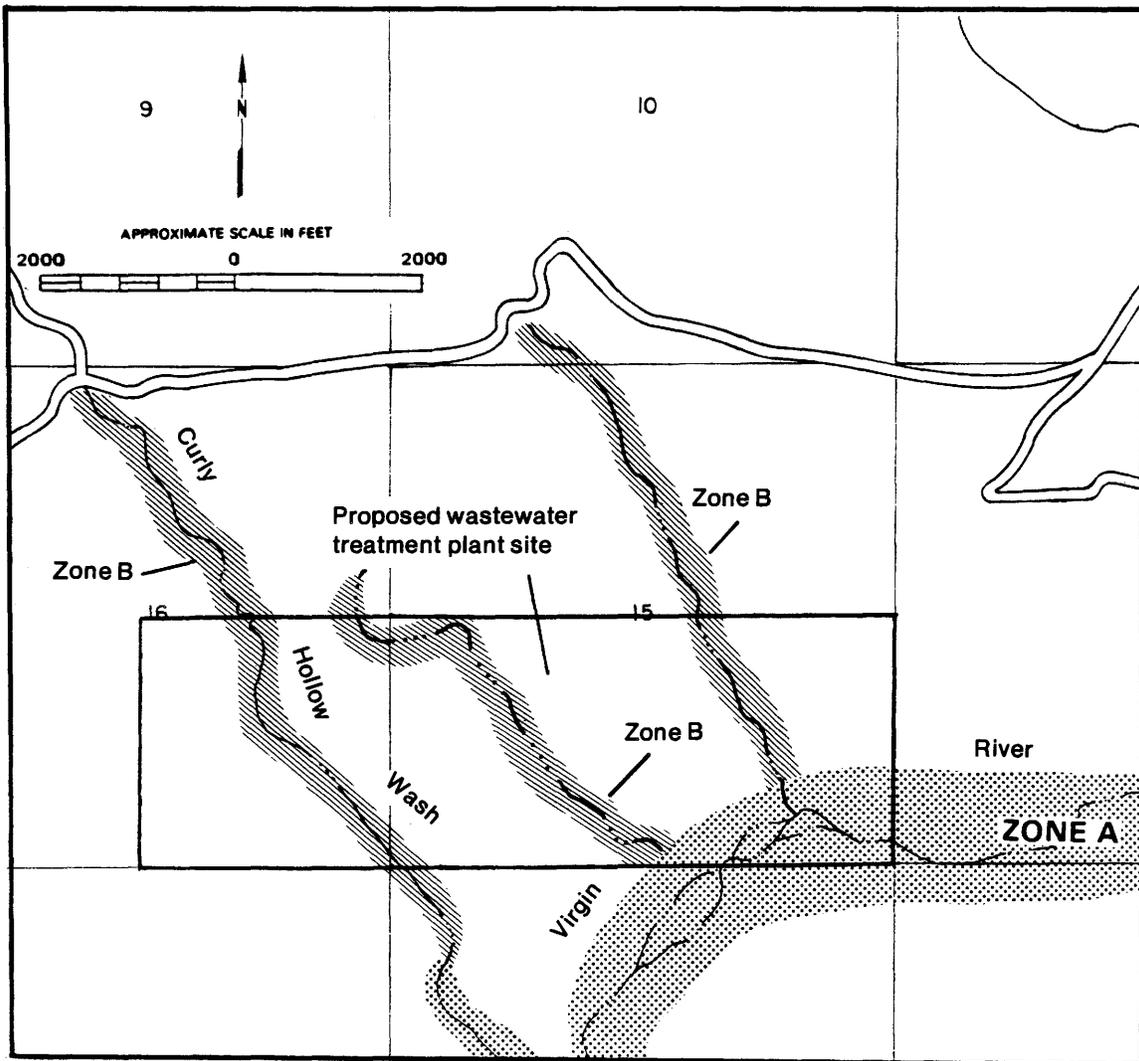
Figure 3.- Map of flood-prone areas in the vicinity of the proposed wastewater treatment plant site (modified from U.S. Dept. of Housing and Urban Development.).

The Virgin River and three large ephemeral streams cross the site (fig. 3). The river and its flood plain are subject to overbank flooding during the spring snowmelt or in response to prolonged precipitation at other times of the year. Zone A on figure 3 identifies areas susceptible to flooding along the Virgin River. During the summer months, intense localized thunderstorms are common in the St. George area. Heavy precipitation associated with these storms can result in flash floods along otherwise dry drainages. All three ephemeral streams on site show evidence of flow in the recent (one year) past. Areas subject to flash floods are designated as Zone B on figure 3.

**Zone A**

Areas susceptible to overbank flooding along the Virgin River.

**Zone B**

Areas susceptible to flash floods along ephemeral stream channels.

- o The single greatest geologic hazard affecting the site is from flooding. Unless flood-control measures are taken, treatment plant facilities should avoid the flood plain of the Virgin River (Zone A, fig. 3) and the channels of the three ephemeral drainages crossing the site (Zone B, fig. 3). A setback distance of at least 100 feet from the edges of the ephemeral streams is recommended for all treatment plant facilities to avoid both flooding and erosion hazard.

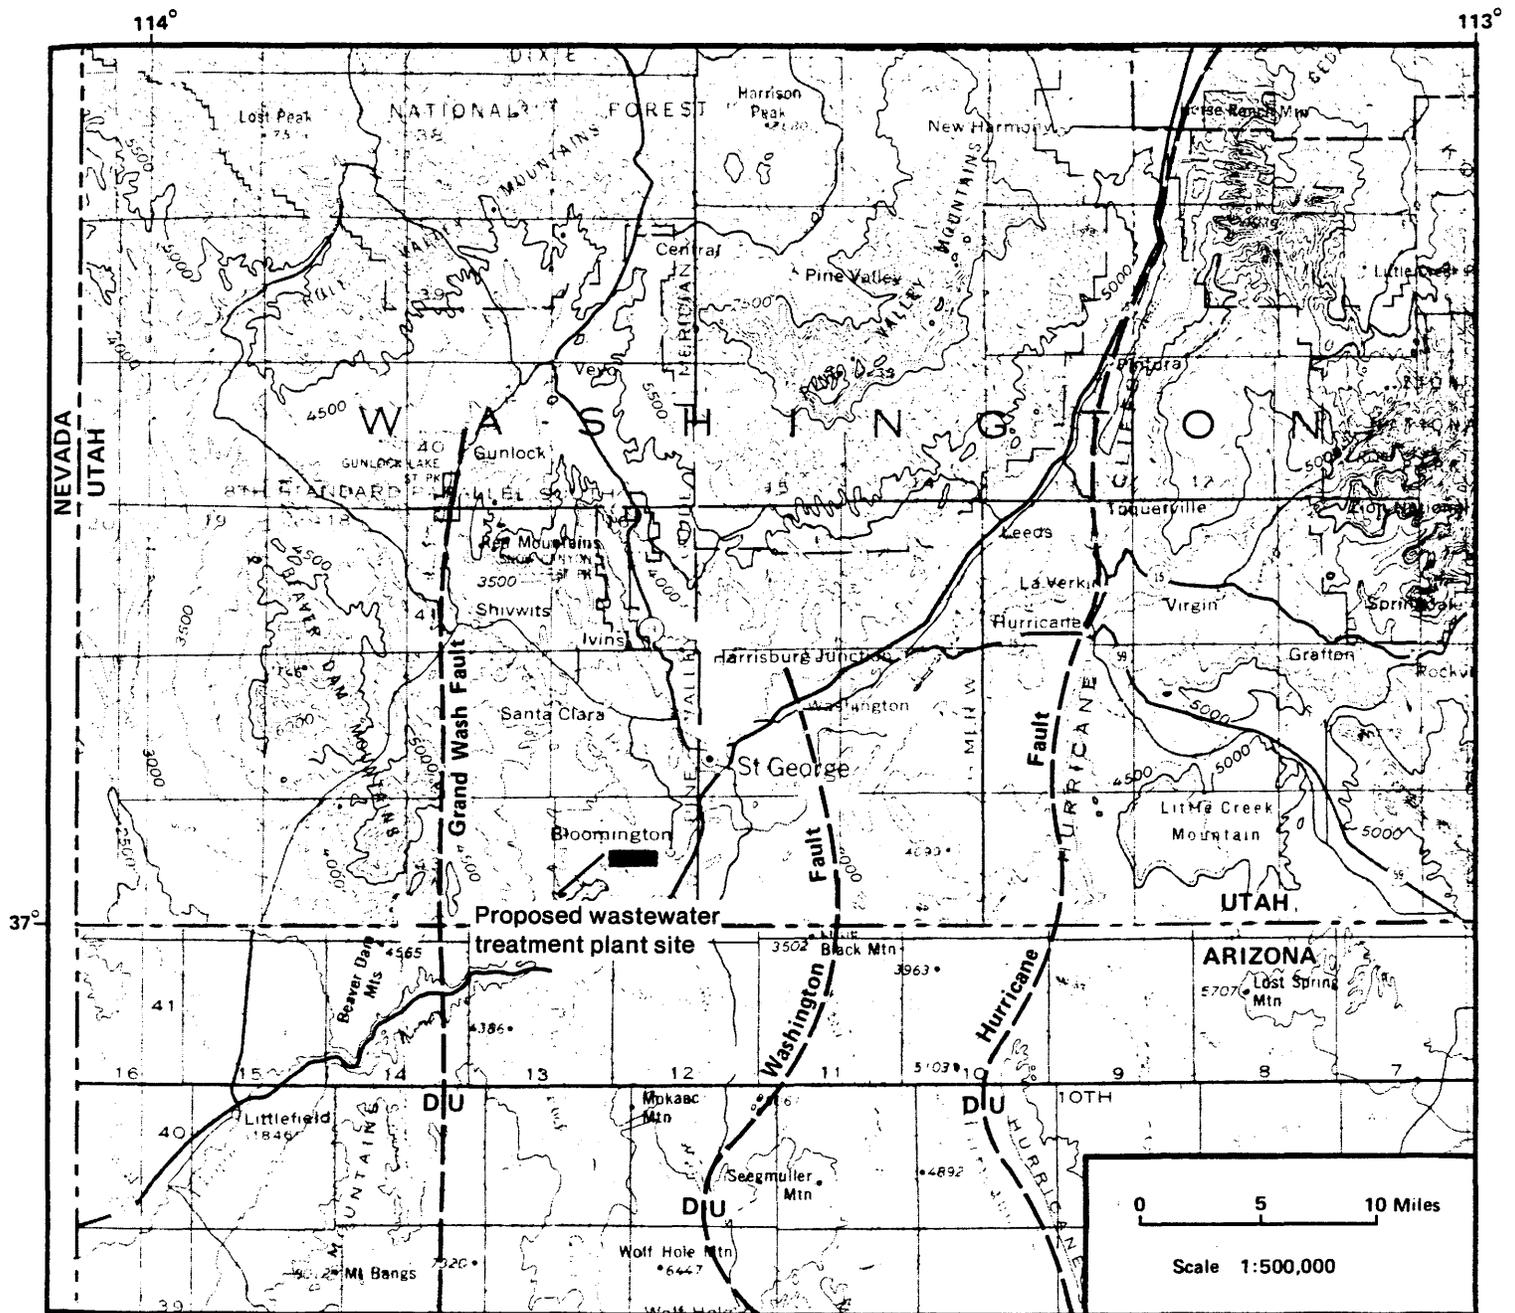
Figure 4.- Map showing the approximate locations of main traces of Quaternary and suspected Quaternary faults in the vicinity of the proposed wastewater treatment plant site.

the zone of seismicity generally follows the north-south-trending Hurricane fault which passes approximately 14 miles east of St. George. The Hurricane fault is suspected to have experienced surface rupture during Quaternary time. Faults that show evidence of movement during the Quaternary are considered active and capable of generating earthquakes. A second major structure suspected, but not proven, active during Quaternary time is the Grand Wash fault located about 6.5 miles west of the site (fig. 4). This fault forms the west edge of the St. George Basin and trends northward from the Grand Wash Cliffs in Arizona to Gunlock, Utah. A third fault in the site vicinity which does show evidence of Quaternary activity (Christenson and Deen, 1983) is the Washington fault. It extends from north of the town of Washington to south of the Utah-Arizona border (fig. 4). The northern segment of the fault has been shown to be active during Holocene time (Earth Science Associates, 1982). At its closest point, the Washington fault is about 7 miles east of the site.

Because Quaternary faults are not present at the site itself, the principle concern at the property is with ground shaking. Shaking would likely result in rockfall along the cliffs on site during a moderate to large earthquake (Richter magnitude 6.0 or larger), and liquefaction may occur in the saturated flood-plain sediments along the Virgin River.

- o The UGMS accepts the UBC zone 2 designation and accompanying design specifications as appropriate for most construction in Washington County. However, for critical facilities with relatively long design lives (such as a regional wastewater treatment plant), it is recommended that the more stringent construction specifications for seismic zone 3 be followed to provide an added factor of safety.
