TECHNICAL REPORTS FOR 1992 - 1993 APPLIED GEOLOGY PROGRAM

REPORT OF INVESTIGATION 224 APRI **UTAH GEOLOGICAL SURVEY** *a division of* UTAH DEPARTMENT OF NATURAL RESOURCES TAKE PRICEIN

Project: Geologic hazards investigation for a proposed fire station site in Lewiston, Cache County, Utah				Requesting Agency: Lewiston City/ Cache County Fire Department
^{ву:}]	Bill D. Black Gary E. Christenson	Date: 2 - 25 - 92	_{County:} Cache County	Job No:
USCS Quadrangle: Richmond (1494)				92-02 (PF-1)

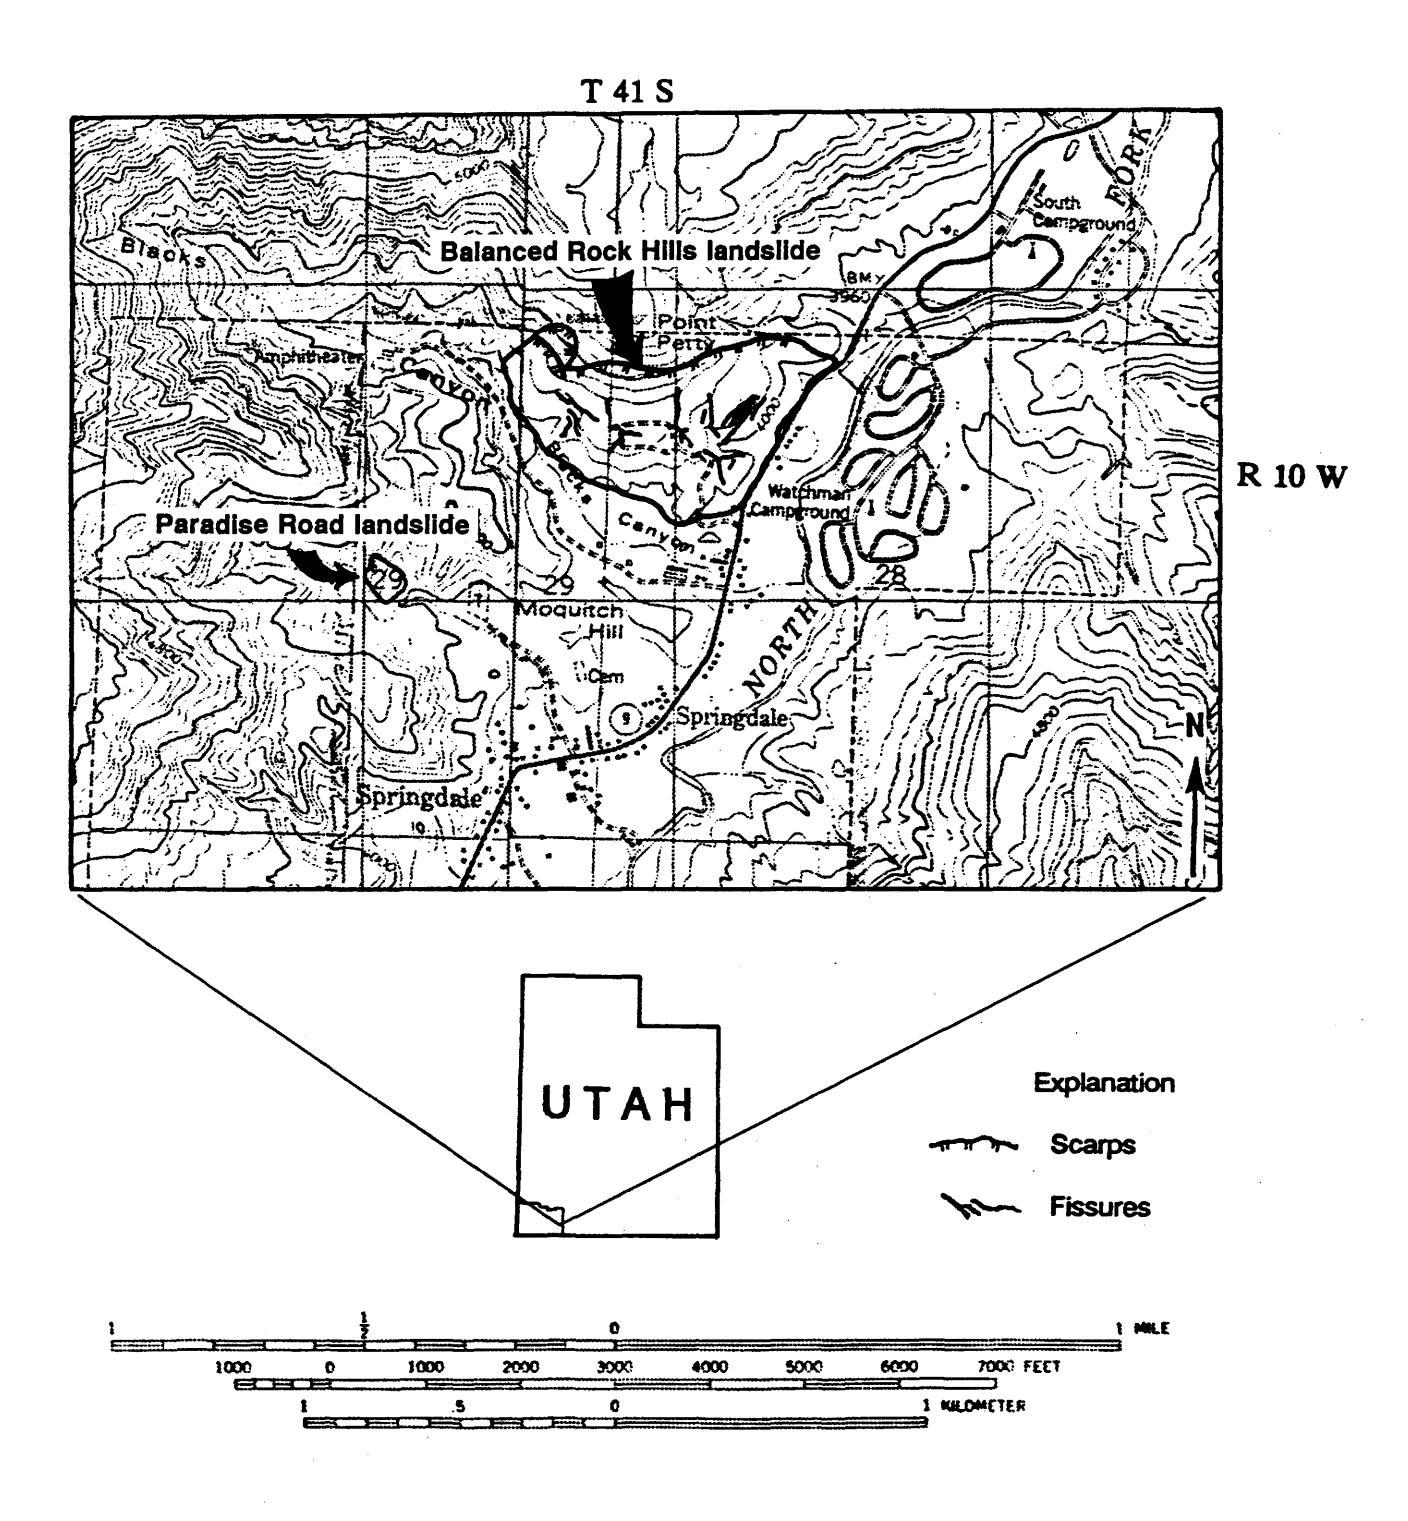
Attachment 2. Balanced Rock Hills and Paradise Road landslides.

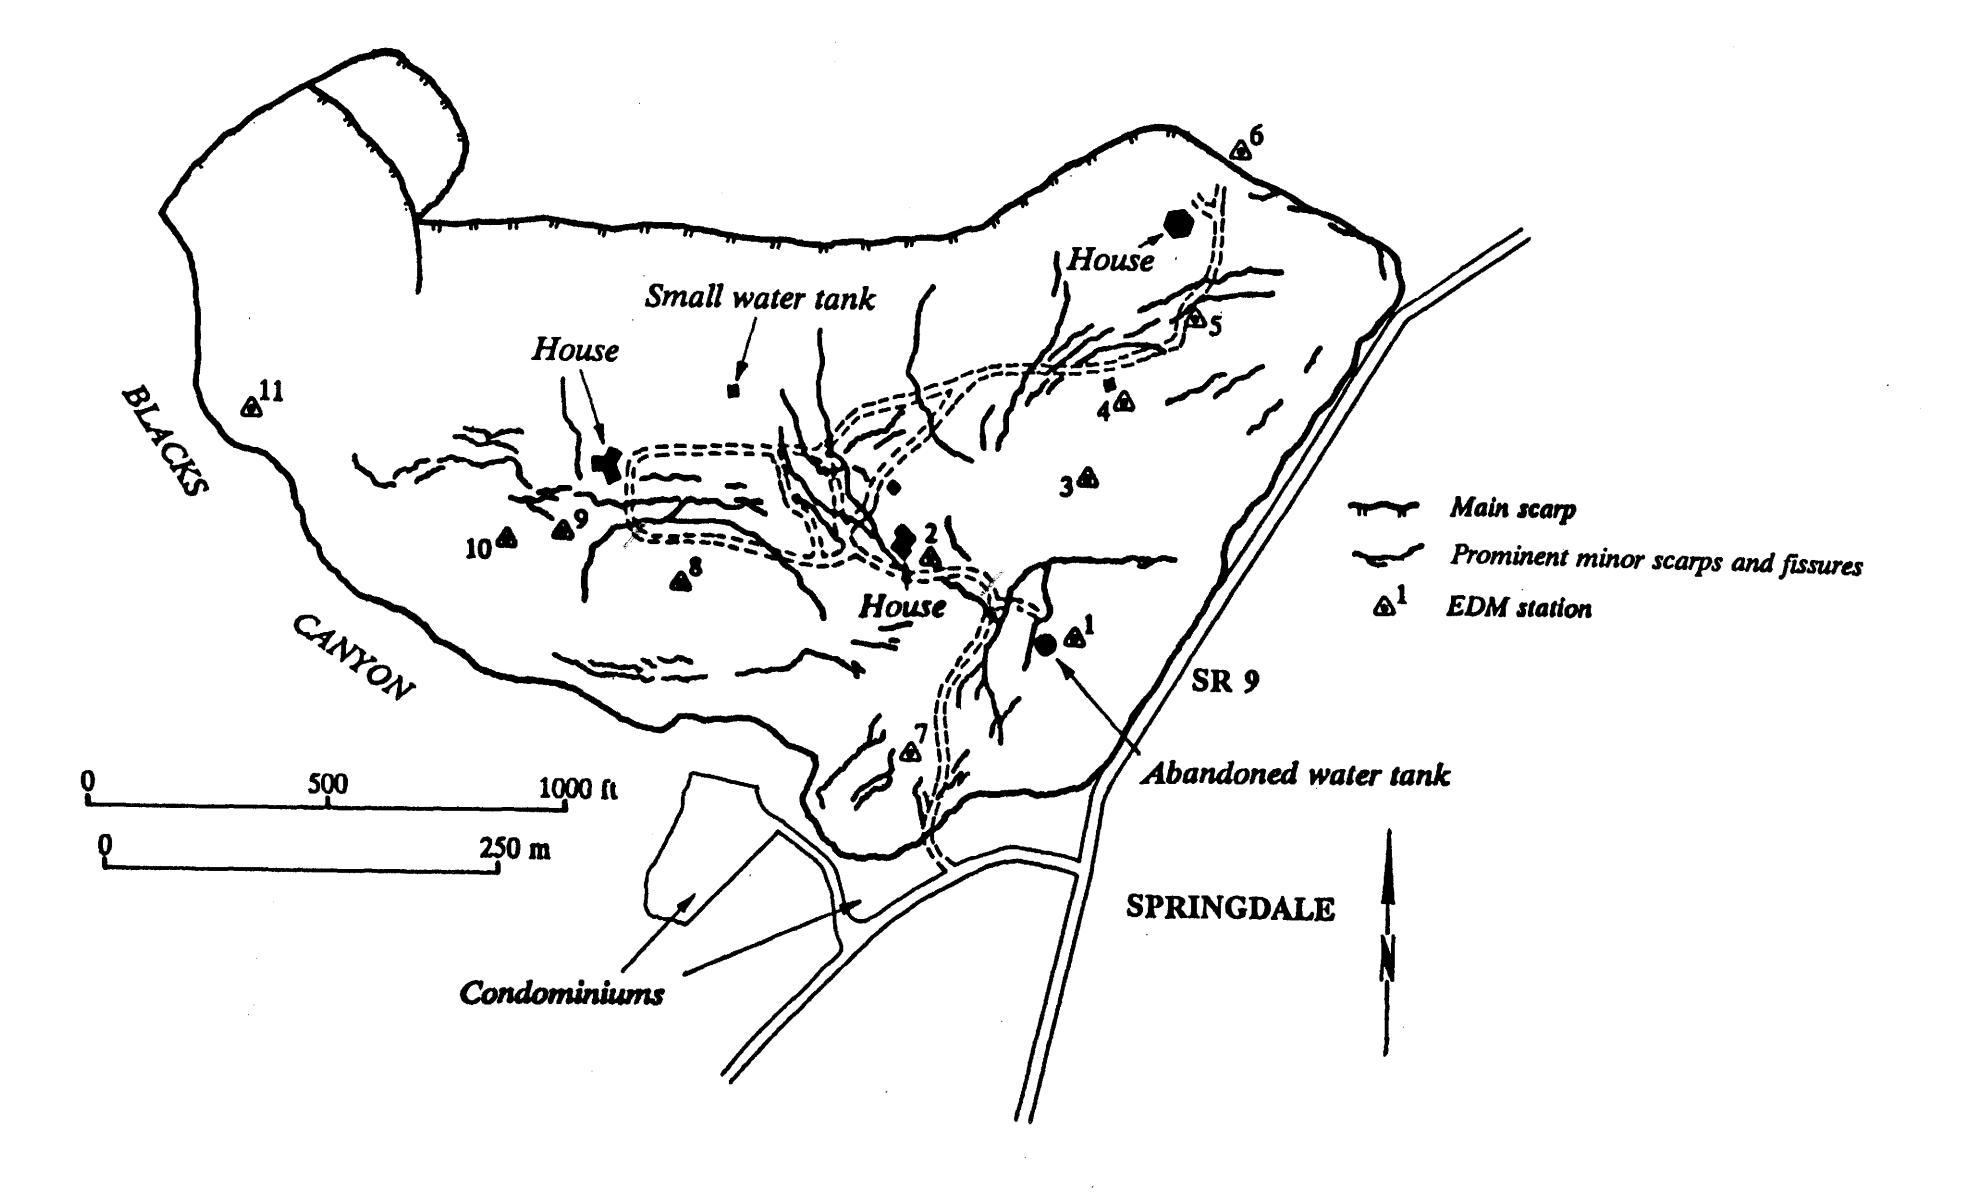
Attachment 3. Main scarp, prominent minor scarps and fissures, and location of EDM reflector stations on the Balanced Rock Hills landslide.

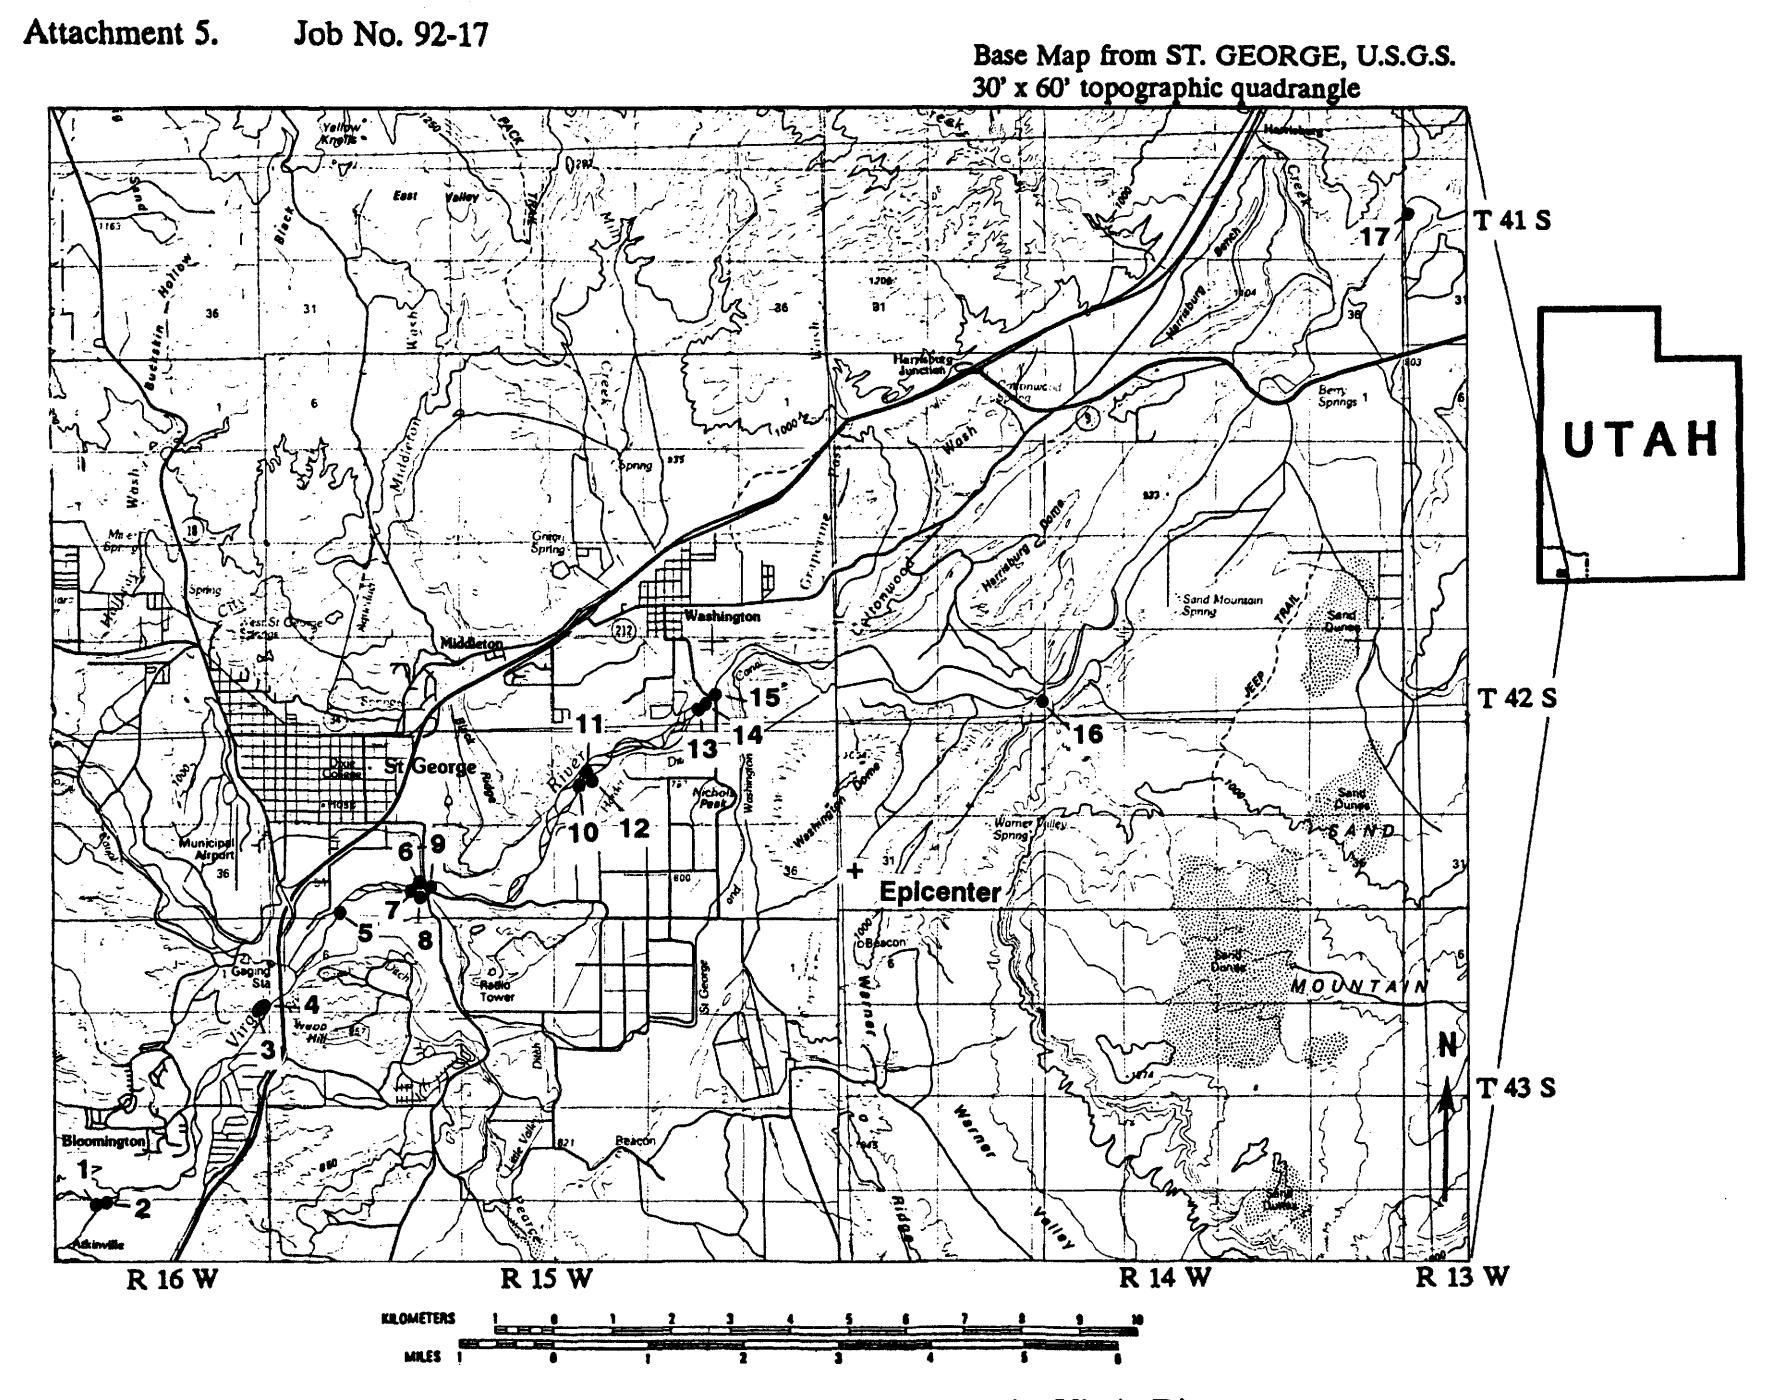
Attachment 5. Location of liquefaction features investigated along the Virgin River.
