INVESTIGATION OF THE DECEMBER 12, 2013, FATAL ROCK FALL AT 368 WEST MAIN STREET, ROCKVILLE, UTAH

by William R. Lund, Tyler R. Knudsen, and Steve D. Bowman

REPORT OF INVESTIGATION 273 UTAH GEOLOGICAL SURVEY

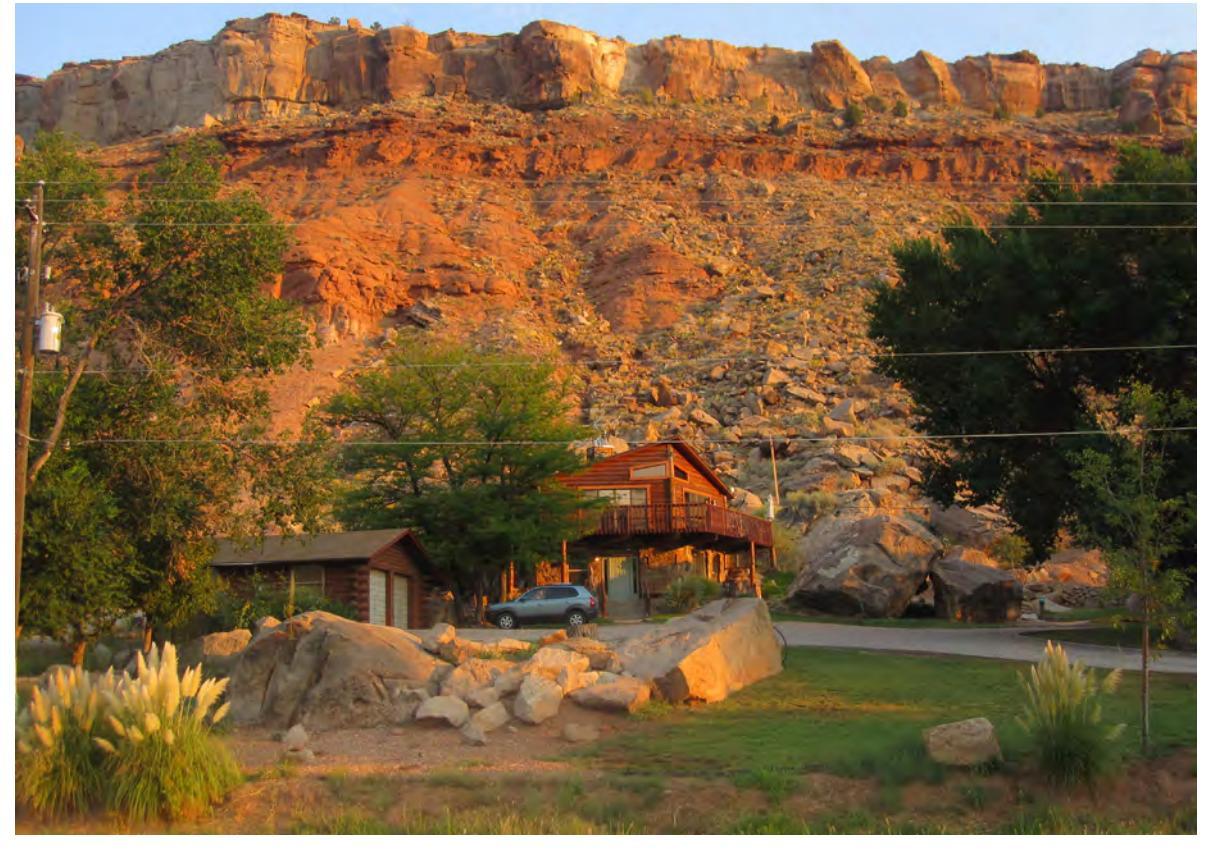
Figure 2. View of the property at 368 West Main Street in Rockville, Utah, taken on September 29, 2010. The house, garage, and car were subsequently destroyed by a rock fall on December 12, 2013; note large pre-existing rock-fall boulders within the property; view is to the north.

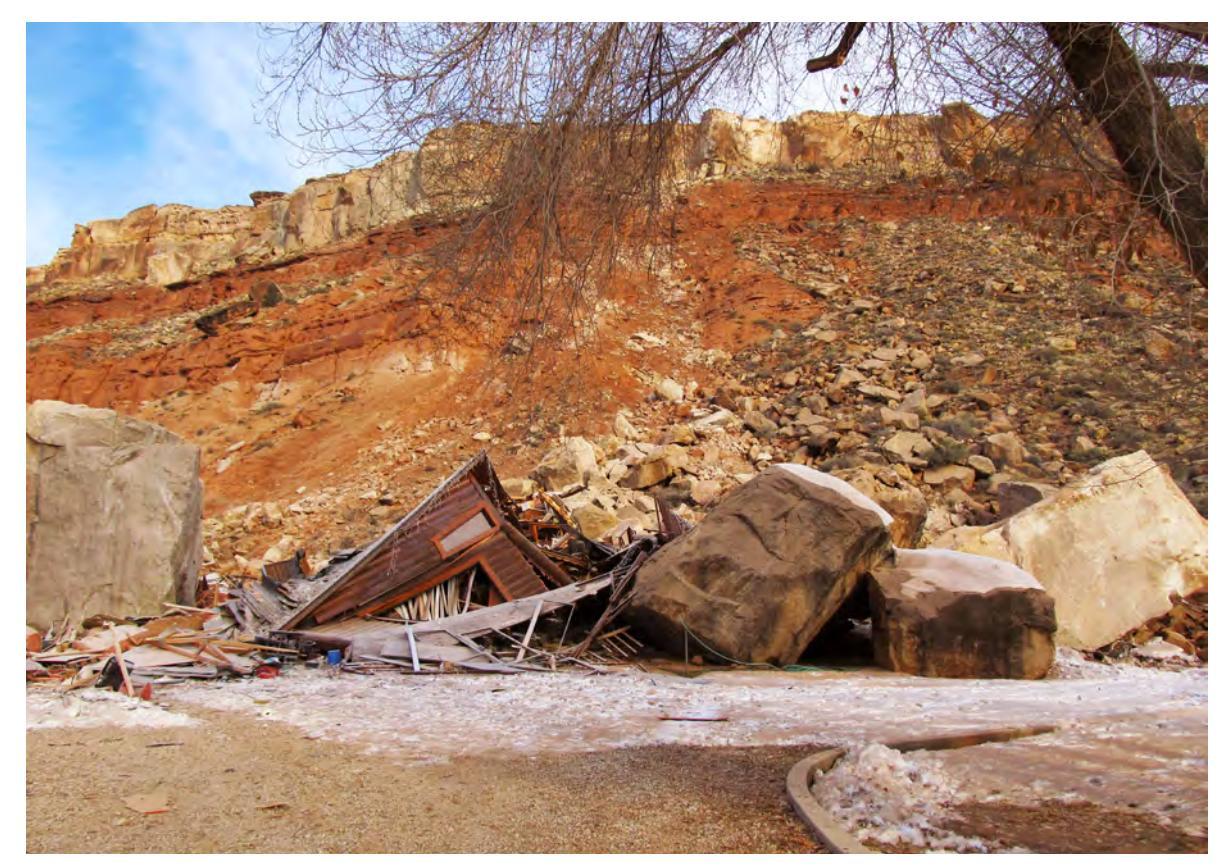
Figure 3. Remains of the house at 368 West Main Street, Rockville, Utah, following the December 12, 2013, rock fall. Photograph taken December 13, 2013, view is to the north.

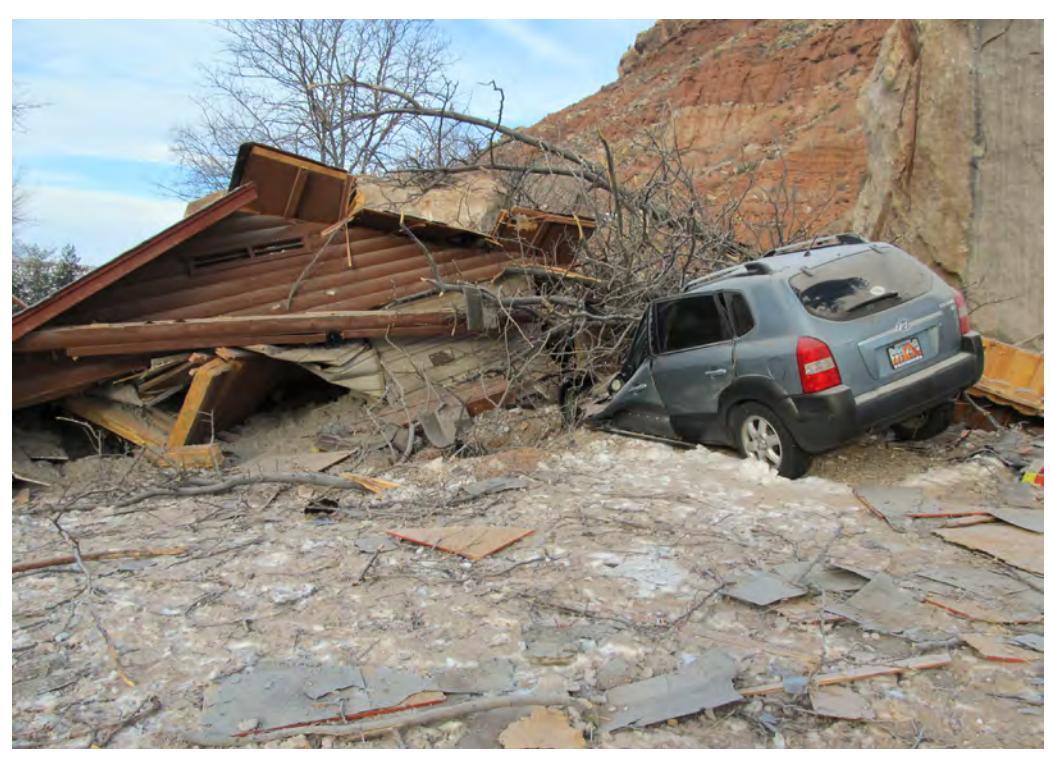
Figure 4. Detached two-car garage and car at 368 West Main Street, Rockville, Utah, destroyed by the December 12, 2013, rock fall. Photograph taken on December 13, 2013, view is to the northwest.

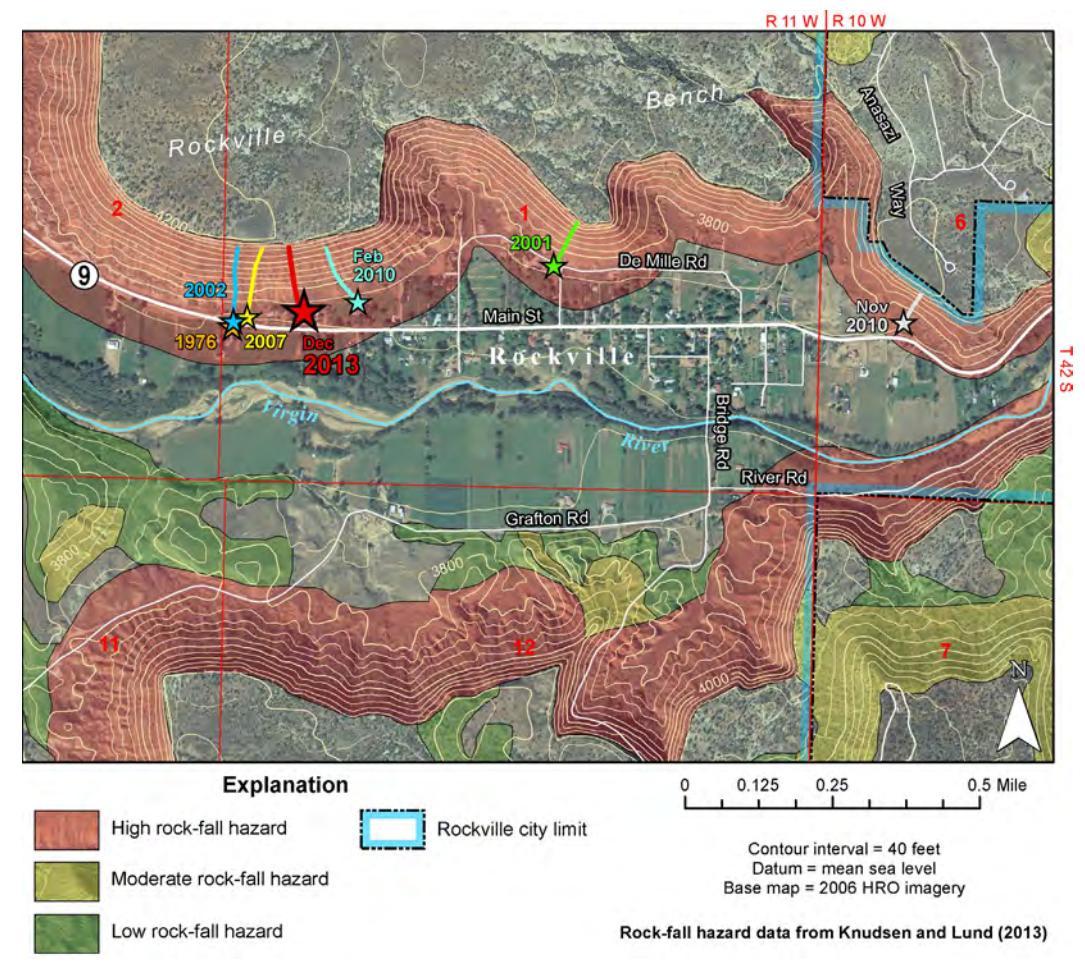
Figure 5. Rock-fall hazard zones and significant historical rock falls (stars) and their travel paths (bold colored lines) in the Town of Rockville. Modified from Knudsen (2011).

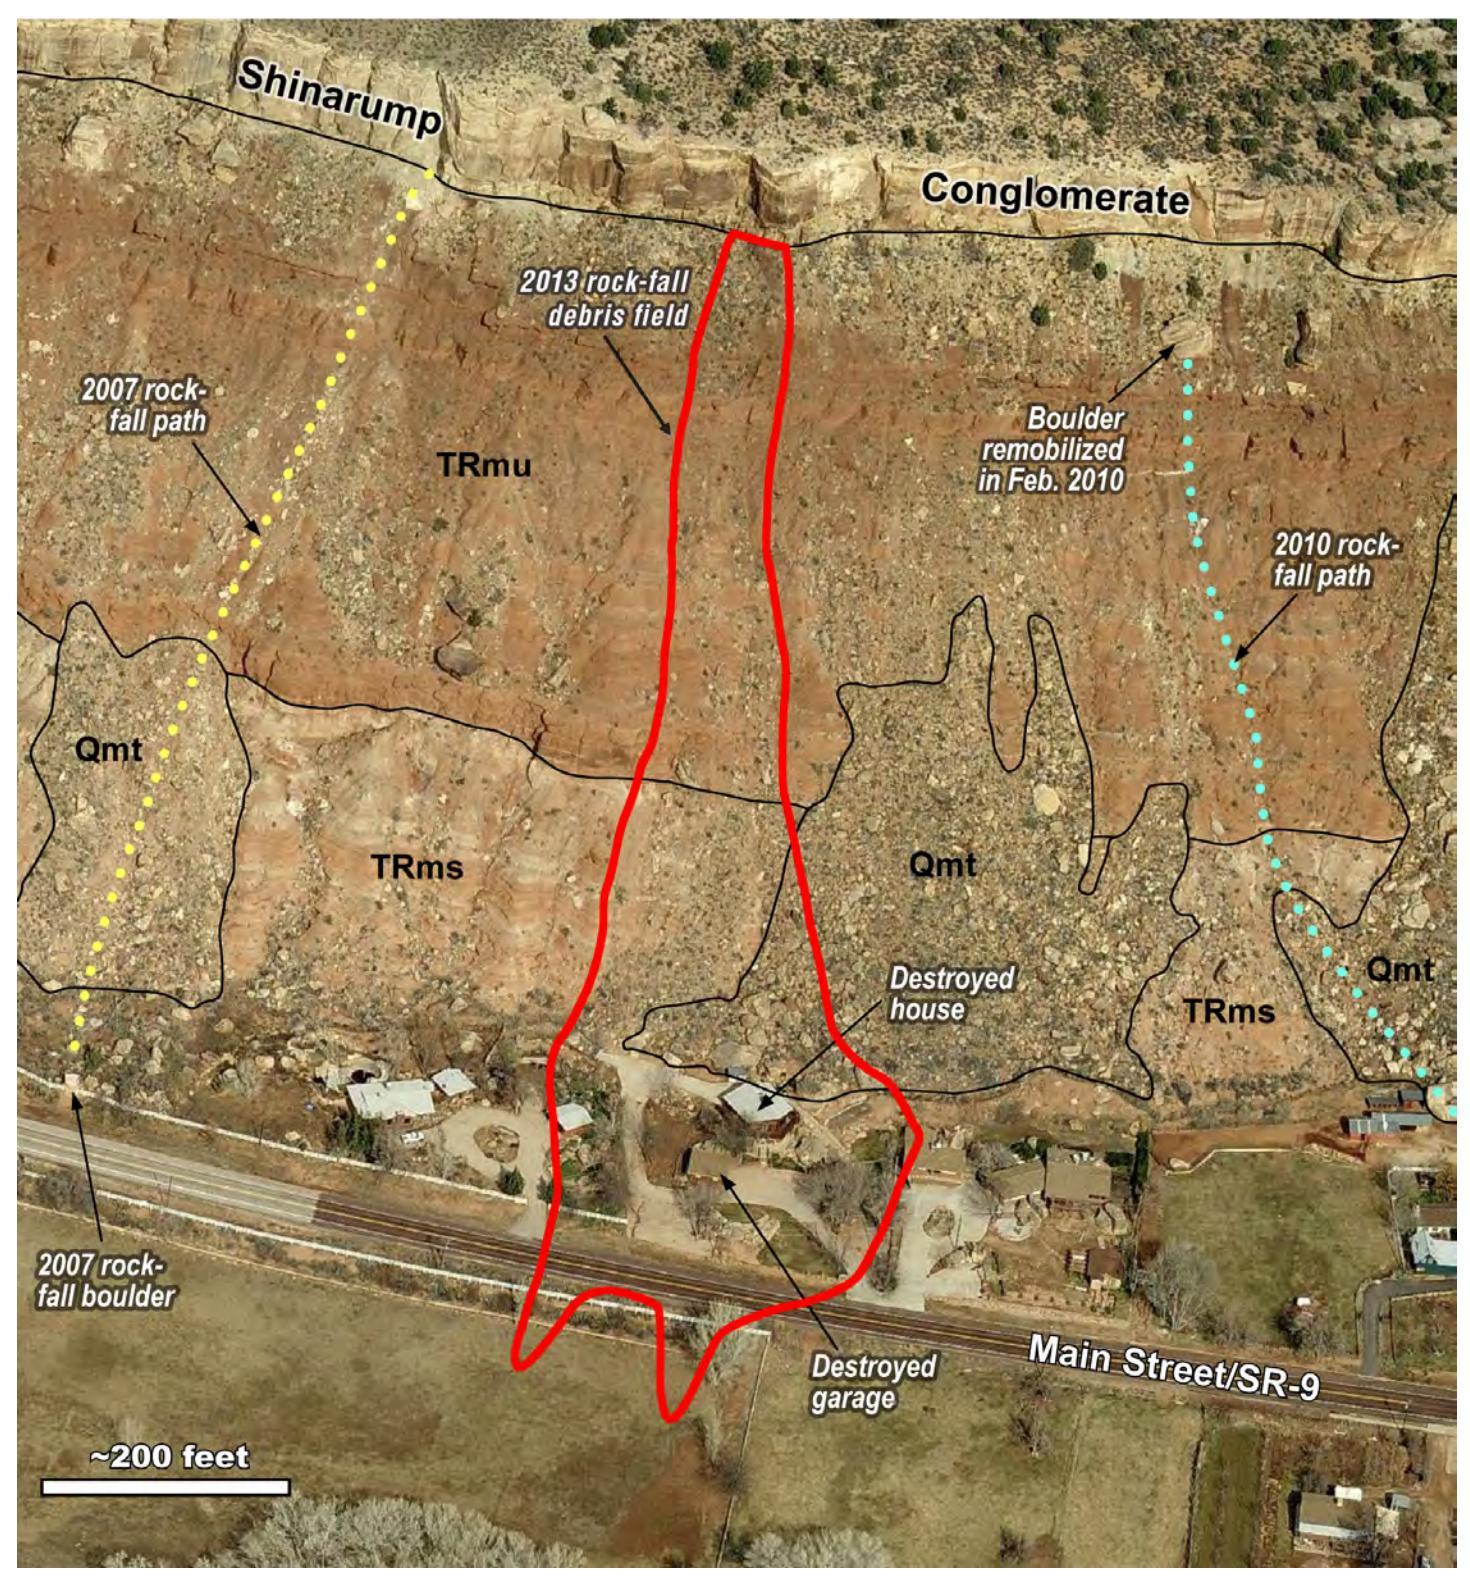
Figure 6. North-directed, circa-2008, oblique aerial view of Rockville Bench showing maximum extent of debris field of the December 12, 2013, rock fall (red line); house destroyed by the December 12, 2013, rock fall; other recent Rockville rock falls in the vicinity; and major geologic units— TRmu=upper red member of the Moenkopi Formation, TRms=Shnabkaib Member of the Moenkopi Formation, Qmt=talus (rock fall) deposits. Photo from Microsoft Bing Maps (<u>http://www.bing.com.maps/</u>).

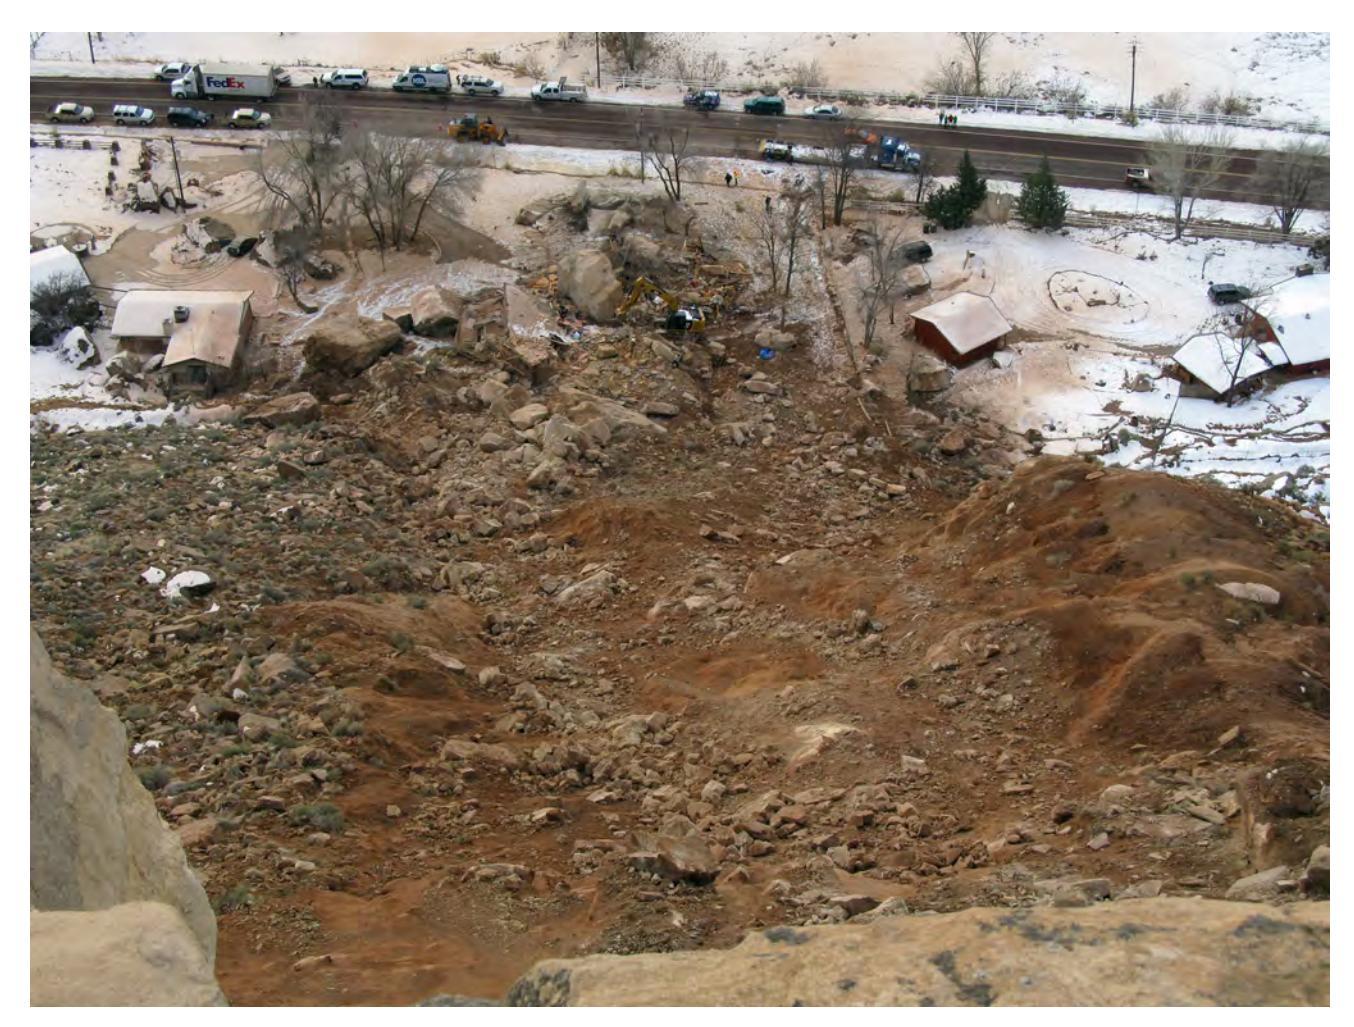
Figure 7. After falling onto the Moenkopi slope, the rock mass broke into hundreds of individual fragments ranging from cobble-size material to multiple-hundred ton boulders as it moved downslope. Photograph taken on December 13, 2013, view is to the south.

of tons, see below), which rolled and bounced rapidly down the slope (figure 7). The owner of the house immediately west of the rock-fall site was home at the time of the event, and estimated that as few as 5 seconds elapsed between hearing a sharp cracking noise that likely signaled the rock mass detaching from the cliff, and the time when boulders struck the house next door. A passing motorist photographed the dust cloud resulting from the rock fall (figure 8), and estimated the fall occurred in 10 seconds or less.

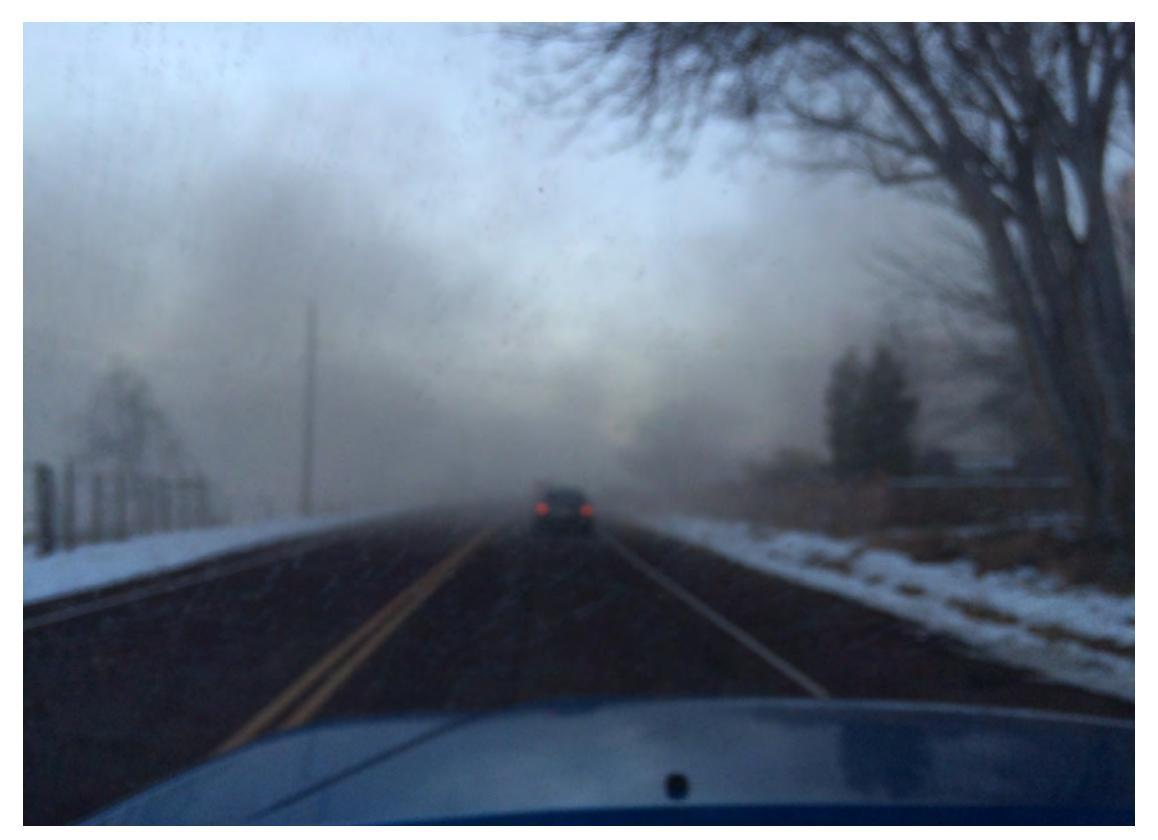
Figure 8. Dust cloud resulting from the December 12, 2013, rock fall in Rockville, Utah. The motorist who witnessed the event estimated that the duration of the rock fall was 10 seconds or less. Photograph taken by Jack Seegmiller on December 12, 2013, view is to the west.

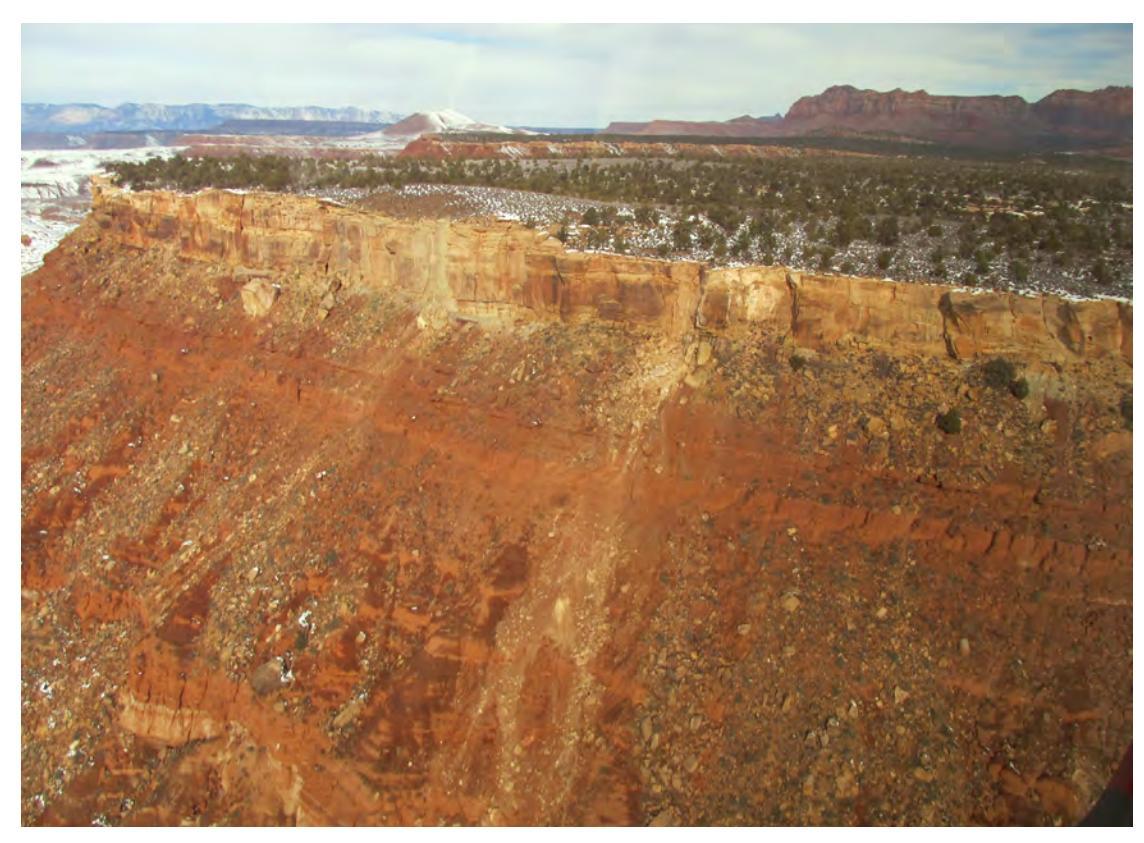
The rock-fall path was partially influenced by the presence of small, pre-existing gullies on the Moenkopi slope (figure 9), and was delineated by churned soil and vegetation, fresh rock deposition, both soil and rock gouge, and impact craters (figure 10). Some of the rapidly moving rock-fall debris collided with large, previously fallen boulders at the base of the slope (figures 2 and 6) and shattered into hundreds of additional fragments. Numerous large boulders continued beyond the base of the slope (likely including fragments shattered from the previously fallen boulders), several of which struck and destroyed a house, a two-car detached garage, and a car parked in the garage driveway at 368 West Main Street.

Figure 9. Upper part of the path taken by the December 12, 2013, rock fall. Note how pre-existing small gullies on the Moenkopi slope split and redirected a portion of the rock fall. Numerous freshly fallen boulders of unknown stability remain on the slope along the rock-fall path. Photograph taken on December 13, 2013, view is to the northwest.

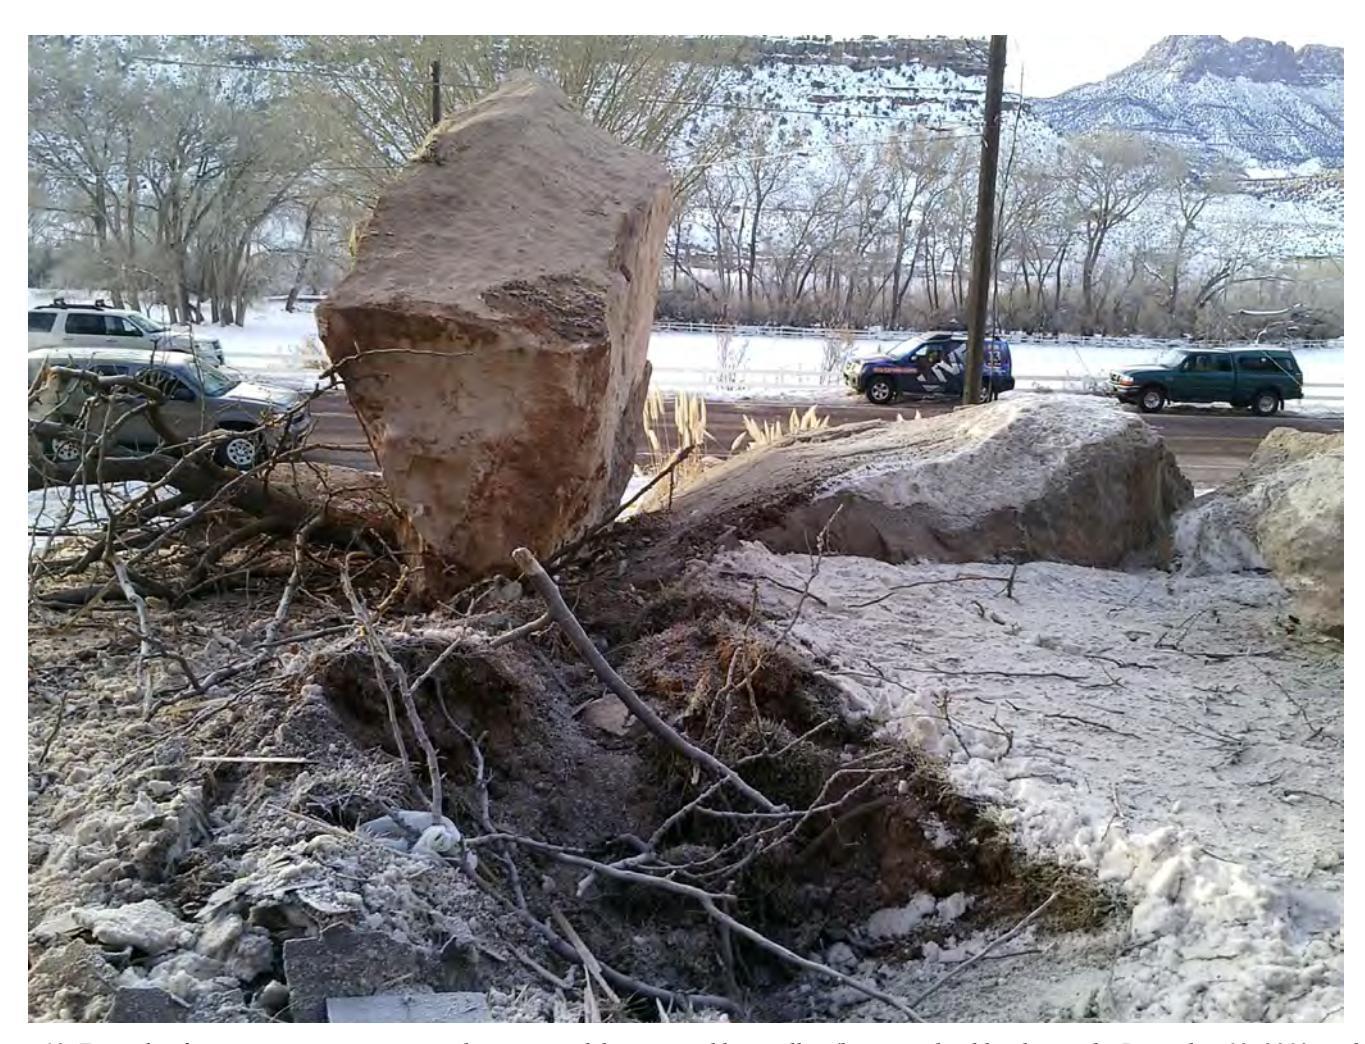
Figure 10. Example of an impact crater, gouge, and vegetative debris created by a rolling/bouncing boulder during the December 12, 2013, rock fall. Photograph taken on December 13, 2013, view is to the south.

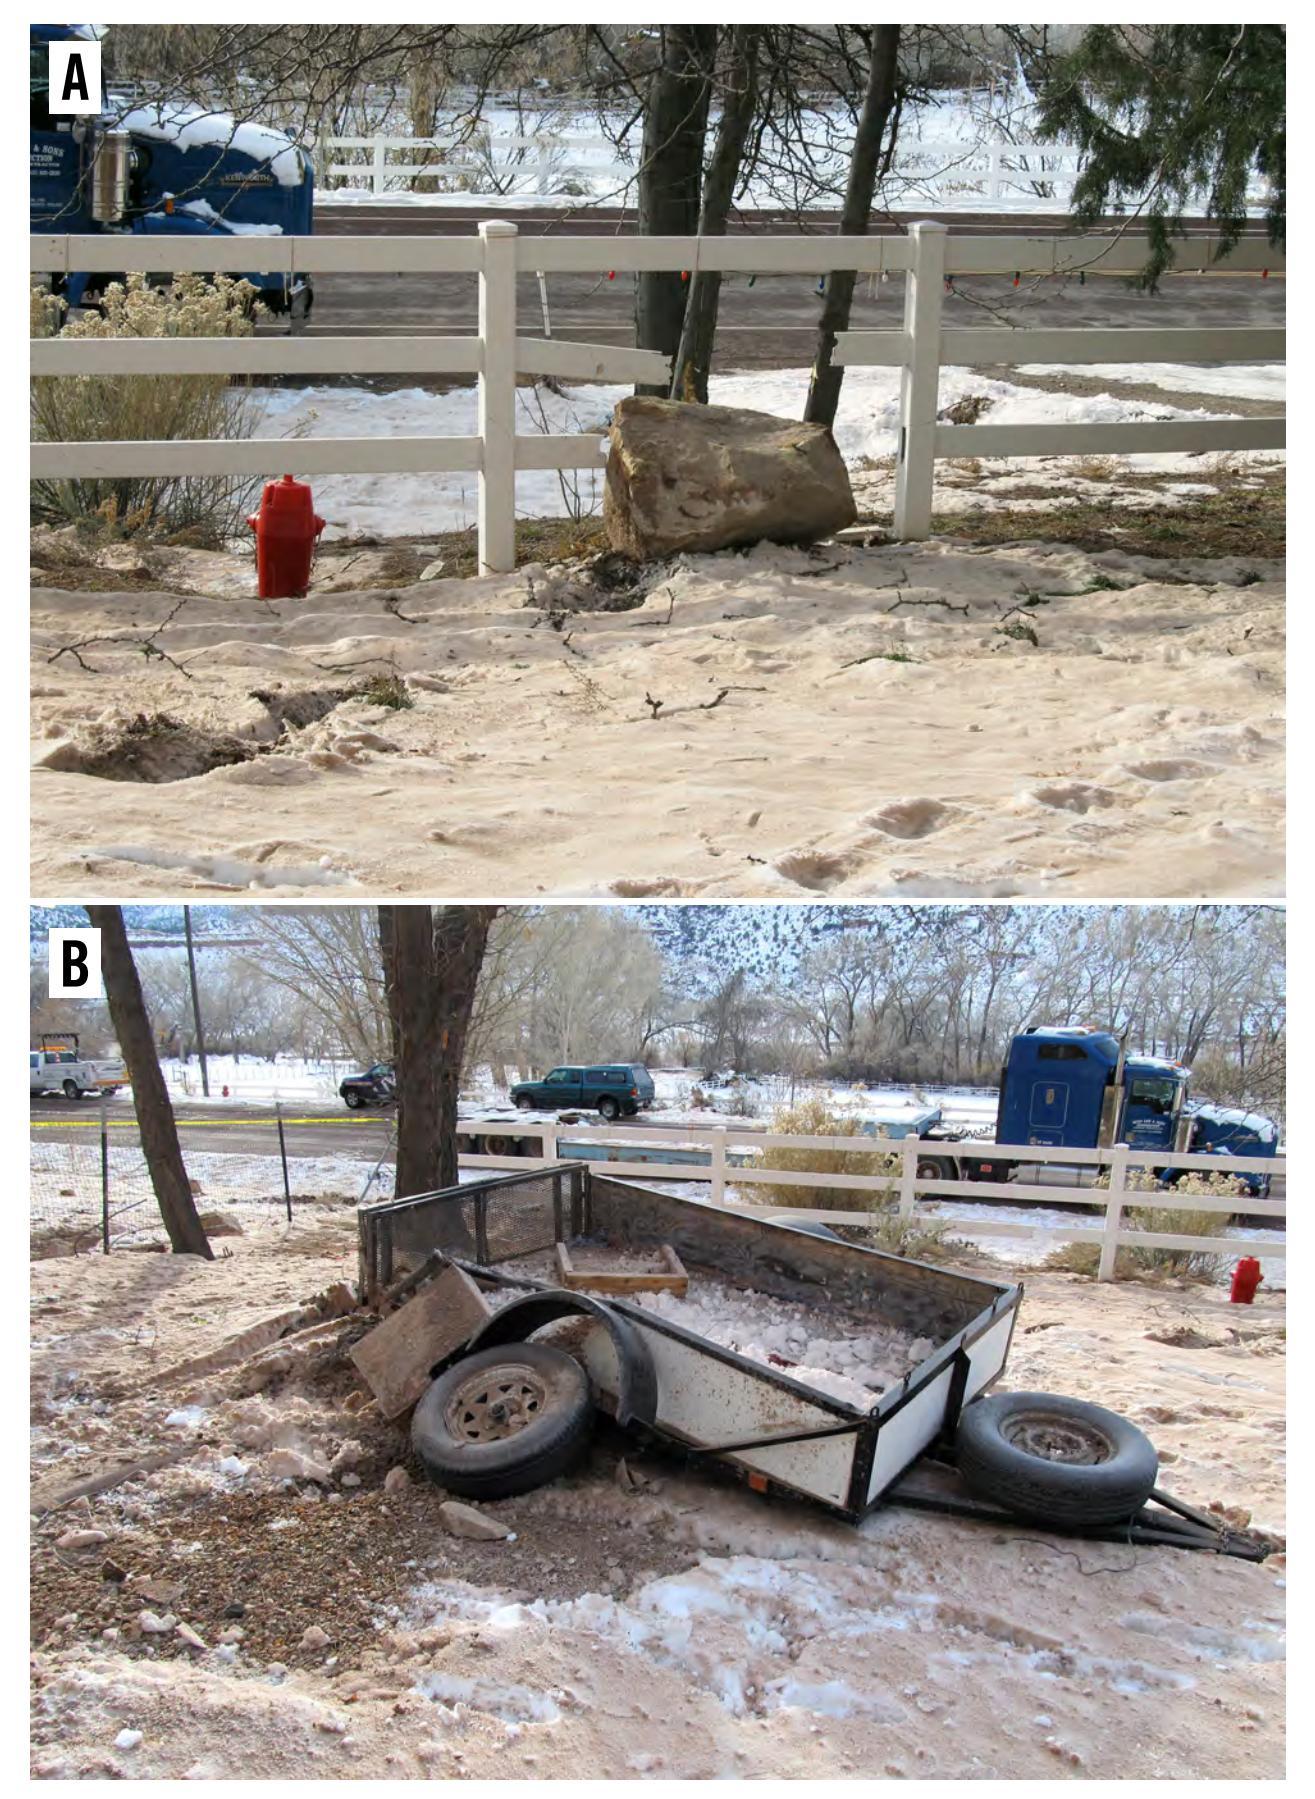
Figure 11. Boulder (*A*) with an estimated volume less than one cubic yard that destroyed a small utility trailer (*B*) on the property immediately west of the December 12, 2013, rock-fall location. Photographs taken on December 13, 2013, views are to the south.

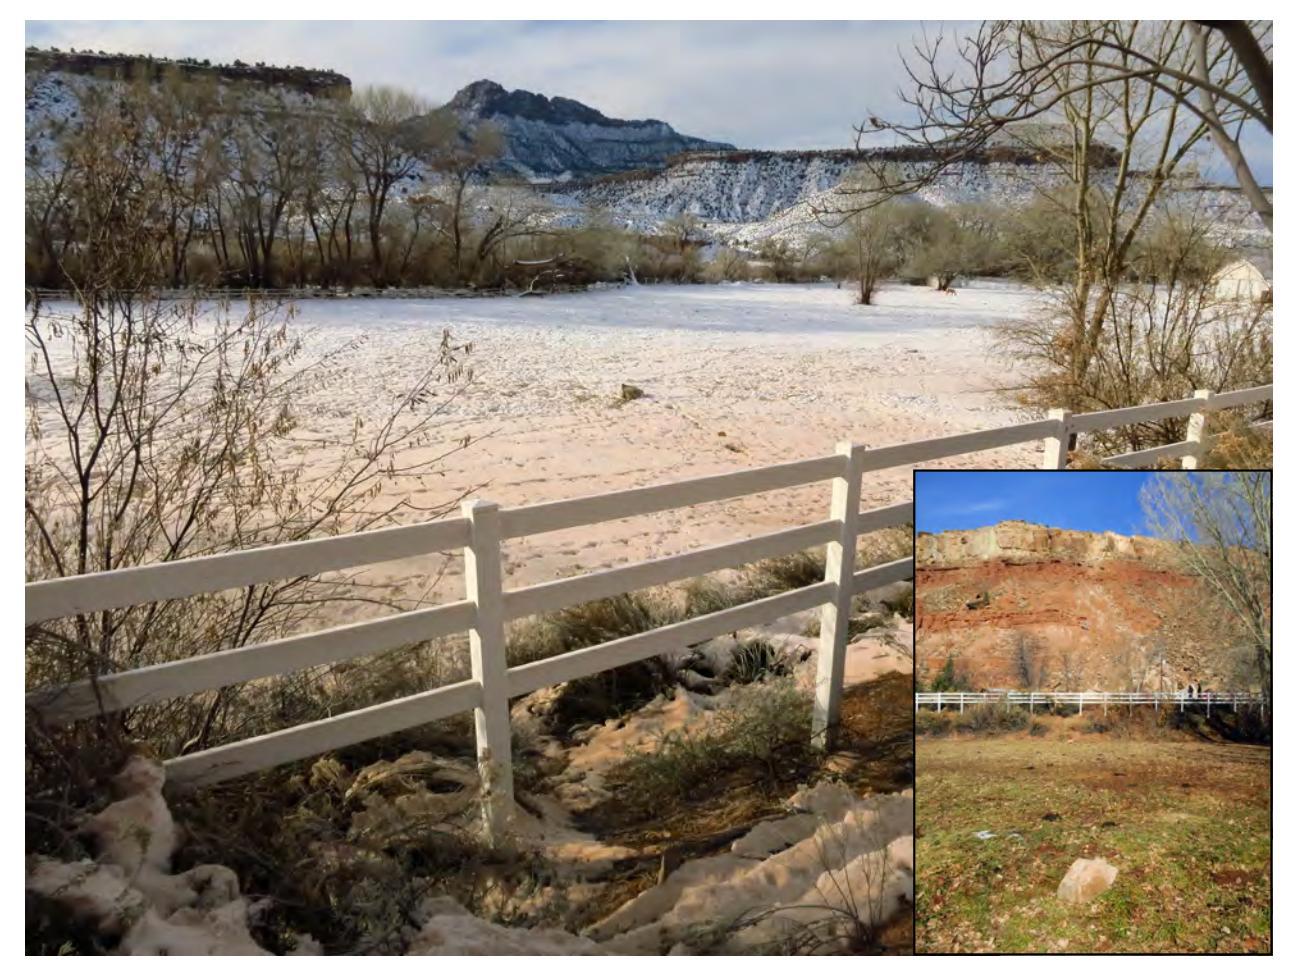
Figure 12. Largest of two boulders that represent the farthest traveled rock-fall debris from the December 12, 2013, rock fall. The boulder is in a pasture on the south side of Main Street/SR-9 directly across from the rock-fall site (see figure 6). The boulder has an estimated volume of 19 ft³ and weight of 2700 pounds, and is approximately 895 horizontal feet (map distance) from the Shinarump cliff on top of the Rockville Bench that sourced the rock fall. The boulders apparently bounced/flew across Main Street (no gouge marks in road pavement, shoulder, or embankment) and cleared both an above-ground telephone line and the fence in the foreground without damaging either. Note the beginning point of the boulder roll path in the snow. Large photograph taken on December 13, 2013, view is to the southwest. Inset photograph taken on December 17, 2013, view is to the northeast.

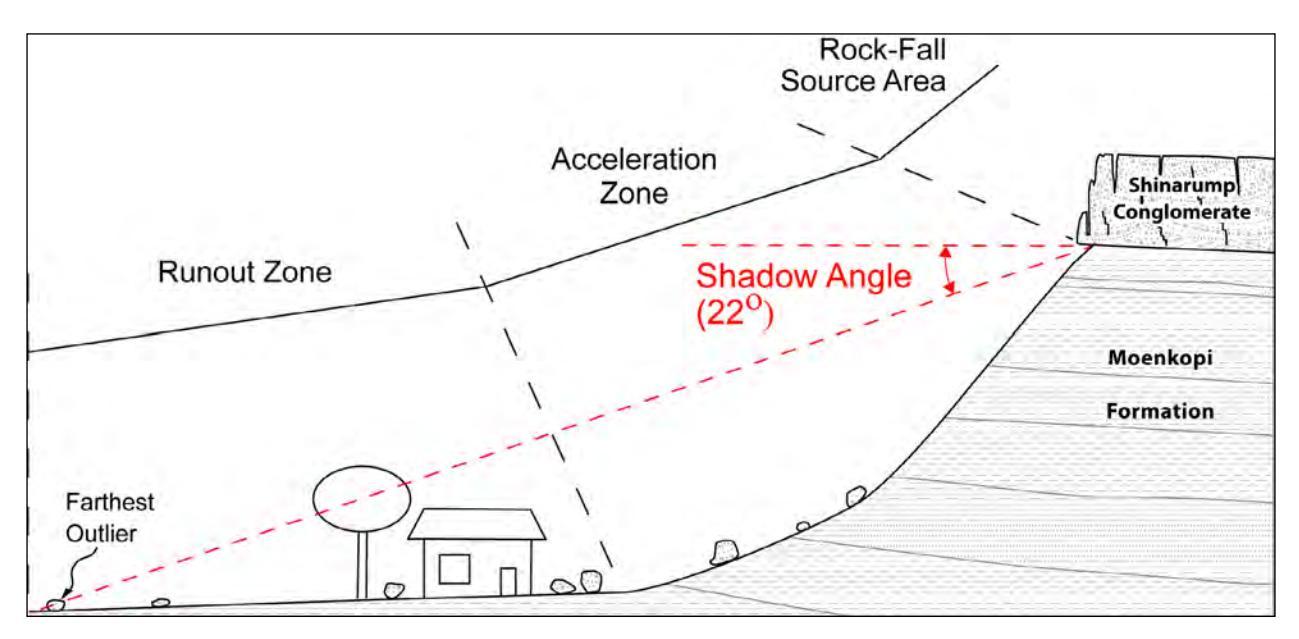
the average angle of an imaginary line extending from the bottom of a rock-fall source (in this case, the Shinarump Conglomerate) to the rock's final resting place (figure 13). Lund and others (2010) and Knudsen (2011) measured dozens of the farthest outlying boulders of rock-fall deposits in Zion National Park and Rockville, respectively, and concluded that a 22° shadow angle is a reasonable value for estimating maximum rock-fall runout distance in the Zion Canyon area.

Figure 13. Components of a characteristic path profile for rock falls sourced from Rockville Bench (modified from Lund and others, 2008).

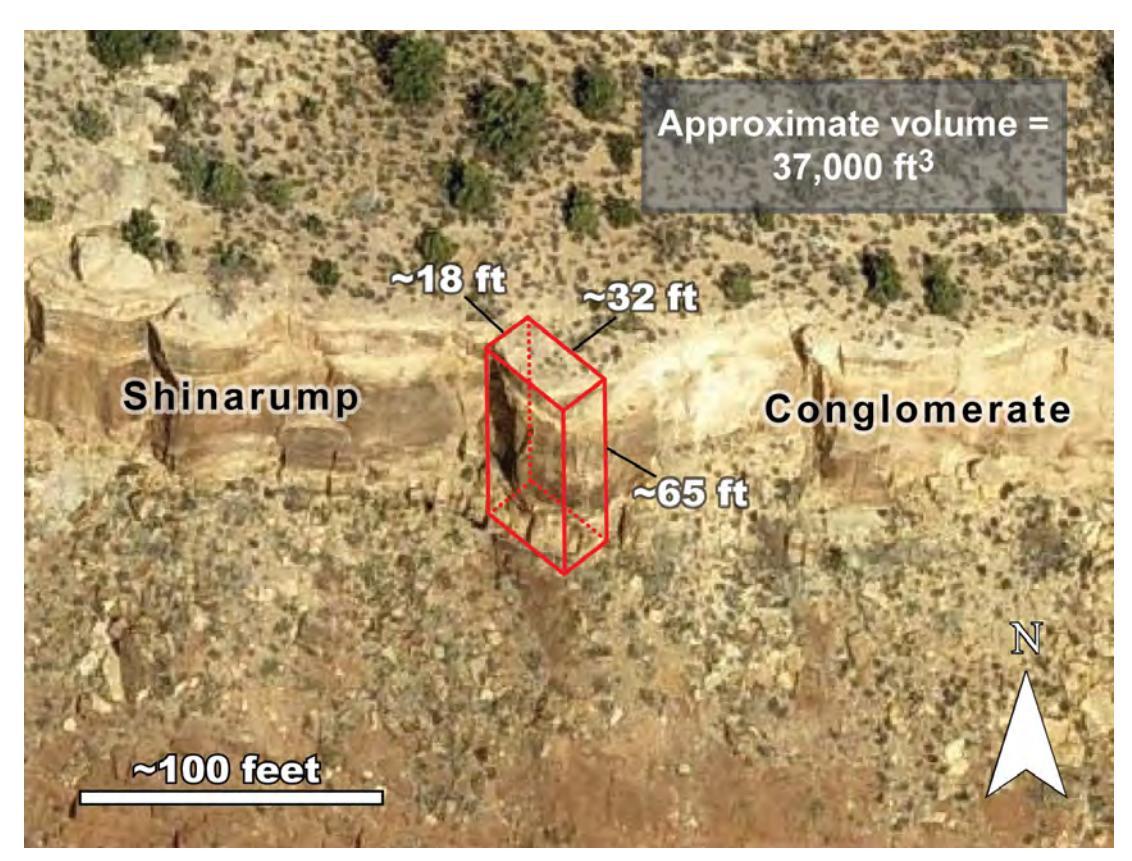
Based on aerial-photo analysis, the size of the detachment surface, thickness of the Shinarump Conglomerate Member, and amount of material at the bottom of the slope, we estimate the rock mass was roughly rectangular with dimensions of about 18 x 32 x 65 feet (figure 14) and a volume of approximately 37,000 ft³ (1400 yd³); all volume and mass estimates are rounded to two significant figures. Using a specific gravity of 2.3 for the Shinarump Conglomerate, the weight of the rock mass that sourced the rock fall was approximately 2700 tons. The largest rock-fall boulder to reach the site weighed an estimated 520 tons and came to rest within the shattered remains of the house (figure 15). A second, very large boulder with an estimated weight of 490 tons (figure 16) came to rest within several feet of the house to the east. Other large boulders ranging from 20 to likely greater than 100 tons also reached the site. Large boulders mostly buried by the rubble of the house and garage could not be accurately measured for a volume estimate, but the boulder that hit the car in the driveway (figure 17) weighed an estimated 41 tons, as did the largest boulder to reach the property immediately west of the site (figure 18).

Figure 14. Circa-2008 oblique aerial view of cliff face and source area showing estimated rock mass dimensions. Photo from Microsoft Bing Maps (<u>http://www.bing.com/maps/</u>).

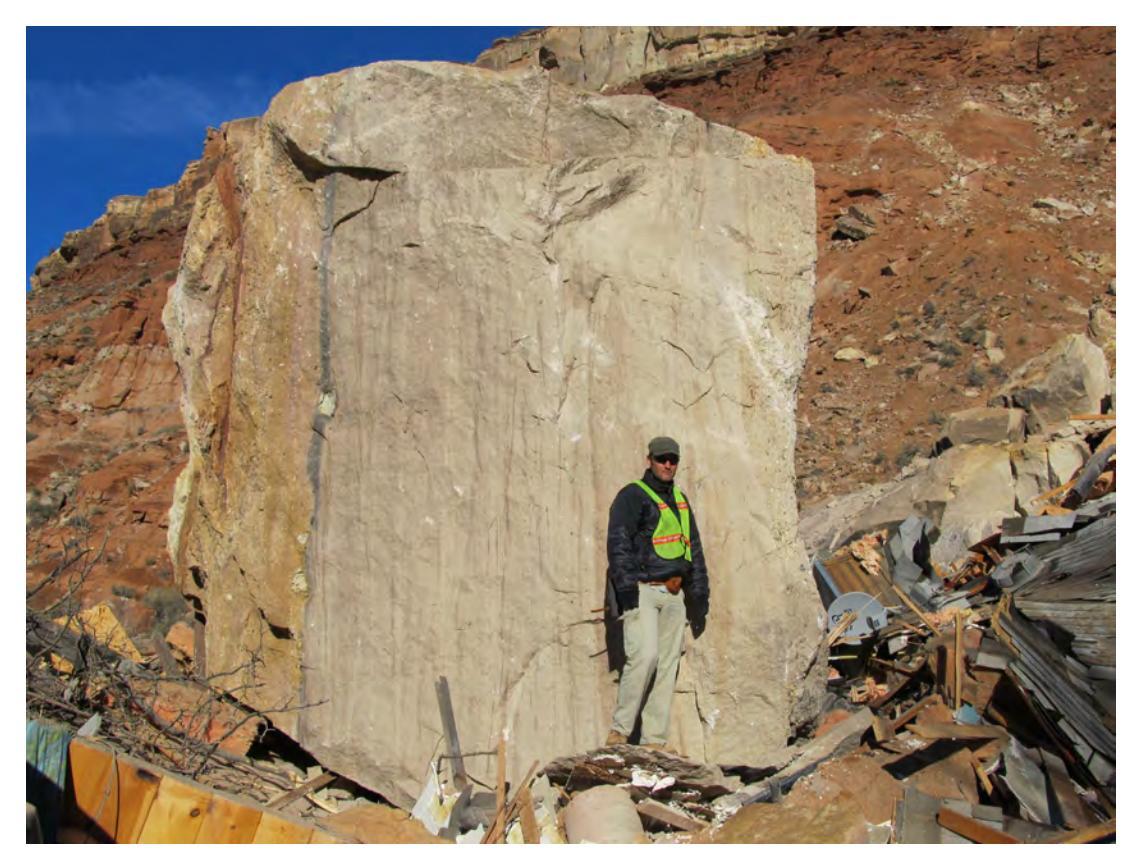
Figure 15. The largest boulder to reach the December 12, 2013, rock-fall site. The boulder is situated within the debris of the destroyed house, and has an estimated volume of 270 yd^3 and mass of 520 tons; average boulder dimensions are $27 \times 16 \times 16.8$ feet. Photograph taken December 17, 2013, view is to the north.

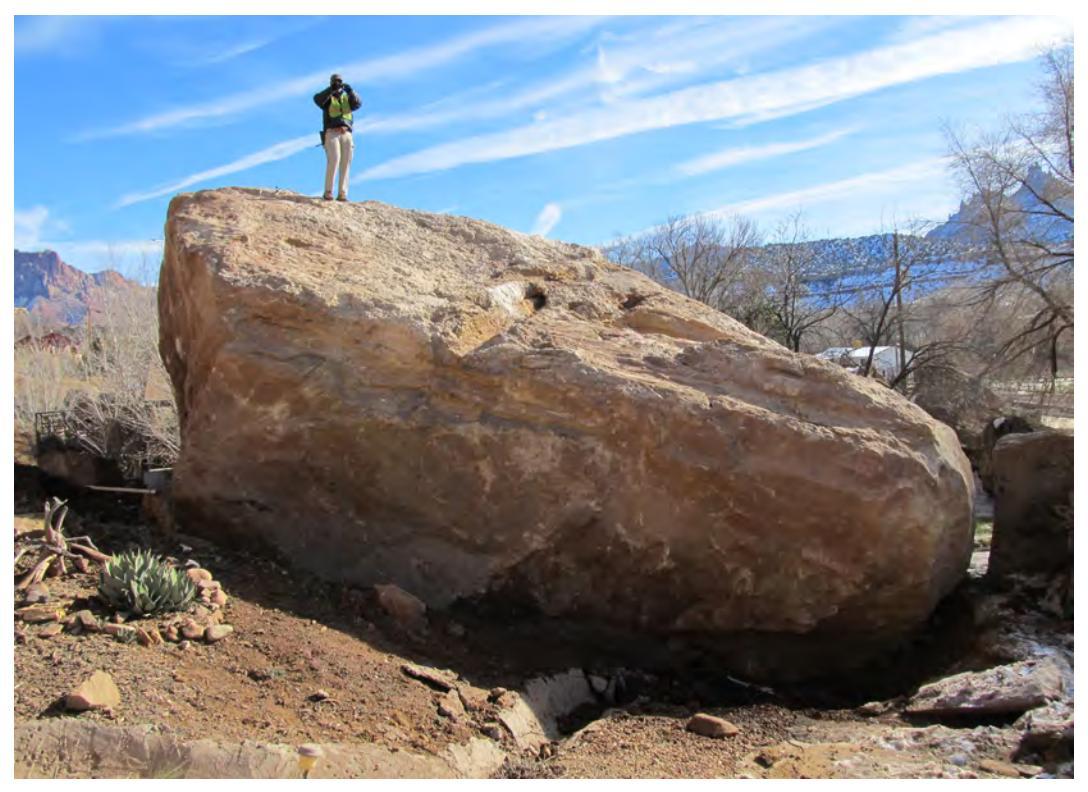
Figure 16. Second largest boulder to reach the December 12, 2013, rock-fall site. This boulder came to rest a few feet from the house on the property immediately east of the rock-fall site, and has an estimated volume of 250 yd^3 and mass of 490 tons; average boulder dimensions are $38 \times 13.75 \times 13$ feet. Photograph taken on December 17, 2013, view is to the southeast.

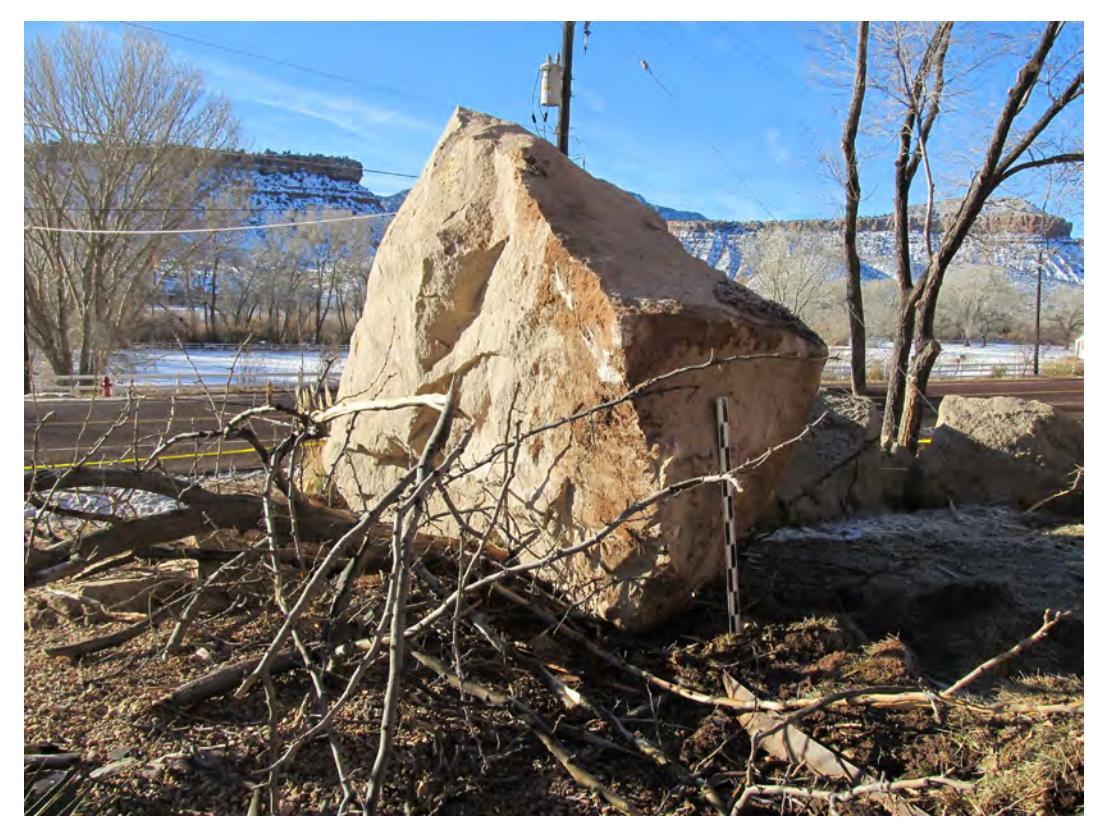
Figure 17. Boulder that destroyed the car during the December 12, 2013, rock fall; scale provided by a 1-meter stick marked in 10-centimeter increments. After striking the car, this boulder bounced across the remainder of the driveway (no gouge marks) before churning up and coming to rest on the lawn. The boulder has an estimated volume of 21 yd³ and mass of 41 tons; average boulder dimensions are 7.9 x 15.9 x 4.5 feet. Photograph taken on December 17, 2013, view is to the southwest.

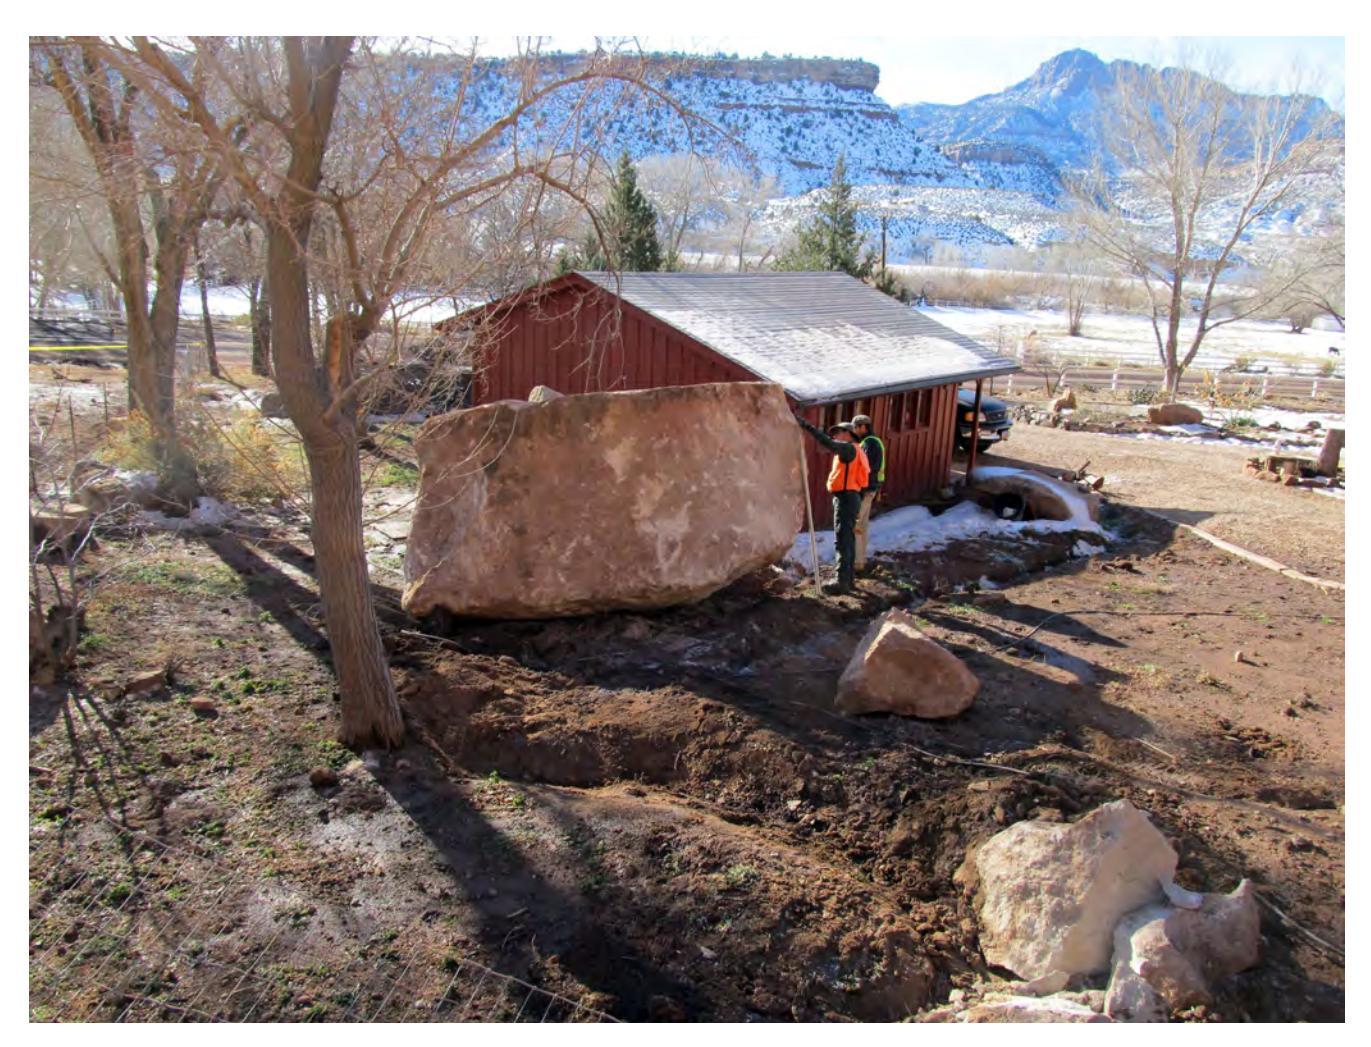
Figure 18. Largest boulder to reach the property immediately west of the December 12, 2013, rock-fall site. The boulder has an estimated volume of 21 yd³ and mass of 41 tons; average boulder dimensions are 7.5 x 11 x 7 feet. Photograph taken on December 17, 2013, view is to the southwest.
