INVESTIGATION OF THE DECEMBER 12, 2013, FATAL ROCK FALL AT 368 WEST MAIN STREET, ROCKVILLE, UTAH

by William R. Lund, Tyler R. Knudsen, and Steve D. Bowman

REPORT OF INVESTIGATION 273 UTAH GEOLOGICAL SURVEY

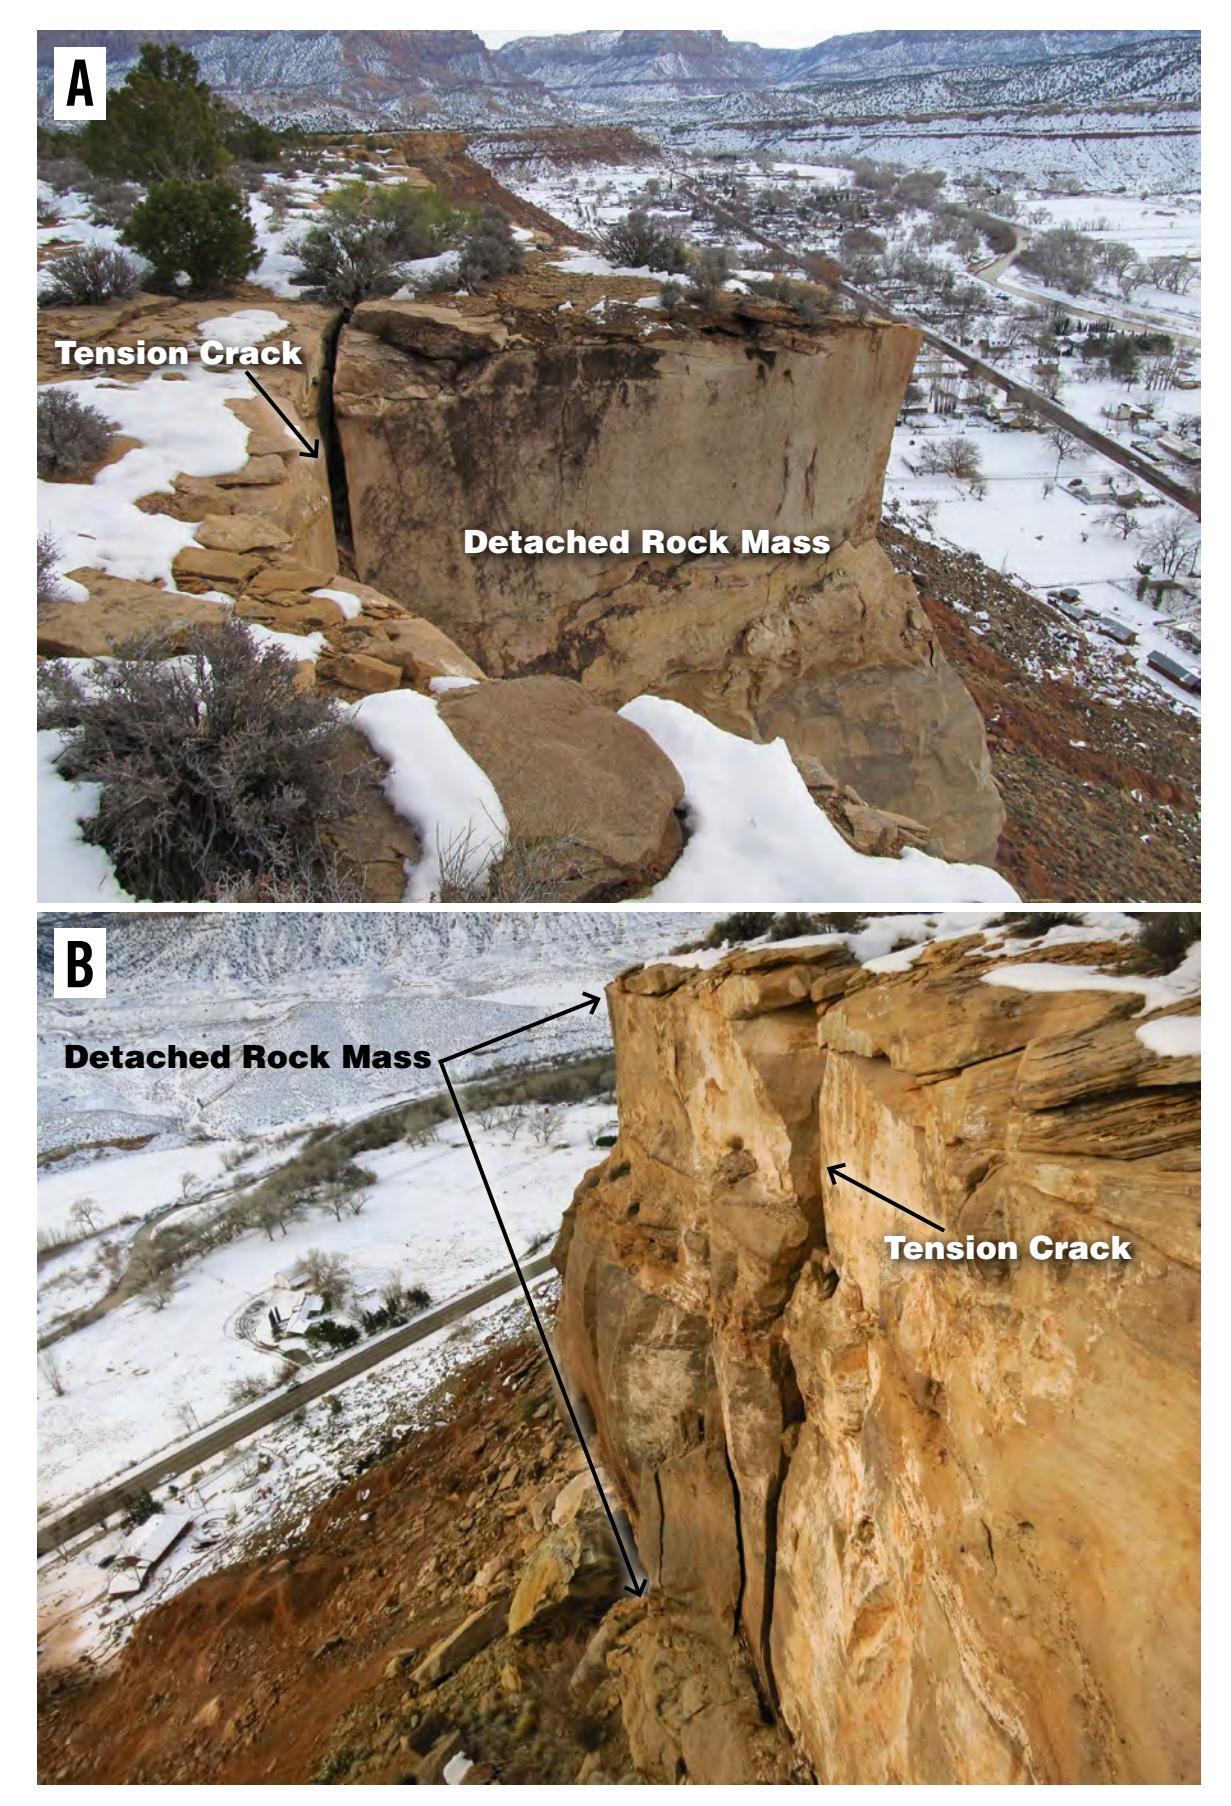
Our helicopter and foot reconnaissance of the cliff at the top of the Rockville bench conducted with Chief Wright, showed that a second, large, joint-controlled rock mass is partially detached from the cliff face (figure 19) above the site, and could fall at any time. Additionally, the slope below the cliff is littered with boulders related to both the December 12th and earlier rock falls (figures 6 and 7), all of unknown stability. Elsewhere along the cliff, we observed large, cliff-face-parallel joints, which, although apparently not affected by the December 12th rock fall, can serve as detachment surfaces for subsequent rock falls. We concluded that the rock-fall hazard at and adjacent to this site remains very high, due chiefly to the recentness of the December 12th rock fall and consequent presence of a now partially detached section of the cliff above the site. However, predicting the precise timing of future rock falls is not possible (see Knudsen, 2011), and it is not known when the partially detached rock mass will fall. The rock-fall-hazard map prepared by the UGS for the SR-9 corridor between La Verkin and Springdale (Knudsen and Lund, 2011, 2013) (figure 5) shows a high rock-fall-hazard zone is present all along the base of the Rockville Bench in Rockville. The December 12th rock fall, and the frequency and distribution of past rock falls in Rockville (Knudsen, 2011), amply validate the map's hazard zones. Residents living anywhere within a high rock-fall-hazard zone in Rockville face the possible consequences of a large rock fall similar to the one that occurred at 368 West Main Street (figure 20). For those interested, Knudsen (2011) provides details regarding historical Rockville rock falls, rock-fall-hazard runout distances, and hazard characterization techniques.

Figure 19. Partially detached rock mass (A) view toward the east and (B) view toward the west still present at the face of the Shinarump cliff above the location of the December 12, 2013, rock fall at the time of this investigation. Photographs taken on December 13, 2013.

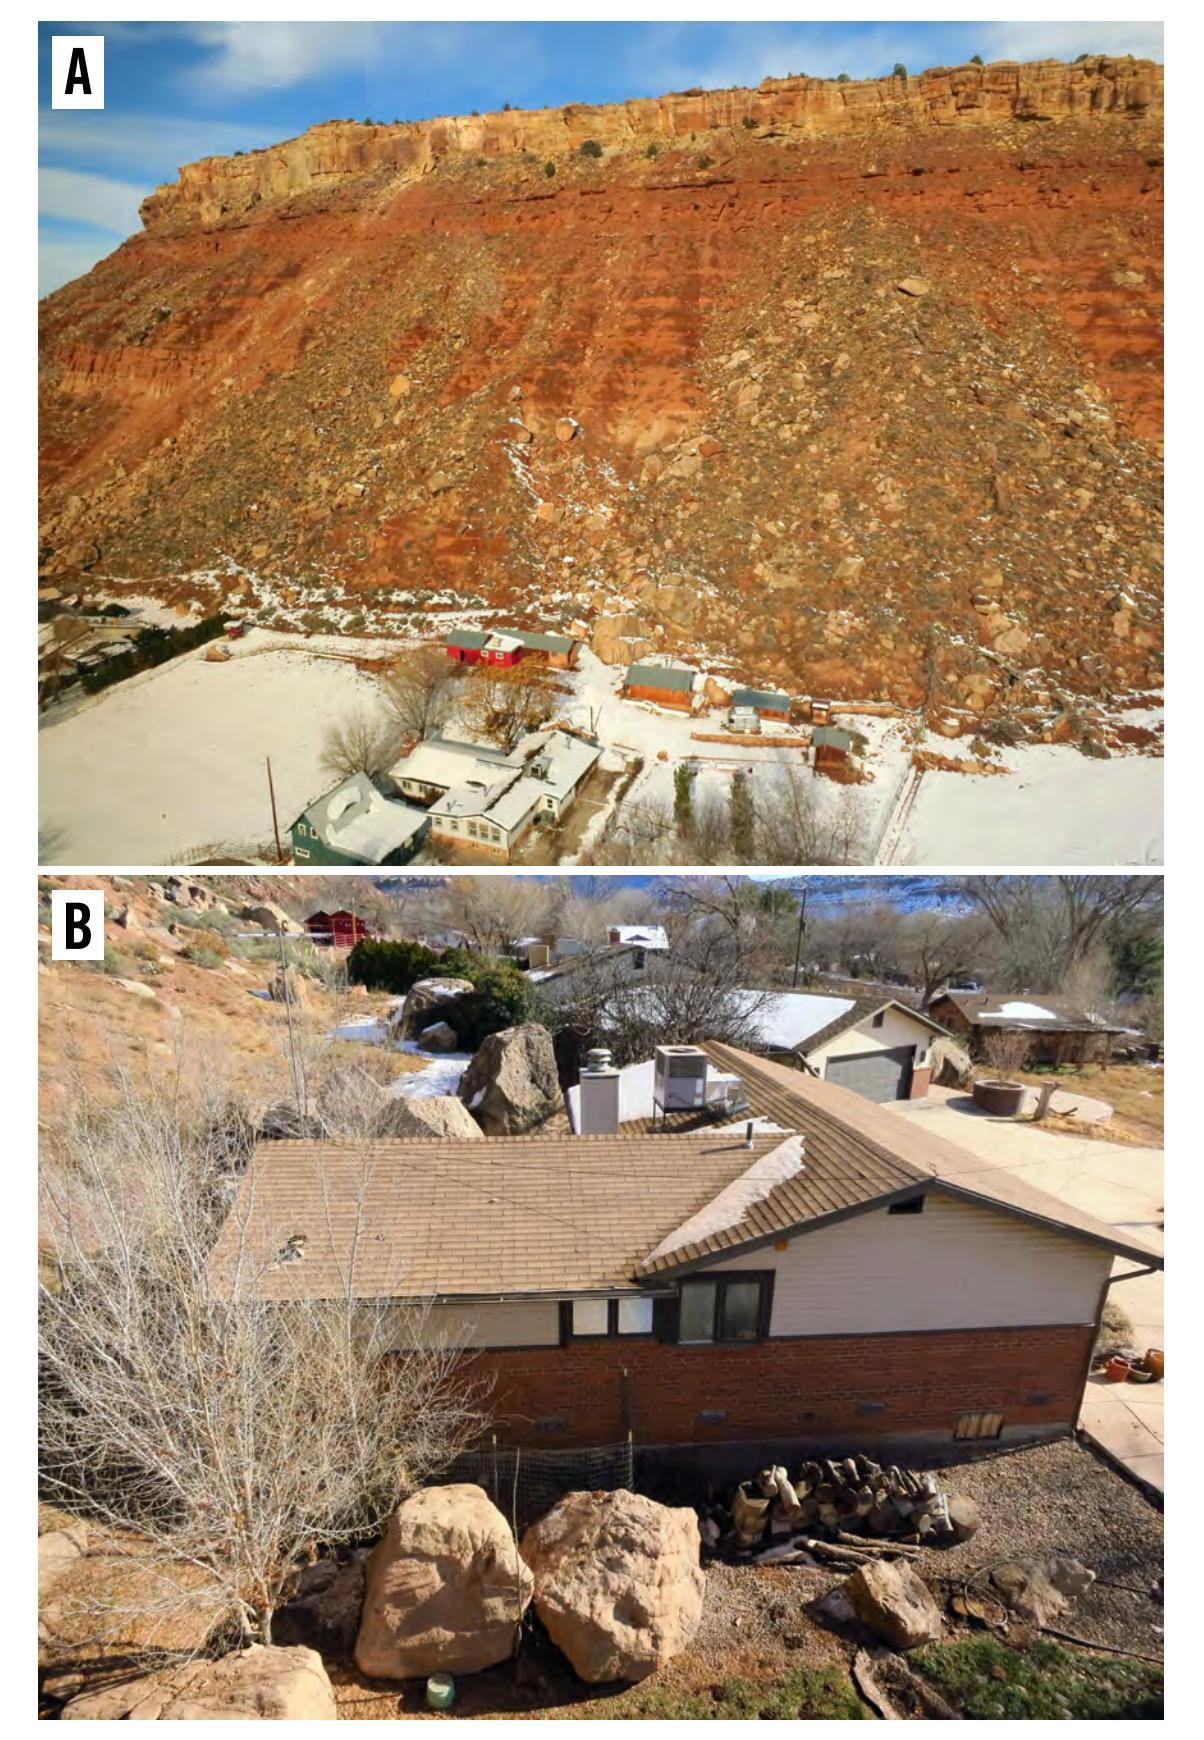
Figure 20. Two views showing structures endangered by rock falls along the base of the Rockville Bench in Rockville, Utah. (A) The white house in the foreground was struck by a rock fall in February 2010. (B) The house in the foreground is immediately east of the December 12^{th} , 2013, rock-fall site and was struck by small rock-fall fragment; additionally, a very large boulder (figure 16) from that event came to rest only a few feet from this house. Boulders near homes in the middle and far distance are from previous rock falls of unknown timing.
