**PRELIMINARY GEOTECHNICAL-ENGINEERING
SLOPE-STABILITY INVESTIGATION OF
THE PINE RIDGE LANDSLIDE,
TIMBER LAKES ESTATES, WASATCH COUNTY, UTAH**

*F.X. Ashland and M.D. Hylland
Utah Geological Survey*

REPORT OF INVESTIGATION 232 July 1997
UTAH GEOLOGICAL SURVEY
a division of
UTAH DEPARTMENT OF NATURAL RESOURCES

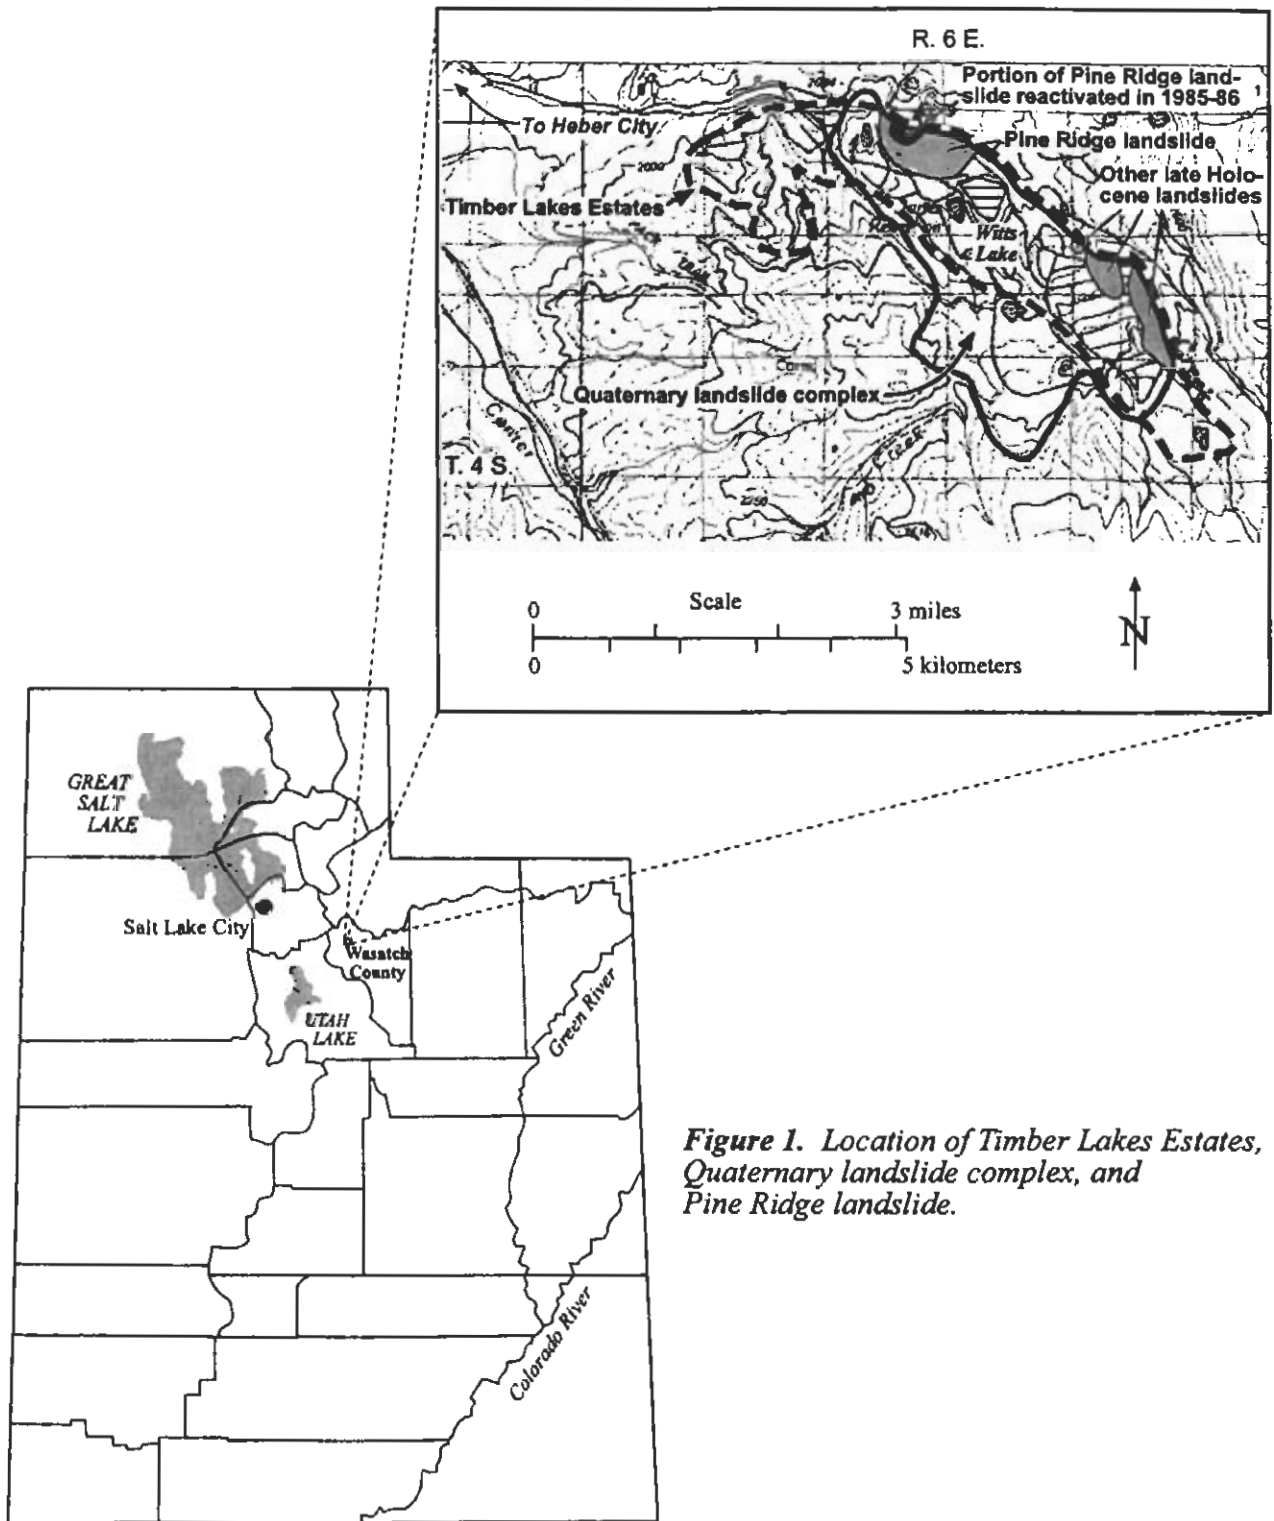
Figure 1. Location of Timber Lakes Estates, Quaternary landslide complex, and Pine Ridge landslide.

The Pine Ridge landslide is the largest of several deep-seated late Holocene landslides in Timber Lakes Estates (figure 1). In either the winter or early spring 1985-86, a part of this slide reactivated as a deep-seated slump. The slump is about 11 acres (4.4 ha) in area and caused damage to a mobile home/cabin. Approximately 114 lots, some currently with homes, are on or immediately abut the Pine Ridge landslide. Presently, individual septic-tank soil-absorption (STSA) systems are used for sewage treatment and add water to the slide mass. Although home construction continues, no assessment of the cumulative affect of development, particularly STSA systems, on the overall stability of the slide has been performed. Such information is important to prudent development in the slide area.

Timber Lakes Estates is in the Lake Creek drainage about seven miles (11 km) east of Heber City in Wasatch County, Utah (figure 1). The Pine Ridge landslide is in the north-central part of the subdivision and north-northwest of Witts Lake (figures 1 and 2). The slide formed on a north-northeast-facing slope in the Lake Creek drainage and is crossed by two minor north-northwest-flowing drainages in its eastern half (figure 2). These drainages presently flow from Jones Reservoir and Witts Lake.

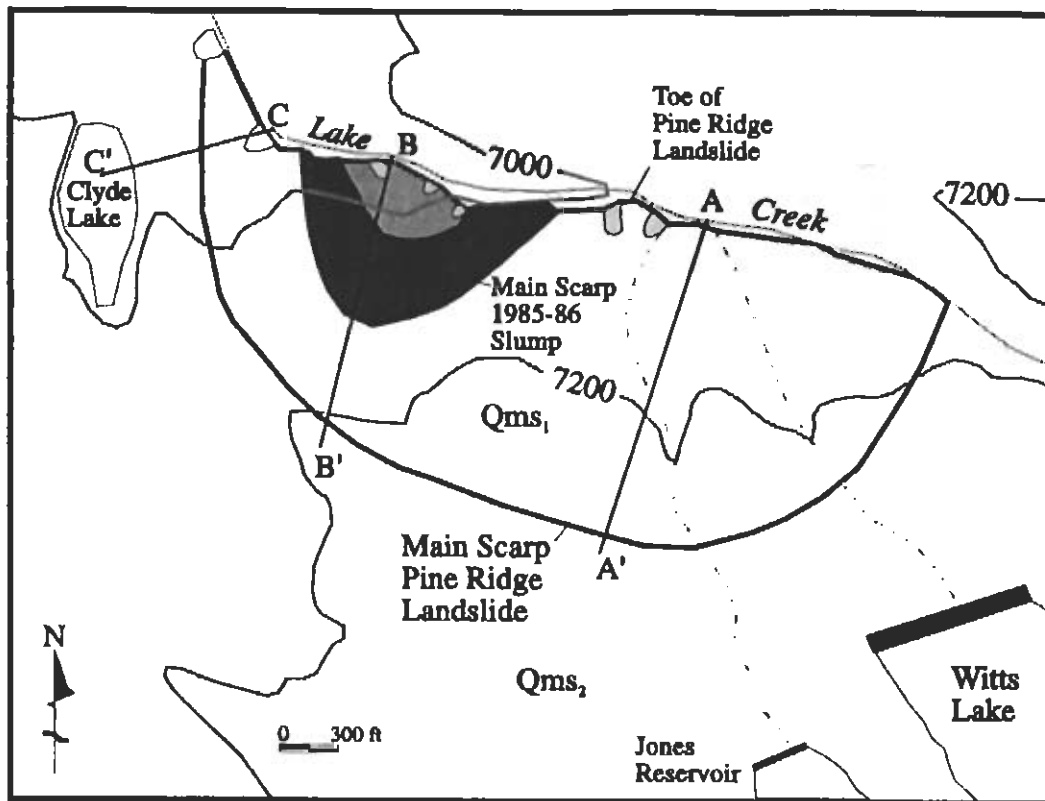
Figure 2. Map of Pine Ridge landslide and surrounding area showing locations of profiles A-A', B-B', and C-C'. Lower slump block (medium shaded area) and main body (darker shaded area) of 1985-86 slump also shown. Drainages discharging from Jones Reservoir and Witts Lake cross the eastern part of the slide. Debris slides (lightly shaded areas) along Lake Creek are as mapped by UGS geologist Mike Lowe (unpublished mapping). Qms₁ = late Holocene landslide deposits; Qms₂ = late Pleistocene-Holocene(?) landslide and undifferentiated deposits. Elevations in feet above mean sea level.

The landslide is underlain by Pinedale-age glacial moraine deposits (Baker, 1976; Bryant, 1992) and sits in a deep-seated, Quaternary landslide complex (figures 1 and 2) within these deposits. Landsliding within the complex possibly involves the underlying Tertiary Keetley Volcanics (Hylland and Lowe, 1995); however, the depth to the top of the volcanics is unknown. Southward-tilted Jurassic sedimentary rocks including the Nugget Sandstone and Twin Creek Limestone, underlie the volcanic rocks. The maximum age of the Pine Ridge landslide is interpreted to be late Holocene (Hylland and Lowe, 1995), but part of the slide reactivated as a deep-seated slump in 1985-86.

The main body of the landslide is generally bowl-shaped in plan view as viewed toward the north-northeast (figure 2). In maximum dimension, the slide is about 4,000 feet (1,220 m) wide and 1,800 feet (550 m) long from toe to main scarp, and covers an area about 600,000 square yards (500,000 m²) or 124 acres (50 ha). The depth to the main slip surface is unknown, thus volume estimates for the slide are not possible.

The landslide has a somewhat subdued main scarp (figures 2 and 3) that is, however, easily discernable on aerial photographs along most of its trace. In the eastern part of the slide (profile A-A'), the main scarp is about 25 feet (7.6 m) high and slopes to the northeast about 22 degrees. In the central part of the slide (profile B-B'), the main scarp is 45 feet (13.7 m) high and

Sometime in 1985-86, about an 11-acre (4.4-ha) area of the landslide reactivated as a deep-seated slump (Hylland and Lowe, 1995) (figure 2; figure 3, profile B-B'). The main scarp of this slump extends for about 2,000 feet (610 m) and ranges from about 2 to 15 feet (0.6-4.6 m) high. A part of the composite main scarp with approximately 1 foot (0.3 m) of vertical displacement passes directly under a mobile home/cabin, which has been kept level by placing jacks and shims beneath the steel frame of the cabin on the downdropped landslide block. The 1985-86 slump contains several internal secondary scarps, two of which form a small graben that is about 110 feet (34 m) north of the main scarp. Two other secondary scarps within 50 feet

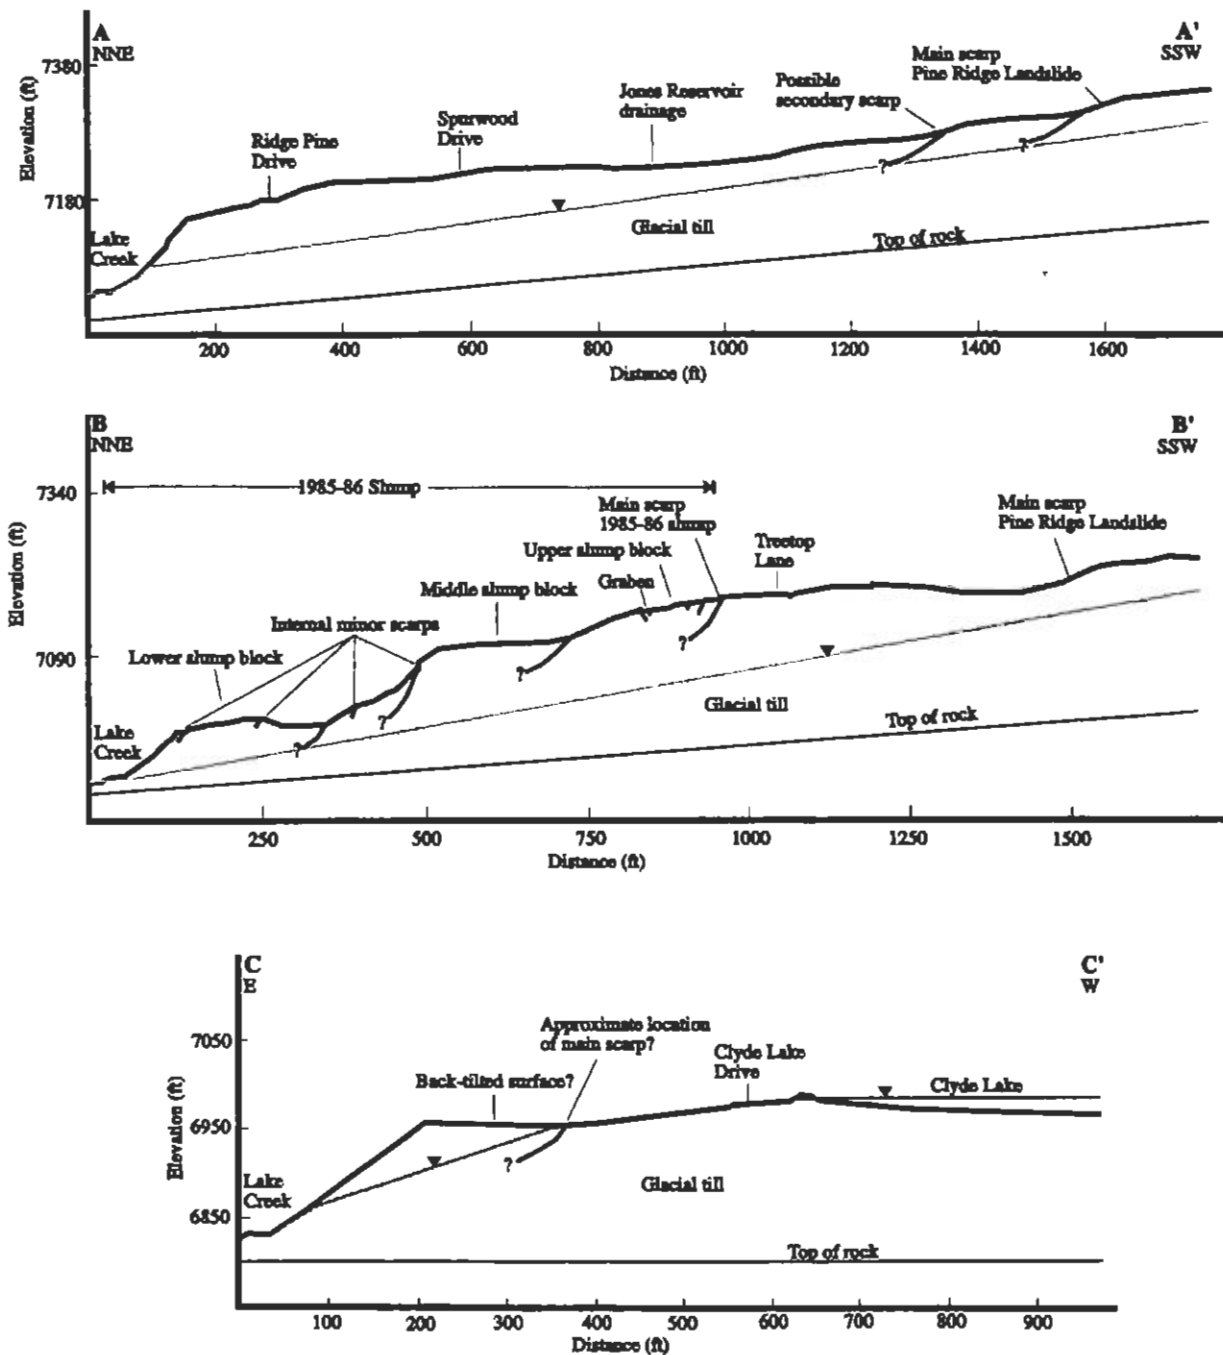
Figure 3. Profiles across the Pine Ridge landslide. Profile A-A' (top) is in the eastern part of slide and crosses the Jones Reservoir drainage. Profile B-B' (middle) is in the central part of slide and crosses 1985-86 slump. Profile C-C' (bottom) is in the northwestern part of slide and ends in Clyde Lake. Locations of profile lines are shown on figure 2. Depth to top of rock is shown as estimated for slope-stability analyses. Profiles A-A' and B-B' show estimated ground-water levels at the time the profiles were measured (summer to fall). Profile C-C' shows estimated ground-water levels when Clyde Lake is at high-water level.

slopes to the northeast about 24 degrees. In the northwestern corner of the slide (profile C-C'), the scarp is not easily located. However, we estimate the slip surface intersects the ground surface about 120 feet (37 m) west of the crown of the active debris slide area in the steep slope abutting Lake Creek. Near the crown, the ground surface dips about 5 degrees west and away from Lake Creek over a distance of about 60 feet (18.3 m). About 140 feet (43 m) west of the crown, the ground surface begins to slope to the east at about 8 degrees. We interpret the west-sloping ground to be a back-tilted surface resulting from rotation caused by movement of the slide. We also believe that the lack of expression of the scarp on the northwest flank of the slide reflects mostly local strike-slip rather than dip-slip movement on the flanks of the slide during landsliding.

In addition to the main scarp, geomorphic evidence suggests the existence of secondary scarps. In the east part of the landslide (profile A-A'), we interpret a possible secondary scarp approximately 260 feet (79 m) northeast of the main scarp. The secondary scarp is about 16 feet (4.9 m) high and slopes about 17 degrees northeast. In the northern and central part of the slide, episodes of partial reactivation of the slide by deep-seated slumping have resulted in numerous secondary scarps. The scarps in this group related to the 1985-86 slump are discussed in more detail below.

The toe of the Pine Ridge landslide consists of a very steeply sloping front that is actively being modified by shallow debris slides. Maximum local slopes at the toe range from 38 (profile C-C') to 49 (profile A-A') degrees. Local relief (Lake Creek to crest of abutting steep slope) ranges from 129 feet (39.3 m) (profile C-C') to 74 feet (22.6 m) (profile B-B'). Numerous recent shallow debris slides exist in the toe of the landslide. These debris slides typically involve movement of topsoil, thin colluvium, and underlying glacial till, and generally cause the removal of mature vegetation, consisting of mixed aspens and conifers, where present. The maximum depths of failure surfaces of these debris slides are typically less than about 13 feet (4.0 m). Shallow debris sliding may temporarily cause flattening of the overall local slope as material moves downward and laterally into the zone of accumulation. However, our profiling indicates that the upper part of the slope is generally as steep after debris sliding as before. Eventual erosion of slide debris from the toe by Lake Creek during high-flow periods each spring completes the cycle of slope modification. The net result of this process is a lateral migration of the slope of about 10 to 15 feet (3.0-4.6 m) with no significant change in local slope gradient after erosion of slide debris at the toe.

Overall, the 1985-86 slump has a complex geometry. In profile, the slump is benched and can be separated into three slump blocks (figure 3, profile B-B'). The lowest and northernmost block is approximately 95 feet (29.0 m) above Lake Creek, at its highest point, and is about 360 feet (110 m) long from toe to upper bounding scarp where it is crossed by profile B-B'. At least two internal scarps formed in the lower block during slumping in 1985-86. In addition, a presumably contemporaneous scarp formed in the northern slope near Lake Creek as a result of shallow debris sliding. The middle slump block is relatively flat, ranges from approximately 200 to 210 feet (61-64 m) above Lake Creek, and is about 180 feet (55 m) long where it is crossed by profile B-B'. The middle and lower slump blocks are separated by a zone of both active and inactive scarps. The total local relief across this zone is about 120 feet (37 m) where it is crossed by profile B-B'. We interpret this relief to be the result of downdropping of the lower block during multiple episodes of slumping. Two of the five scarps in the zone moved during slumping in 1985-86. The upper and southernmost slump block is approximately 275 feet (84 m) above Lake Creek, at its highest point, and is about 230 feet (70 m) long where it is crossed by profile B-B'. Internal deformation during slumping in 1985-86 formed five scarps within the block. Two of these scarps bound a graben that is about 20 feet (6.1 m) wide and about 2 feet (0.6 m) deep where it is crossed by profile B-B'. Displacement is greatest on the antithetic, southwest-facing scarp that bounds the graben on the northeast. The upper and middle slump blocks are separated by a single inactive scarp with about 47 feet (14.3 m) of local relief along profile B-B'.

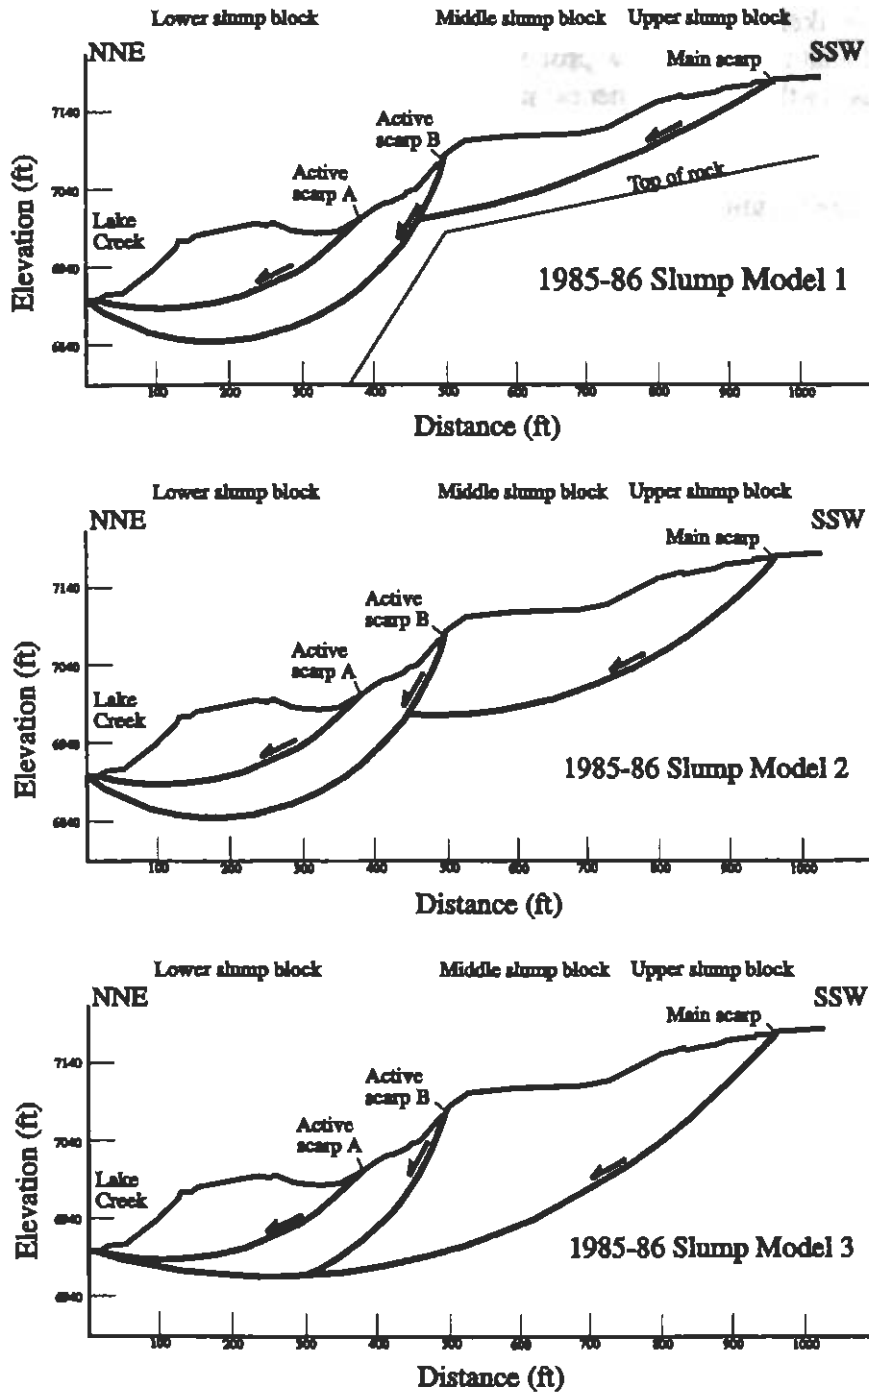
Figure 4. Landslide models used in slope-stability analyses of the 1985-86 slump. In model 1, movement of two independent slip surfaces forms scarps A and B in the boundary zone between the lower and middle slump blocks. A displacement-dependent slip surface forms the main scarp and toes in the upper part of the slip surface that forms scarp B. Moderately shallow rock controls the depth to the slip surface. Model 2 is similar to Model 1 except that the depth to the upper slip surface is not controlled by the depth to rock. In Model 3, movement of two dependent slip surfaces forms scarps A and B. Movement of one independent slip surface forms the main scarp. The deeper slip surface toes near Lake Creek and acts as a detachment. Rock is assumed to be relatively deep.

Three separate models were analyzed in our evaluation of slumping in 1985-86 (figure 4). In model 1, movement of two independent slip surfaces forms scarps A and B in the boundary zone between the lower and middle slump blocks. Movement of a displacement-dependent slip surface forms the main scarp. The slip surface is displacement dependent because it toes in the upper part of the downslope slip surface and movement of the upper and middle slump blocks is dependent on movement of the lower block toward Lake Creek. Moderately shallow rock in the upper part of the slump controls the depth of this slip surface. Model 2 is similar to model 1 except that the depth to rock does not control the depth of the uppermost dependent slip surface. In model 3, movement of two dependent slip surfaces forms scarps A and B. Movement of a deep-seated independent slip surface that toes in Lake Creek forms the main scarp. This slip surface also acts as a detachment for the two shallower slip surfaces. In all three models, the same critical (having the lowest factors of safety) slip surfaces form scarps A and B, however we evaluated three possible critical slip surfaces that could have formed the main scarp.

An understanding of the stability of the 1985-86 slump requires consideration of the differences in the failure models (see figure 4). In models 1 and 2, movement of the entire slump is dependent on movement of the lower slump block toward Lake Creek. However, our analyses suggest that either the phreatic (unconfined ground water) or piezometric (confined ground water) surface would locally have to be above the ground surface for slumping to initiate, assuming we have not overestimated the lower bound shear strength of the till. Profile B-B' (see figure 3) shows that the lower slump block is mound shaped with a sag between it and the scarp zone that separates the lower and middle slump blocks. Under unconfined ground-water conditions, the upslope sag elevation is the likely high ground-water level in the lower slump block assuming that the phreatic surface slopes downward to Lake Creek. Without ponded surface water in the sag, the likelihood of completely saturated conditions in the mound part of the lower slump block is low, but such conditions appear necessary for independent slumping of the block. The simplest scenario where slumping appears possible is when a piezometric surface (confined ground water) is at or slightly above the ground surface (onset of artesian conditions on top of the mound). Another possibility is that unconfined ground water exists and that the near-surface soils are frozen, including in the steep slope adjacent to Lake Creek, and act as a barrier to downslope ground-water flow. In such a scenario, ground water could back-up and fill the overlying soils in the mound because the frozen ground prevents seepage in the steep slope near Lake Creek or surface ponding in the sag. Artesian pressures could likely build up temporarily beneath the frozen surficial soils. Such requirements for slope failure appear to restrict independent slumping of the lower block to the winter months when frozen ground conditions are possible.

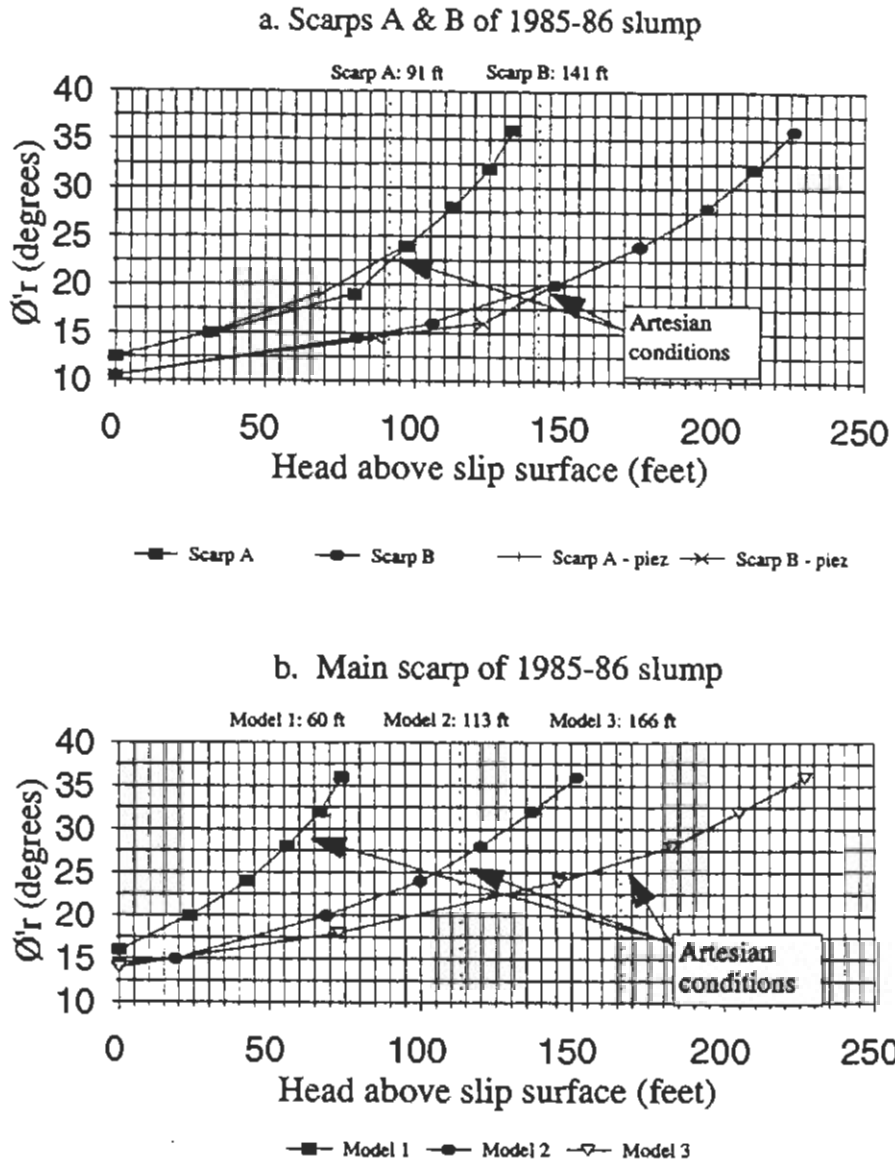
Figure 5. Estimated shear strengths of glacial till in the 1985-86 slump. Shear strength (ϕ'_{r}) as a function of head (height of phreatic or piezometric surface) above slip surface as measured at centerline of the local slump. (a) Shear-strength estimates for two independent slip surfaces that formed scarps A and B. Alternate curves show slight variation in results using PC-STABL5M program option to selectively define piezometric surface. Option can be used to simulate confined ground-water conditions where the piezometric surface is below ground surface and gives results similar to the method used. (b) Shear-strength estimates for three possible slip surfaces (models 1-3) that could have formed main scarp. Minor differences in estimated shear strengths at onset of artesian conditions suggest results are not highly dependent on model selected.

On this basis, we believe that upper bound shear strengths can be defined by where artesian conditions are required to initiate slumping (see figure 5). Because the onset of artesian conditions is also equivalent to the worst-case unconfined ground-water conditions (entire thickness of soil above slip surface is saturated), the upper bound shear strengths are likely the best estimate of shear strengths in the slump (table 4). The range in estimated shear strengths is consistent with published residual shear strengths of glacial tills and similar soils (figure 6). We infer from this that the probable episodic movement history of the slump, and particularly the lower slump block, has caused shear strengths to approach their residual values at least adjacent to slip surfaces. Shear strength likely increases with distance from slip surfaces and may reach peak values in the centers of slump blocks.

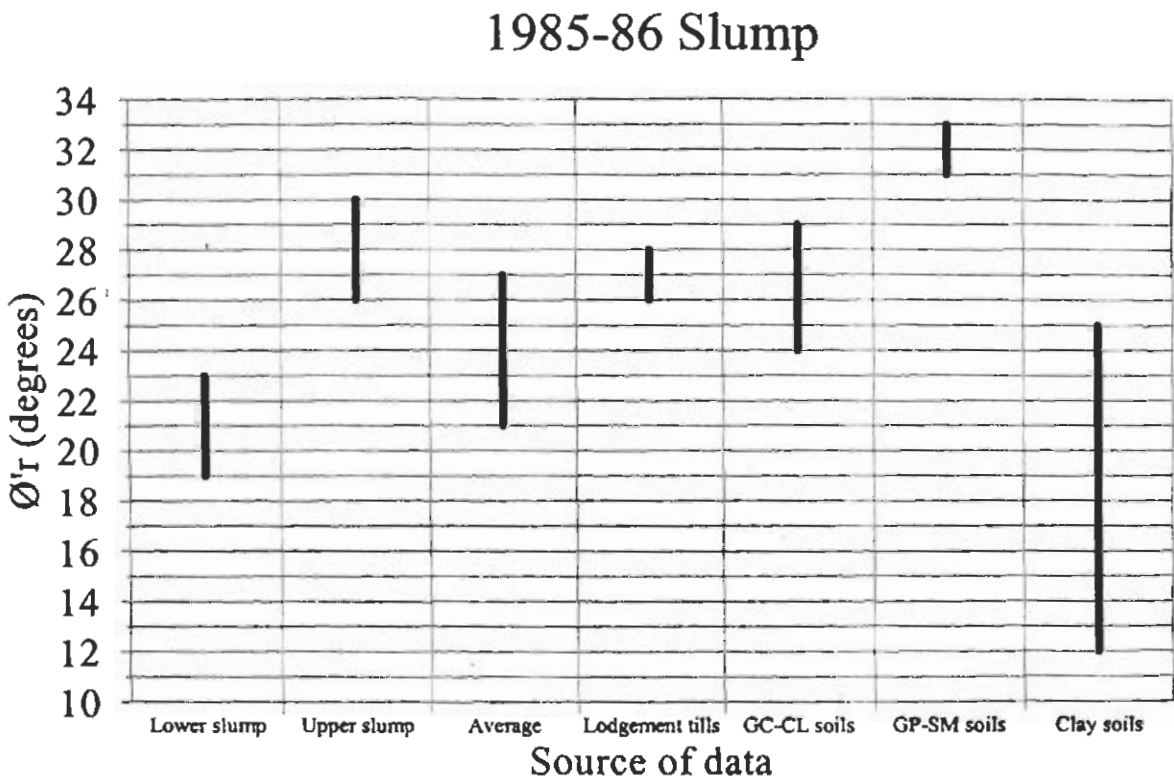
Figure 6. Comparison of estimated residual shear strengths in the 1985-86 slump with published data. Upper bound of average residual shear strengths ($\phi_r = 21-27$ degrees) of glacial till in slump falls within published ranges for lodgement tills and soils with Unified soil classifications of GC-CL. Lower bound of average falls within upper part of range for clay soils and may be consistent with multiple episodes of reactivation in lower part of slump. Range of residual shear strengths for lodgement tills from Eyles (1983); for GC-CL soils from Vaughan and Walbancke (1978); and for GP-SM and clay soils from Renteria (1994).

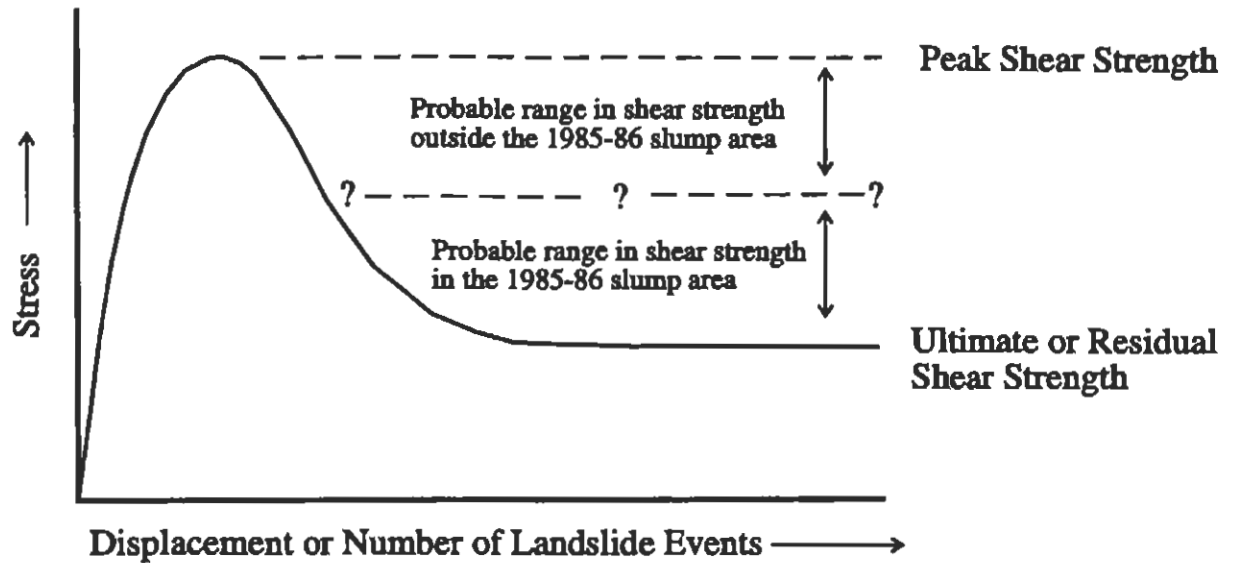
Figure 7. Conceptual diagram showing relation between shear strength and repeated movement along a landslide slip surface. Landslide movement causes shear strength to move along curve from left to right. Eventually, repeated movement, as in the 1985-86 slump area, reduces strength to lowest possible (ultimate) value. Geologic evidence suggests fewer landslide events have occurred outside the slump area and therefore we speculate that shear strengths are somewhat higher. Modified from Jibson and Harp (1996)

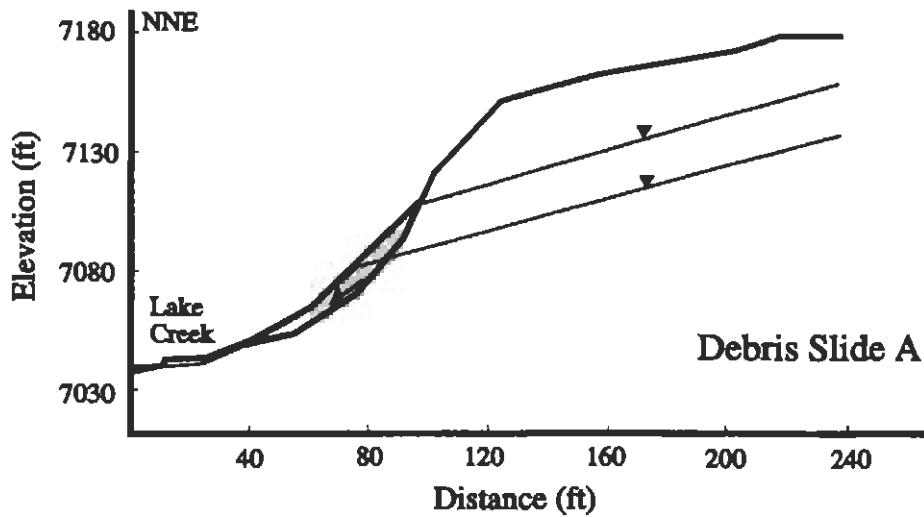
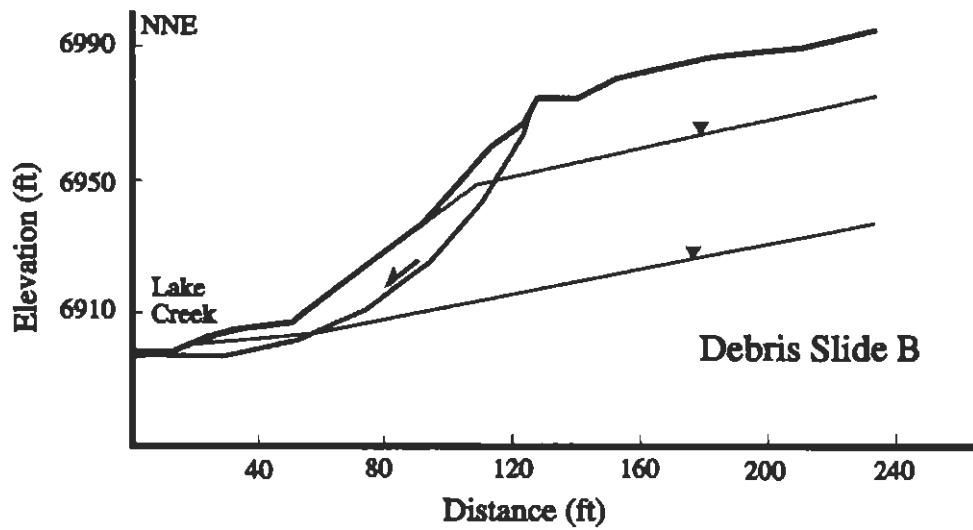
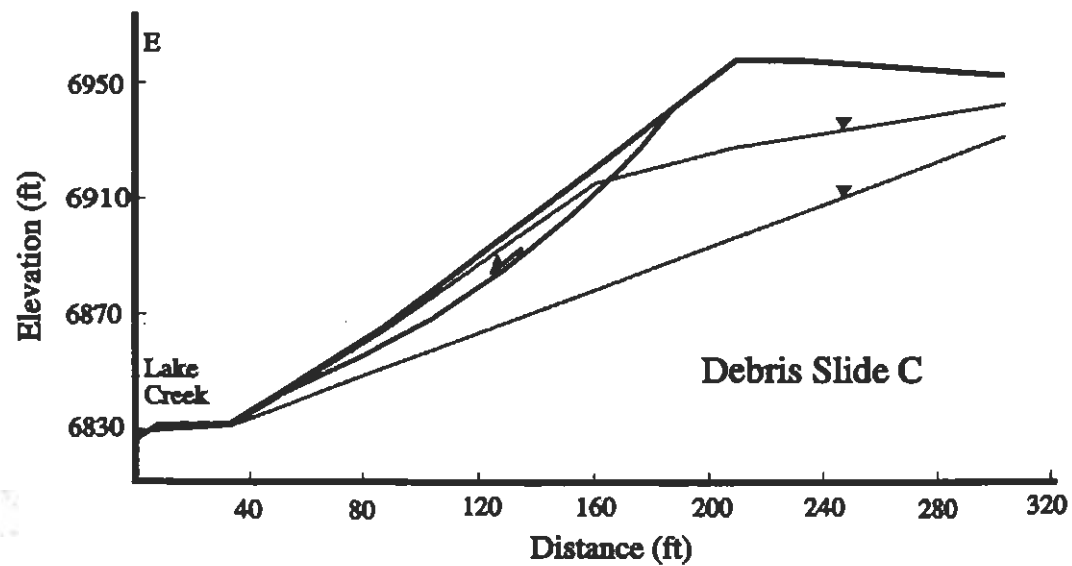
Figure 8. Debris slides along Lake Creek used in slope-stability analyses. Debris-slide letter designation corresponds to profile line that crosses debris slide. Probable ranges of ground-water levels when debris sliding is triggered are shown.

We estimated peak shear strengths of the glacial till by back-calculating failure conditions of three debris slides along Lake Creek crossed by our three topographic profiles (figure 8). Although debris sliding along Lake Creek causes movement of overlying topsoil and colluvium, we observed the slip surfaces cut mostly through the underlying glacial till, thus providing an opportunity to estimate the peak shear strength of the till. In the northwesternmost debris slide C, we profiled both the pre- and post-failure topography from Lake Creek to the crest of the steep slope above the slide. Pre-failure topography was estimated for debris slide A, whereas post-failure geometry was used for slide B because only minor movement was evident.

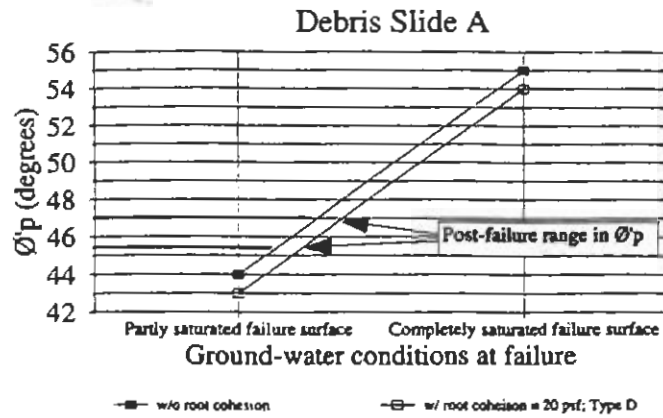
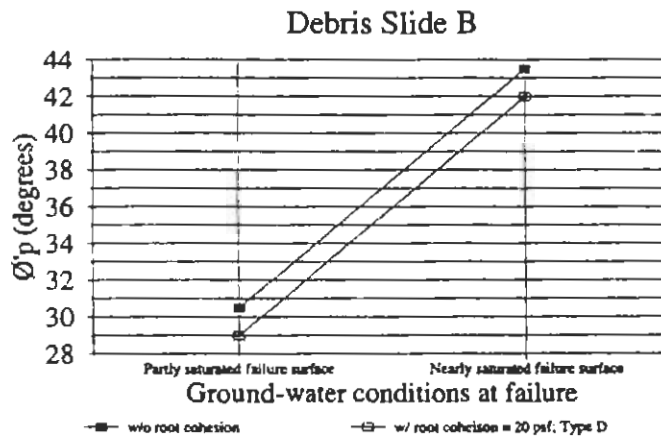
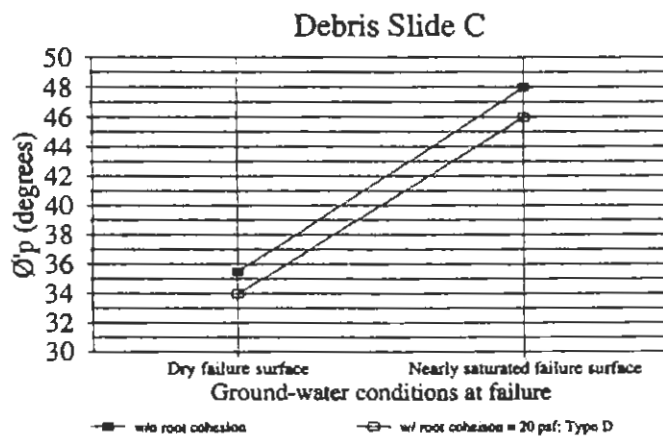
Figure 9. Estimated peak shear strengths of glacial till. Shear strength as a function of ground-water conditions when debris sliding initiated (see figure 8). Plots show range in estimated peak shear strength (ϕ_p) with (lower line) and without (upper line) the contribution in total shear strength from supplemental root cohesion. Estimated post-failure range in ϕ_p is likely upper bound of shear strength in debris slide A and assumes slide is presently metastable.

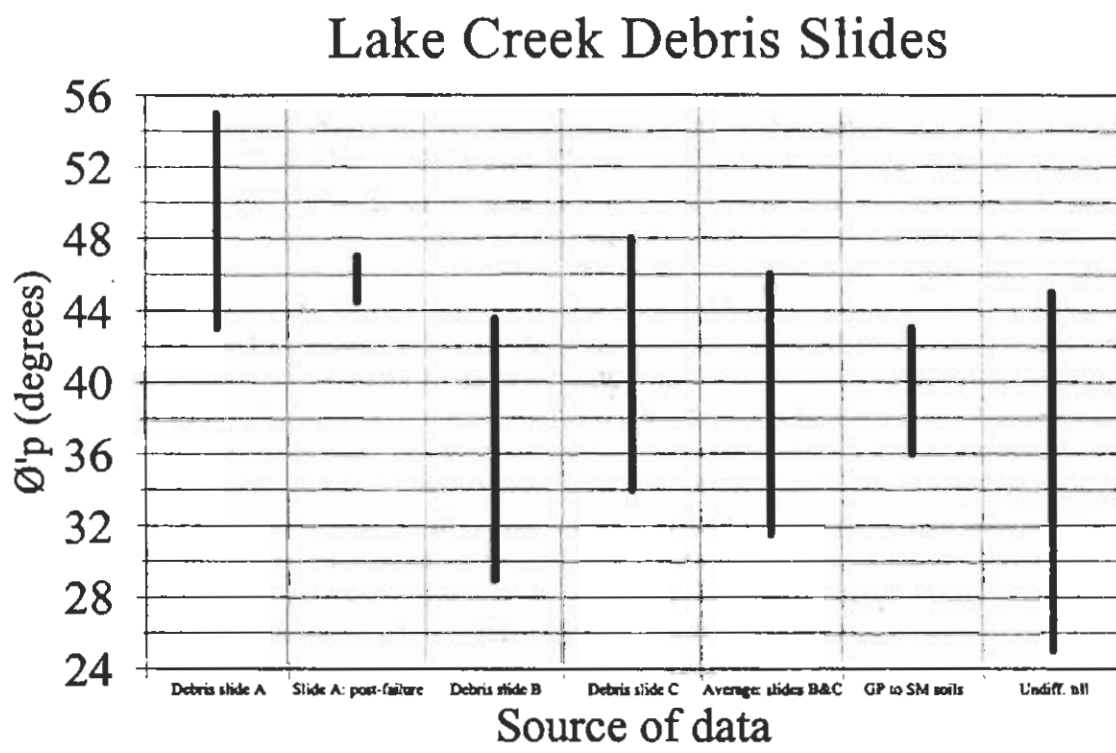
Figure 10. Comparison of estimated peak shear strengths of glacial till with published data. Ranges in estimated shear strength derived from analysis of debris slides B and C generally fall within published ranges for undifferentiated glacial till and soils with Unified soil classification of GP to SM. Apparent high shear strength of till in debris slide A may be anomalous or could possibly reflect uncertainties regarding degree of saturation of slide or metastable state. We regard shear strength determined assuming metastable post-failure conditions as the upper bound of peak shear strength at that location. Range of peak shear strengths for GP to SM soils from Rose (1994); for undifferentiated tills from Kazi and Knill (1969) and Hammond and others (1992).

We must also clarify that the uppermost shear-strength values (upper half of ranges in table 5 and figure 10) in all three slide areas reflect the assumption that debris sliding initiates only at the highest ground-water levels. We believe this requirement may be inconsistent with the observed low ground-water levels in the dry season despite the large number of debris slides along Lake Creek. In our opinion, debris sliding may be triggered at ground-water levels perhaps one-third to one-half as high as the highest levels portrayed in figure 8. Thus, probable shear strengths are more likely to fall within the lower half of the range shown in table 5 and figure 10.

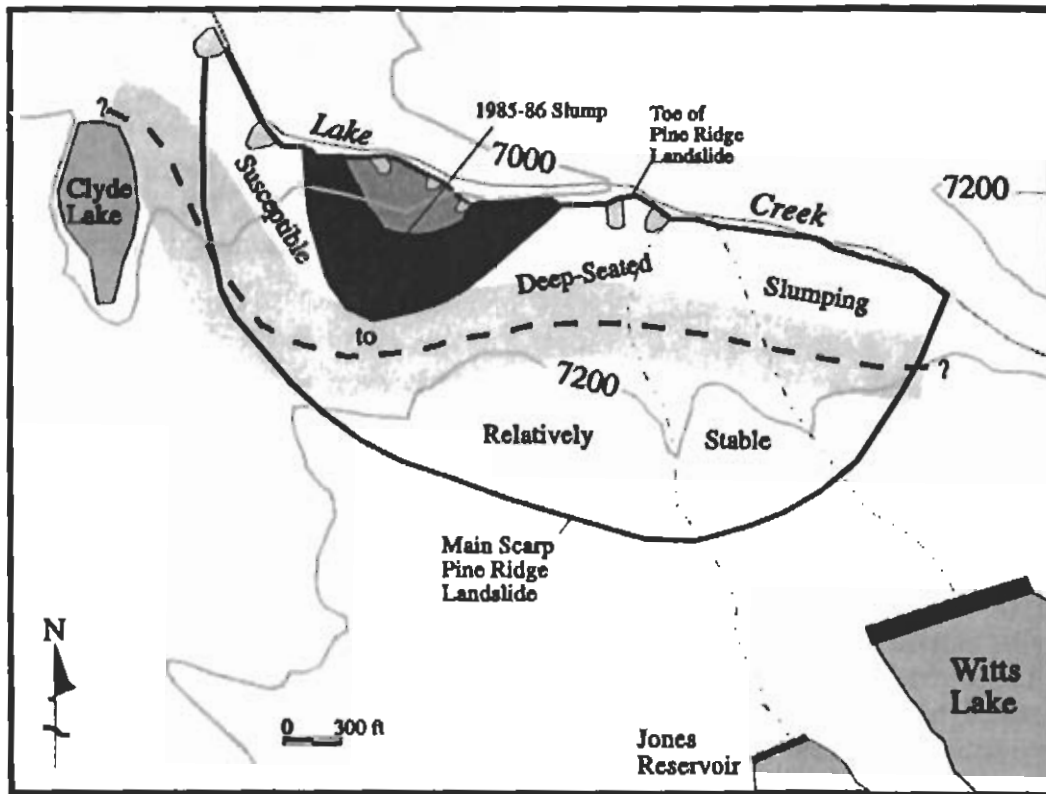
Figure 11. Map showing area susceptible to deep-seated slumping. Results of our analyses suggest northern part of landslide is susceptible to deep-seated slumping at high ground-water levels even if shear strengths of soils approach peak values. Boundary is based on using average shear-strength value. Shaded zone surrounding boundary is zone of uncertainty regarding actual location of boundary. See figure 2 for additional explanation of base map. Elevations in feet above mean sea level.

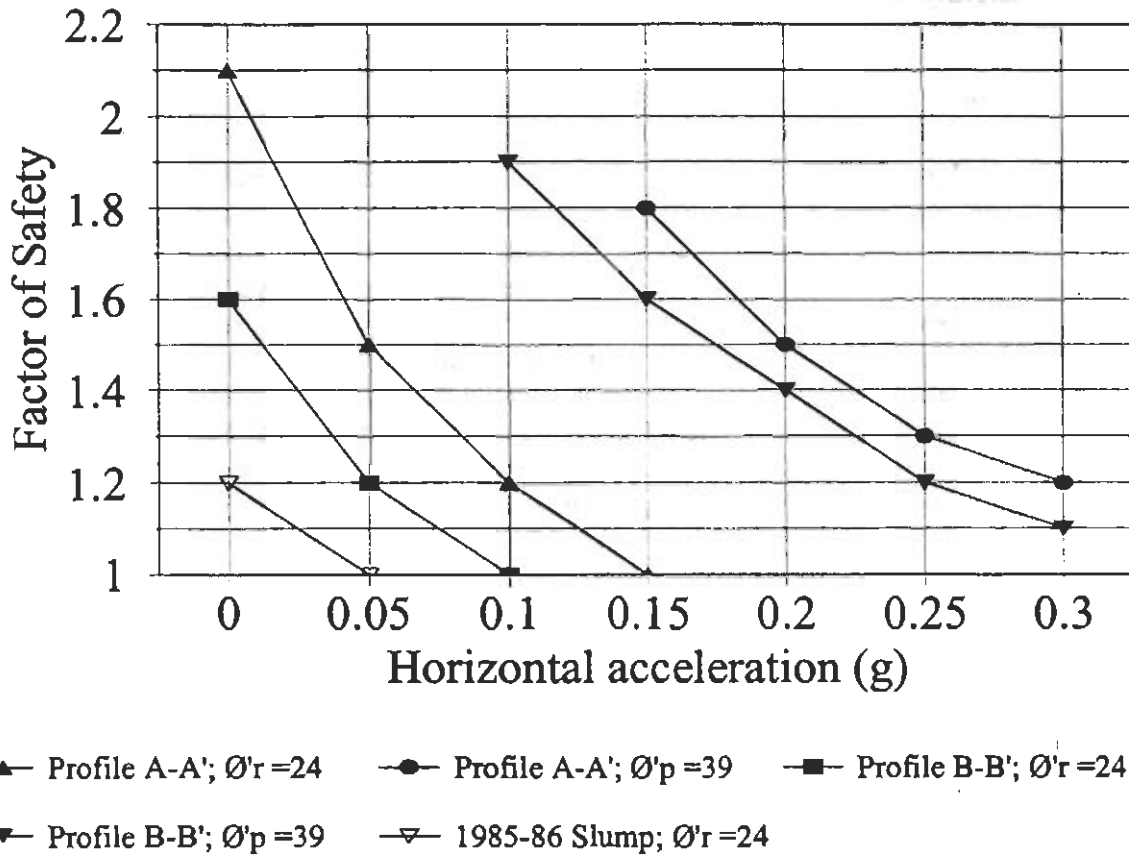
Figure 12. Results of pseudostatic analysis of Pine Ridge landslide. Plot shows a potential for earthquake-induced movement if ground accelerations (PHAs) exceed 0.15 g assuming residual shear strengths prevail along slip surface and high ground-water levels. If shear strength values (ϕ') exceed about 33 degrees earthquake induced movement would require PHAs exceeding the deterministic ground acceleration value of 0.28 g estimated by AGRA Earth & Environmental (1995).

We evaluated the potential for earthquake-induced landsliding using a pseudostatic approach within the range of possible PHAs described above. We assumed that only horizontal acceleration acts on the slide mass and in a direction toward Lake Creek. We also only evaluated earthquake ground shaking during periods of relatively high ground-water levels. Figure 12 shows the results of the pseudostatic analysis of the entire slide (profiles A-A' and B-B') and the 1985-86 slump. Assuming residual shear strength conditions prevail along the pre-existing slip surface of the slide, earthquake-induced movement of the entire slide is possible if ground acceleration exceeds 0.15 g. Higher ground acceleration values are required to induce movement if shear strengths are closer to peak values. If shear strength values (ϕ') exceed approximately 33 degrees, then earthquake-induced landsliding would require PHAs higher than the deterministic PHA value and thus is unlikely.
