SURVEY NOTES

Vol. 17, No. 2

GEOLOGIC HAZARDS OF 1983

THISTLE LANDSLIDE: UTAH'S FIRST PRESIDENTIAL DISASTER DECLARATION

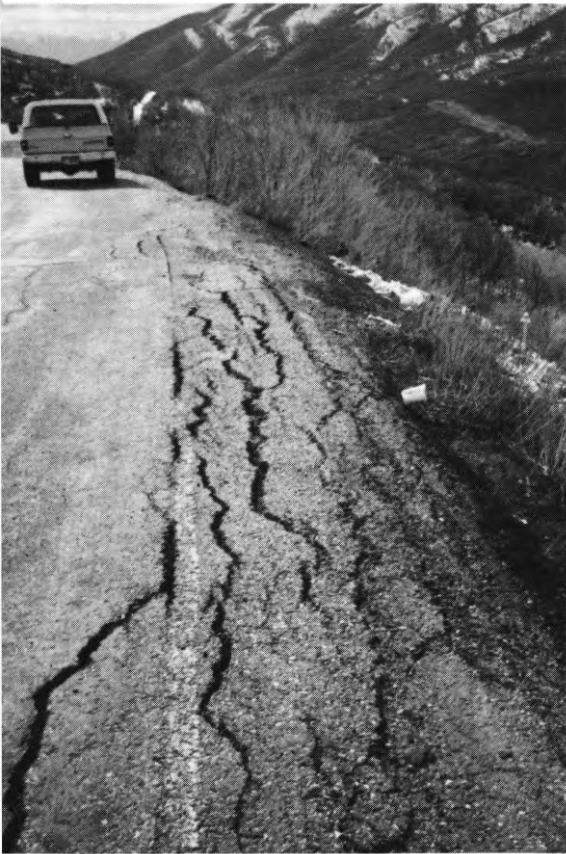
Tension cracks in asphalt surface of State Highway 65, Emigration Canyon, Salt Lake County, caused by insipient slope failure in Triassic shale derived residual soils and road fill. Total failure occurred two months later.

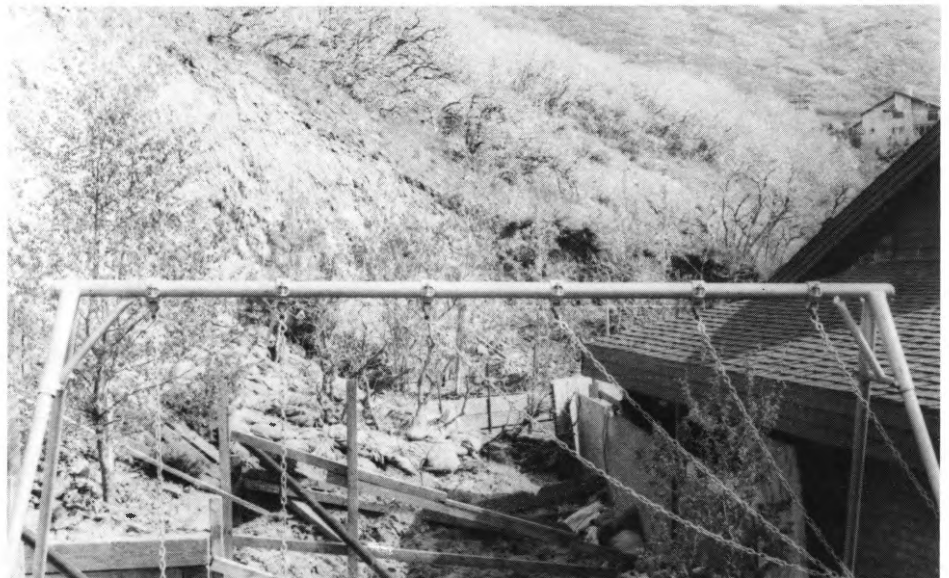
Slope failure of colluvium behind home along mountain front in Salt Lake City. Note projective measures with debris against house.

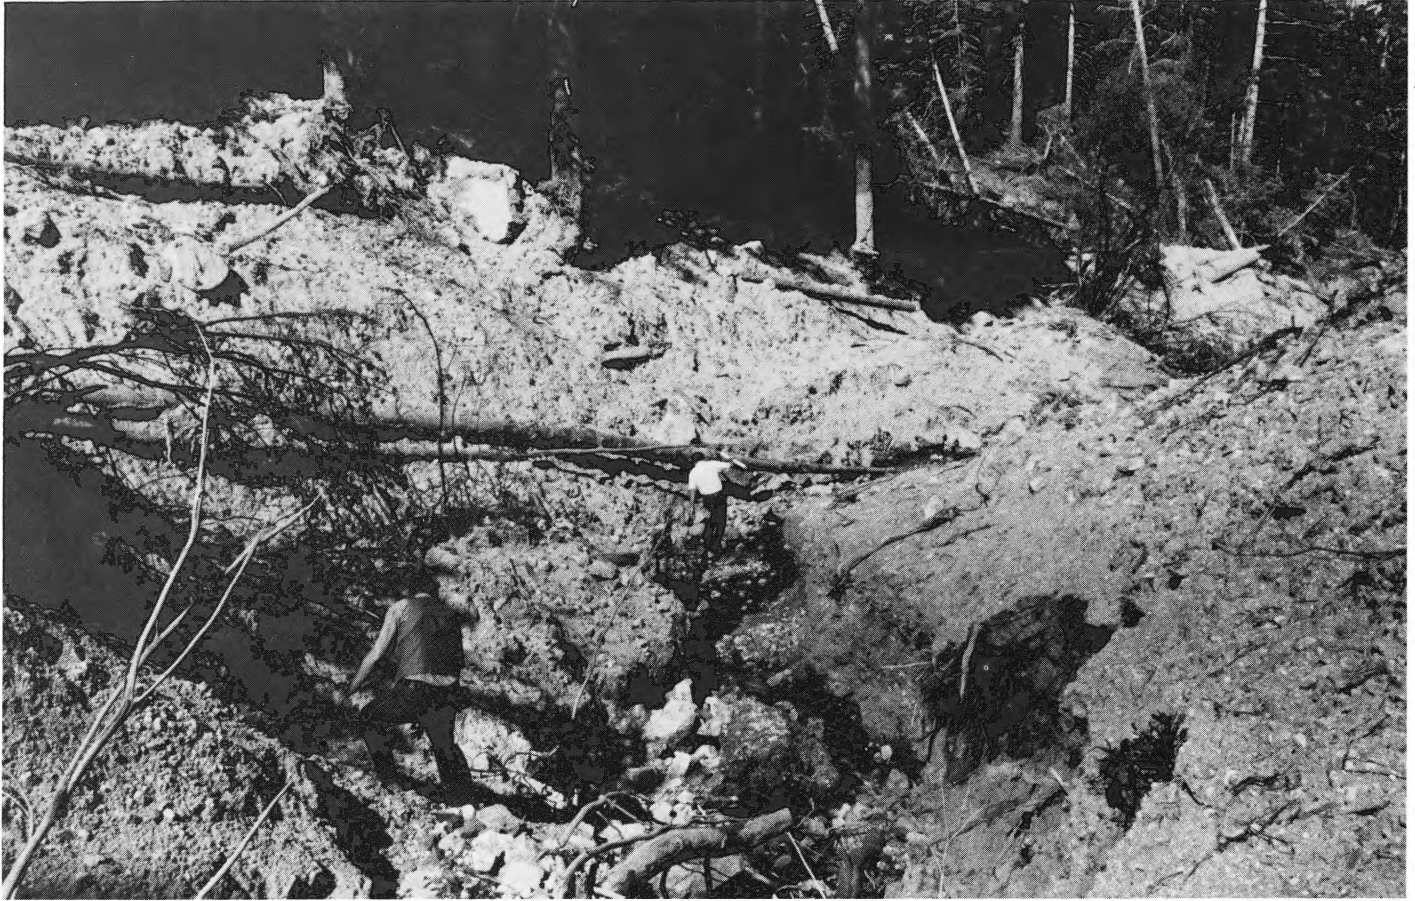
Debris choked channel of Holbrook Canyon, Bountiful.

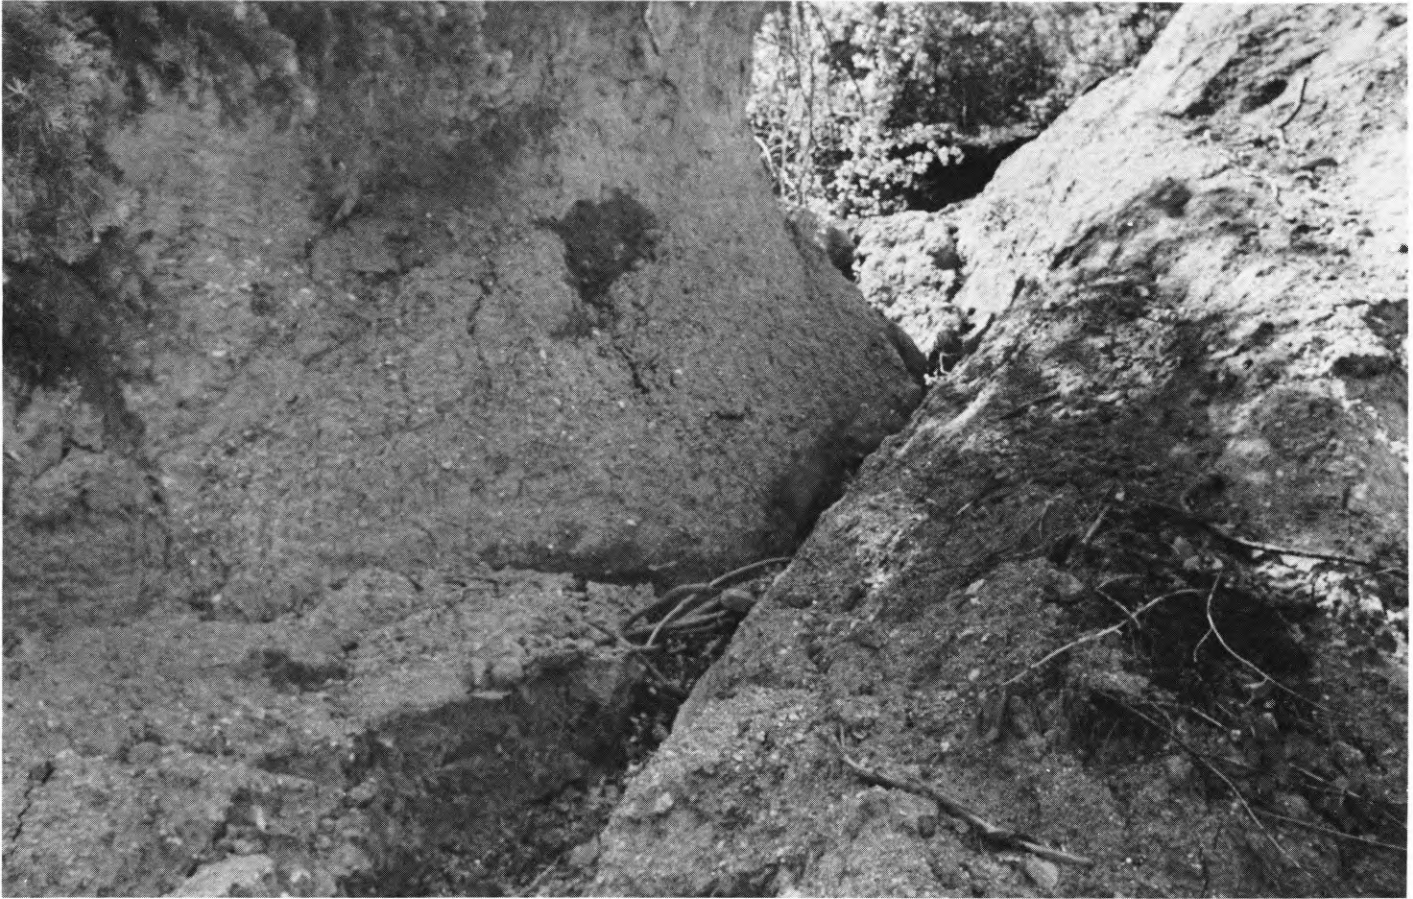
Canyon channel scour in unconsolidated sediments of Barton Creek, Bountiful.

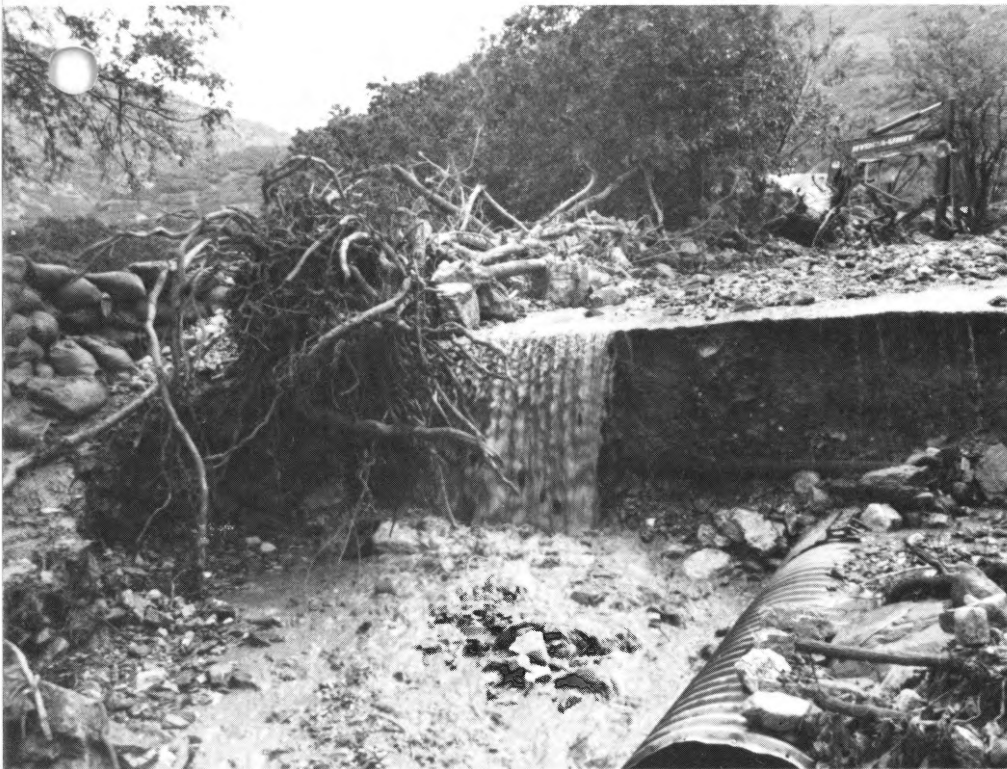
Debris flood damage at top of residential subdivision, mouth of Coldwater Canyon, North Ogden City.

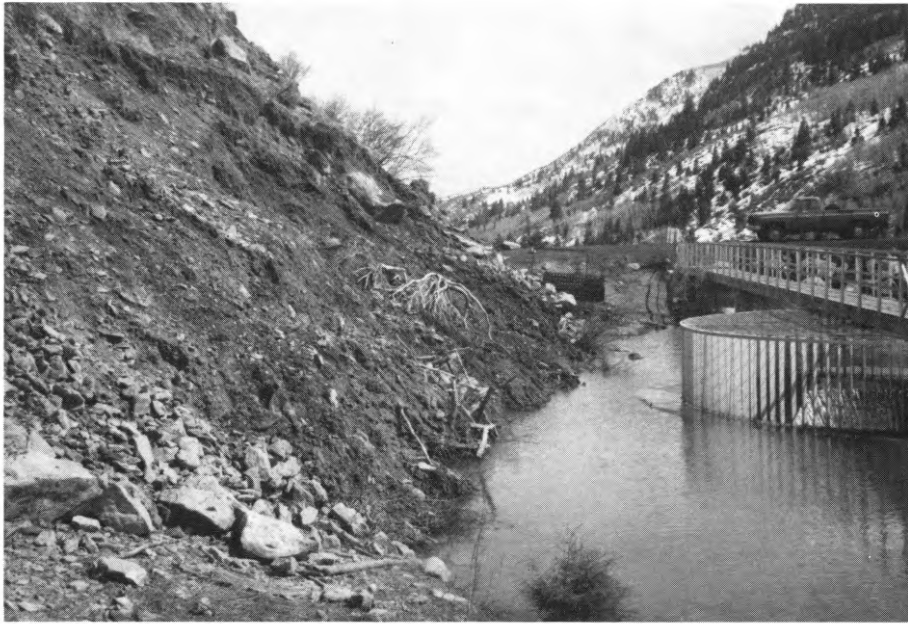
Disturbed slope on left is toe of landslide which comprises left abutment to dam and reservoir slope immediately upstream.

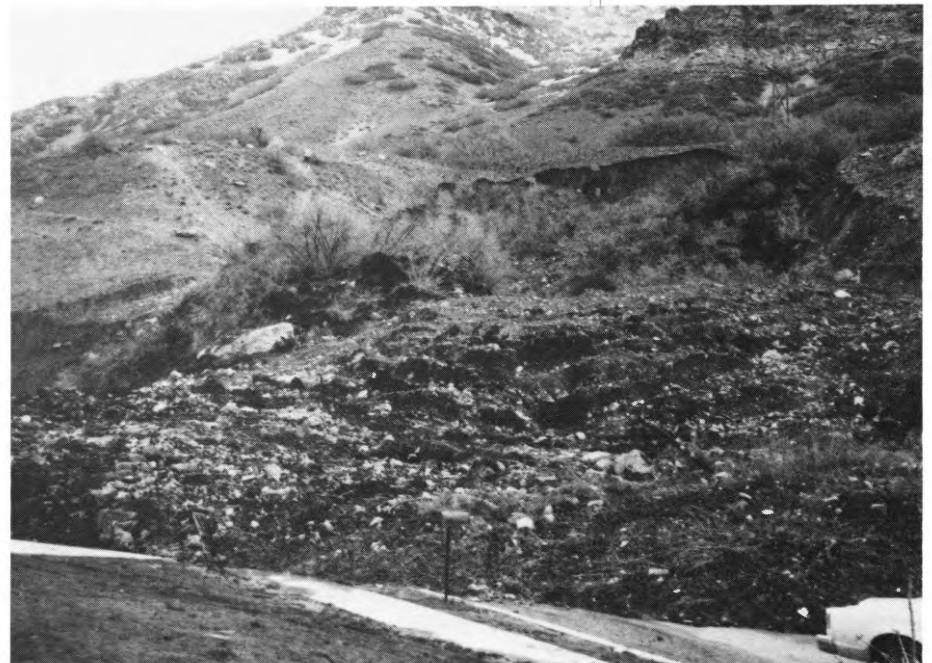
Typical circular (failure plane) landslide on Provo City's high east bench, in ancient landslide terrain. Note toe crossing 1500 East Street and resting on front yard (left, foreground).

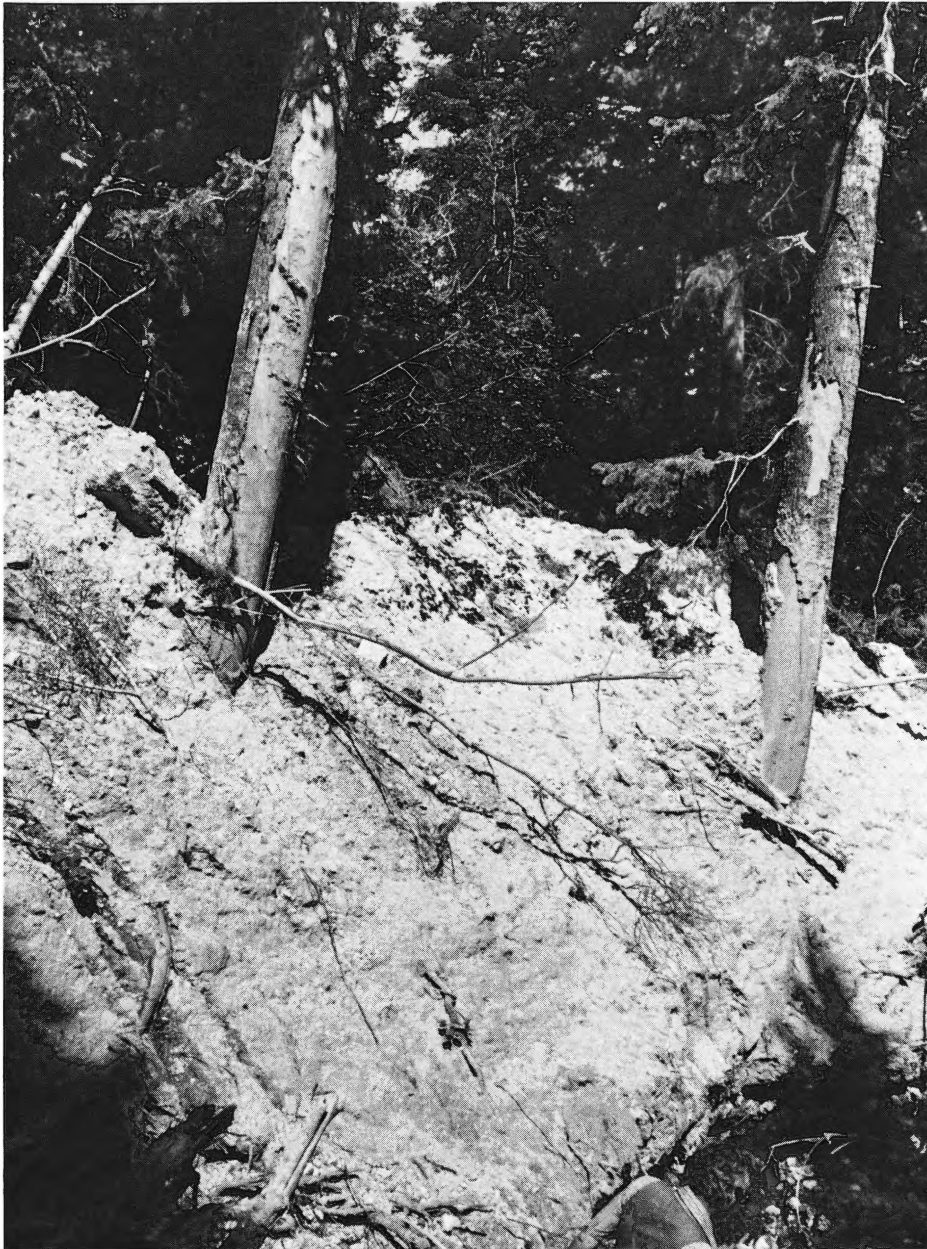
Tree damage indicating maximum debris flow surge height in Barton Creek, Bountiful.
