APPENDIX E:

**SCANNING ELECTRON MICROSCOPY,
EPIFLUORESCENCE, CATHODOLUMINESCENCE,
AND FLUID INCLUSIONS, LISBON FIELD,
SAN JUAN COUNTY, UTAH**

**B-610 WELL,
LISBON FIELD**

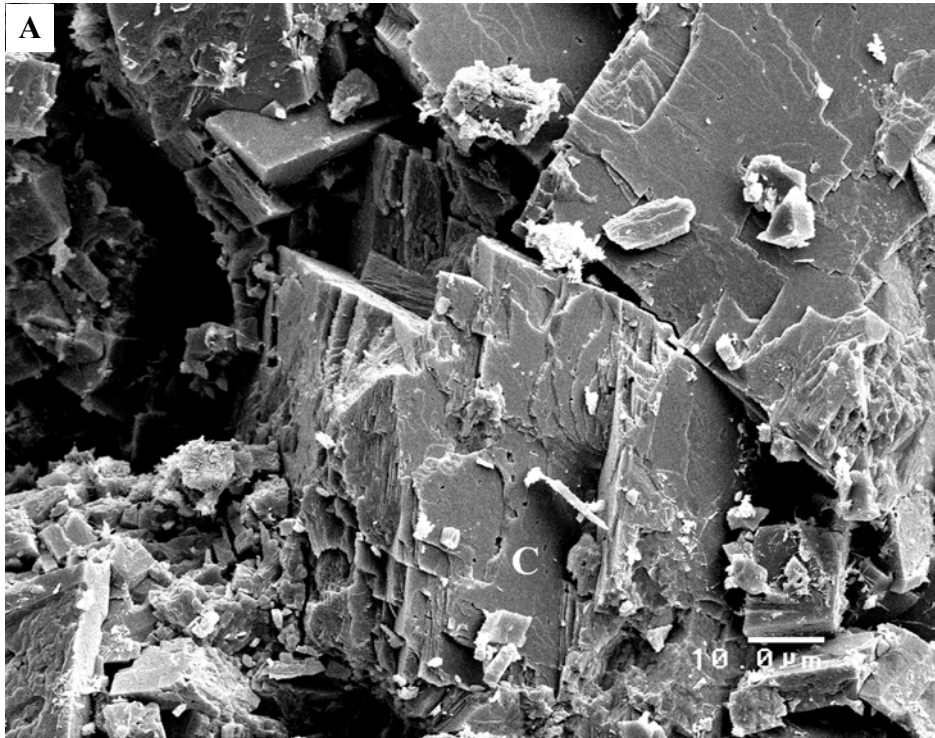
Photomicrograph 3A.
Lisbon B-610. SEM
photomicrograph of a
core plug from 7886'.
Enlargement showing
rare calcite cement
(C). Black is porosity.
Scale represents 10
microns (0.01 mm).

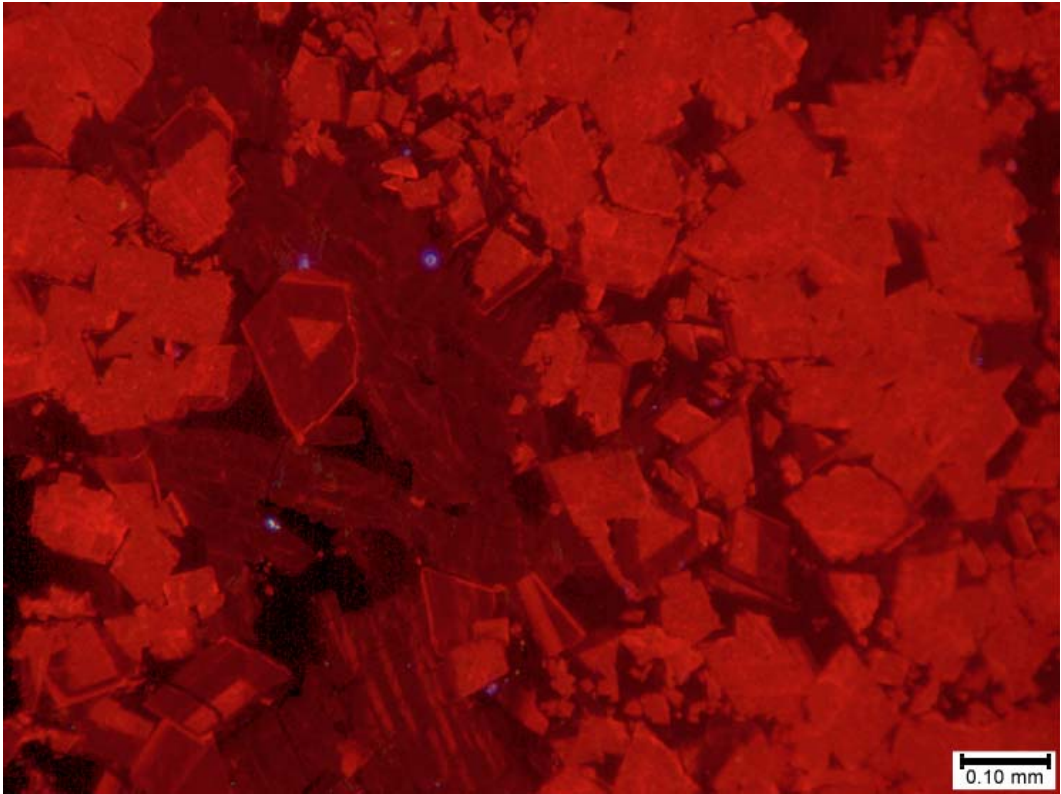
Two types of cathodoluminescence response are visible within these moderately coarse dolomite crystals. Bright red luminescence can be seen within the interiors of most of the replacement dolomite. However, many of the crystals exhibit non-luminescent overgrowths of variable thickness. In addition, some crystals, especially from the band of material between the upper left and the lower center, exhibit mostly non-luminescent material. These particular crystals may be largely dolomite cements. Finally, some dolomite crystals exhibit a thin rind of red luminescing dolomite overlying the non-luminescent overgrowth stage. Dissolution and corrosion of some crystals is evident between the second (non-luminescent) and the final luminescent rim (see the “healed” large zoned crystal in the left center of this image.)

The same field of view as the previous photomicrograph is shown here under plane light. Note the generally coarse nature of these subhedral to euhedral dolomite crystals. The copper-colored areas in this view are open pores (with impregnated epoxy that has been discolored by the electron beam used for cathodoluminescence). The black areas within this field of view are due to black pyrobitumen coatings on many of the dolomite crystal surfaces.

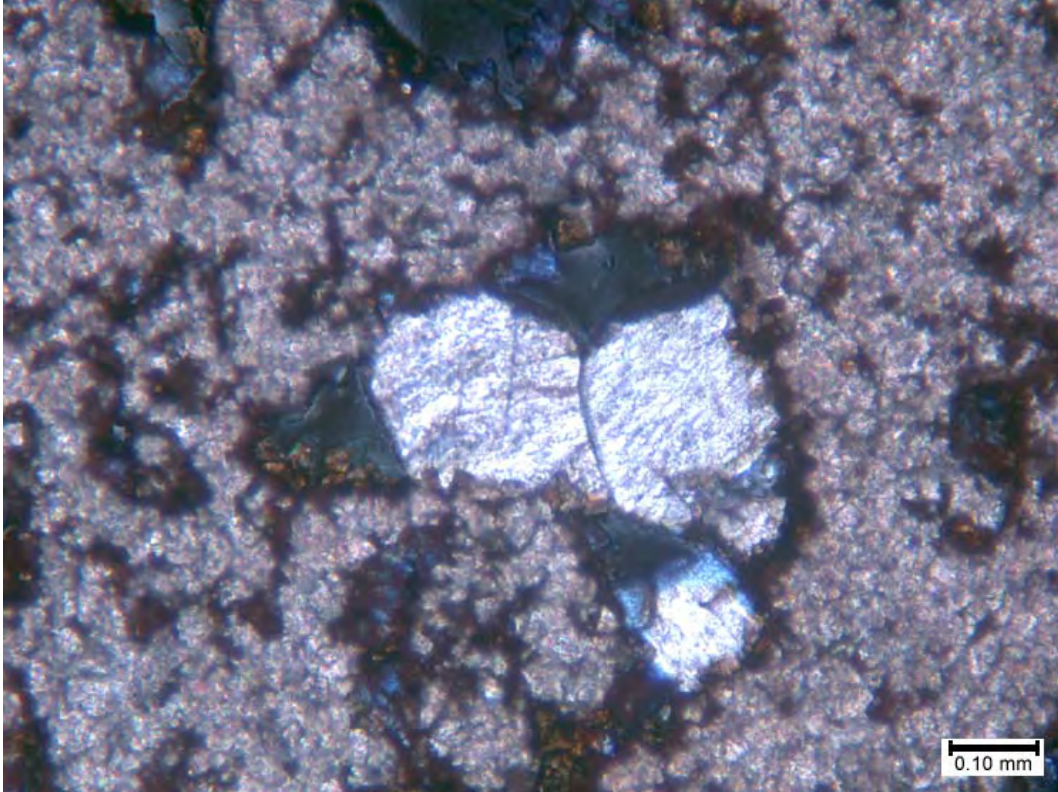
8486 feet

The same field of view as the previous two photomicrographs is shown here under crossed nicols. The replacement dolomites mostly display thick, cloudy interiors and thin clear rinds or overgrowths. The larger dolomite rhombs and “saddles” occur as cements that display some yellow to gold colors in their pore-lining habits. Upon close examination, these cements frequently display sweeping extinction and evidence of strained crystals. The late calcite spar cements have plane extinctions. The black (opaque) material lining most pores and crystals surfaces is mostly pyrobitumen.

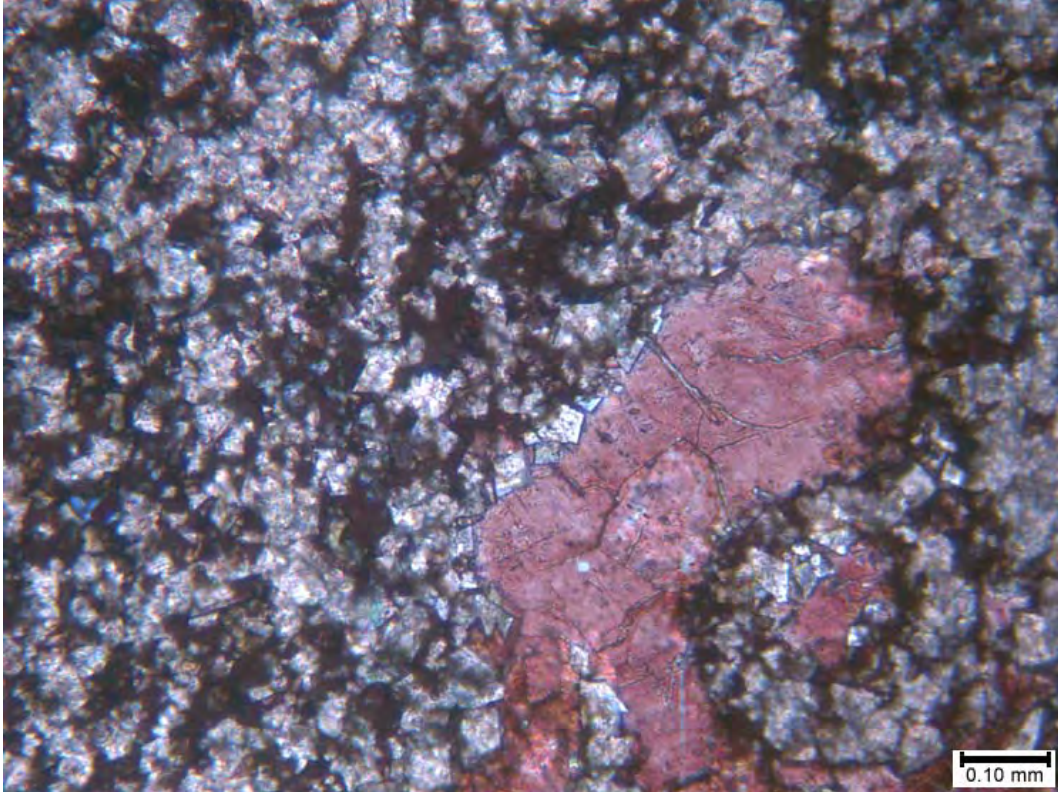
8486 feet

The same field of view as the previous two photomicrographs is shown here under crossed nicols. Note that some of larger dolomite rhombs seem to exhibit undulose or sweeping extinction indicative of possible saddle dolomites. The red-stained area of original (non-replaced) limestone (calcite) displays straight extinction.
