**APPENDIX I:
THIN SECTION EPIFLUORESCENCE
AND DESCRIPTIONS, BUG AND
CHEROKEE FIELDS, SAN JUAN
COUNTY, UTAH**

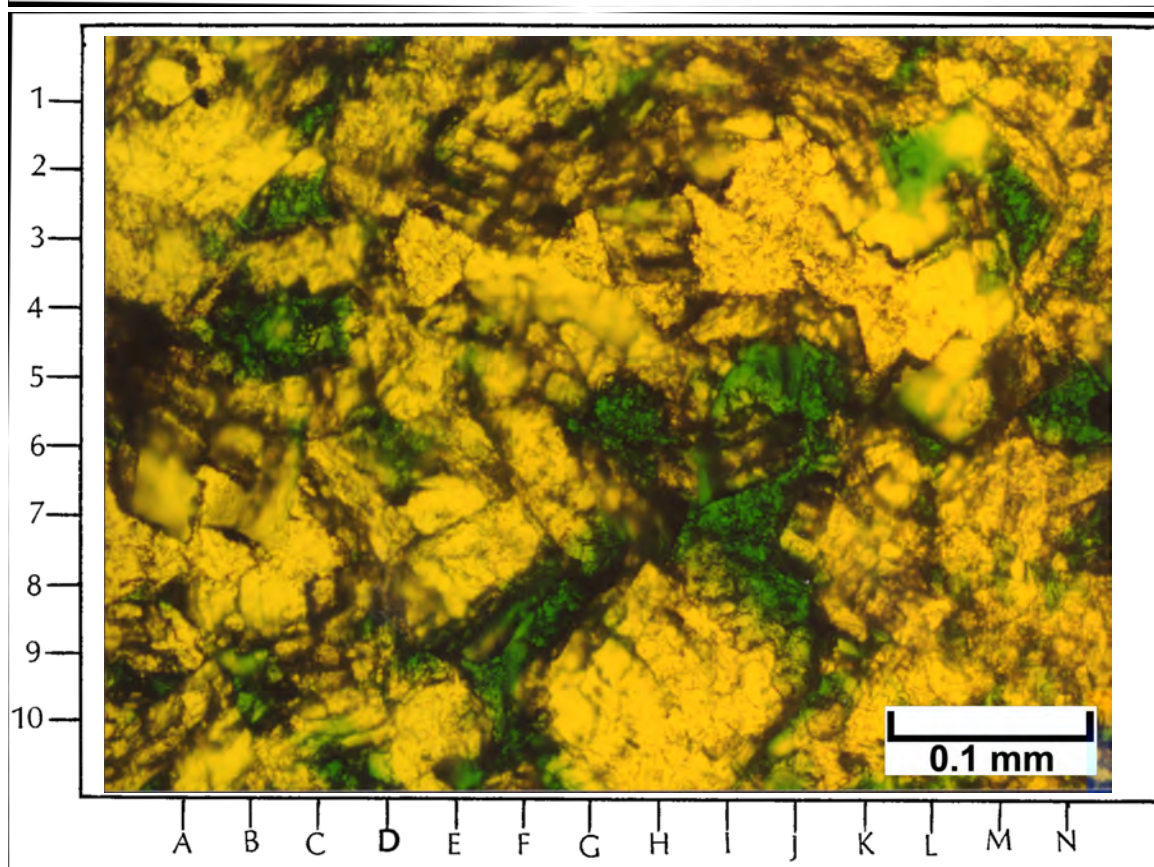
This PI view shows the same view as above at the same magnification. Note that the outlines of pores are indistinct, despite the impregnation of these pores with blue-dyed epoxy. In addition, it is not possible to see the corroded dolomite rhomb margins with PI microscopy.

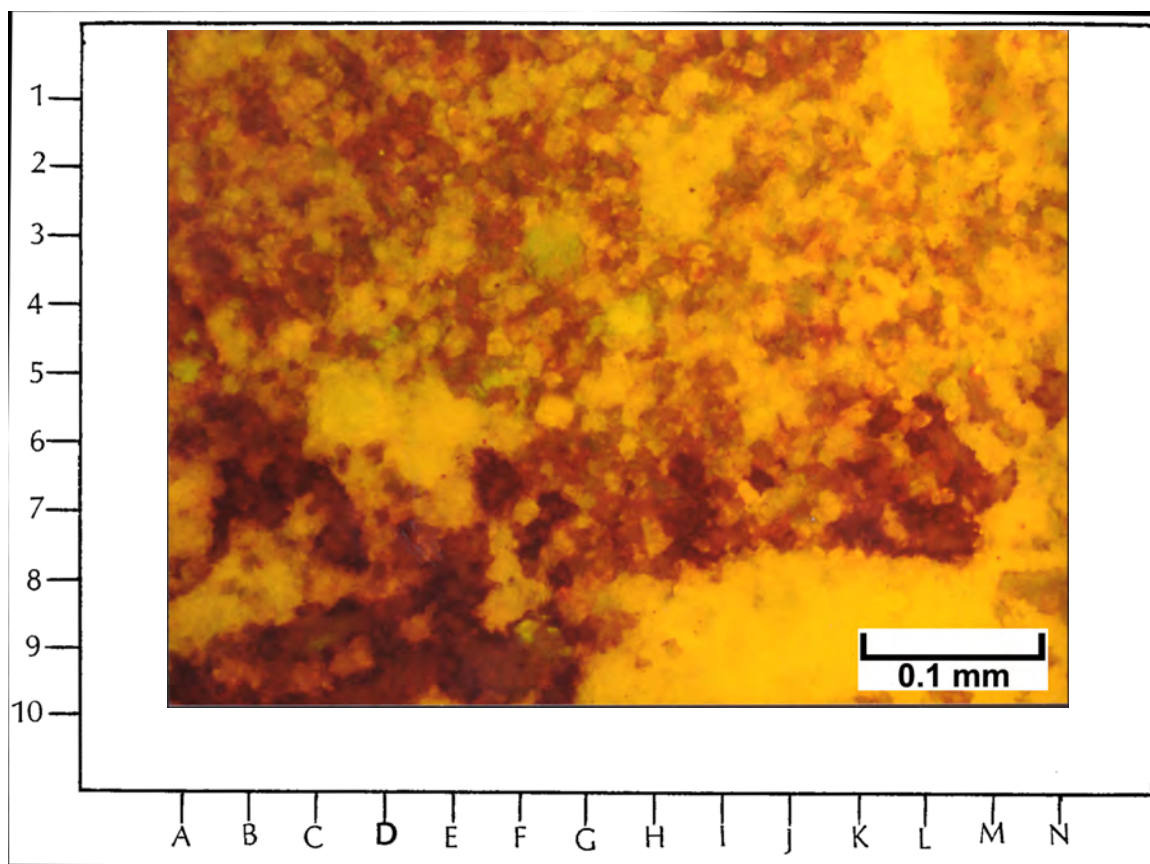
Bottom Photomicrograph

The same field of view as above is shown under PI at the same magnification. Significant portions of this image show porosity (in blue), but much of the additional porosity is invisible due to opaque linings of bitumen which blocks the viewing of the other impregnated pores. Also, the pore outlines and shapes are much more difficult to see than in the fluorescence microscopy view above.
