THE SEPTEMBER 2, 1992 M_L 5.8 ST. GEORGE EARTHQUAKE, WASHINGTON COUNTY, UTAH

CIRCULAR 88
UTAH GEOLOGICAL SURVEY
a division of
UTAH DEPARTMENT OF NATURAL RESOURCES

This circular presents scientific observations and documents damages and losses from the St. George earthquake. Each agency listed above contributed a report summarizing their findings. These reports are edited to remove duplication where possible and are formatted to conform to UGS editorial standards. However, all conclusions and recommendations are those of the agency and author contributing the report.

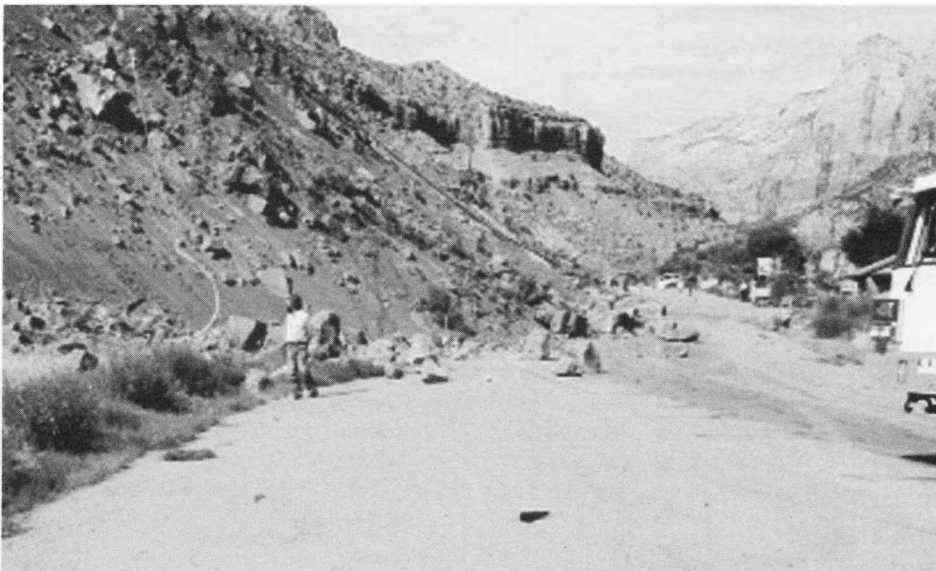
Figure 5. Toe of the Springdale landslide near State Route 9. Note ruptured utility lines in the toe of the slide. Photo by B.D. Black.

(SR) 9 leading to Zion National Park, and ruptured both buried and above-ground utilities in the subdivision and along SR 9 (figure 5); condominiums and businesses around the periphery of the slide were temporarily evacuated. A smaller slope failure west of the Springdale landslide, called the Paradise Road landslide (figure 2), was also triggered by the earthquake but caused no damage.

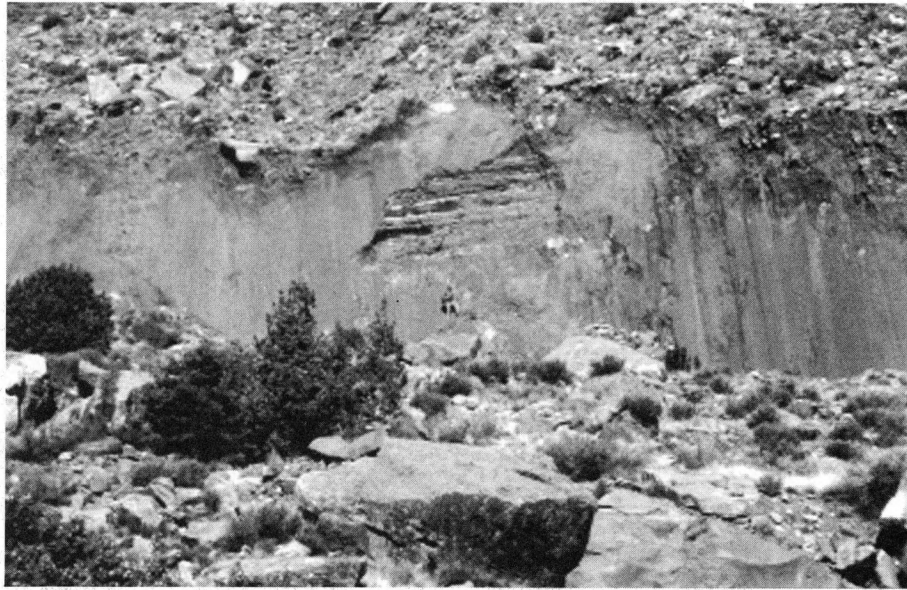
Figure 6. Main scarp of the Springdale landslide. Photo by S. Olig.

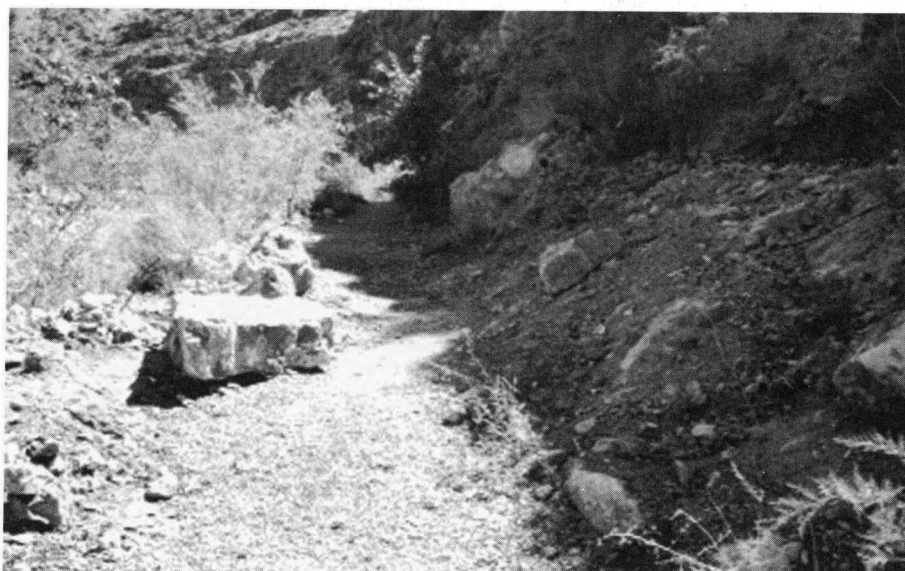
Figure 9. Rock fall on a footpath at Pah Tempe Resort in La Verkin. Photo by B.D. Black.

Numerous rock falls were observed along the steep cliffs above SR 9 from La Verkin to Zion National Park, in the Hurricane Cliffs along the Hurricane fault, and in St. George along the Red Hills and West Black Ridge. In most cases, the rock falls either occurred in uninhabited areas (causing no damage) or fell onto roads and were quickly cleared away (figure 8). However, at an unreported location a truck was hit by a boulder, and in St. George a boulder crashed through a wall and damaged a car (unpublished Utah Division of Comprehensive Emergency Management final field report). Rock falls also caused damage to footpaths and irrigation lines at Pah Tempe Resort in La Verkin (figure 9), and blocked an unused section of the Hurricane Canal east of Hurricane. Numerous fresh rock-fall scars, probably from rock falls caused by the earthquake, are present in cliffs of the Moenkopi Formation near the Arizona border (figure 10).

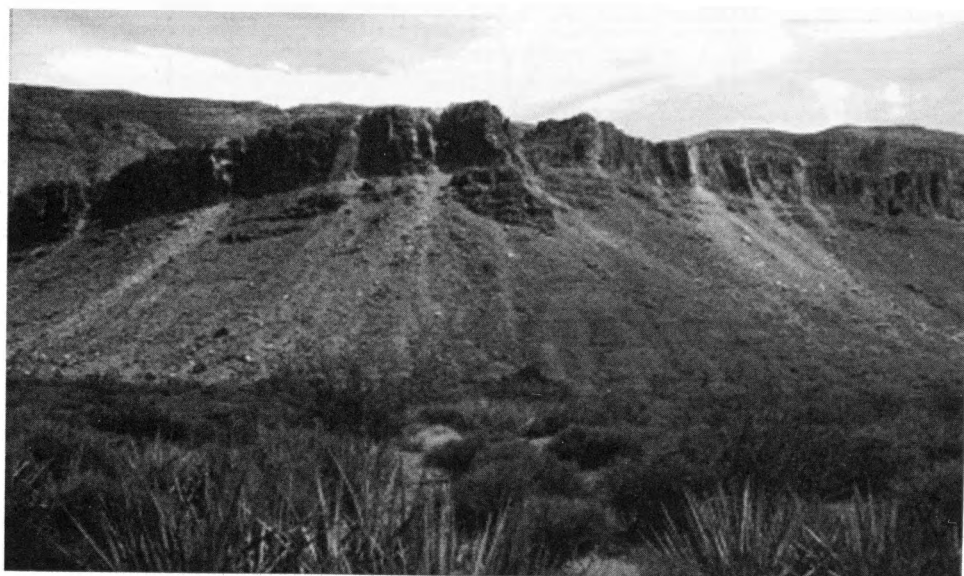
Figure 10. Rock-fall scars in cliffs of the Moenkopi Formation near the Arizona border. Photo by W.E. Mulvey.

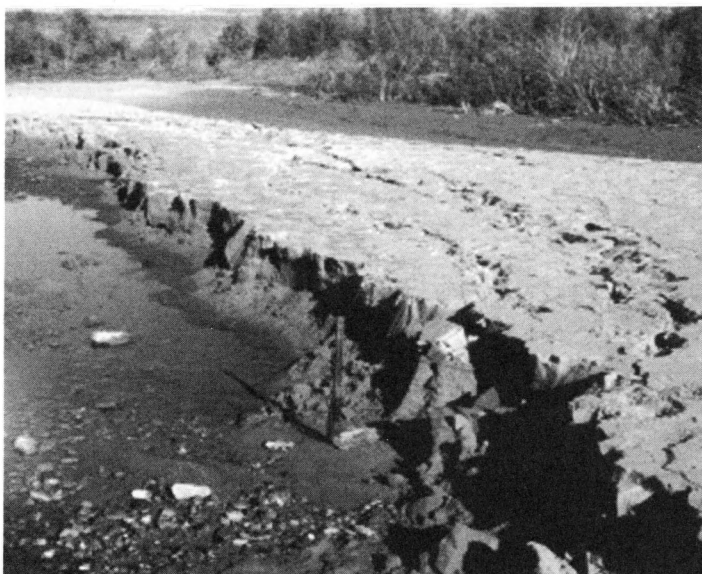
Figure 12. Lateral-spread cracking from liquefaction along the Virgin River. Photo by W.E. Mulvey.

Lateral spreads result when liquefaction of a shallow subsurface layer causes overlying intact layers to crack and "raft" downslope. They were common on gentle (0.5 - 3 degree) slopes underlain by alluvial sands along the modern flood plain of the Virgin River (figure 12). Most cracks were arcuate, extending up to 20 meters (65 ft) parallel and 8 meters (25 ft) perpendicular to the river. The largest lateral spread extended along the river for 60 meters (196 ft) and perpendicular to the river for 20 meters (65 ft) (no. 5, figure 11). Cumulative crack width, which indicates the total amount of lateral movement, was more than 48 centimeters (19 in).

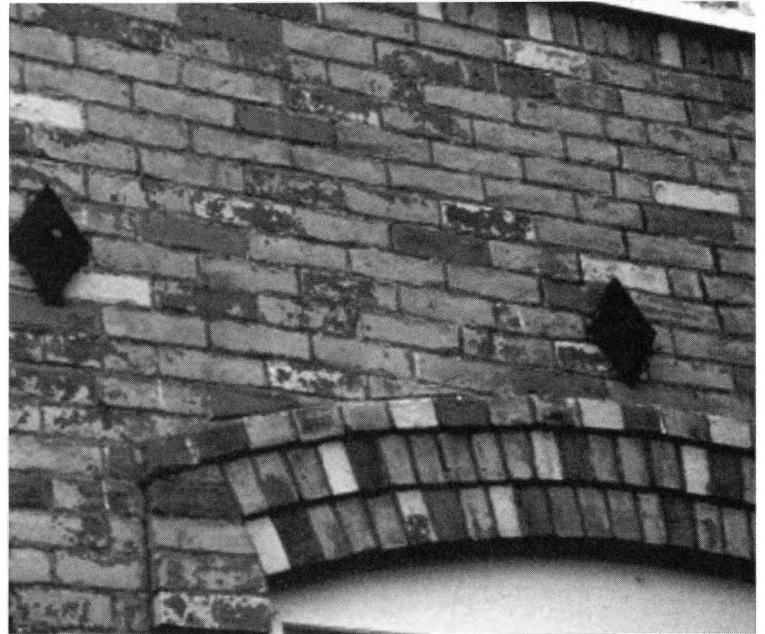
Figure 3. (A) Damage to an unreinforced 2-story brick house in Hurricane historically referred to as the Stanworth home. Chimneys were twisted and partially fell, the walls and foundation were severely cracked, and two walls partially separated from the first-story ceiling, necessitating bracing and eventually structural repair (shown in figures 3B and 3C) to prevent collapse. (B) Anchor bolts used to repair one of the damaged walls in the Stanworth home. (C) Tie rod used to repair one of the damaged walls in the Stanworth home. Photos provided by Charles M. Sheperd, Utah State Historical Society.

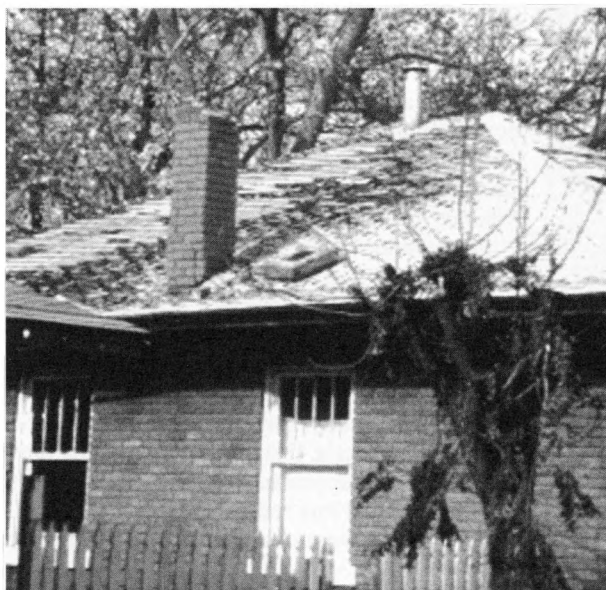
Figure 5. Chimney damaged in Hurricane. Photo provided by Charles M. Sheperd, Utah State Historical Society.

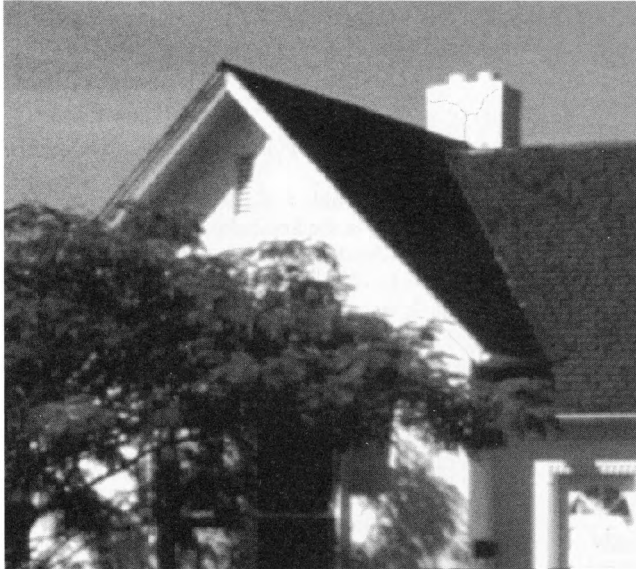
Figure 6. Shear cracks in chimney at a house in St. George. Photos provided by Charles M. Sheperd, Utah State Historical Society.

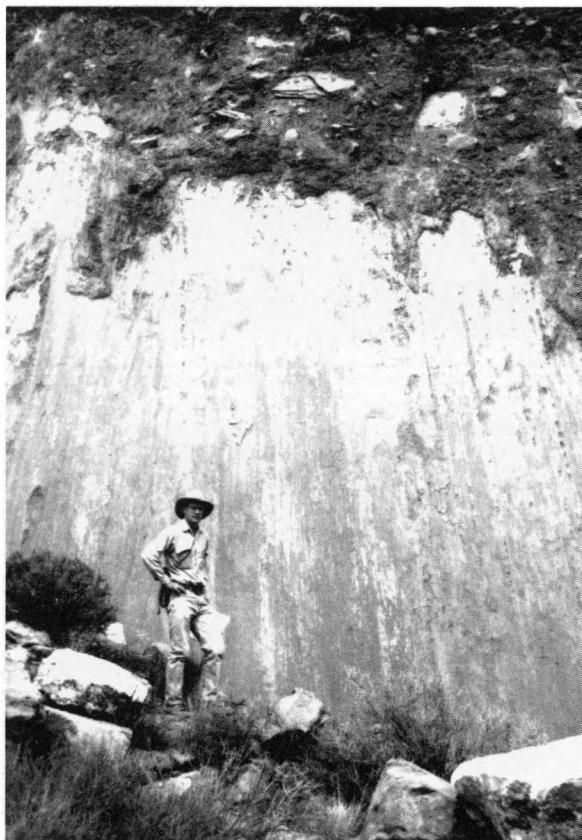
Figure 4. Main scarp of the Springdale landslide showing well-developed slickensides.

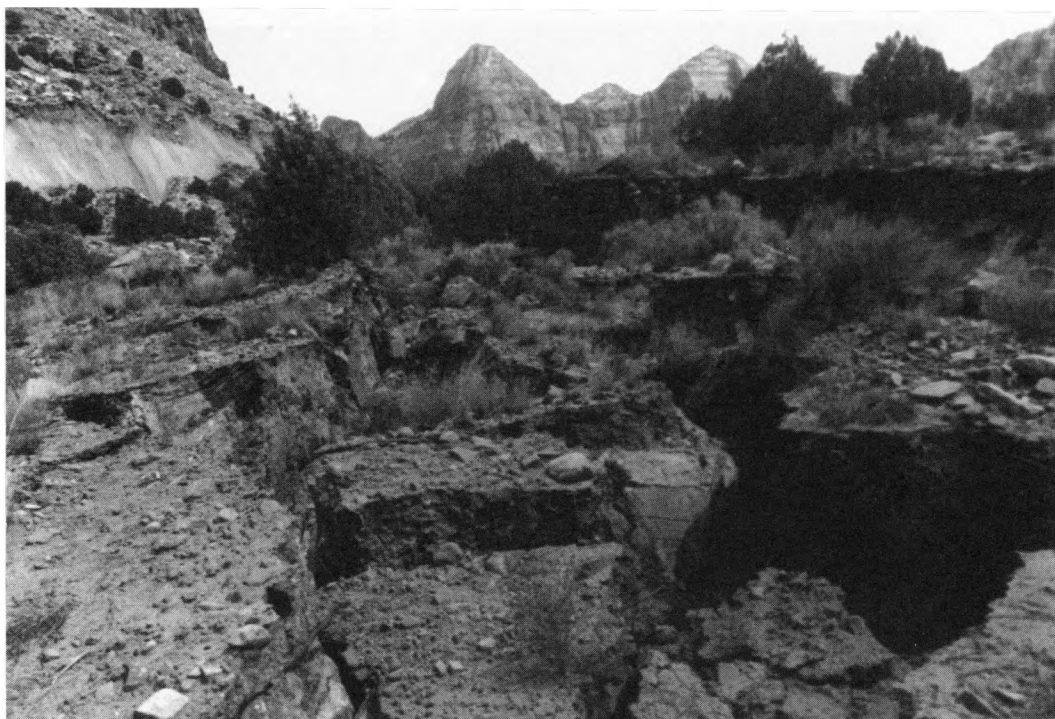
Figure 5. Extension fractures within graben that extends parallel to main scarp (upper left).

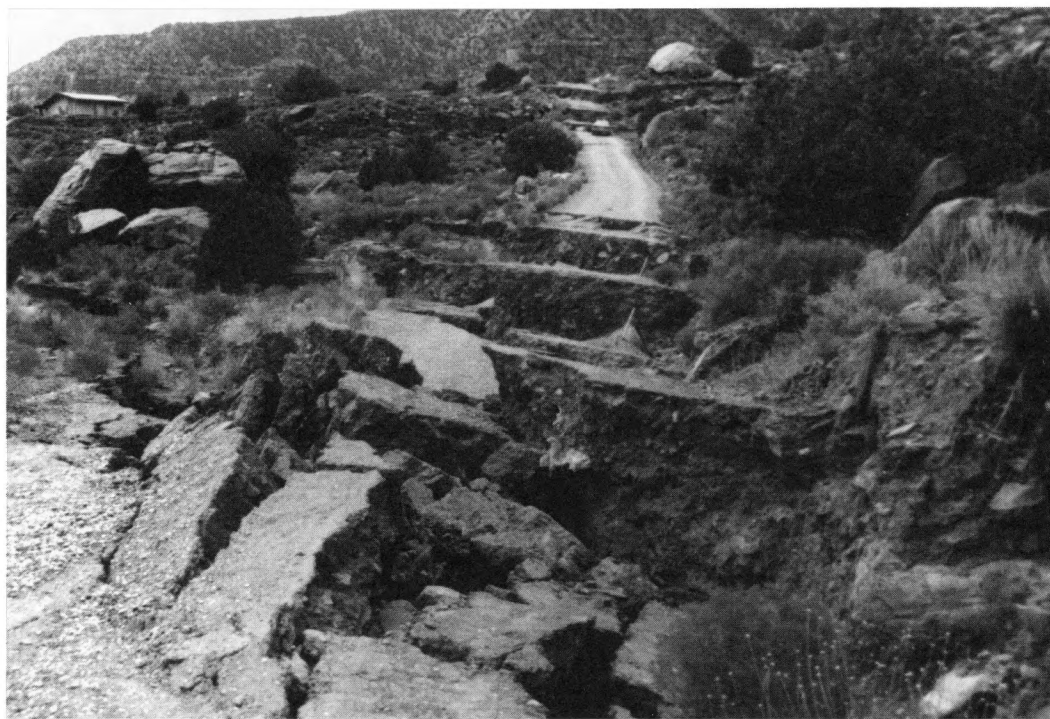
Figure 6. Graben extending parallel to direction of landslide movement (right to left). The car (visible in the upper center) was abandoned by homeowners trying to escape the landslide; the road was blocked by the far wall of the graben, which must have formed before the near wall (foreground).

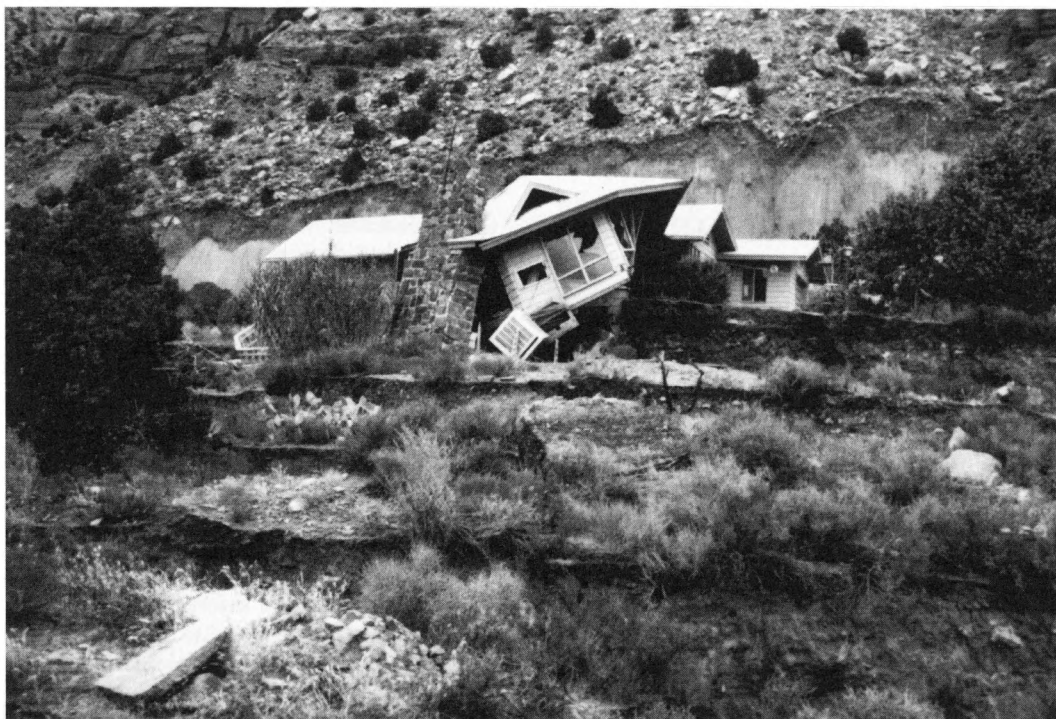
Figure 7. House on the western part of the Springdale landslide destroyed by differential movement along internal scarps and other fractures. Main scarp is visible behind the house.

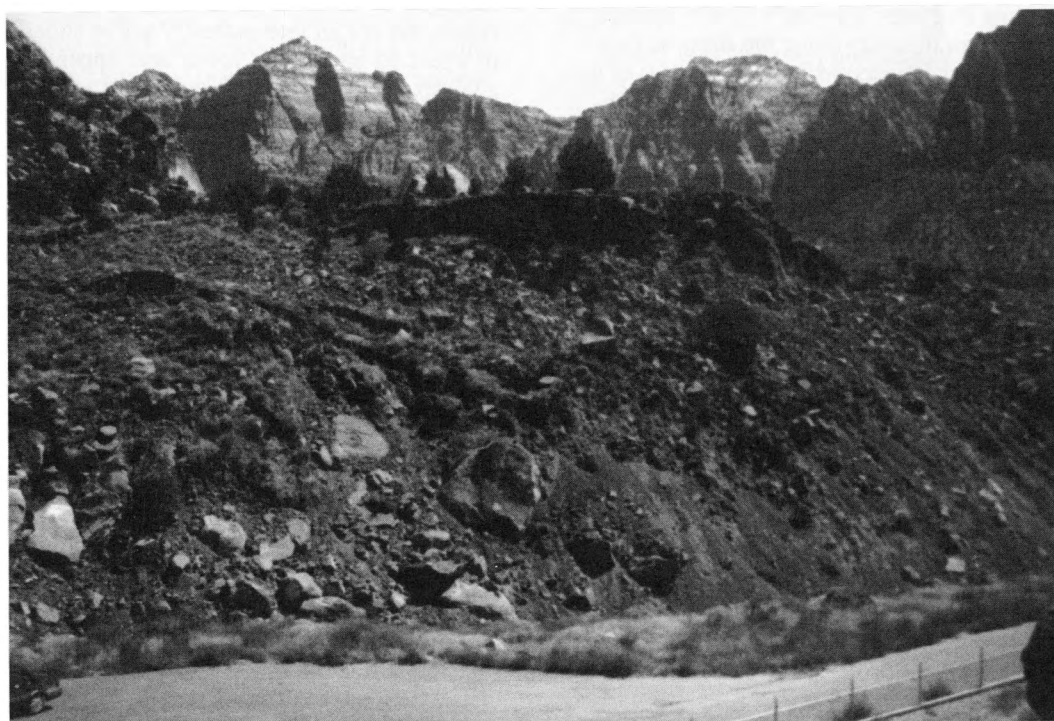
Figure 8. Western part of landslide toe near mouth of Blacks Canyon. The toe is very steep and has dilated, also shallow slides and falls of soil and rock have formed.

The toe of the landslide consists of a very steep, bulging front that moved laterally outward several meters (figure 8). The southeast part of the toe moved part way across State Route 9, temporarily blocked access to Zion National Park, and destroyed utility lines. The southernmost lobe of the toe moved to within a few meters of a condominium complex that had to be temporarily evacuated. The western part of the toe moved into and partially blocked the stream draining Blacks Canyon. Landslide material at the toe was dilated and oversteepened, which gave rise to several shallow debris slides.

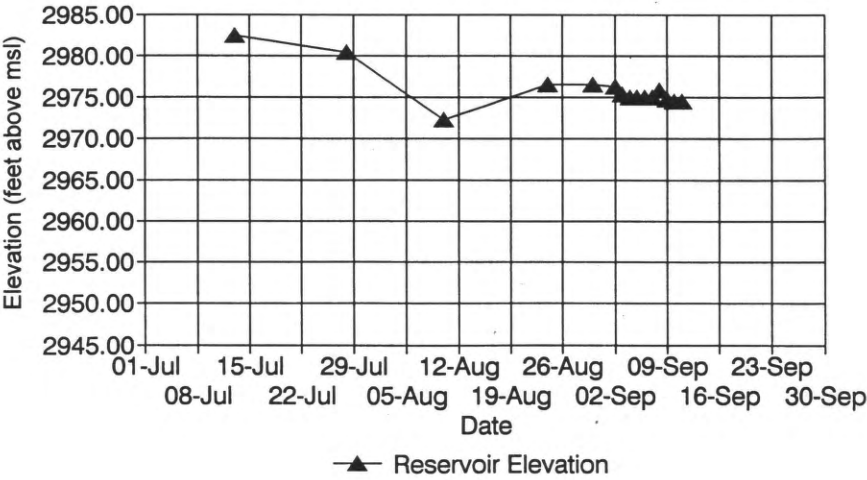
Figure 2. Quail Creek Reservoir level.

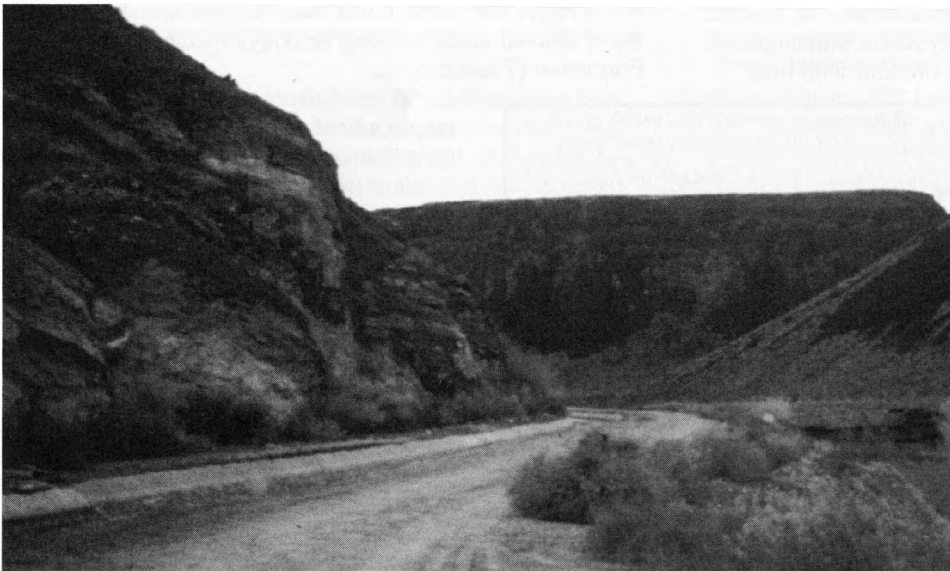
Figure 3. *Shinob Kibe canal.*

A portion of this canal is at or very near the epicenter of the earthquake (figure 1). It is a non-reinforced, concrete-lined canal (2.5 inches [6.4 cm] thick) along the north face of Shinob Kibe hill, and it transports water from the Washington Fields diversion dam. The canal was not damaged in the area of the diversion. In the area of Shinob Kibe hill, however, about every fourth slab of concrete along the canal had a visible crack that was nearly vertical in the middle of the slab. This cracking is probably earthquake related. Some of these cracks showed differential settlement (figures 6 and 7). One slab had seriously cracked and failed by foundation piping and displacement (figure 8) and will need repair. The other cracks will require frequent inspection, especially in the late winter and spring. The damage extends for the entire length of the concrete-lined portion of the canal near Shinob Kibe hill. Displacement and piping failure also occurred along joints in the concrete-slab lining. The cracking-piping damage represents a significant increase in normal annual concrete maintenance problems on the canal.

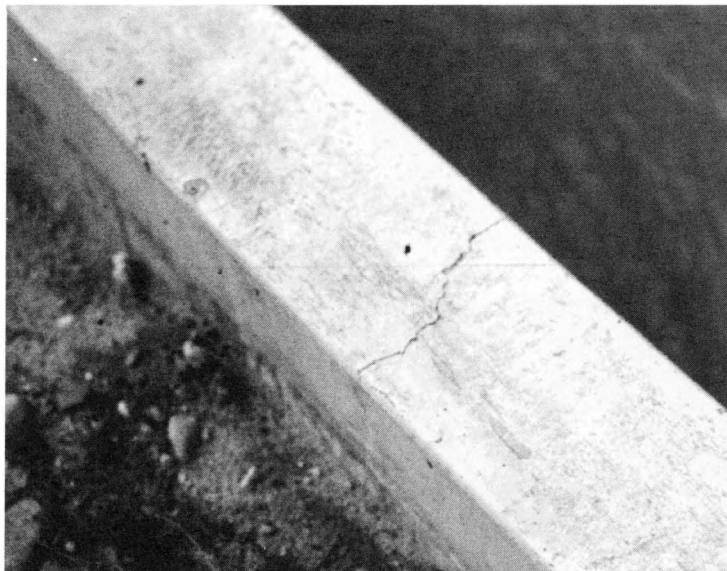
Figure 5. Crack in a wing wall of the Washington Fields diversion dam.

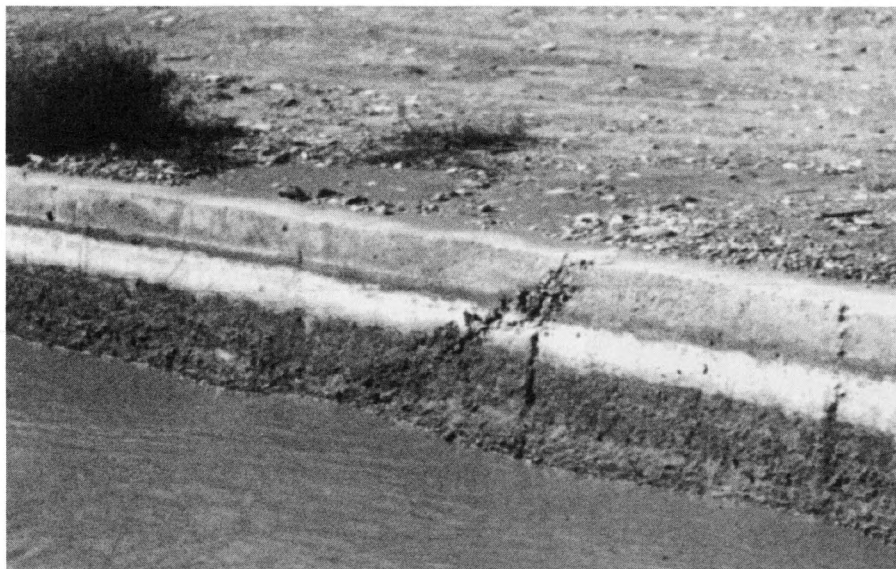
Figure 7. Cracks in the concrete lining of the Shinob Kibe canal.

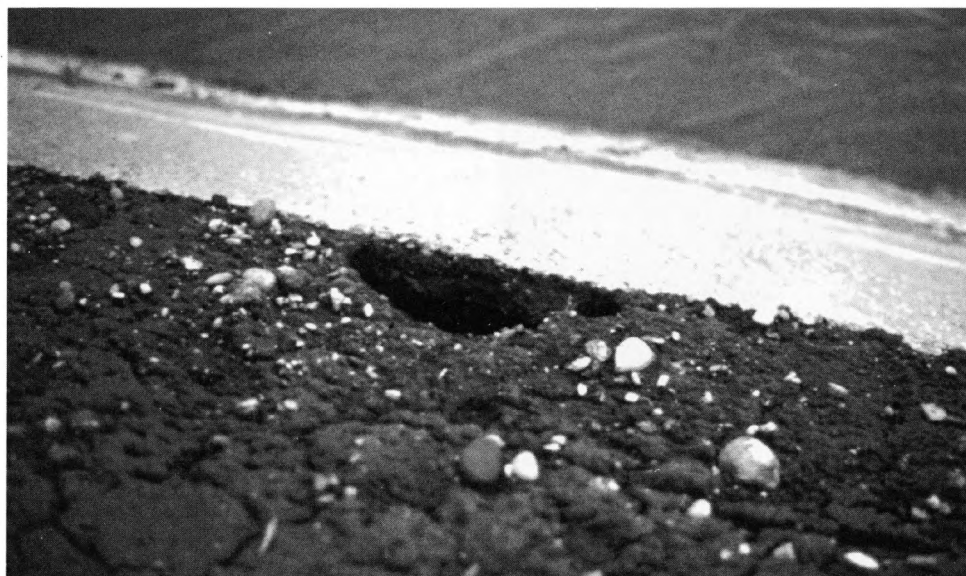
Figure 8. Cracked lining and piping along the Shinob Kibe canal.

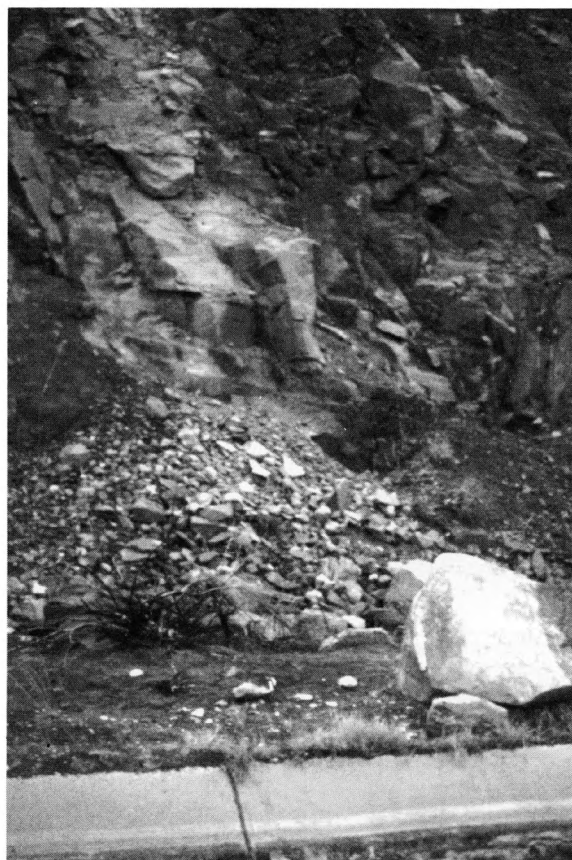
Figure 9. Rock fall adjacent to the Shinob Kibe canal.

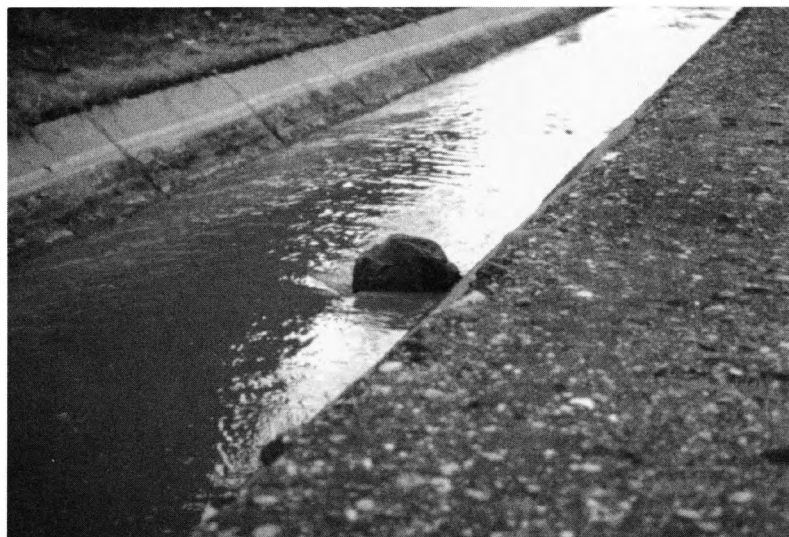
Figure 10. Rock fall into the Shinob Kibe canal.
