**GEOLOGIC CONSEQUENCES
OF THE 1983 WET YEAR IN UTAH**

Bruce N. Kaliser and James E. Slosson, Ph D

Miscellaneous Publication 88-3

1988

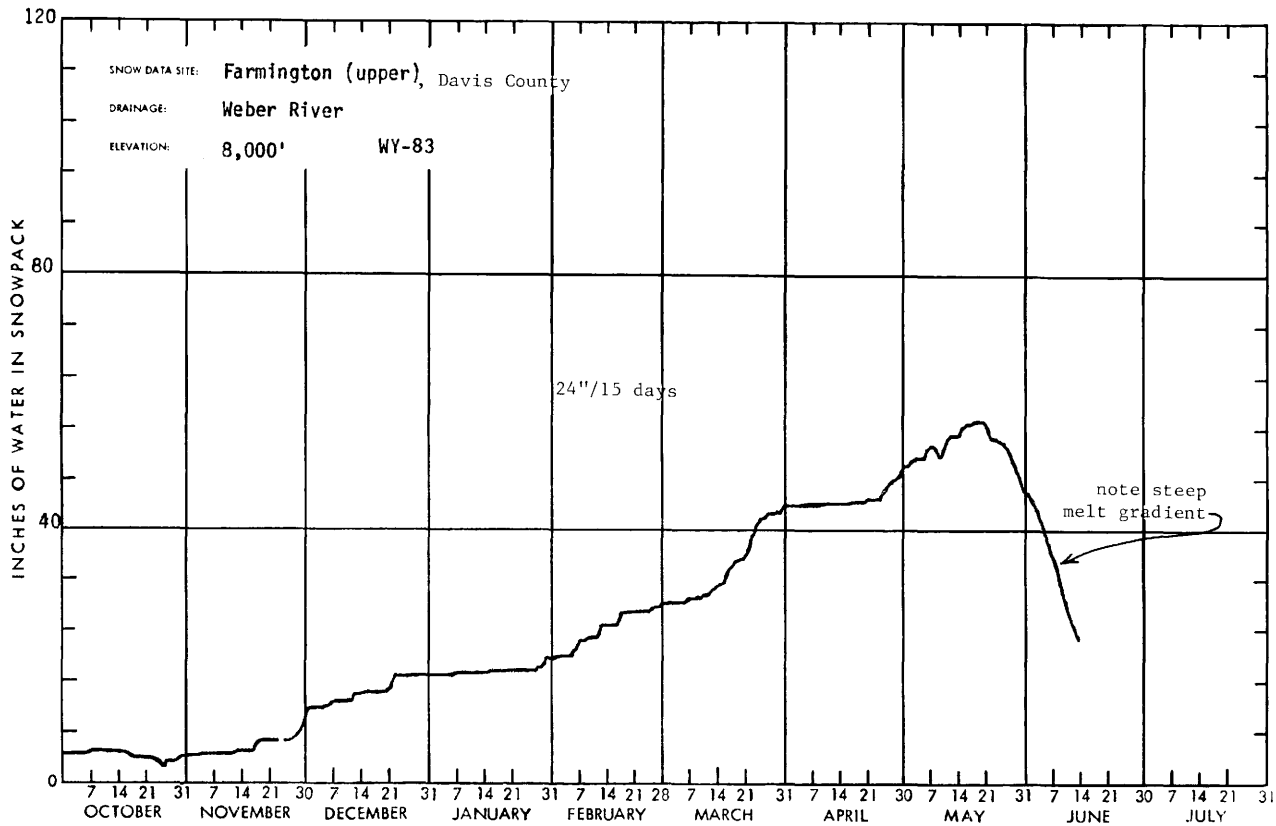
Figure 6b.
 Daily snow pack moisture measurements for 8000 feet elevation Wasatch Front station.

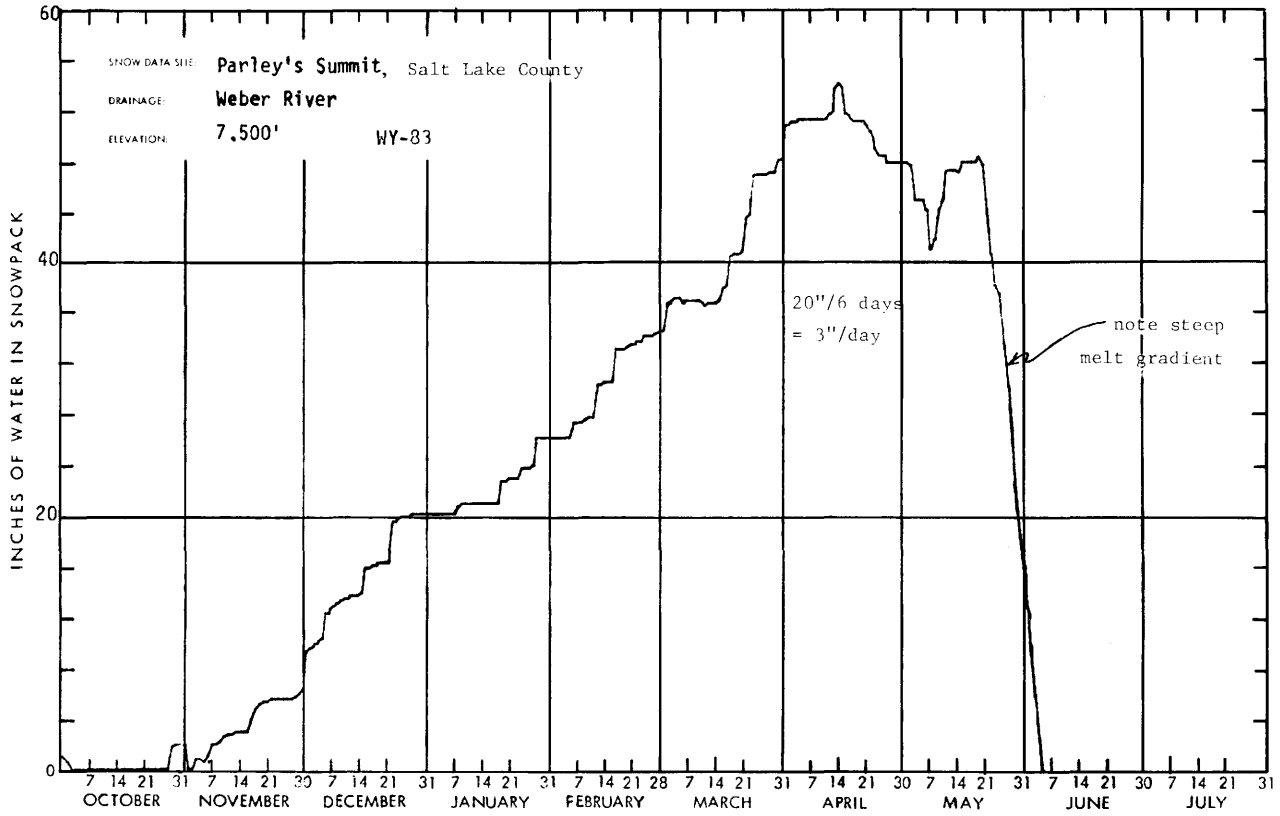
Figure 6c.
 Daily snow pack moisture measurements for 7500 feet elevation Wasatch Front station.

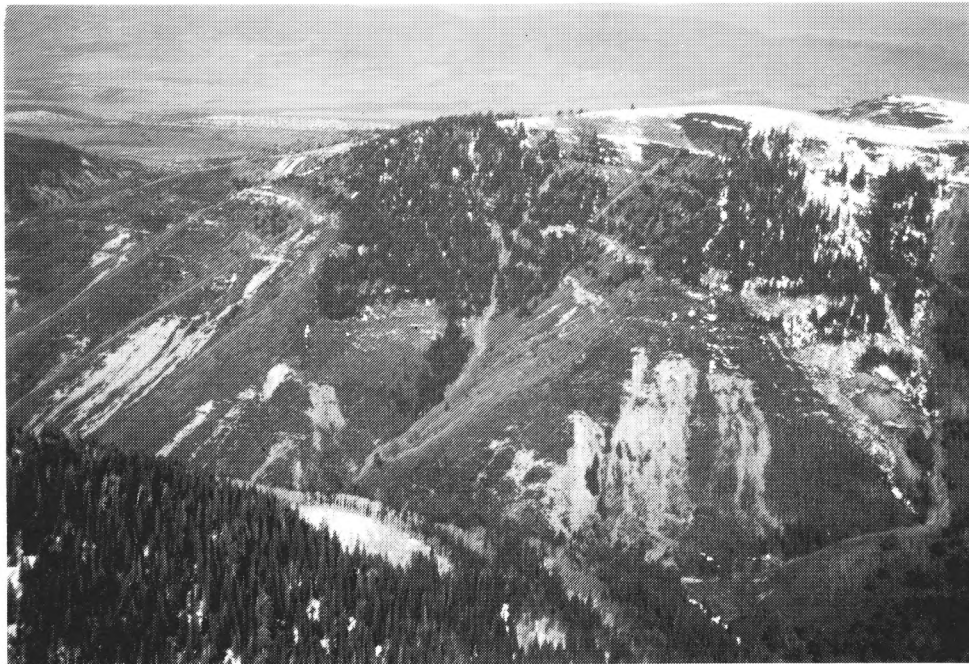
Figure 12.

- a. Schematic diagram of typical mountainland debris slide.
- b. Photograph of debris slides on Wasatch Plateau.

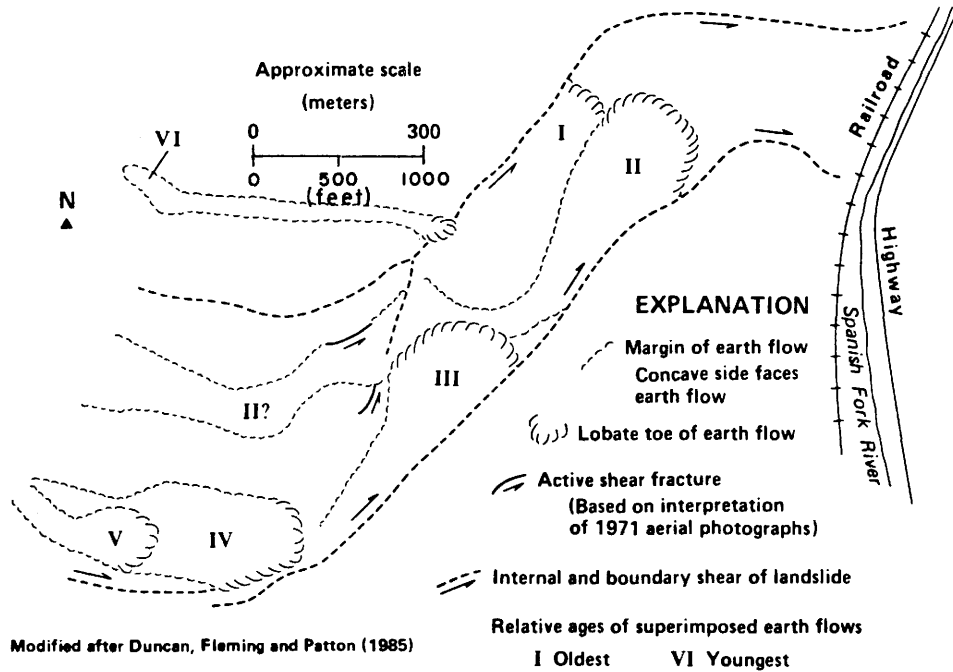
Figure 15a.
Map of pre-1983 Thistle landslide (from aerial photos).

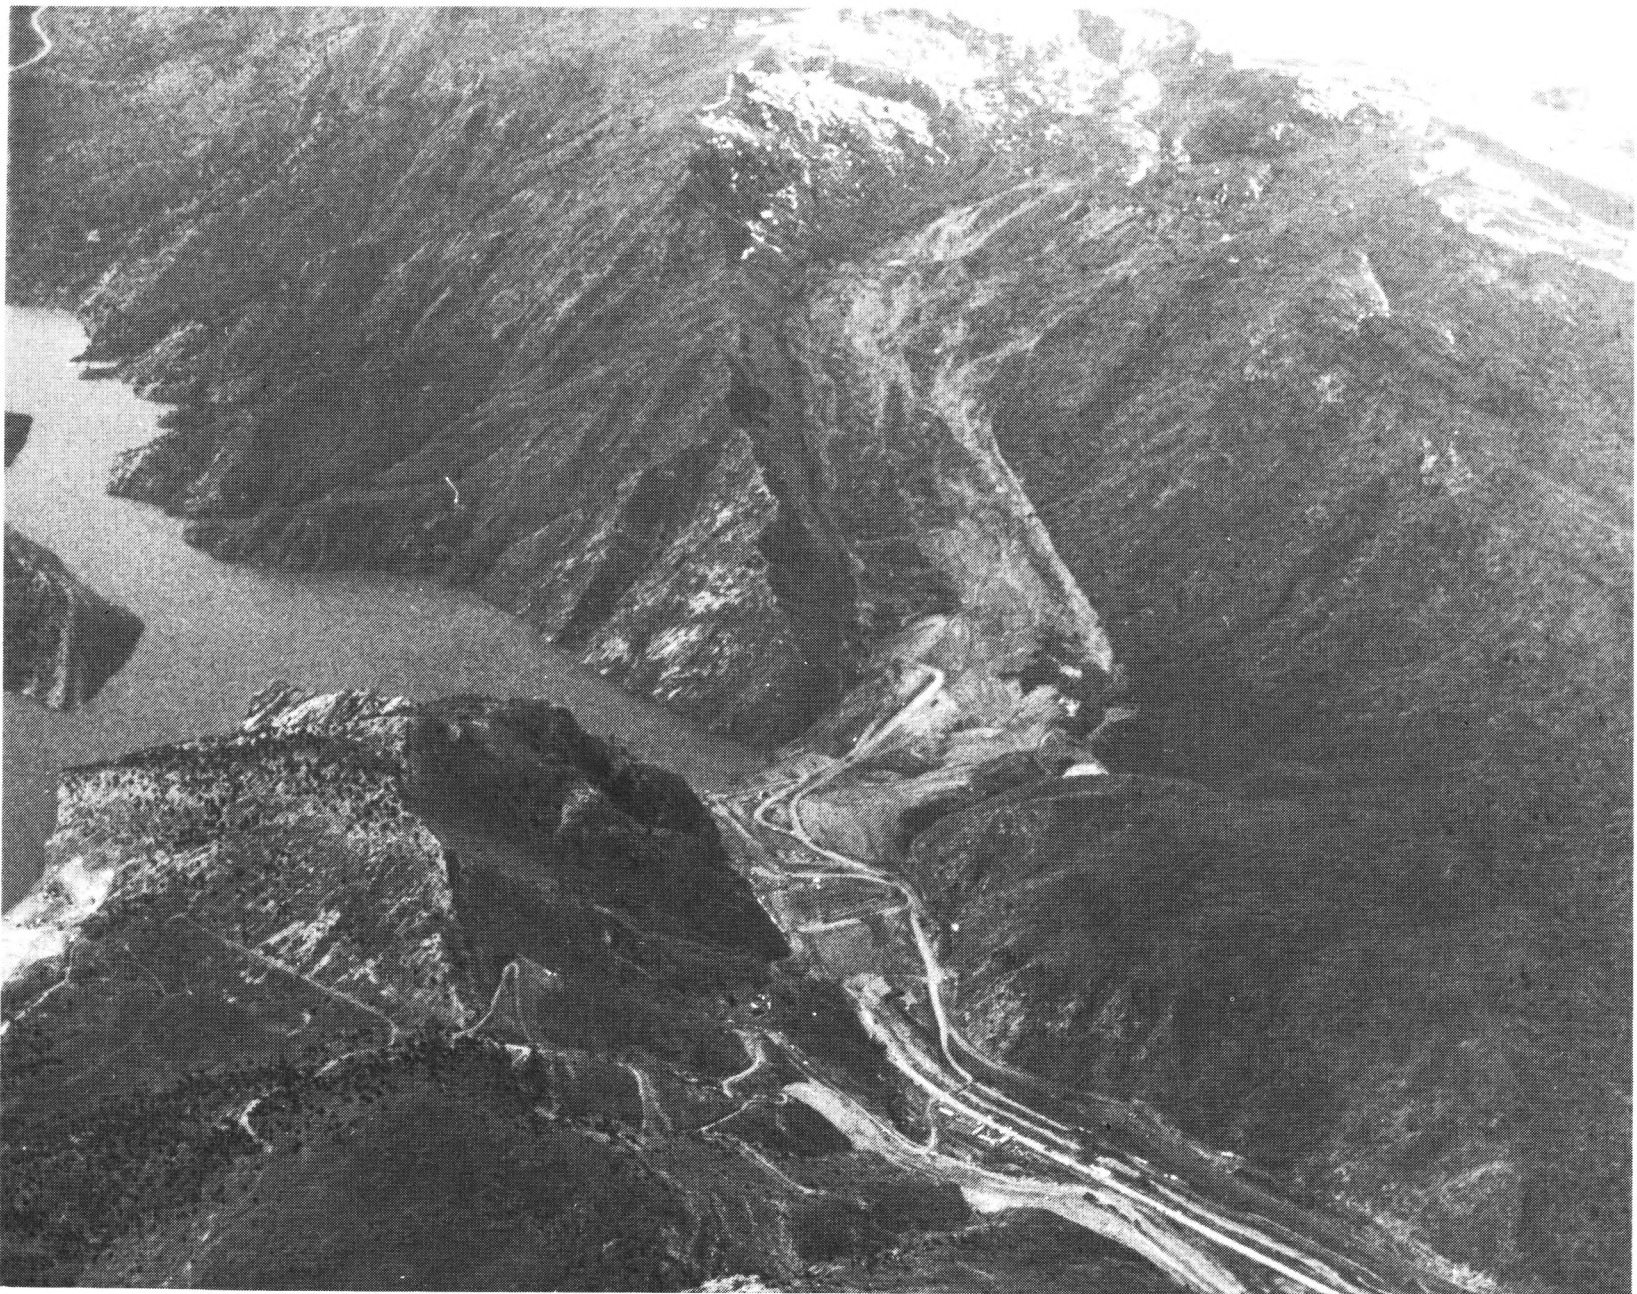
Figure 17. Thistle landslide oblique aerial, looking southwest.

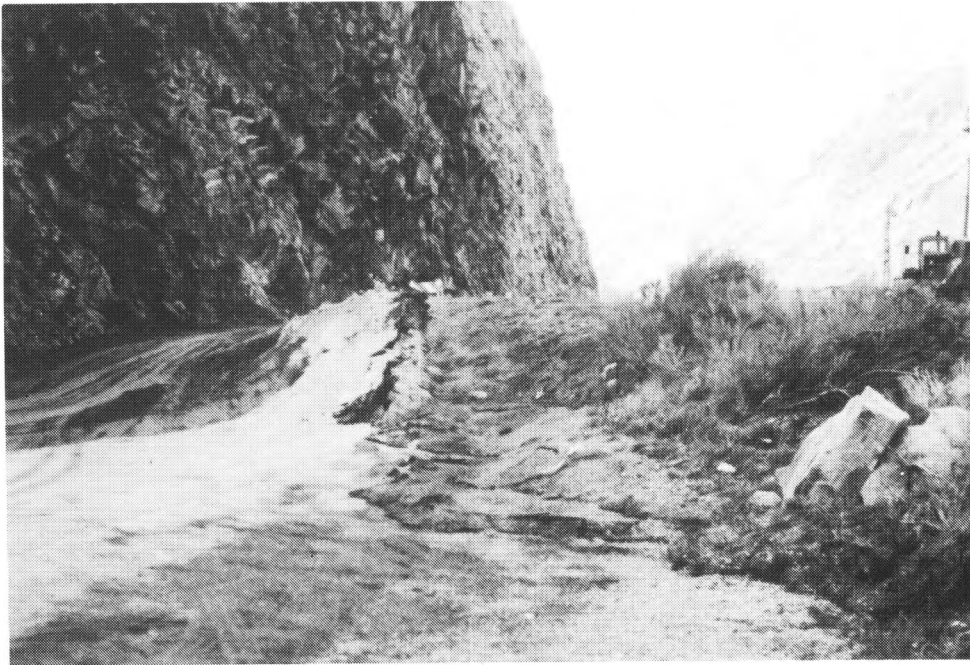
Figure 18.
Thisle landslide a) Early deformation of Hwy. 89 in Spanish Fork Canyon; appearance of first thrust. b) Toe of slide, about end of first week's movement.

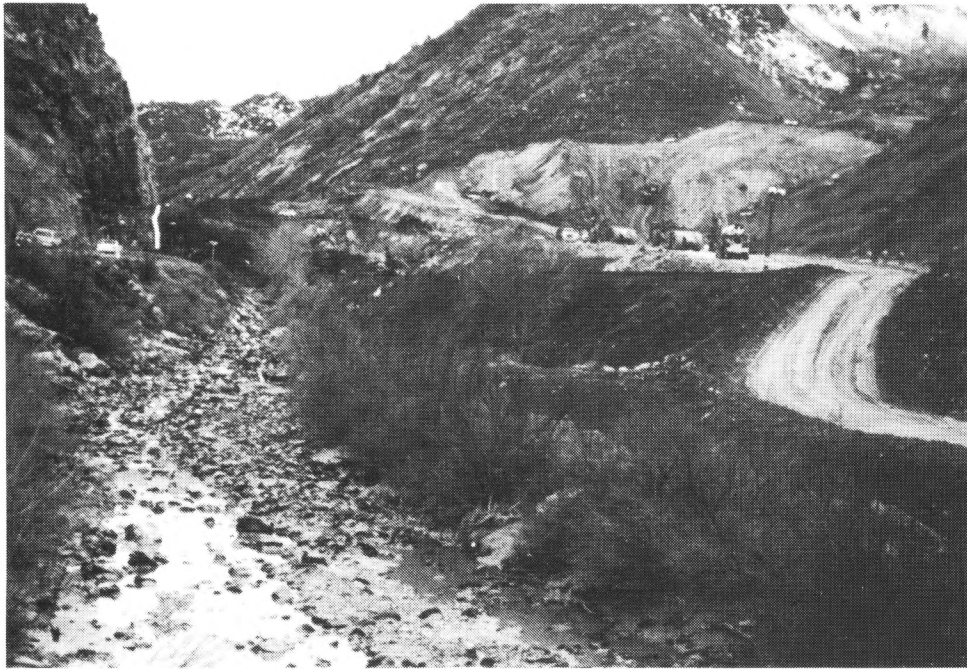
Figure 19.
This slide landslide. Approximately one week later than shown in Figure 18.

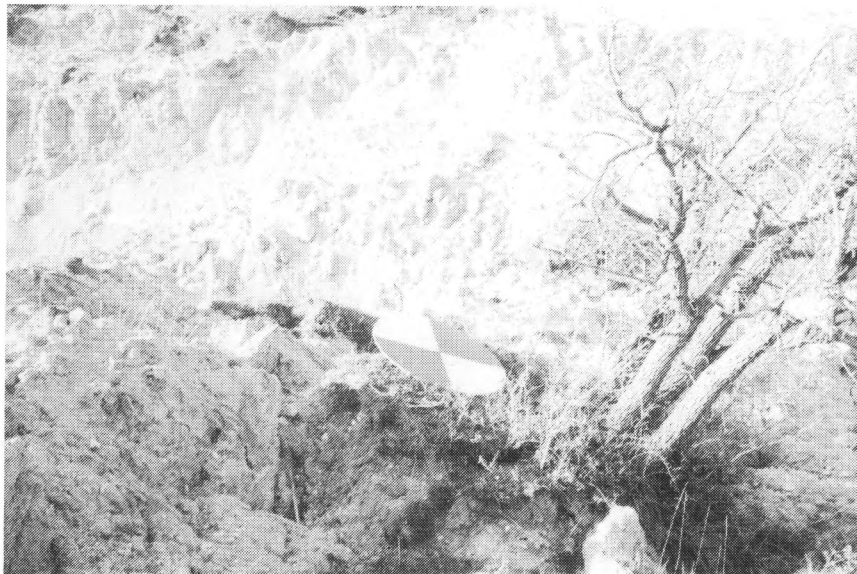
Figure 20.
Thistle landslide a) Sedimented-in depression b) UGMS survey target placed on clump to ride along without burial.

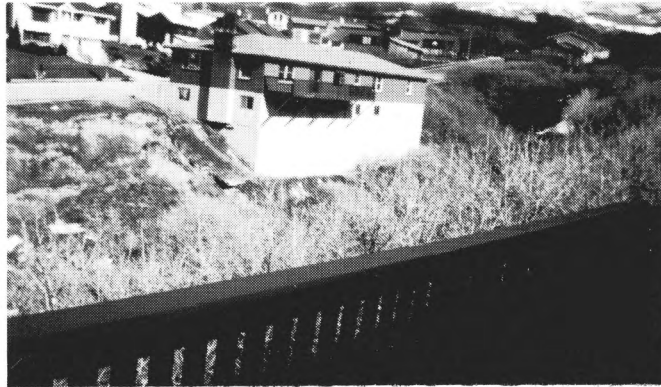
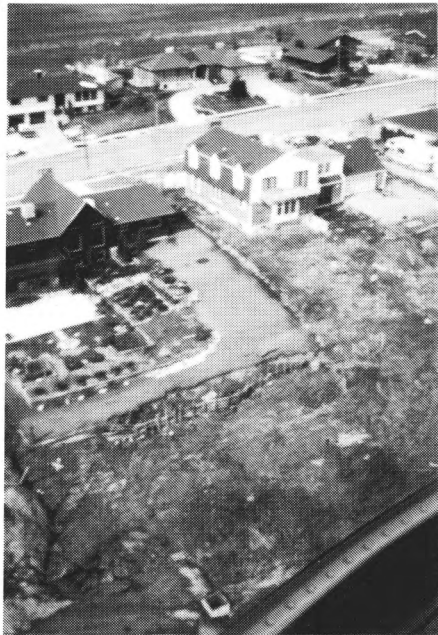
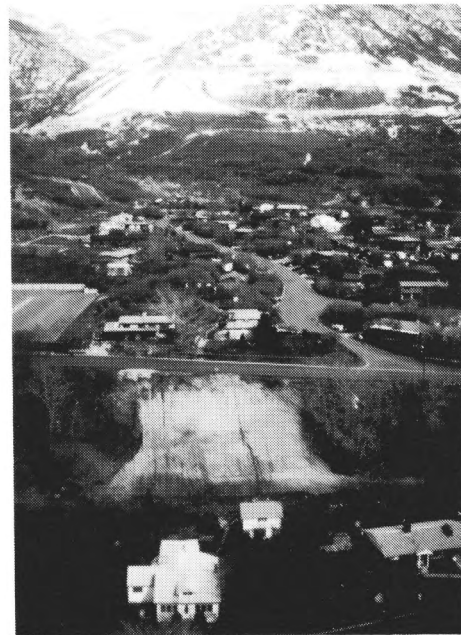
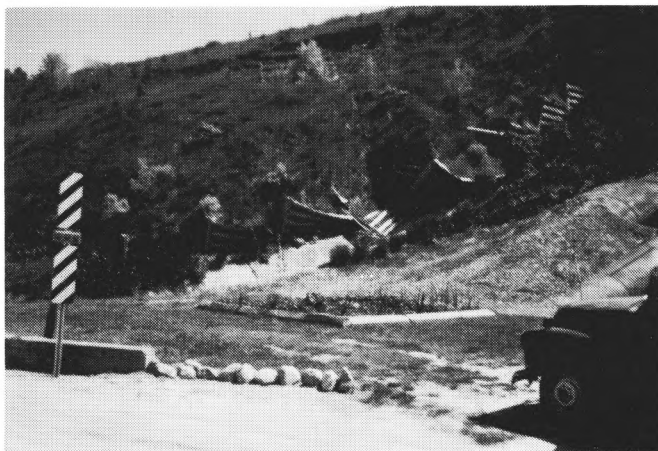
Figure 22.
Benchland landslide contributed to by grading. a) Fill over lacustrine sediments on drainage slope, North Salt Lake City. b) Fill over lacustrine sediments on drainage slope, Layton. c) Fill over lacustrine sediments on Lake Bonneville Terrace, Farmington. d) Fill over lacustrine sediments on south bluff Ogden River, Riverdale.

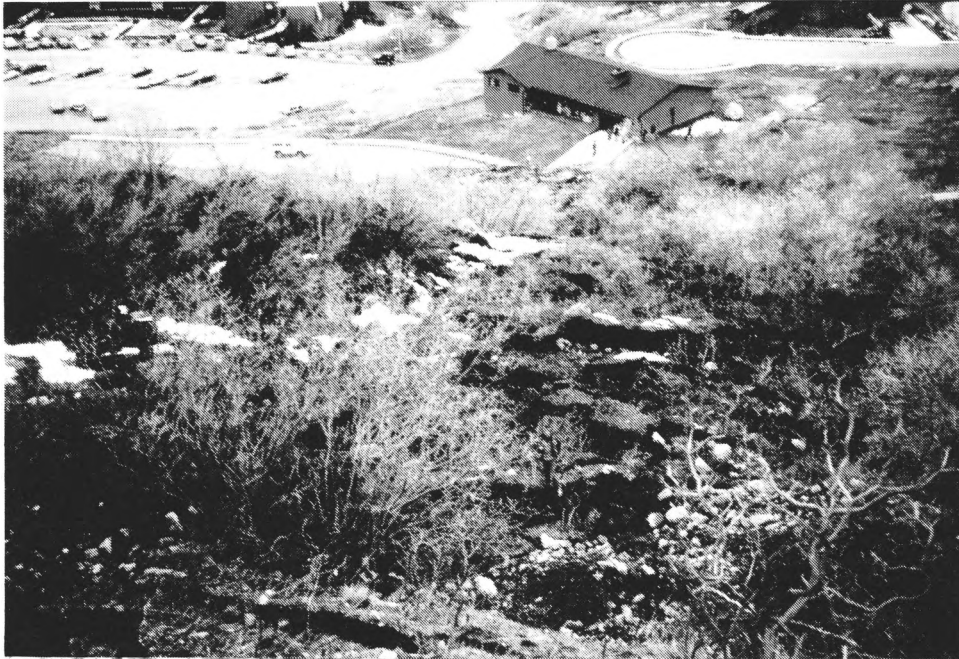
Figure 23. Debris slump on high east bench of Provo.

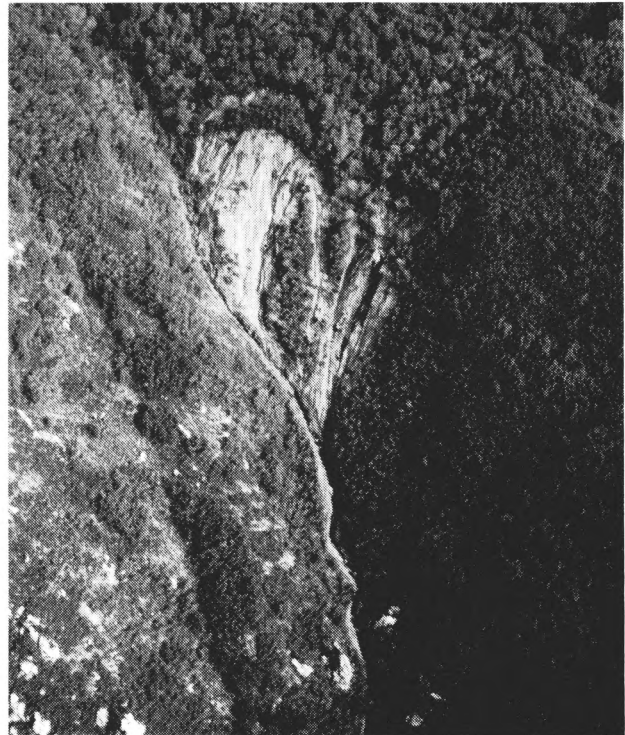
Figure 26.

Partly detached landslide mass perched in debris slide in steep mountainous terrain. Note channel scour below the clustered slides, indicative of debris flow run-out.

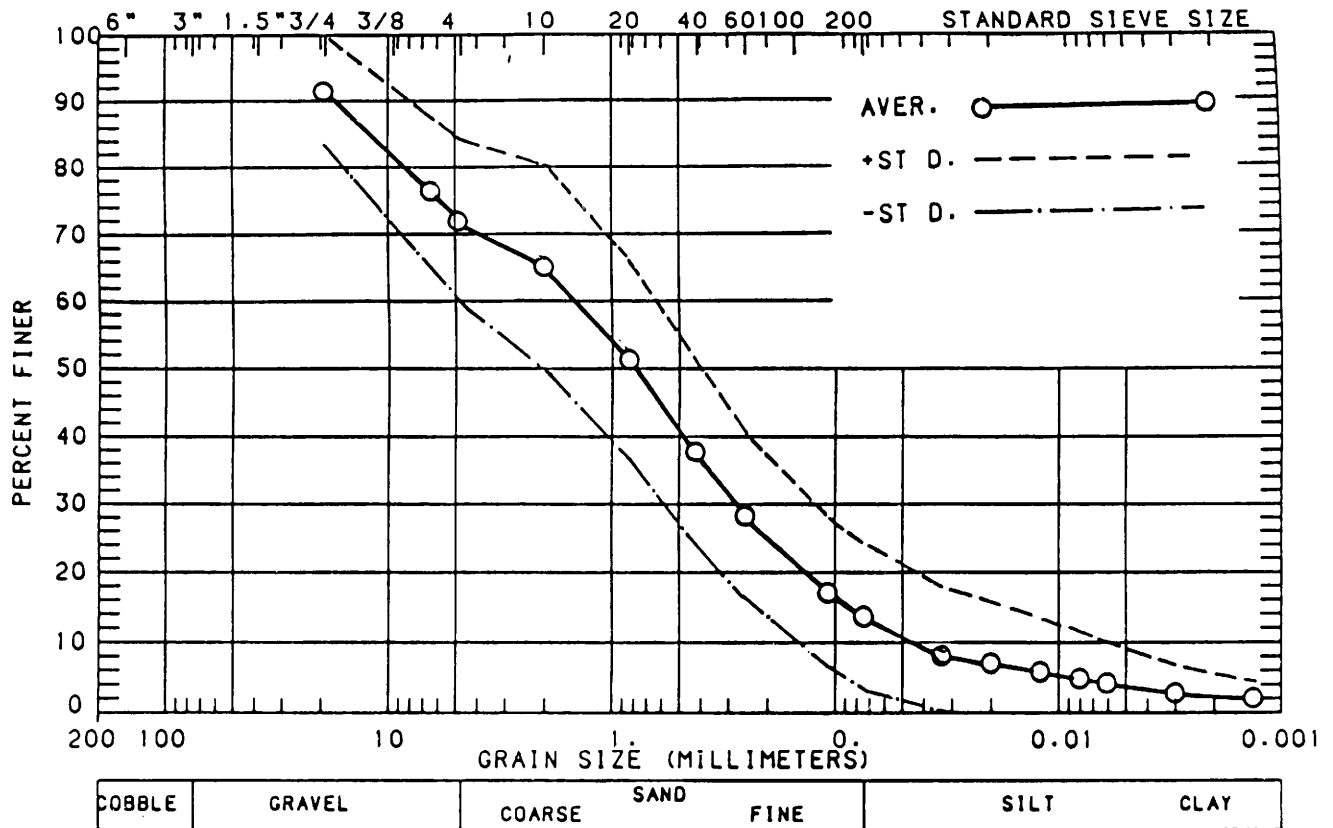
Figure 27.
Average grain size distribution curve for 65 soil samples taken from 1983 debris slide areas on Farmington Canyon complex terrain, Davis County.

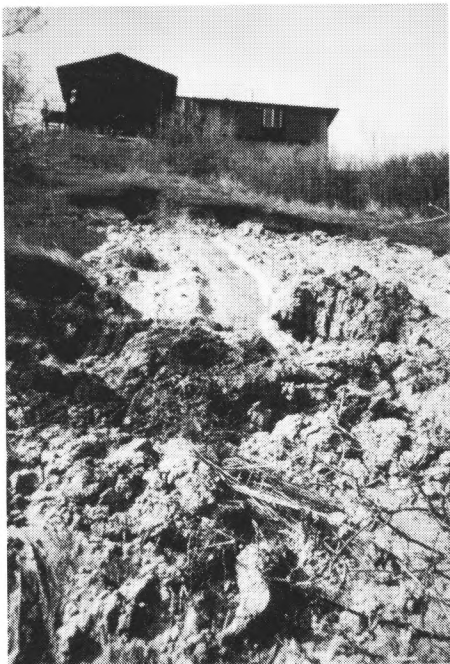
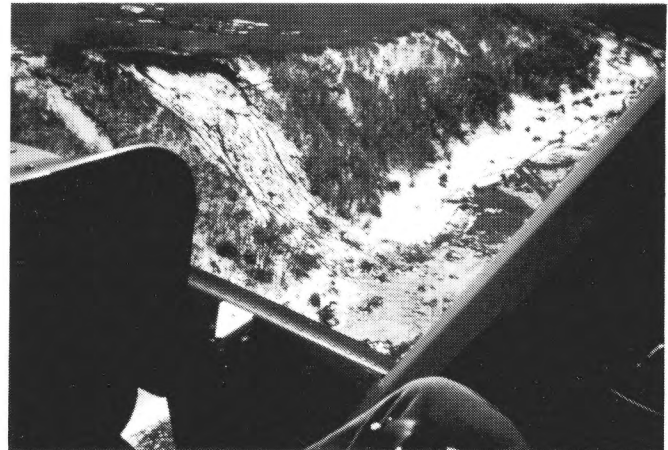
Figure 28.

a) Layton; fine lacustrine sediments stopped on slopes. b) Layton; sediments deposited on valley bottom, beyond toe of slope.

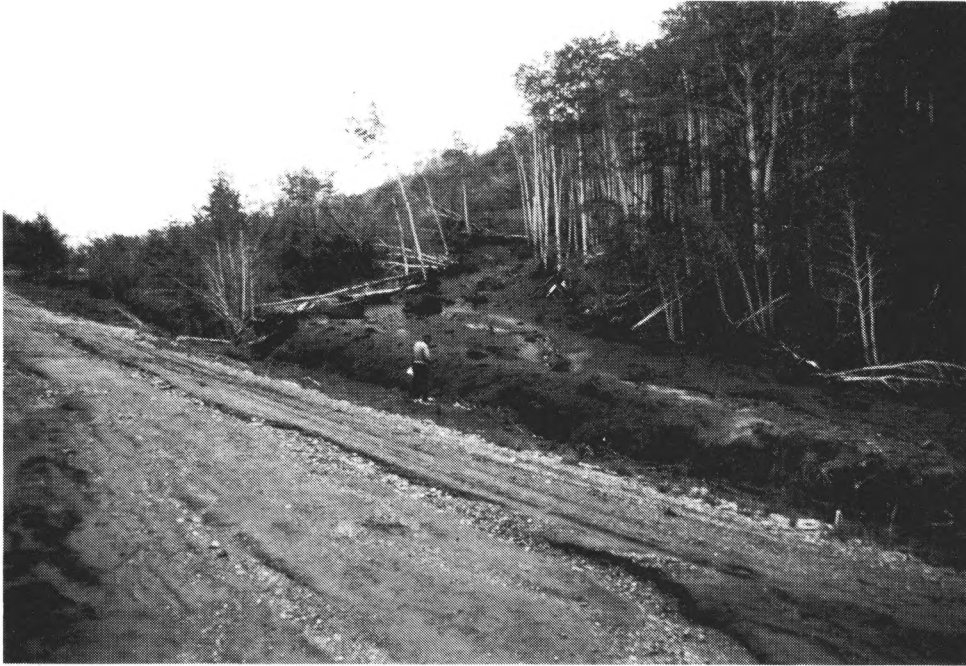
Figure 30.
Debris flow into Little Clear Creek, Indianola. a) Bend at confluence with main drainage. b) Material and striations indicate two episodes of flow.

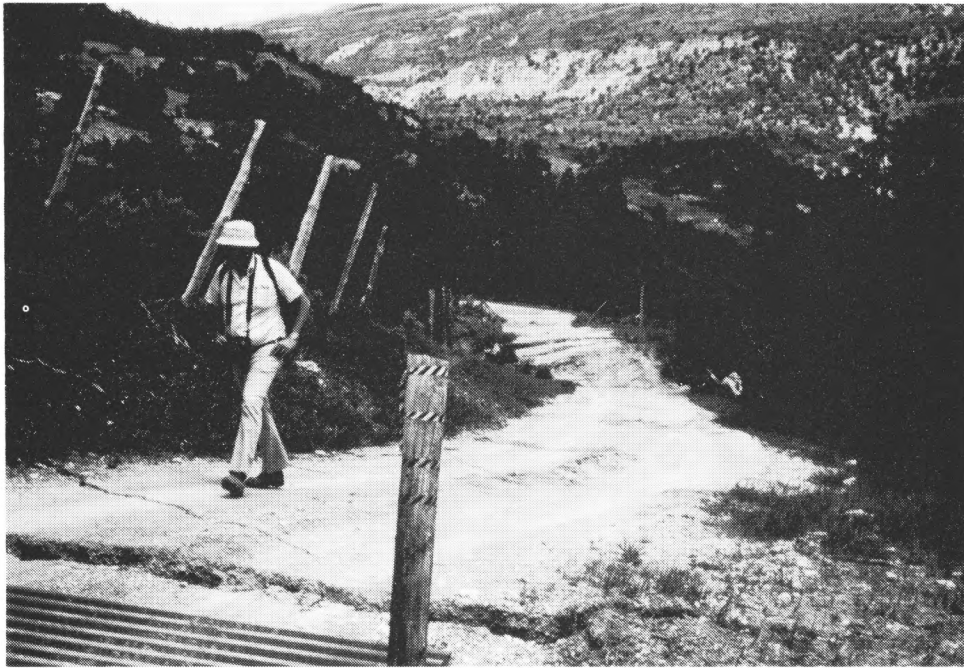
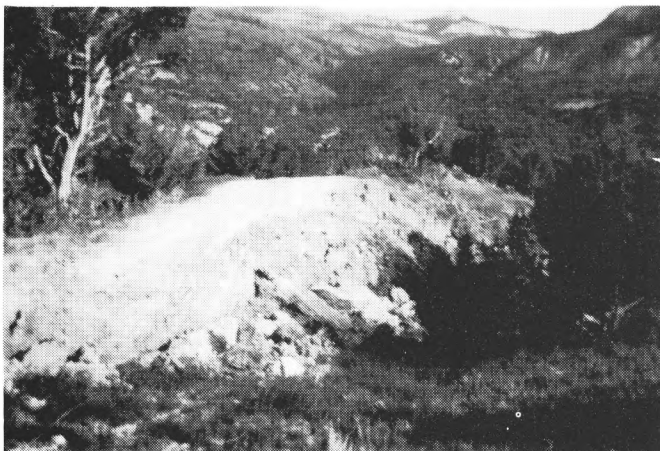
Figure 32. Twin Lakes slide. a) & b) Heaving of road across toe. c) Stretched roots demonstrate direction of movement.

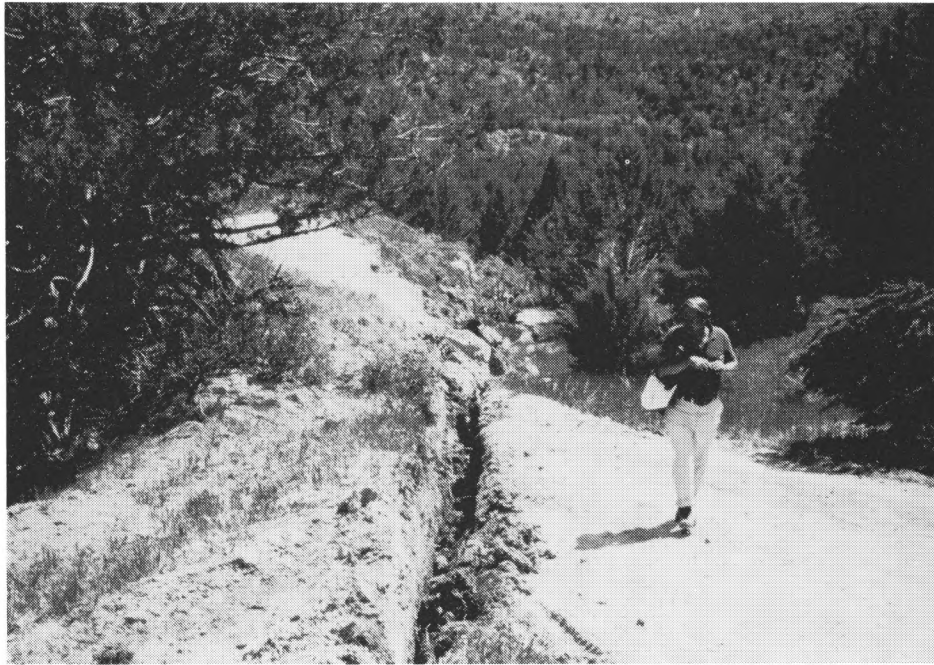
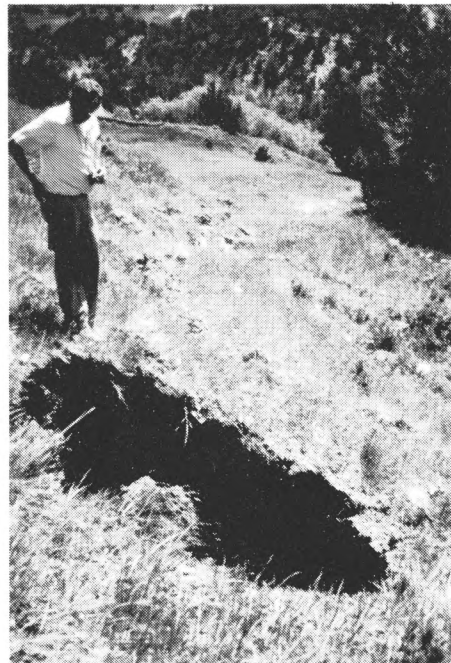
Figure 33. Twin Lakes slide, June, 1983. a) Flank shear. b) Collapse feature.
