Stanley, ID Earthquake Response

Basin and Range Earthquake Summit

October 17-21, 2022

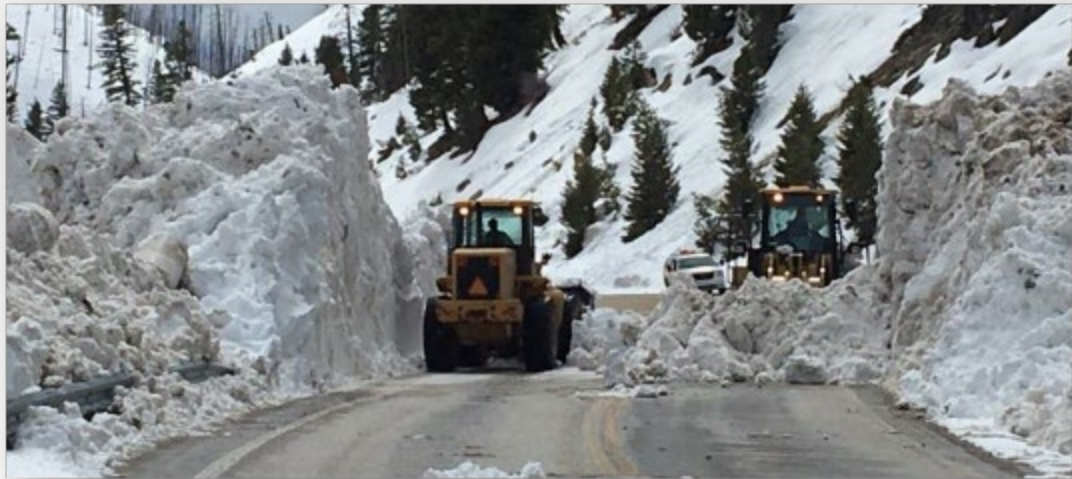
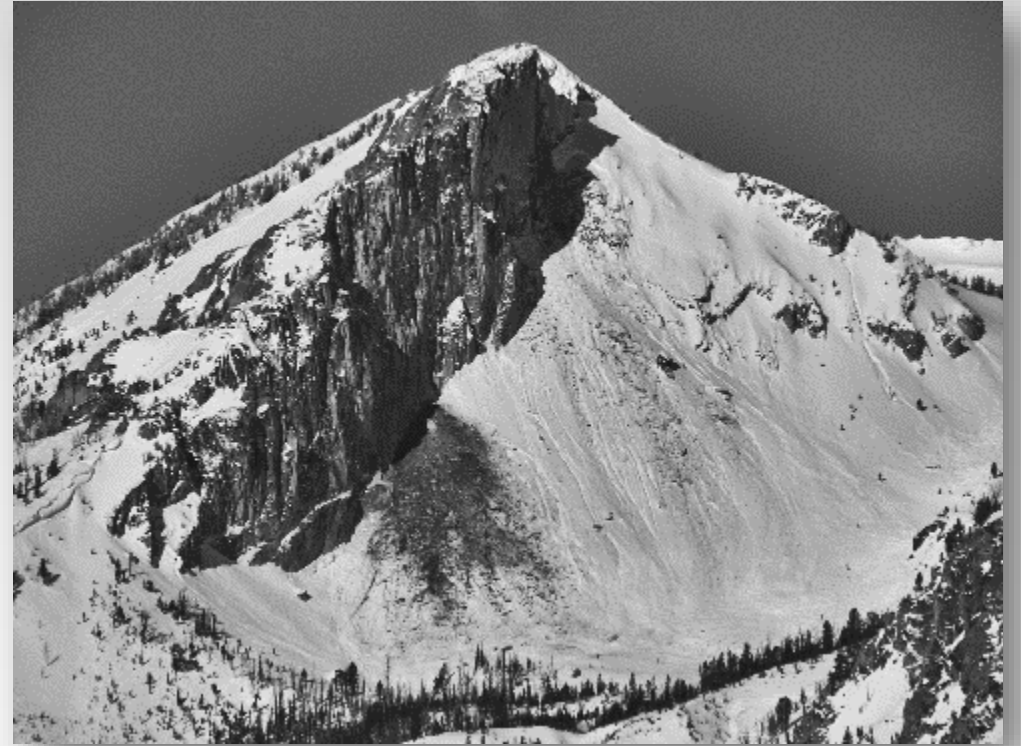
Sawtooth Avalanche Center - Apr 1, 2020
Avalanches and rockfall at the head of
Crooked Creek in the northern Sawtooths
that likely released as a result of the March
31, 2020 earthquake

ITD clears HWY 21

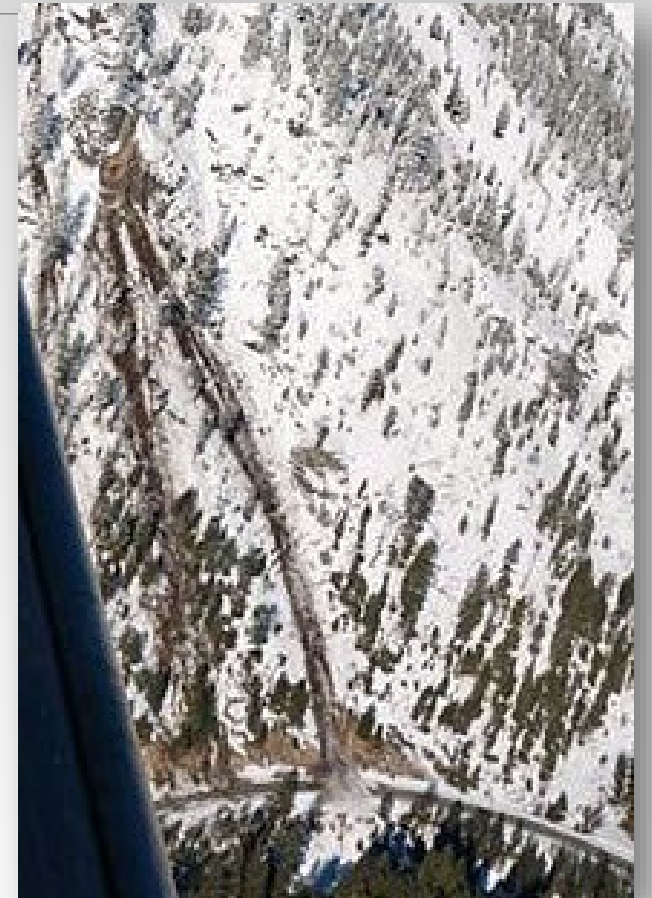
Slides on Middle Fork of the Salmon River temporarily blocked flow

Several slides impacted river west of the epicenter in steeper canyons, north of Cape Horn, west of Ruffneck between Morgan Ranch and Cape Horn near Stanley, ID

Twin Falls County had a small non-threatening landslide at river

Red Fish Lake had slides and liquefaction

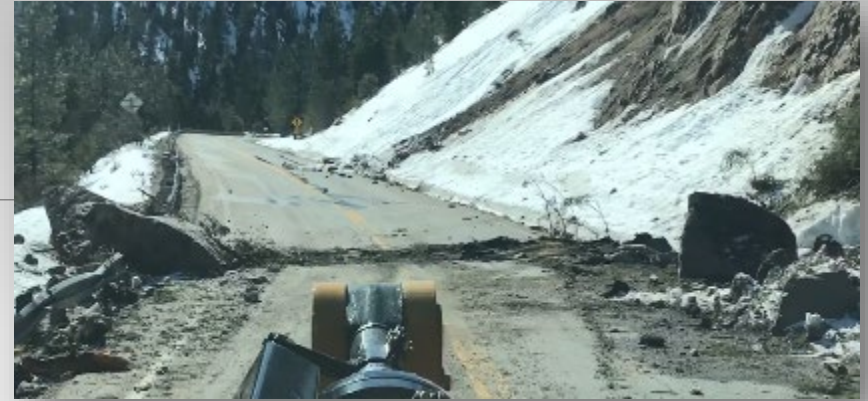
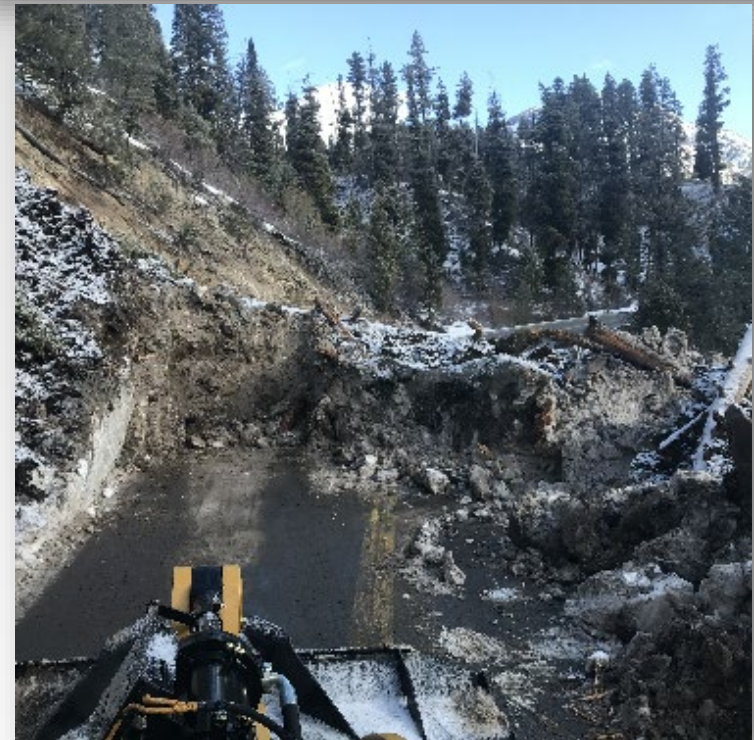
Picture from ITD Division of Aeronautics

Gem County cleaned up “fair amount” of rocks and dirt from roads

Landslides, rockfall on Highways 21 and 75

Hwy 21 - Large boulder and three dirt slides from the Grandjean junction to 4 miles north of the junction

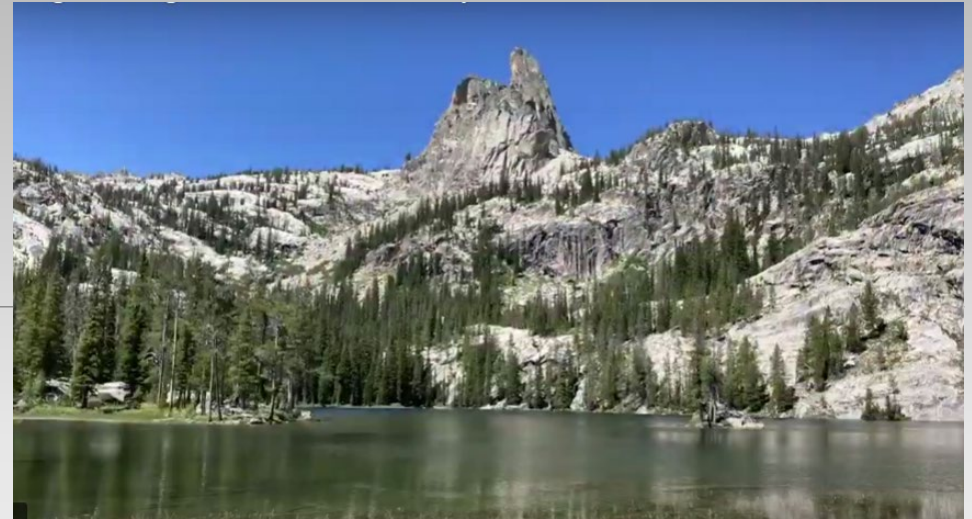
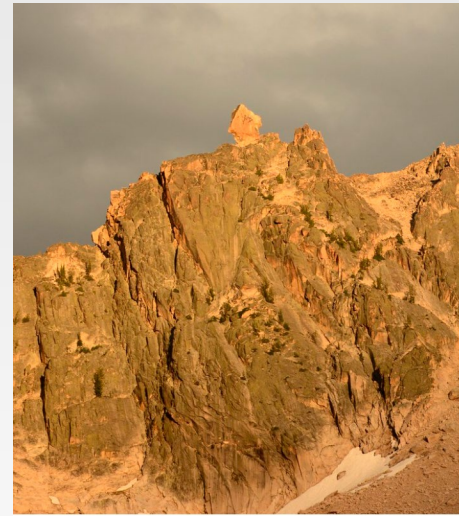
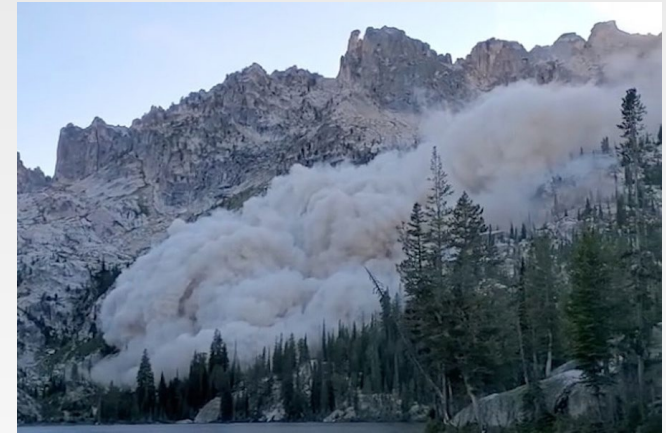
Climbing sites

- Finger of Fate – multiple boulders toppled
- Arrowhead - destroyed
- Old Smoothie Baron Spire - gone

Craters of the Moon National Monument

- Caves threatened and closed

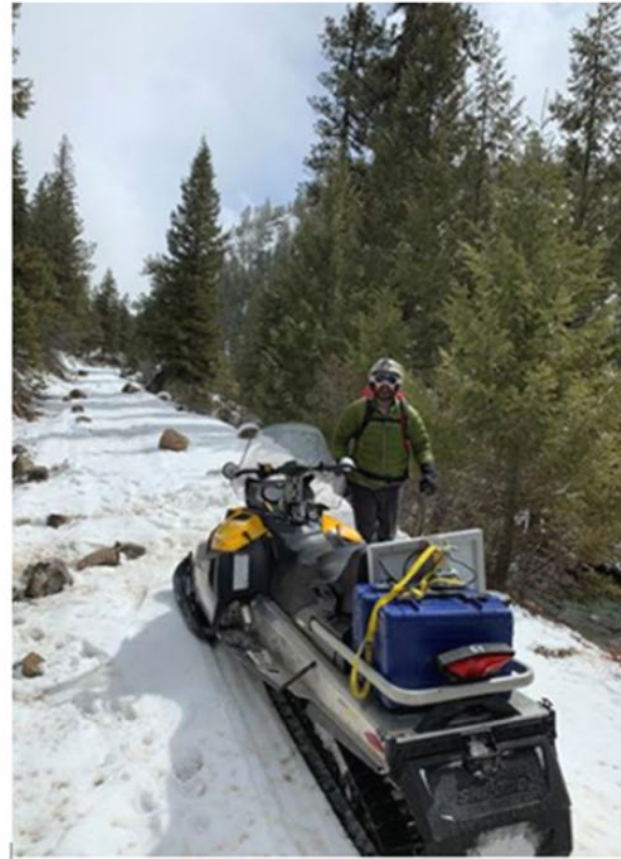
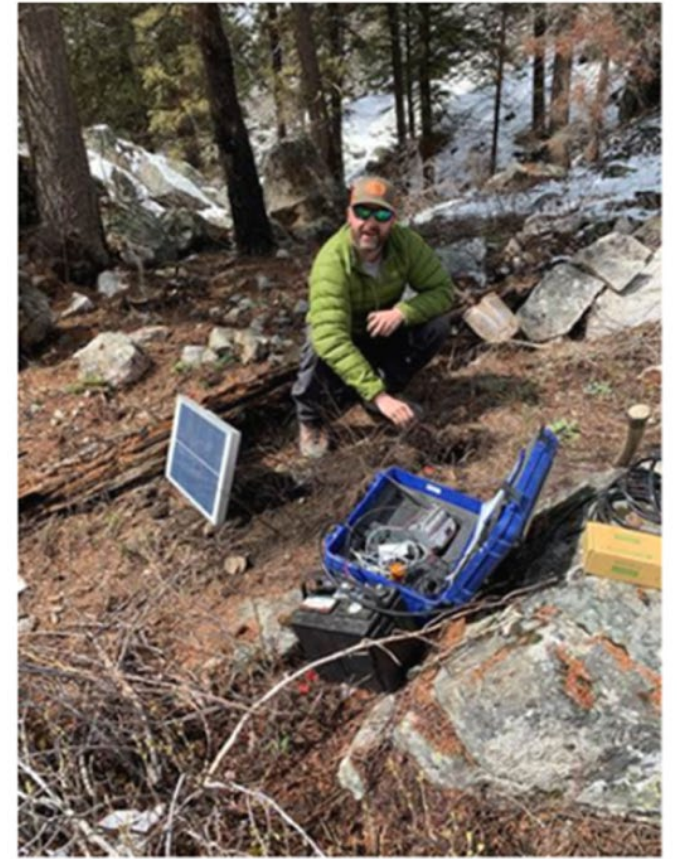
Thomas Otheim, Boise State geosciences tech, deploys seismic monitoring station near Grandiean, ID. 4/1/2020
