## Utah Geological Survey

Project: The Sage Vista Lane landslide, Cedar Hills, Utah			
By: Francis X. Ashland, P.G., and Greg N. McDonald, P.G.	Date: 09-16-05		County: Utah
USGS Quadrangles: Timpanogas Cave (1129)	Section/Township/Range: Section 32, T. 4 S., R. 2 E., Salt Lake Base Line and Meridian		
Requested by: David Bunker, Cedar Hills Engineer		Job number: 05-14

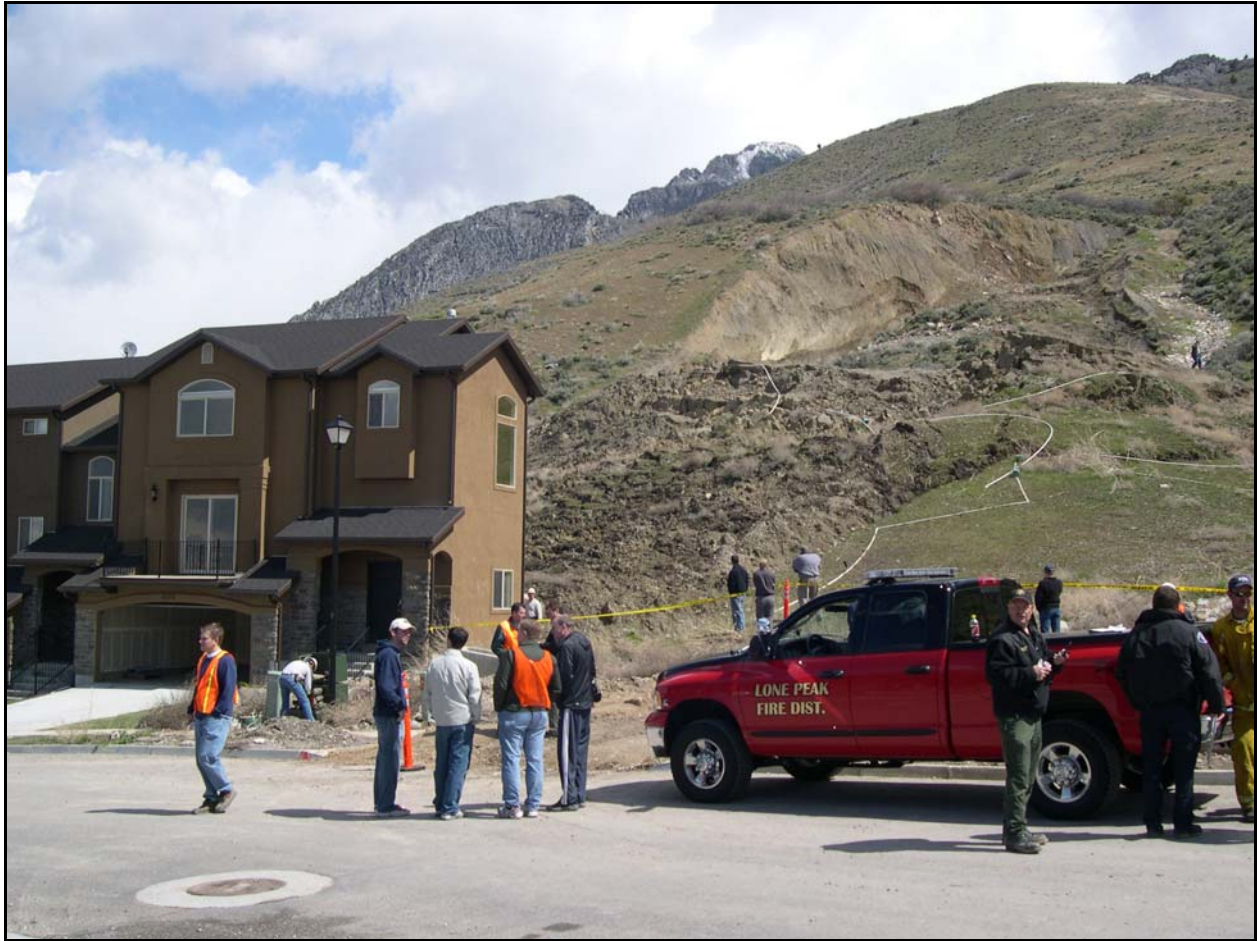
**Figure 2.** View to the northeast of the landslide on April 29, 2005, from Sage Vista Lane.

On the afternoon of April 28, 2005, a landslide that had moved previously in 1983 (Machette, 1992) reactivated above Sage Vista Lane in a Cedar Hills subdivision (figure 1) and moved against the lower portion of the back wall of a four-unit townhouse (figure 2). Residents of the affected townhouse evacuated and the belongings of a neighboring family in a separate duplex across the street were moved out of their home temporarily. By April 29, the landslide toe had crushed vinyl fencing, air conditioners, and deck supports at the back of three of the units in the townhouse. After the damaging movement on April 29, the rate of landslide movement rapidly decreased to a very slow rate. Following a multiday storm event, during which about 3 inches of precipitation fell, the rate of landslide movement increased again, and by May 13 structural damage to the upslope foundation walls of two units in the four-unit townhouse had occurred. Landslide debris subsequently entered the lower parts of the two units as landslide movement again slowed to a very slow rate as defined by Cruden and Varnes (1996).

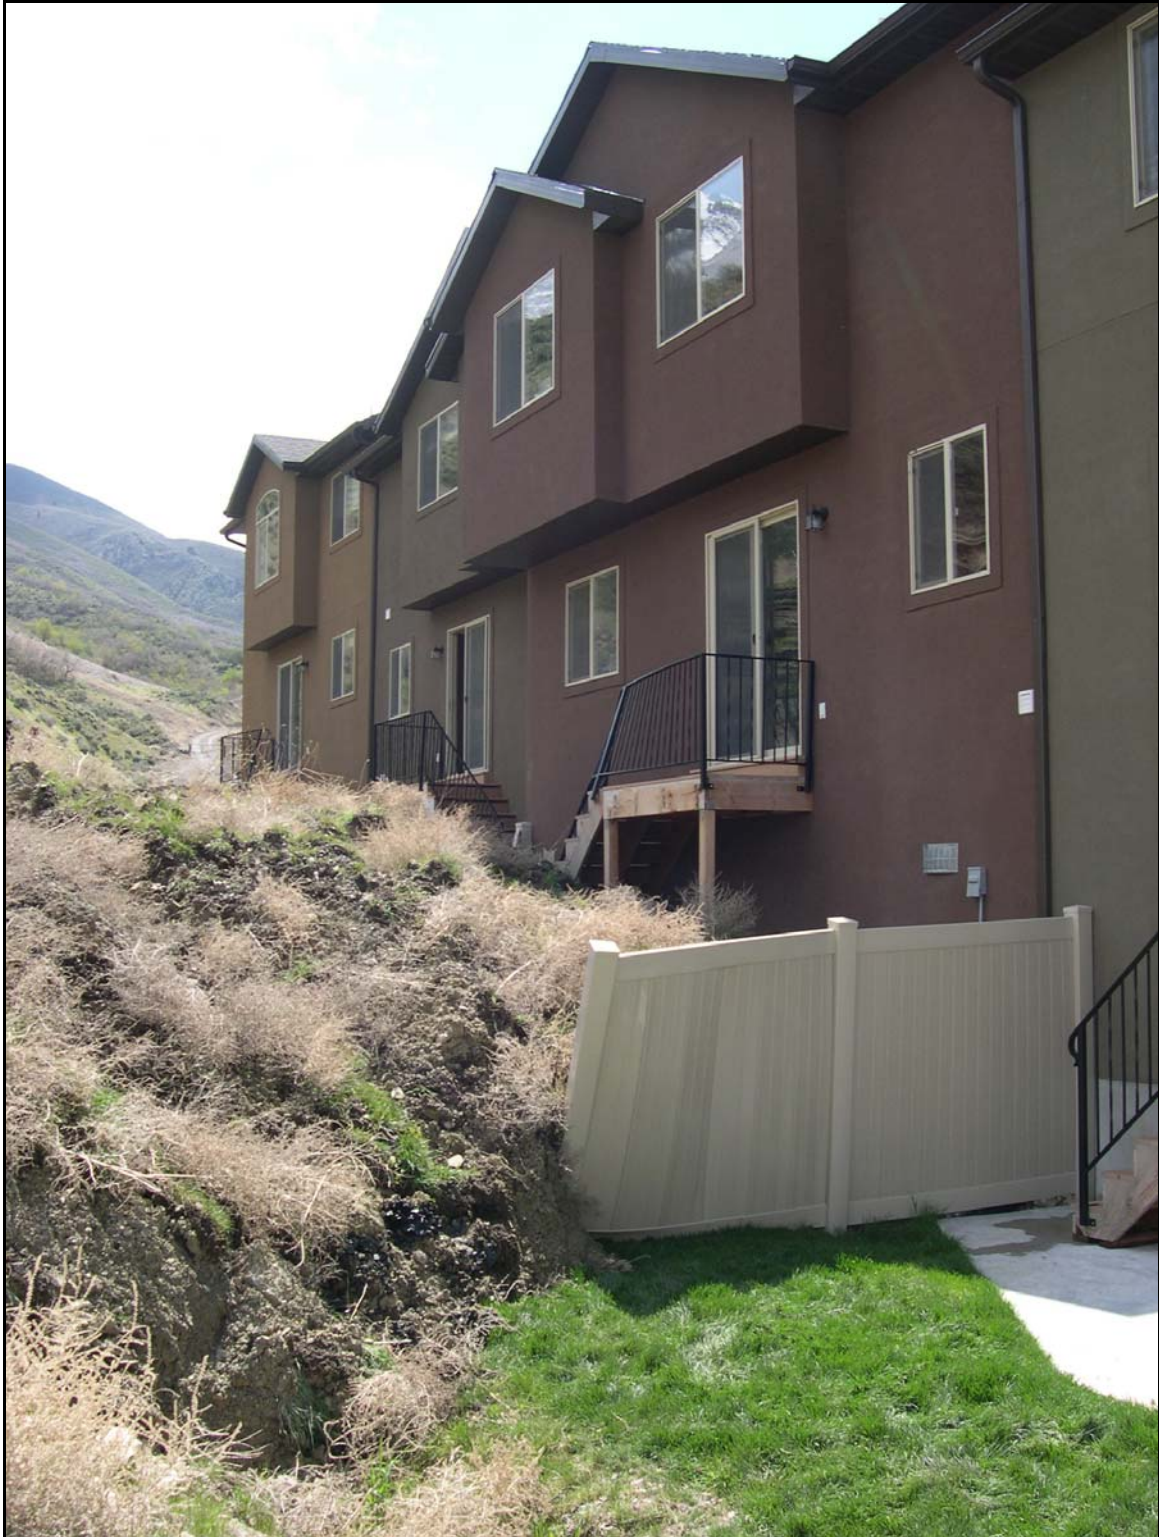
**Figure 5.** View of the disrupted soil at toe of the landslide and damage to back of townhouse on April 29, 2005.

The foundation of the damaged townhouse may be acting as a temporary buttress, possibly protecting against further downslope movement of the slide. We do not recommend removing any of the landslide debris abutting the upslope side of the townhouse while the slide is active and relatively moist. This could increase the movement rate and/or enlarge the landslide.

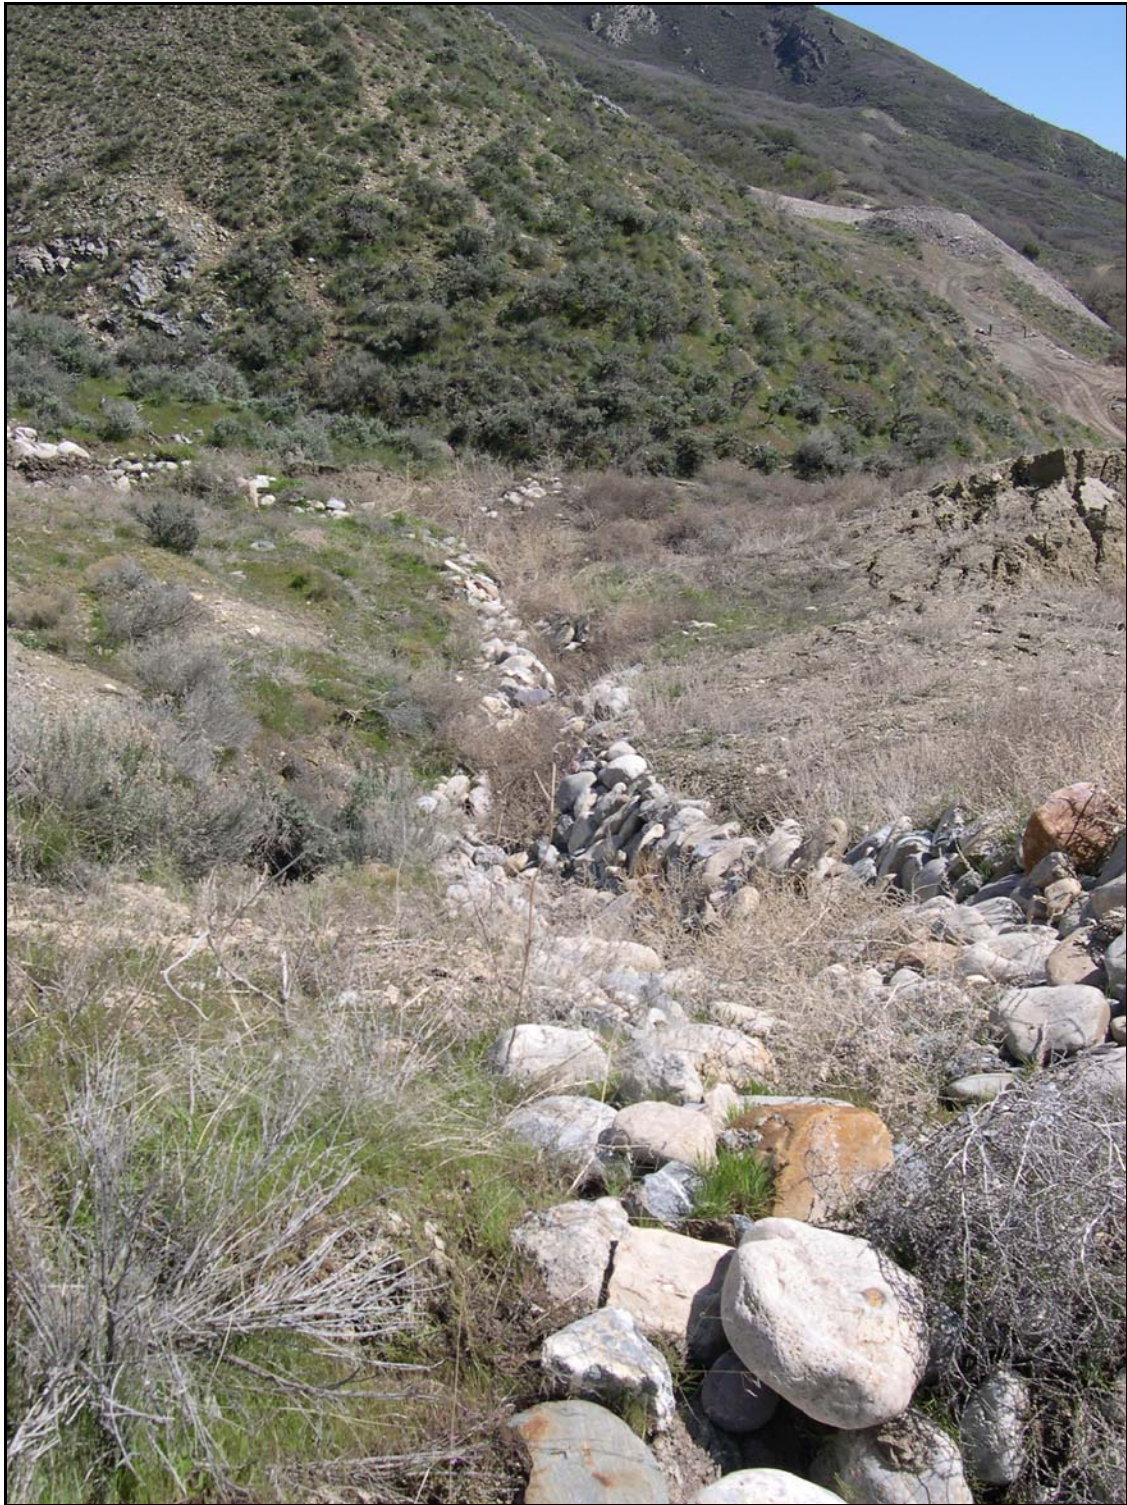
**Figure 6.** View of relatively intact, translated blocks near the middle of the landslide. Cobble-lined drainage ditch that was originally atop cut slope is translated downslope but relatively undeformed.

The middle part of the landslide was relatively intact and consisted of fractured soil, whereas the upper part of the landslide was somewhat more deformed and disrupted. A cobble-lined drainage ditch in this area remained mostly linear suggesting that it was mostly translated in intact and undeformed blocks (figure 6). Dark gray, highly polished slickensides were locally exposed on top of exposed black clay in the upper part of the landslide, suggesting the upper part of the slide is locally shallow (possibly less than 10 feet deep; figure 7).

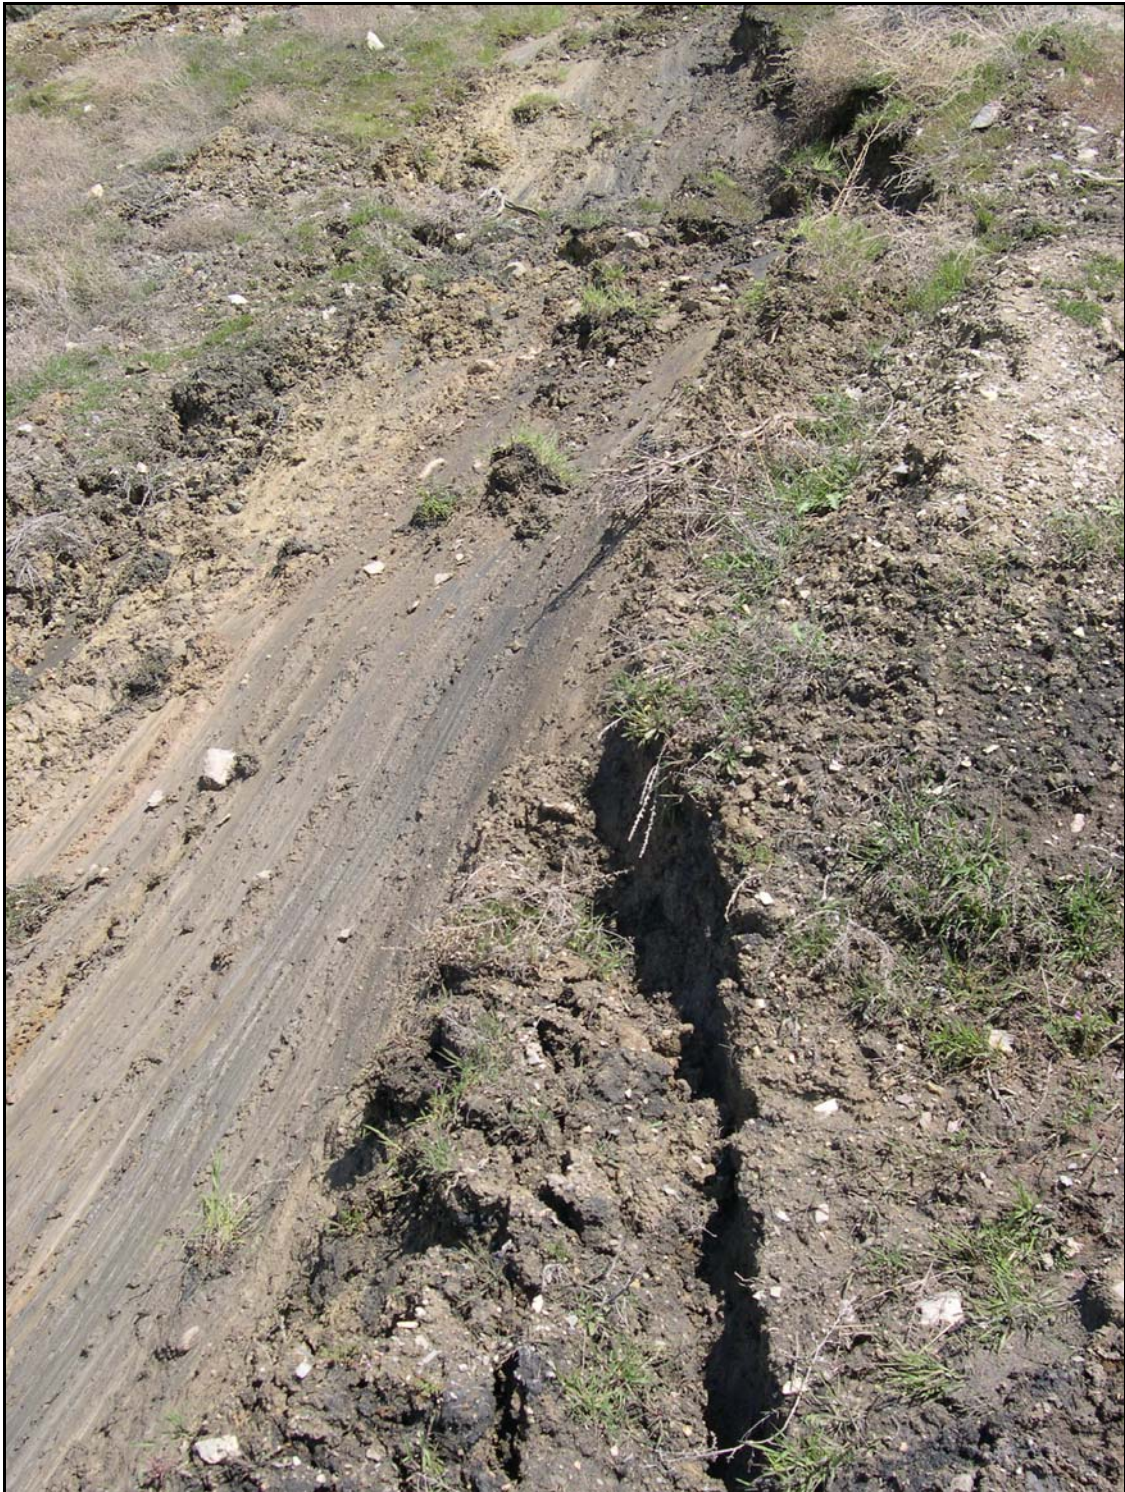
**Figure 7.** View of slickensides in the upper, shallow part of the landslide.

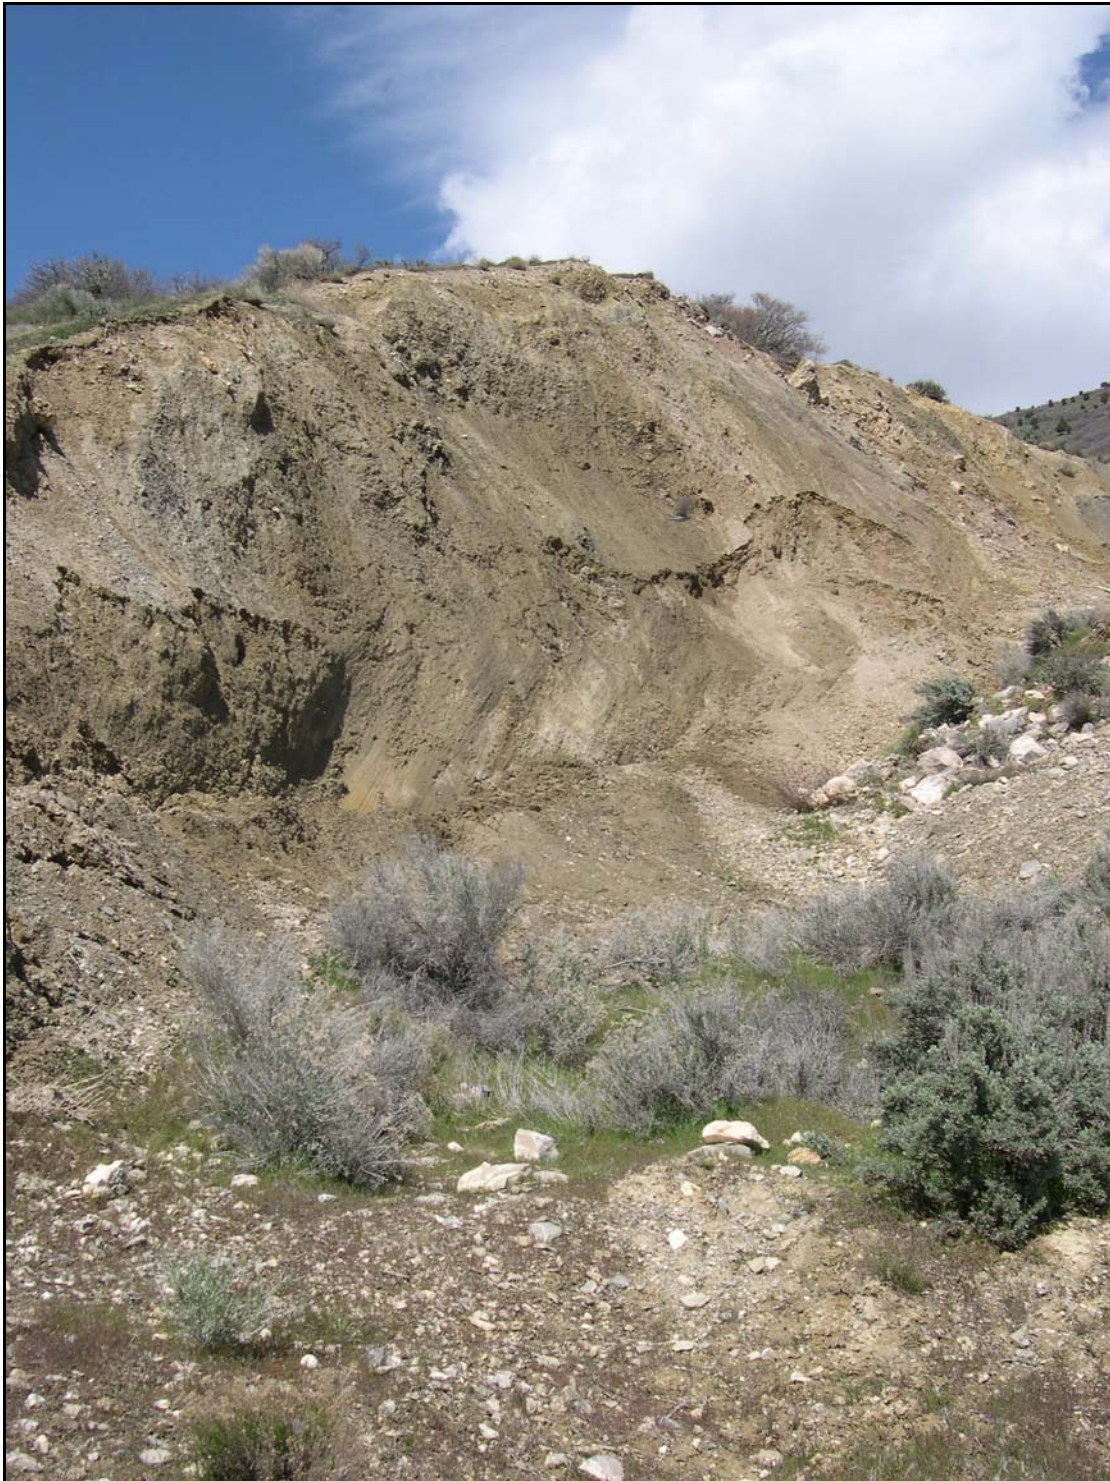
**Figure 8.** View of south-facing scarp along north edge of landslide on April 29, 2005. The upper part of the scarp is from movement of the slide in 1983. The lower nearly vertical part is from movement of the Sage Vista Lane landslide in 2005.

The main scarp zone is in the upper narrowest part of the landslide, and on April 29 consisted of several scarps less than 2 feet high in an area of relatively shallow translational landsliding. The main scarp zone joins with the nearly vertical south-facing scarp that bounds the north flank of the 2005 landslide, and that may have been the main scarp of the 1983 slide. On April 29, the combined height of the 2005 and 1983 scarps along the north flank of the landslide was about 40 to 50 feet; the upper 30 to 35 feet representing the scarp of the 1983 event (figure 8). Movement of the landslide caused scarps to form in a colluvial wedge at the base of the 1983 scarp as the colluvium moved downslope on the active part of the slide. The near-vertical scarp suggests that the subsurface geometry of the head of the landslide in a northwest-southeast direction may be asymmetrical with the deepest part being in the northwest part of the head nearest the south-facing scarp.

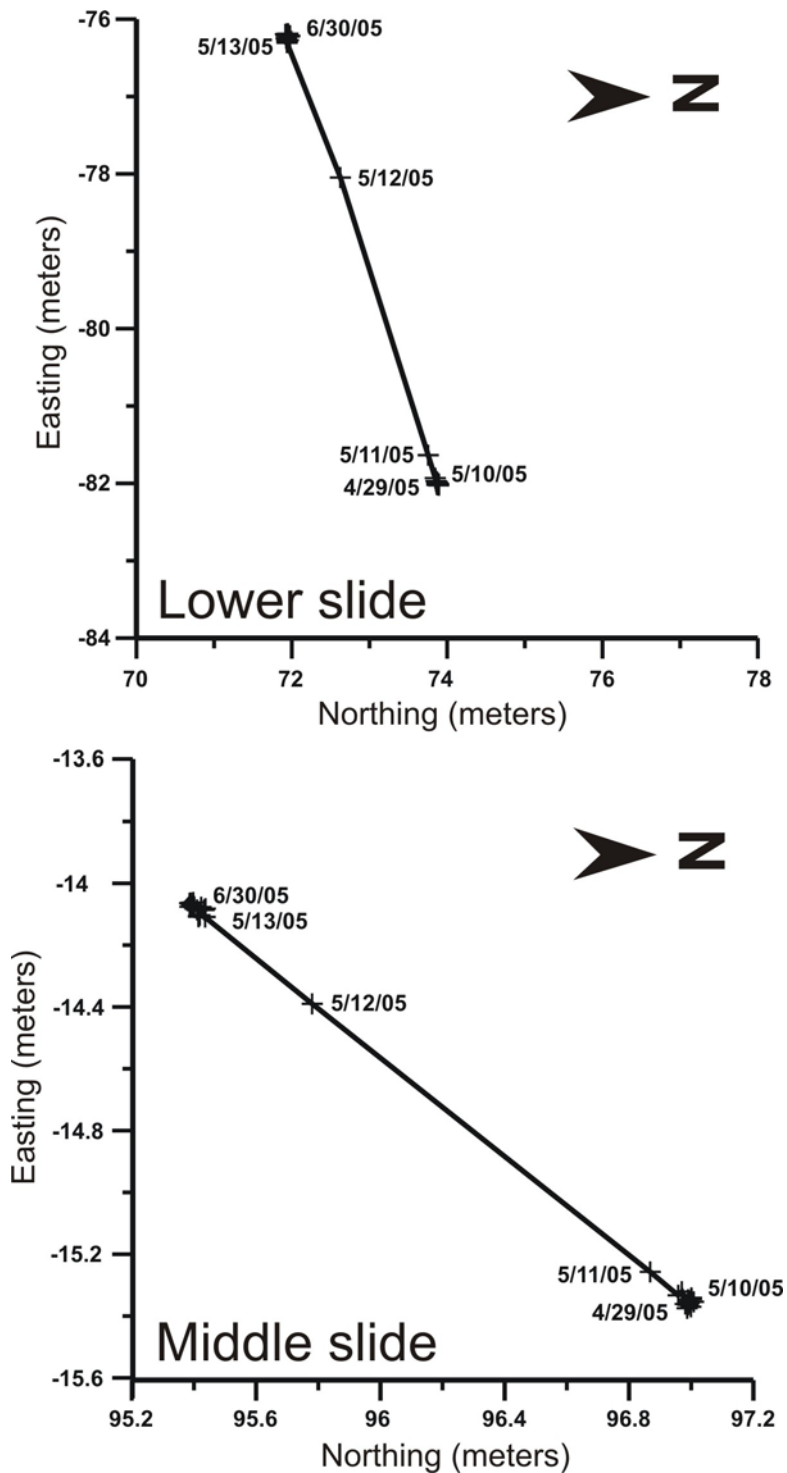
**Figure 11.** Plot showing movement of the lower and middle parts of Sage Vista Lane landslide between April 29 and June 30, 2005. Total movement during the measurement period was about 21 feet (6.4 m) and 7.5 feet (2.m), respectively. Positions of stakes 2 and 3 (see figure 4 for locations) surveyed by Utah County using accurate GPS equipment. Stake coordinates reported in SI units by Utah County.

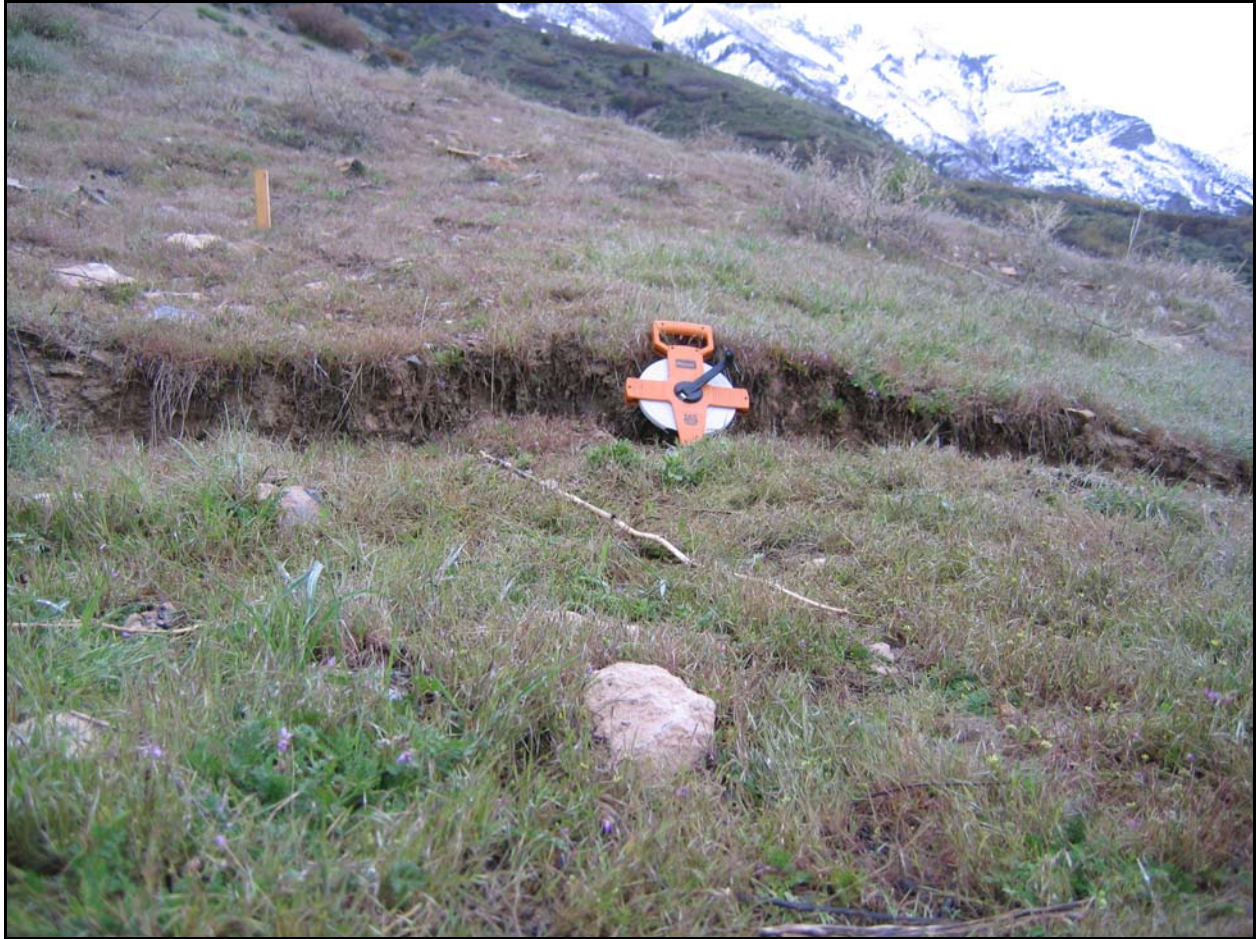
**Figure 13.** View of main scarp of small landslide upslope of main slide on May 12, 2005. By May 5, 2005 another scarp connected this small slide to one farther upslope joining the two slides into a single shallow landslide.

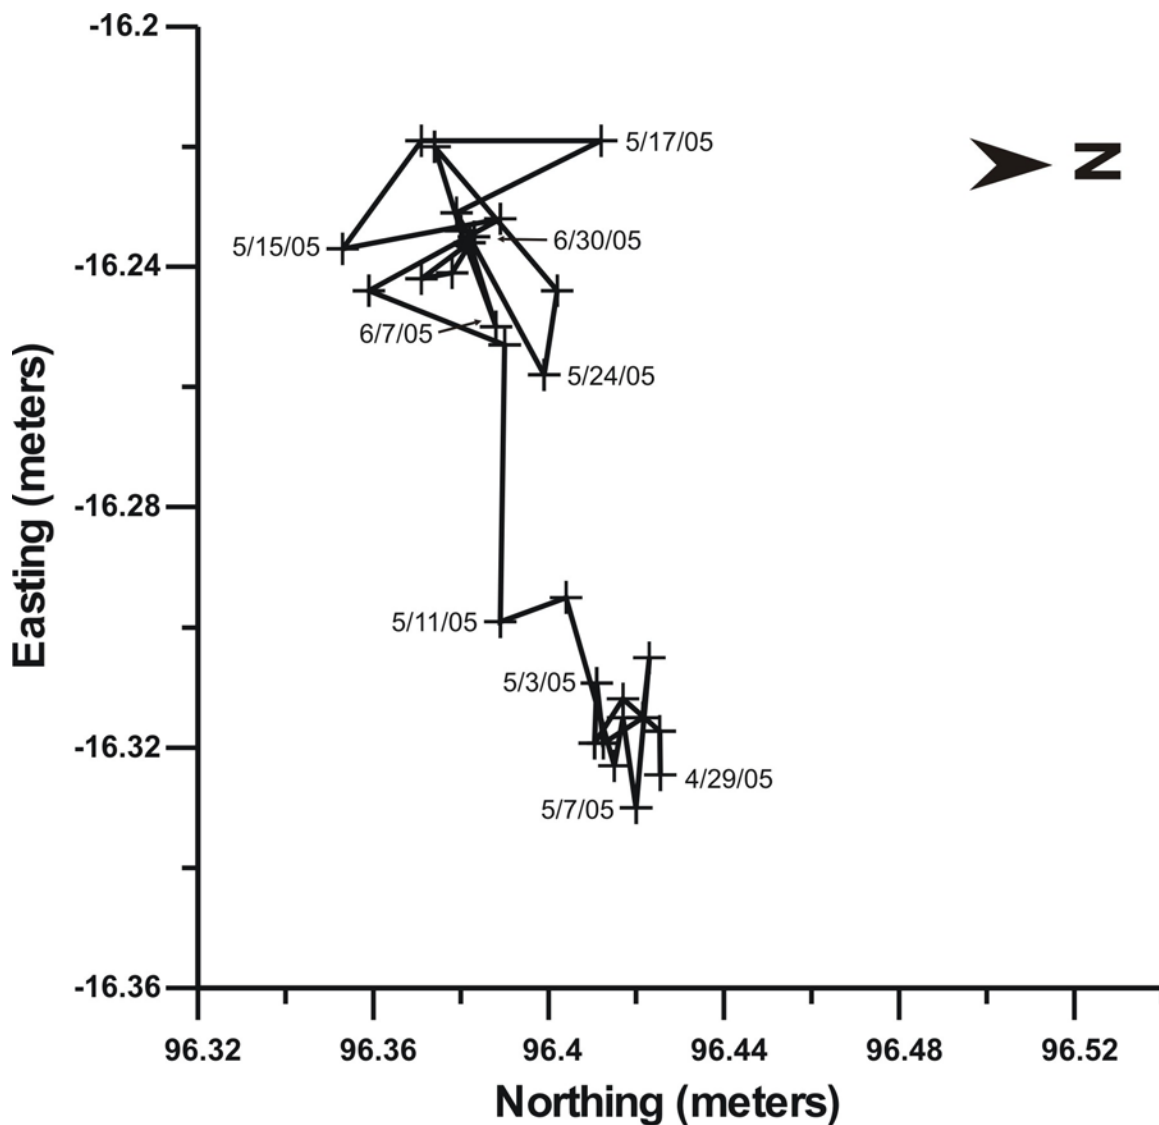
**Figure 15.** Plot showing movement of lower part of upper shallow landslide area above Sage Vista Lane landslide between April 29 and June 30, 2005. Total movement during the measurement period was about 5 inches (13 cm). Positions of stake (see figure 4 for location) surveyed by Utah County using accurate GPS equipment. Stake coordinates reported in SI units by Utah County.
