## **ASSESSING THE STABILITY OF LANDSLIDES - OVERVIEW OF LESSONS LEARNED FROM HISTORICAL LANDSLIDES IN UTAH**

Gary E. Christenson and Francis X. Ashland  
Utah Geological Survey

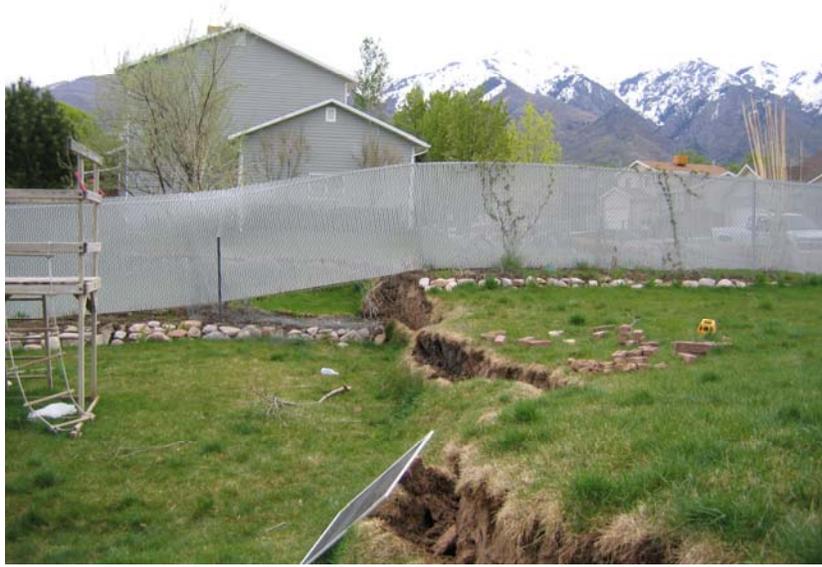
*Figure 5. Main scarp of the 2006 Sunset Drive landslide showing small displacement main scarp in the crown of prehistoric landslide. Photo by Ashley Elliott, UGS.*

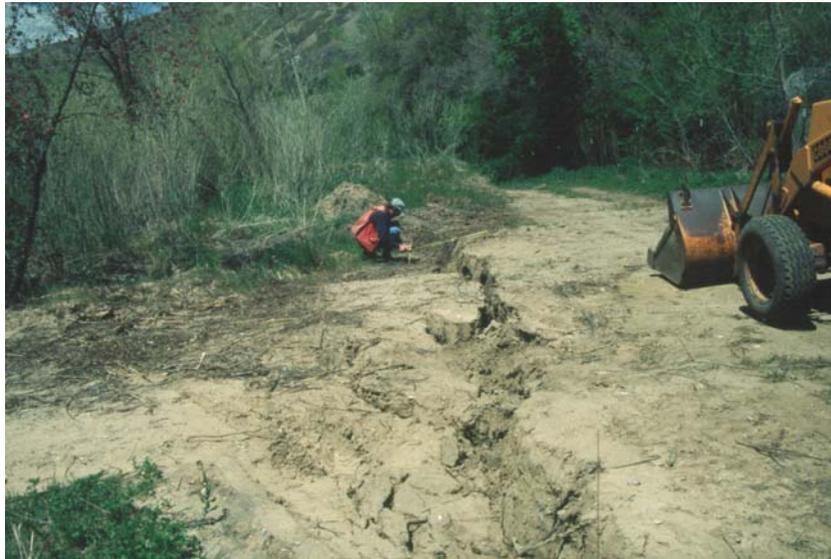
*Figure 6. Scarps in the 1999 Osmond Drive landslide showing small displacements within the older landslide complex.*

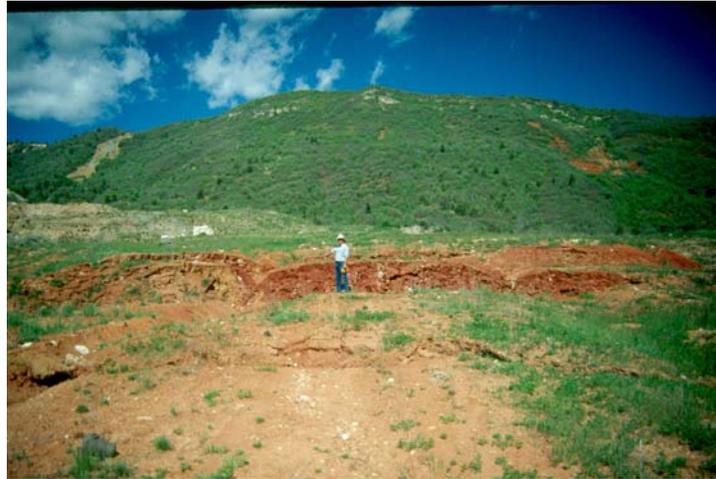
*Figure 7. Toe thrust just above natural buttress in the Thistle landslide caused by 1998 failure in head area.*

Probably the best example of the potential for continued movement in both the upper and lower parts of a naturally buttressed landslide is the 1983 Thistle landslide. In 1983 the landslide blocked Spanish Fork Canyon and became buttressed against rock in the opposite canyon wall. Heavy equipment was used to mechanically compact and flatten the local slopes of the lowermost part of the deposit mainly to reduce the likelihood of failure of the landslide dam (Shuirman and Slosson, 1992), but also to improve the material to act as a buttress. However, in 1983 during the last stages of movement, the lower part of the landslide overthrust the buttress. Movement continued upslope through 1985 (Duncan and others, 1986). Again in 1998, a significant failure in the head caused up to 7 meters of movement just above the buttress as the lower part of the landslide overthrust the buttress (figure 7; Ashland, 2003b). Movement farther

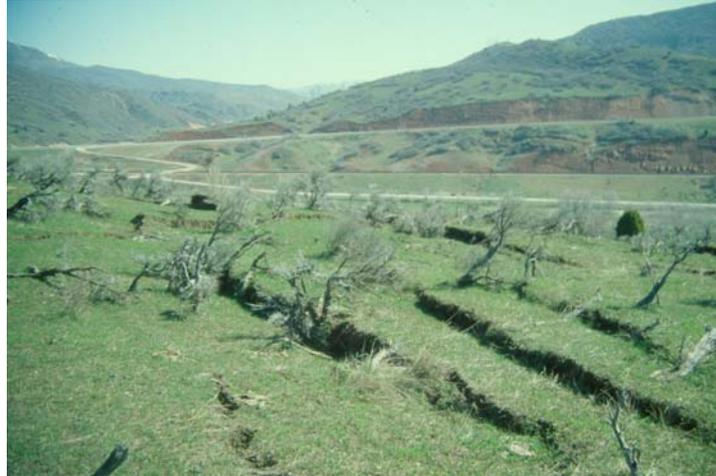
*Figure 8. Deformation in 1998 in lower landslide deposits caused by the 1997 Shurtz Lake landslide.*

The 1997 Shurtz Lake landslide demonstrated how movement in the upper part of a prehistoric landslide complex can induce movement in the lower part. In 1997, several earth flows in the landslide complex were deposited at the base of a bluff (figure 4) atop the lower part of the complex. The lowermost part of the complex showed signs of incipient reactivation by late May 1997 (Ashland, 1997), and in 1998 nearly the entire lower part reactivated, forming a zone of uphill-facing minor scarps, lateral strike-slip shear zones, and a toe thrust system (figure 8). The total amount of movement of the lower landslide locally exceeded 3 meters (Ashland, 2003b) and would have caused extensive damage to any structures built on the lower landslide deposits.

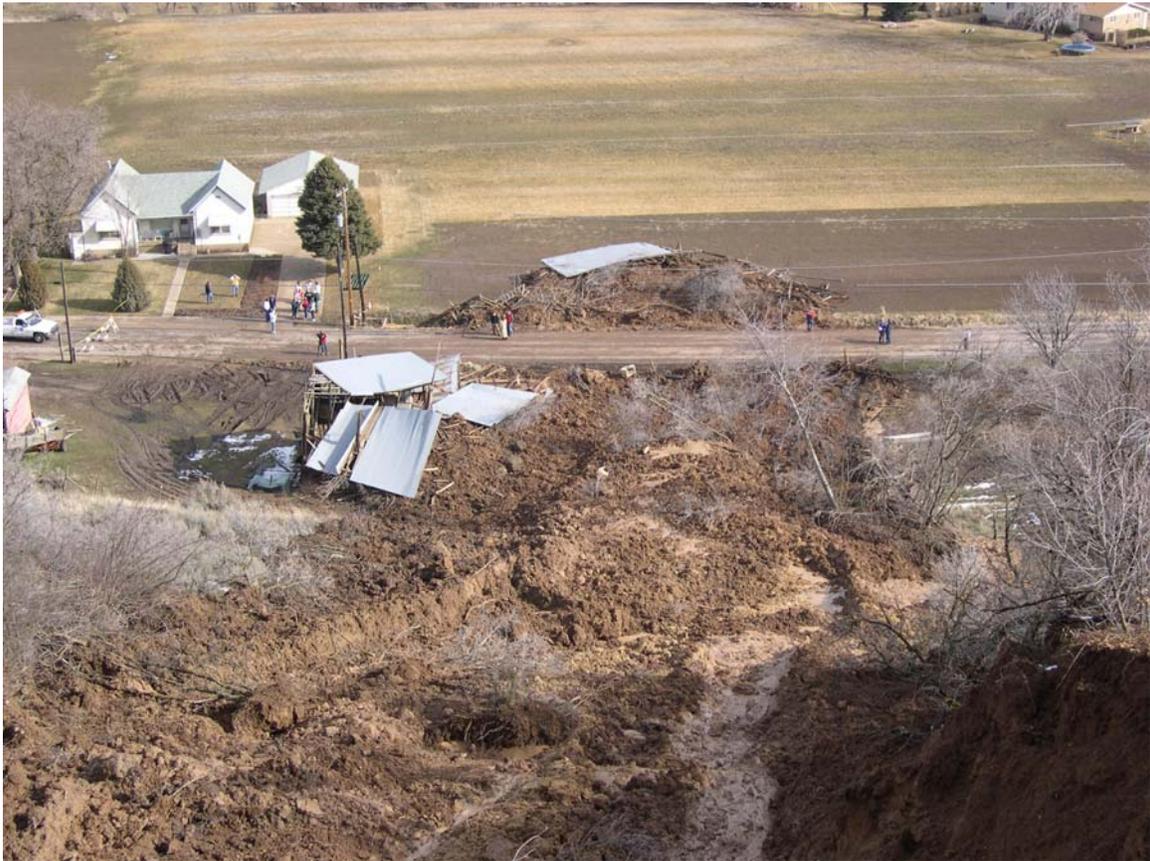
*Figure 10. Toe of the 2005 425 East South Weber landslide that ran out over 50 meters from the base of the slope. Photo by Richard Giraud, UGS.*

Building on or at the base of slopes characterized by landslides also involves predicting future landslide types and runout distances, particularly if rapid flow-type failures are possible. This is especially important because rapid-runout landslides have implications for life safety as well as property damage. Several recent landslides in areas characterized by both slow-moving rotational landslides and rapid, long-runout flow-type movements have demonstrated the importance of considering all likely types of landslides. The bluffs on the north side of the Weber River in the Washington Terrace area of southern Weber County are typically characterized by large, presumably slow-moving coherent rotational slides (Pashley and Wiggins, 1972), but a 1981 landslide in Washington Terrace (Gill, 1981) was a large, rapid, disrupted complex earth slide-earth flow that ran out a sufficient distance to knock a Union Pacific train off the tracks below the landslide and into the Weber River. Likewise, in the bluffs on the south side of the Weber River in South Weber, the 425 East South Weber Drive landslide in 2005 (figure 10; Giraud, 2005) and the 1650 East South Weber landslide in 2006 failed as rapid, shallow, long-runout slides and flows.

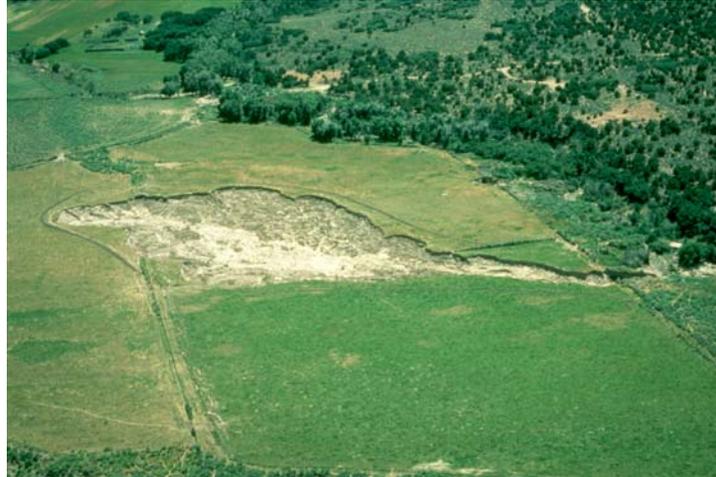
*Figure 11. Evacuated area in alluvial-fan deposits along Gooseberry Creek in 1983 resulting from non-earthquake-induced liquefaction.*

Similar flow-type failures have occurred due to non-earthquake-induced liquefaction in granular alluvial-fan deposits at very low slope angles of less than 4 degrees (7%) (Larrabee, 1984). During the record spring snowmelt in 1983, a flow failure in alluvial-fan deposits along Gooseberry Creek, a southern tributary to Salina Creek in Sevier County east of Salina, likely resulted from liquefaction caused by high

pore pressures which were heightened by infiltration from an unlined canal above the failure (figure 11).
